January 6, 2005

Subject: Changes to Alabama's Particulate Monitoring Network

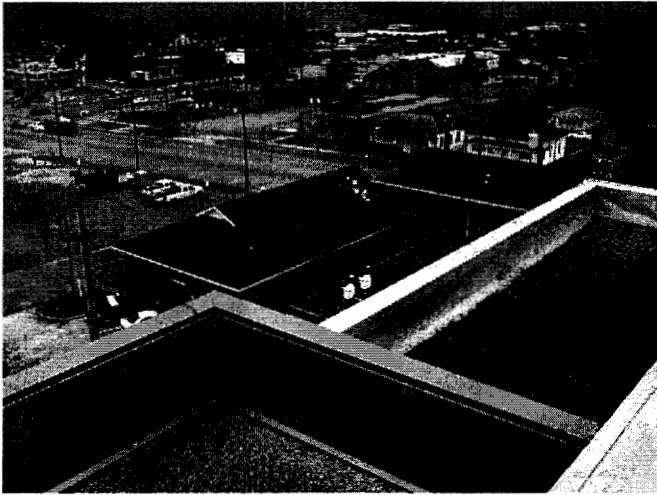
During US EPA visits to the site Mr. Burger and yourself indicated that the monitor placement may be unduly influenced by its proximity to buildings and the Russell County Courthouse parking lot. It was suggested that a better location would have been on the roof of the adjacent courthouse building. ADEM has been in contact with the County Administrator and inspected the courthouse roof. ADEM has determined that the roof location is feasible and agrees that the monitors should be relocated to this area. This would be a move of approximately 50 meters and would give an unobstructed siting of the area this monitor is intended to represent. Please see the attached photos of the two locations. ADEM is making arrangements to accomplish this move and would like to begin sampling at the new location in the beginning of January 2005.

Figure 1 view of existing site from courthouse roof

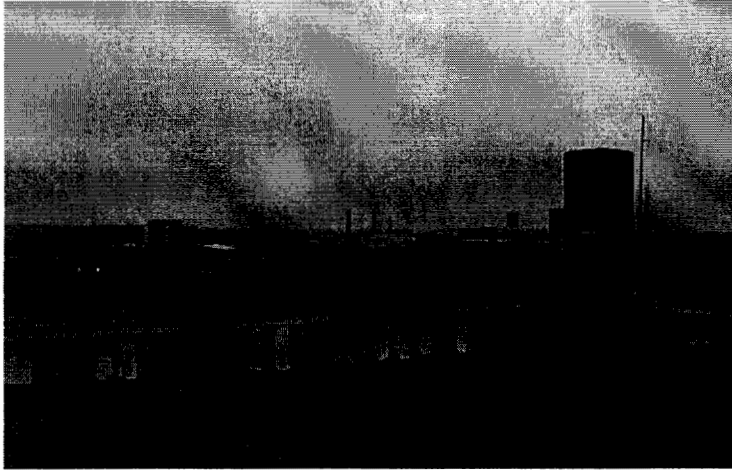
Figure 1 Roof view facing Southeast
