**HUDSON RIVER PCBs SUPERFUND SITE  
ARCHAEOLOGICAL DATA RECOVERY OF  
UNDERWATER RESOURCE U-2**

*Prepared for:*  
General Electric Company  
Albany, New York

URS Corporation  
200 Orchard Ridge Drive, Suite 101  
Gaithersburg, Maryland 20878  
301-258-9780

SEPTEMBER 2011

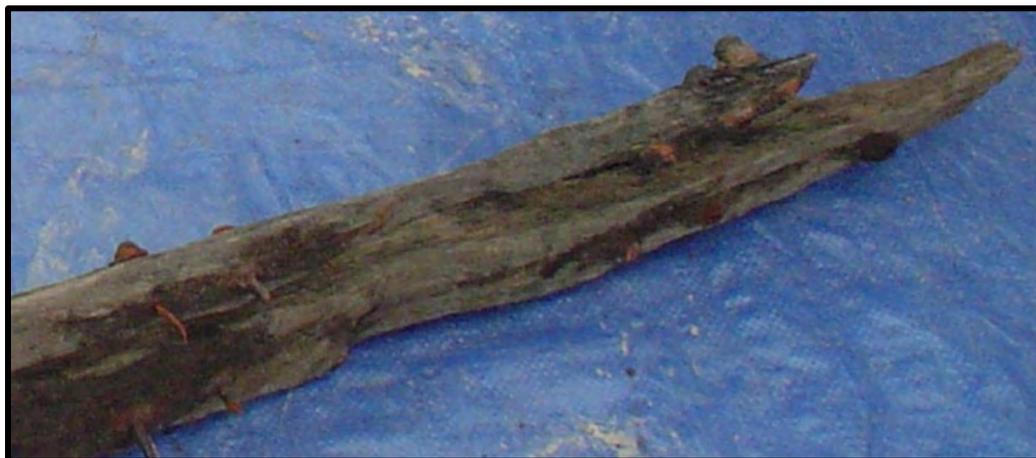
Figure 6-1. The Deteriorated Terminus of Frame 7.

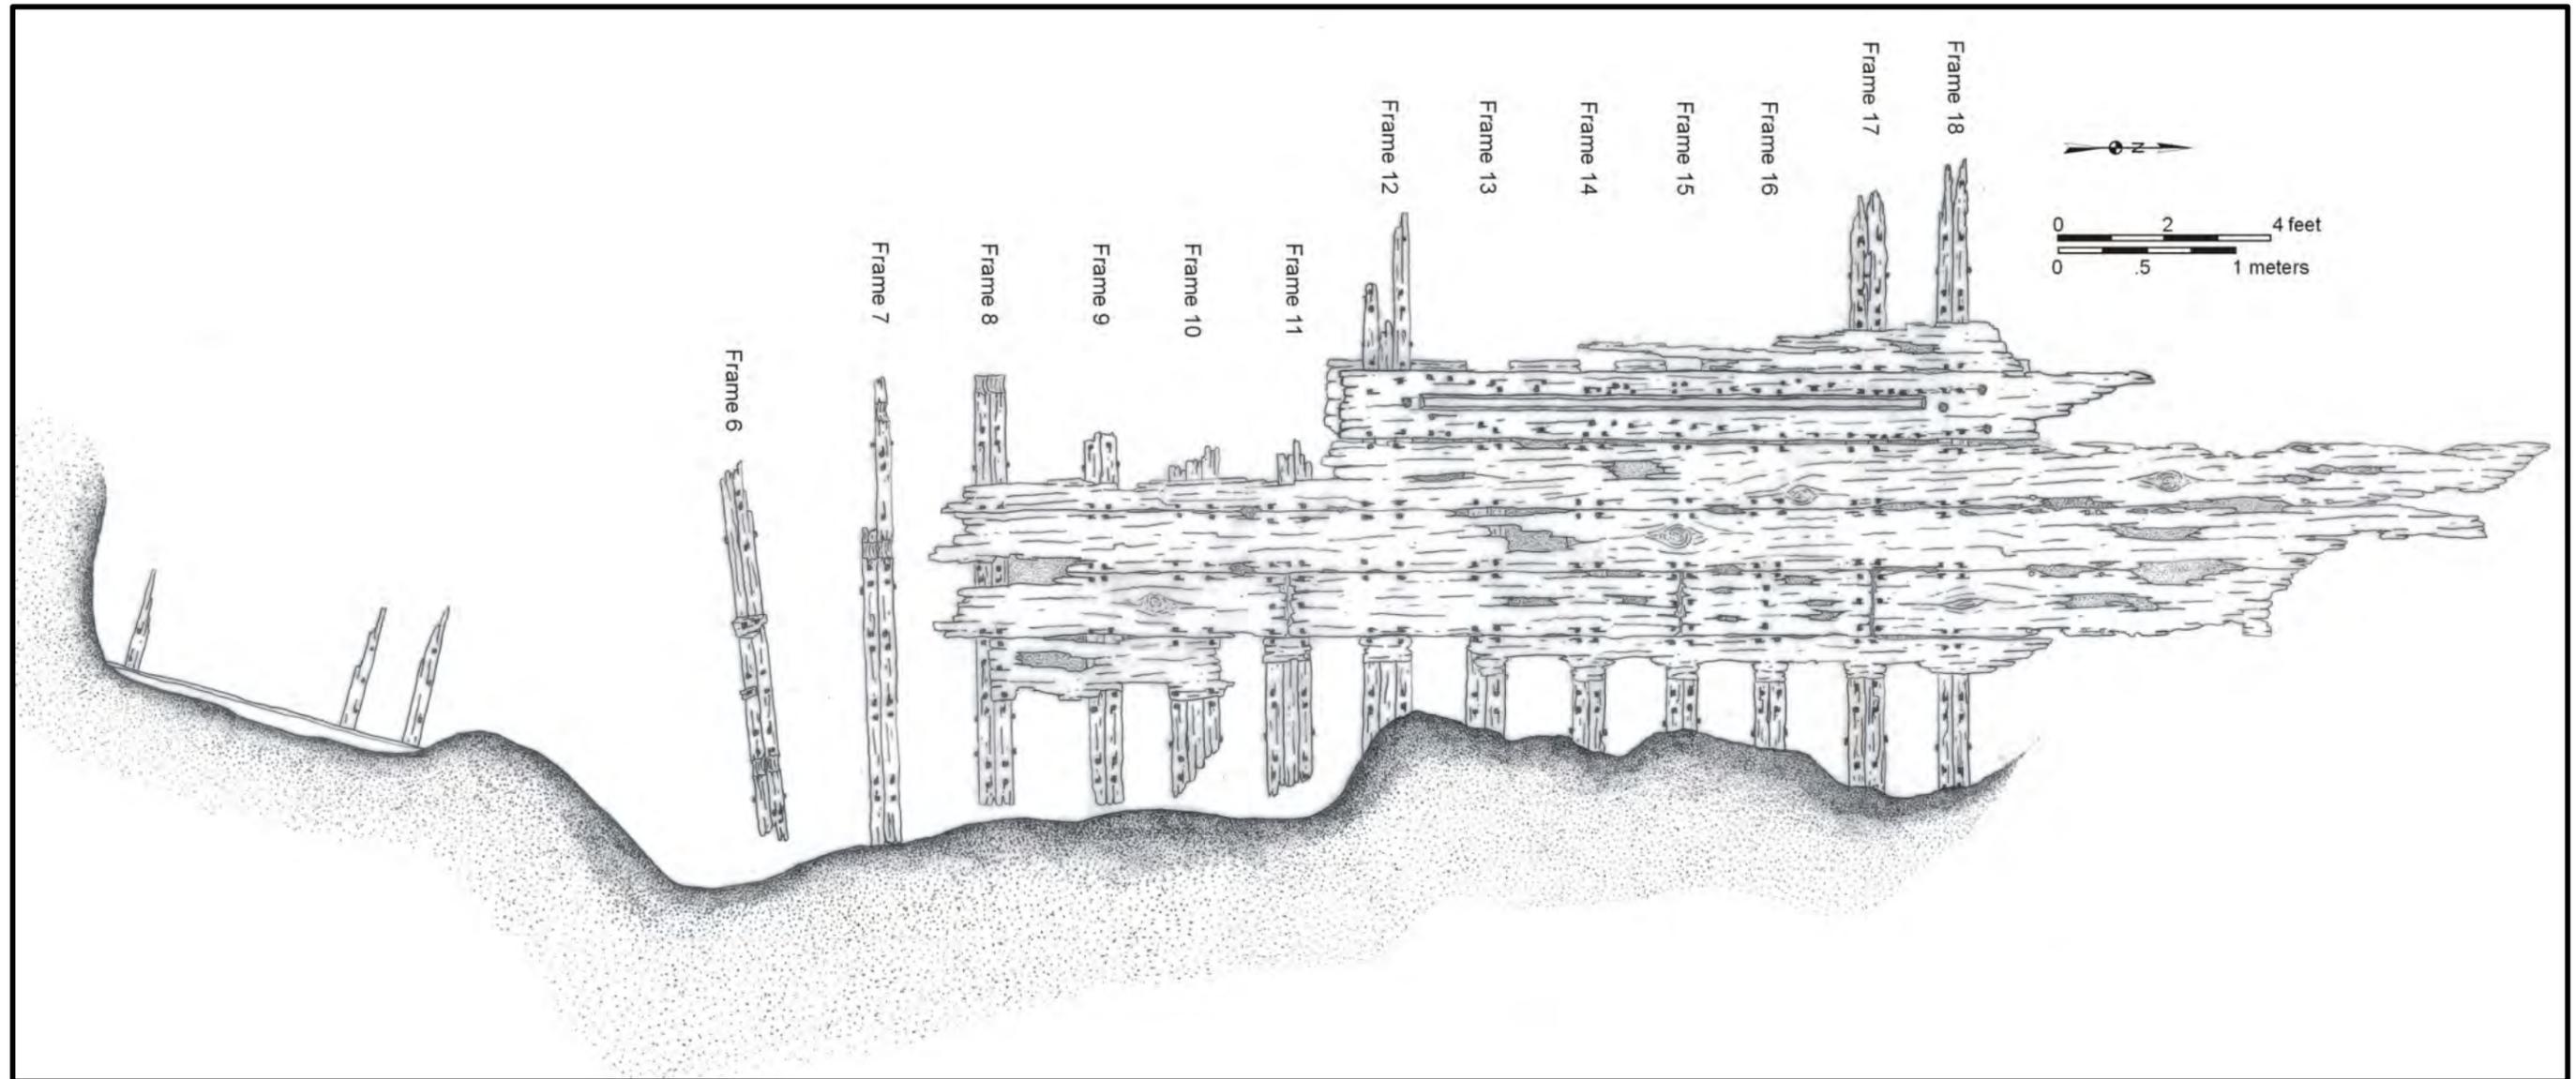
Figure 6-2. Overall Site Plan of U-2, as of May 2009

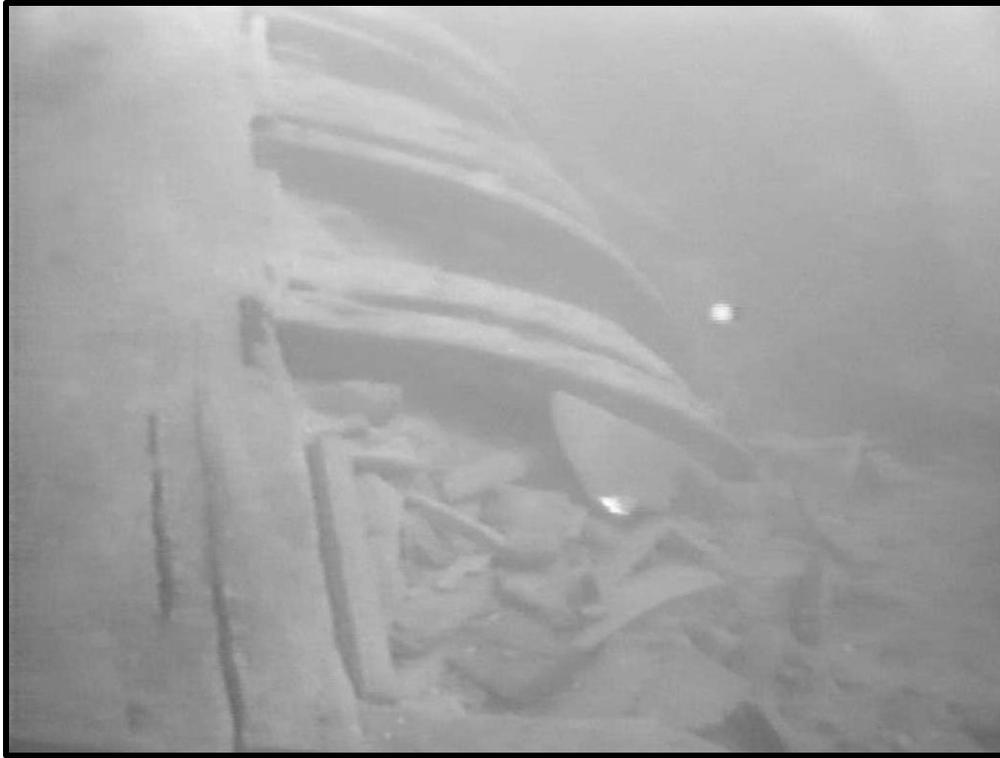
The frames of U-2 were flat bottomed with an abrupt turn of the bilge that quickly formed straight, parallel sides (Figures 6-12 to 6-15). They were lightly constructed of white oak and were composed of doubled or tripled floors and futtocks. Both floors and futtocks were curved at the turn of the bilge. Basic wood grain analysis indicates that the vast majority of curved framing elements were compass timbers, but some curved frame components were further shaped to match the shape of mated pieces.

Figure 6-12. Video Image of Frames 9, 10, and 11 Curving into the Sediment, Facing North.

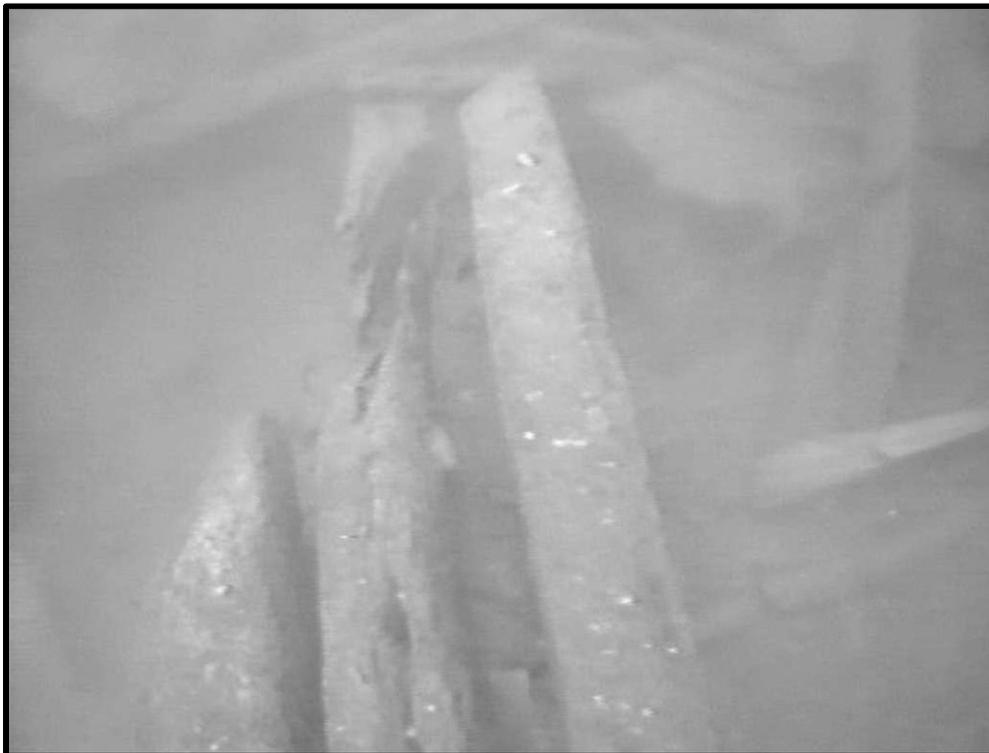
Figure 6-13. Video Image of the Eastern Extreme of Frame 10, Facing East.

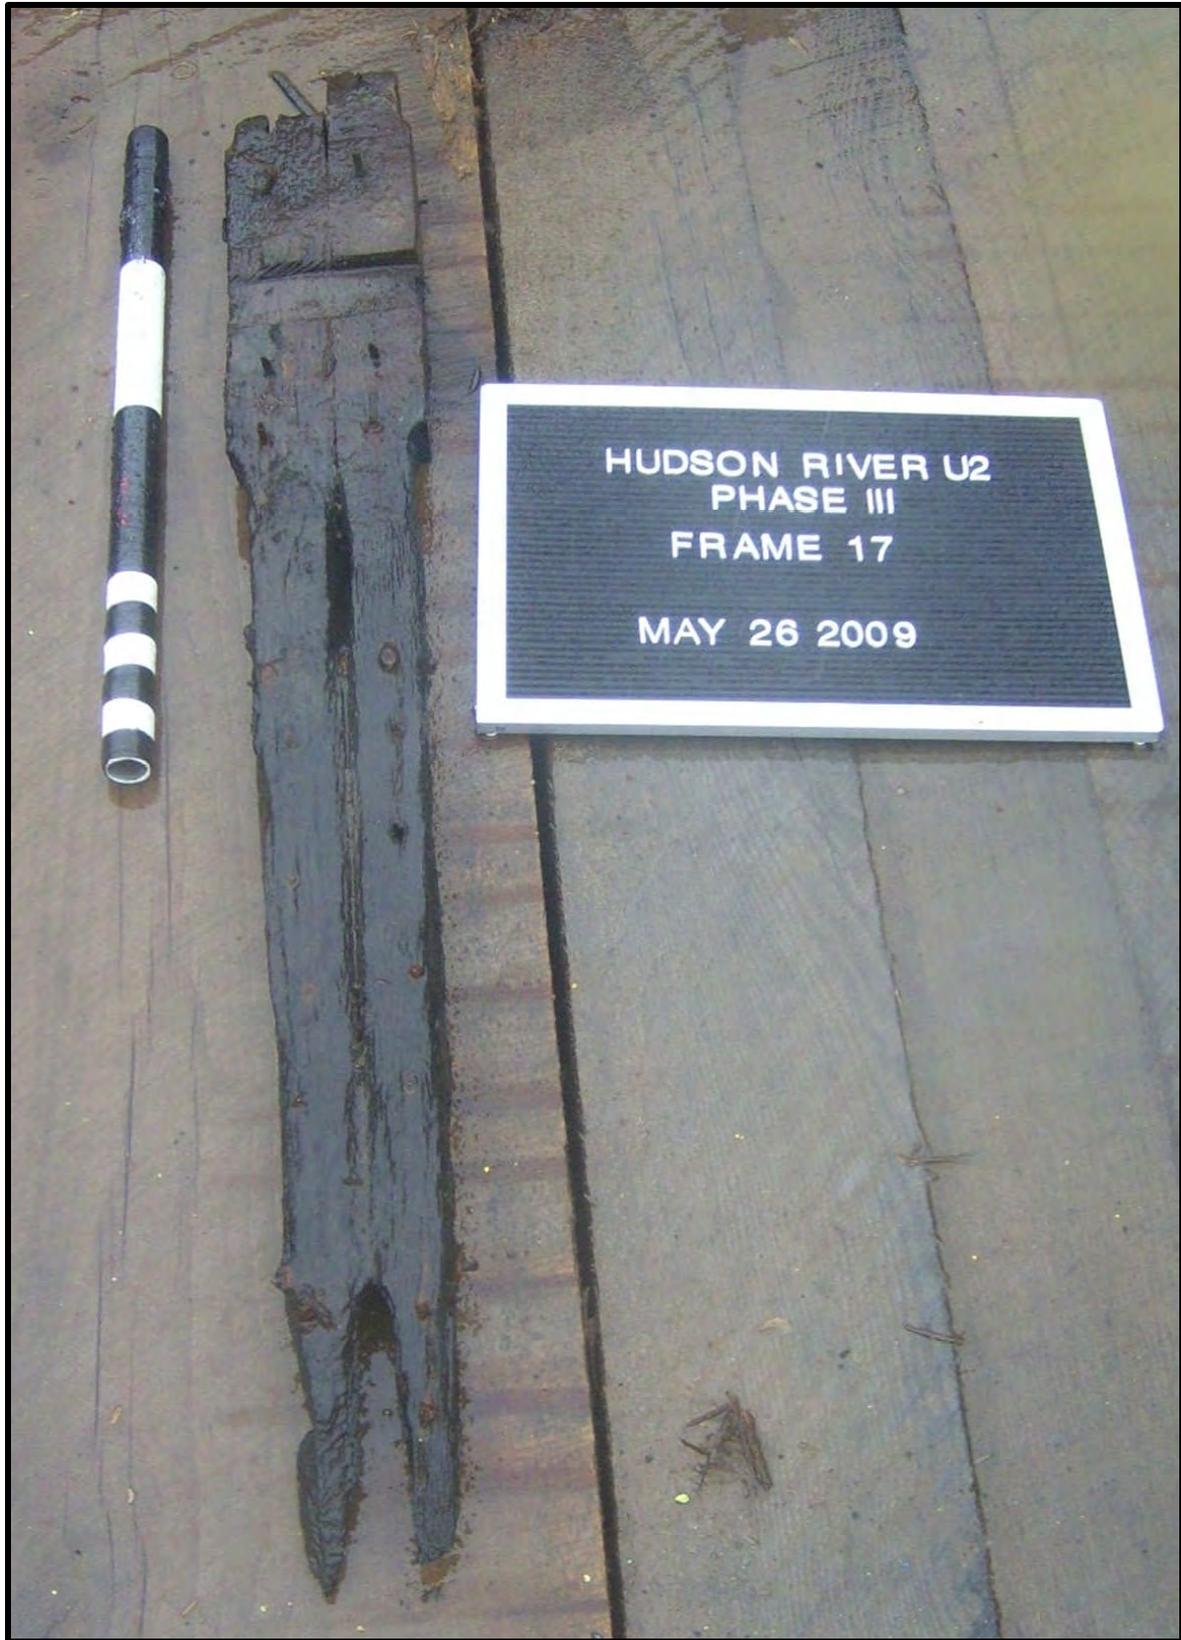
Figure 6-14. Example of a Doubled Floor from Frame 17.

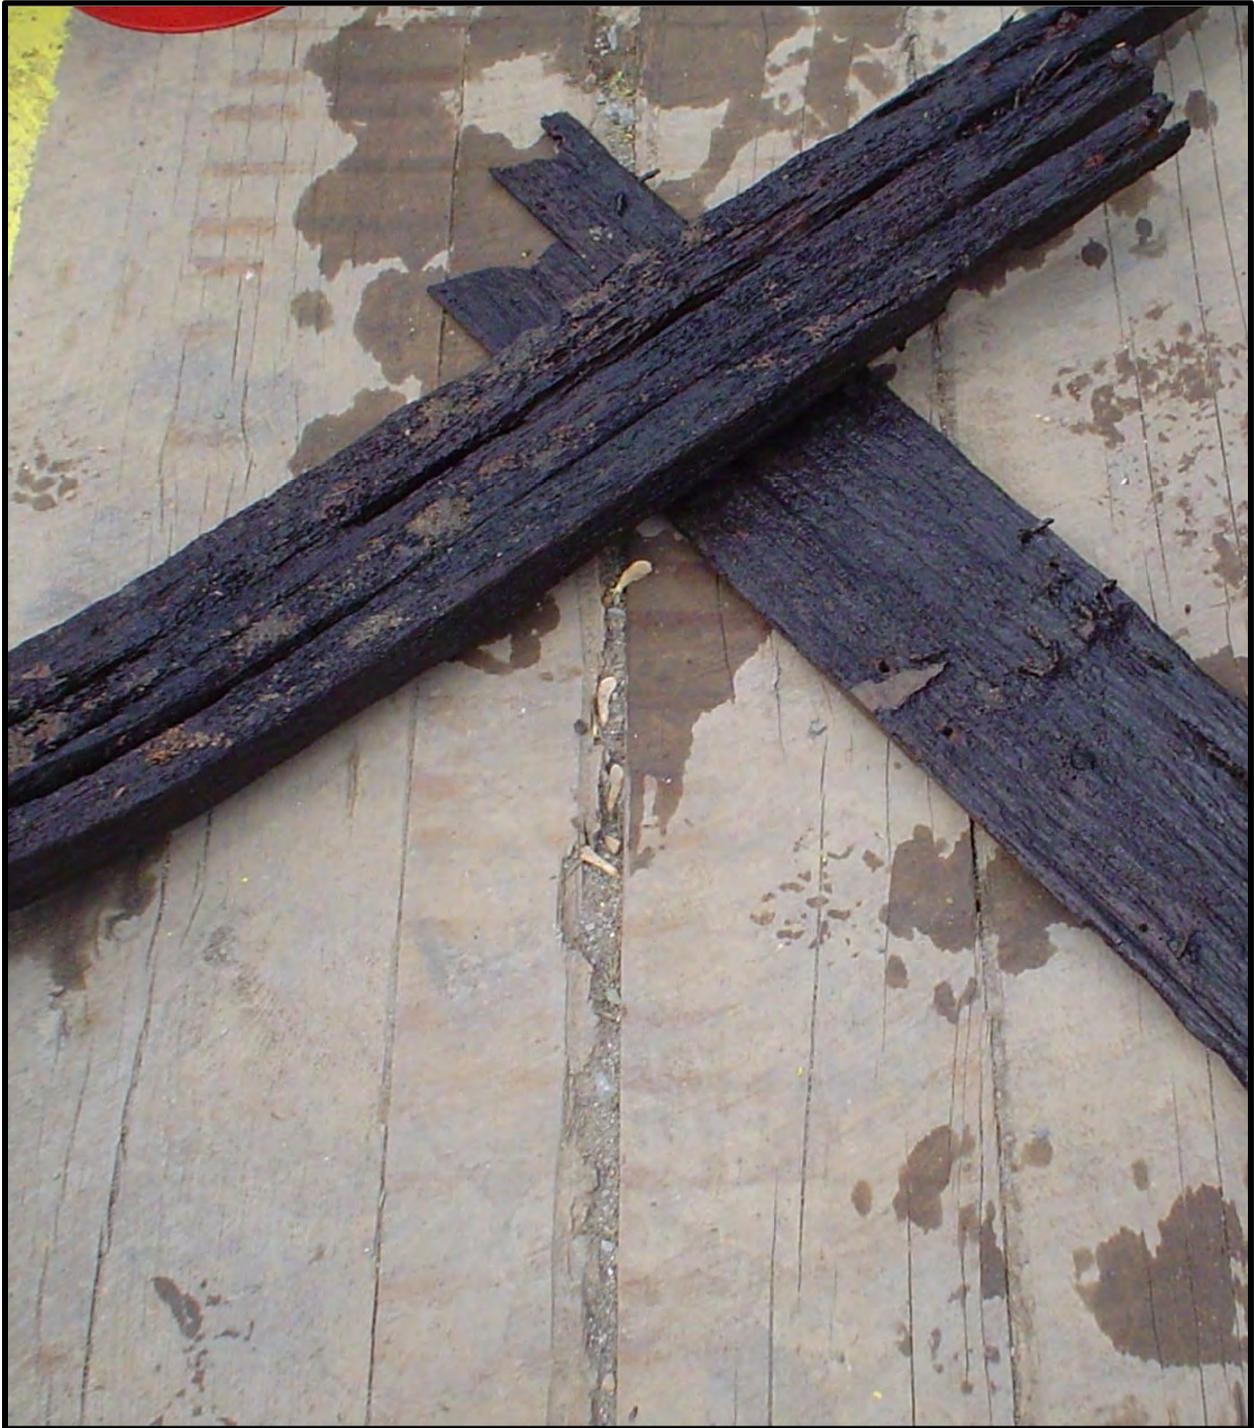
Figure 6-15. Example of a Tripled Floor, Frame 11.

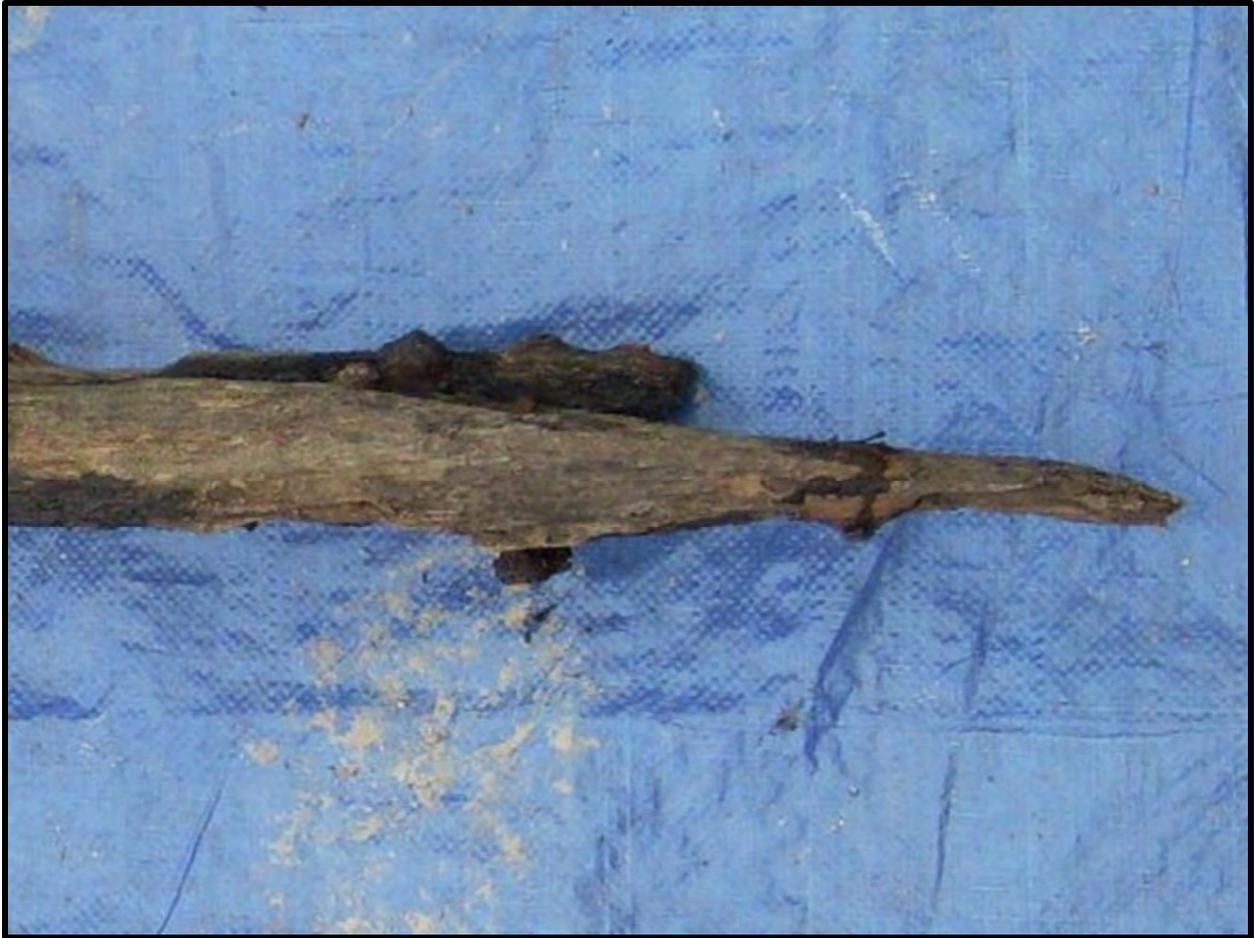
Figure 6-16. Example of a Diagonal Scarf on a Floor Timber.

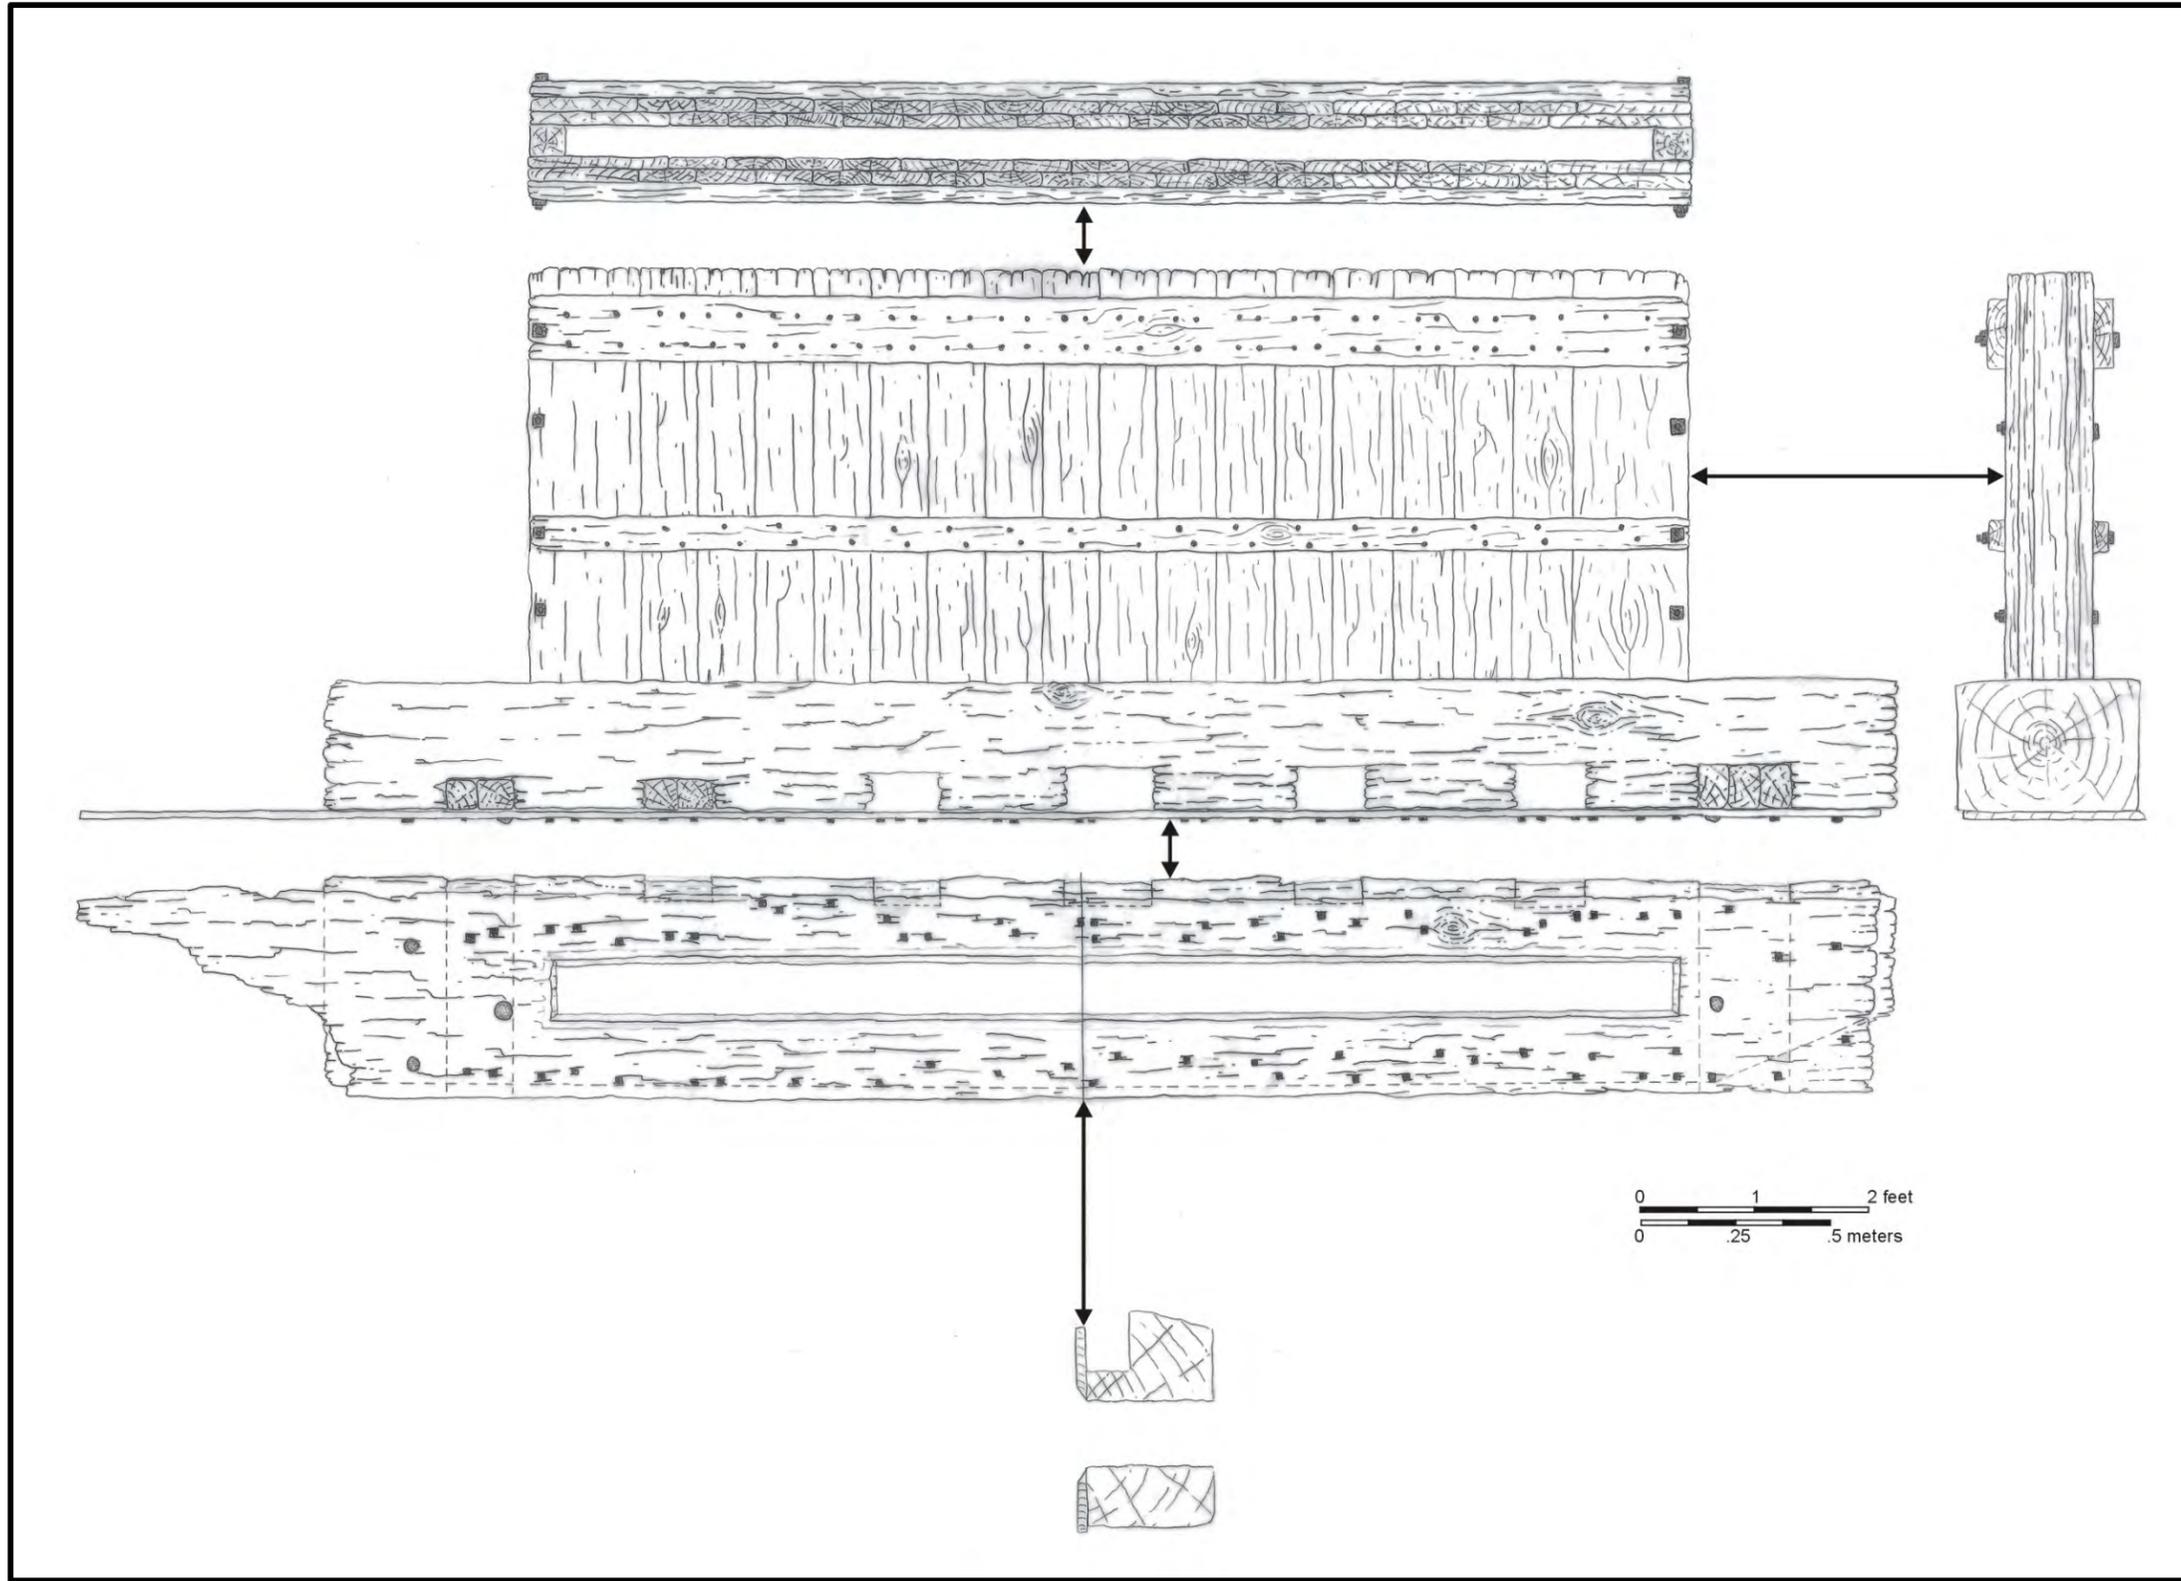
The most diagnostic feature of U-2 is the daggerboard trunk and box assembly (Figure 6-19). A daggerboard, or slip keel, served as a keel that could be raised and lowered through a watertight housing, or box. The board was lowered when sailing in water deep enough to contain it, and was gradually raised as waters became shallower. The daggerboard provided sailors with the flexibility to traverse shoal waters, and also reduce lateral drift when sailing in a more open environment. Boats with this design feature could access shallow ports and pass over dangerous rock outcrops, and could also more efficiently transport goods and people in deeper waters due to less lateral drift. These shallow and deeper water ports are common to the upper Hudson River and Lake Champlain waters in which U-2 operated.

Figure 6-19. Schematic Drawing of Daggerboard Assembly.

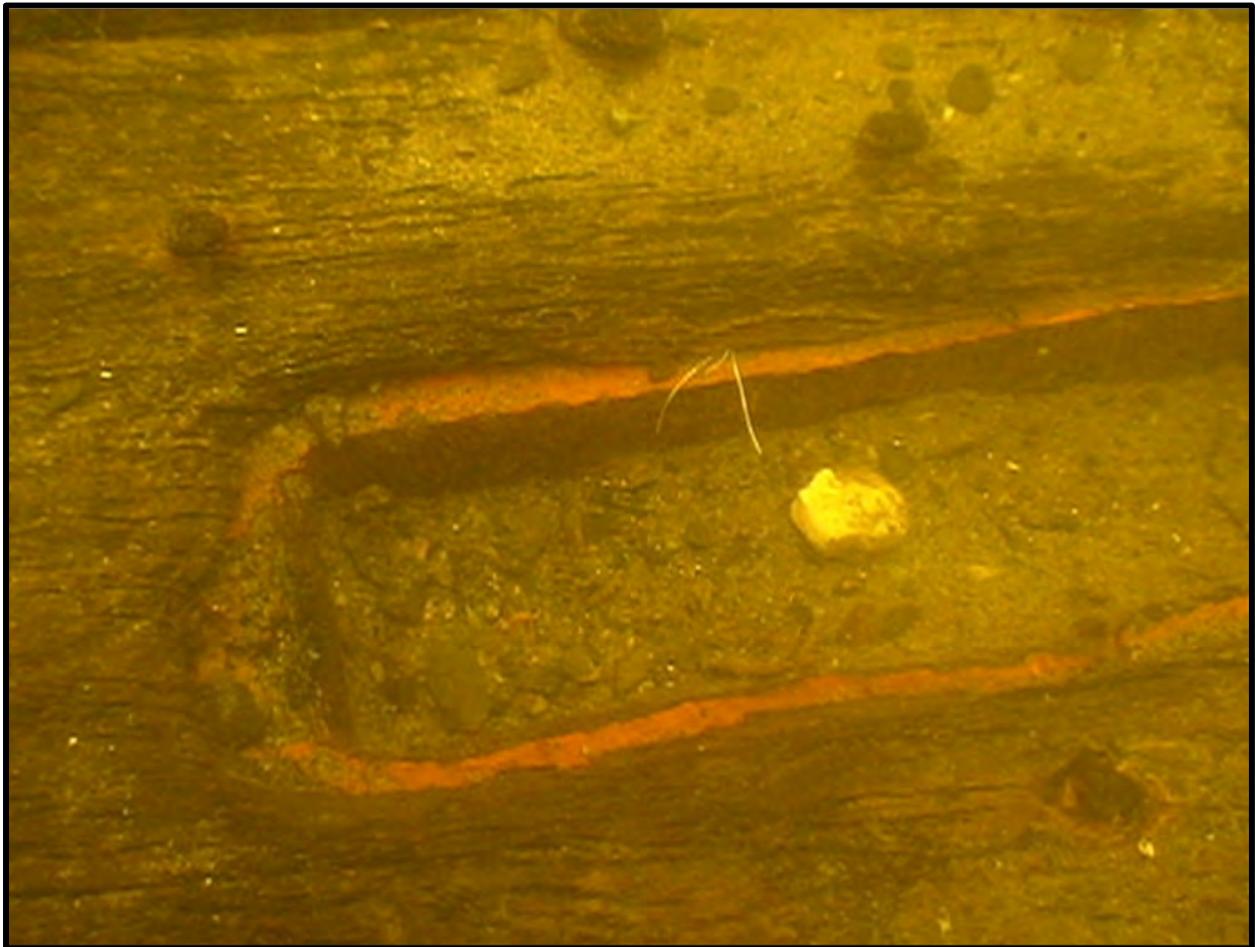
Figure 6-20. Photograph of the Daggerboard Slit taken During the 2005 Phase II Investigations.

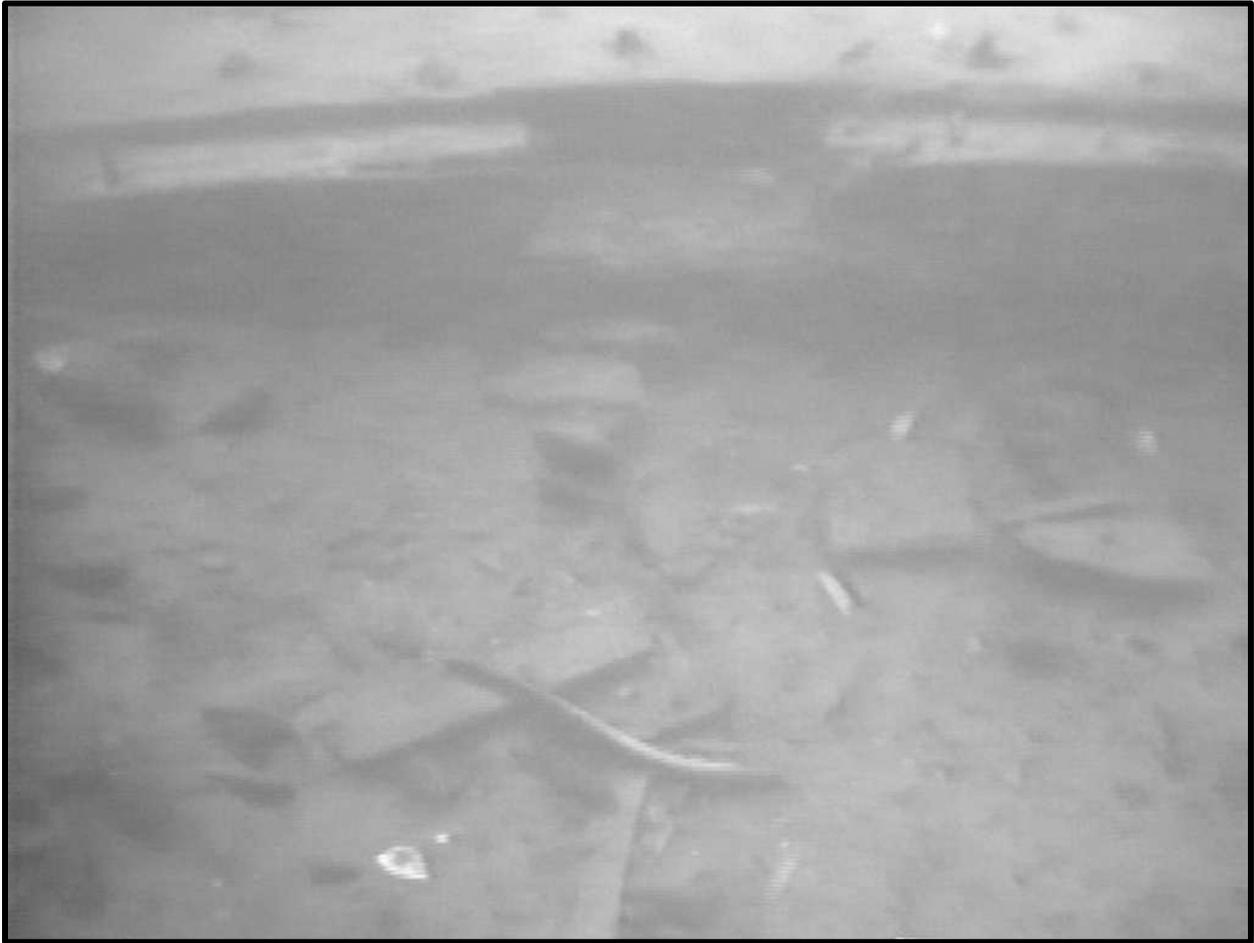
Figure 6-21. Video Image of the Notch of Daggerboard Trunk that Once Housed Frame 14, Facing East.
