# Assessment of Dam Safety

## Coal Combustion Surface Impoundments (Task 3)

Pleasants Power Station

McElroys Run Dam

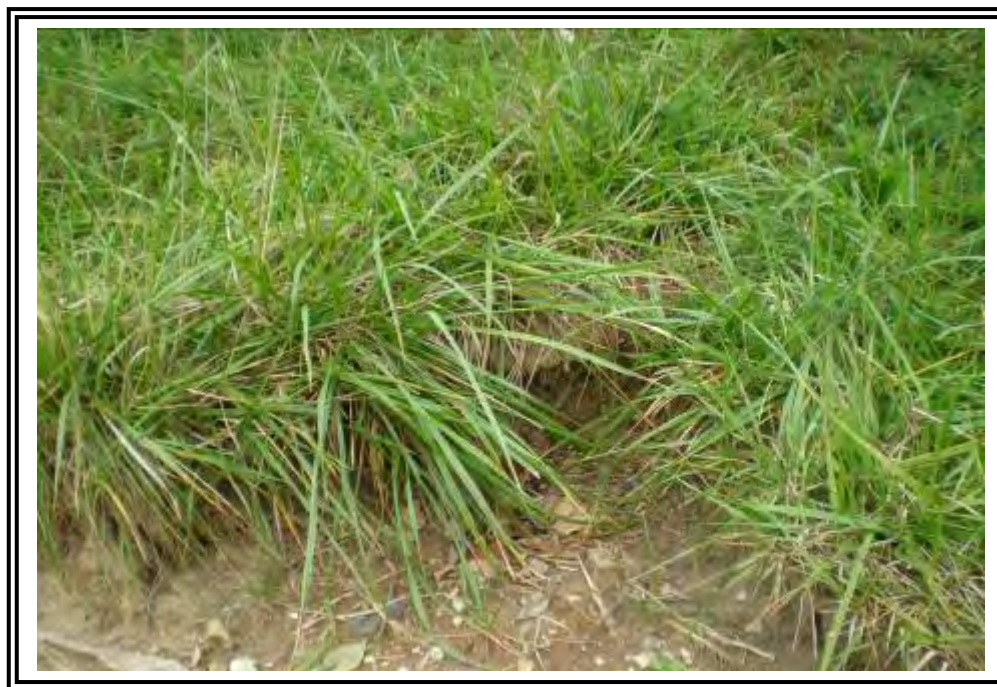
12

Close up of beaching erosion on upstream slope.

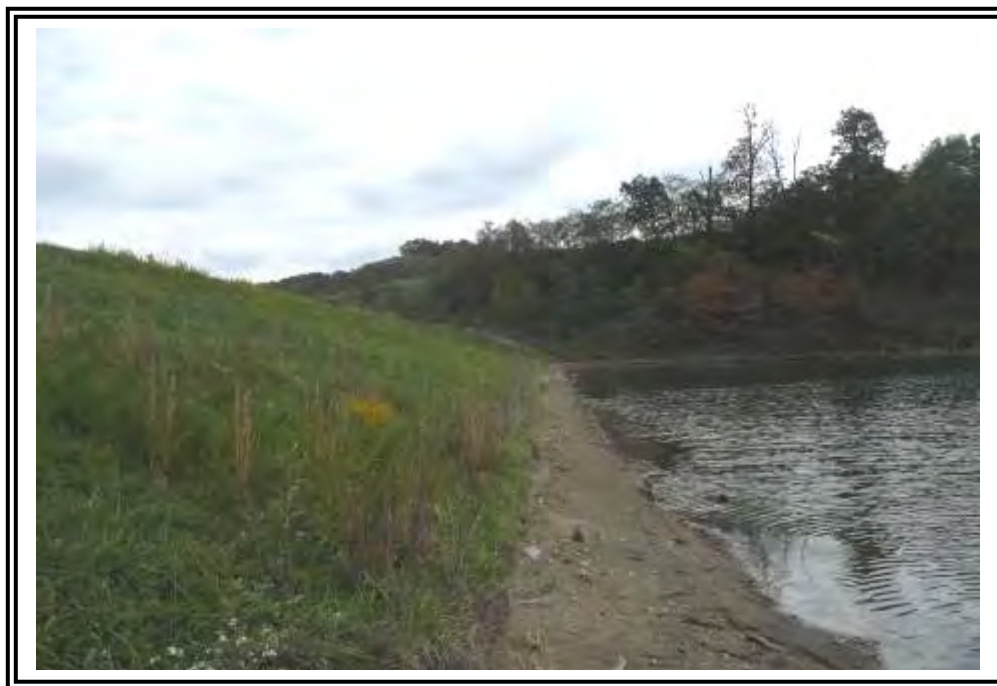
13

Looking east along upstream slope face with another view of the soil exposed below the grass line.

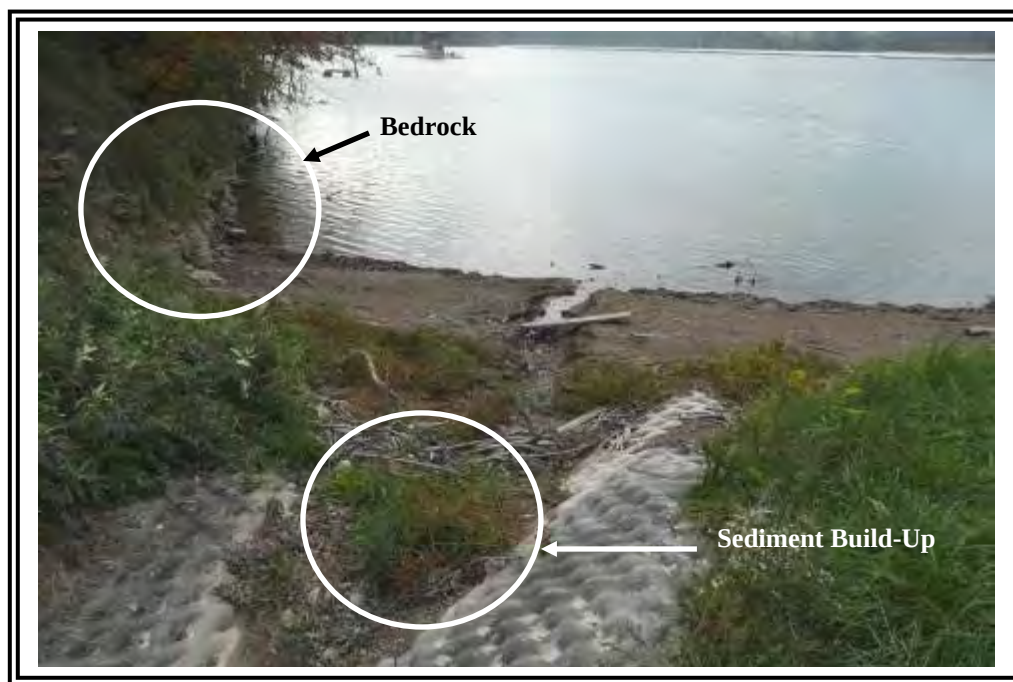
16

Upstream slope right abutment groin looking toward toe and lake.  
Note sediment build-up near end of groin and bedrock exposed to the left of the groin

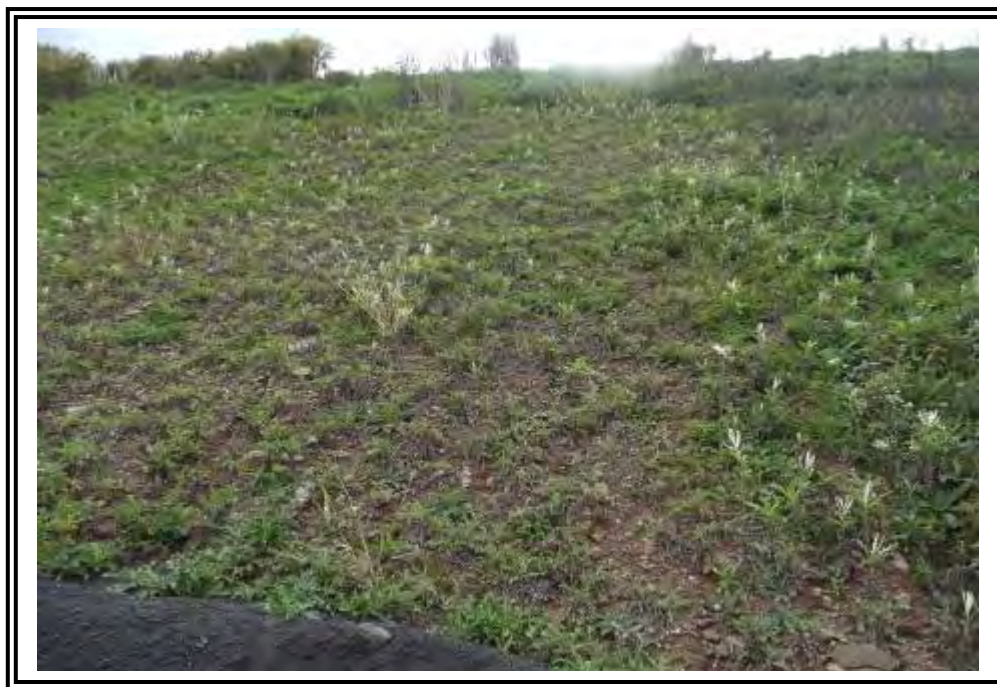
25

Another area of thinning grass cover and potential erosion above bottom ash drainage blanket.

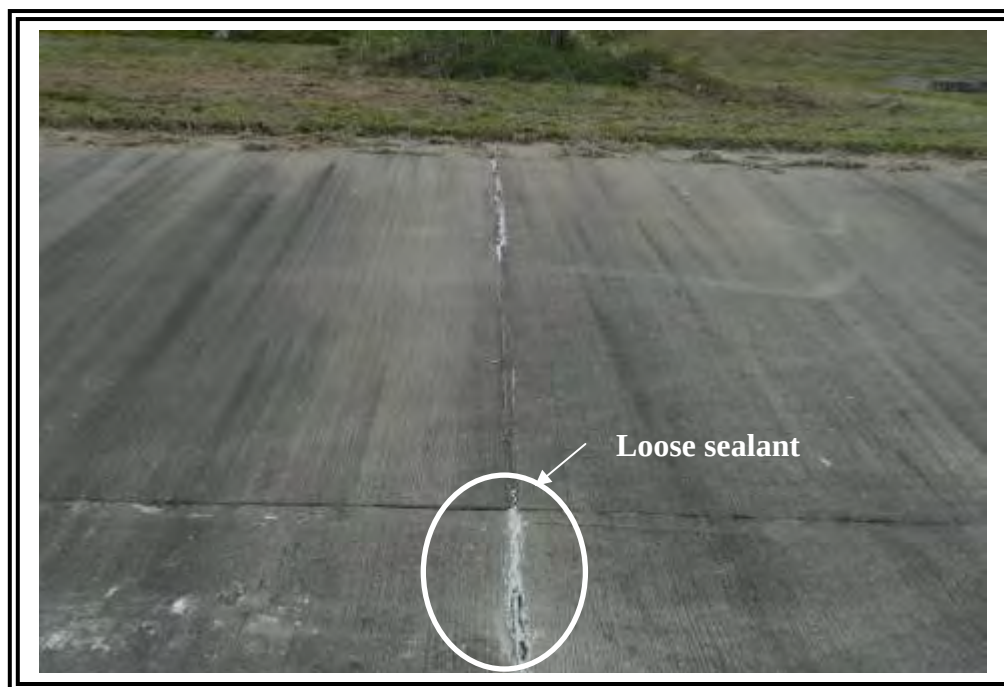
33

To the west of the dam there is a concrete emergency spillway as shown in Photos 31 through 35. The approach to the concrete paving is lined with stone rip rap (Photo 31), and there is grouted riprap protection at the outlet of the emergency spillway as shown in Photo 35. Loose caulk was noted at some of the joints between concrete paving panels as shown in Photo 33.

Expansion and crack control joints in concrete spillway. Note loose sealant in joints.

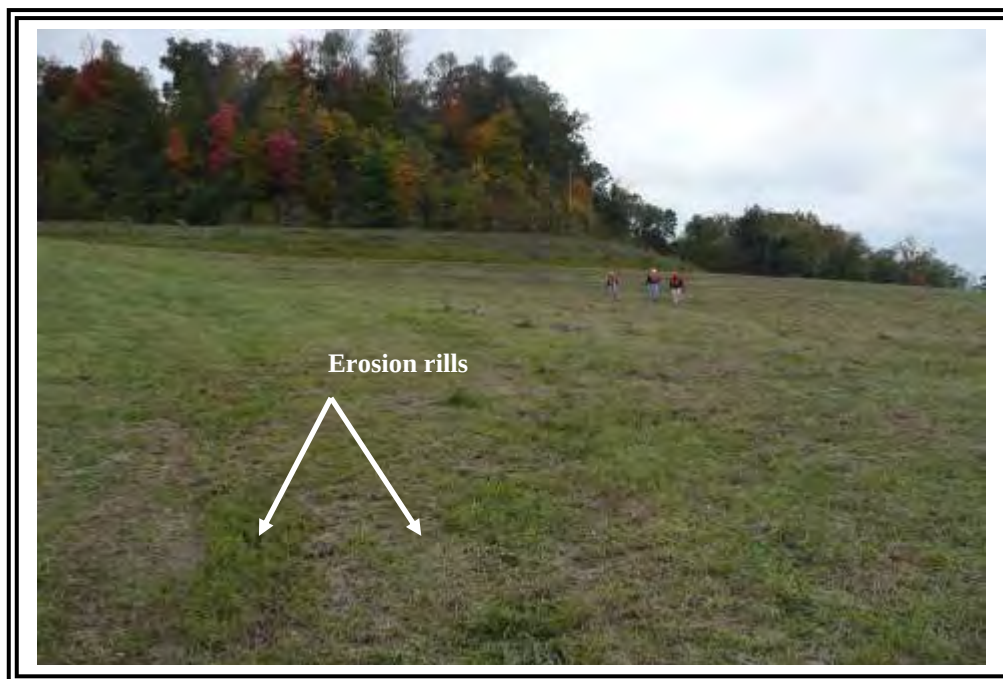
36

Looking west at downstream slope below emergency spillway.  
Grassed erosion rills (slightly darker green areas in grass cover) can be seen in this area.

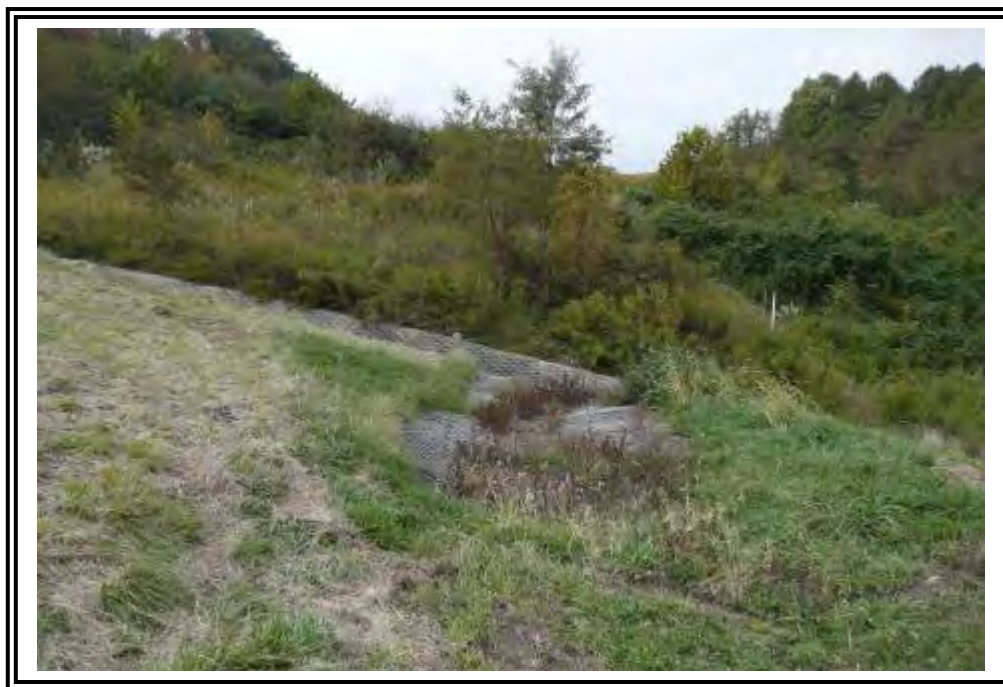
39

Fabric formed concrete lined tie-in from bench (Bench H) to left abutment groin.  
Note vegetation beginning to become established in sediment deposited in ditch over time.

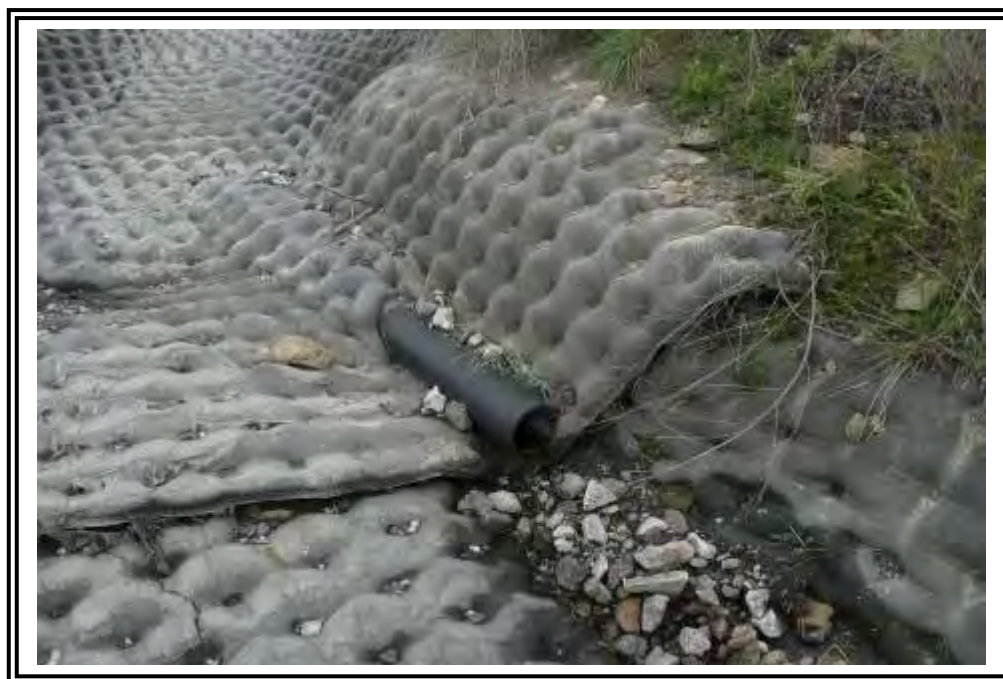
52

6" diameter abutment drain outlet to west (left) abutment groin below active bench; seepage clear. Groin dry above this level.

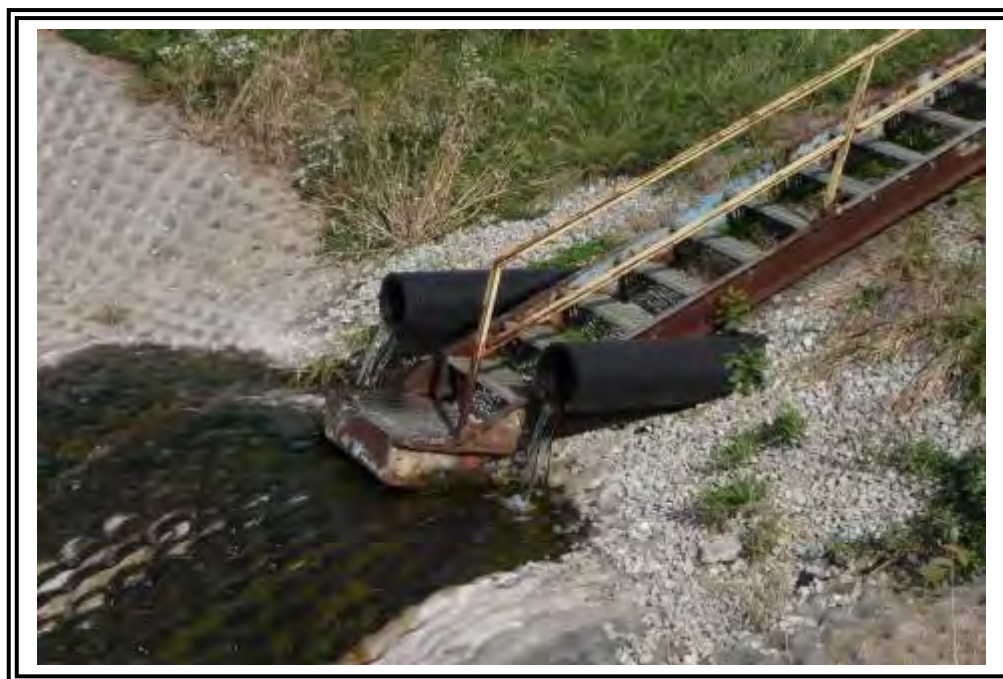
58

Blanket drain seepage collection system outlet. Approximately 36 gallons per minute. Seepage was clear.
