# Dam Safety Assessment of CCW Impoundments

**ALLEGHENY ENERGY COMPANY, LLC  
HATFIELD'S FERRY POWER STATION**

February 27, 2014

Allegheny Energy Company, LLC  
Hatfield's Ferry Power Station

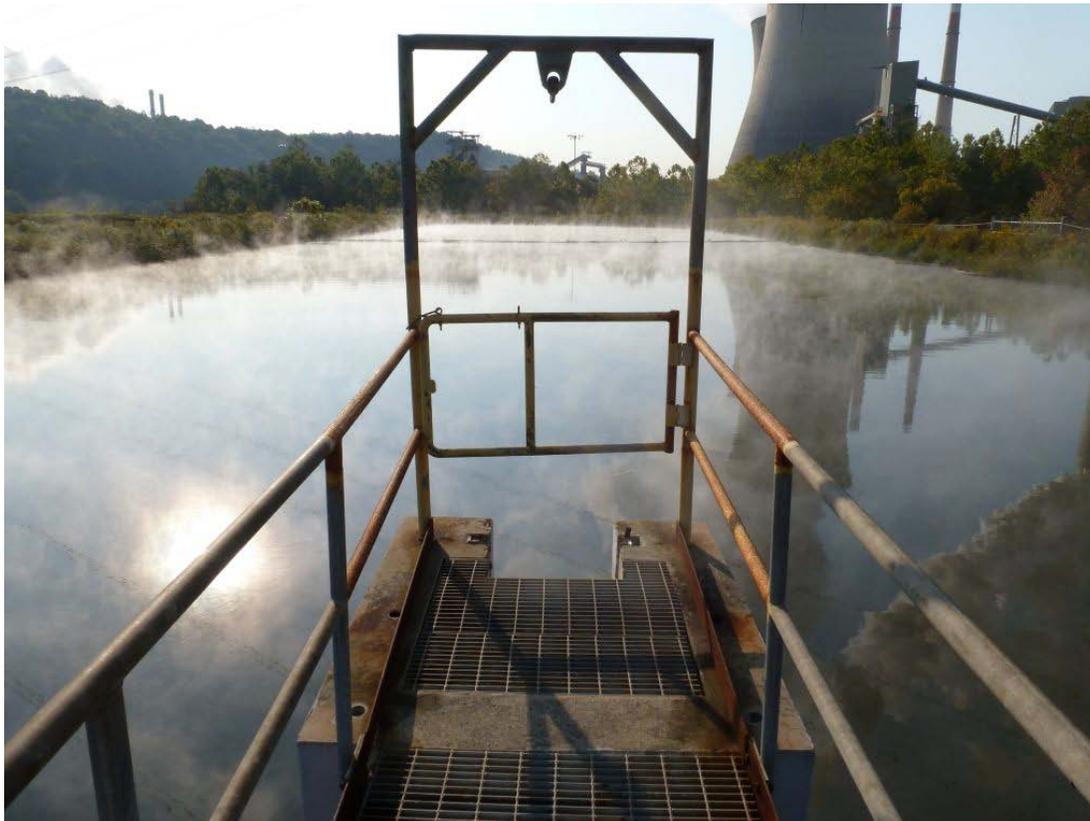
Orientation:  
SEDescription:  
Ash Settling  
Basin 1 in  
operation, view  
from outlet  
tower.

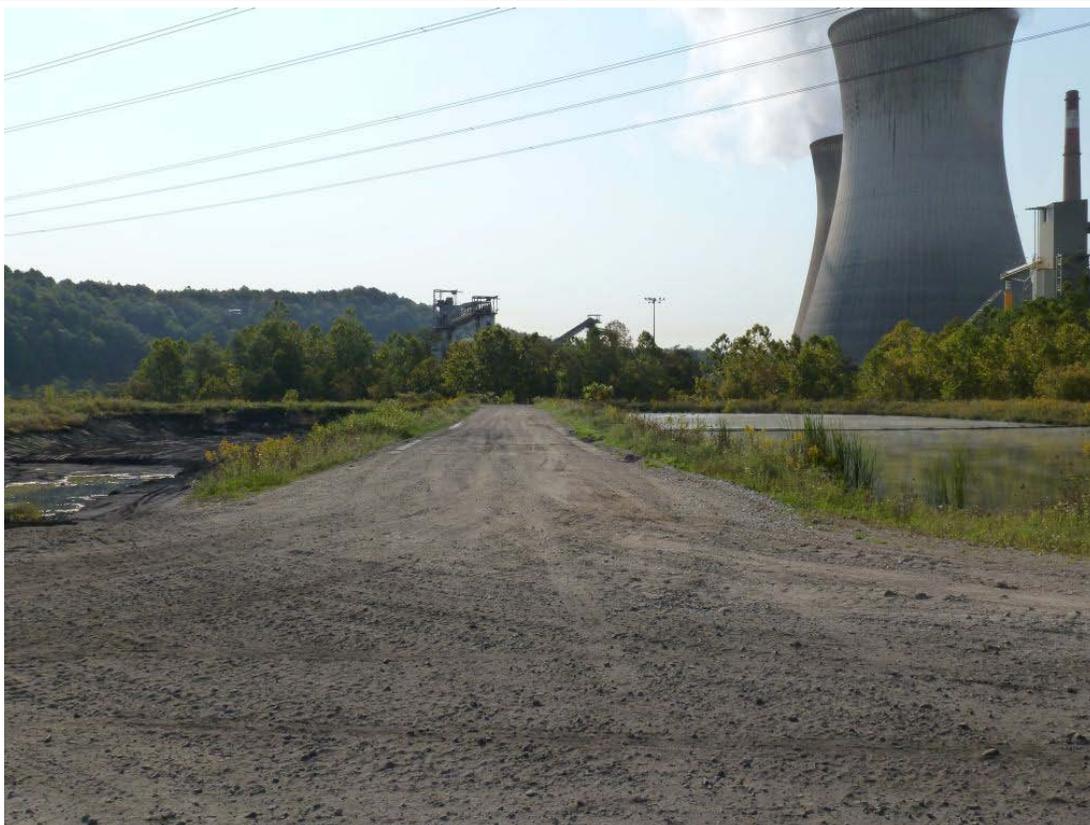
Date:  
9/25/12Photo Number:  
2Photographer:  
DDW

Date:  
9/25/12Photo Number:  
1Photographer:  
DDWOrientation:  
SEDescription:  
Divider dike  
between 2 Ash  
Settling Basins.  
Basin 1 in  
operation on  
right. Drained  
Basin 2 on left.

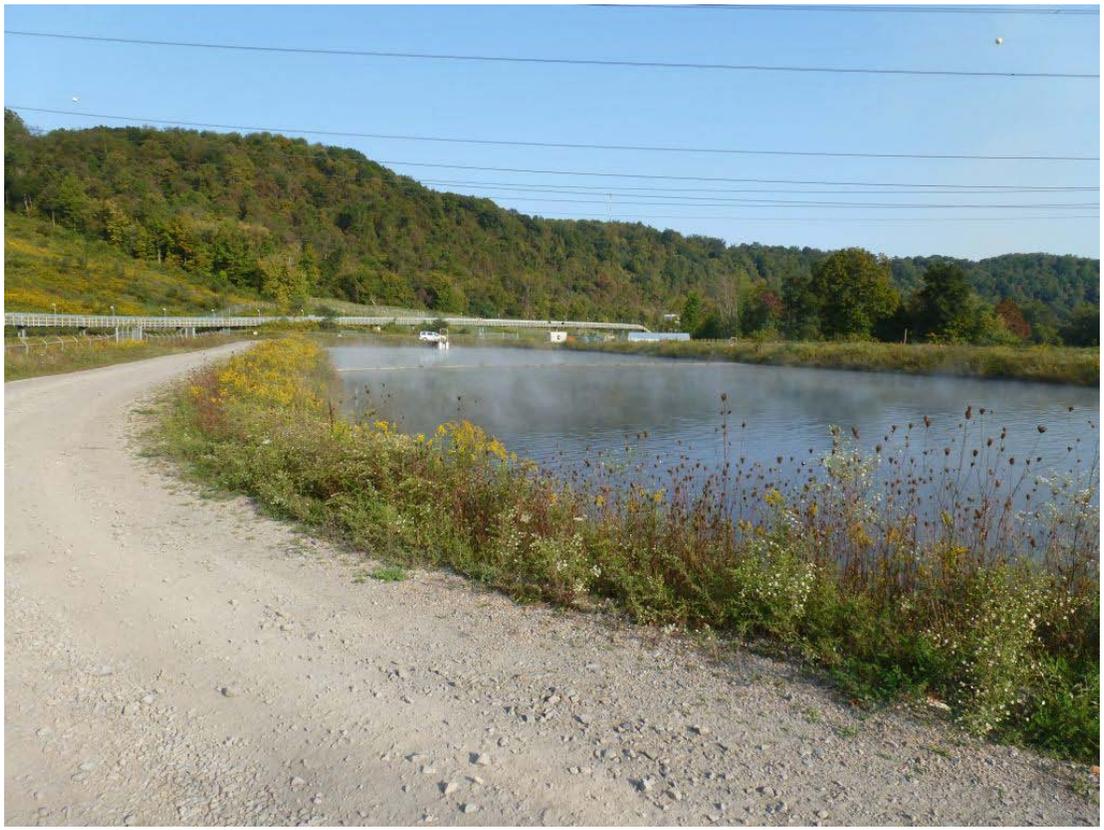
Photo Number:  
3

Description:  
Ash Settling Basin 1, view from basin south corner. Note boom across center of basin in background.

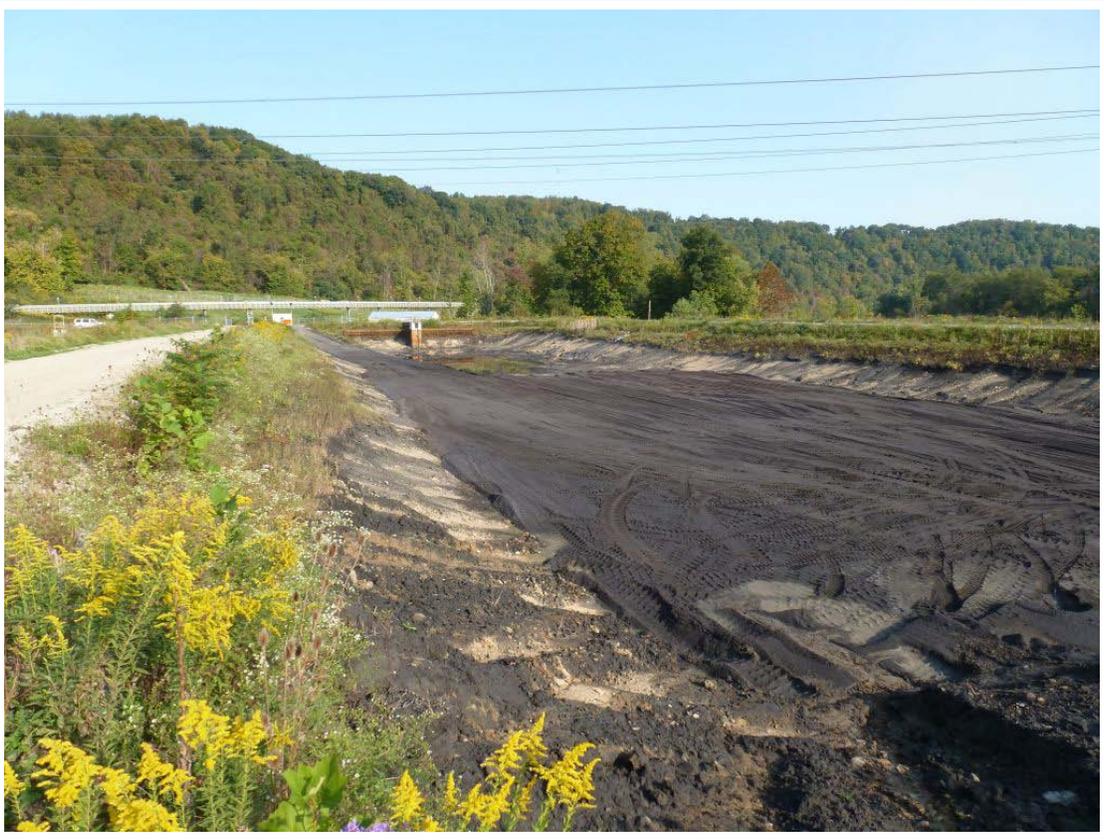
Photo Number:  
4

Description:  
Ash Settling Basin 2, view from basin south corner.

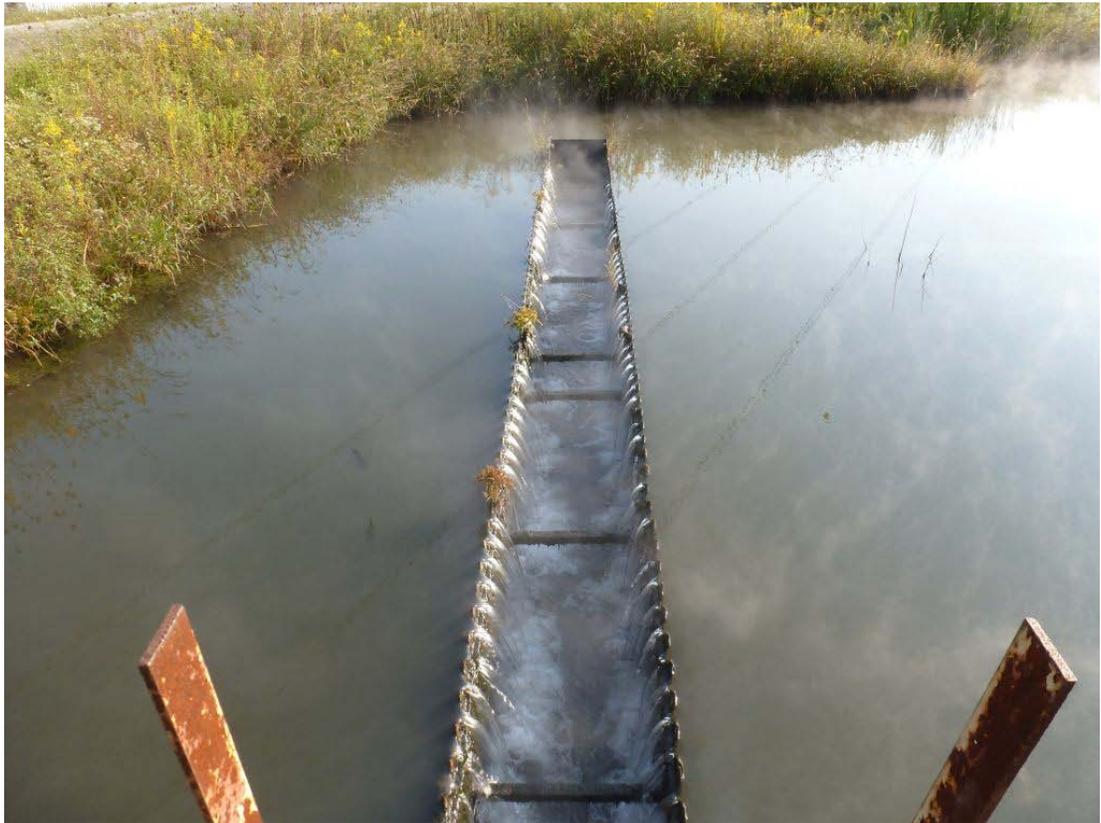
- Plant personnel stated that the adjustable stop plates for draining the lagoons are operational.
- Metal outflow weir troughs and other metal components were rusted, but the outlet works showed no other significant signs of wear.

Orientation: NE  
Description: Weir trough in operation in Ash Settling Basin 1.  
Date: 9/25/12  
Photo Number: 5  
Photographer: DDW

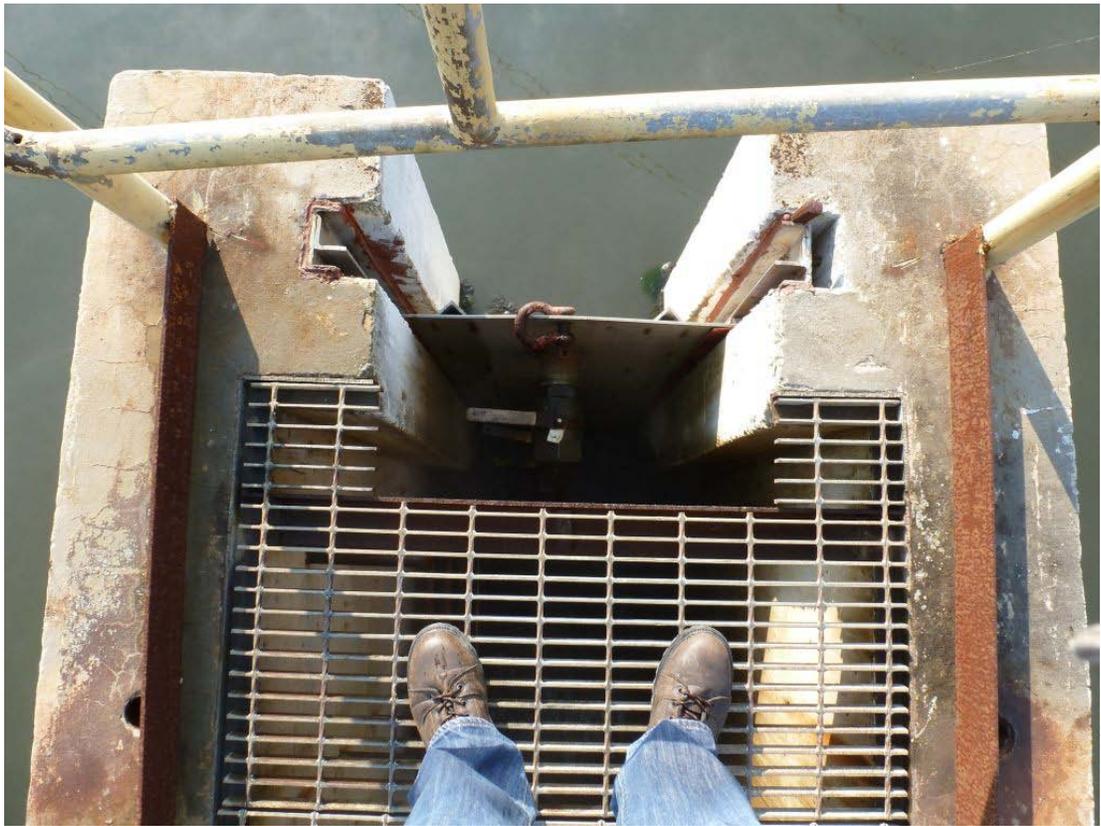
Orientation: SE  
Description: Concrete outlet tower with adjustable stop plate in Ash Settling Basin 1.  
Date: 9/25/12  
Photo Number: 6  
Photographer: DDW

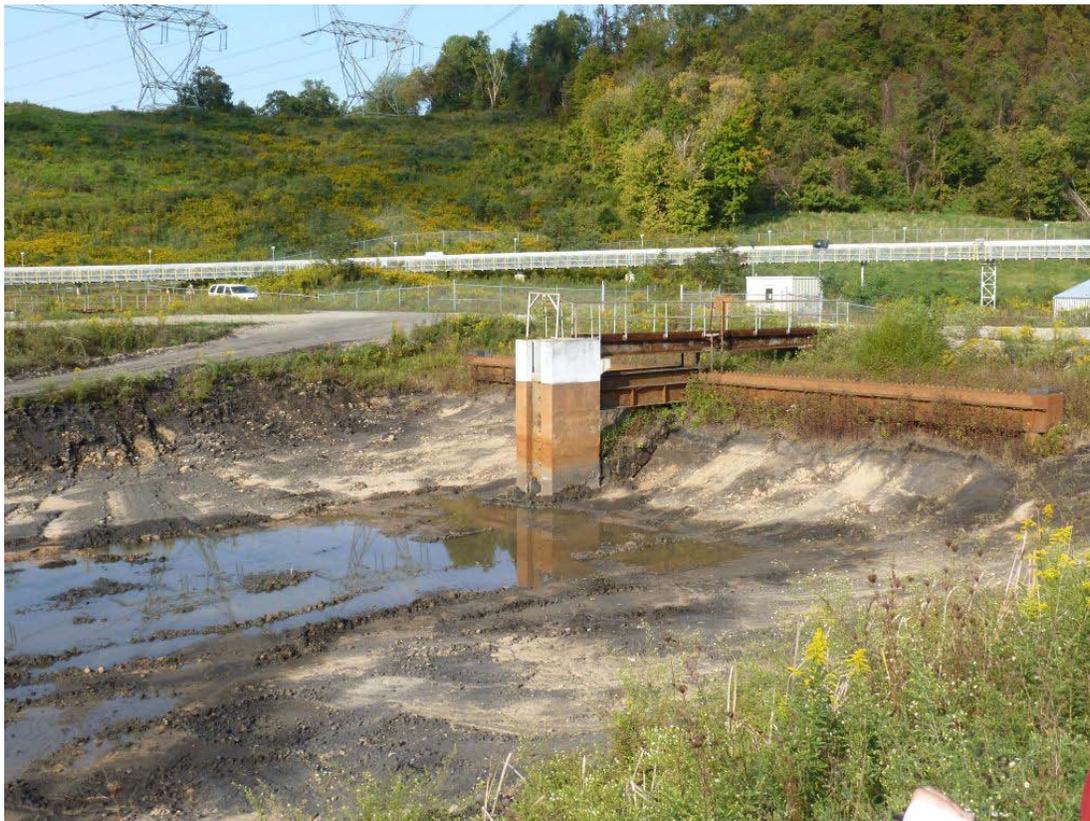
Photo Number:  
7

Description:  
Ash Settling  
Basin 2 bottom,  
inboard slopes,  
concrete outlet  
tower, and weir  
trough.

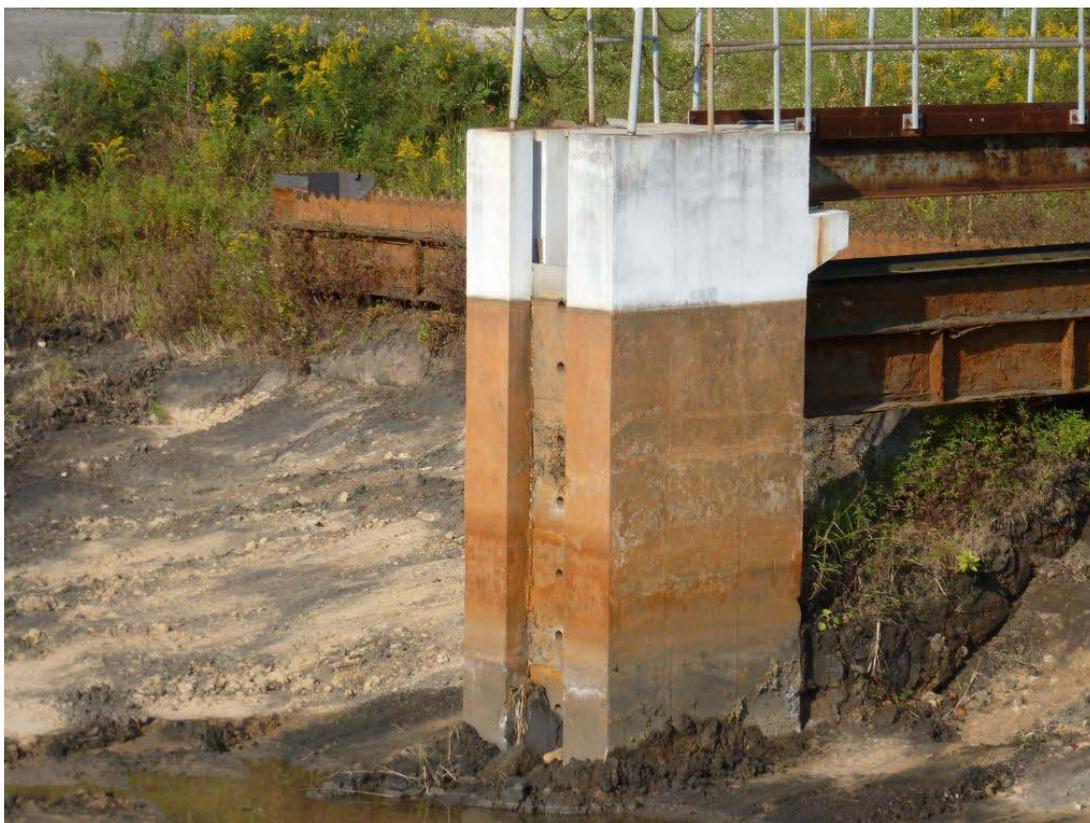
Photo Number:  
8

Description:  
Exposed  
concrete outlet  
tower with  
adjustable stop  
plate in Ash  
Settling Basin 2.

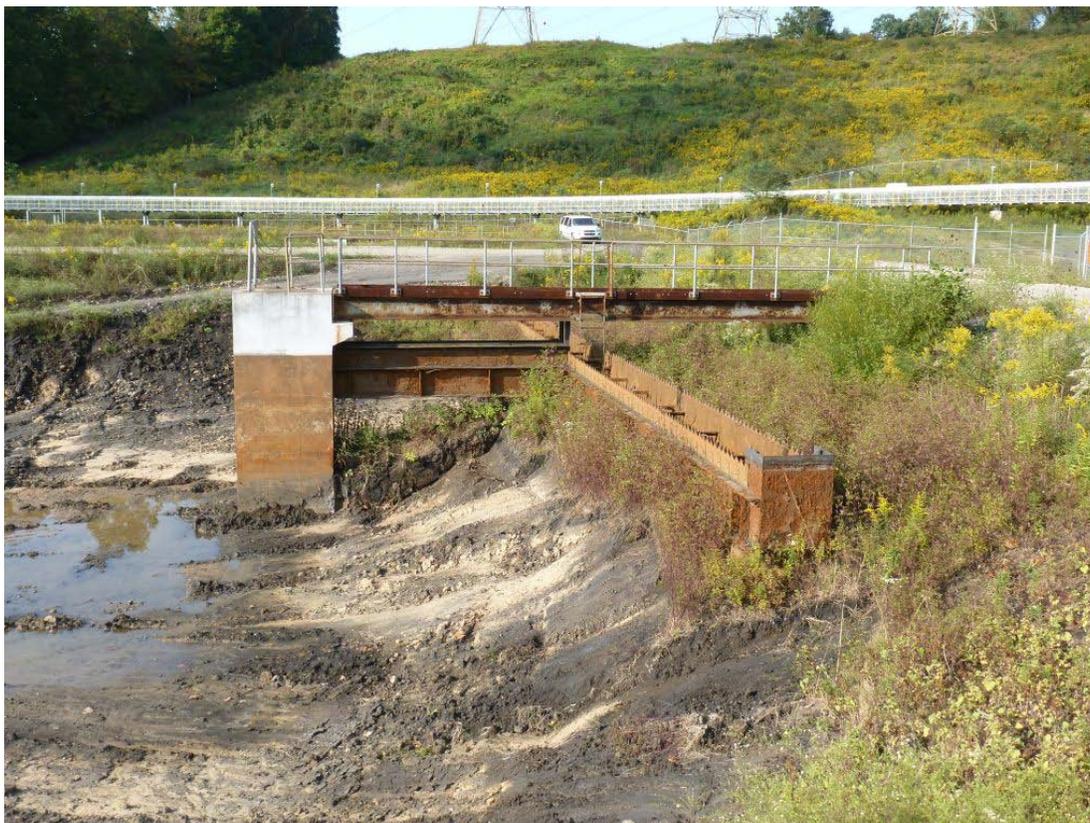
Photo Number:  
9

Description:  
Ash Settling  
Basin 2 inboard  
slopes near  
concrete outlet  
tower and weir  
trough.

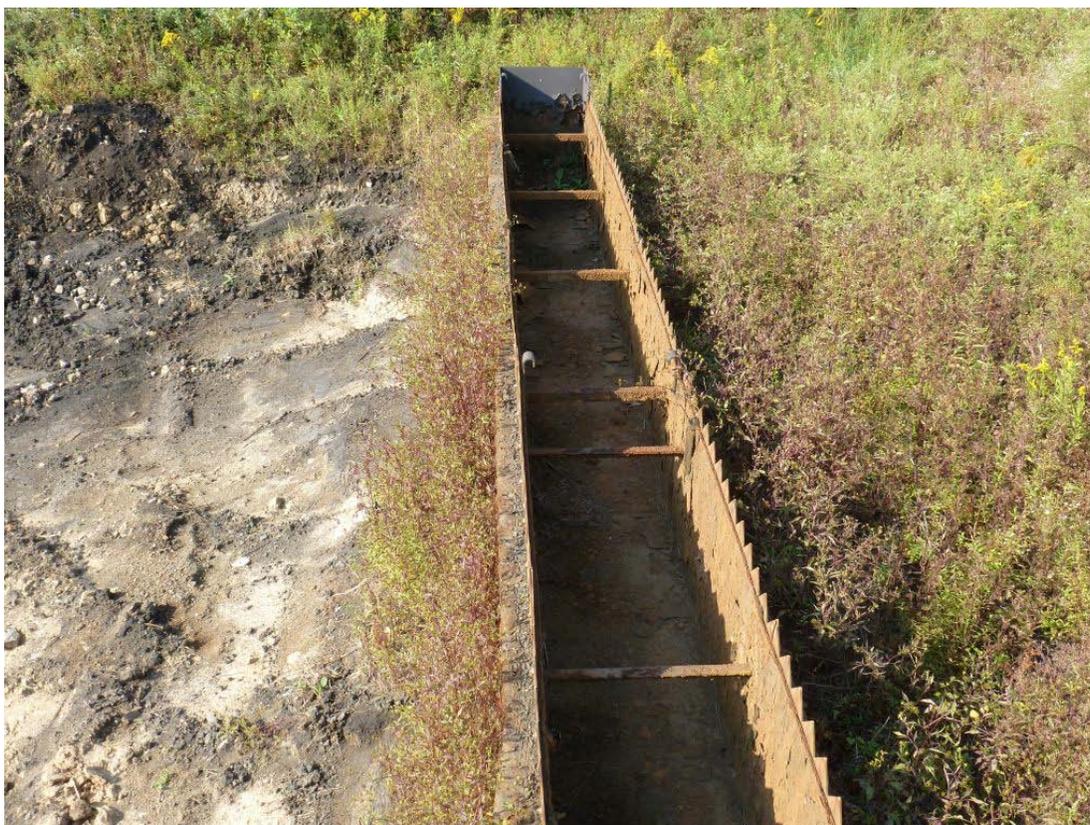
Photo Number:  
10

Description:  
Weir trough out  
of operation in  
Ash Settling  
Basin 2.

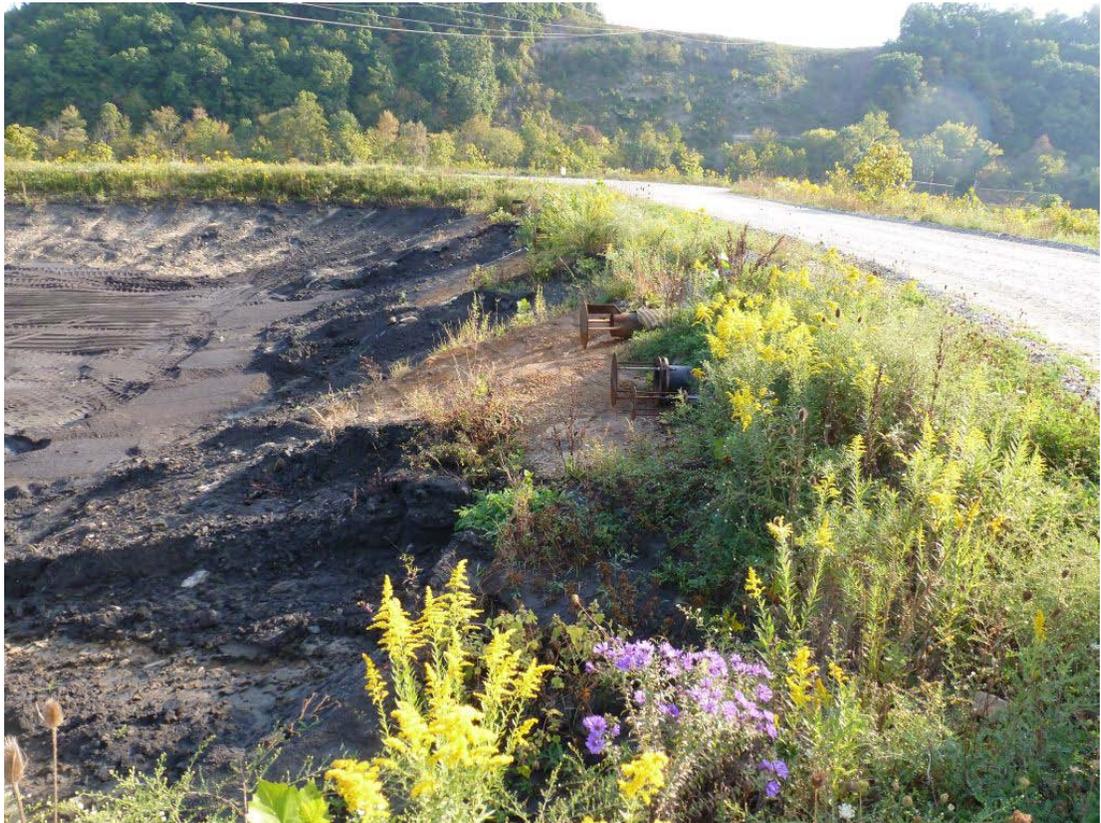
Photo Number:  
11

Description:  
Inflow pipes on  
inboard slope of  
drained Ash  
Settling Basin 2.

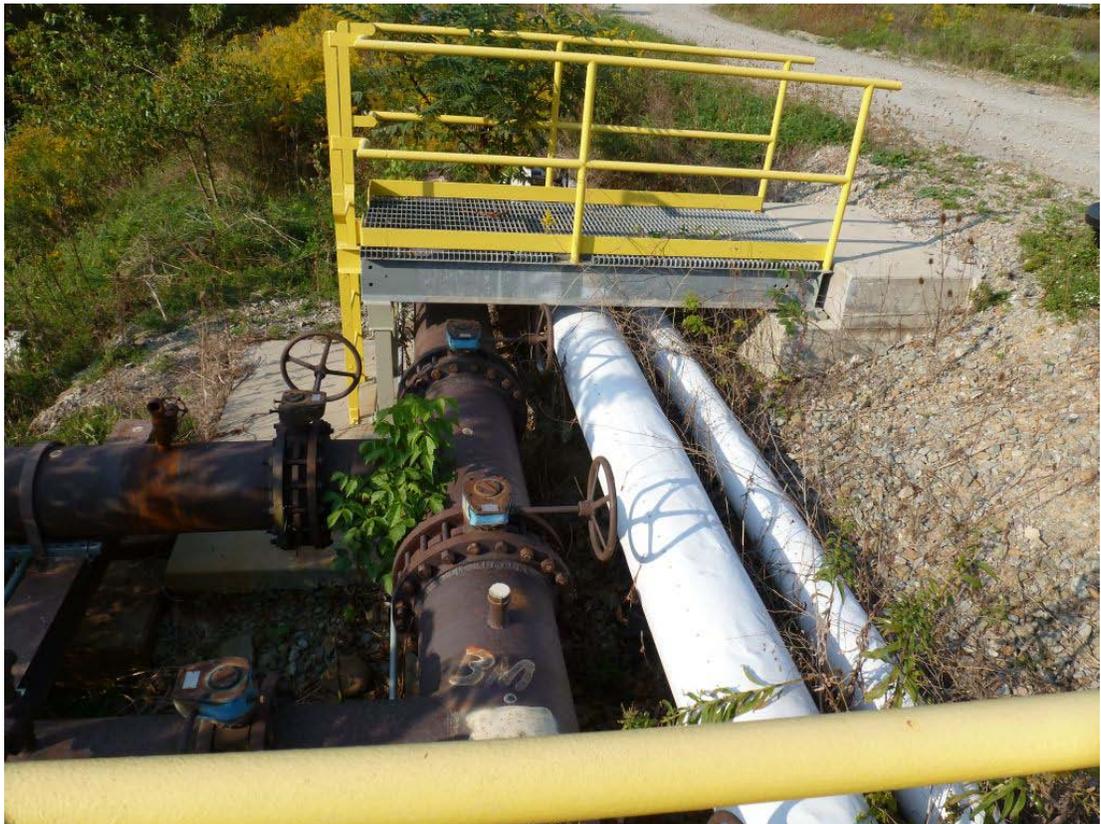
Photo Number:  
12

Description:  
Ash Setting  
Basin inflow  
pipes and valves  
near top of  
southern  
embankment  
outboard slope.

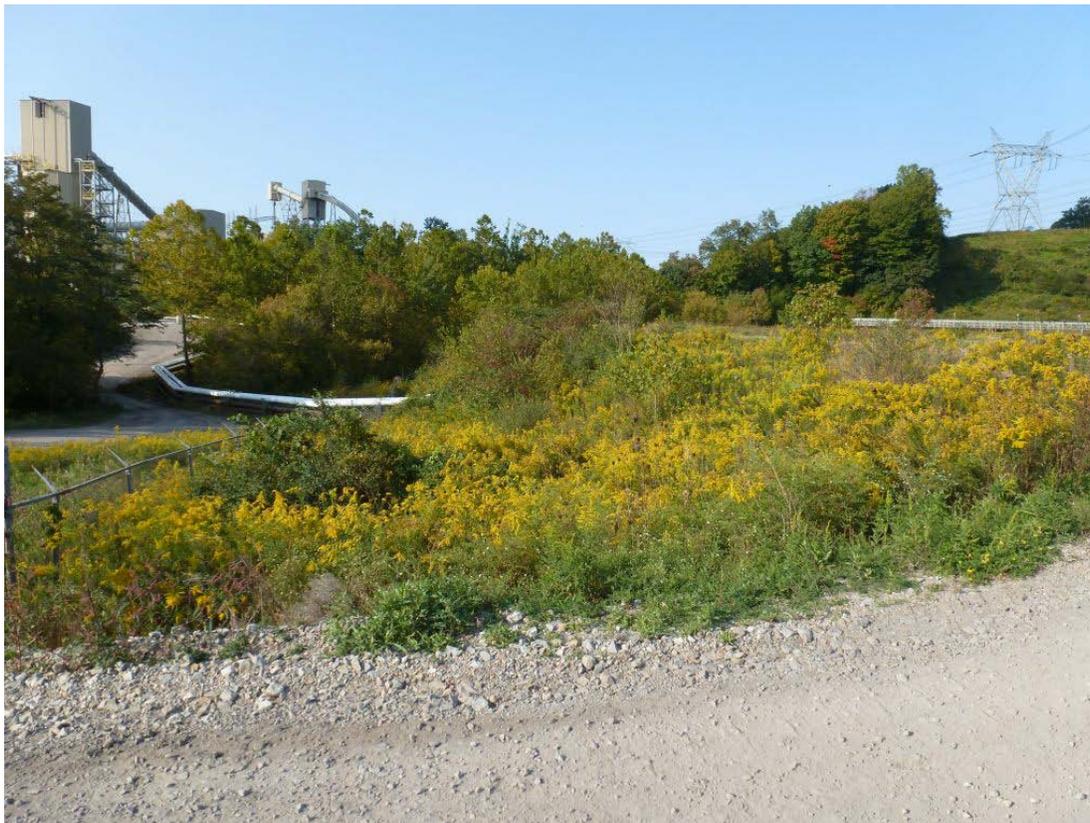
Photo Number:  
13

Description:  
Access road and southern embankment of Ash Settling Basins.

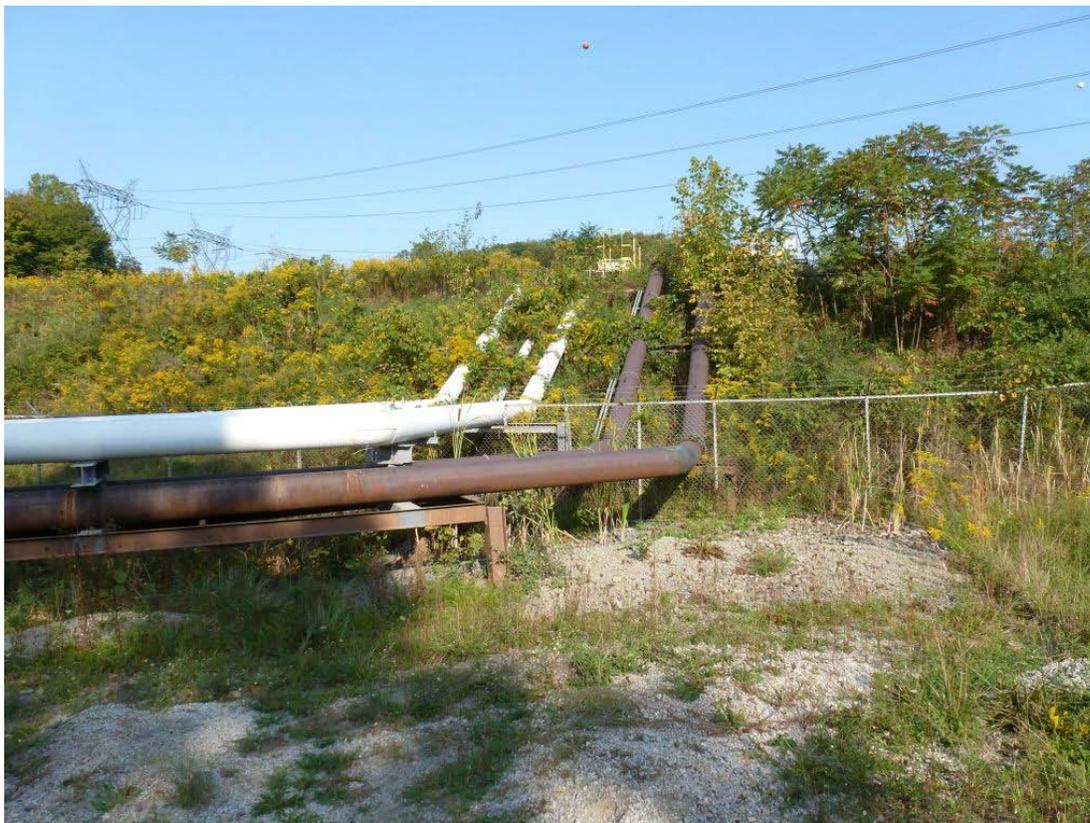
Photo Number:  
14

Description:  
Inflow pipes along southern embankment of Ash Setting Basins.

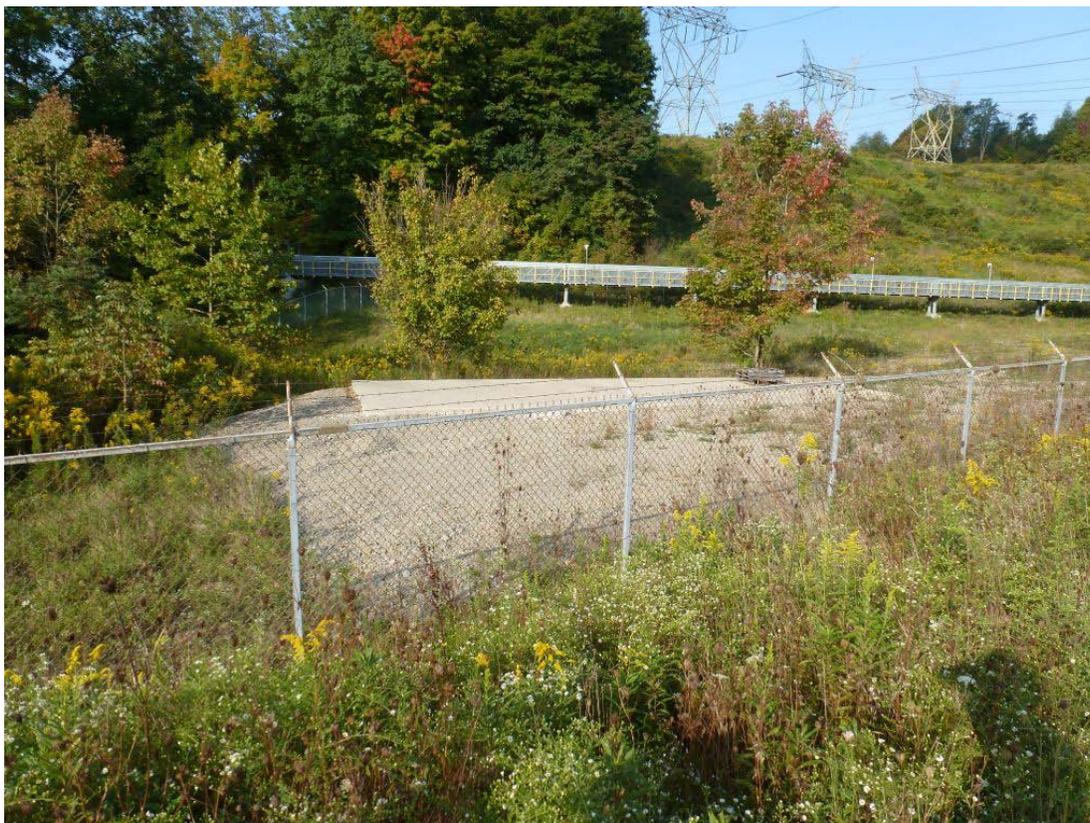
Photo Number:  
15

Description:  
Flat area west of Ash Settling Basins, limestone conveyor and hillside in background.

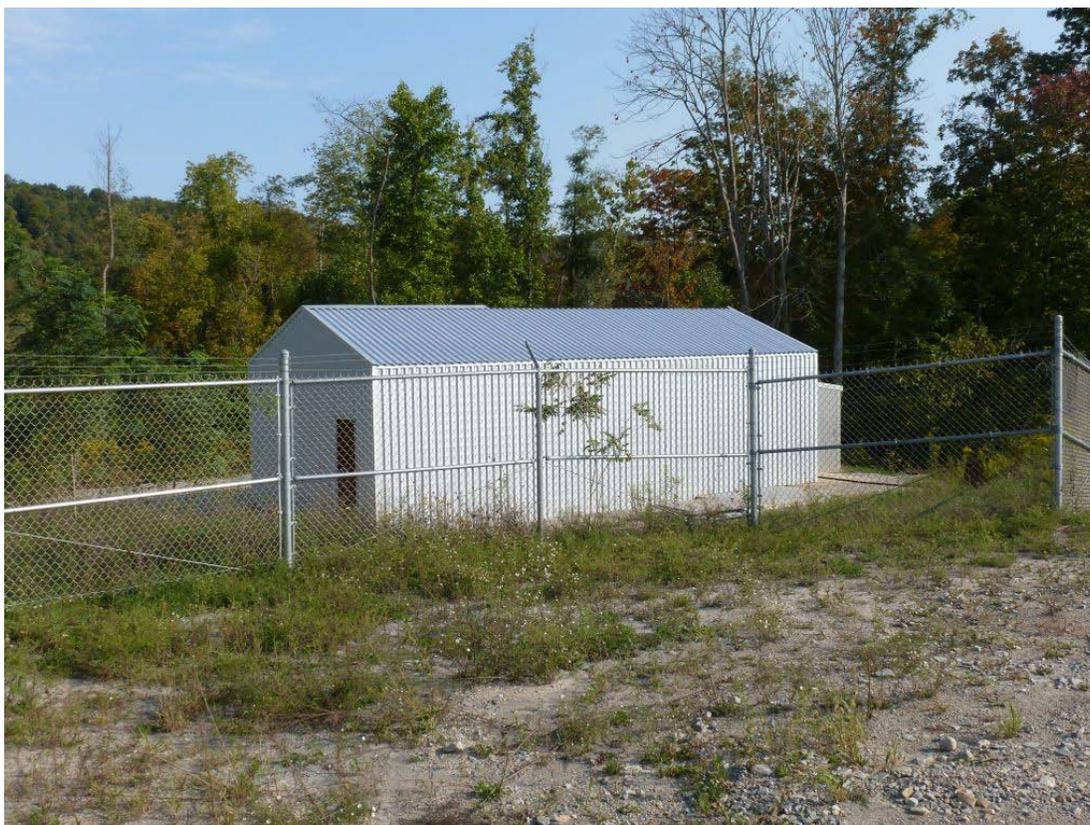
Photo Number:  
16

Description:  
Sampling building for Ash Settling Basin outflow prior to outfall at the Monongahela River.

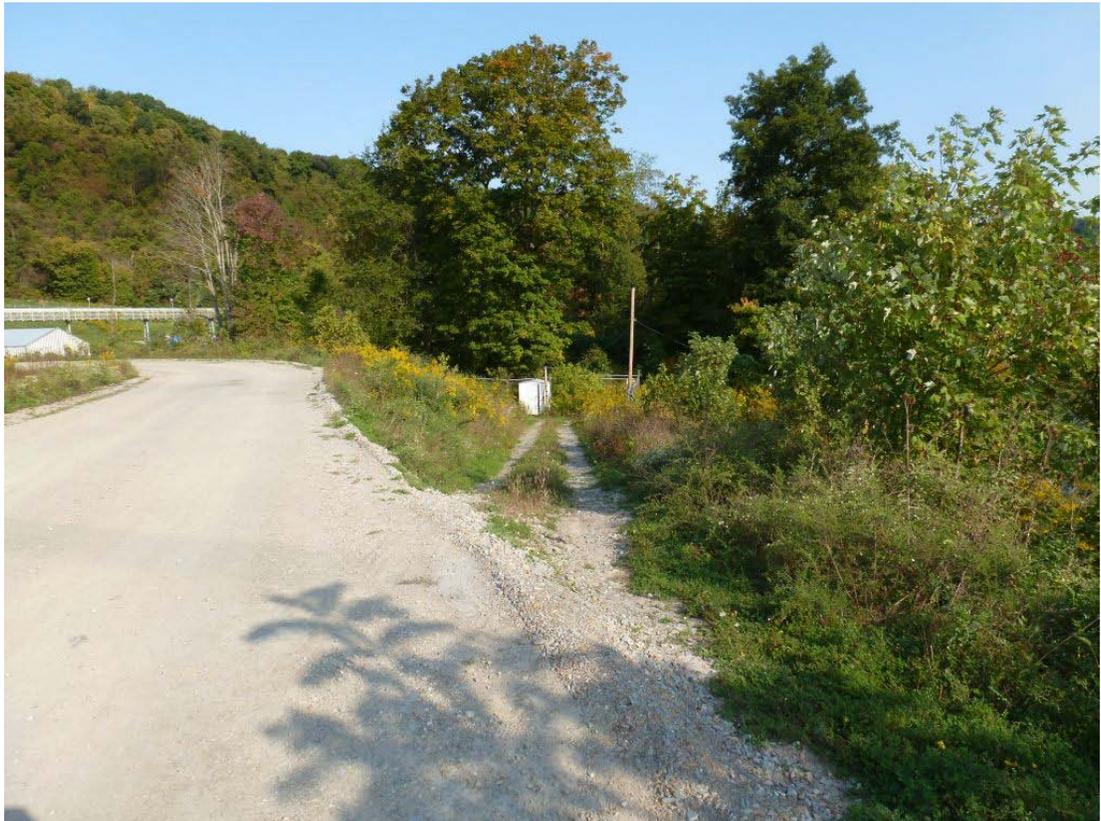
Photo Number:  
17

Description:  
Access road to Monongahela River on Ash Settling Basin 2 eastern embankment.

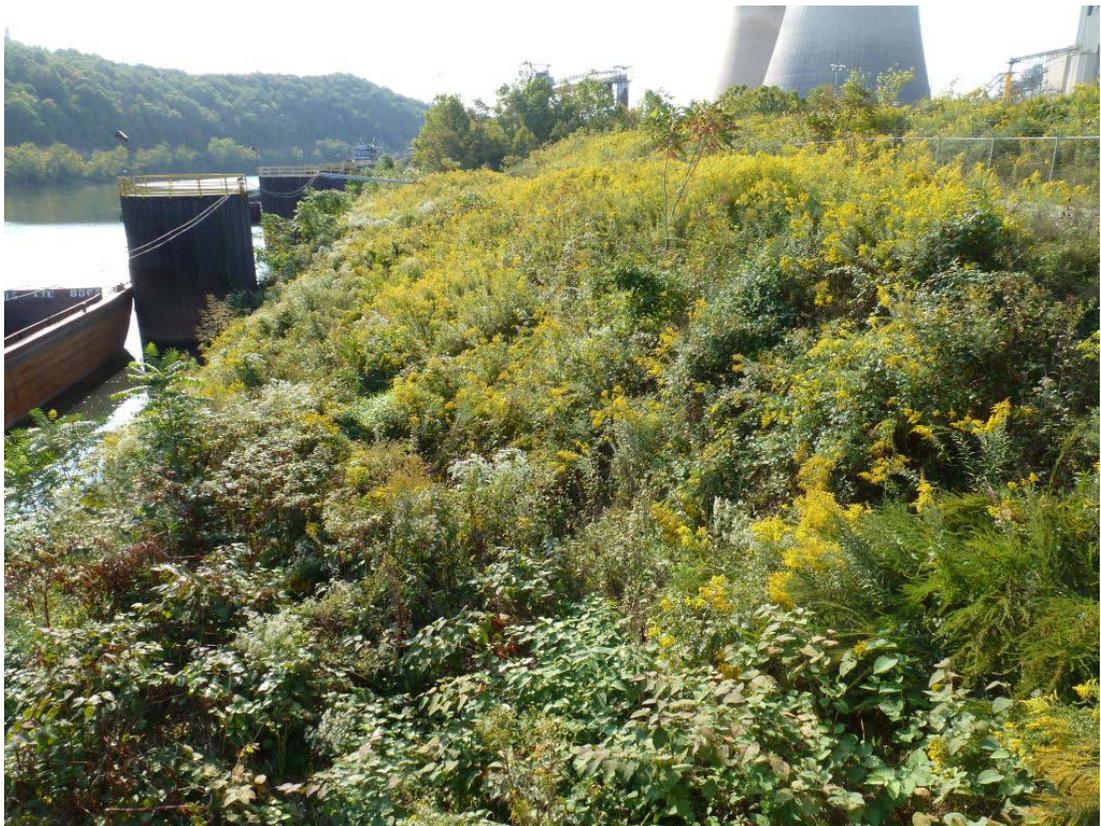
Photo Number:  
18

Description:  
Natural riverside slope along Monongahela River and toe of constructed eastern embankment of Ash Settling Basin 2. Planted as mitigation area.

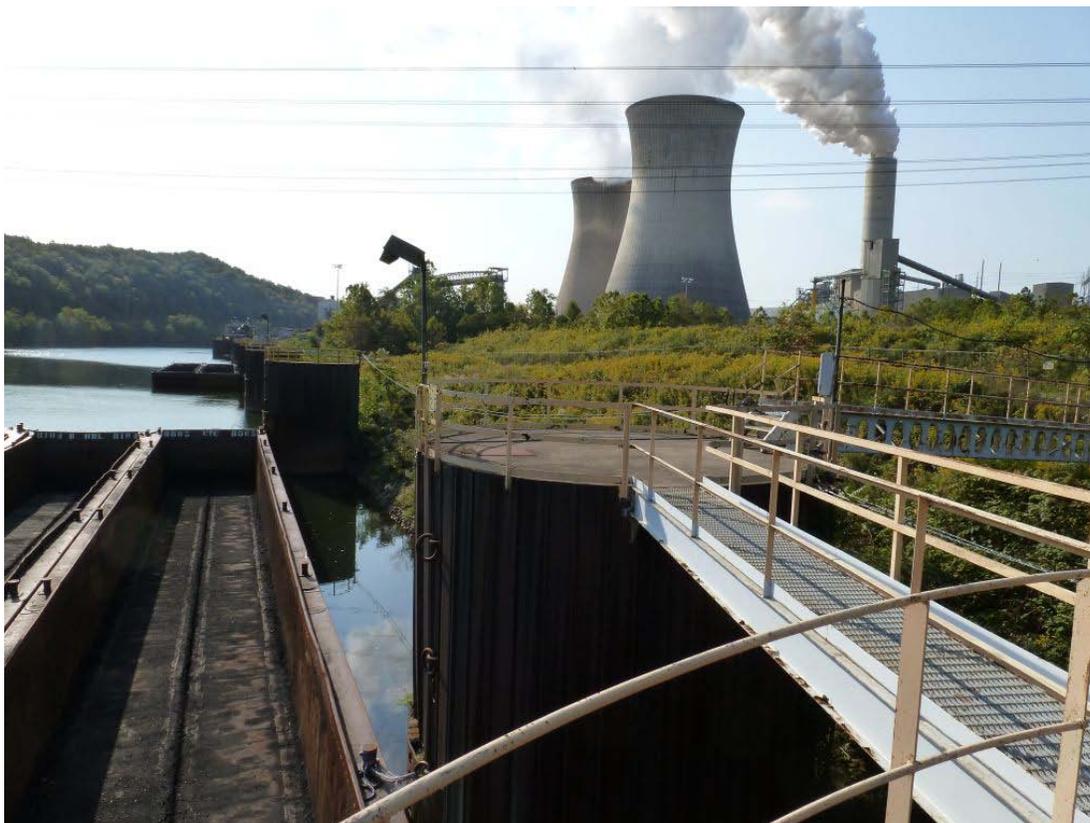
Photo Number:  
19

Description:  
Mooring cells along  
Monongahela  
River adjacent  
to Ash Settling  
Basins.

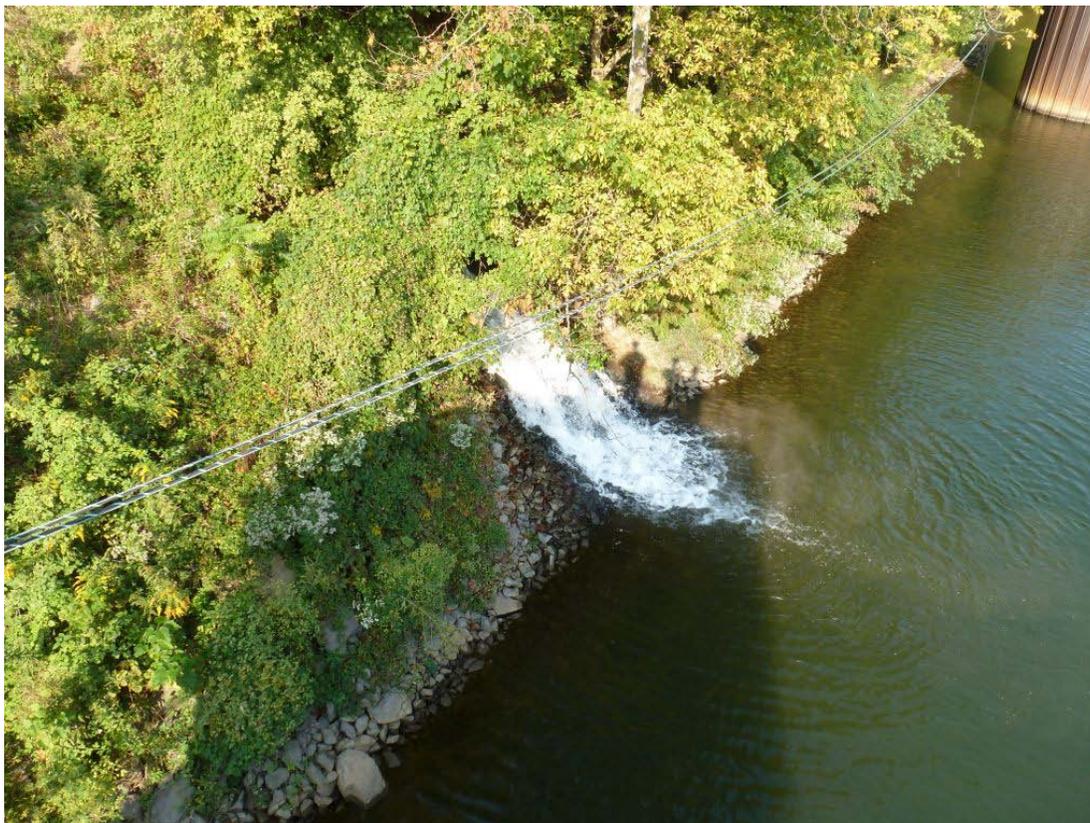
Photo Number:  
20

Description:  
Ash Setting  
Basins outfall to  
Monongehela  
River.

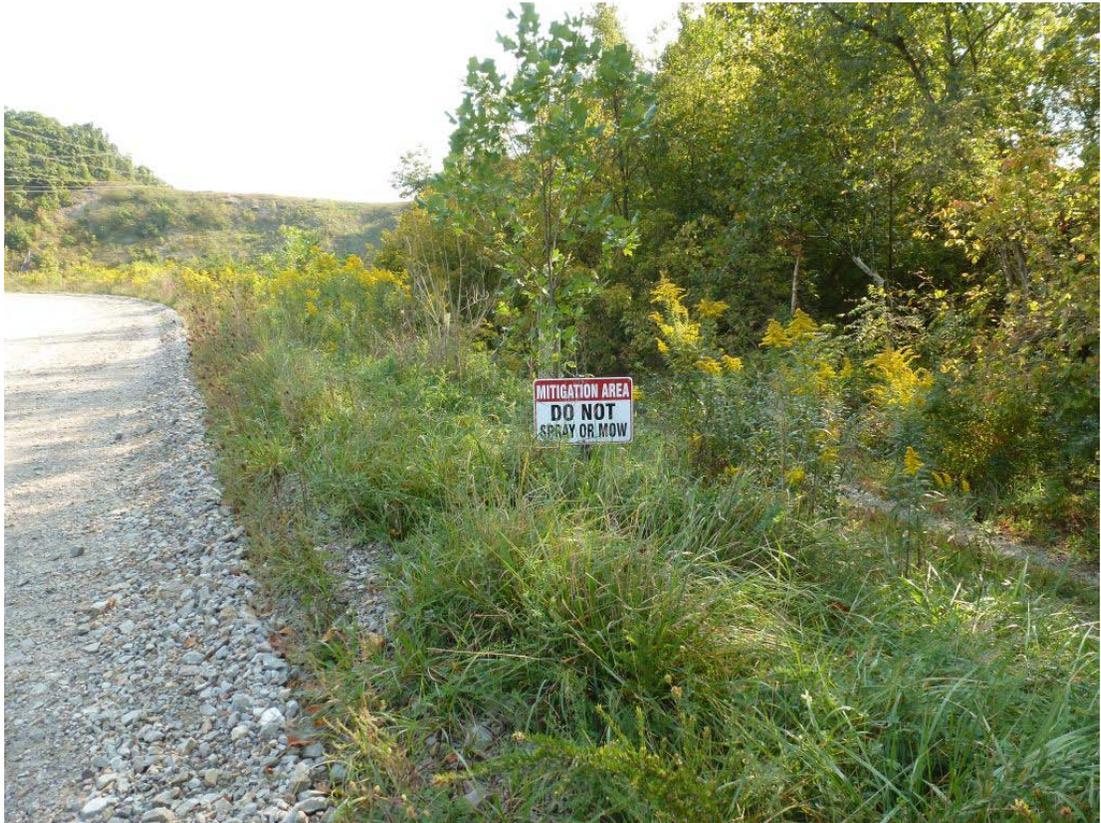
Photo Number:  
21

Description:  
Access road to  
Ash Settling  
Basins.  
Mitigation area  
along access  
road and  
riverside  
embankment.

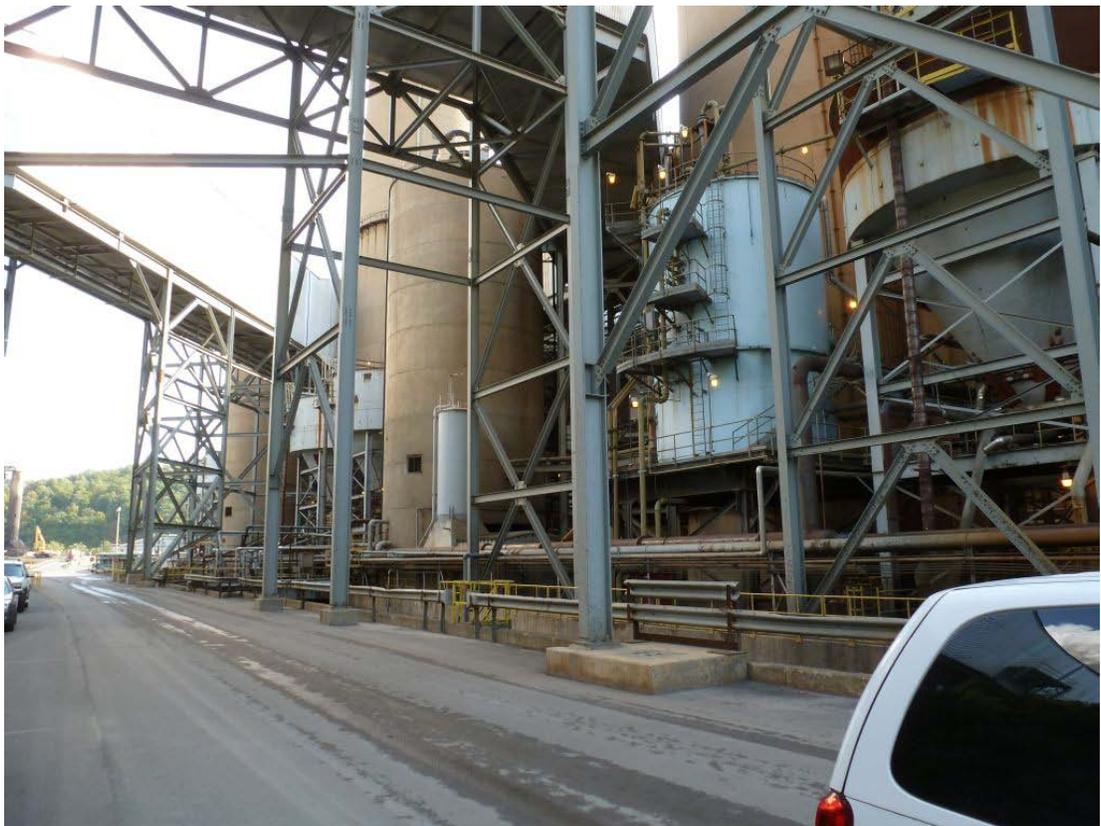
Photo Number:  
22

Description:  
Ash storage  
silos and  
hydrobins.

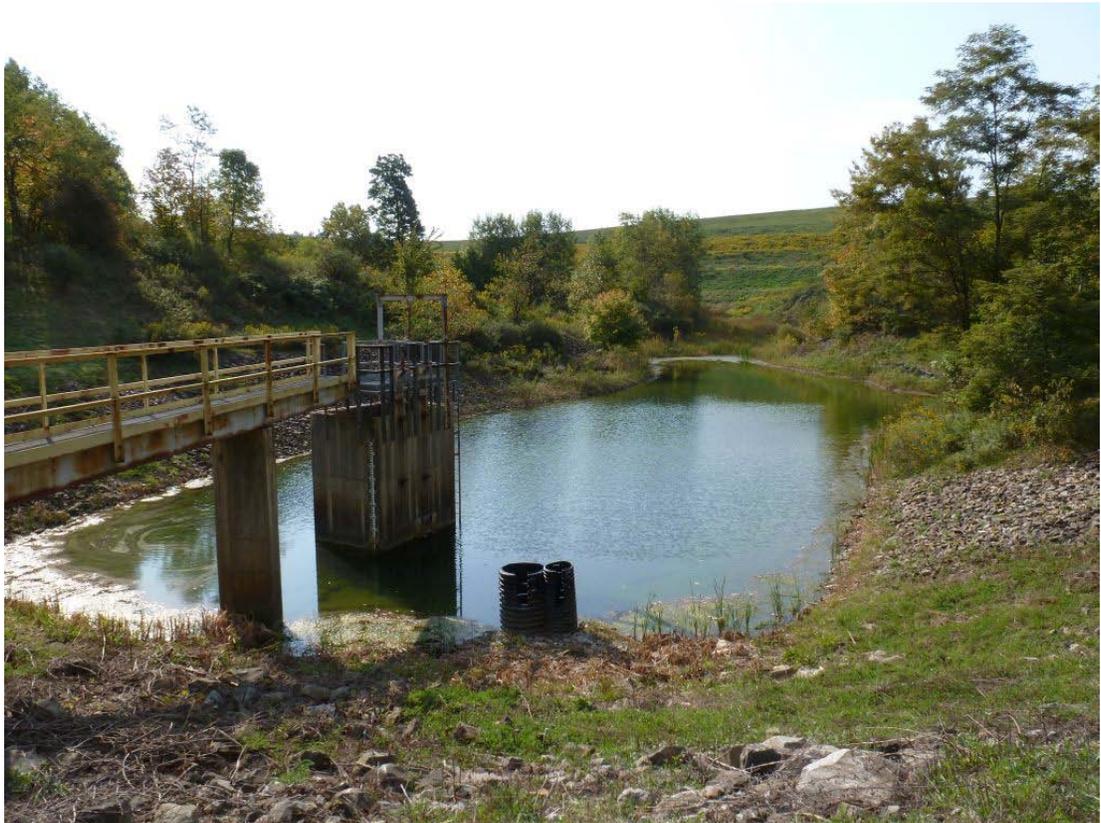
Photo Number:  
23

Description:  
Closed Landfill  
Pond 007, view  
from right of  
outlet structure.  
Closed landfill  
in background.

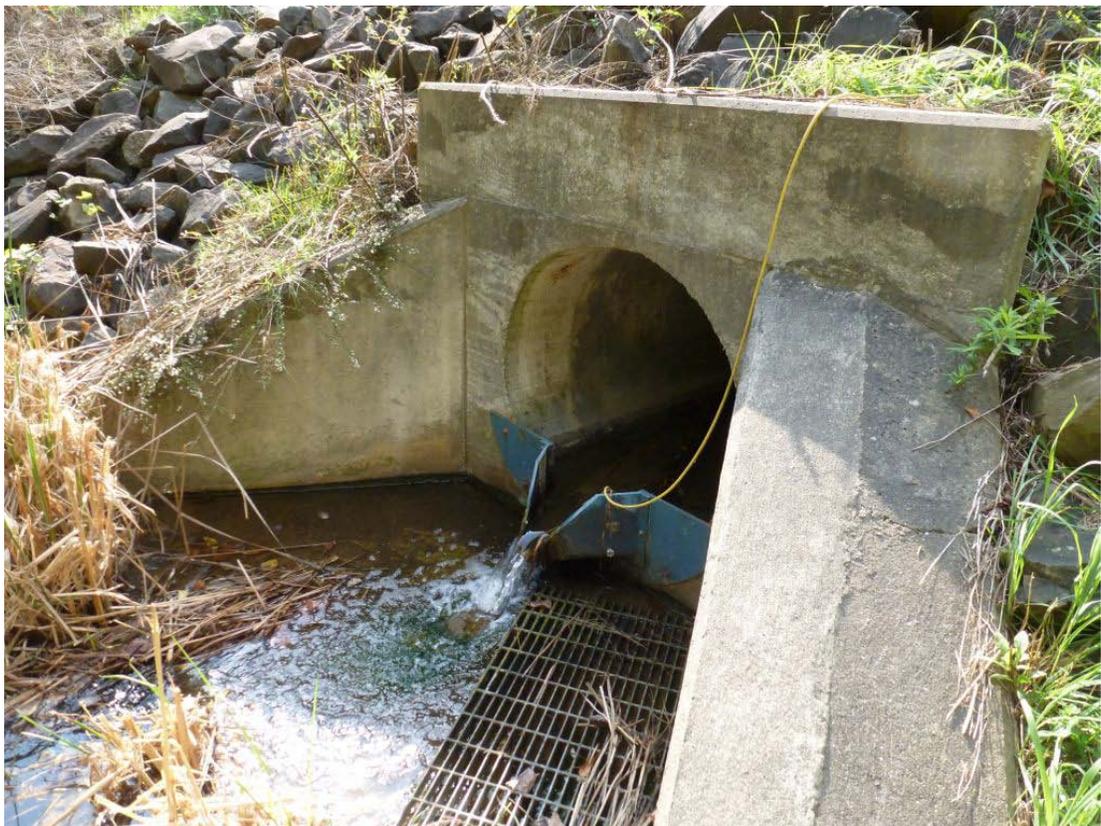
Photo Number:  
24

Description:  
Closed Landfill  
Pond 007  
outfall.
