# Dam Safety Assessment of CCW Impoundments

**ALLEGHENY ENERGY COMPANY, LLC  
HATFIELD'S FERRY POWER STATION**

February 27, 2014

Allegheny Energy Company, LLC  
Hatfield's Ferry Power Station

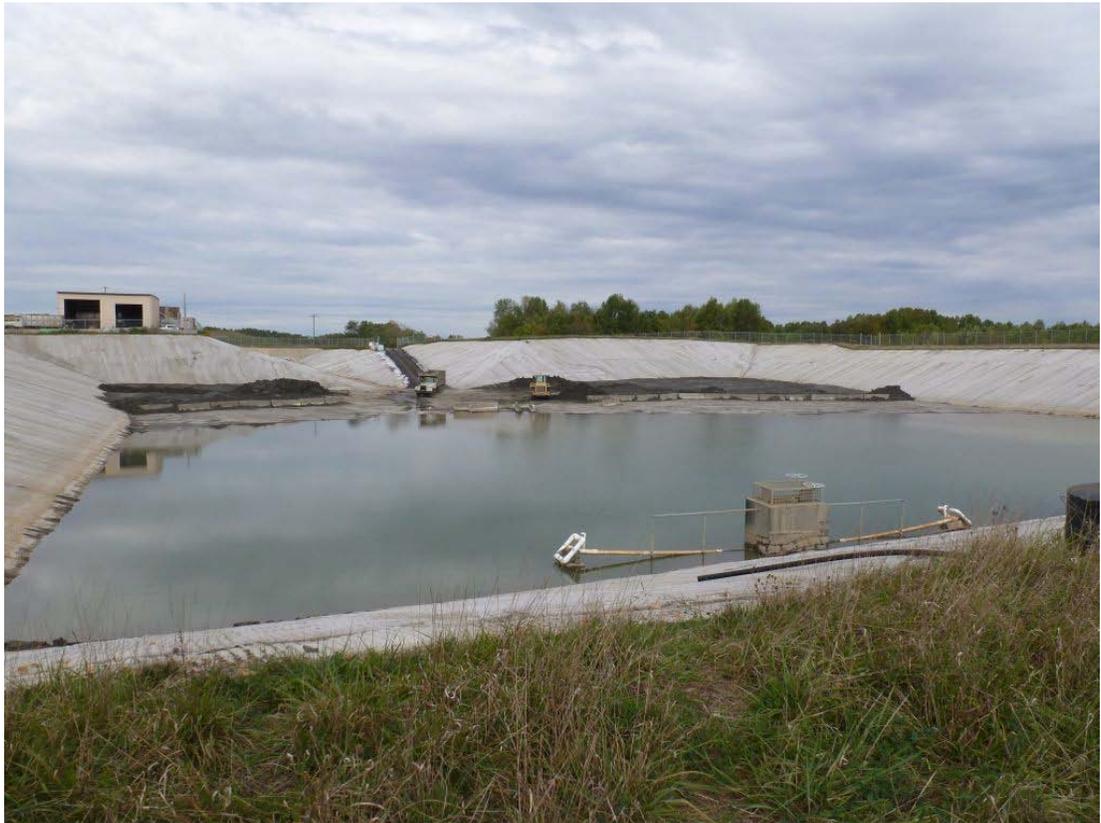
Orientation:  
W  
Description:  
Leachate  
Storage  
Impoundment  
(LSI).

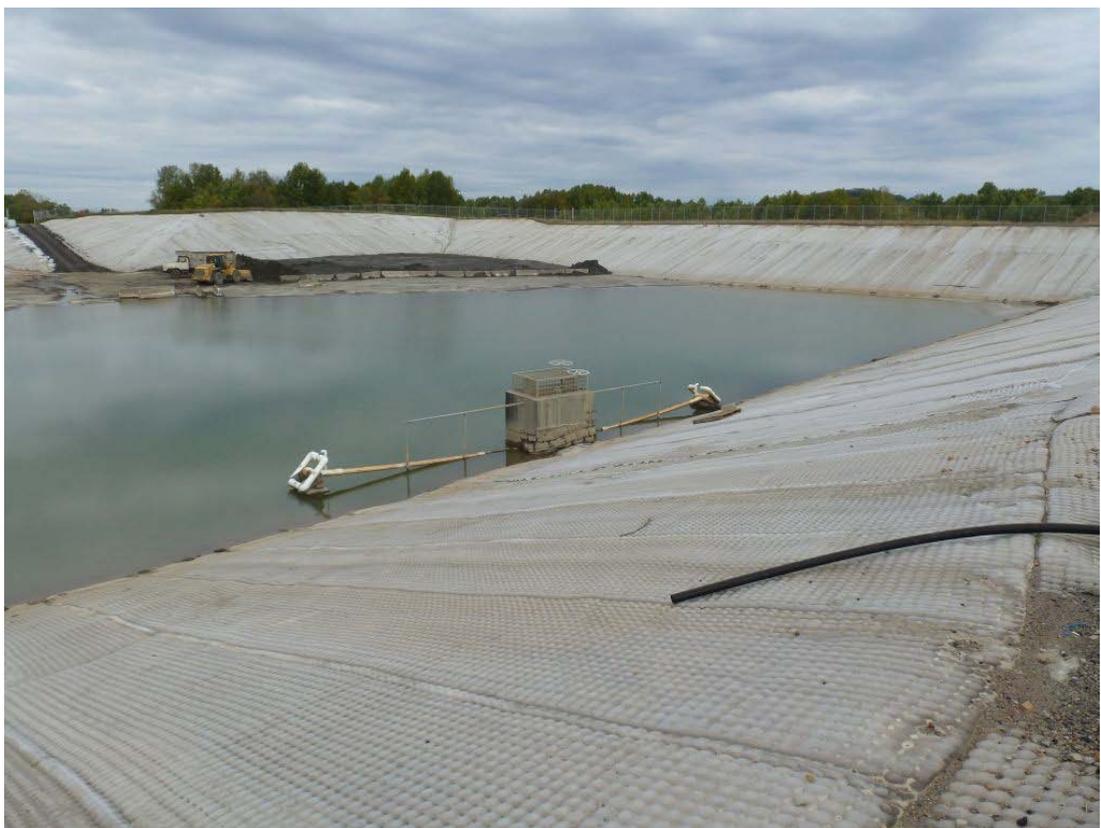
Orientation:  
NW  
Description:  
Leachate  
Storage  
Impoundment  
(LSI).

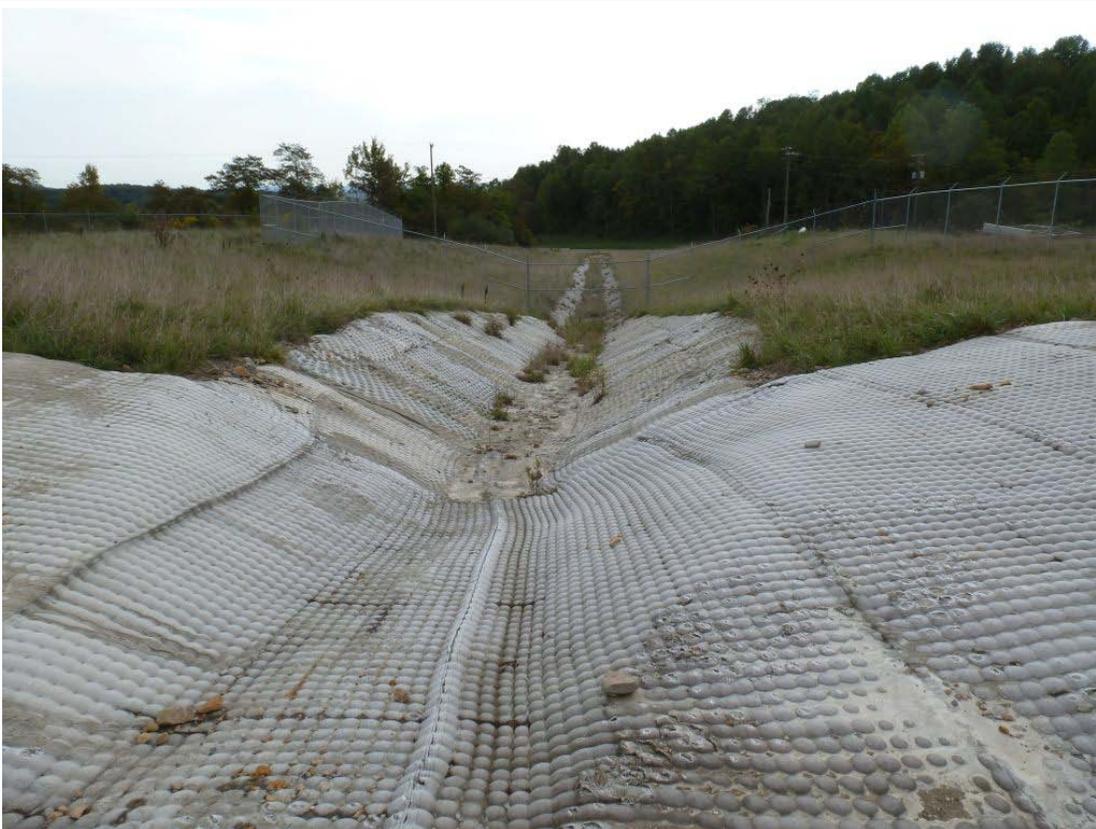
Photo Number:  
27

Description:  
Leachate  
Storage  
Impoundment  
(LSI) outflow  
channel.

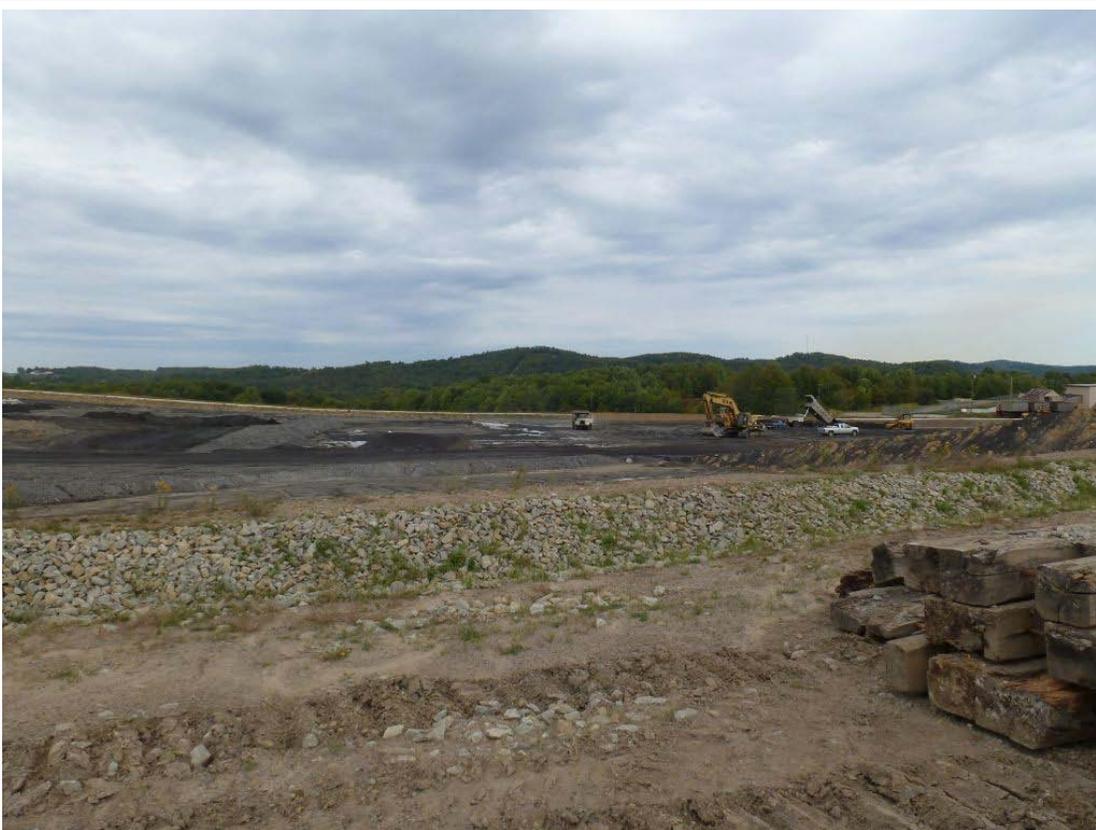
Photo Number:  
28

Description:  
On-site landfill  
in operation.
