**Coal Combustion Waste Impoundment
Task 3- Dam Assessment Report**

John E. Amos Plant (Site 26)

*Bottom Ash Dam
American Electric Power
St. Albans, West Virginia*

**October 2009
Revised December 9, 2009**

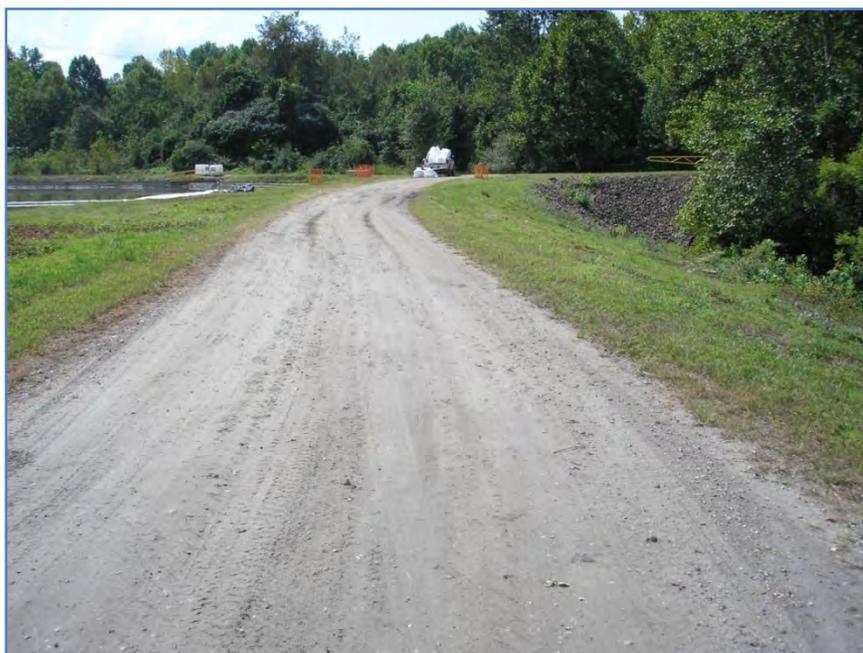
The crest had no signs of any depressions, tension cracks or other indications of settlement or shear failure, and appeared to be in satisfactory condition. Figure 5.2.1-1 shows the crest of the main dam of the Bottom Ash Complex.

Figure 5.2.1-1 Crest of Main Dam Bottom Ash Complex Looking Westward.

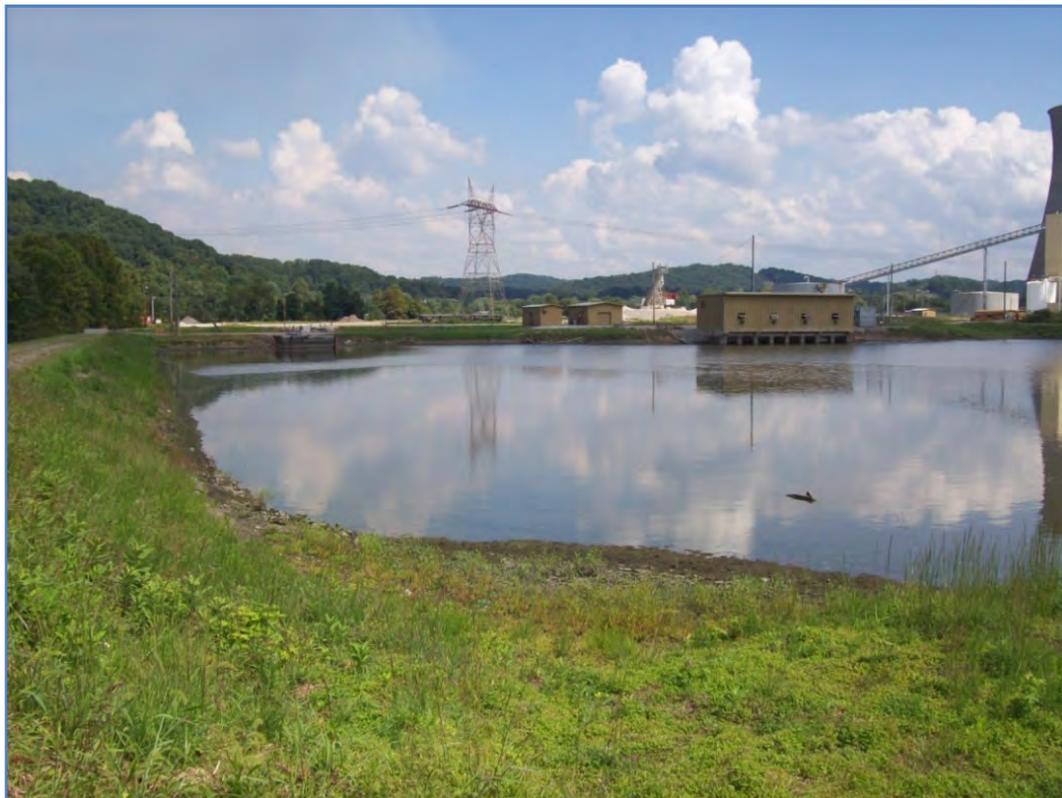
The upstream slope mostly consists of unprotected compacted soil except for part of the upstream face of the Pond 1B which remains heavily vegetated with woody plants. Figure 5.2.2-1 shows the upstream slope of the main dam embankment (on the left side of the picture) on the north side of Area No. 3 where it is protected with scattered grass. Scarps, sloughs, bulging, cracks or scraps or depressions or other indications of slope instability or signs of erosion were not observed.

Figure 5.2.2-1. The upstream Slope of the Main Dam (the Embankment on the Left Side of the Picture)

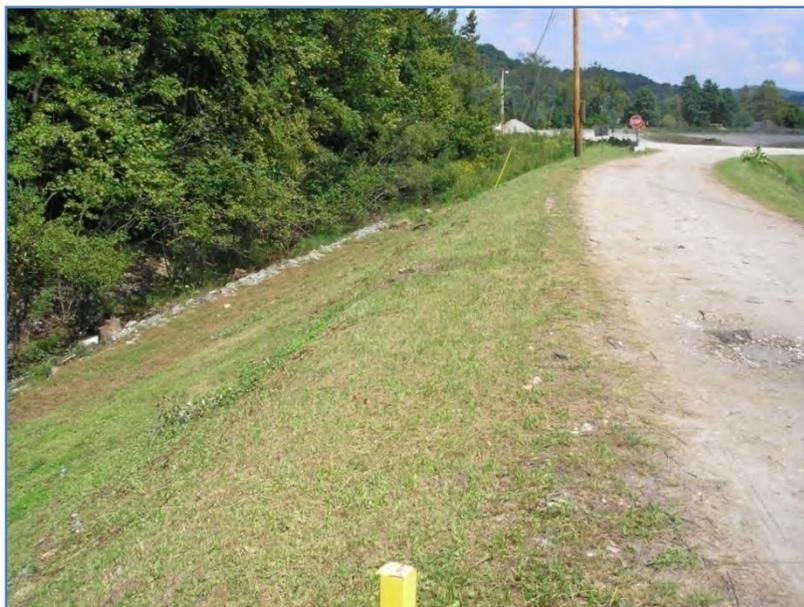
The downstream slope is protected with some grass. Scarps, sloughs, depressions or other indications of slope instability or signs of erosion or uncontrolled seepage were not observed. Figure 5.2.3-1 shows the downstream slope of the center area of the main dam. Scattered rip-rap was observed along a section of the lower slope as shown in this picture.

Figure 5.2.3-1. Downstream Slope at the Center Area of Bottom Ash Complex Main Dam (Looking Eastward).

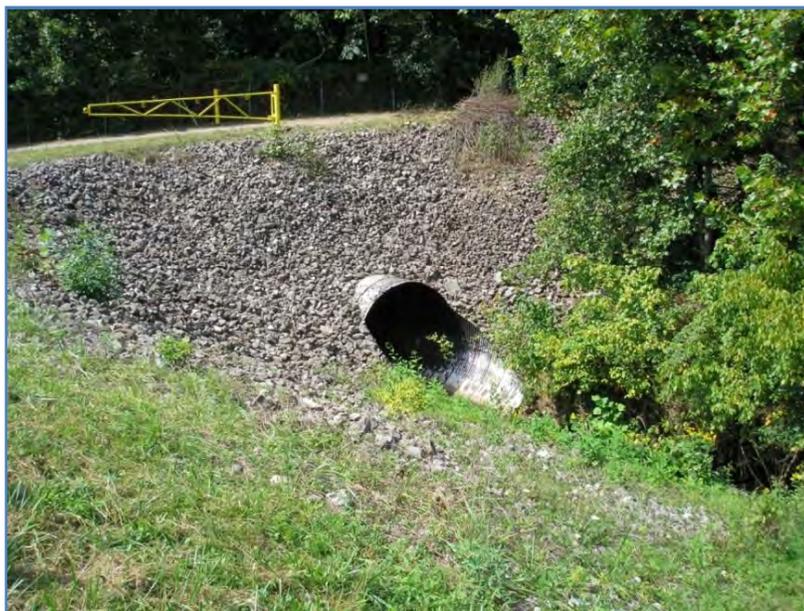
The abutments and groin areas appeared to be in good condition. Figure 5.2.4-1 shows the West Abutment of the main dam is protected with rip-rap. Culvert in this picture carries Bill's Creek beneath the West Abutment.

Figure 5.2.4-1. West Abutment of Bottom Ash Complex Main Dam.

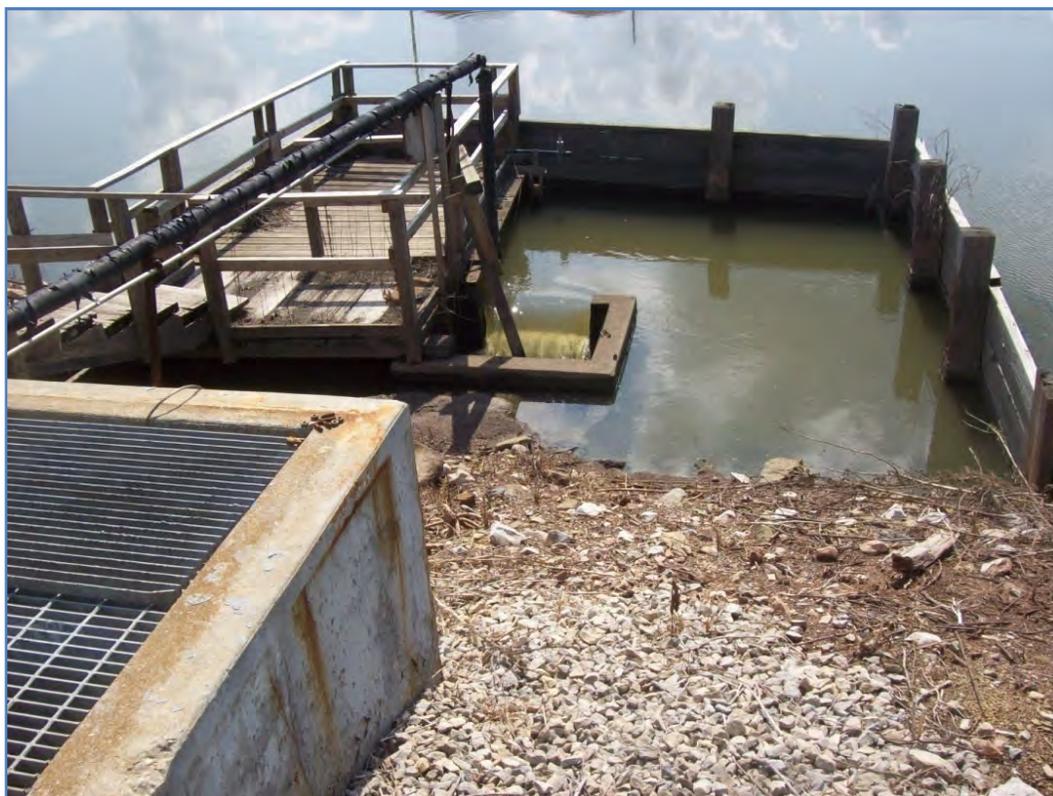
Currently there are two principal spillway outlets, one with a low inlet and one with a high inlet. The low inlet is an overflow structure with inlet crest elevation of 576.1 ft and a discharge capacity of 28.2 cfs which is the reservoir drain capacity. This drop inlet structure consists of a square concrete box approximately 36 inches on each side with an approximately 24 inches long weir on the west side. The outlet pipe is a 24 inch corrugated metal pipe which takes the water from the Treatment Basin to the outfall at Kanawha River. The primary overflow structure was observed to be working properly, discharging flow from the pond, and visually appeared to be in satisfactory condition. There was no sign of clogging of the spillway and the water exiting the outlet was flowing clear. Figure 5.3.1-1 shows the low inlet overflow structure.

Figure 5.3.1-1. Low Inlet Overflow Outlet Structure at the North Corner of the Treatment basin.

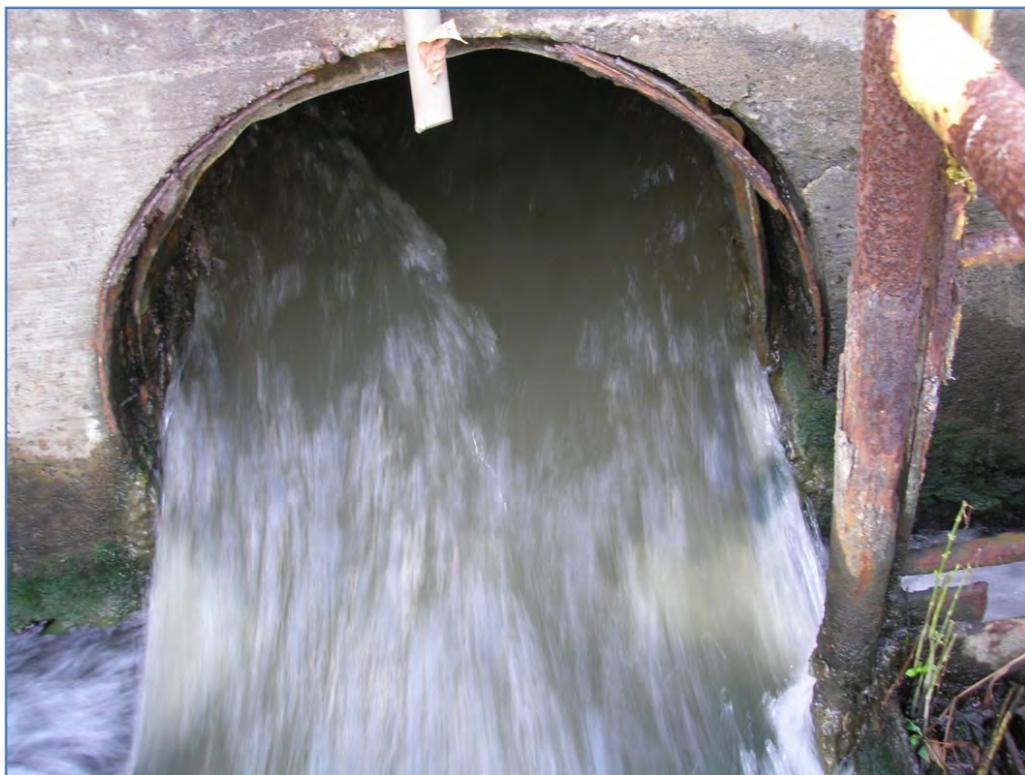
The outlet pipe is a 24 inch corrugated metal pipe which takes the water from the Treatment Basin to the outfall at Kanawha River. Figure 5.3.2-1 shows the outlet end of the Treatment Pond Spillway discharging water to Kanawha River. There is a minor crack on the headwall of the outlet section. The visible section of the outlet conduit seemed to be in good condition with no sign of flow blockage.

Figure 5.3.2-1 The outlet of the Treatment Pond Spillway Discharging Water to Kanawha River.

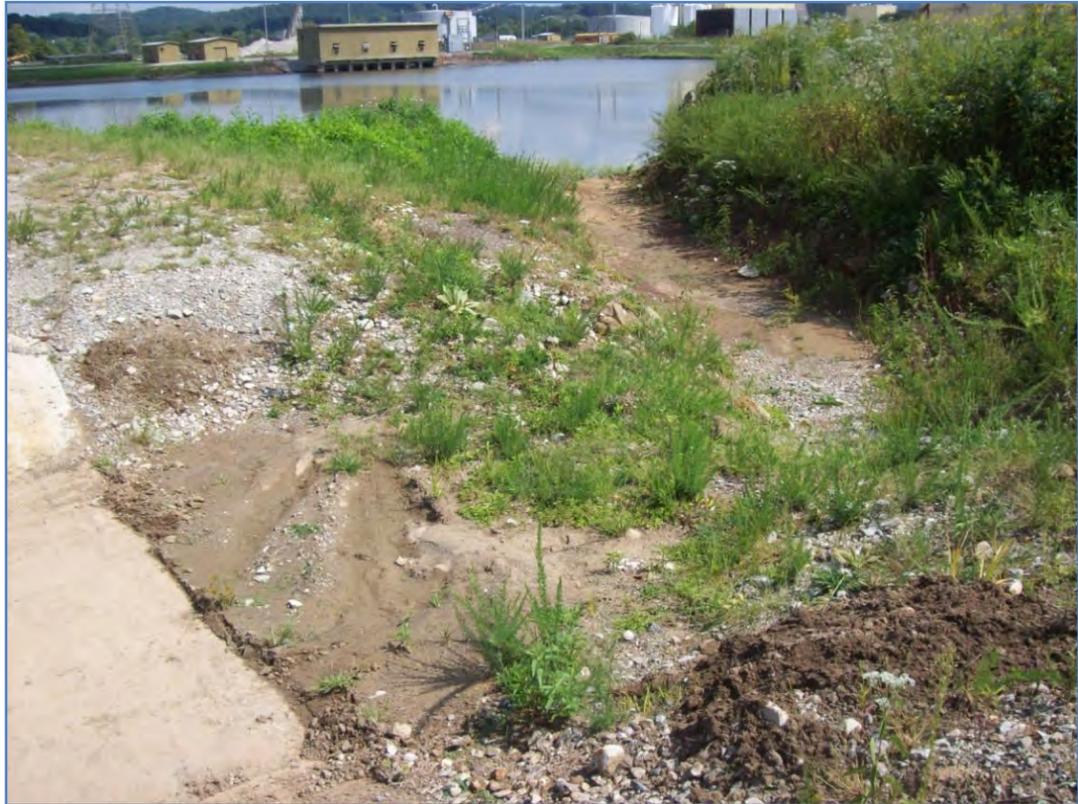
Figure 5.3.3-1. Approach Channel to Emergency Spillway Excavated to on the Main Dam Embankment. The Upstream Side of the Overflow Concrete Spillway is Visible on the Left Side of the Picture.

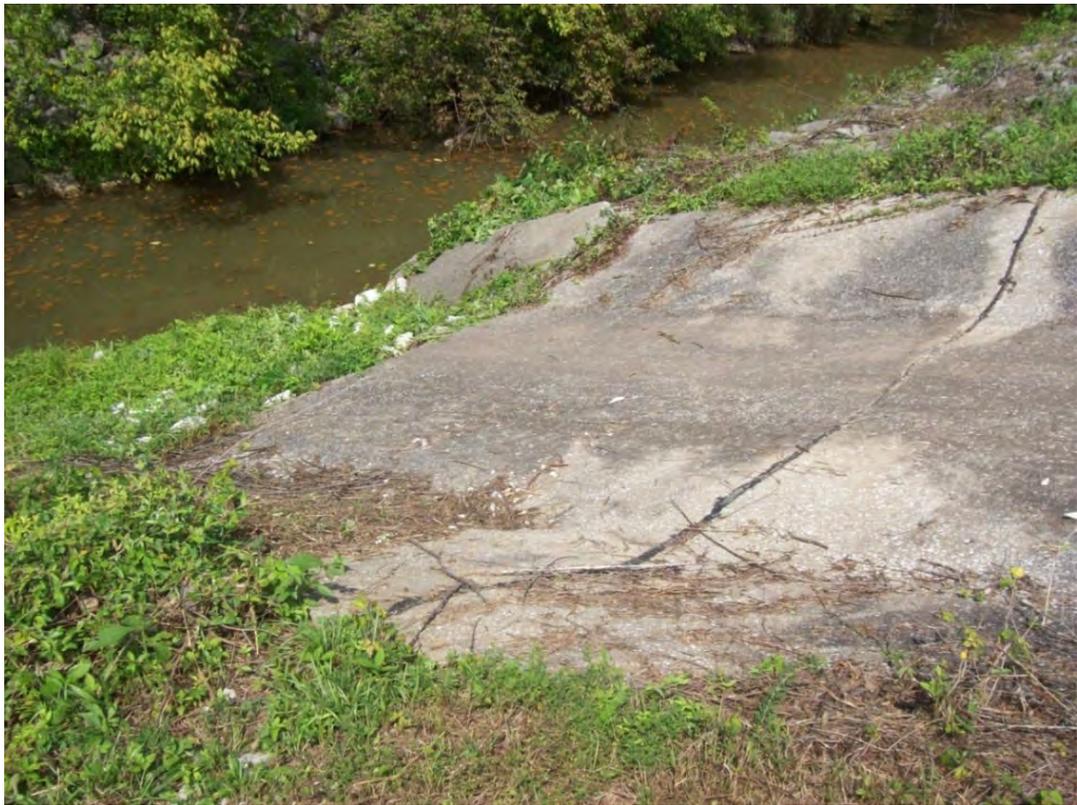
on the slope needs to be monitored and repaired with sign of further deterioration. Other than the concrete breakage, the spillway appeared to be in good condition with no sign of clogging.

Figure 5.3.3-2. The Downstream View of the Emergency Spillway. The Broken concrete Section Filled with Rip-rap and Covered with Grass is Visible on the Downstream Side.

- Upon approval of the proposed upgrades to the Bottom Ash Pond complex, proceed with due speed to implement the improvements.
- The observed crack in the concrete spillway discharge channel and the vegetation in the joints should be sealed and repaired as needed, especially if the spillway is not removed with the proposed modifications to the complex;

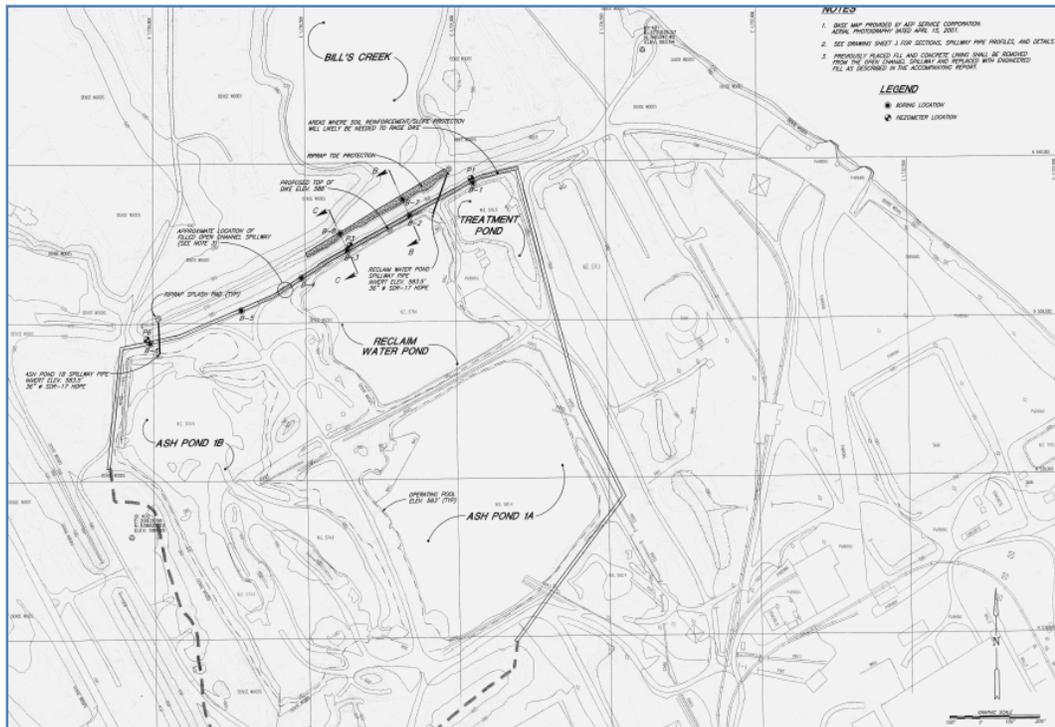
There was no instrumentation plan provided. Figure 9.2.1-1 shows the location of the piezometers and the borings used for the dam modification study (image from Appendix A- Doc 04).

Figure 9.2.1-1- John Amos Bottom Ash Pond Piezometer and Boring Locations for the Dam Modification Study.
