# Assessment of Dam Safety Coal Combustion Surface Impoundments (Task 3) Draft Report

American Electric Power

Cardinal Power Plant

Brilliant, Ohio

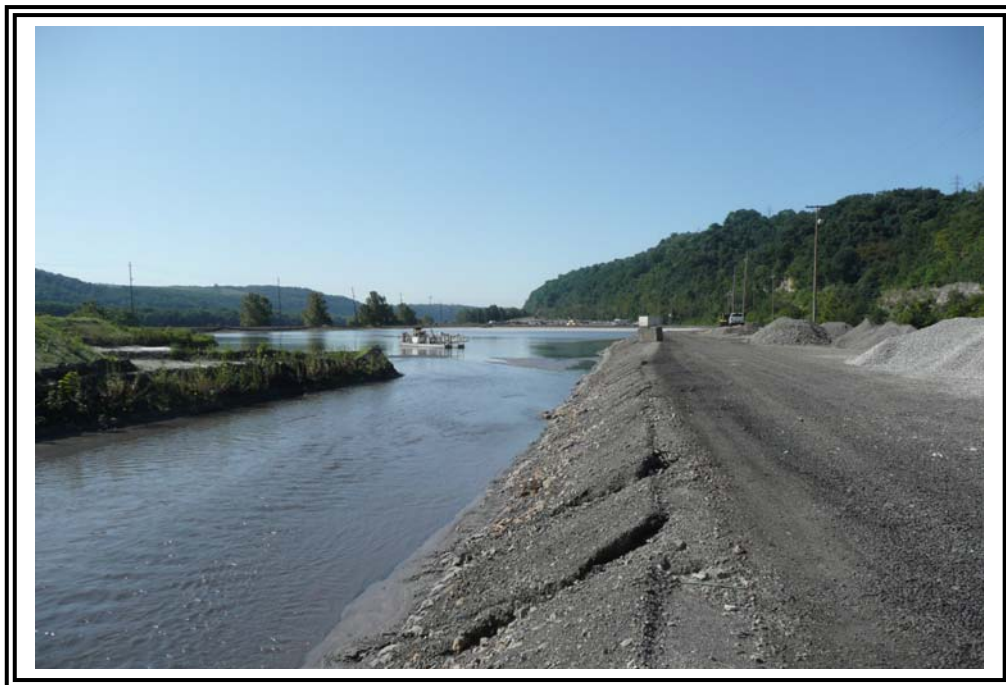
8

Upstream slope and crest of west dike looking south. Note erosion rills in granular surface

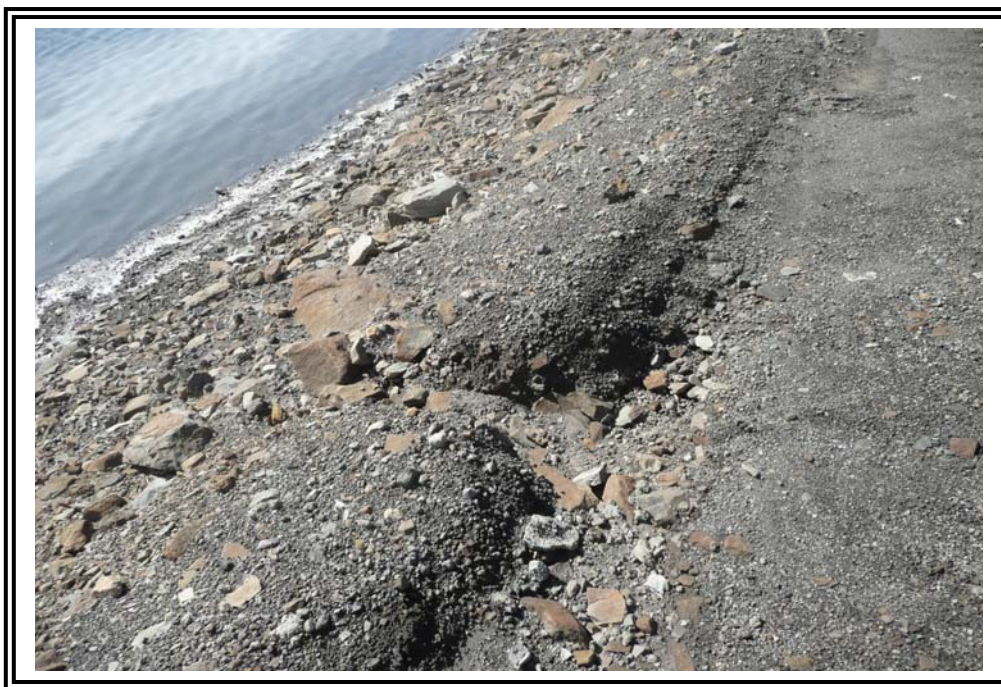
Up-close view of erosion noted in Photo # 11 showing large rock fragments in dike material.

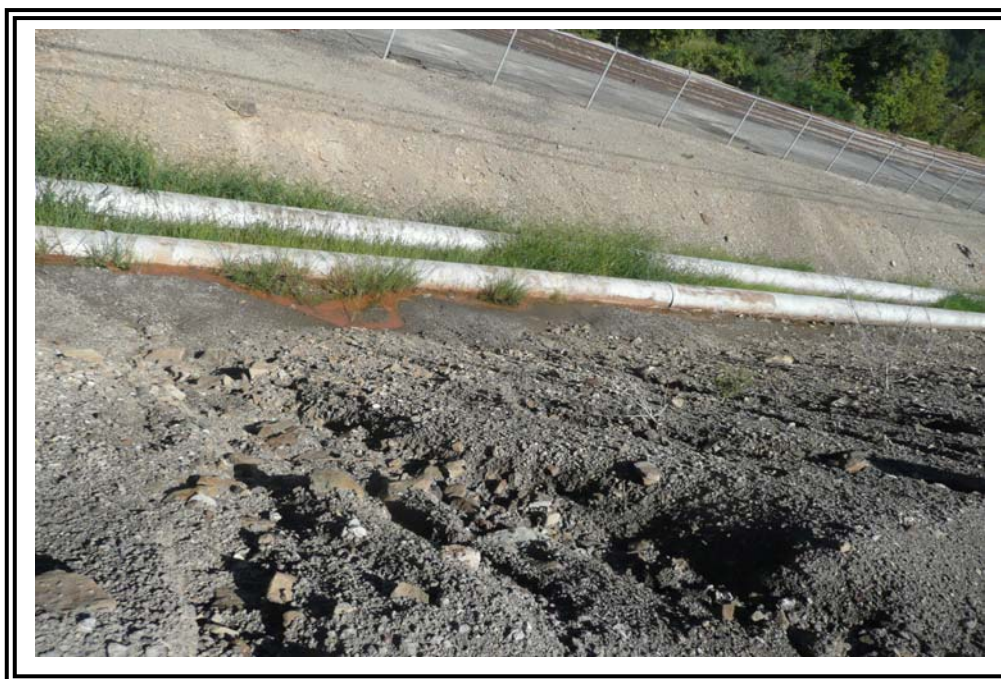
The dike toe area terminates in a drainage swale that also functions as a pipe trace for the recirculation pipes. This drainage swale conveys runoff and other facility surface flow into the site sump located at the north end of the Bottom Ash Pond and pumps that water into the pond. During the site visit, standing water was observed in the drainage swale along approximately 2/3 of the dike length. This water had a reddish brown color in some areas where the pipes had been partially submerged, however it was difficult to determine if the water coloration was due to corrosion or loss of pipe coating. An attempt to probe the toe area in the standing water indicated firm conditions. Given the 30-foot width of the dike and the fairly low head differential of about 5 feet, the water in the swale is not likely hydraulically connected to the pond. However, the grass growth in the swale at that area does suggest that water collects there and stands for a period time. Photos 12 and 13 show the water collected in this area of the toe swale.

Downstream slope of the west dike, looking west. Note surface erosion and reddish brown water collecting in drainage swale around pipes showing signs of apparent corrosion and loss of coating.

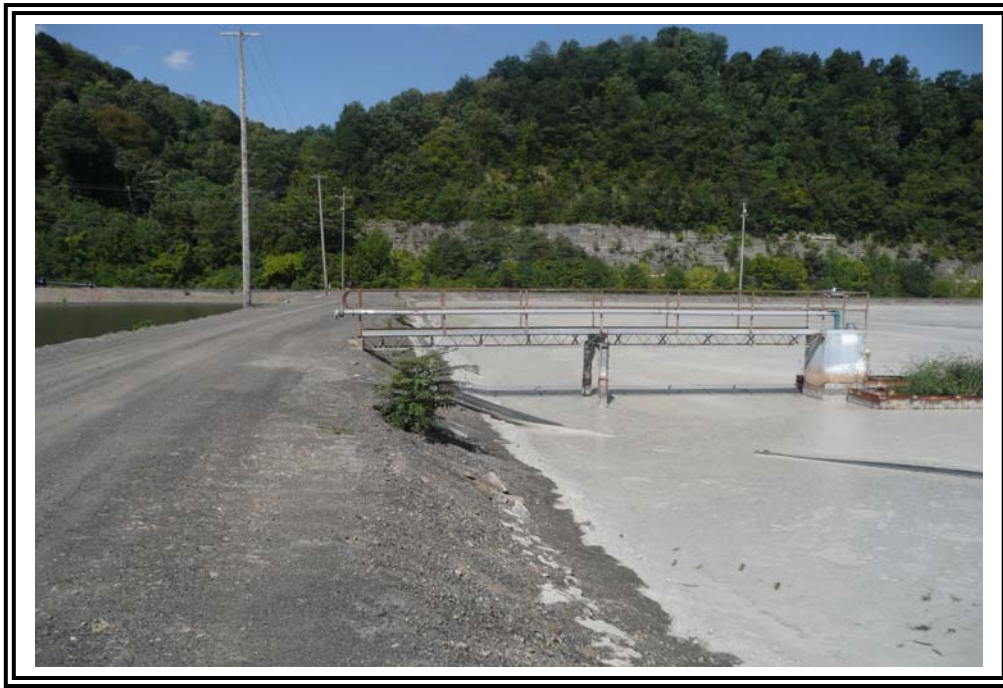
19

Upstream slope and crest of separator dike, looking west. Note isolated vegetation.

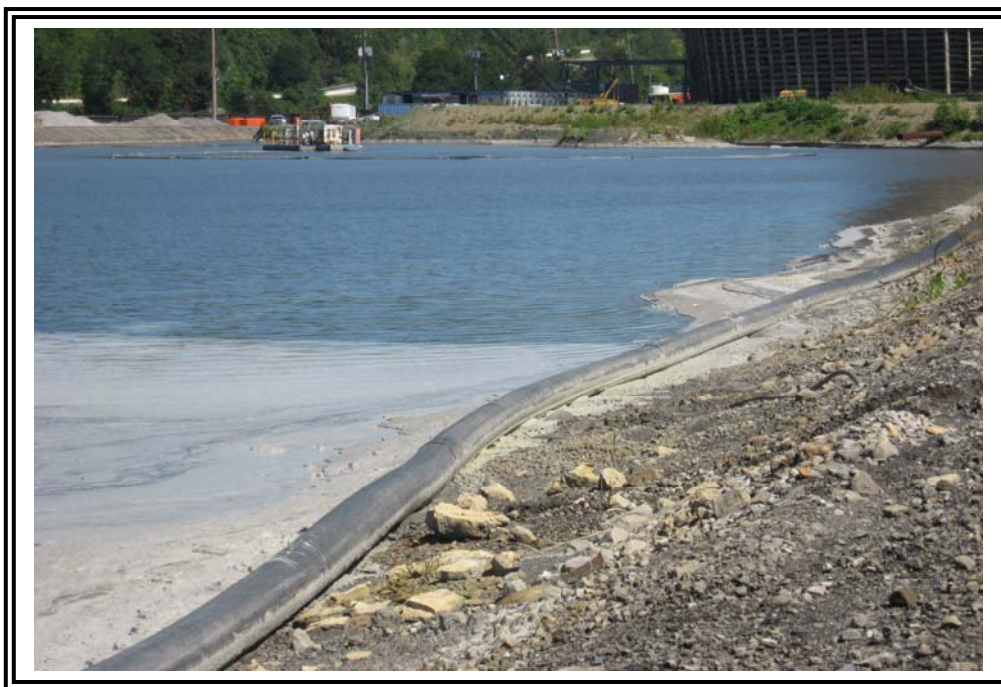
21

The upstream face of east dike is essentially non-vegetated with a fairly coarse granular surface. Erosion from crest runoff has exposed fairly large sized rock fragments in the slope as shown in Photo 21. Beyond the intermittent erosion rills, cracking, slumping, or slough was observed in the upstream face.

Closer view of upstream slope of east dike, looking north.

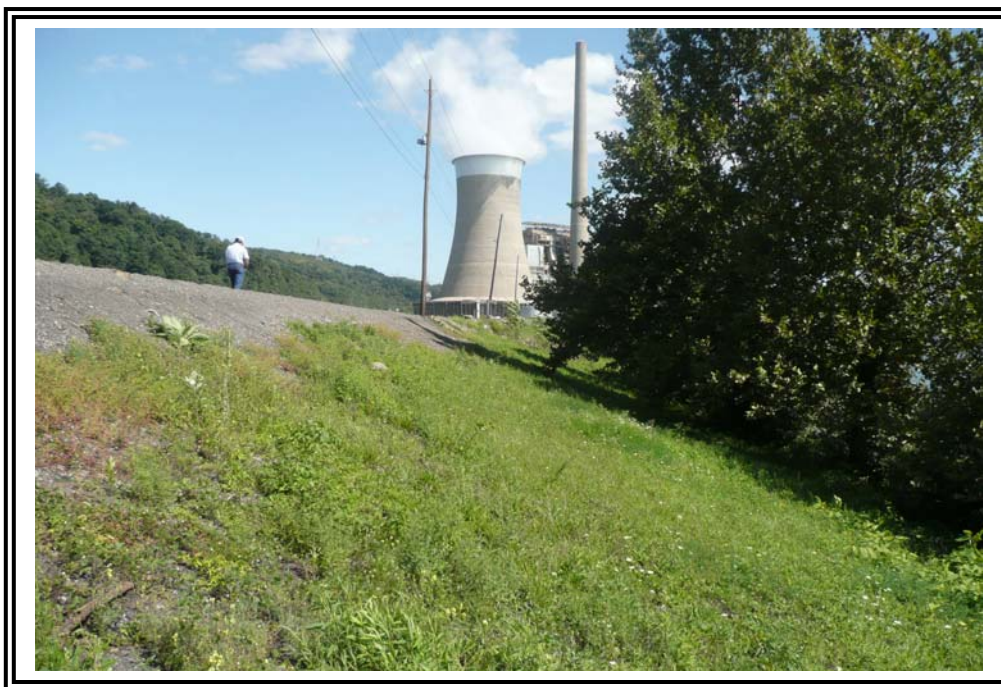
23

The downstream face of the dike was generally vegetated up to within about 3 to 5 feet of the crest as shown in Photos 22 and 23. In areas adjacent to the river a change in vegetation from grasses and weeds to heavier broad leafed plants and woodier brush and trees can be observed. Based upon the available topographic mapping and older design plans, this vegetation change appears to be where the constructed slope transitions to the river bank. Several of the trees were fairly mature on the order of 16 to 24 inches in diameter. Photos 24, 25, 27, and 28, show examples of this vegetation change. Soil conditions in the slope at these vegetation changes were firm to hand probing and did not exhibit excessive moisture.

Downstream slope of east dike, looking north, showing effect of routine grading activities at the crest where vegetation is not established.

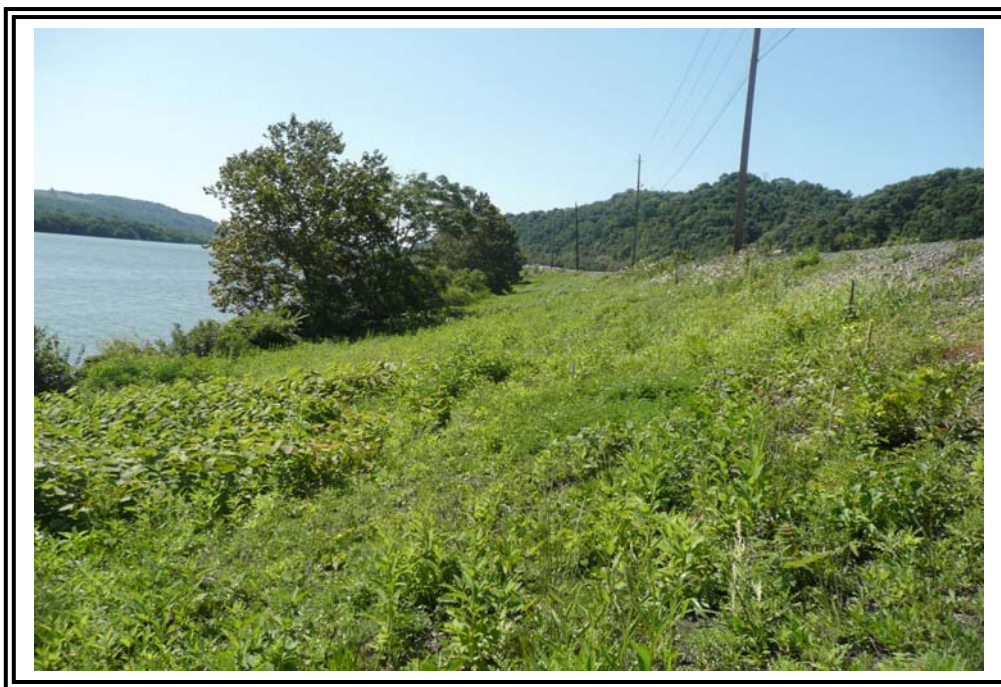
27

Downstream slope of east dike, looking south. Typical loss of vegetation shown at crest and change in vegetation shown adjacent to river bank.

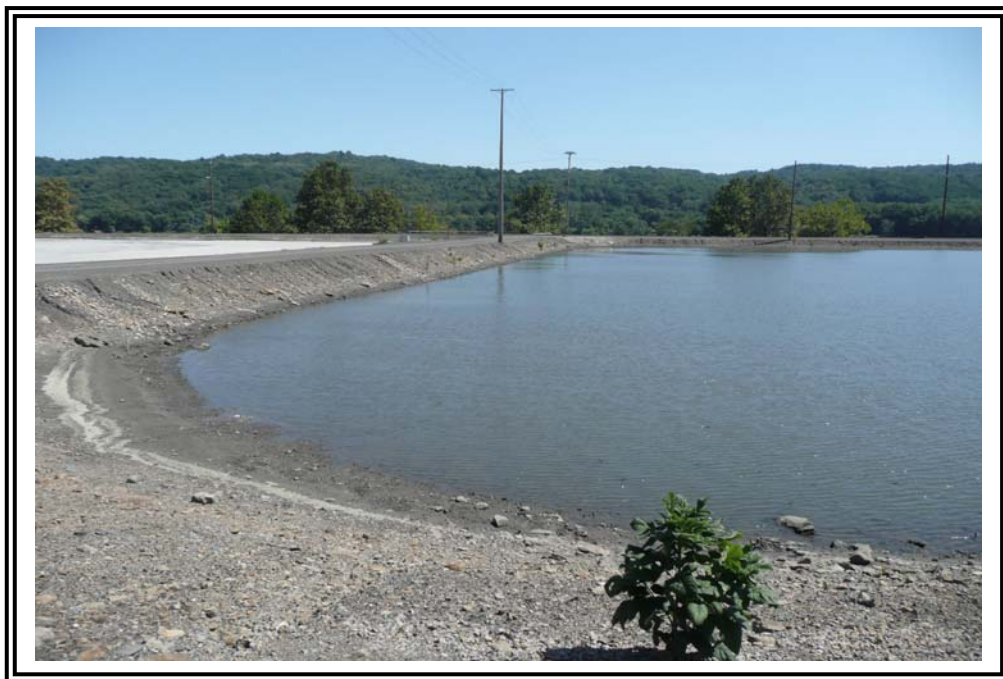
34

The separator dike has a general granular surface and is sparsely vegetated in similar fashion to the west dike as shown in Photos 16 and 34. Erosion features typical of the west dike are evident on this dike which is also about 10 feet wider at the crest than shown in the original site drawings (total measured width of approximately 31 feet). No unusual slumps or bulges were observed in the upstream or downstream slope.

Downstream slope of the separator dike on the north side of the pond. Erosion features noted in separator dike slope.

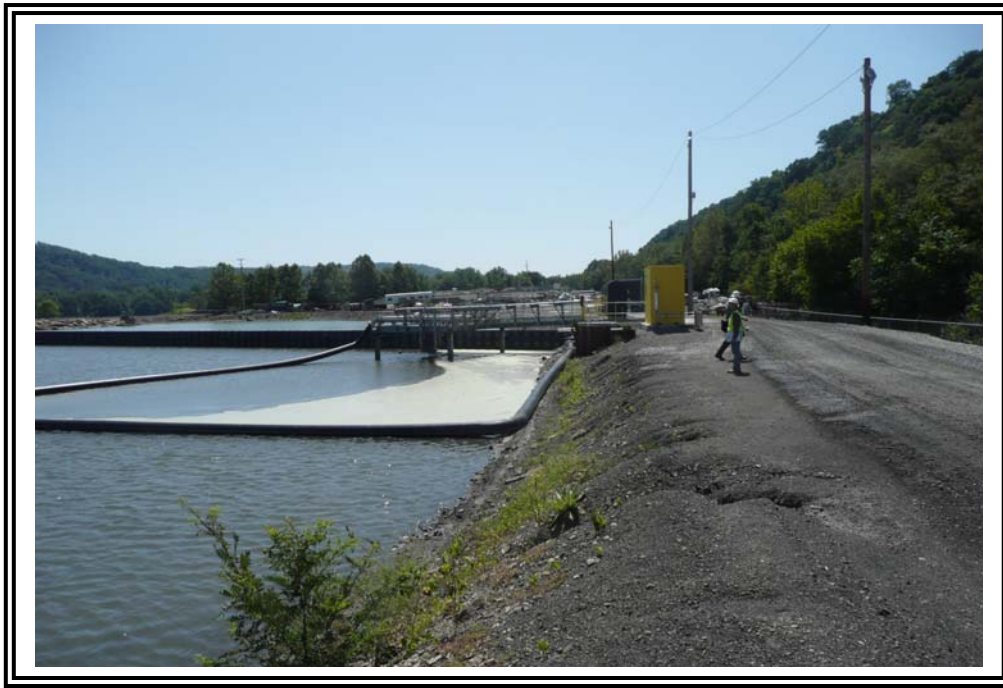
37

Upstream slope and crest of west dike, looking south. Note erosion feature and isolated brush. Vinyl sheet pile wall is in background.

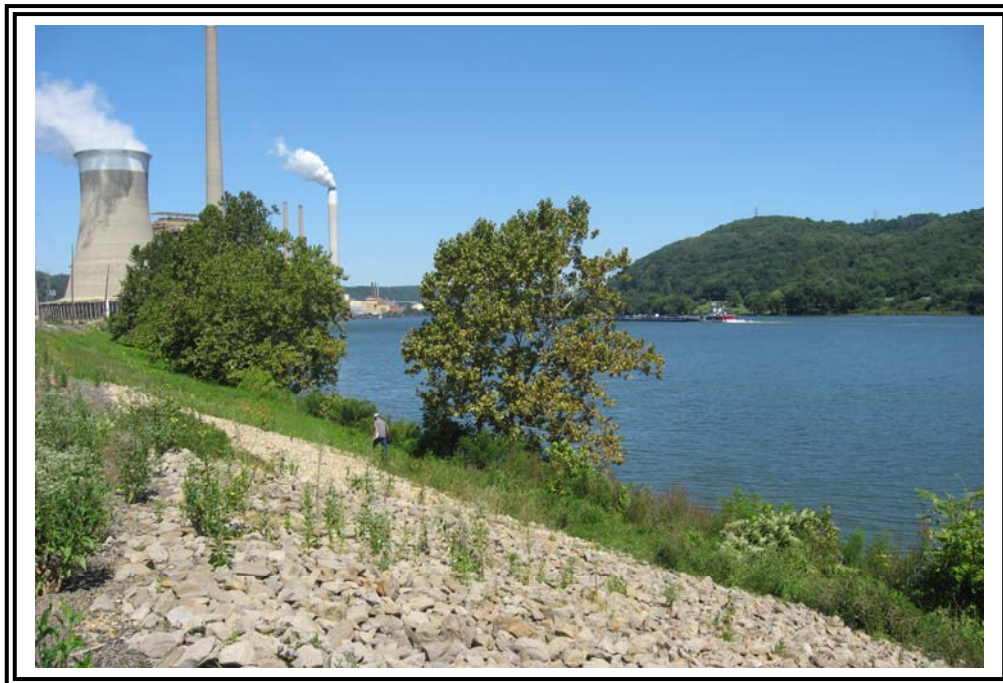
46

The downstream face has had a stone slope repair apparently as a result of seepage (Photo 46). This area covers roughly half of the Recirculation Pond dike length and appeared dry during the site visit with no outward signs of seepage. Beyond the slope protection area, the downstream slope is vegetated with the exception of the top few feet at the crest where sight grading activities have affected the vegetation growth (Photos 49 and 50).

Looking north on east dike at stone facing in area of apparent seep.  
Seepage was not readily observed during site visit.

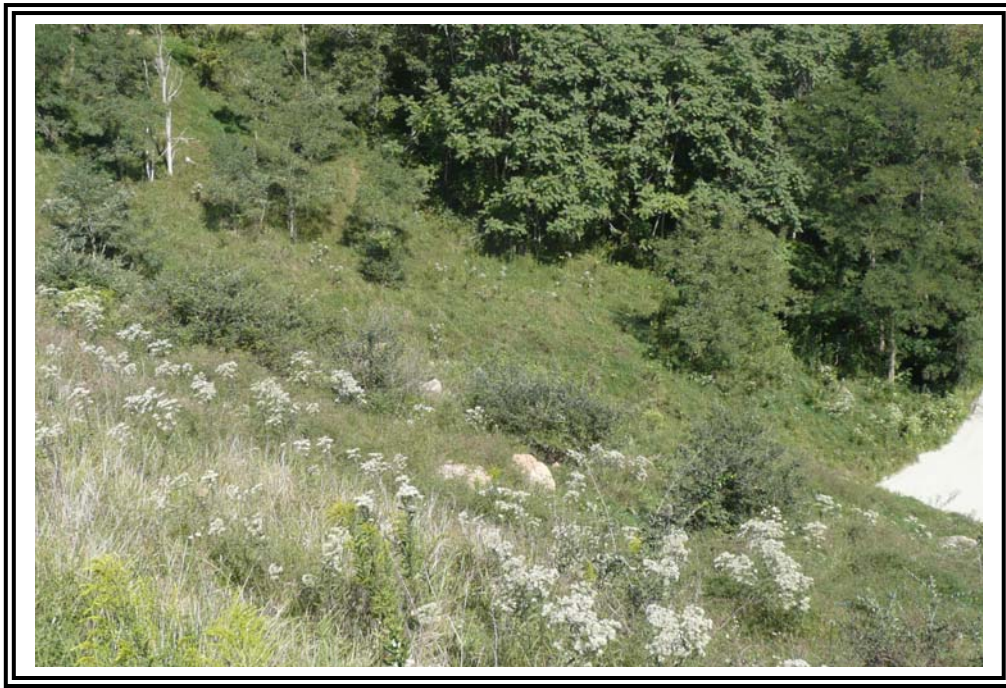
The downstream slope is heavily vegetated and armored with large rip rap (Photos 51 and 52). This rip rap has deteriorated over time and the heavy vegetation obscured much of it, giving it the appearance of having been randomly placed (Photos 59 and 60). Heavy vegetation was also observed in the north (left) abutment groin (Photos 57 and 58).

Downstream slope showing sporadic rip-rap (boulders).

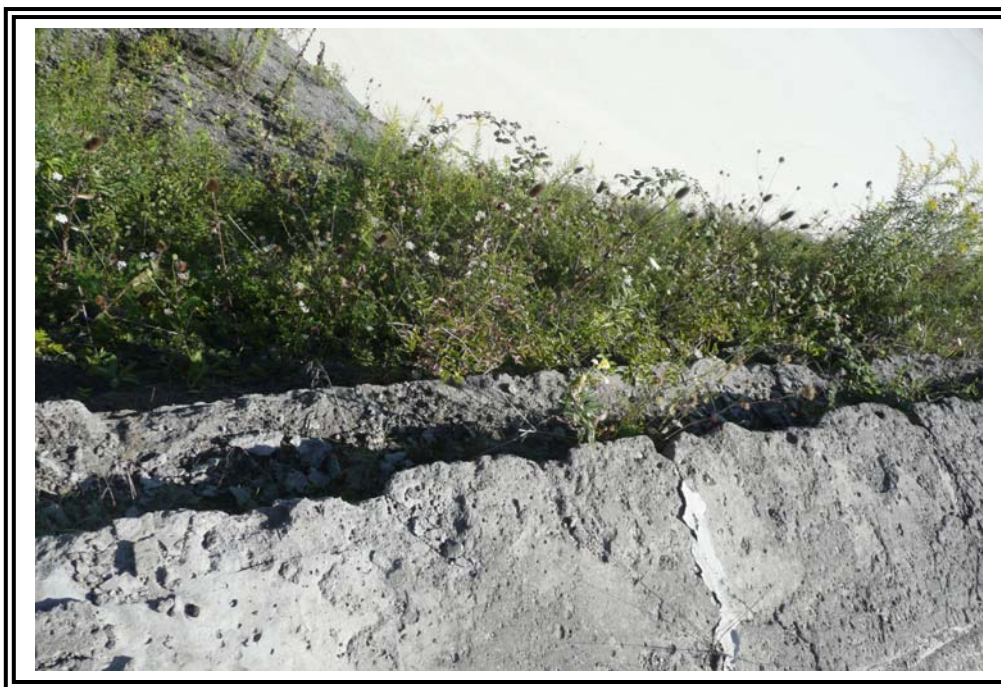
Weathering effects were also observed in the roller compacted concrete surface during the site assessment. These occurred in the form of edge spalling and isolated erosion (Photos 69 and 72) in the outer surfaces of the material.

Close-up at weathered roller compacted concrete (RCC) surface and sealed crack on crest at upstream face.  
Note vegetation below crest level.

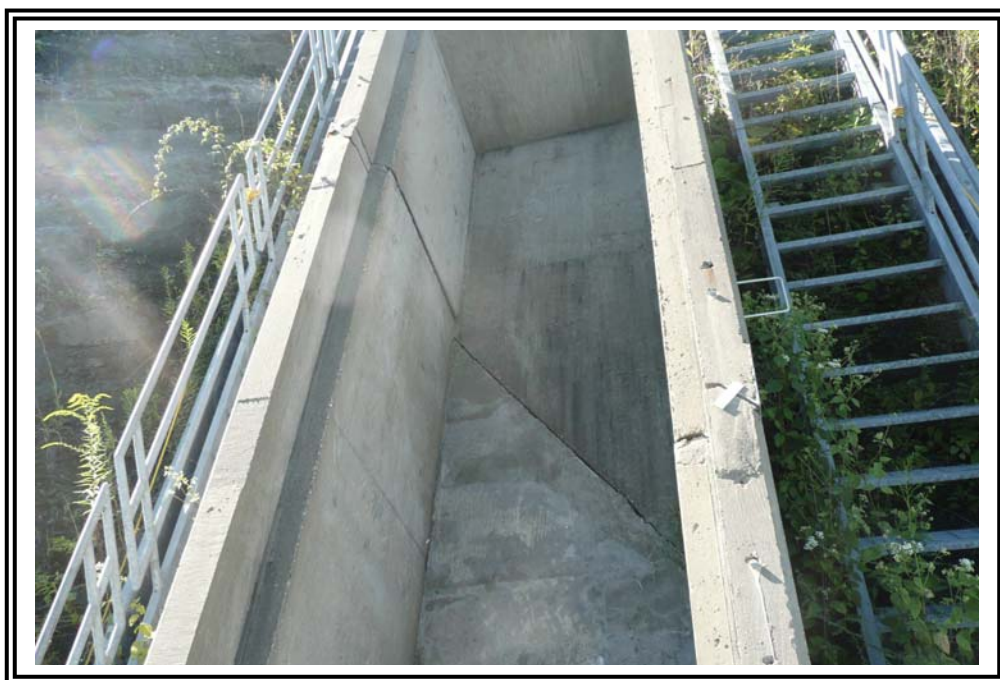
Fly Ash Dam No. 2 has an inclined Principal Spillway connected to a 54-inch diameter prestressed concrete cylinder pipe through the RCC embankment which transitions to a 42-inch diameter steel pipe. This steel pipe is exposed along the east abutment and outlets at the base of the slope in a concrete energy dissipater (Photos 99 and 107). The inclined spillway was constructed with a diagonal construction joint to allow potential deformation along a crack in the RCC that had formed while the RCC was being placed. Crack deformation gauges have been placed along this joint to track movement (Photo 74 and 75). Shear displacement along this joint was not readily observable.

Inclined spillway looking at upstream face. Note diagonal construction deformation joint. Joint was formed to allow for some deformation due to crack in RCC during construction.

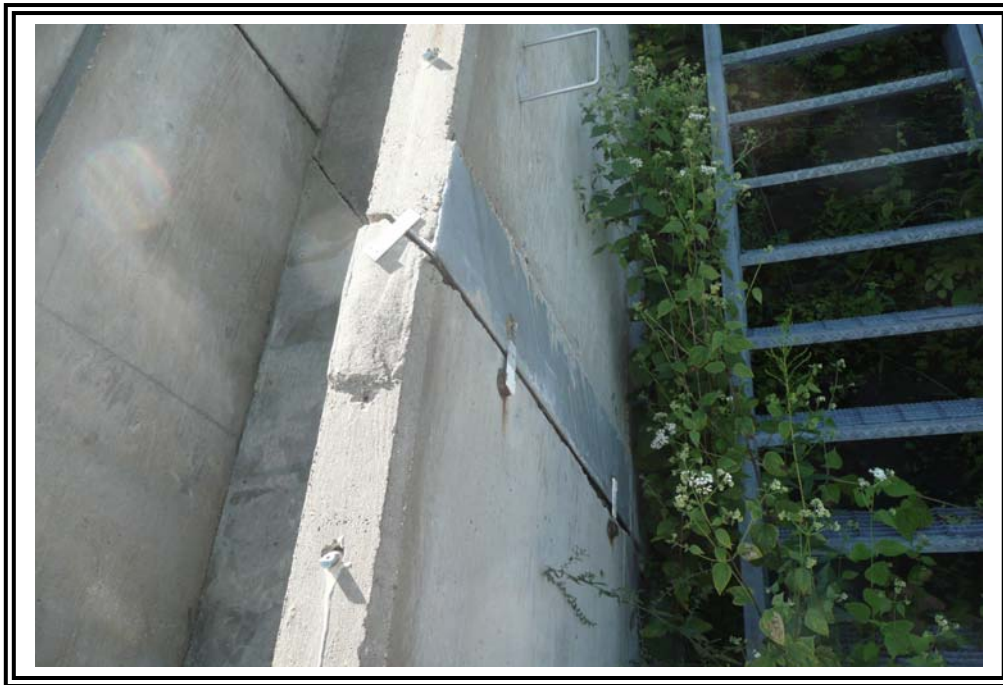
75

Close-up of crack gauges on inclined spillway diagonal joint.

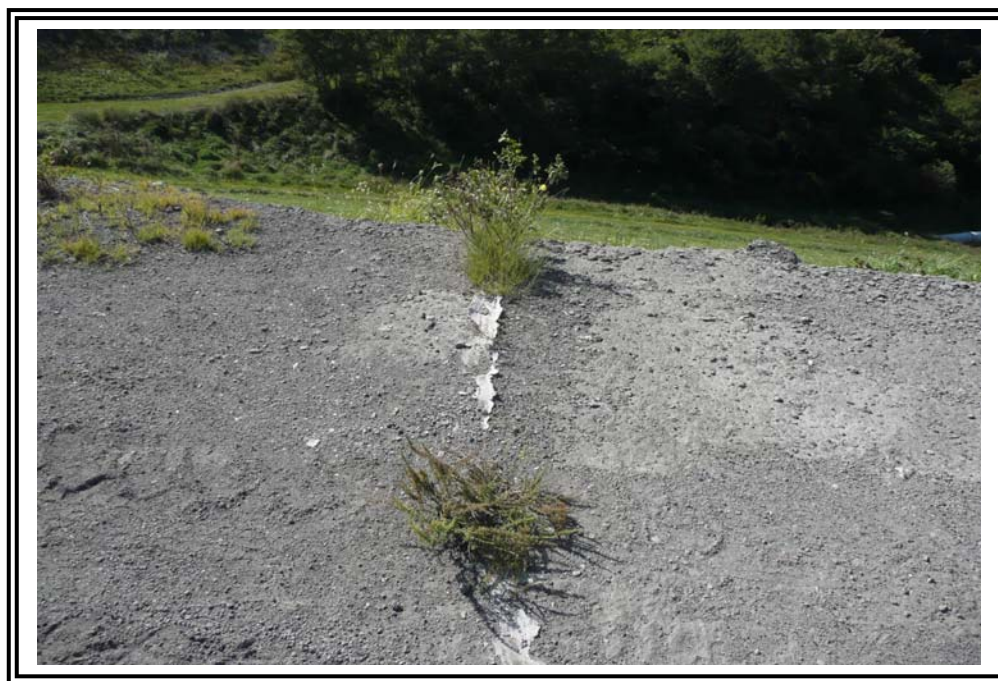
78

Two distinct cracks sealed with caulking were also observed in the crest adjacent to the west (right) abutment and spillway (Photo 78). These cracks apparently occurred during the RCC construction as a result of differential settlement between the RCC crest supported directly on the

Surface expression of sealed crack at crest in RCC that initiated the diagonal joint the in inclined spillway.

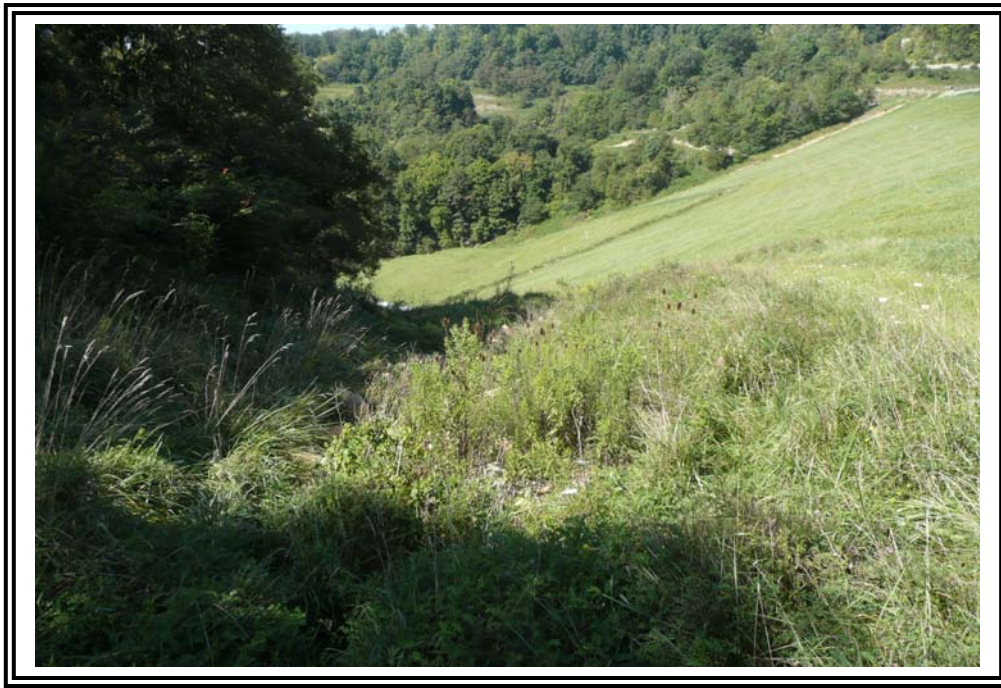
85

Left (east) rock groin at abutment contact. Note moderate to heavy vegetation.

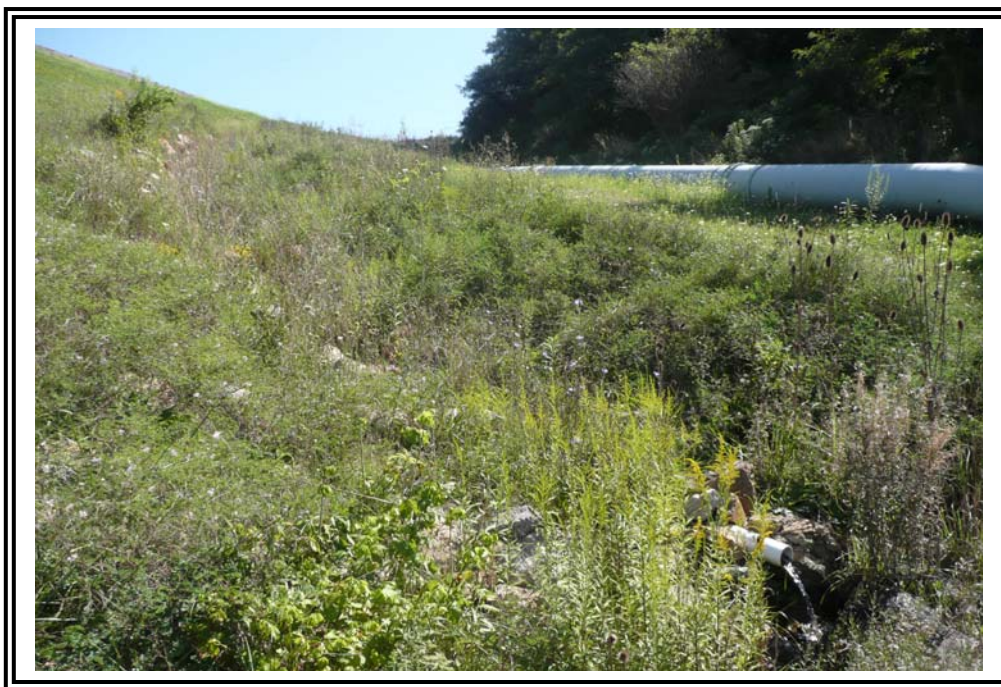
87

Active seepage outlet in left (east) rock groin. Water flowed clear.

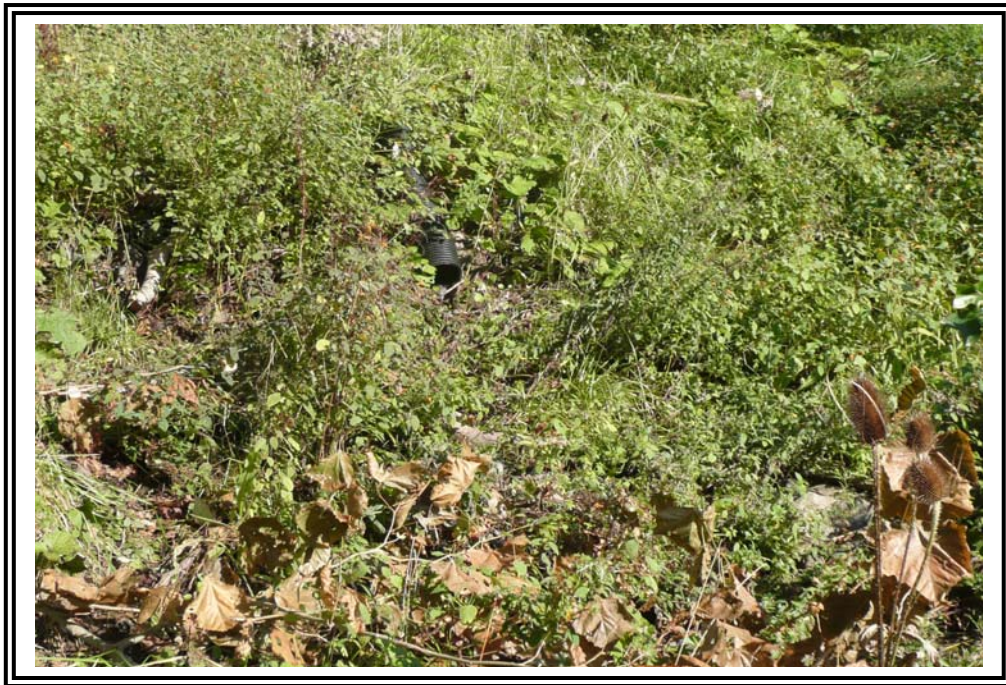
89

Active drain exiting from natural hillside feeding into right (west) groin. Note brush vegetation.

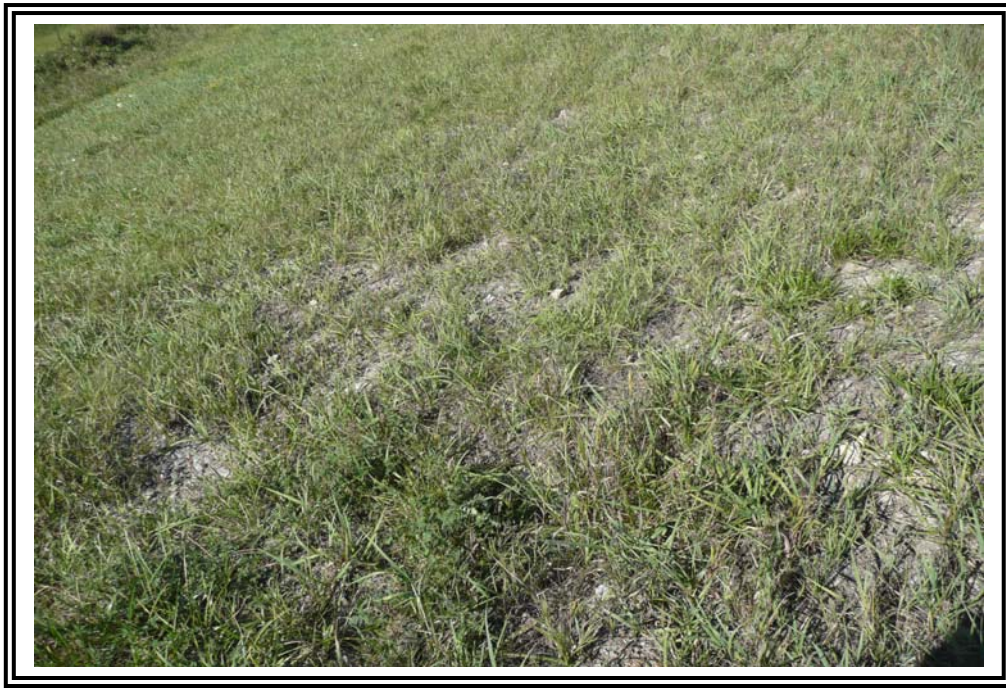
103

Isolated loss of grass cover and possible erosion on upper portion of downstream slope above slope groin.
