**Coal Combustion Residue Impoundment  
Round 9 - Dam Assessment Report**

*Clinch River Power Plant*  
*Ash Pond Management Units*  
*Appalachian Power*  
*d/b/a American Electric Power*  
**Carbo, VA**

Dewberry & Davis, LLC  
Fairfax, Virginia

**April 2011**

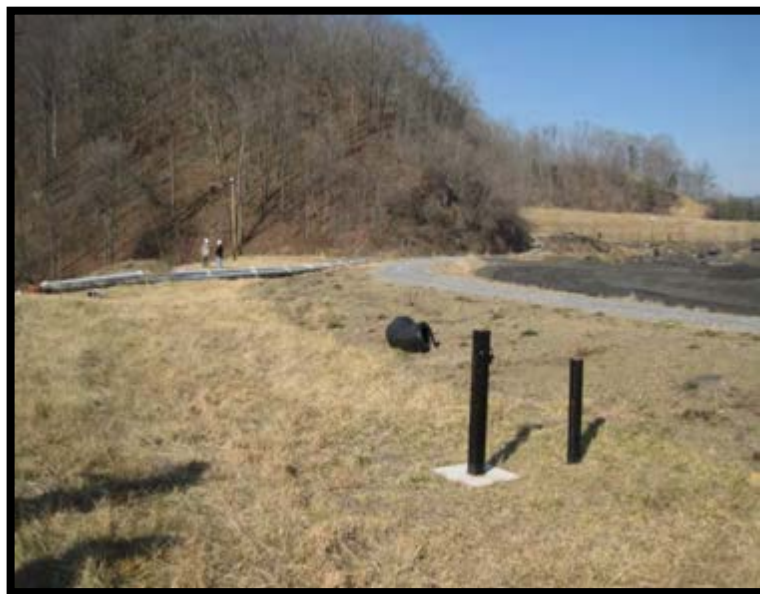
The crest of the perimeter dike had no significant signs of depressions, tension cracks or other indications of settlement or shear failure. Figure 5.2.1-1 and Figure 5.2.1-2 shows the typical crest conditions along the perimeter dike.

**Figure 5.2.1-1:** Crest, West. Clinch River Power Plant to left not seen in this figure.

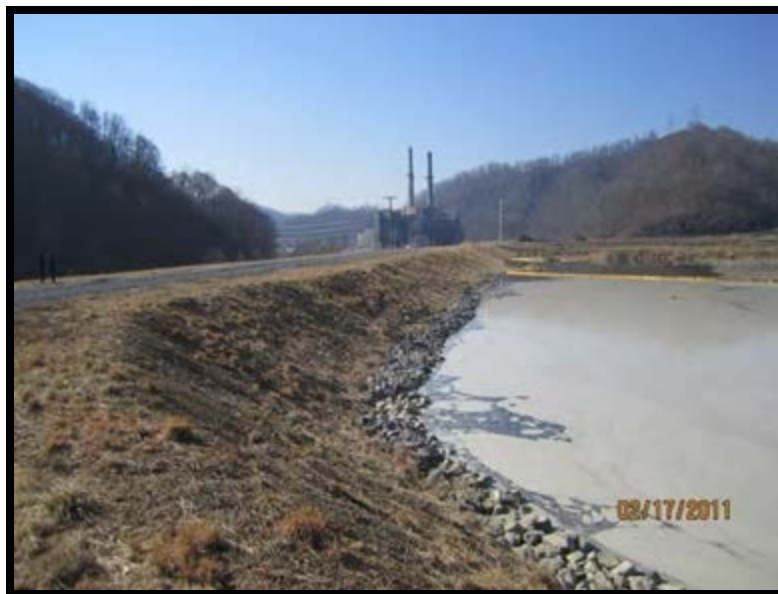
The visible upstream slope of the perimeter dike, including all groins, had adequate and well maintained cover of grasses/weeds. The upstream slope below the permanent pool was not observed. There were no obvious signs of scarps, bulging cracks, depressions or other indications of slope instability. Rip-rap armoring was observed at operating pool elevations to mitigate wave erosion. Figure 5.2.2 shows a representative upstream slope section of the perimeter dike looking south.

**Figure 5.2.2:** Upstream slope, South. Plant shown in background.

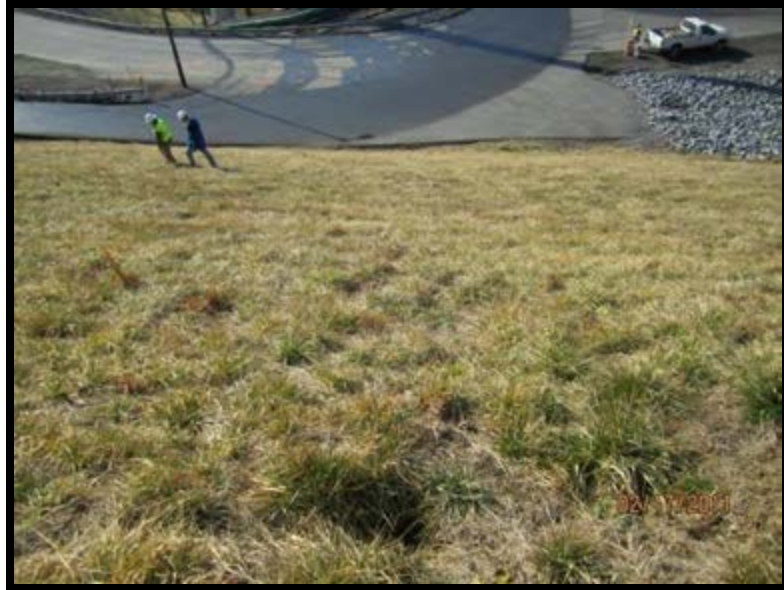
**Figure 5.2.3-1:** Downstream slope near access road entrance off Route 665. Note animal burrow near the crest.

It is recommended that all animal burrows located along the perimeter dike of Ash Pond 1 and Ash Pond 2 be backfilled in accordance with standard geotechnical engineering practices for dams, and monitored for future reoccurrence.

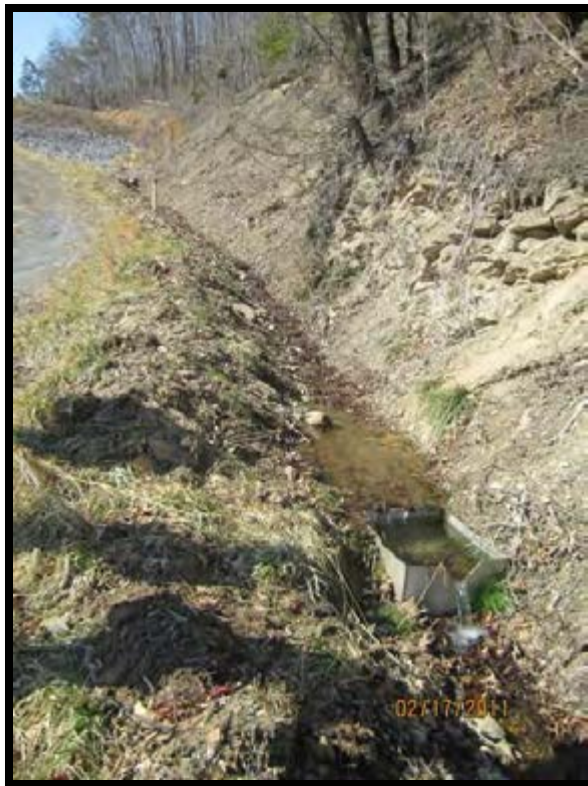
The perimeter dike has two abutments; the south and north abutments. Both abutment contacts consist of a drainage ditch. The south ditch shows some signs of erosion due to wet weather flow runoff from the adjacent hillside. The north ditch appeared in better condition with some stone and a v-notch weir that is used to monitor seepage, which was present on the day of the assessment. Apart from some minor erosion along the south abutment ditch, both abutments were well maintained. There were no observed scarps, sloughs, bulging, cracks, depressions or other indications of slope instability. Figures 5.2.4-1 and 5.2.4-2 show south and north abutment contacts.

**Figure 5.2.4-1:** North abutment ditch. Note upstream riprap and v-notch weir used to monitor seepage.

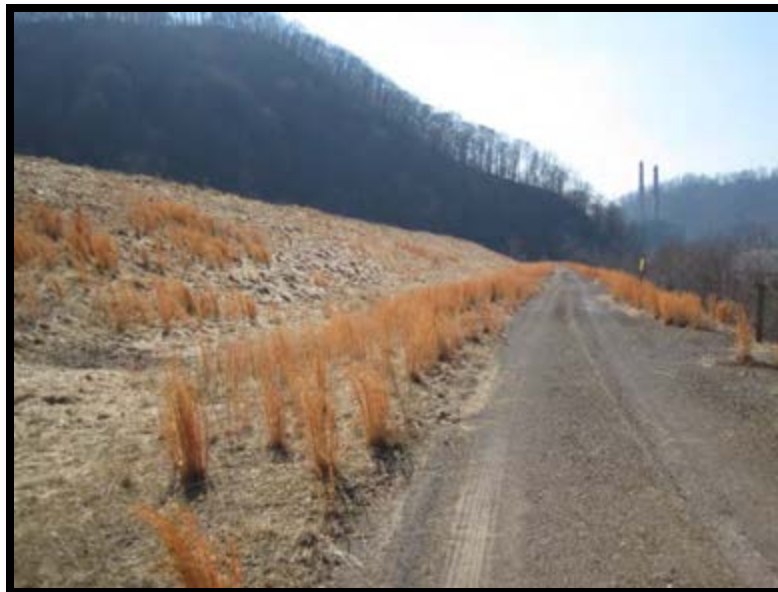
Portions of the upper dike have been removed and some re-grading has been completed near the crest of the middle dike. A small sized animal burrow was observed along the crest of the middle dike. No depressions, tension cracks or other indications of settlement or shear failure were observed on the crest of the middle or lower dike. Figure 5.3.1-1 and Figure 5.3.1-2 show typical crest conditions along the dike.

**Figure 5.3.1-1:** Lower dike crest, South.

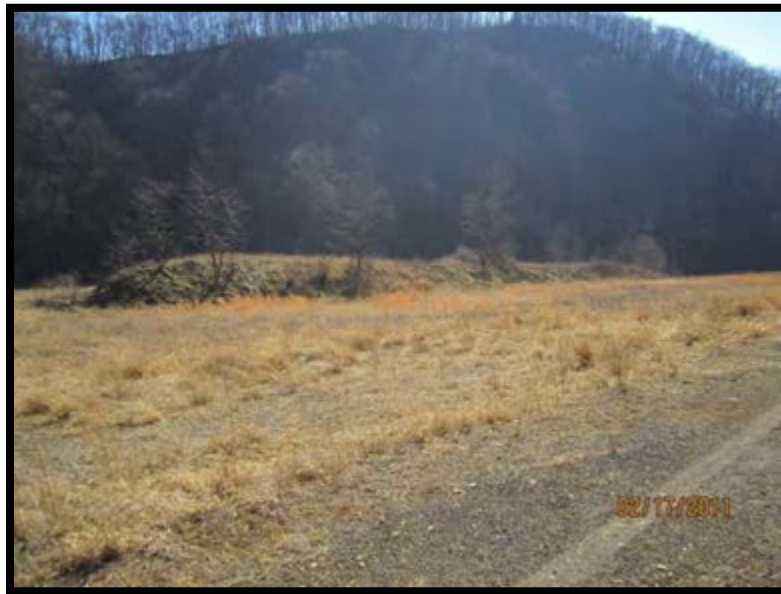
The downstream slopes of the dikes are covered in high grass/weeds. The upper dike had some areas of tree growth. Significant tree growth between the toe of the lower dike and Dumps Creek made visual observations difficult. Based on what could be observed there were no scarps, sloughs, bulging, cracks, depressions or other indications of slope instability along any portion of the dikes. Figures 5.3.3-1 thru 5.3.3-3 show representative sections of the downstream slopes and toe.

**Figure 5.3.3-1:** Remaining portion of upper dike, Southeast. Note tree growth on downstream slope.

It is recommended that all underbrush and trees be removed from the Ash Pond 2 perimeter dike in accordance with VA DCR, Division of Dam Safety requirements.

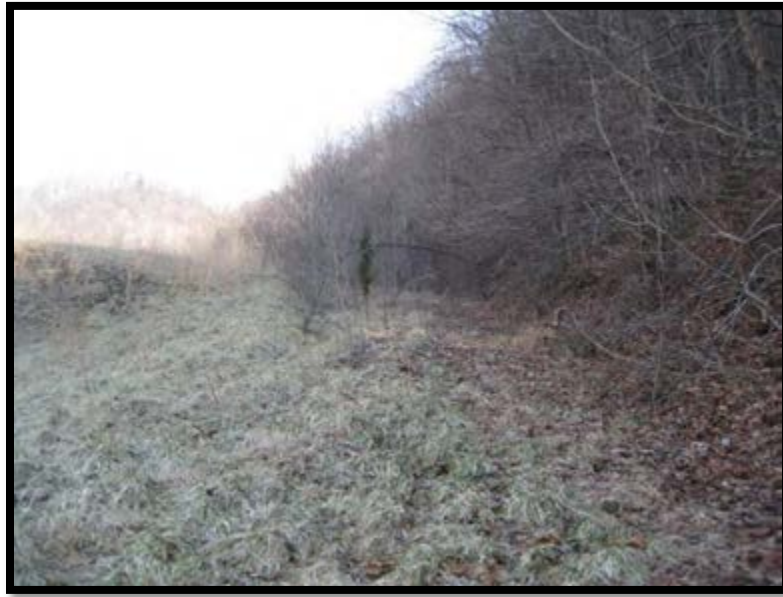
There were no observed scarps, sloughs, bulging, cracks, depressions or other indications of slope instability at dike abutments and groin areas of upper dike. Significant tree growth was observed along south abutment as shown in Figure 5.3.4.

**Figure 5.3.4:** South abutment. Note tree growth to the right along hillside; Ash Pond 2 is to the left.

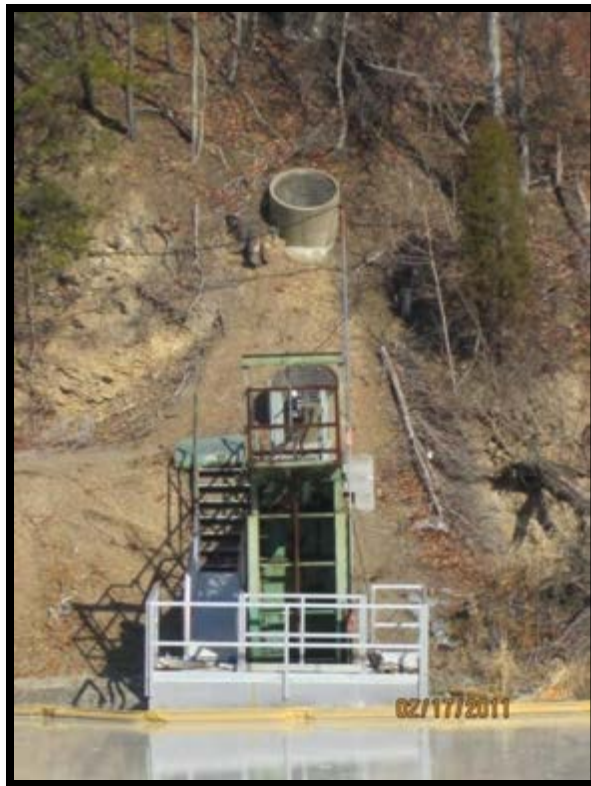
The overflow spillway structure for Ash Pond 1 is located in the north corner of the facility (Figure 5.4.1-1). The structure appeared to be in satisfactory condition and operating as designed. There were no obvious signs of trash and/or debris around the intake. Water was observed entering the spillway but could not be seen exiting the spillway as the outfall pipe consists of a long storm sewer that outfalls into the existing reclaim pond below its permanent pool.

**Figure 5.4.1-1:** Overflow spillway structure

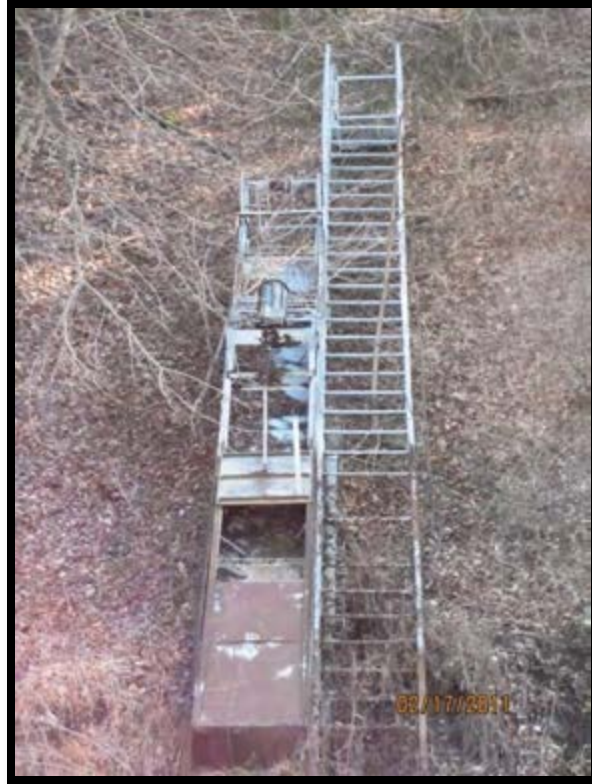
The overflow spillway structure for Ash Pond 2 is located at the eastern midpoint of the facility (Figure 5.4.1-2). The structure appeared to be in poor condition with obvious signs of corrosion and encroaching vegetation. The spillway is currently inactive. Fissures/cracks were observed immediately west of the spillway where it appeared runoff had been migrating into existing ash residuals. The overflow spillway structure is located at an elevation significantly higher than the current finished grade around it. Discharge through the structure and outfall pipes is not possible at this time.

**Figure 5.4.1-2:** Ash Pond 2 overflow structure.

It is recommended that the Owner perform an interior inspection of all outfall pipes from the Ash Pond 1 & 2 outlet structures to the reclaim pond as well as an interior inspection of the pipe systems that bypass off-site drainage through Ash Pond 1. Interior inspections should focus on the structural integrity of the pipes as well as seepage paths into and out of the
