**Coal Combustion Residue Impoundment  
Round 9 - Dam Assessment Report**

*Glen Lyn Power Plant  
Ash Pond Management Units  
Appalachian Power  
d/b/a American Electric Power  
Glen Lyn, VA*

Dewberry & Davis, LLC  
Fairfax, Virginia

Under Contract Number: EP-09W001727  
**April 2011**

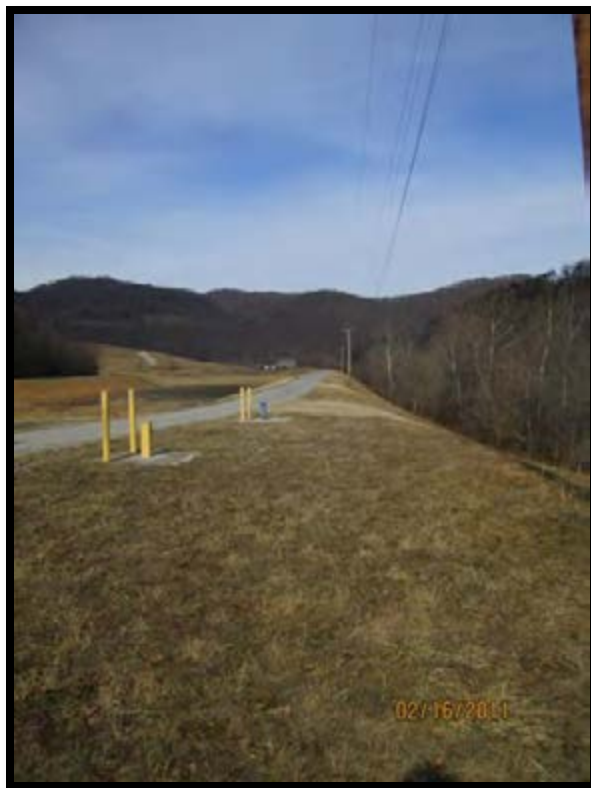
The crest of the perimeter dike had no significant signs of depressions, tension cracks or other indications of settlement or shear failure. Figure 5.2.1-1 and Figure 5.2.1-2 shows the typical crest conditions along the perimeter dike.

**Figure 5.2.1-1:** Crest, Northwest. New River to the right not seen in this figure.

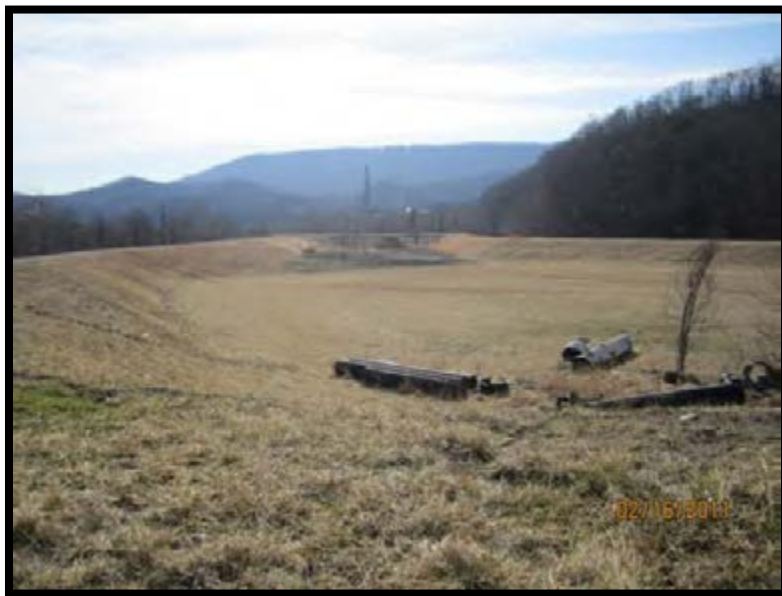
The upstream slope of the perimeter dike, including all groins, had adequate and well maintained cover of grasses/weeds. There were no obvious signs of scarps, bulging cracks, depressions or other indications of slope instability. Some woody vegetation was noted growing on the northwest upstream slope of the pond. Figures 5.2.2-1 and 5.2.2-2 show representative upstream slope sections of the perimeter dike.

**Figure 5.2.2-1:** Upstream slope, Southeast. Note woody vegetation to right in foreground.

It is recommended that all underbrush and trees be removed from the Fly Ash Pond and Bottom Ash Pond in accordance with VA DCR Dam Safety requirements. This includes all woody vegetation at and beyond the toe of the Fly Ash Pond perimeter dike as well as the embankment and toe of the Bottom Ash Pond adjacent to East River.

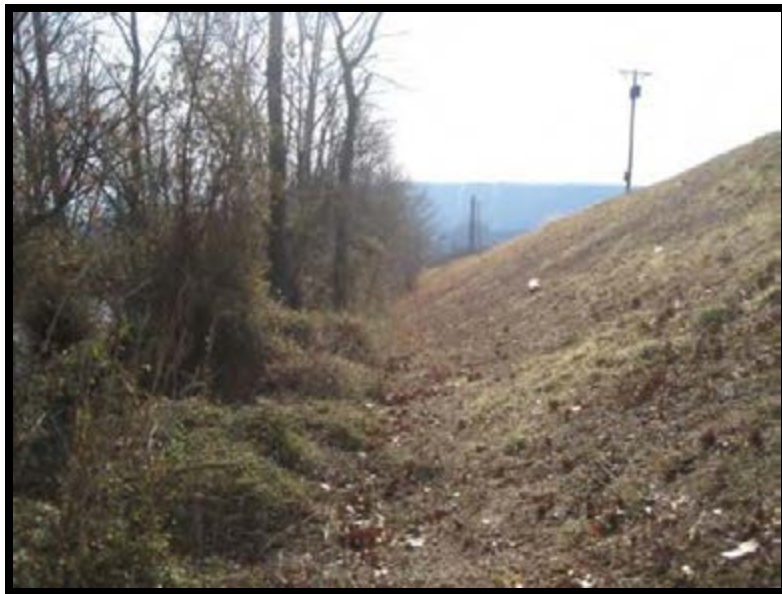
The downstream slope of the perimeter dike is vegetated with various species of maintained grasses and weeds. Significant woody vegetation and underbrush was noted growing at and beyond the toe of the north dike towards the New River. Based on what could be visually assessed, there were no scarps, sloughs, bulging, cracks, depressions or other indications of slope instability. Figures 5.2.3-1 thru 5.2.3-3 show representative downstream slope sections of the perimeter dike.

**Figure 5.2.3-1:** Downstream slope, Southeast. Note woody vegetation and trees growing at toe of the embankment.

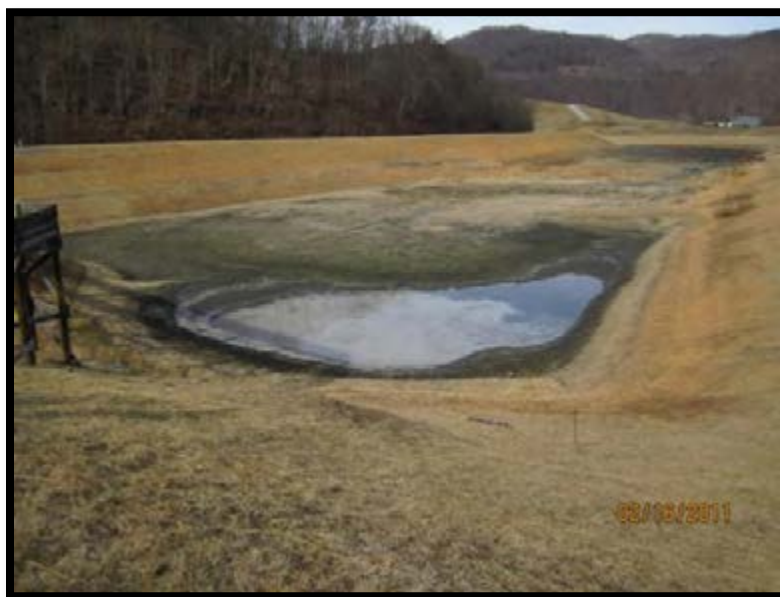
All groins appear stable with a well maintained cover of grass. There were no observed scarps, sloughs, bulging, cracks, depressions or other indications of slope instability.

**Figure 5.2.4:** Groin, Northwest.

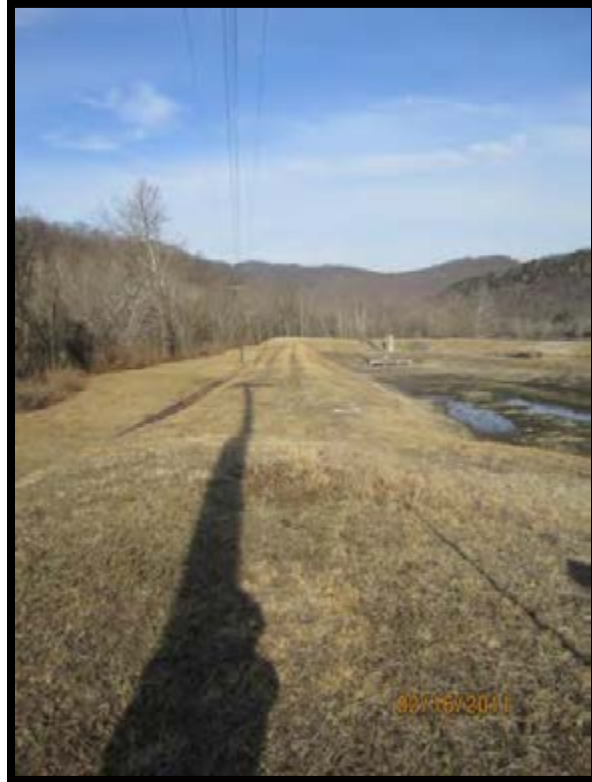
The crest of the perimeter dike had no significant signs of depressions, tension cracks or other indications of settlement or shear failure. Figure 5.3.1-1 and Figure 5.3.1-2 shows the typical crest conditions along the perimeter dike.

**Figure 5.3.1-1:** Crest, Northwest.

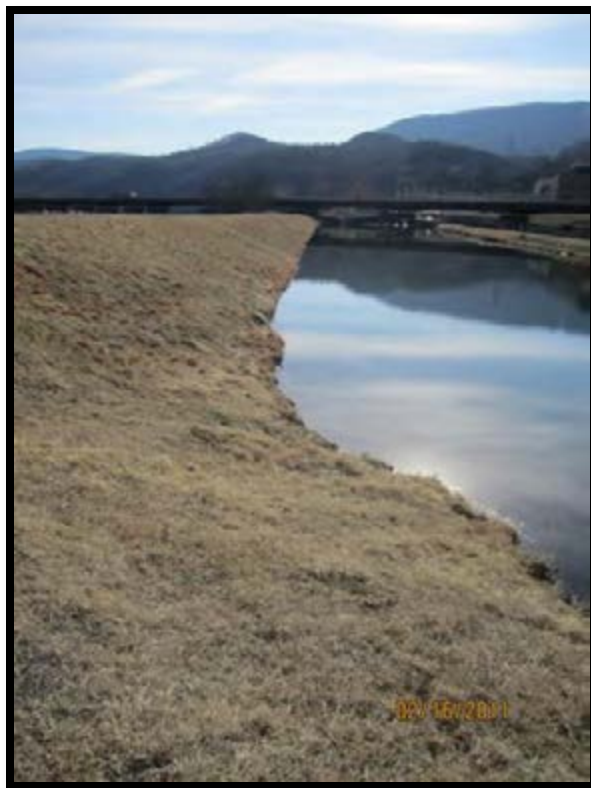
The upstream slope of the perimeter dike, including all groins, had adequate and well maintained cover of grasses/weeds. Some minor erosion repair work done along the upstream slope adjacent to outlet structure but overall no obvious signs of scarps, bulging cracks, depressions or other indications of slope instability. Figures 5.3.2-1 and 5.3.2-2 show representative upstream slope sections of the perimeter dike.

**Figure 5.3.2-1:** Upstream slope, Southwest.

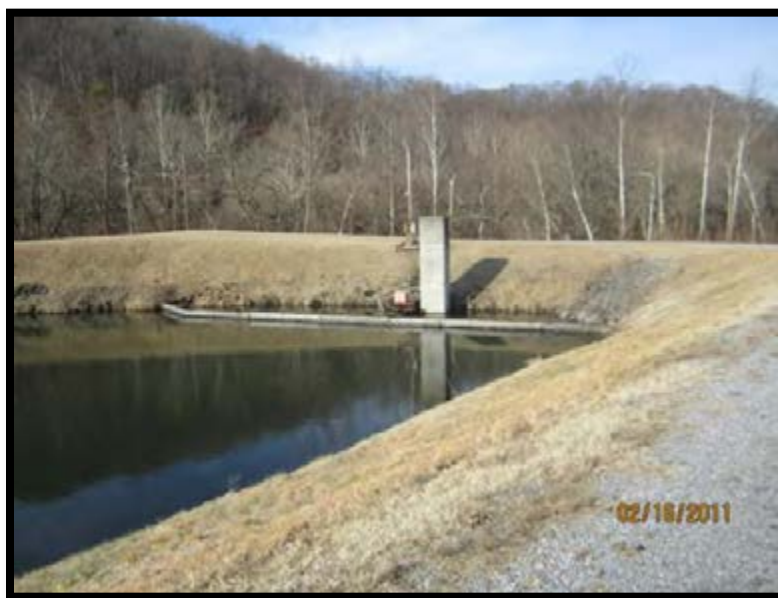
**Figure 5.3.2-2:** Upstream slope, Southwest. Outlet structure in the background with erosion repairs to the right.

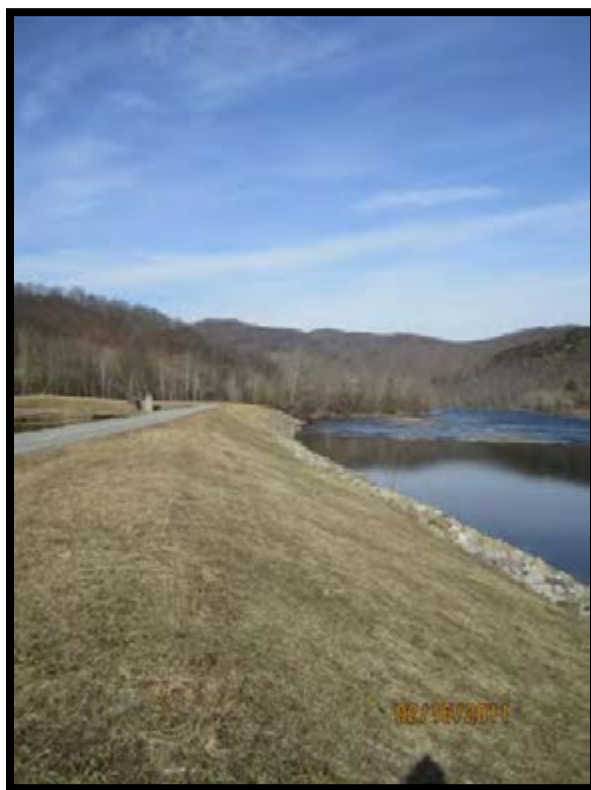
The downstream slope of the perimeter dike is vegetated with various species of maintained grasses and weeds. Significant woody vegetation and underbrush was noted growing on the slope of the dike adjacent to East River. Lower section of the dike adjacent to New River is protected with rip-rap armoring. Based on what could be visually assessed, there were no scarps, sloughs, bulging, cracks, depressions or other indications of slope instability. Figures 5.3.3-1 thru 5.3.3-2 show representative downstream slope sections of the perimeter dike.

**Figure 5.3.3-1:** Downstream slope, Northwest. New River to the right.

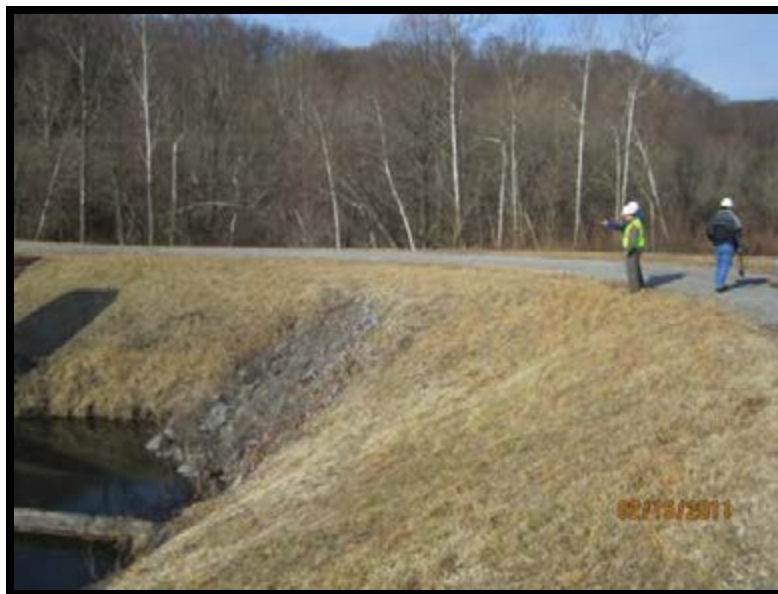
All groins appear stable. All are covered with grass that is maintained except the north groin adjacent to the outlet structure where erosion has been repaired with rip-rap armor. There were no observed scarps, sloughs, bulging, cracks, depressions or other indications of slope instability. Figure 5.3.4 shows the groin with the repair.

**Figure 5.3.4:** North groin, Note rip-rap placed in groin area.

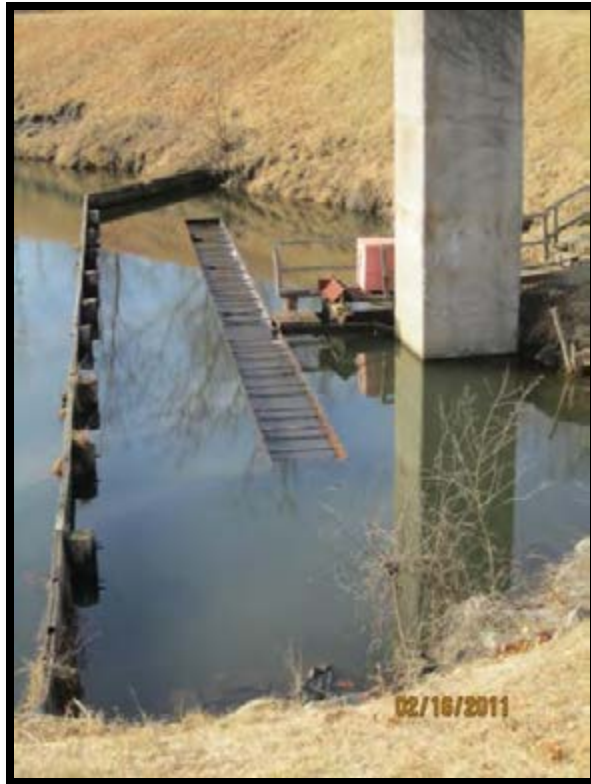
The overflow spillway structure is located at the northwest perimeter dike (Figure 5.4.1). The structure appears to be in satisfactory condition. The water exiting the outlet structure into the East River appeared to be flowing clear and there were no signs of clogging.

**Figure 5.4.1:** Outlet Structure, Southwest.

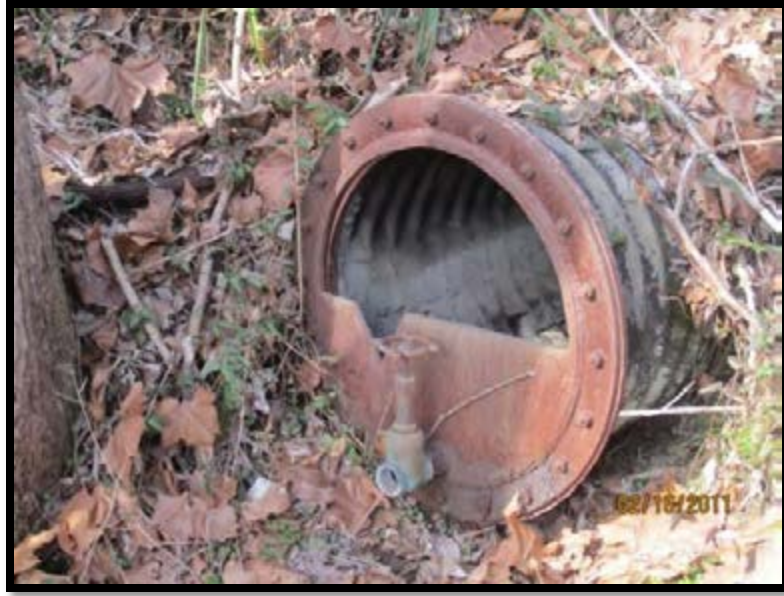
Outlet conduit (Figure 5.4.2-1) consists of a 24-inch corrugated metal pipe with a weir at its outlet. It's suspected the weir was used for monitoring purposes when the facility was active. The conduit appeared to be in satisfactory shape based on what could be observed in the field. No signs of clogging were observed.

**Figure 5.4.2-1:** Fly Ash Pond outlet conduit to East River.

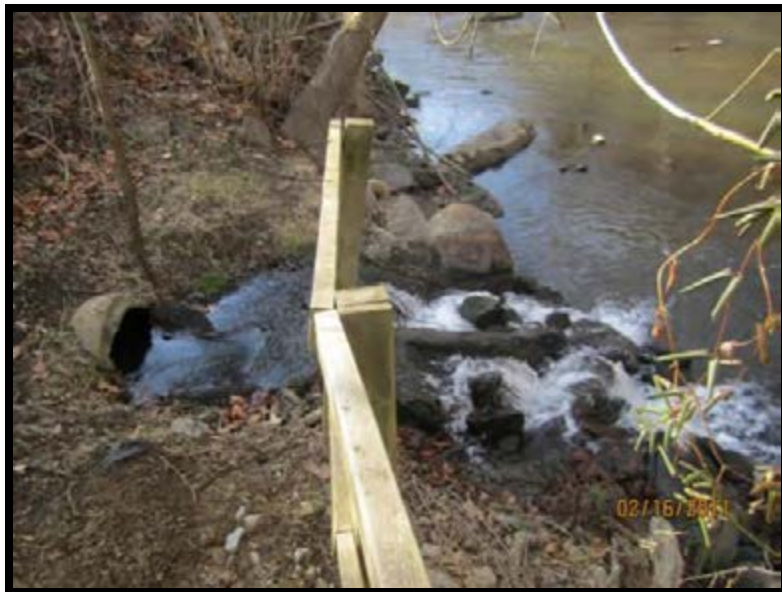
**Figure 5.4.2-2:** Bottom Ash Pond outlet conduit to East River.

It is recommended that the Owner perform an interior inspection of the outlet pipe for the Bottom Ash Pond. Interior inspection should focus on the structural integrity of the pipe, seepage, and debris accumulation. The inspection report should summarize all findings and remedial action required, if any. An interior inspection of the outlet pipe for the Fly Ash Pond doesn't appear warranted at this time as the facility is currently inactive; however, if it becomes active then an interior pipe inspection should be performed as well.

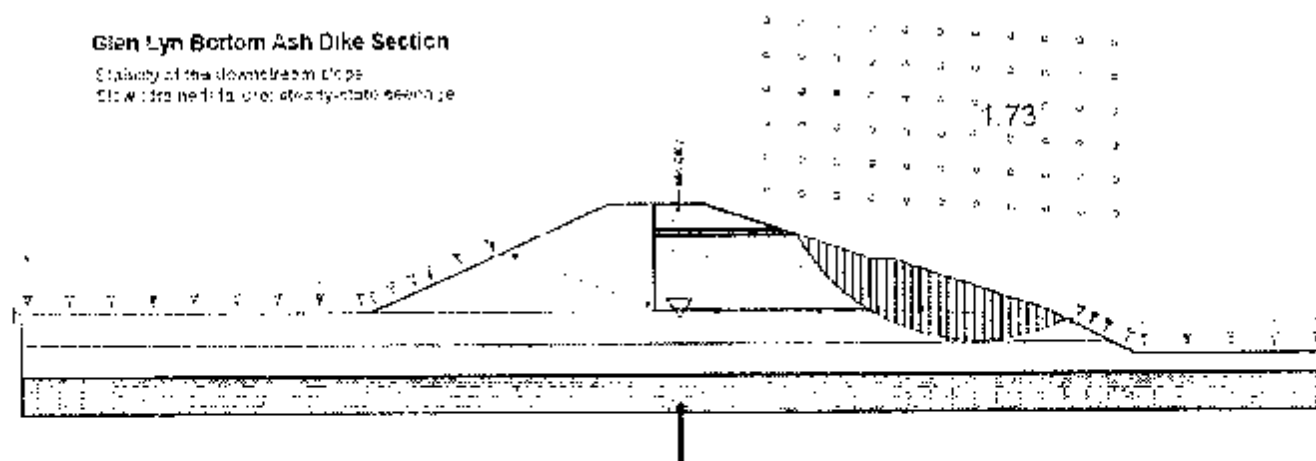
Figure 2. Stability analysis of the outboard slope under steady-state condition.

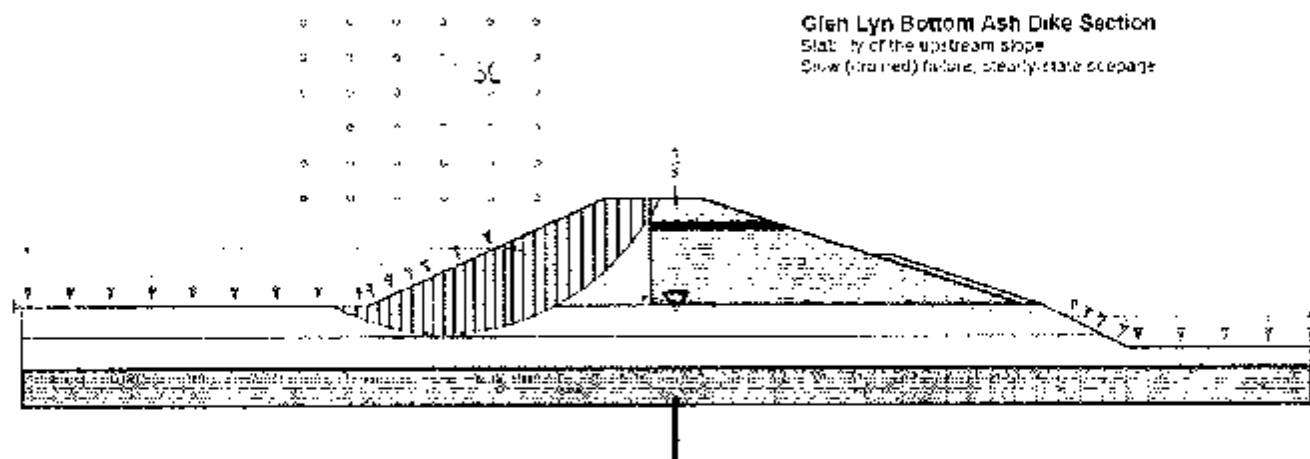
Figure 5. Stability analysis of the inboard slope under steady-state condition.

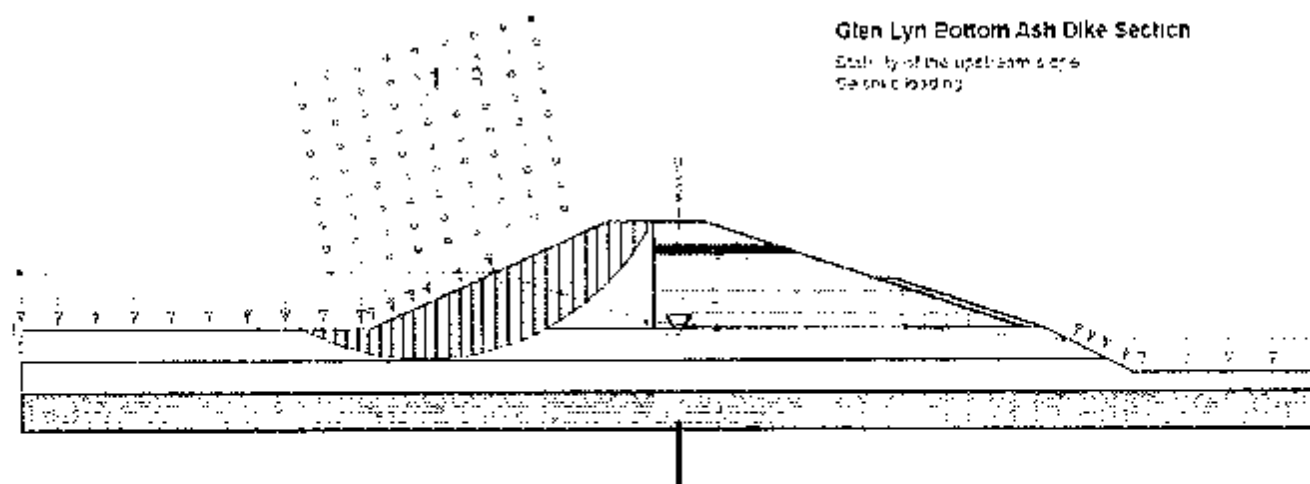
Figure 6. Stability analysis of the inboard slope under seismic loading
