US ERA ARCHIVE DOCUMENT

Coal Combustion Residue Impoundment Round 9 - Dam Assessment Report

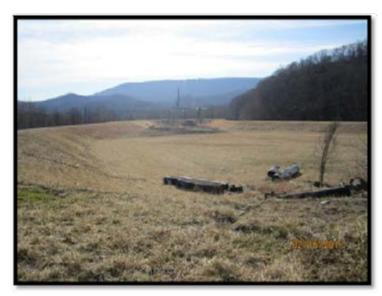
Figure 5.2.2-1: Upstream slope, Southeast. Note woody vegetation to right in foreground.

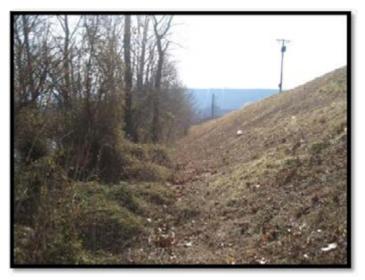
Figure 5.2.3-1: Downstream slope, Southeast. Note woody vegetation and trees growing at toe of the embankment.

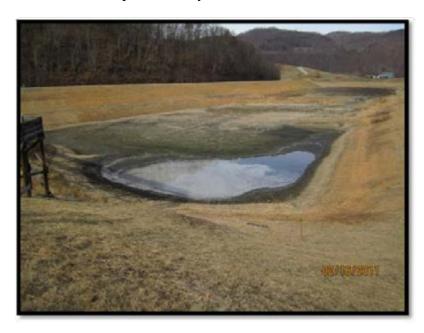
Figure 5.2.4: Groin, Northwest.

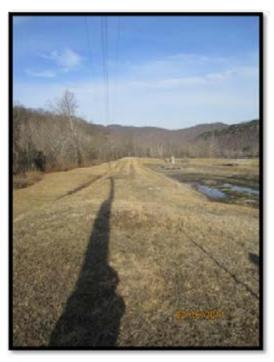
Figure 5.3.1-1: Crest, Northwest.

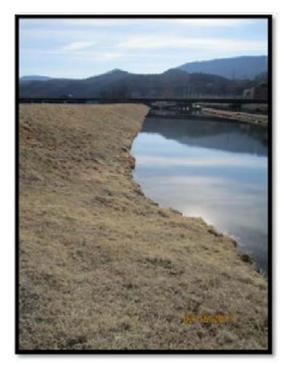
Figure 5.3.2-1: Upstream slope, Southwest.

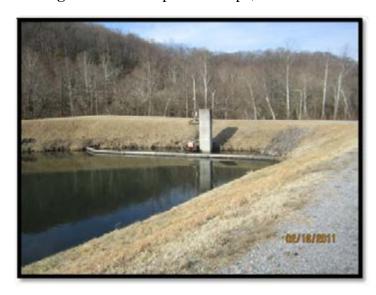
Figure 5.3.2-2: Upstream slope, Southwest. Outlet structure in the background with erosion repairs to the right.

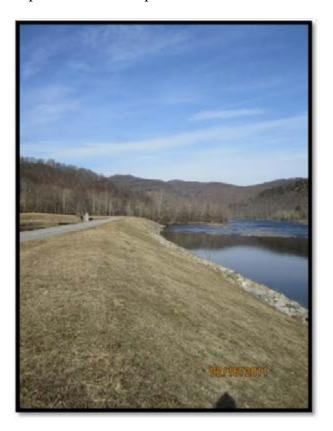
Figure 5.3.3-1: Downstream slope, Northwest. New River to the right.

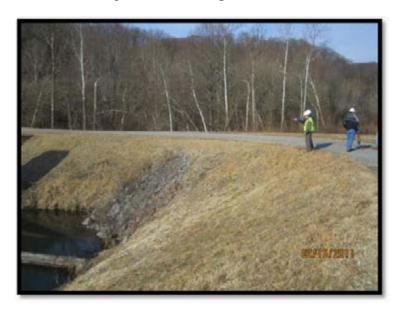
Figure 5.3.4: North groin. Note rip-rap placed in groin area.

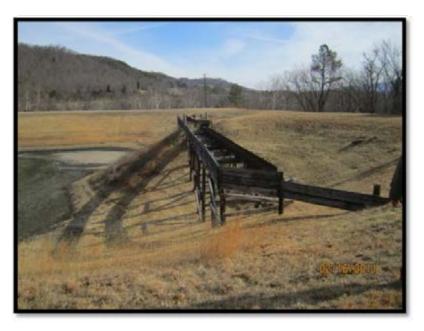
Figure 5.4.1-1: Outlet structure, Northeast.

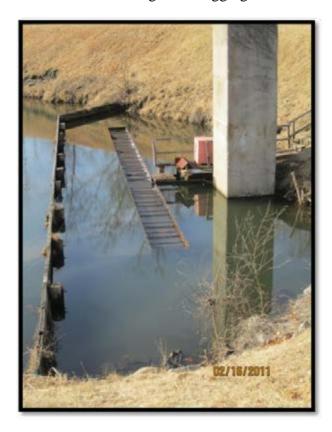
Figure 5.4.1: Outlet Structure, Southwest.

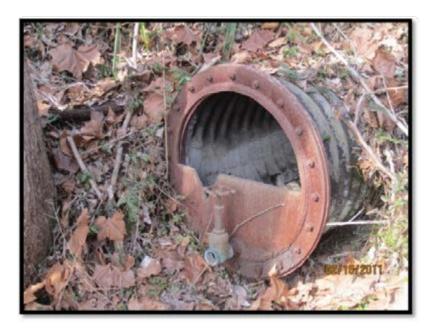
Figure 5.4.2-1: Fly Ash Pond outlet conduit to East River.

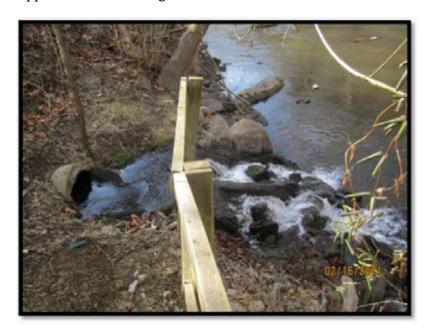
Figure 5.4.2-2: Bottom Ash Pond outlet conduit to East River.

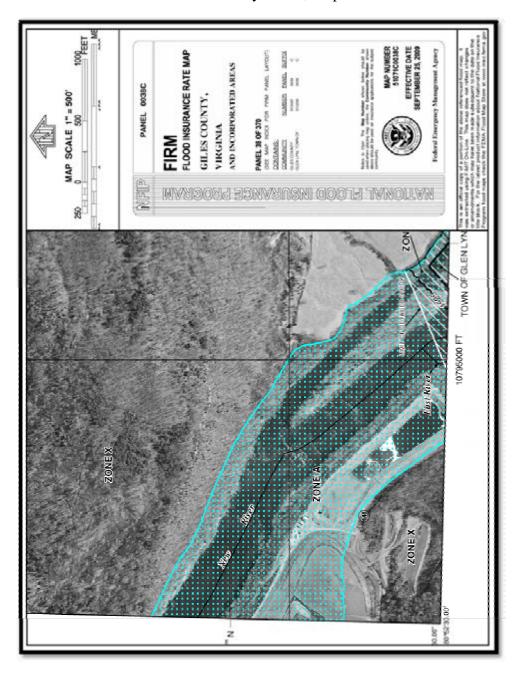
Exhibit 5: USGS Seismic-Hazard Map for Central/Eastern US, 2%/50 Years, 2008

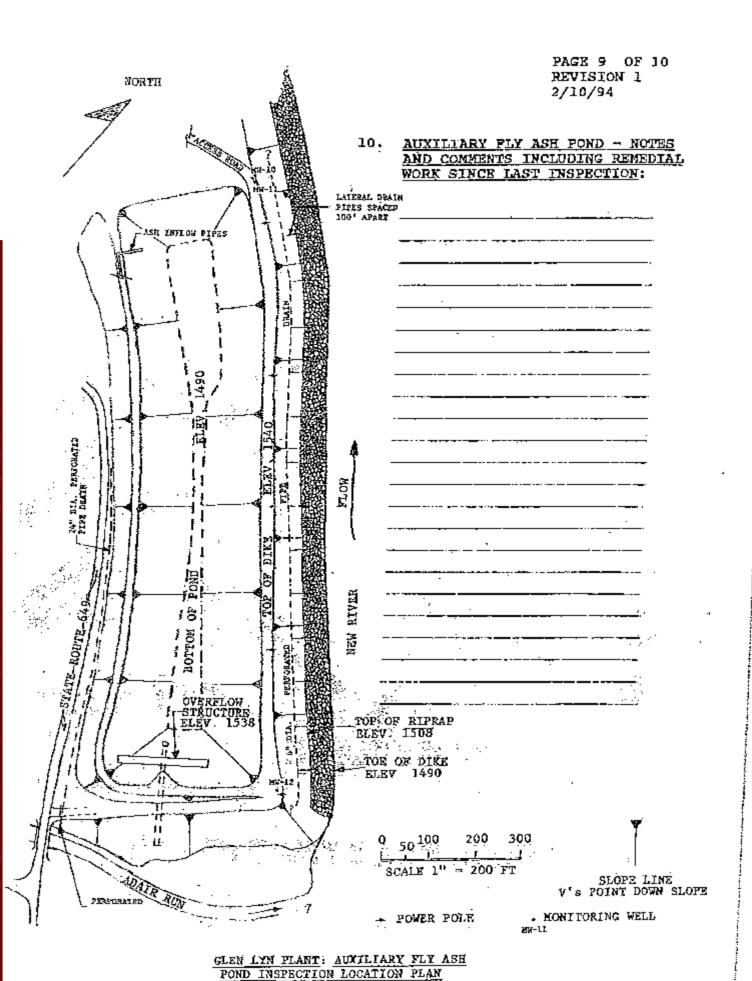
(DCR 199-104) (12/01)

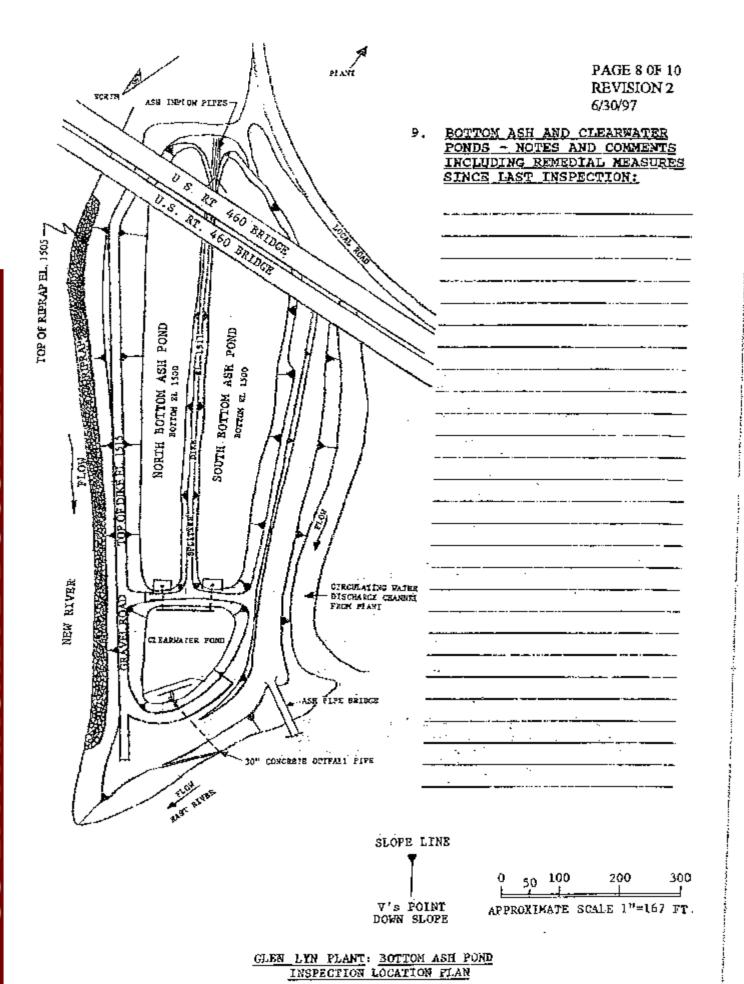
GENERAL ENDANK	MENT CONDITIONS - AI	L PONDS	
Has any mowing, since the previ what was done, location plan.	, brush and tree cut lous inspection? If when and by whom, a	ting or spraying so, please standard ahow the are	ng bea ste be sa on
····		<u> </u>	
		5 × 5	
-	······································		
inspection, and and when?	evel come up signif if so, approximate	ly what elevati	on war

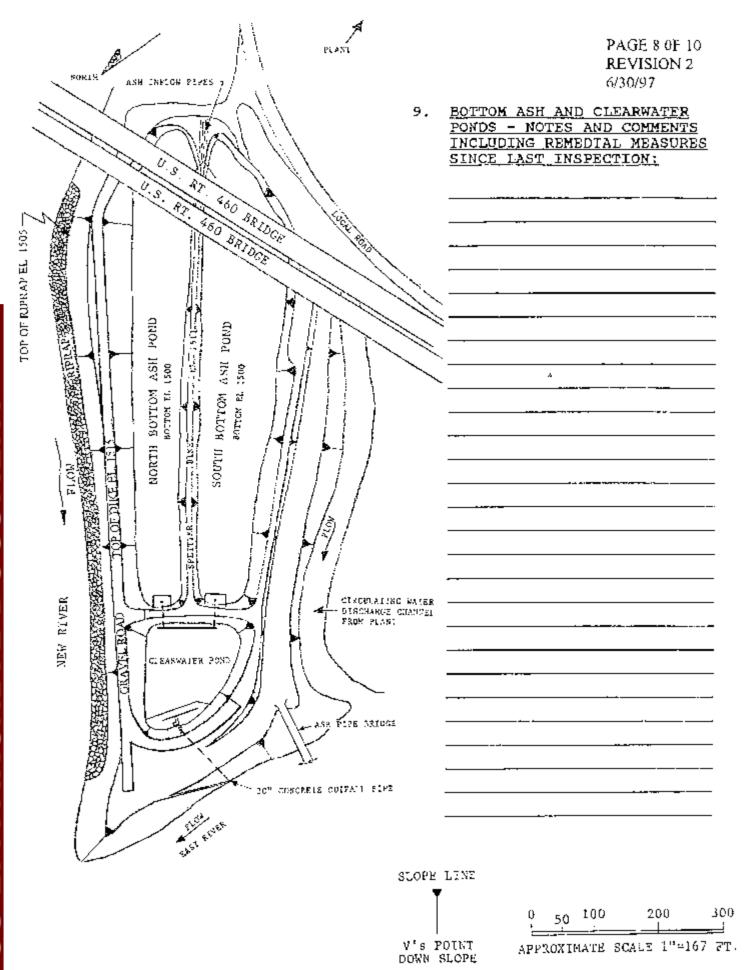
GLEN LYE PLANT: BOTTOM ASH FOND INSPECTION LOCATION PLAN

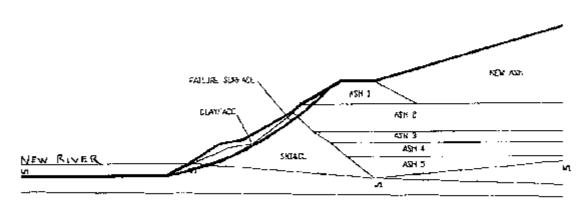
For these analyses, potential failure surfaces within the landfilled CCBs and through the landfill foundation will be evaluated. Generic cross-sections depicting these analysis limits are shown below:

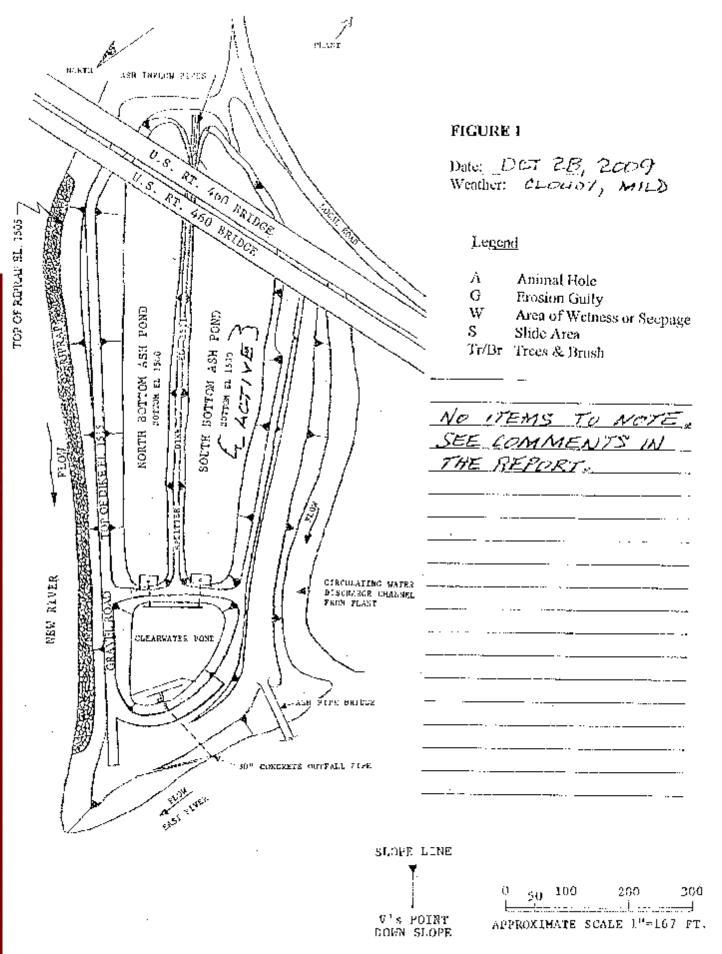
GLEN LYN PLANT: EGITOM ASH POND INSPECTION LOCATION PLAN

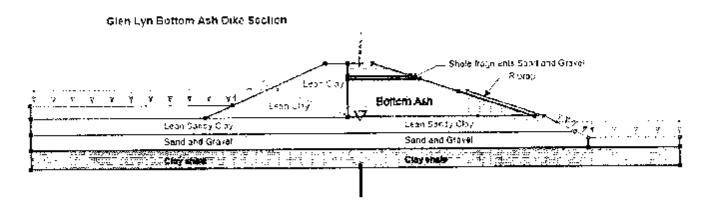
Figure 1. Idealized dike section

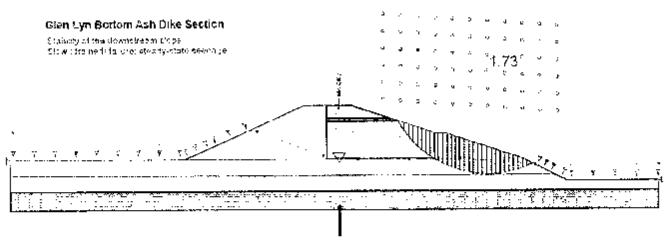
Figure 2. Stability analysis of the outboard slope under steady-state condition.

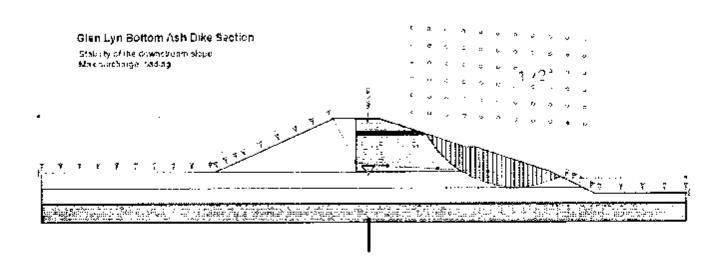
Figure 3. Stability analysis of the outboard slope under maximum surcharge pool level

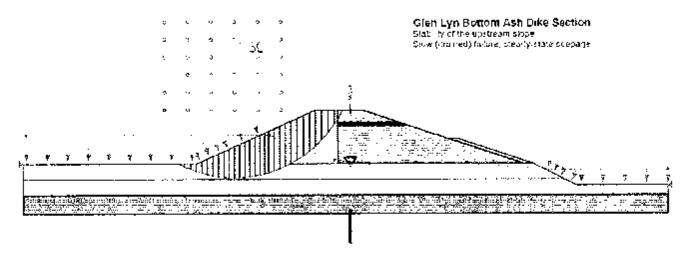
Figure 5. Stability analysis of the inboard slope under steady-state condition.

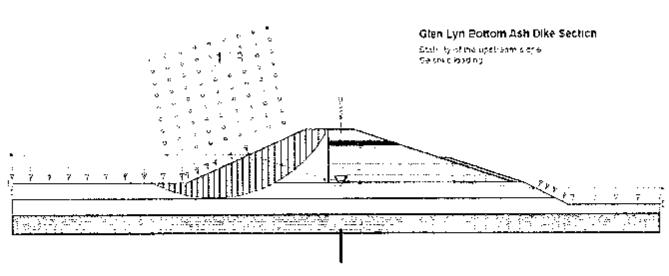
Figure 6. Stability analysis of the inboard slope under seismic loading
