CCW IMPOUNDMENTS INSPECTION REPORT

**MITCHELL POWER PLANT
MARSHALL COUNTY,
WEST VIRGINIA**

**PROJECT NO. 09-4157
DECEMBER 2009**

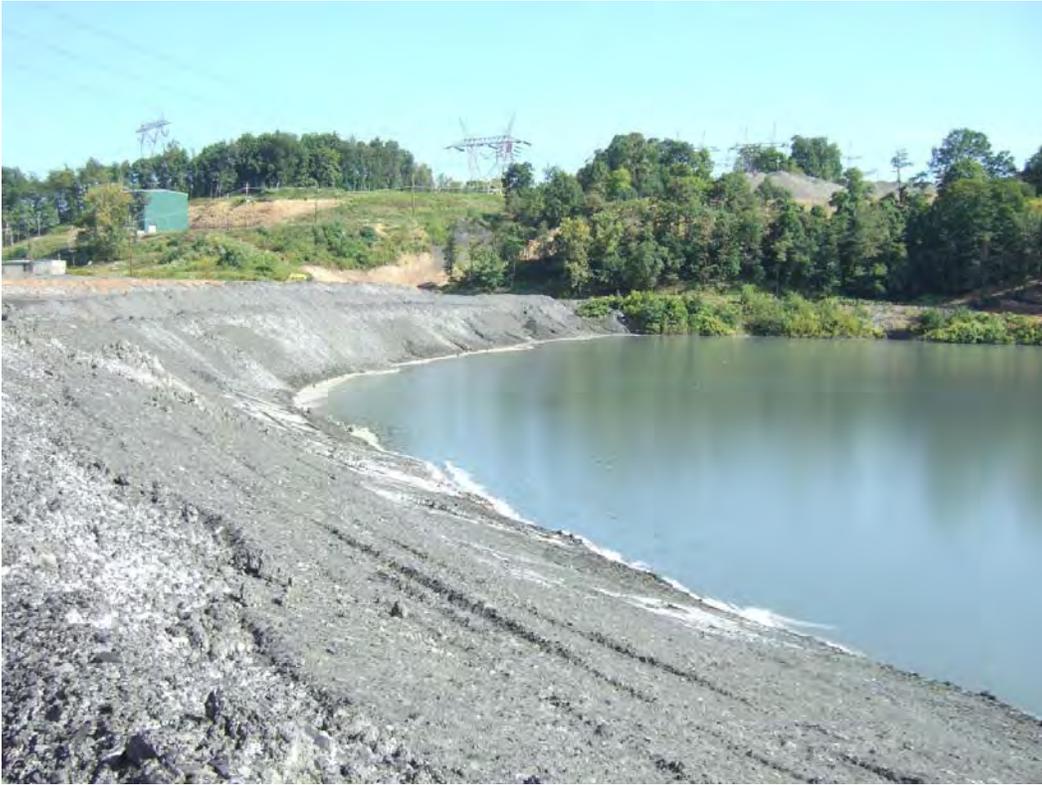
PHOTO 4: CONNER RUN DAM CREST FROM NORTH END

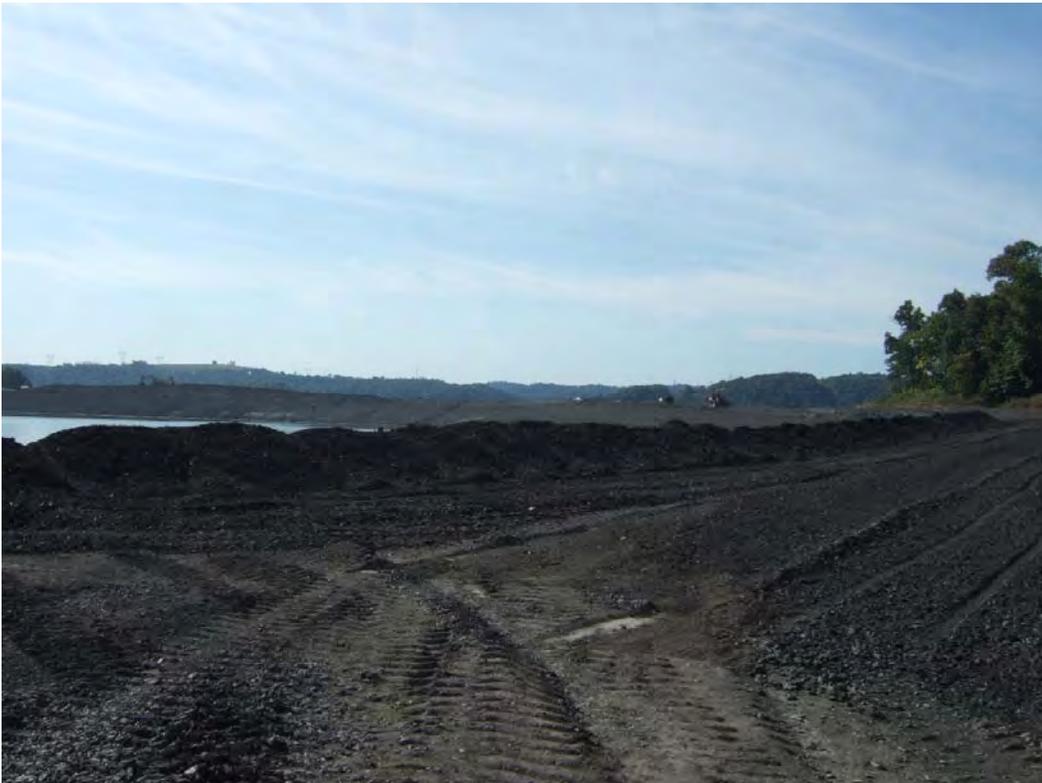
PHOTO 5: CLAY CORE ALONG CREST OF CONNER RUN DAM

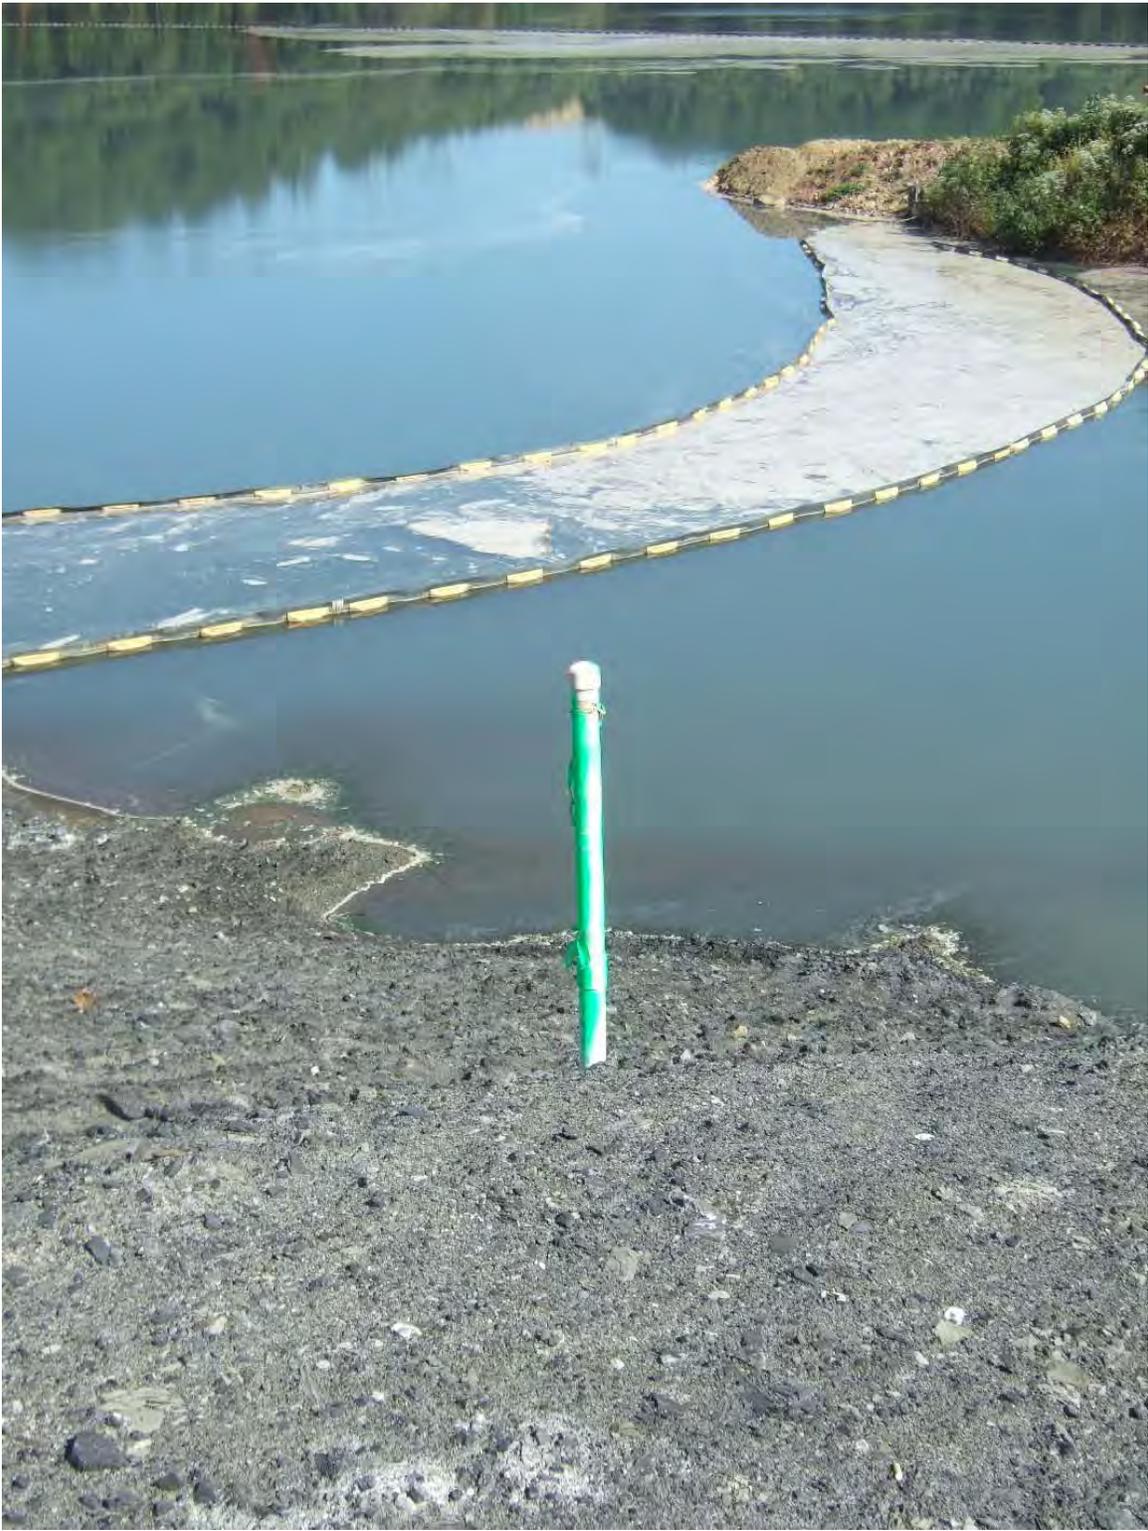
PHOTO 8: DOWNSTREAM COURSE REFUSE BERM FROM CREST

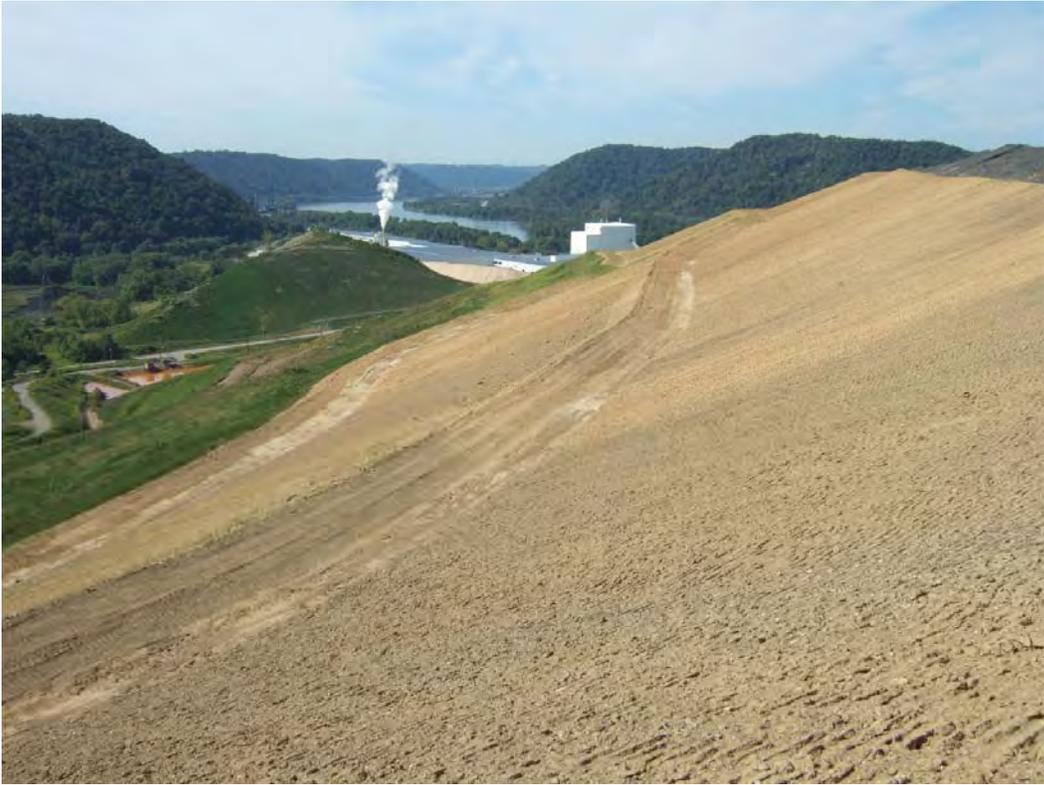
PHOTO 9: DOWNSTREAM COURSE REFUSE BERM FROM SOUTH END

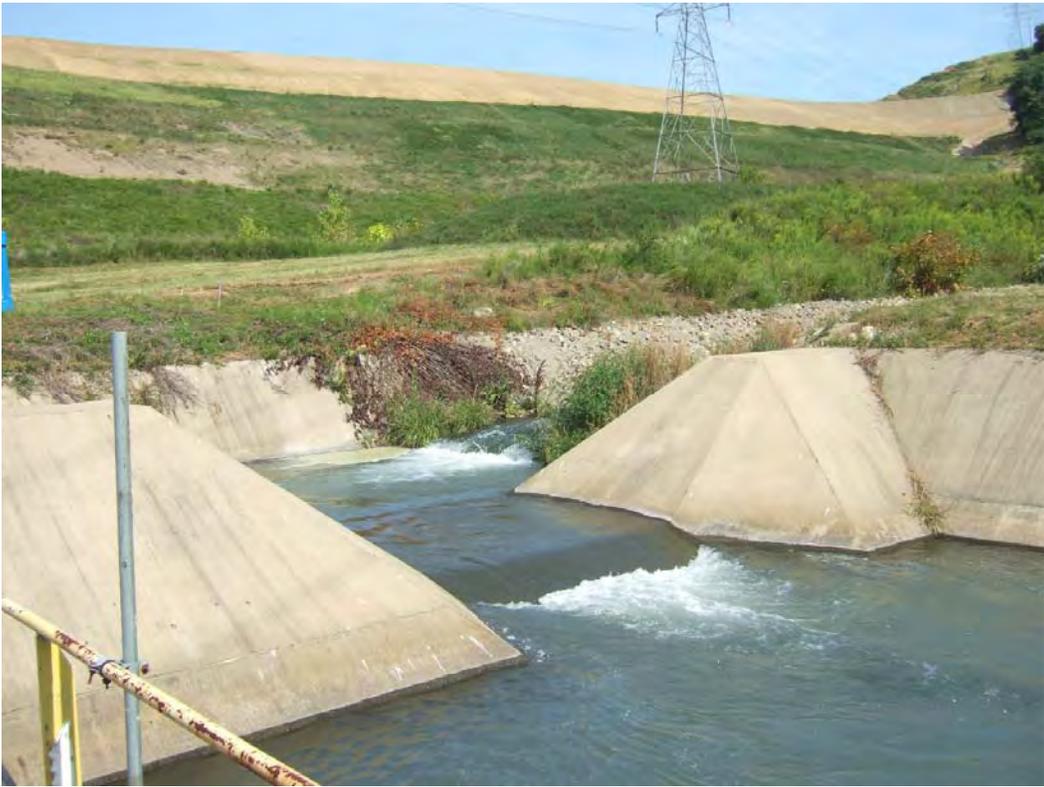
PHOTO 15: SEDIMENTATION POND

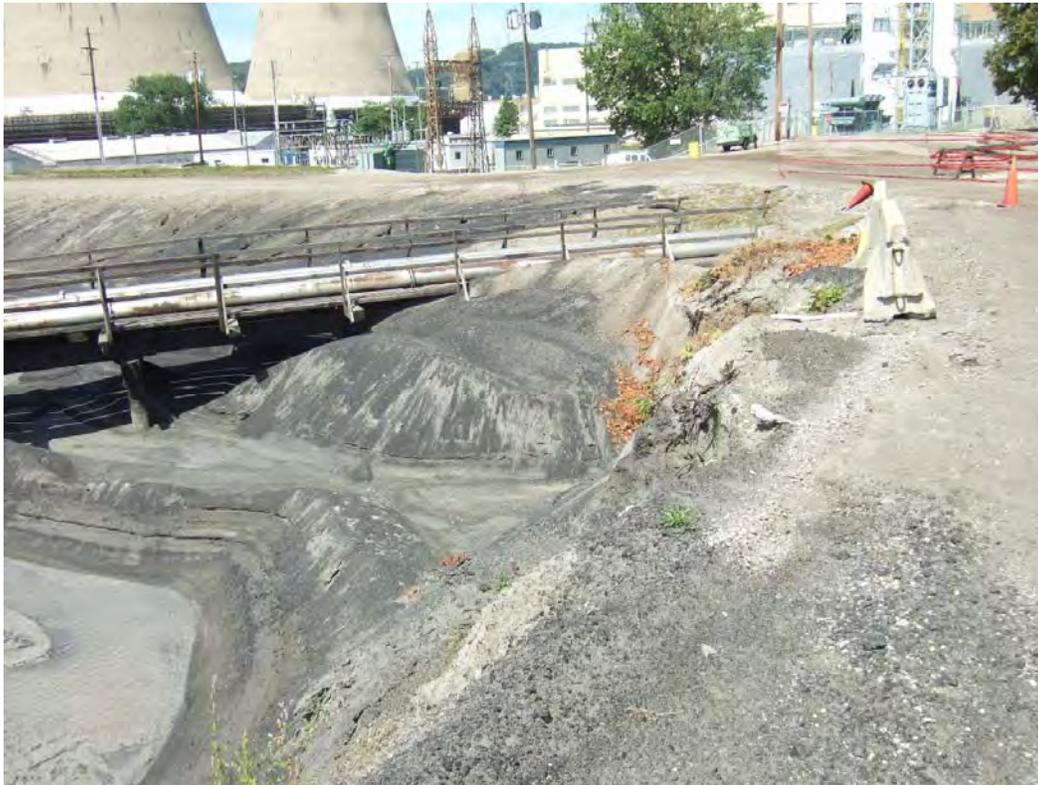
PHOTO 21: REMOVAL OF BOTTOM ASH

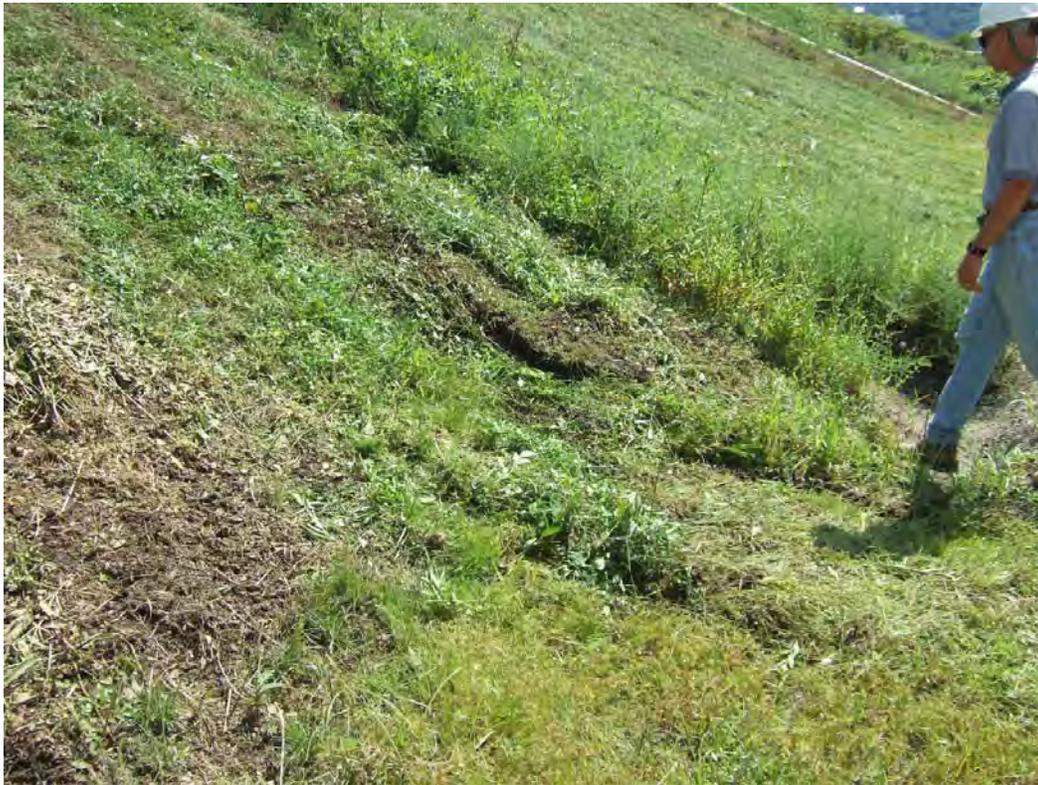
The Bottom Ash Pond was found to be well-maintained and in good condition. A small wet zone was found at the toe of the northwest corner of the impoundment. The source of the water is unknown and could just be ponded surface water. No other seepage was observed. The only inflows to the impoundment include the slurry, which is pumped in from the plant, and storm runoff. The outlet was clear of debris and free-flowing. There were some uneven surfaces and rain ruts along the downstream slope, but no signs of sloughing or sliding. Vegetation control

PHOTO 29: WET AREA AT NORTHWEST TOE OF BOTTOM ASH POND

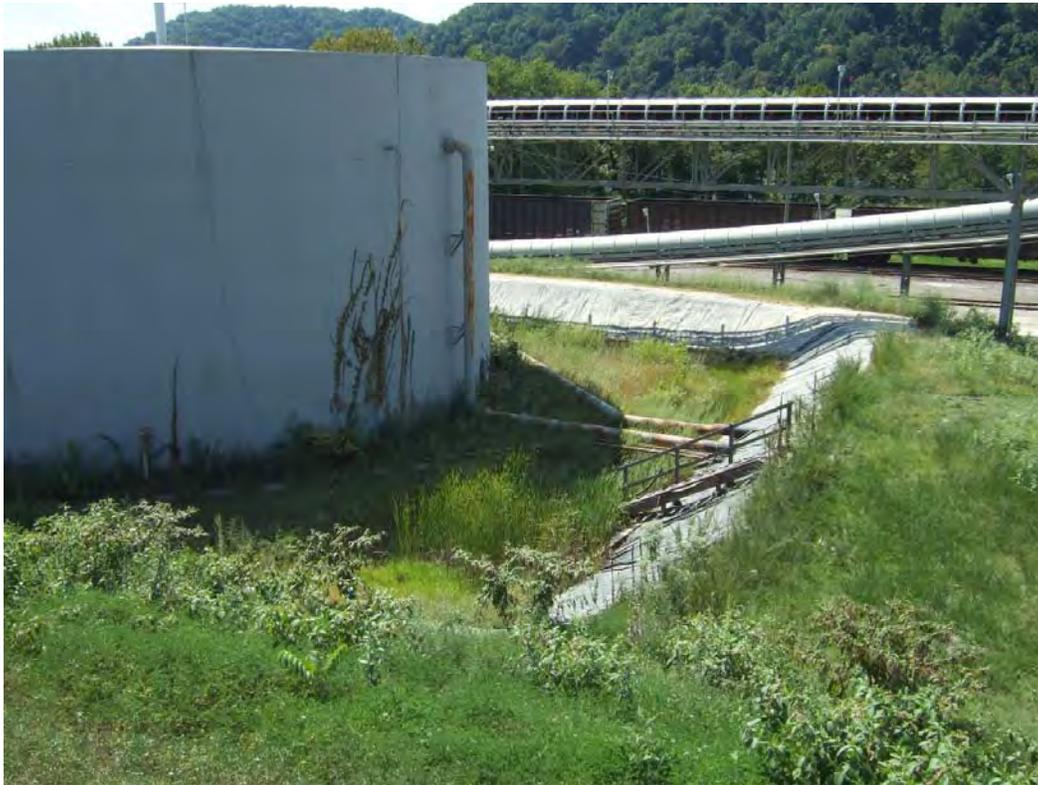
PHOTO 31: BOTTOM ASH POD FROM WEST CREST
