**DRAFT REPORT
ROUND 10 DAM ASSESSMENT
AMERICAN ELECTRIC POWER
PICWAY GENERATING STATION
ASH POND**

November 21, 2011
File No. 01.0170142.30

Re: Round 10 Dam Assessment - Draft Report
EPA Contract No. EP10W001313
American Electric Power – Picway Generating Station
Ash Pond
Lockbourne, Ohio

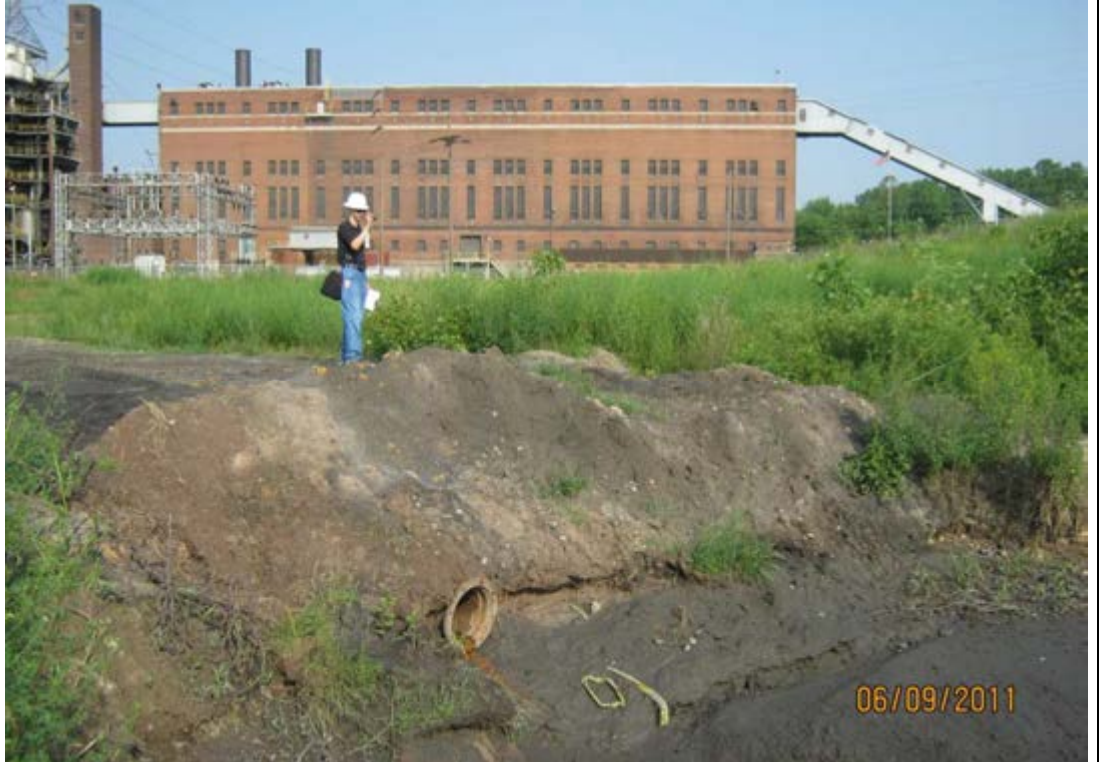
Photo No. 2

Outlet structure located in Cell S3 of south pond.

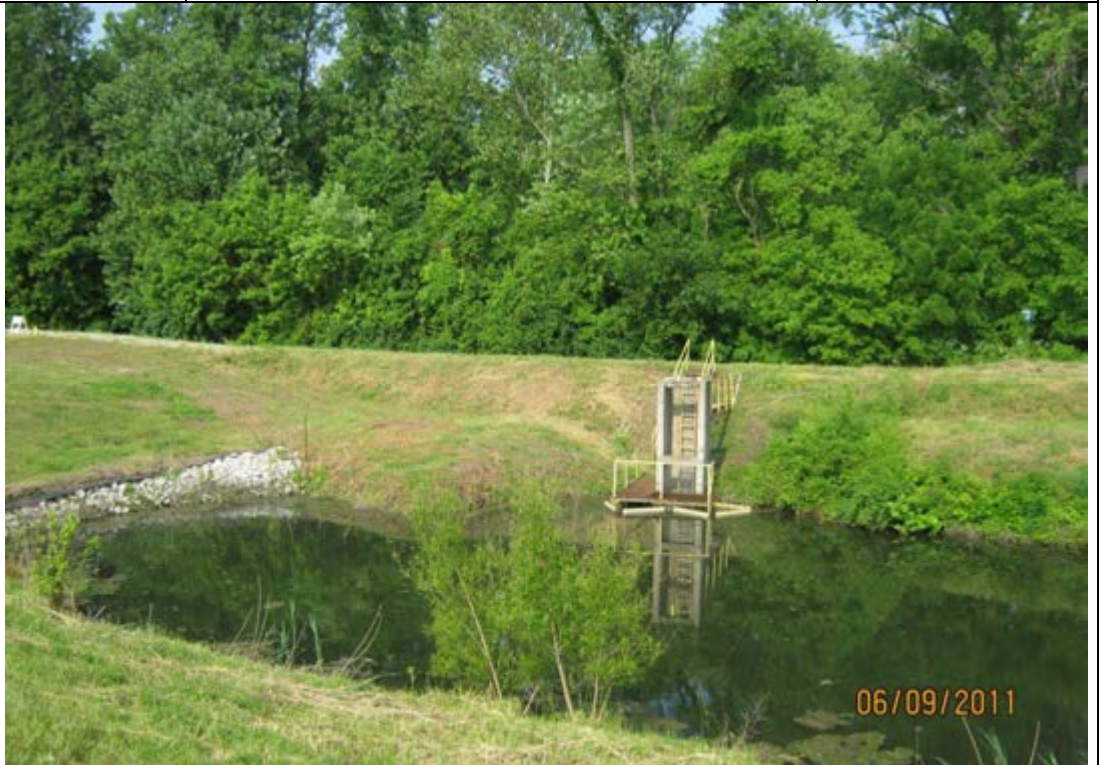
Photo No.
10

10. Minor ruts on crest from vehicle traffic;
11. Minor surficial pitting or flaking/cracking on the concrete discharge structure;

View of concrete discharge structure in clearwater pond.

1. Minor concrete repair work on the concrete discharge structure in the clearwater pond;
2. Re-seed and/or over seed bare areas of the embankments and crest to establish healthy grass cover;
3. Clear the area of established vegetation near the lower portion and toe of the outer embankment slopes near the outfall structure; and,
4. Regrade areas near the toe of exterior slopes to facilitate proper drainage away from the embankments.

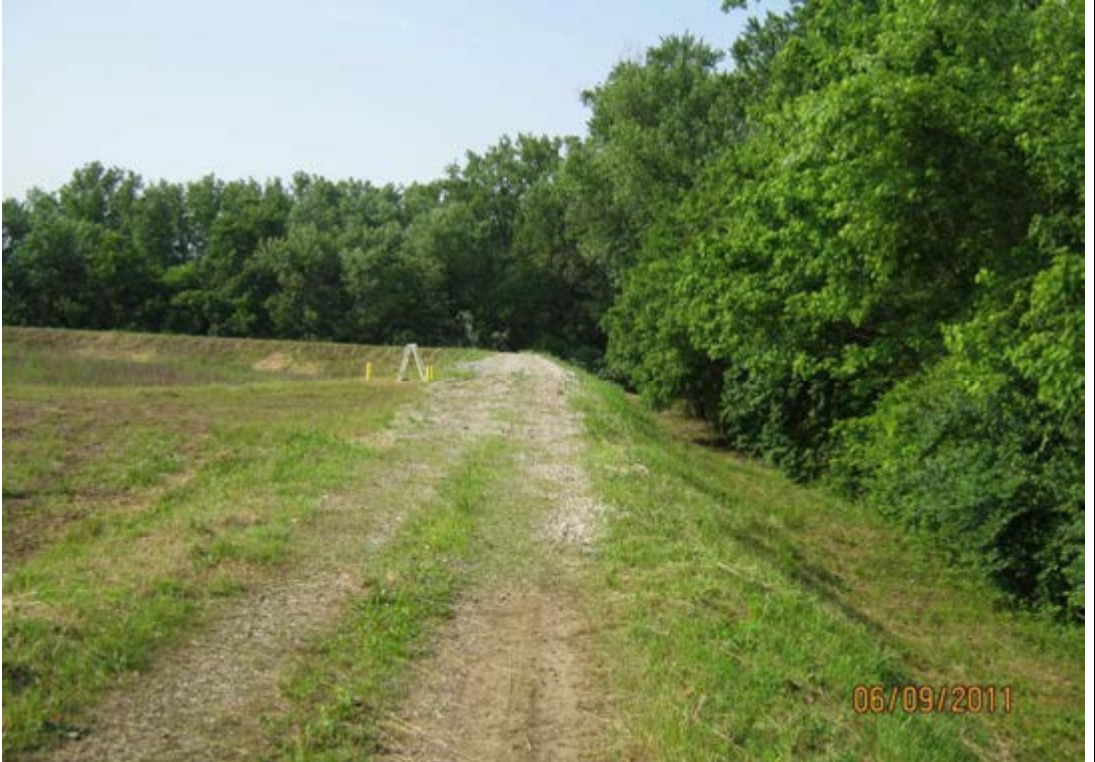
Direction Photo Taken: South			
Description: View of west embankment of the south pond in vicinity of concrete discharge structure in clearwater pond and vicinity of boring B-0903 performed by BBC&M in August 2009. Note variable elevation of crest

1. Survey of the crest of both ponds by a licensed Professional Surveyor to evaluate the current elevation profile of the crest and confirm that survey monuments are not moving horizontally;
2. Monitor the vertical alignment of the crest of the north embankment of the Ash Pond yearly for movement or signs of embankment instability. In the event that settlement monuments are installed and surveyed in the future, survey measurements should be taken along the crest of the north embankment to ensure that the crest elevation is uniform;
3. Evaluate freeboard conditions based on maximum pool elevation and more recent topographical data; and,
4. Provide or perform spillway analysis to demonstrate capacity of discharge structures to accommodate the regulatory Spillway Design Flood with the maximum pool freeboard.
5. Camera survey of the CMP outfall should be performed.

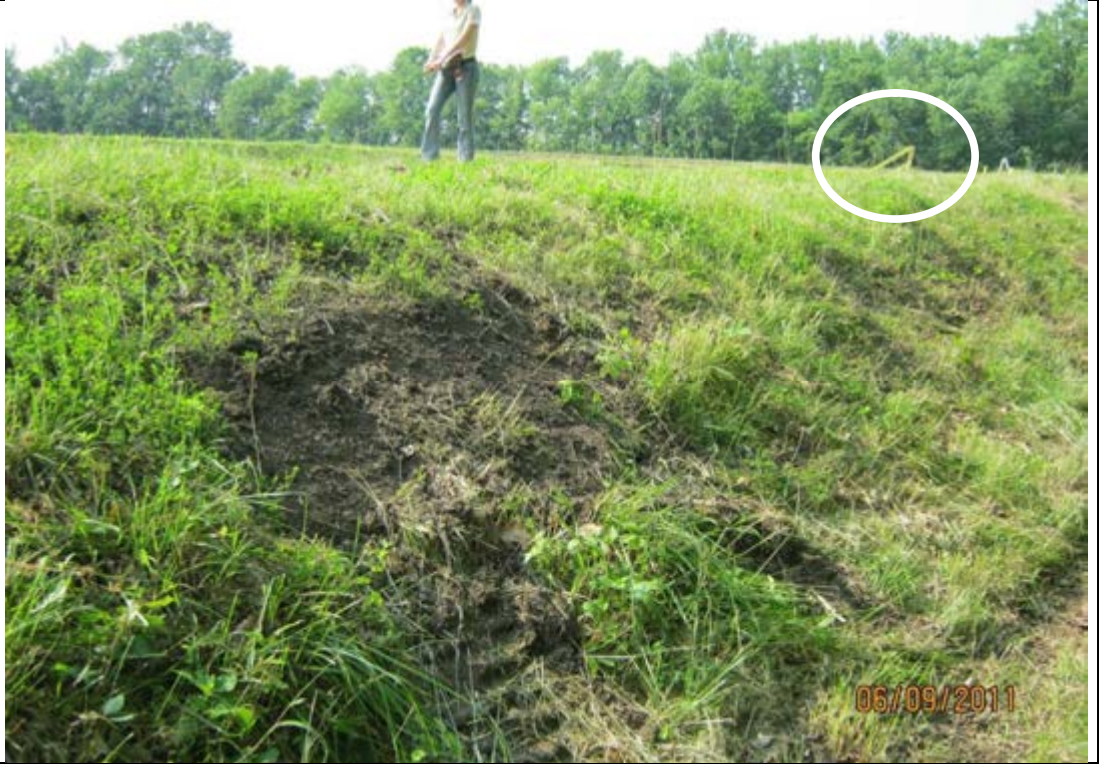
Area of outer west embankment observed to be bare of vegetation. Note hand rail of concrete discharge structure in background for reference point (circled).

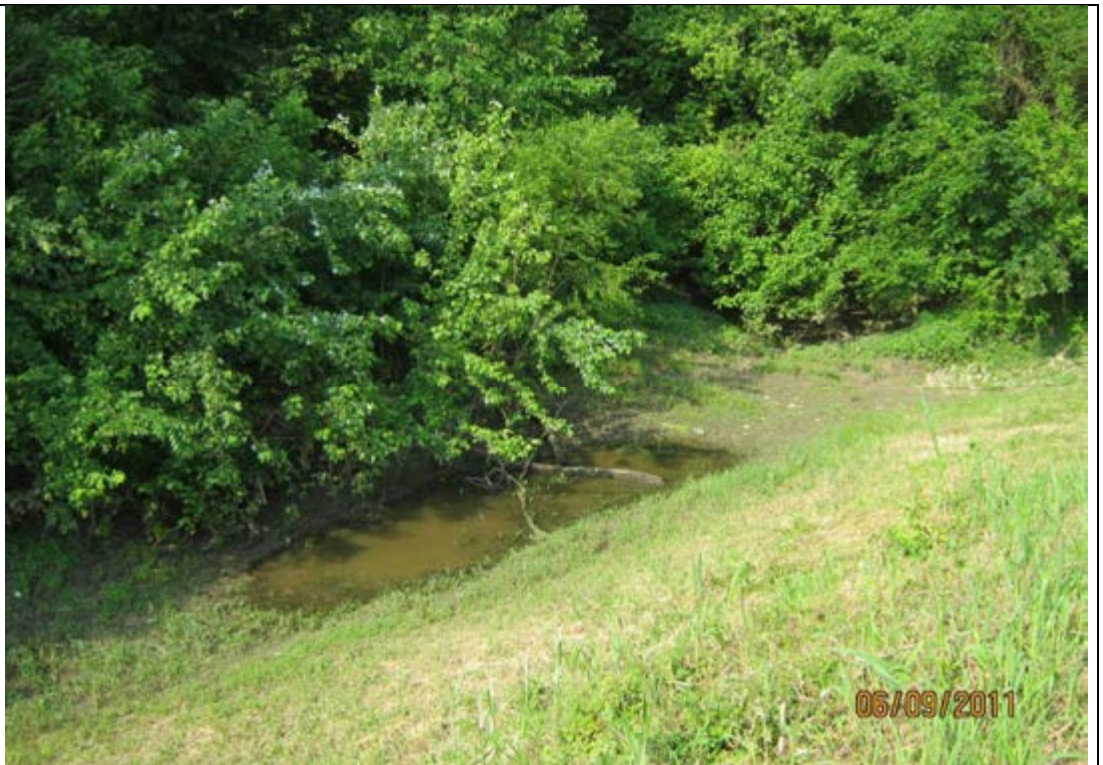
Photo No.
18

Area of standing water at the toe of the southwest corner of the outer south embankment of the south pond.

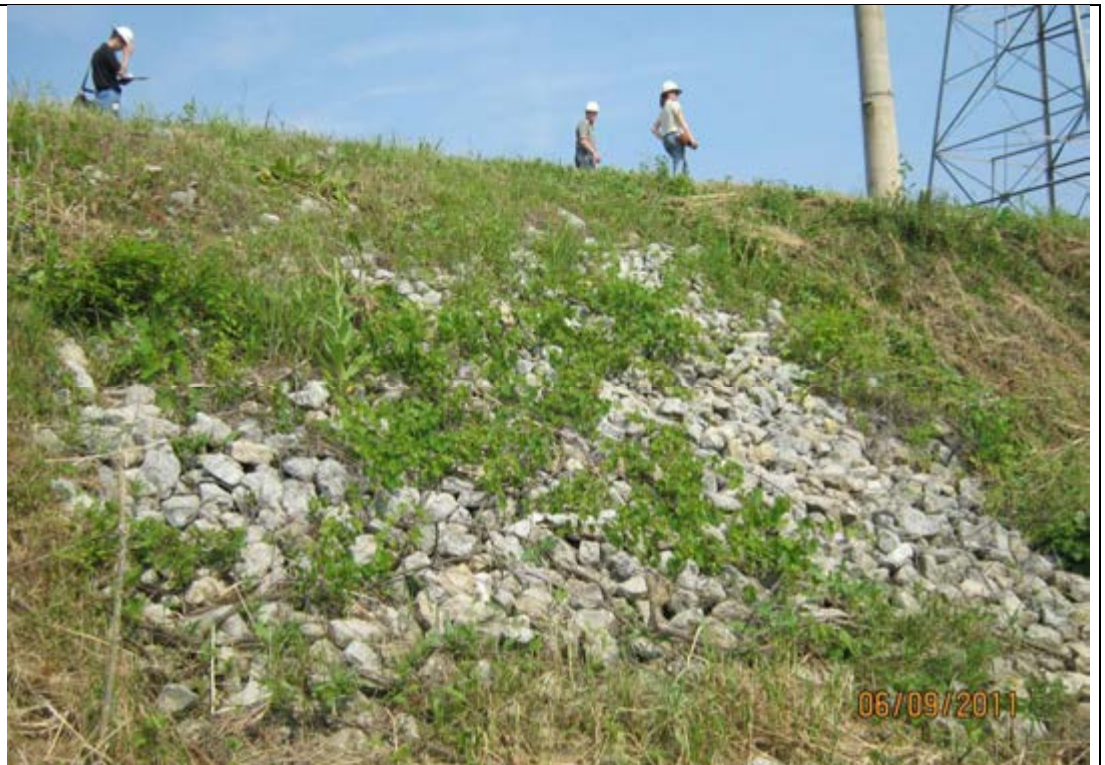
Photo No. 24

The outer embankment slope generally appeared to be steep, but in good condition. Most portions of the slopes had been mowed recently. Mowing in those areas not completed before GZA's site visit (south and east embankment of north pond) was reportedly scheduled to be completed in the near future. Similar to previous inspections by others, rodent burrows were observed in multiple locations, but did not appear to be excessive in size. One area on the western exterior embankment of the south pond was observed to be bare of vegetation (Photo 17). Evidence of standing water at the toe of the embankments was observed, particularly in the southwest corner of the south pond where an area of standing water measuring approximately 30 feet long by 5 feet wide was present (Photo 18). According to AEP personnel, recent rainfall had been excessive and the Scioto River had risen and flooded the portions of the area surrounding the south pond embankments. Rip rap has been used to address areas of erosion on the slope, such as the area shown in Photo 24. No unusual movement or sloughing was observed in the slope.

View of rip rap placed on the outer east embankment to address isolated area of erosion.

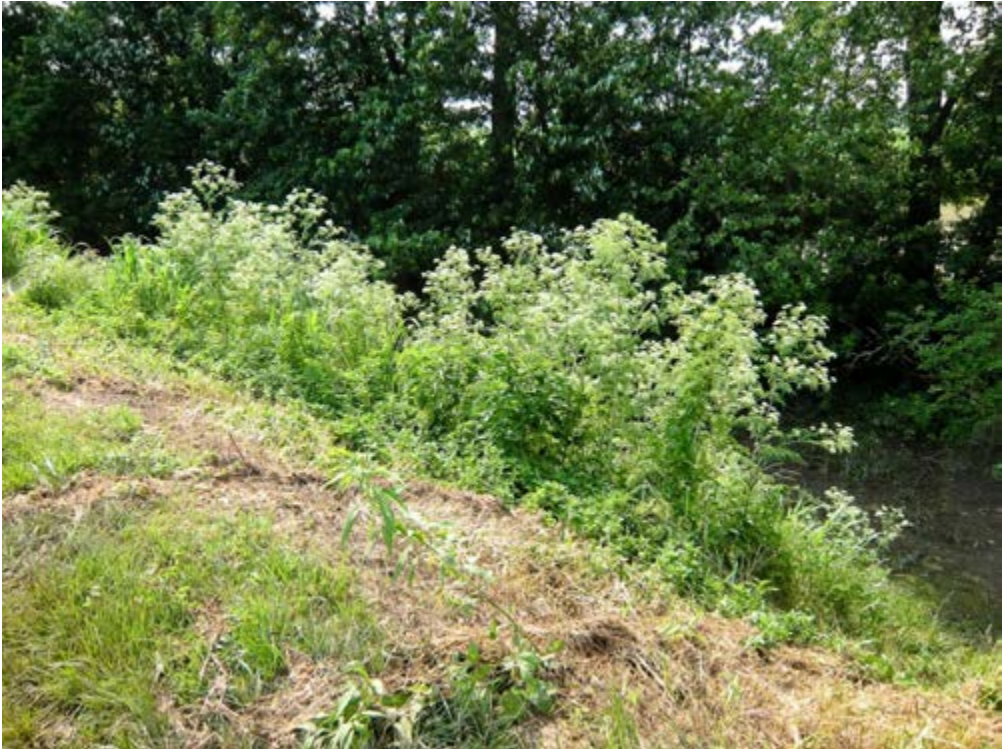
Client Name: U.S. Environmental Protection Agency		Site Location: American Electric Power (AEP) Picway Generating Station Lockbourne, Ohio	Project No. 01.0170142.30
Photo No. 25	Date: 06/09/11

Direction Photo Taken: East-Southeast			
Description: View of crest and outer south embankment of the north pond. Note un-mowed vegetation.

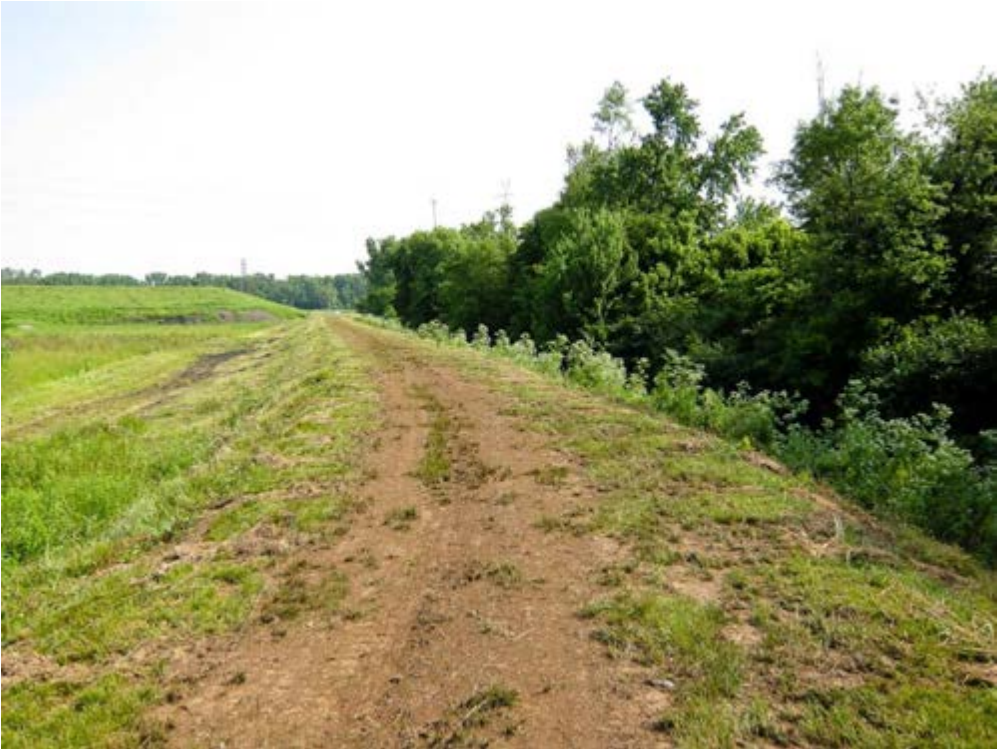
Client Name: U.S. Environmental Protection Agency		Site Location: American Electric Power (AEP) Picway Generating Station Lockbourne, Ohio		Project No. 01.0170142.30
Photo No. 27	Date: 06/09/11

Direction Photo Taken: North				
Description: View of crest of east embankment of the north pond. Note un-mowed vegetation on outer embankment and capped portion of north pond in left background.
