Report of Dam Safety Assessment of Coal
Combustion Surface Impoundments
Alliant Energy
M.L. Kapp Power Station
Clinton, IA

AMEC Project No. 3-2106-0183.0002

December 2010

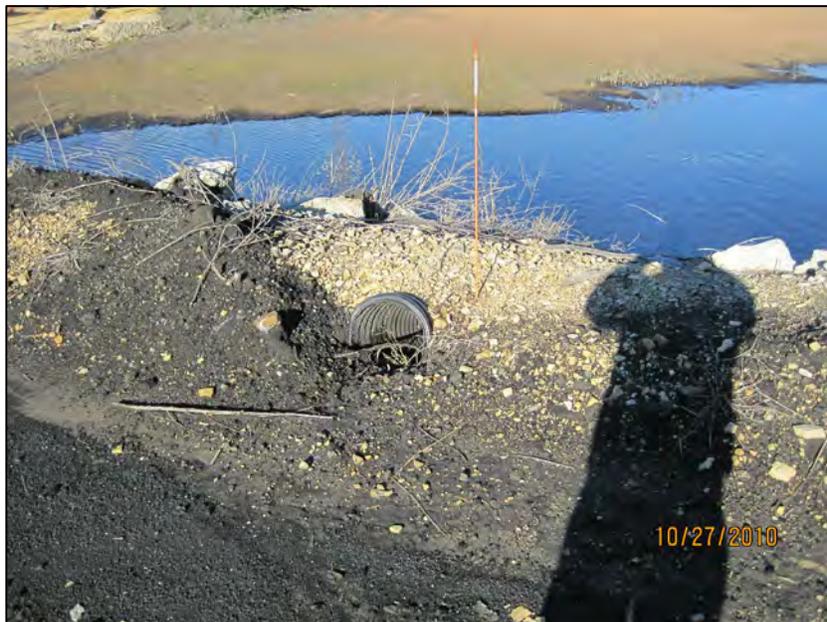
EP-4
UPSTREAM END OF STORM DRAIN PIPE FROM COAL PILE
AREA INTO EMERGENCY ASH PRIMARY SETTLING POND

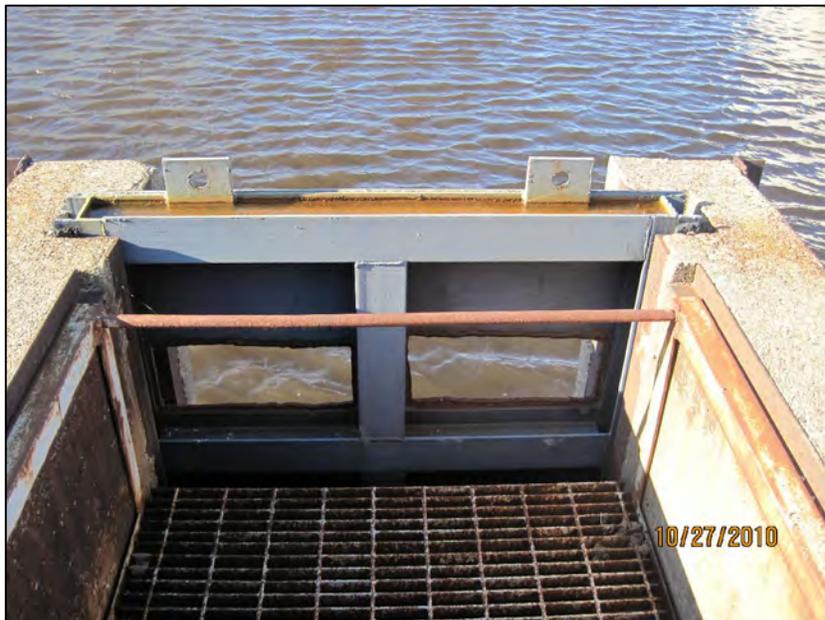
EP-8
EMERGENCY ASH SECONDARY POND ABANDONED
ORIGINAL DISCHARGE BOX STRUCTURE

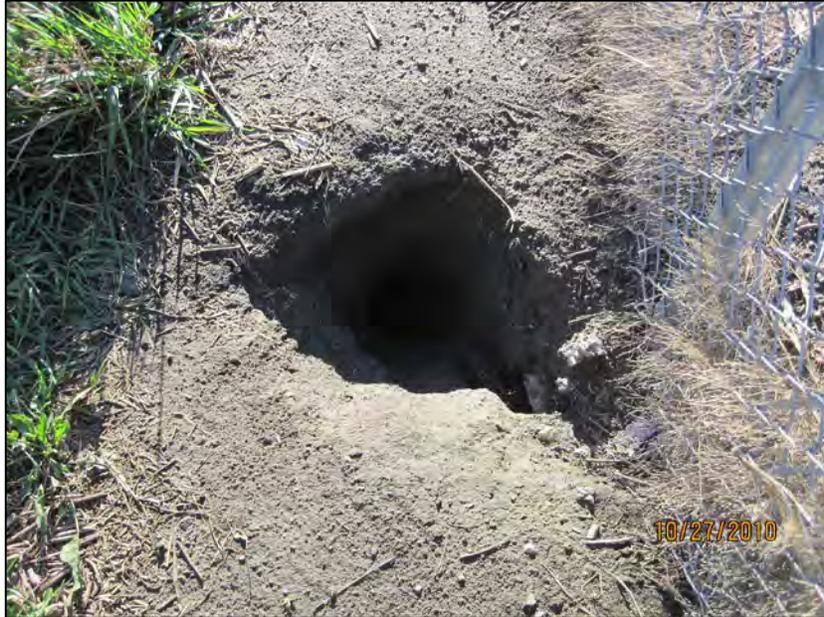
EP-11

ANIMAL BURROW OUTSIDE NORTH FENCE CORNER AT TOP OF EMERGENCY SECONDARY POND DOWNSTREAM EMBANKMENT SLOPE

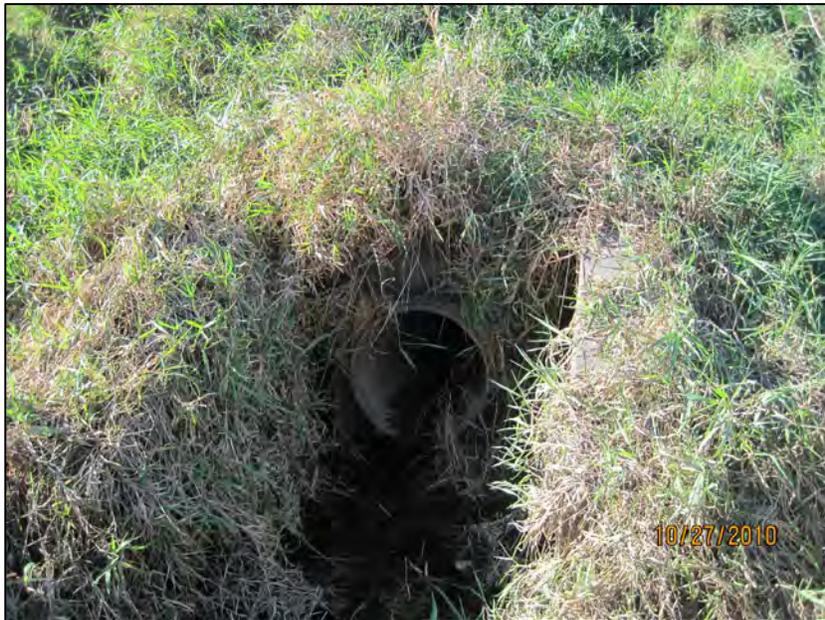
EP-14
DOWNSTREAM PIPE OUTLET OF ABANDONED ORIGINAL DISCHARGE BOX STRUCTURE

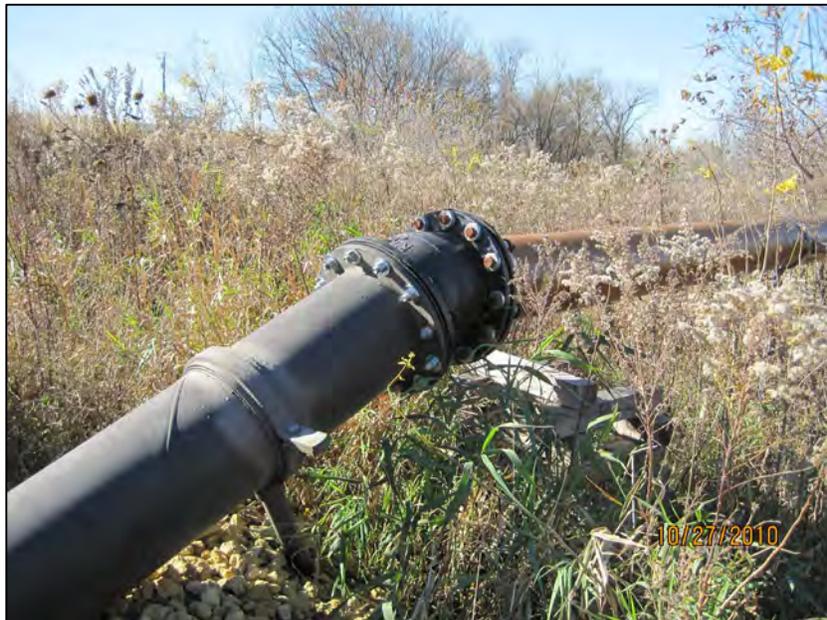
MP-4
CCW INFLUENT PIPE-CONNECTION POINT OF
NEW SECTION OF BASALT LINED CAST IRON

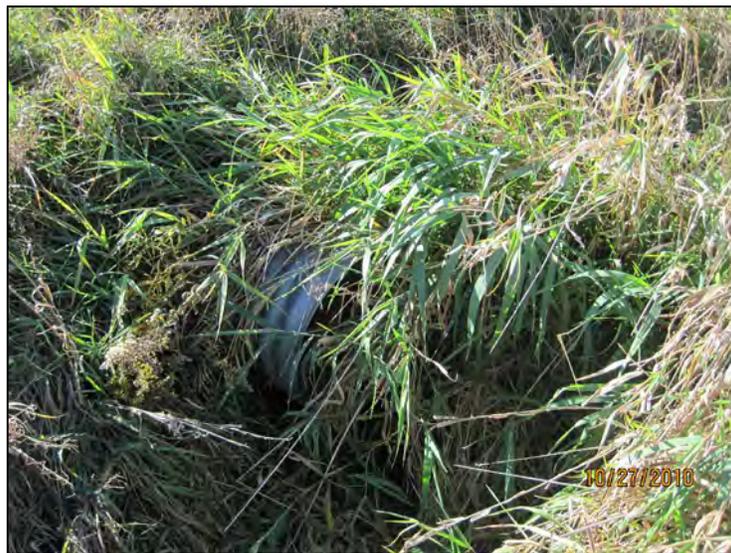
Flow is discharged from the northwest corner Primary Pond into the southwest corner of the Secondary Pond through a drop inlet (Photos MP-5 and MP-8)). The drop inlet was noted to be adjustable using extension pieces located nearby (Photo MP-7). The southwest corner of the Secondary Pond, where flow from the Primary Pond enters, was overgrown with grass and weeds and did not appear to have been active in some time (Photo MP-8).

MP-8
VEGETATION SURROUNDING PIPE DISCHARGE FROM
MAIN ASH PRIMARY POND INTO SECONDARY POND

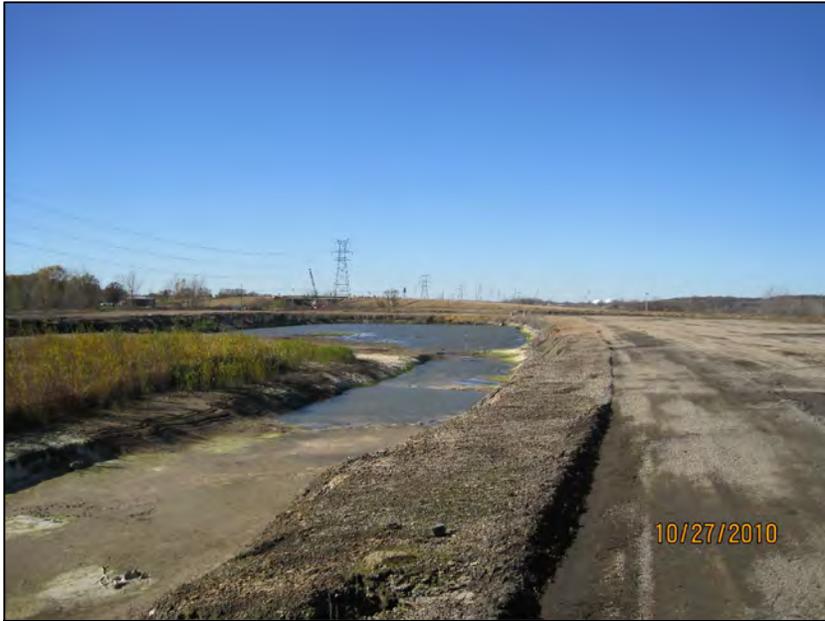
MP-11
LOOKING SOUTHWEST ALONG NORTH EMBANKMENT
AND CREST OF MAIN PRIMARY POND

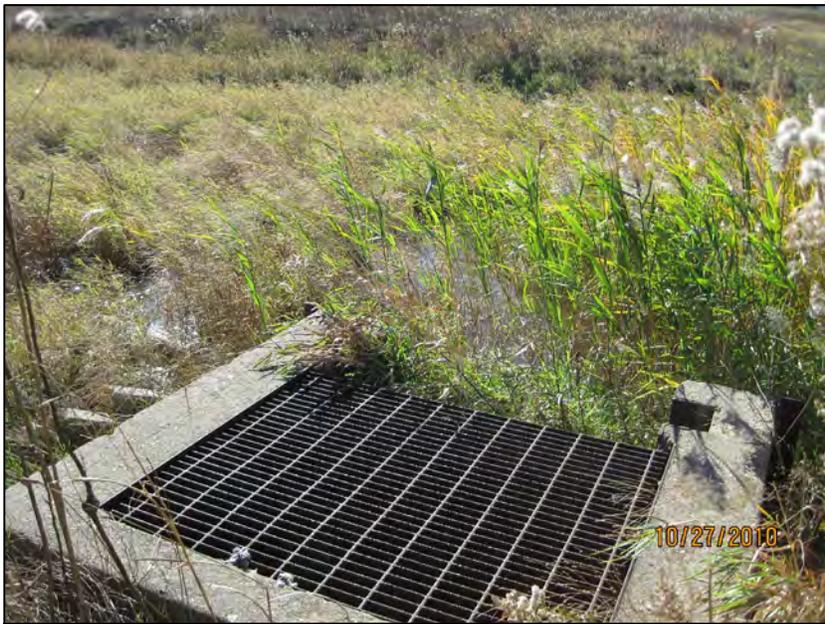
MP-12
TOP OF ABANDONED MAIN POND OUTLET STRUCTURE

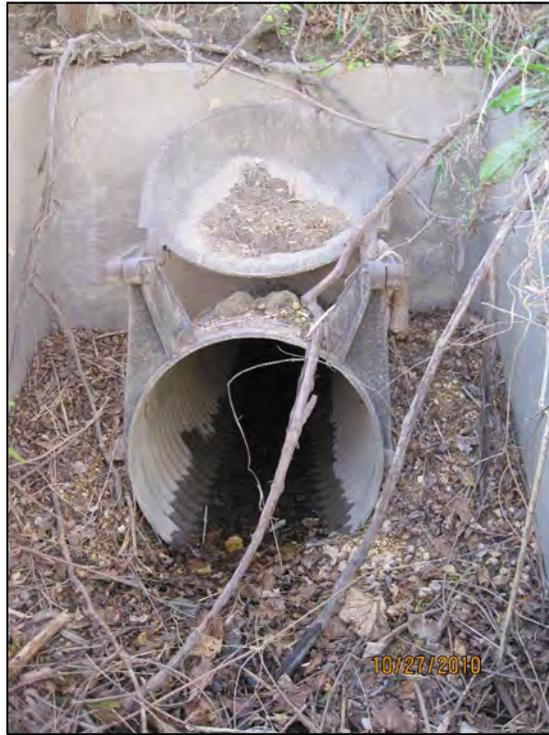
MP-13
DOWNSTREAM END OF ABANDONED MAIN POND OUTLET
STRUCTURE AT TOE OF SLOPE OF ORIGINAL EMBANKMENT

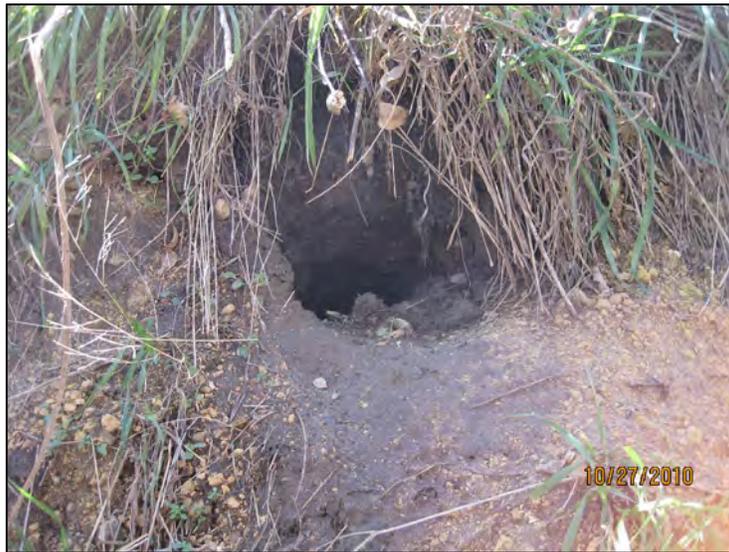
The original pond embankment remains in-place; however, it does not directly support the ash ponds since the ponds themselves are situated well inside this original embankment. The narrowest distance between a pond boundary and the original downstream embankment face appears to be at the Secondary Pond discharge pump house, which is located at the eastern end of the pond. The original embankment has not been maintained and is covered in trees and vegetation (MP-15 through MP-18). An animal burrow was noted at the top of the northeastern embankment (Photo MP-14).

MP-14
ANIMAL BURROW LOCATED AT NORTHEAST
CORNER OF ORIGINAL POND EMBANKMENT

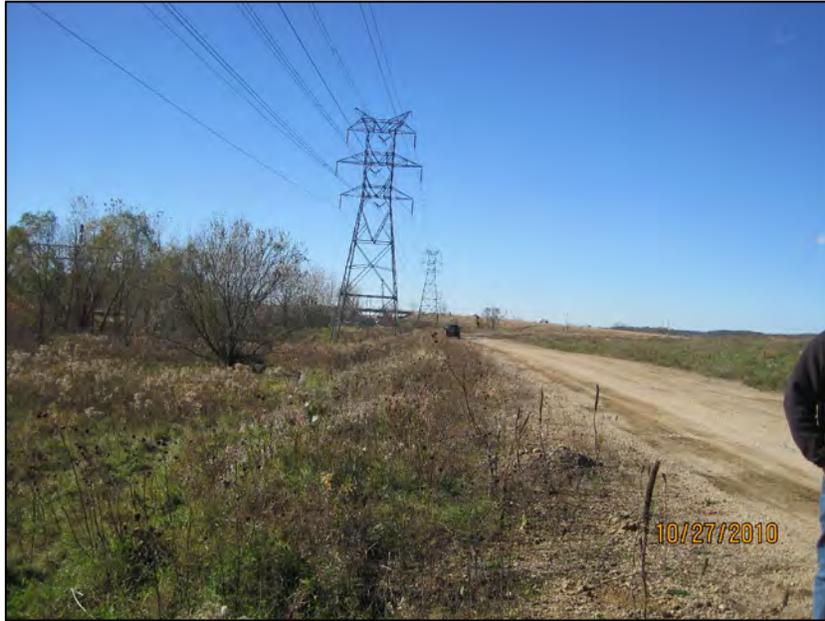
MP-17
LOOKING SOUTHWEST ALONG SOUTHERN
PORTION OF ORIGINAL EMBANKMENT

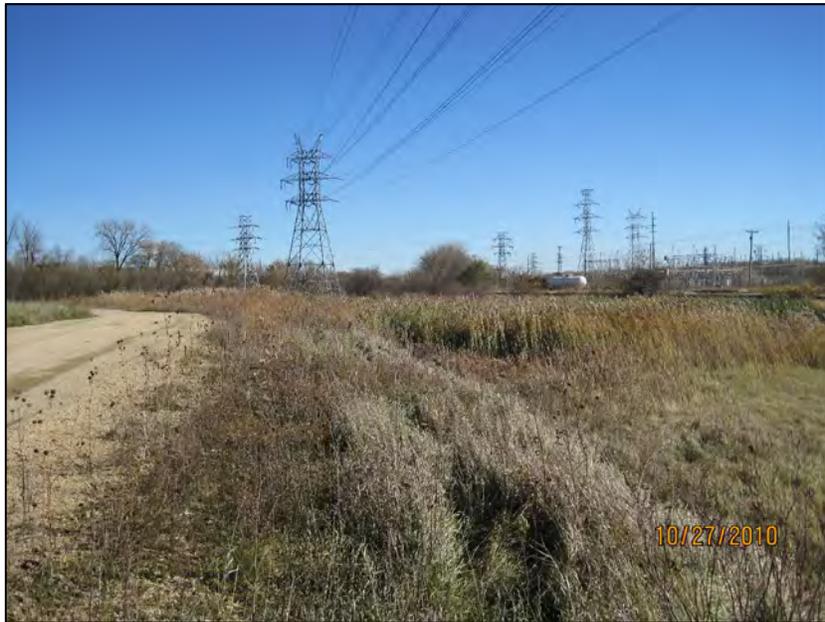
MP-18
LOOKING NORTHEAST ALONG SOUTHERN
PORTION OF ORIGINAL EMBANKMENT
