Report of Dam Safety Assessment of Coal Combustion  
Surface Impoundments  
Interstate Power and Light Company  
M.L. Kapp Generating Station  
Clinton, IA

AMEC Project No. 3-2106-0183.0002

May 2011

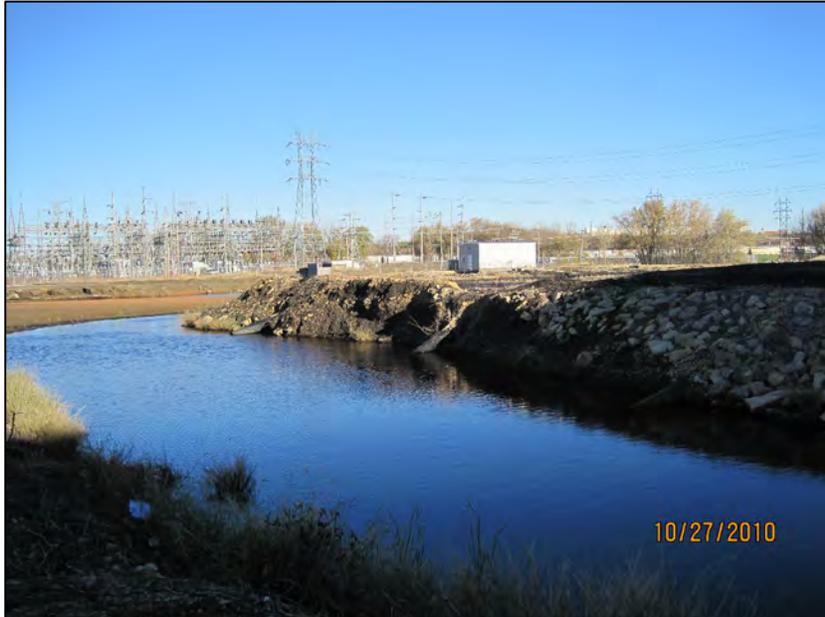
**EP-1  
LOOKING NORTHWEST ACROSS EMERGENCY ASH PRIMARY  
AND SECONDARY SETTLING PONDS**

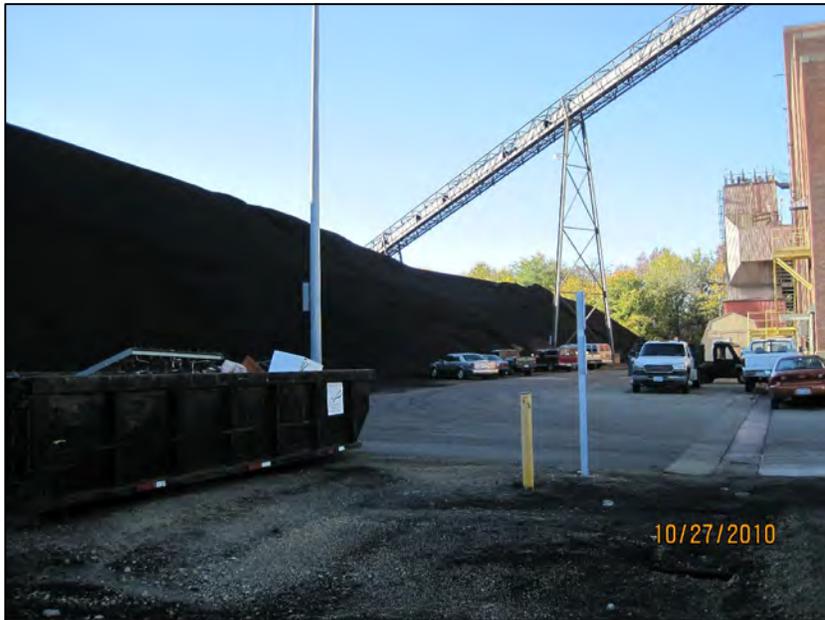
**EP-2  
LOOKING SOUTH AT COAL PILE ADJACENT  
TO OPERATIONS/OFFICE BUILDING**

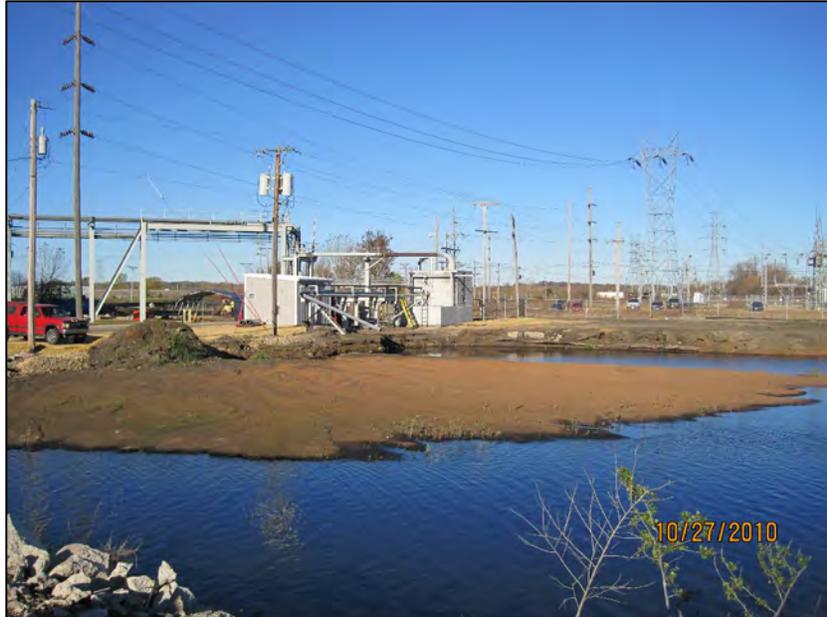
**EP-3**  
**LOOKING WEST AT BOTTOM ASH INFLUENT PIPE**  
**INTO EMERGENCY ASH PRIMARY SETTLING POND**

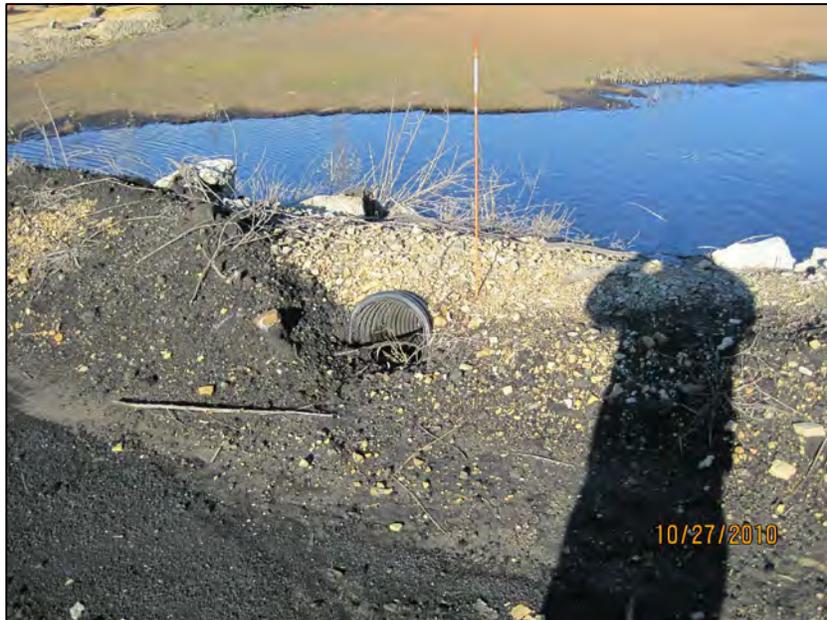
**EP-4**  
**UPSTREAM END OF STORM DRAIN PIPE FROM COAL PILE**  
**AREA INTO EMERGENCY ASH PRIMARY SETTLING POND**

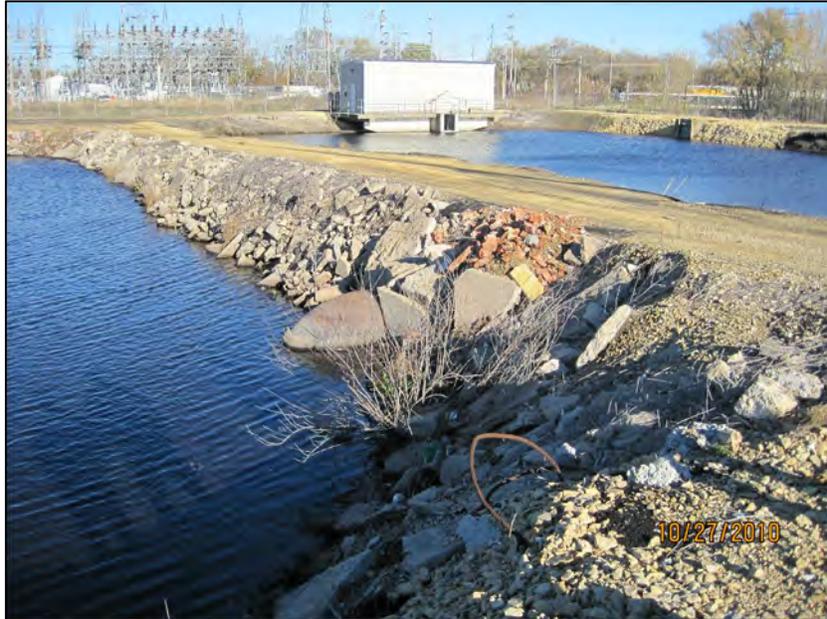
**EP-5**

**LOOKING AT UPSTREAM END OF EMERGENCY ASH PRIMARY AND SECONDARY SETTLING PONDS INVERTED CONNECTION PIPE**

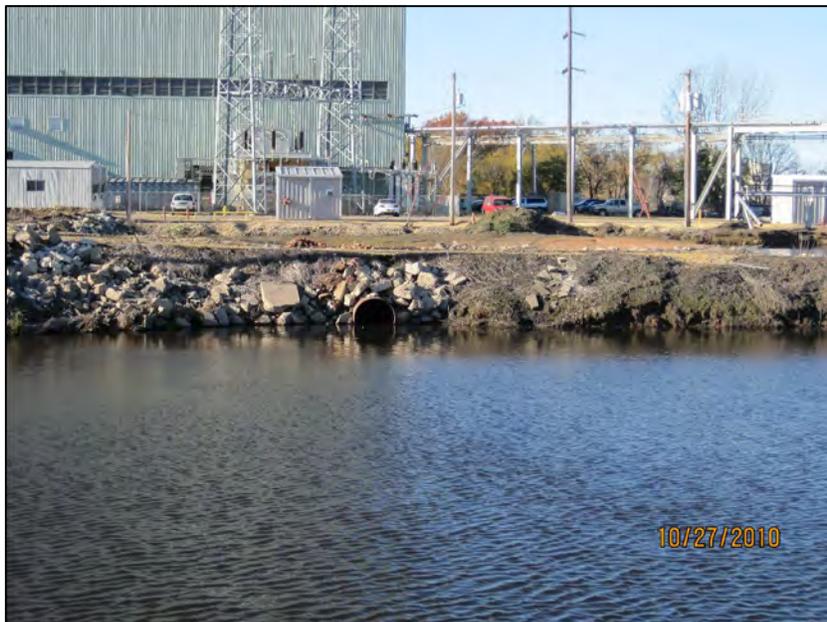
**EP-6**

**LOOKING SOUTHWEST AT DOWNSTREAM END OF EMERGENCY ASH PRIMARY AND SECONDARY PONDS INVERTED CONNECTION PIPE**

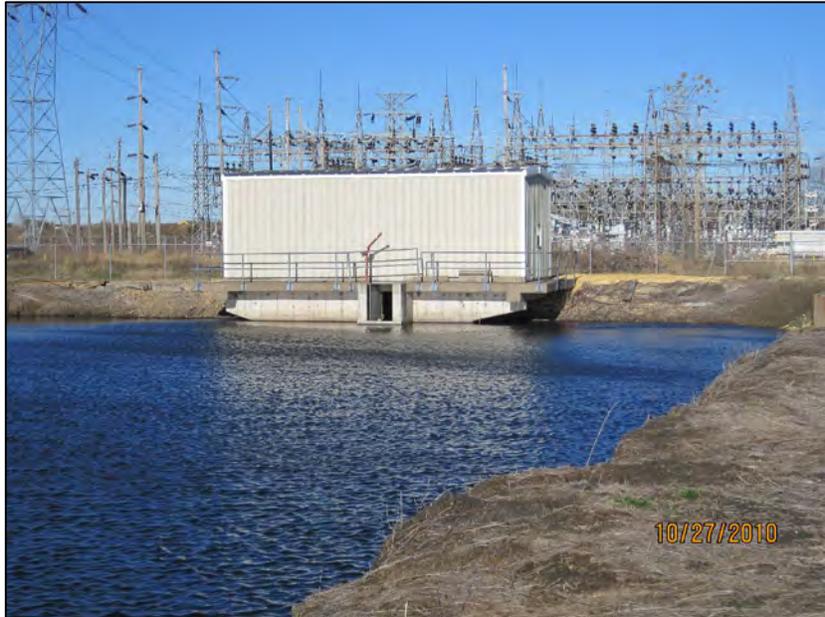
**EP-7**  
**LOOKING WEST AT EMERGENCY ASH SECONDARY**  
**POND OUTFALL PUMP HOUSE**

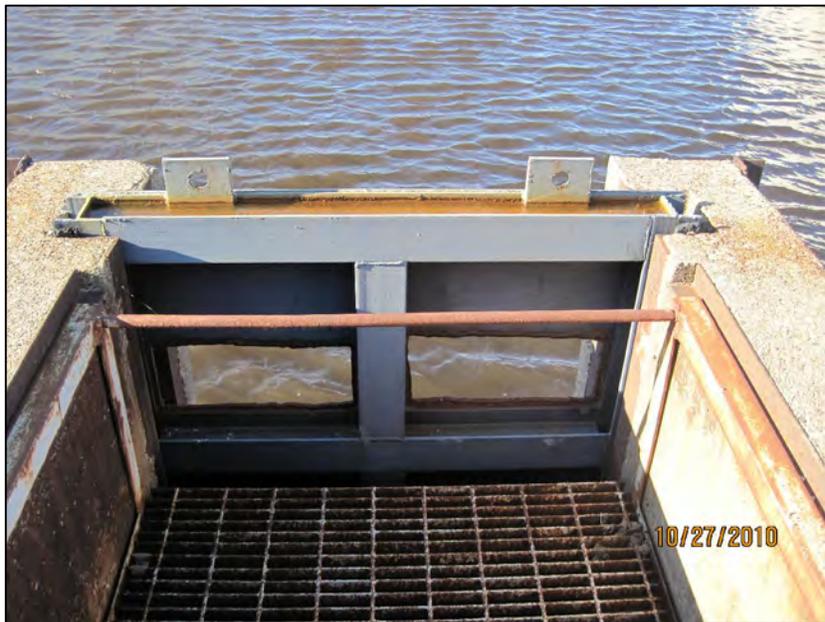
**EP-8**  
**EMERGENCY ASH SECONDARY POND ABANDONED**  
**ORIGINAL DISCHARGE BOX STRUCTURE**

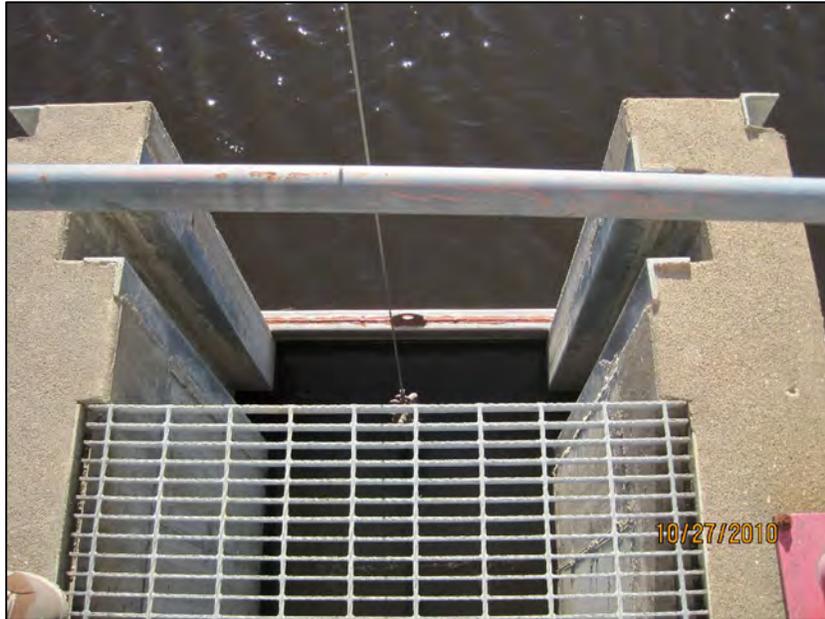
**EP-9**  
**INFLUENT WELL AT EMERGENCY SECONDARY POND PUMP HOUSE**

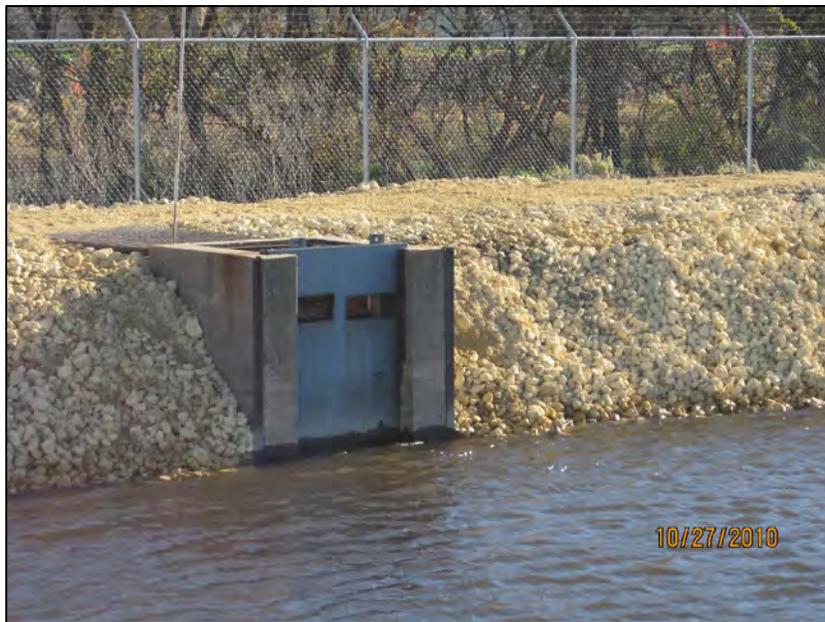
**EP-10**  
**LOOKING EAST FROM PUMPHOUSE AT ABANDONED ORIGINAL DISCHARGE BOX STRUCTURE**

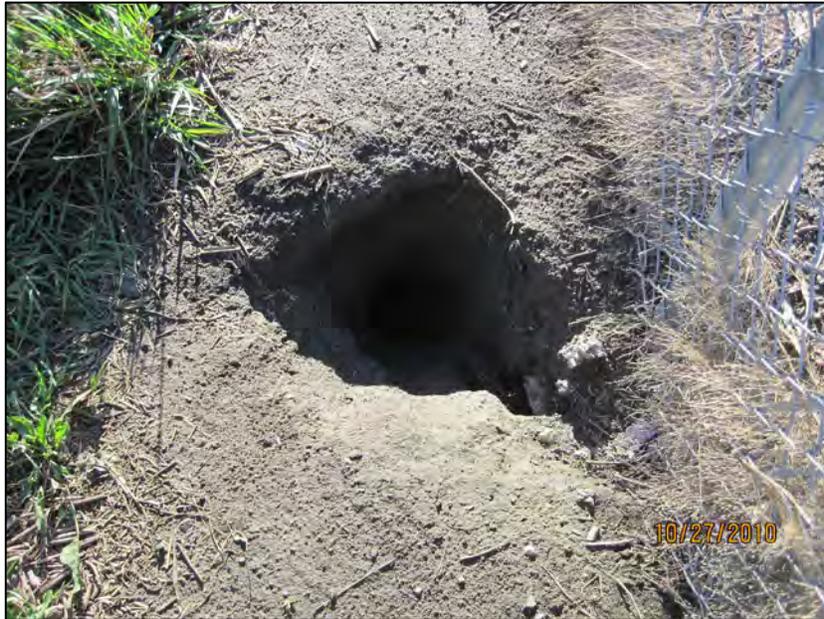
**EP-11**

**ANIMAL BURROW OUTSIDE NORTH FENCE CORNER AT TOP OF EMERGENCY SECONDARY POND DOWNSTREAM EMBANKMENT SLOPE**

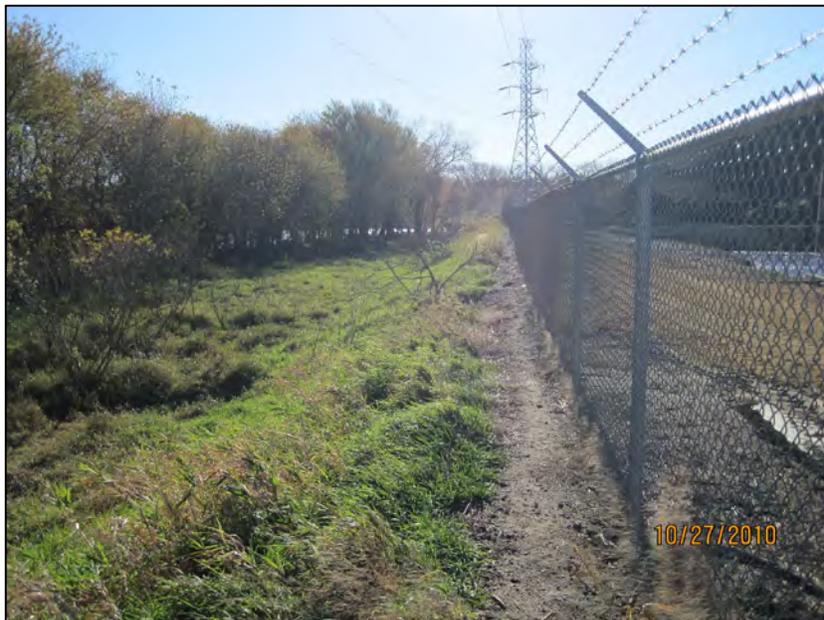
**EP-12**

**LOOKING SOUTHEAST ALONG CREST OF EMERGENCY SECONDARY POND DOWNSTREAM EMBANKMENT-MISSISSIPPI RIVER IN BACKGROUND**

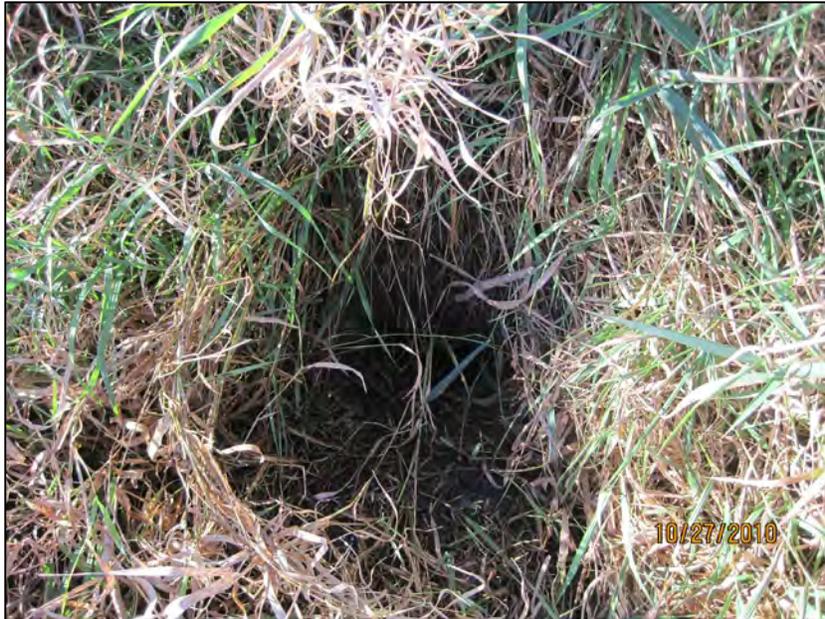
**EP-13**  
**OUTLET OF ANIMAL BURROW SHOWN IN PHOTO EP-11**

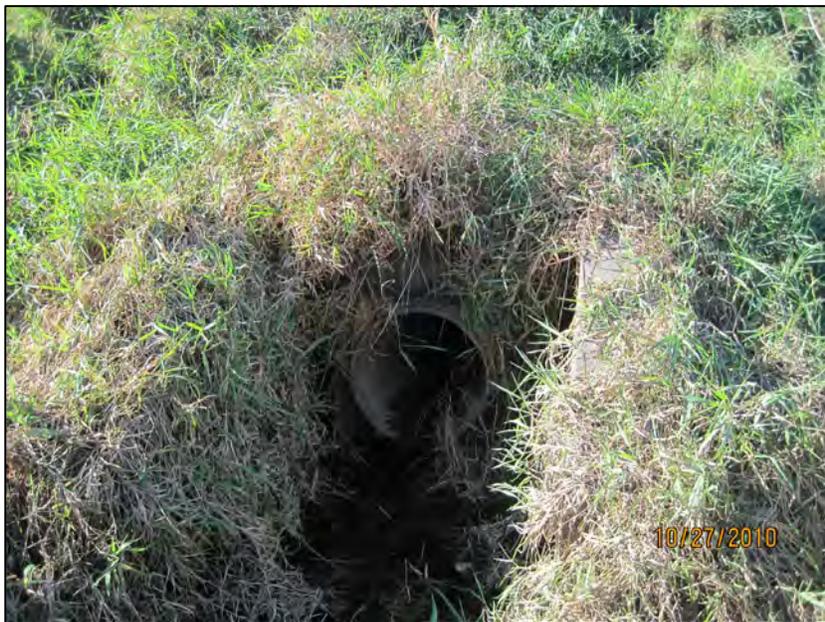
**EP-14**  
**DOWNSTREAM PIPE OUTLET OF ABANDONED ORIGINAL DISCHARGE BOX STRUCTURE**

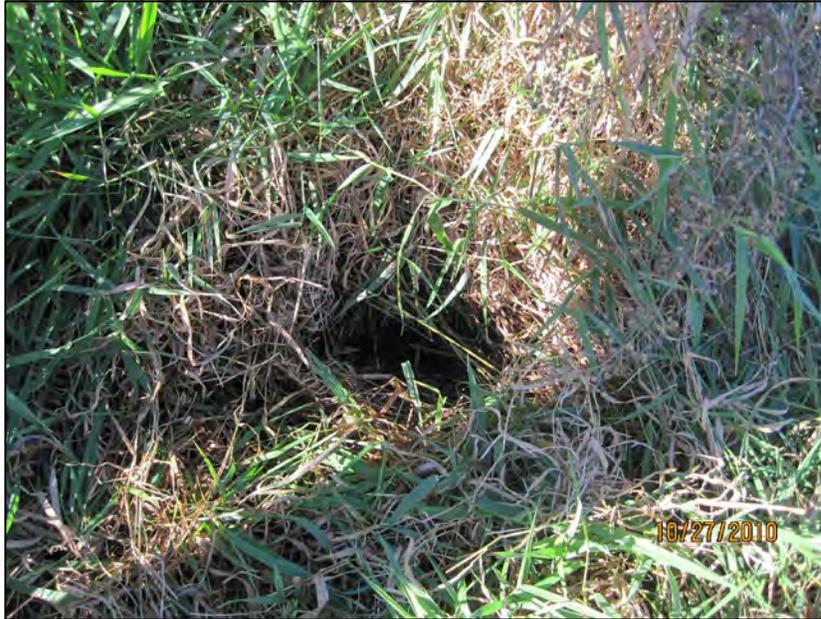
**EP-15  
ANIMAL BURROW IN DOWNSTREAM EMBANKMENT**

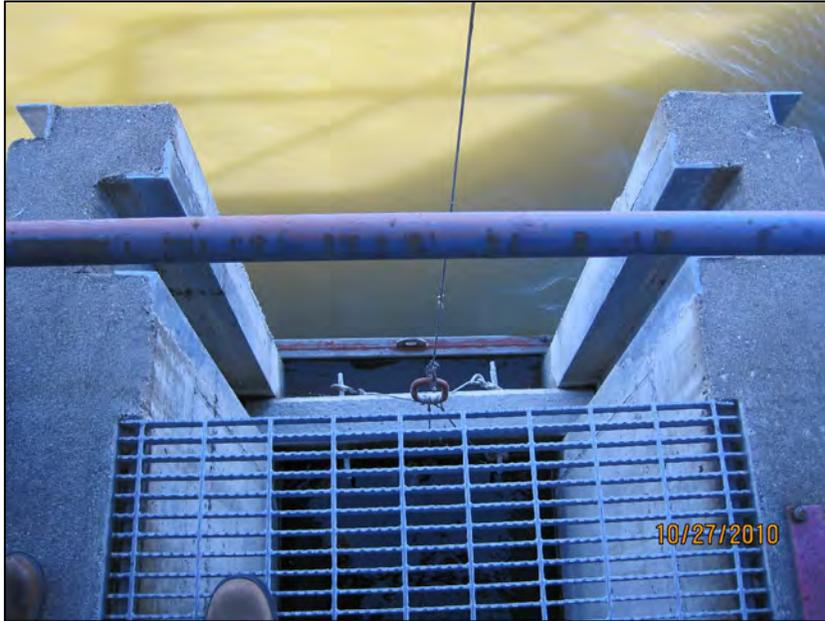
**MP-1  
INFLUENT WELL AT MAIN SECONDARY  
POND DISCHARGE PUMP HOUSE**

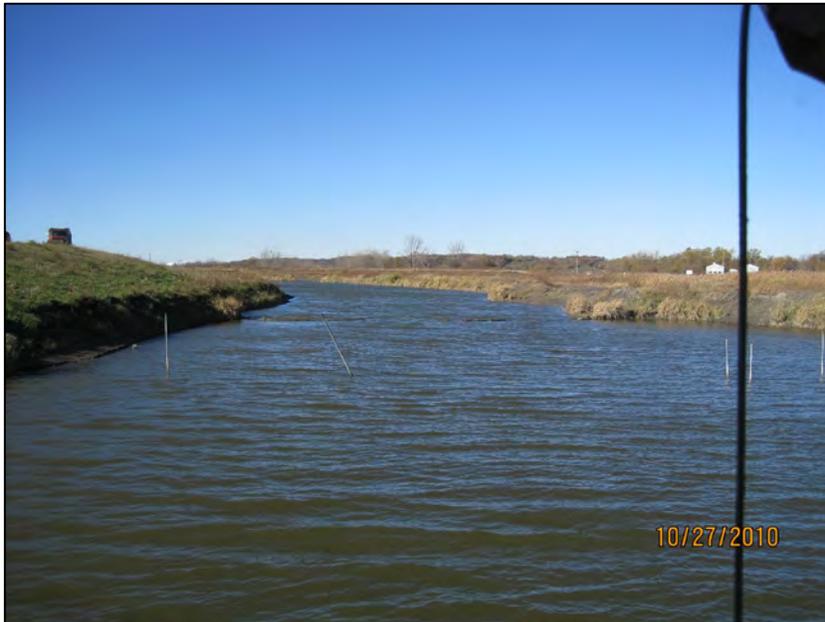
**MP-2  
LOOKING WEST ALONG MAIN ASH SECONDARY  
POND FROM DISCHARGE PUMP HOUSE**

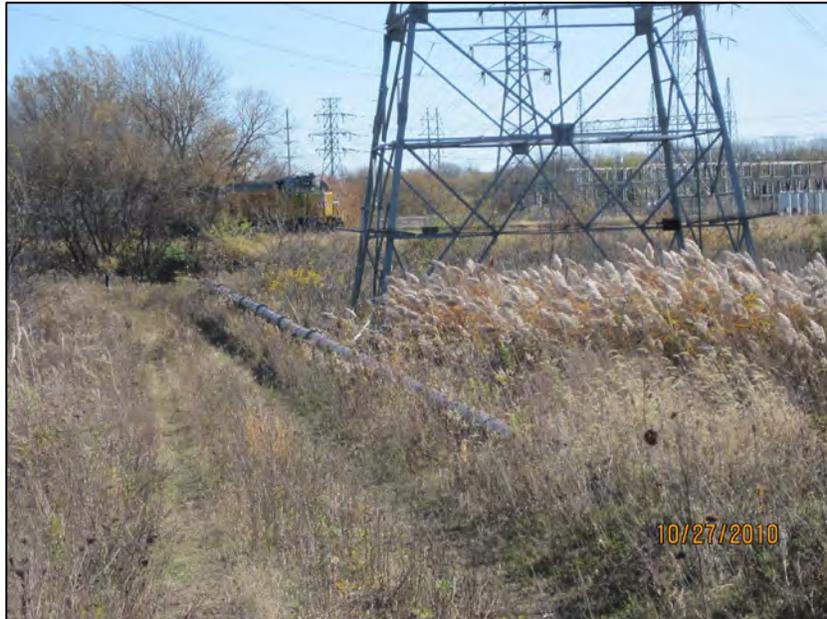
**MP-3**  
**LOOKING EAST AT CCW INFLUENT PIPE**  
**FROM ML KAPP FACILITY**

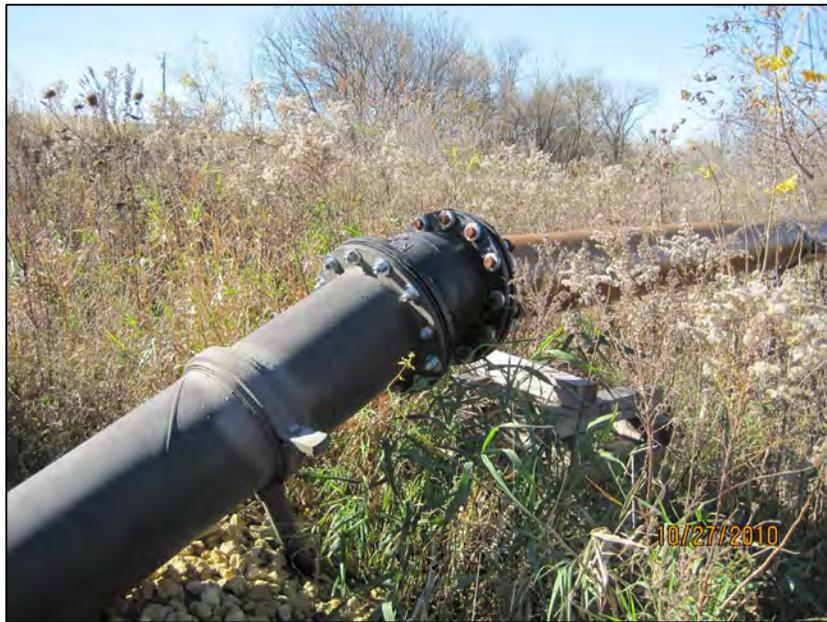
**MP-4**  
**CCW INFLUENT PIPE-CONNECTION POINT OF**  
**NEW SECTION OF BASALT LINED CAST IRON**

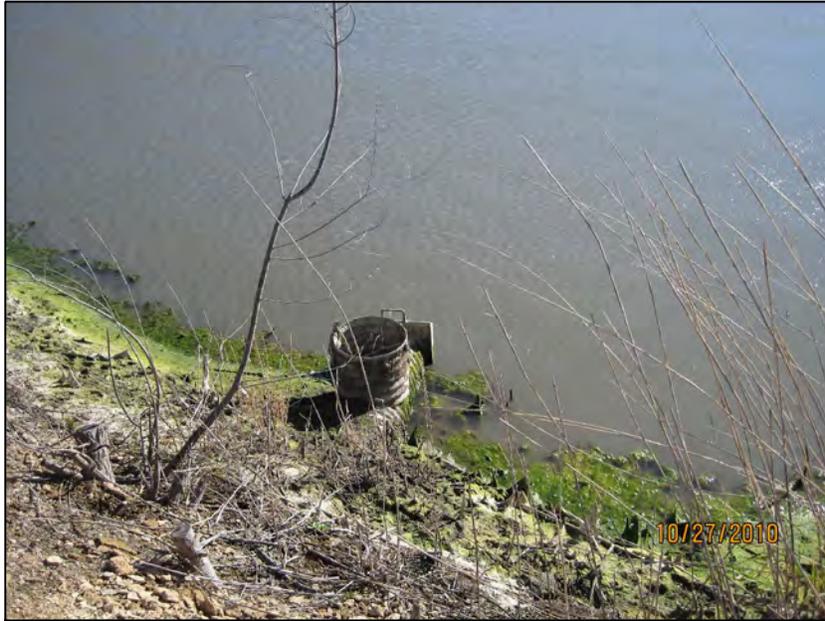
Flow is discharged from the northwest corner Primary Pond into the southwest corner of the Secondary Pond through a drop inlet (Photos MP-5 and MP-8)). The drop inlet was noted to be adjustable using extension pieces located nearby (Photo MP-7). The southwest corner of the Secondary Pond, where flow from the Primary Pond enters, was overgrown with grass and weeds and did not appear to have been active in some time (Photo MP-8).

**MP-5**  
**BOTTOM SECTION OF DROP INLET IN MAIN PRIMARY POND LEADING TO MAIN SECONDARY POND**

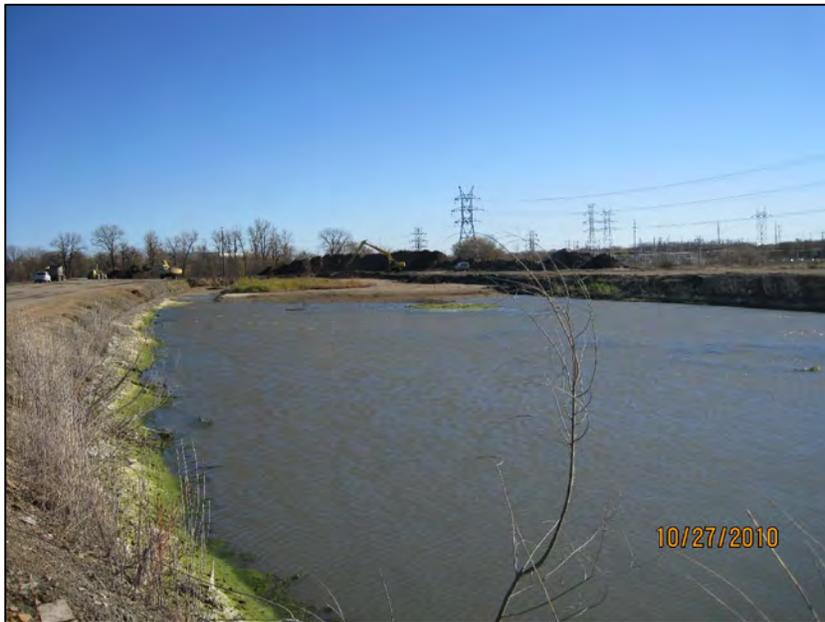
**MP-6**  
**LOOKING EAST FROM WEST CREST ACROSS MAIN ASH PRIMARY POND**

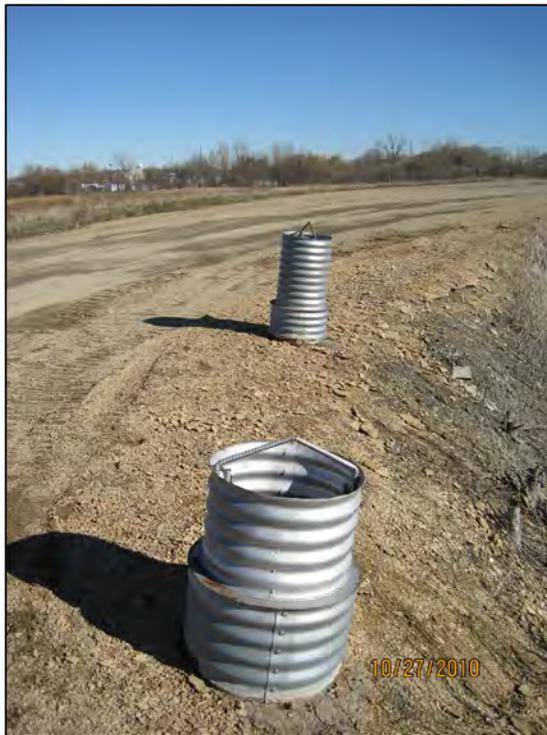
**MP-7**  
**DROP INLET EXTENSION PIECES SITTING UPSLOPE**  
**FROM DROP INLET IN MAIN ASH PRIMARY POND**

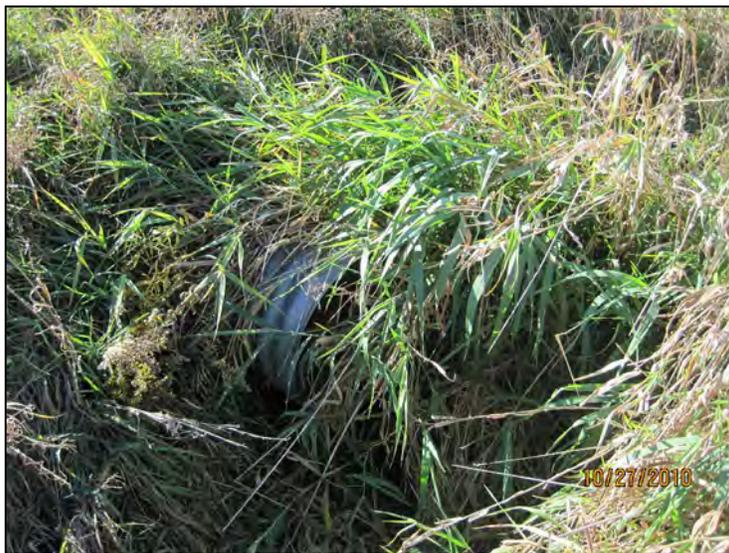
**MP-8**  
**VEGETATION SURROUNDING PIPE DISCHARGE FROM**  
**MAIN ASH PRIMARY POND INTO SECONDARY POND**

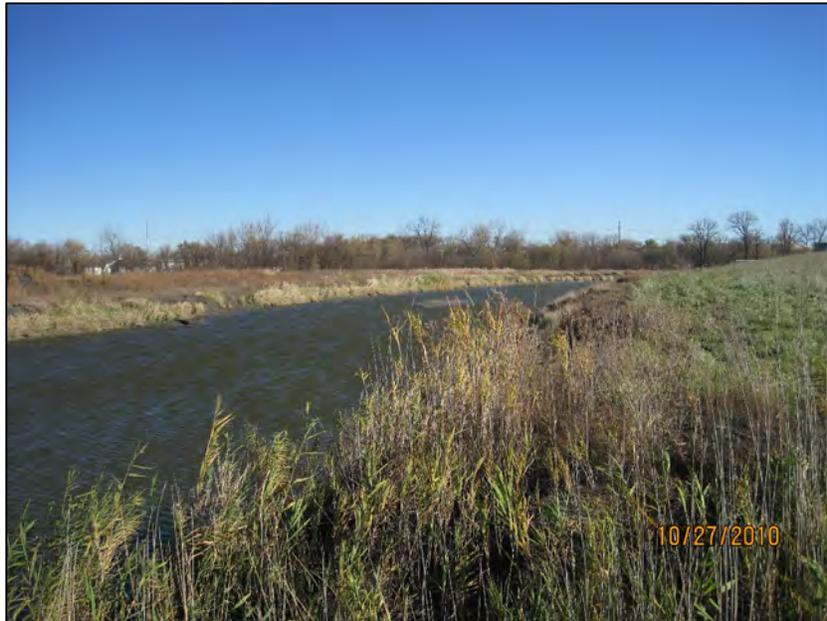
**MP-9**  
**LOOKING NORTHEAST ALONG SOUTH EMBANKMENT**  
**AND CREST OF MAIN SECONDARY POND**

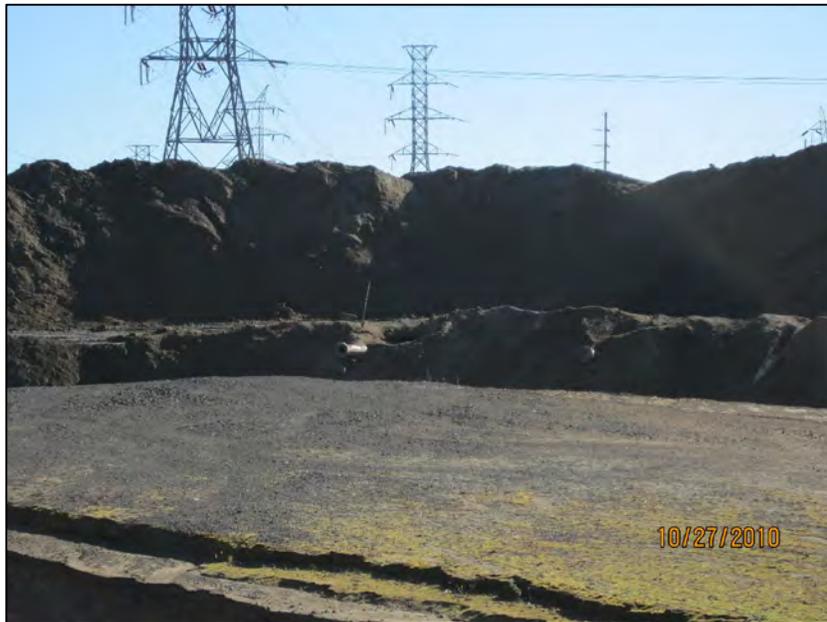
**MP-10**  
**LOOKING SOUTHEAST AT CCW PIPE INFLUENT**  
**INTO MAIN ASH PRIMARY POND**

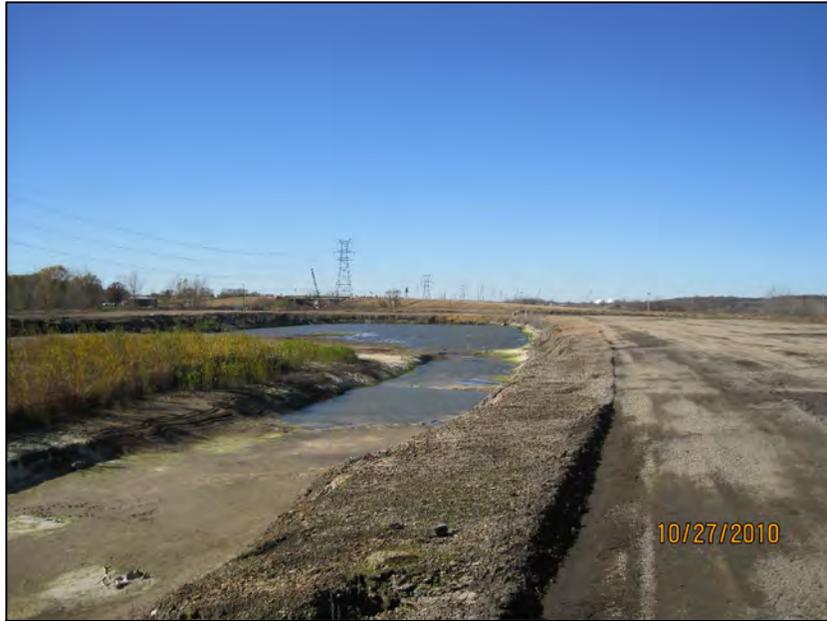
**MP-11**  
**LOOKING SOUTHWEST ALONG NORTH EMBANKMENT**  
**AND CREST OF MAIN PRIMARY POND**

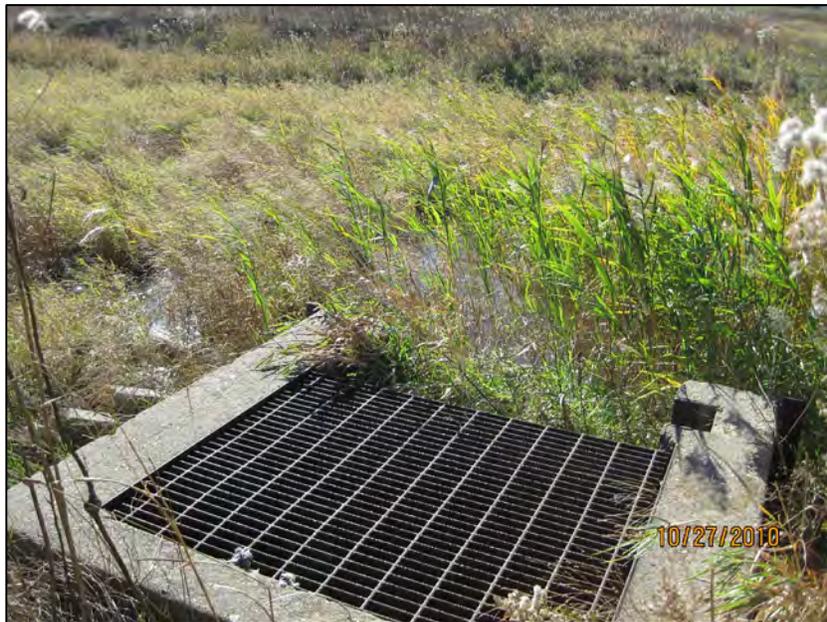
**MP-12**  
**TOP OF ABANDONED MAIN POND OUTLET STRUCTURE**

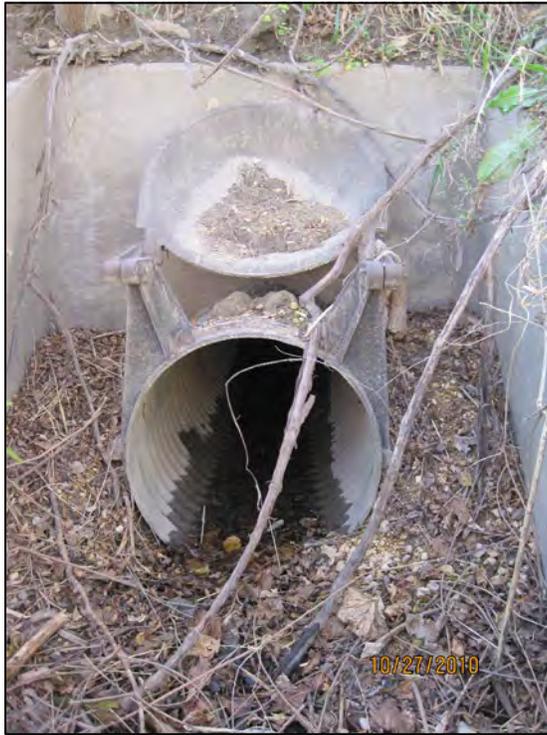
**MP-13**  
**DOWNSTREAM END OF ABANDONED MAIN POND OUTLET**  
**STRUCTURE AT TOE OF SLOPE OF ORIGINAL EMBANKMENT**

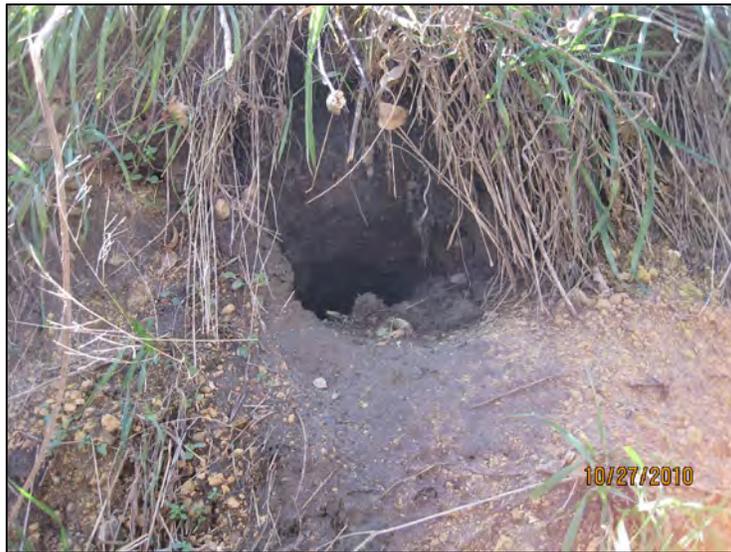
The original pond embankment remains in-place; however, it does not directly support the ash ponds since the ponds themselves are situated well inside this original embankment. The narrowest distance between a pond boundary and the original downstream embankment face appears to be at the Secondary Pond discharge pump house, which is located at the eastern end of the pond. The original embankment has not been maintained and is covered in trees and vegetation (MP-15 through MP-18). An animal burrow was noted at the top of the northeastern embankment (Photo MP-14).

**MP-14**  
**ANIMAL BURROW LOCATED AT NORTHEAST**  
**CORNER OF ORIGINAL POND EMBANKMENT**

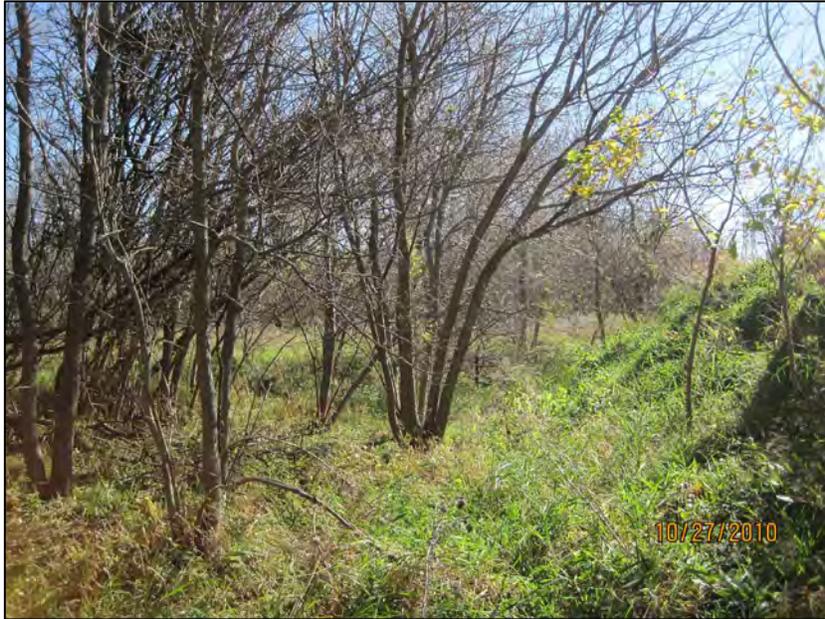
**MP-15**  
**LOOKING EAST ALONG DOWNSTREAM SLOPE OF ORIGINAL EMBANKMENT AT TREES/VEGETATION**

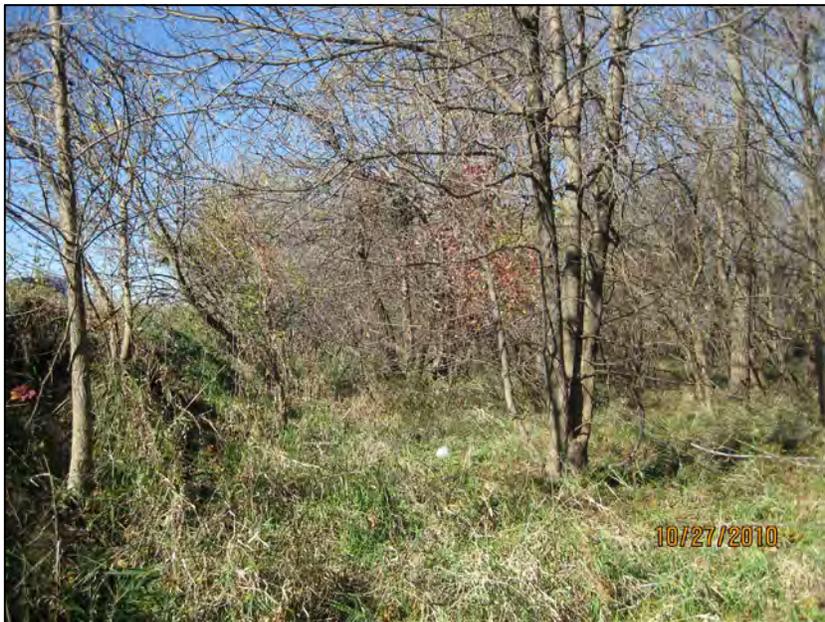
**MP-16**  
**LOOKING WEST ALONG DOWNSTREAM SLOPE OF ORIGINAL EMBANKMENT AT TREES/VEGETATION**

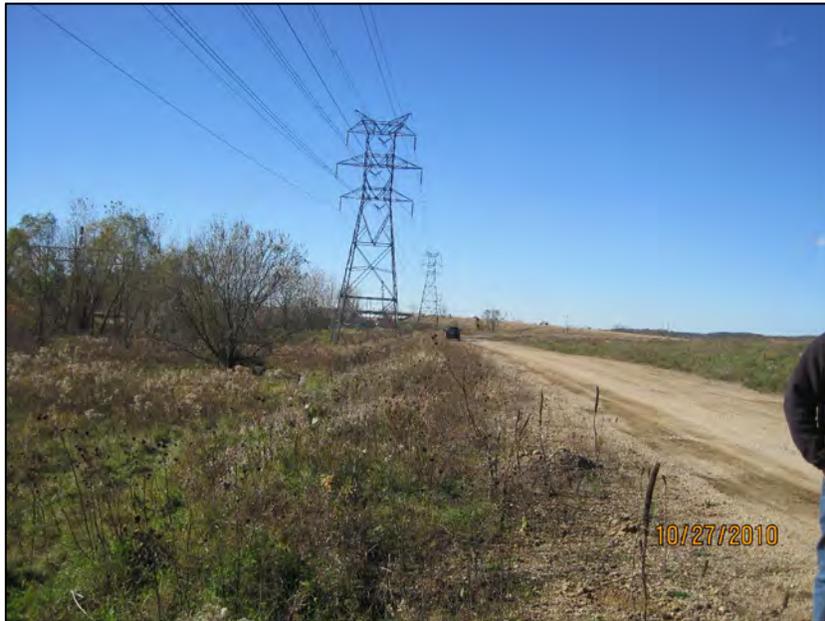
**MP-17**  
**LOOKING SOUTHWEST ALONG SOUTHERN**  
**PORTION OF ORIGINAL EMBANKMENT**

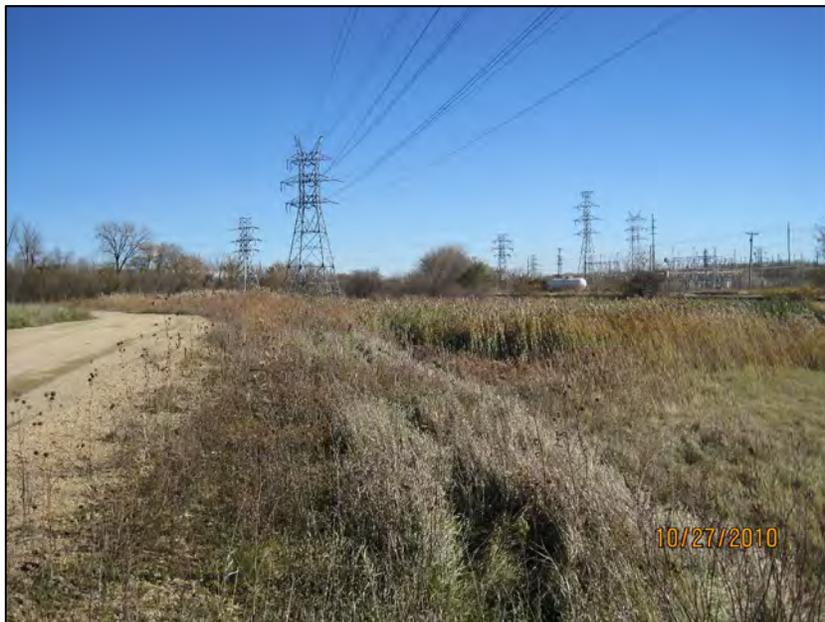
**MP-18**  
**LOOKING NORTHEAST ALONG SOUTHERN**  
**PORTION OF ORIGINAL EMBANKMENT**
