**COAL ASH IMPOUNDMENT
SITE ASSESSMENT DRAFT REPORT**

**Duck Creek Power Station
Ameren Energy Generating Company
Canton, Illinois**

KLEINFELDER PROJECT NUMBER 112618-5

September 16, 2010

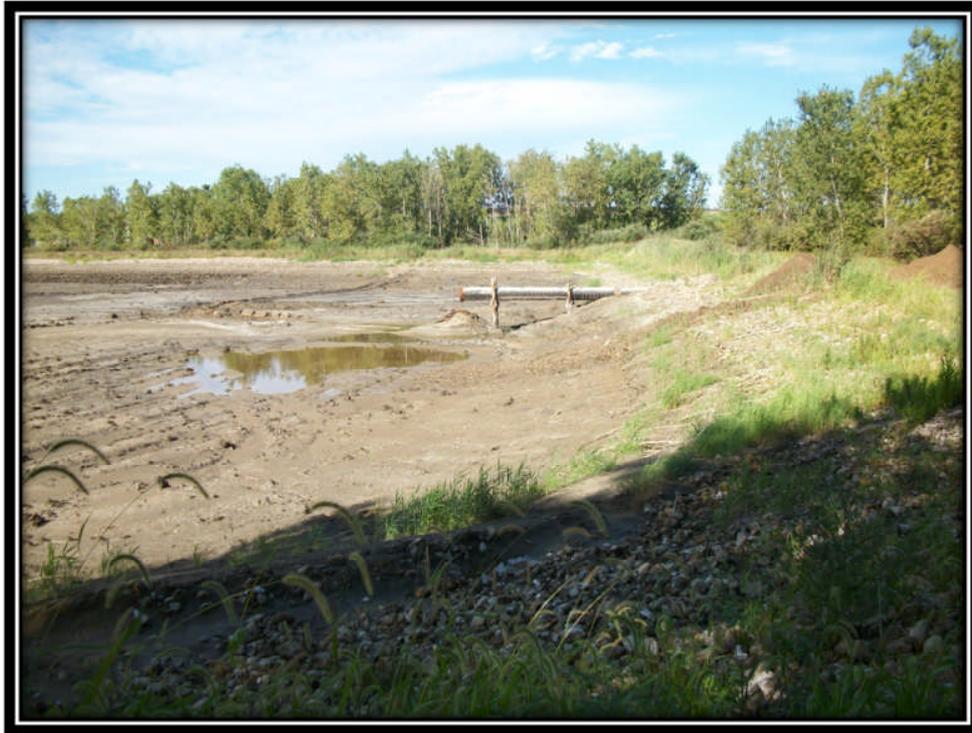
Inflow into the Recycle Pond is from pipes on the northern embankment of the impoundment, as well as stormwater runoff that flows naturally into the pond. The inlet pipe can be seen in Photo 1 of Appendix B. The inlet pipe appears to be in satisfactory condition.

Photo 1 – Recycle Pond Inlet Pipe

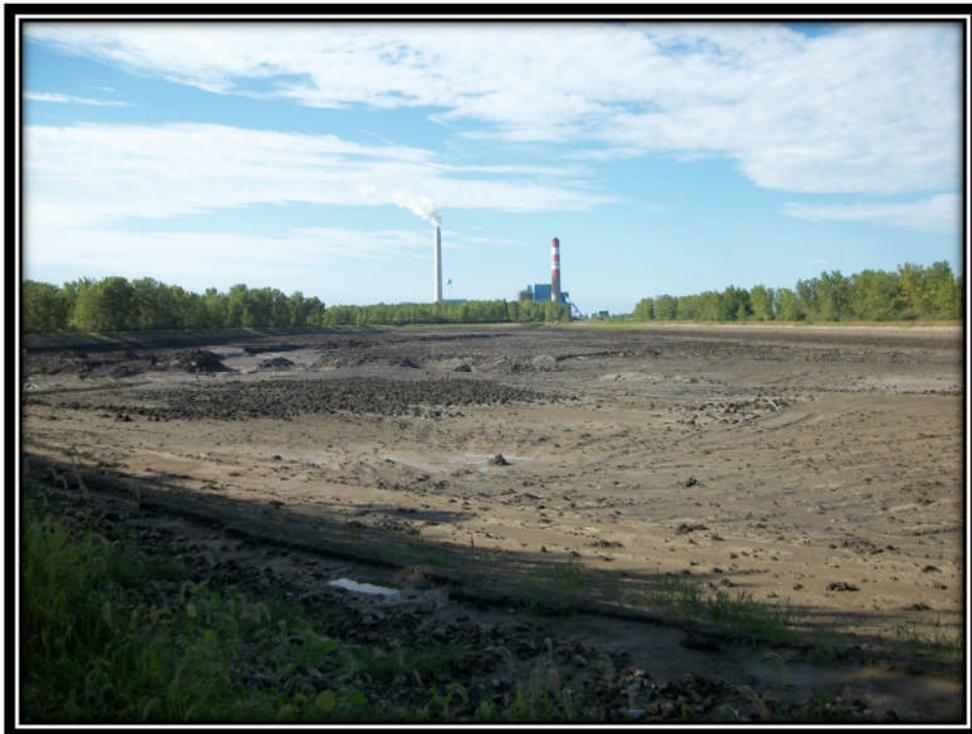
Photo 2 – Typical Condition of Recycle Pond in the Process of Being Decommissioned Looking South

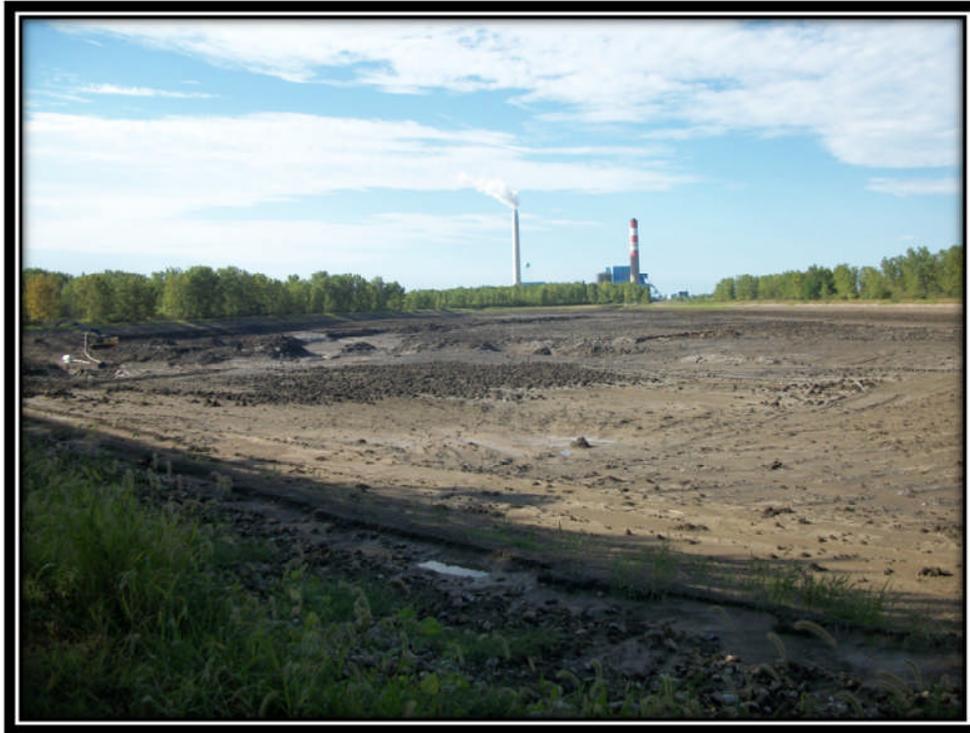
Photo 3 – Typical Condition of Recycle Pond (Note Pumping Operations in Background)

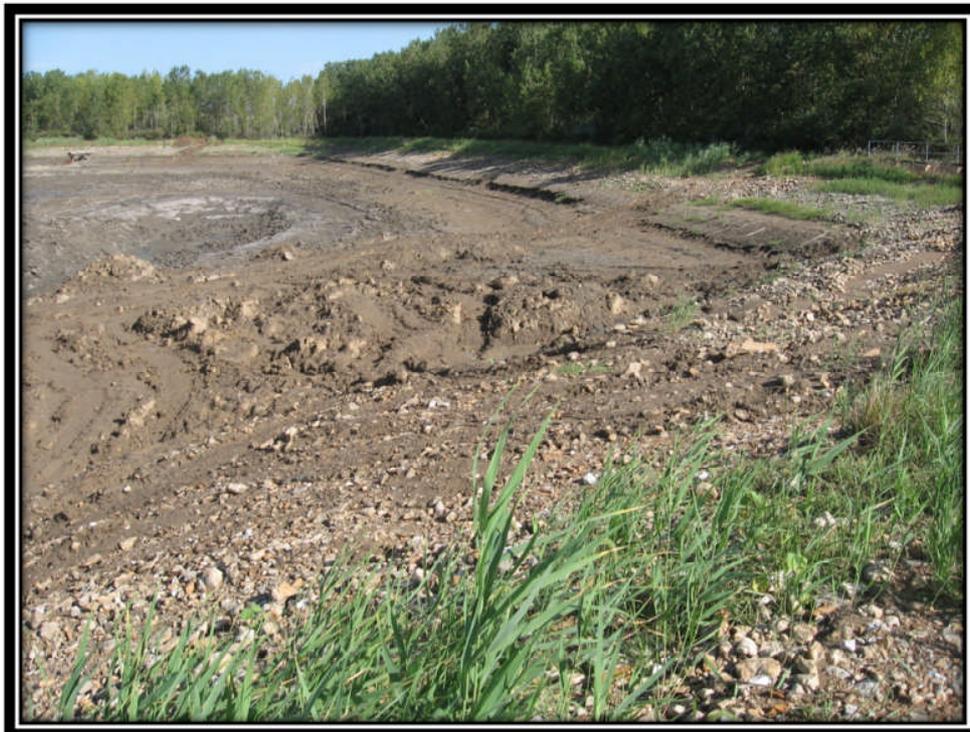
Overall, the upstream slope of the impoundment was in good condition. Photos 1 and 4 in Appendix B show the conditions of the upstream slope. Specific observations include:

- The upstream slope was laid back at approximately 3H:1V, based on visual observations.
- Minor erosion, less than 6 inches, was noted on some of the upstream slopes.
- Grasses and woody bushes were observed on the upstream slope for the majority of the impoundment.
- The upstream embankment was typically covered with riprap.

Photo 4 – Recycle Pond Looking Northwest (Note Inlet Pipe in Background)

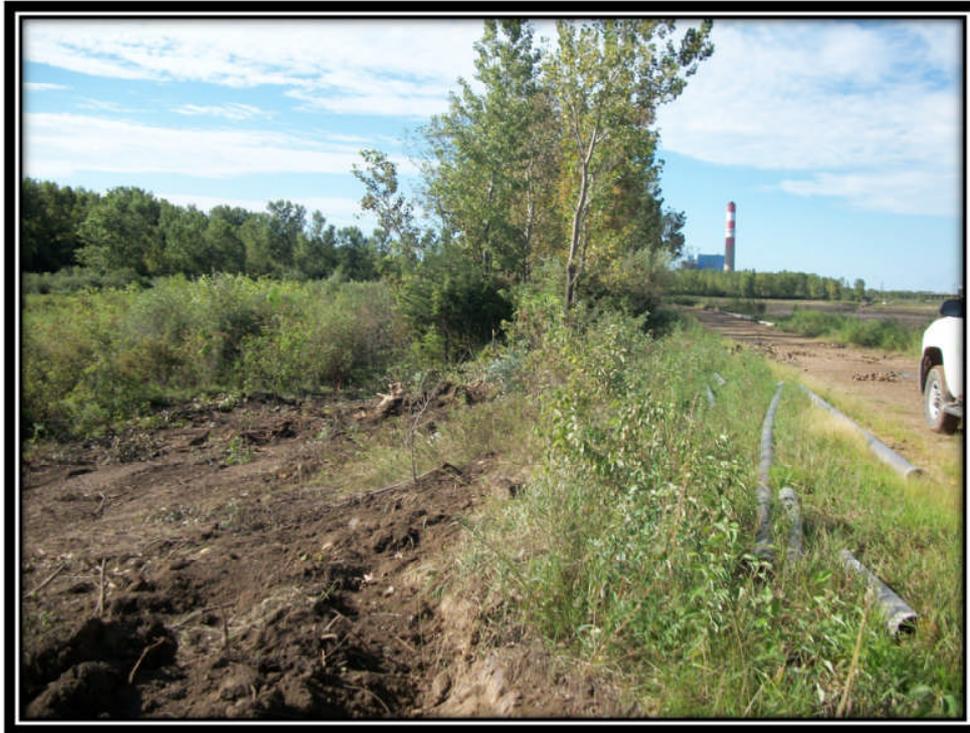
Overall, the crest of the impoundment was in good condition. Photos 5 and 6 show the condition of the crest. Specific observations include:

Overall, the downstream slope was in fair condition. Photo 5 shows the conditions of the downstream slope. Specific observations include:

The toe areas of the embankment were in fair condition. See Photo 5 for the condition of these areas. Key features and observations of these areas include:

Photo 5 – Clearing Operations in Preparation of Recycle Pond Decommissioning

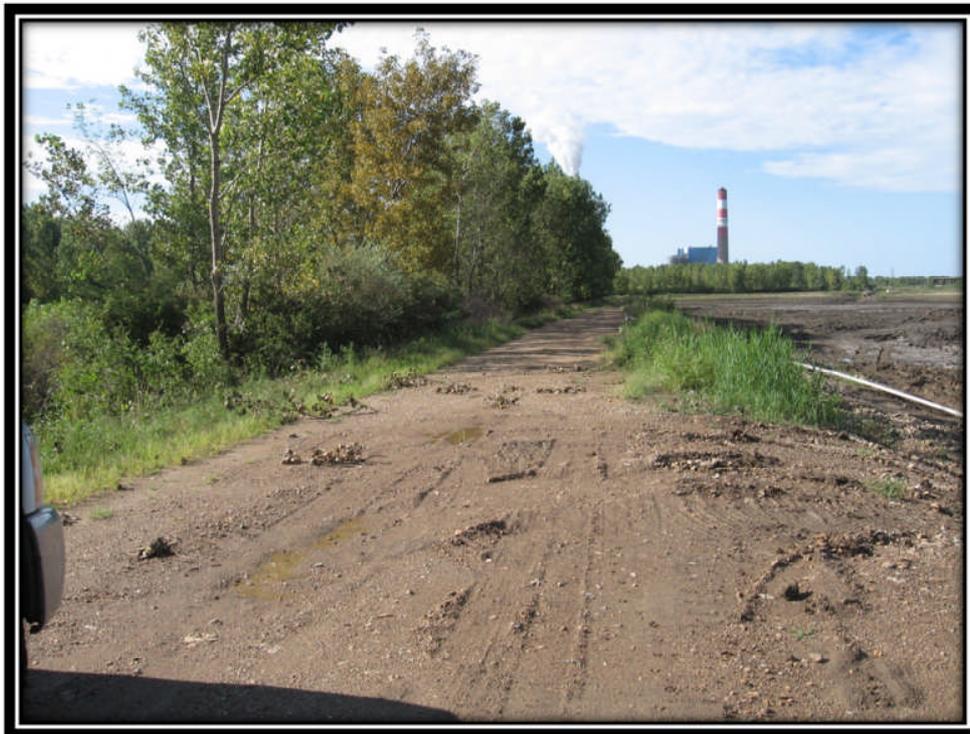
- The impoundment crest is a gravel road.
- Sparse grasses and bushes were observed on the crest.
- No major depressions or ruts were noted on the impoundment crest.
- Minor erosion was noted on the crest in limited locations. This erosion was typically less than six inches in depth and typically appeared on the edges of the crest where grade breaks occurred when transitioning to embankment slopes.

Photo 6 – Typical Crest Condition of Recycle Pond

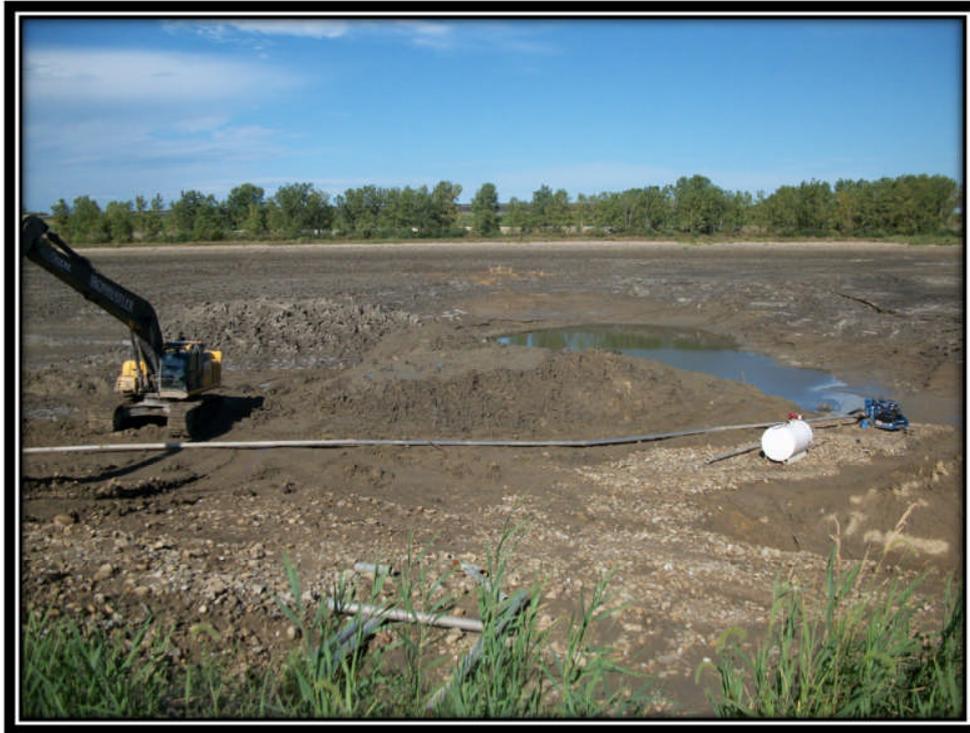
Photo 7 – Pumping Operations to Remove Remaining Water from Recycle Pond

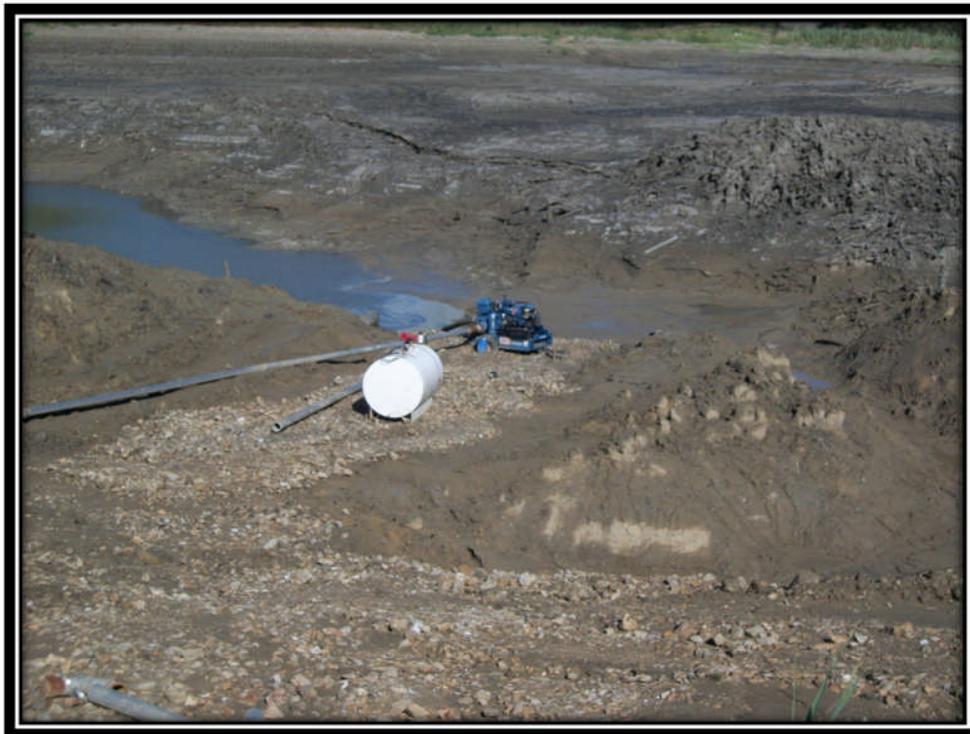
Photo 8 – Pumping Operations to Remove Remaining Water from Recycle Pond

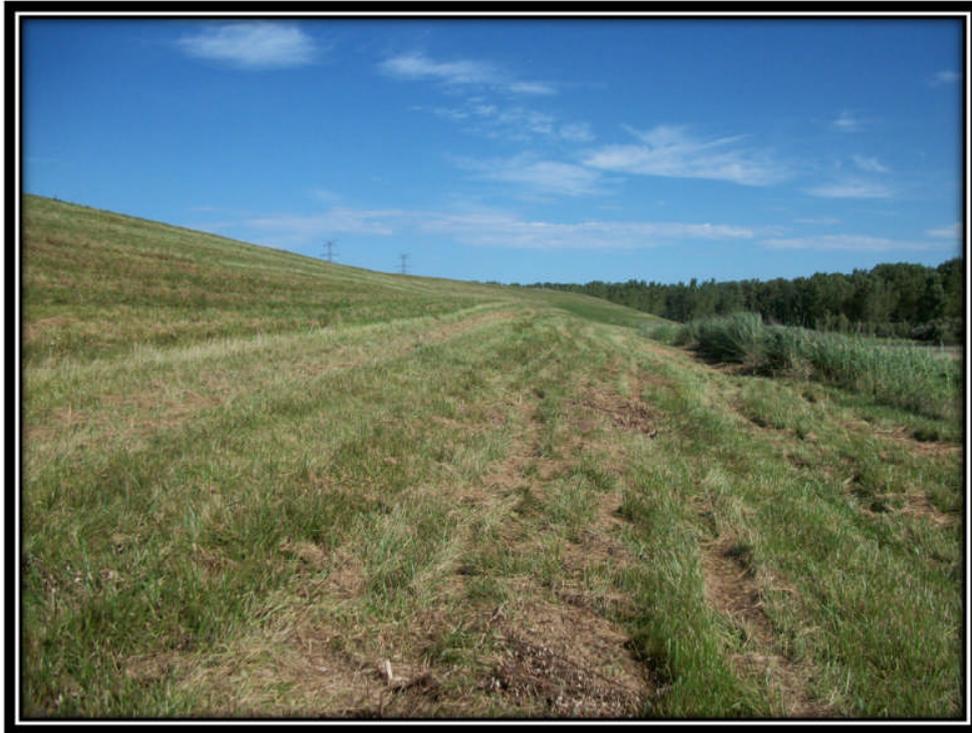
Overall, the downstream slope was in fair condition. Photos 9, 10, 11, and 12 show the conditions of the downstream slope. Specific observations include:

- Substantial grass cover was observed on the downstream slope and at the toe of the embankment for a large portion of the impoundment.
- Typically the embankment was well maintained with what appeared to be regular mowing operations.
- One possible area of seepage was noted on the eastern embankment.
- Slight rutting from mowing operations was noted in a few areas on the eastern embankment near the outlet works location.

Photo 9 – Eastern Embankment Pond 2 (Note Drainage Blanket and Benched Section in Background)

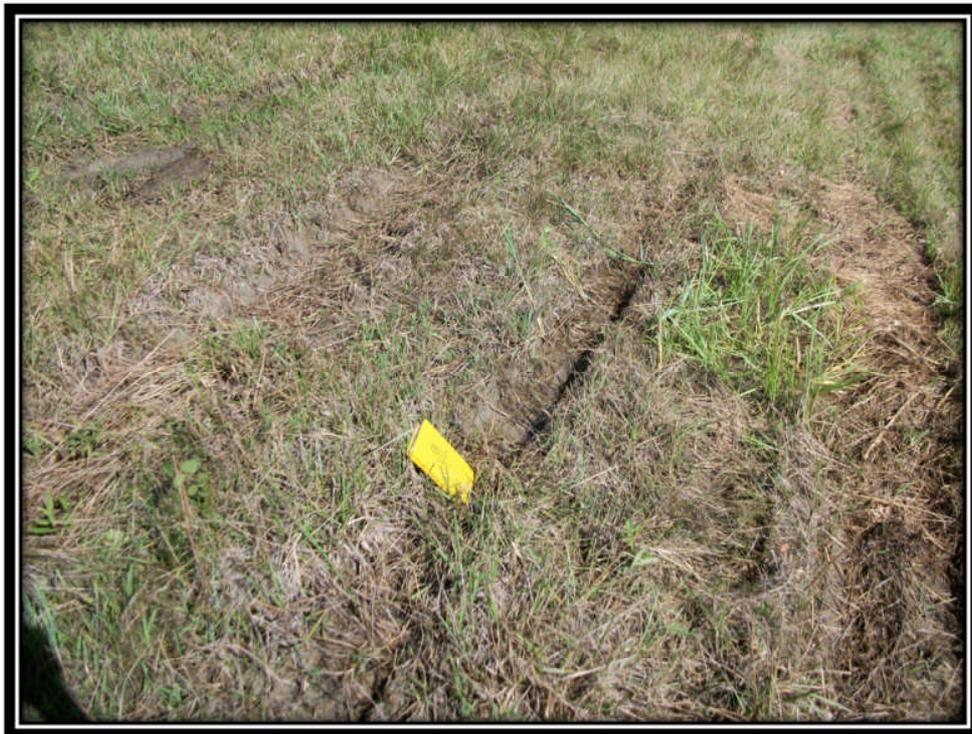
Photo 10 – Possible Slight Seepage Area near Eastern Embankment Toe (Note Rutting)

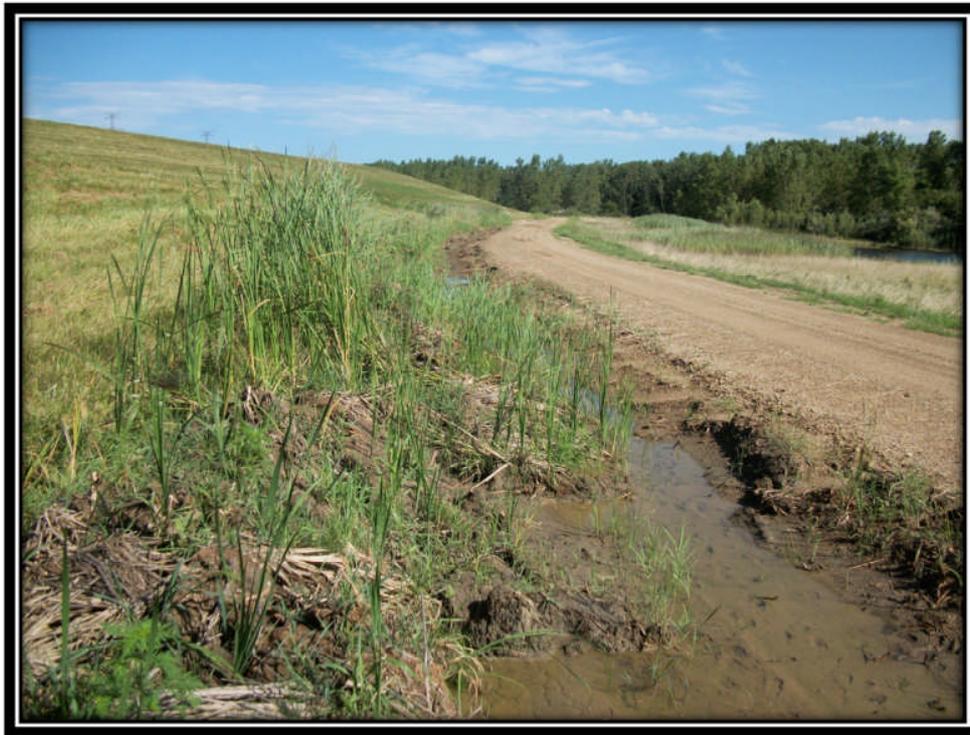
The toe areas of the embankment were in fair condition. See Photos 11 and 13 for the condition of these areas. Key features and observations of these areas include:

- The toe area had a few locations where vegetation had not been mowed.
- Ponding of stormwater was noted against the downstream toe on the eastern embankment. This appeared to be due to poor grading of a drainage channel.
- Typically, the embankment toe was well maintained with what appeared to be regular mowing operations.

Photo 11 – Ponding of Storm Water at Toe of Eastern Embankment between Road and Ash Pond 2

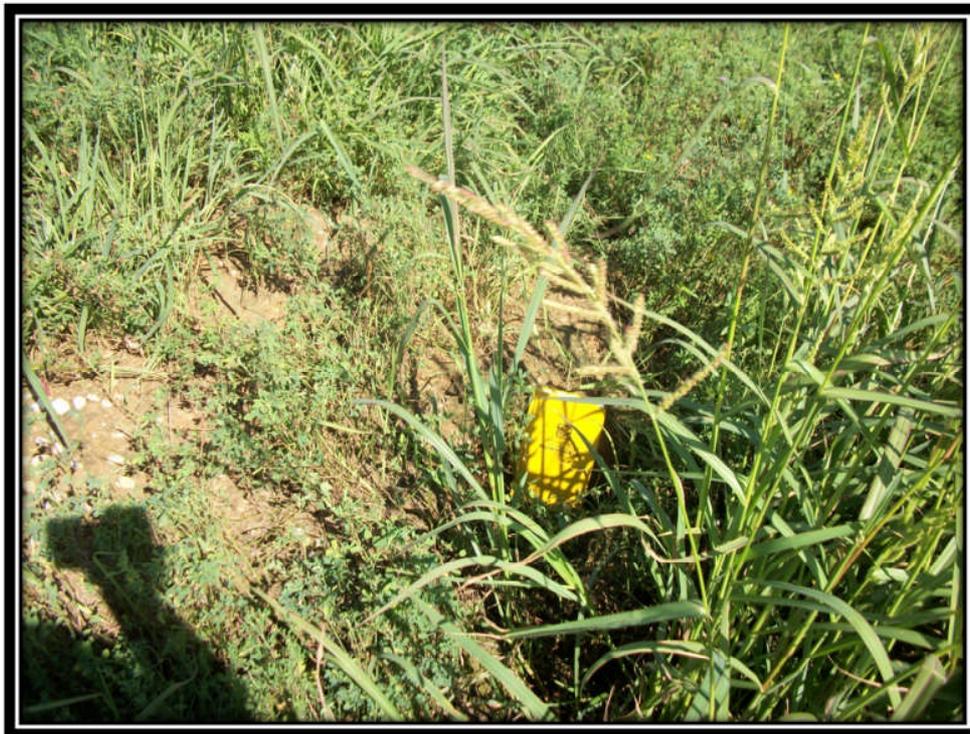
Photo 12 – Surface Erosion near Toe of Eastern Embankment of Ash Pond 2

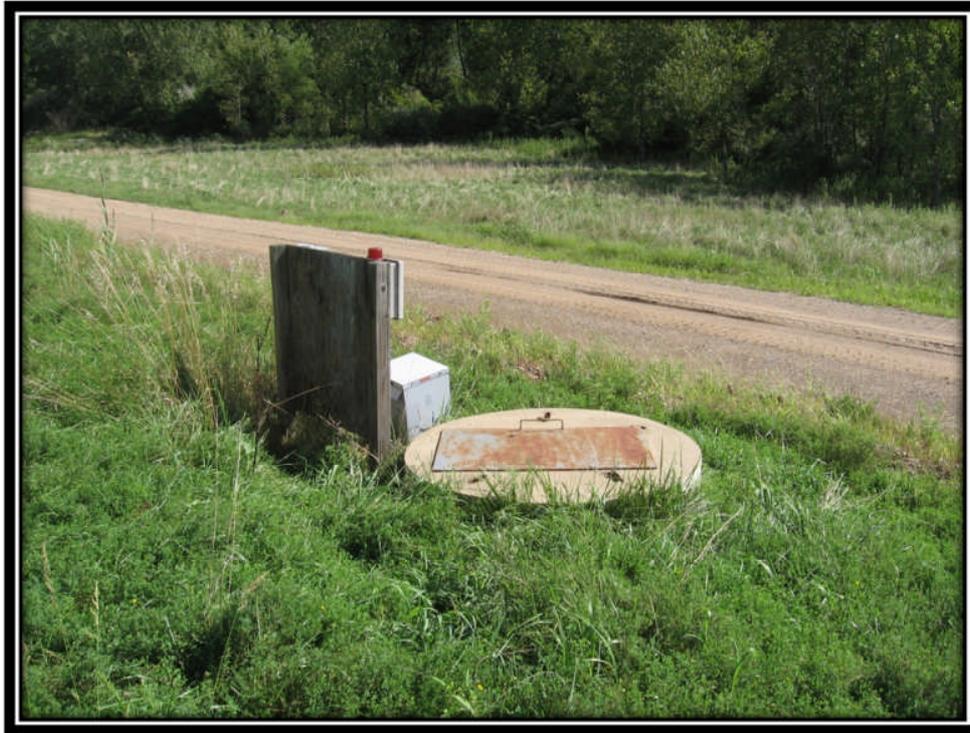
Photo 13 – Pump Station at Seepage Blanket

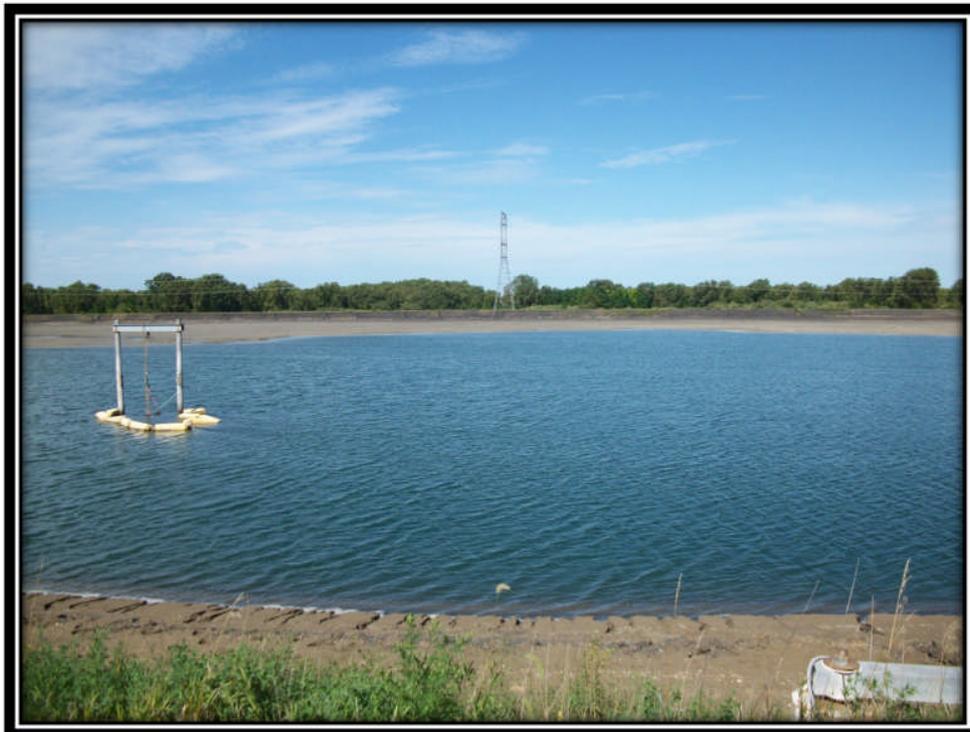
Photo 14 – Outlet Works of Pond 2 and Remaining Impoundment Level

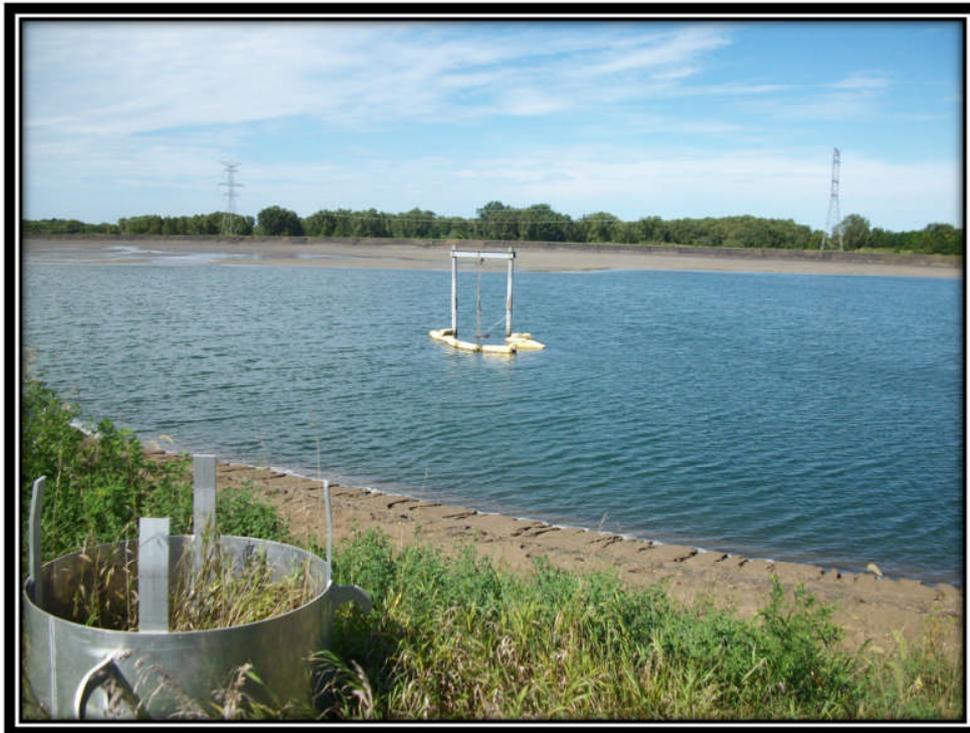
Photo 15 – Outlet Works of Pond 2 with Outlet Pipe Risers in Foreground

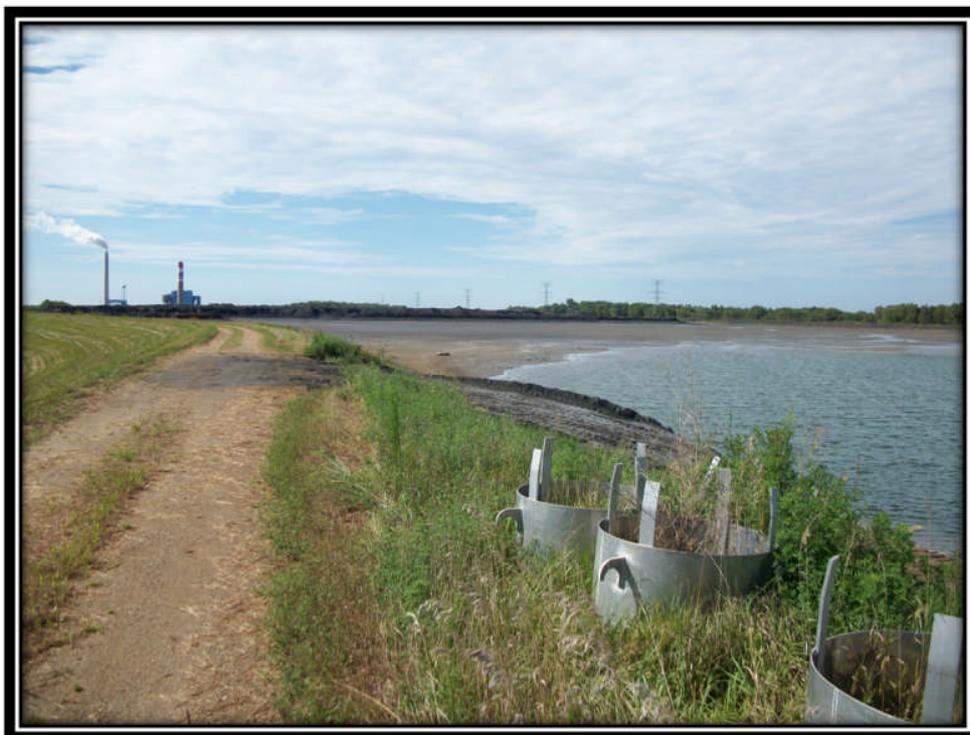
Overall, the upstream slope of the impoundment was in satisfactory condition. Photos 16, 18, 19, 20, 21, and 24 in Appendix B shows the conditions of the upstream slope. Specific observations include:

Overall, the crest of the impoundment was in good condition. Photos 16, 20, 22, 25, and 28 show the condition of the crest. Specific observations include:

Photo 16 – Pond 2 Crest Looking South with Outlet Pipe Risers in Foreground

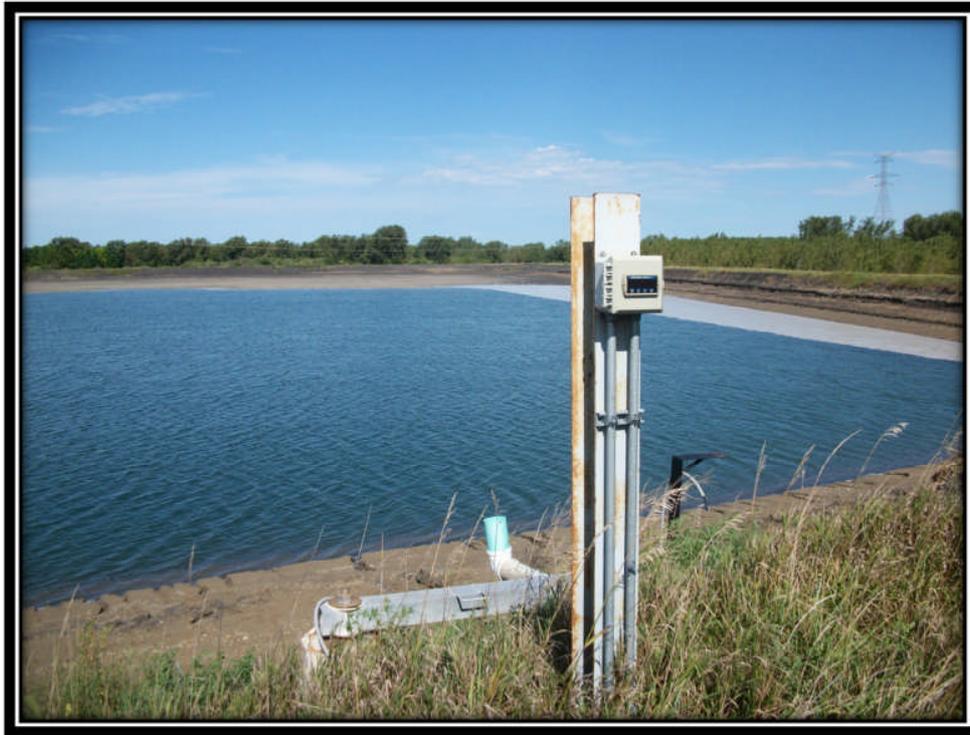
Photo 17 – Electric Control Penetration in Crest near Pond 2 Outlet Works and Seepage Blanket

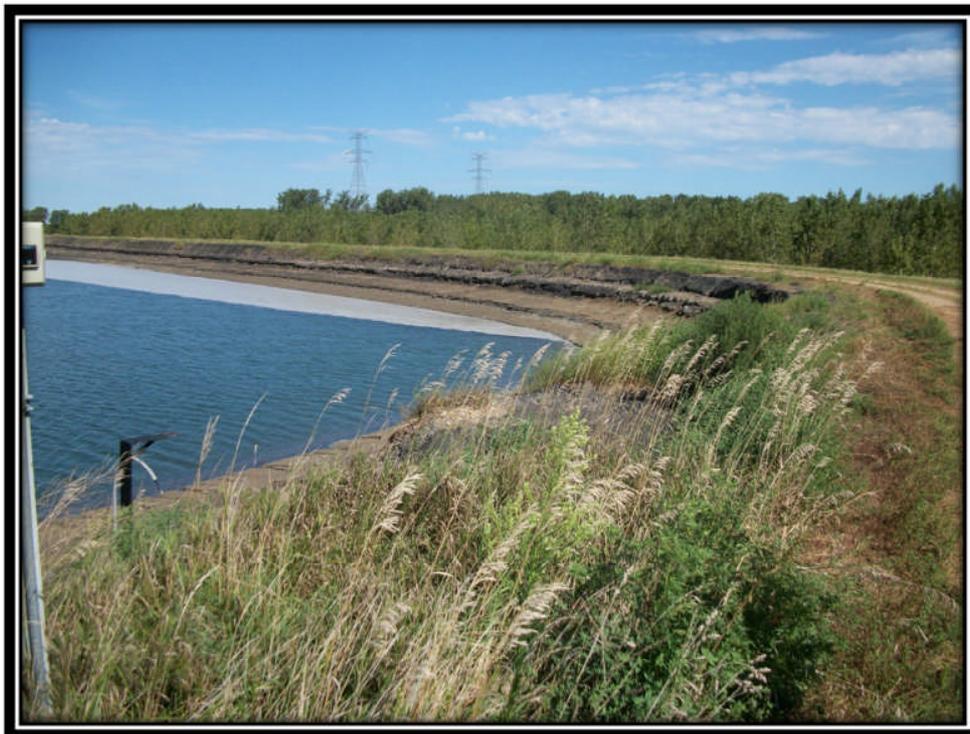
Photo 18 – Northeast Corner of Ash Pond 2 (Note Draw Down and Current Freeboard)

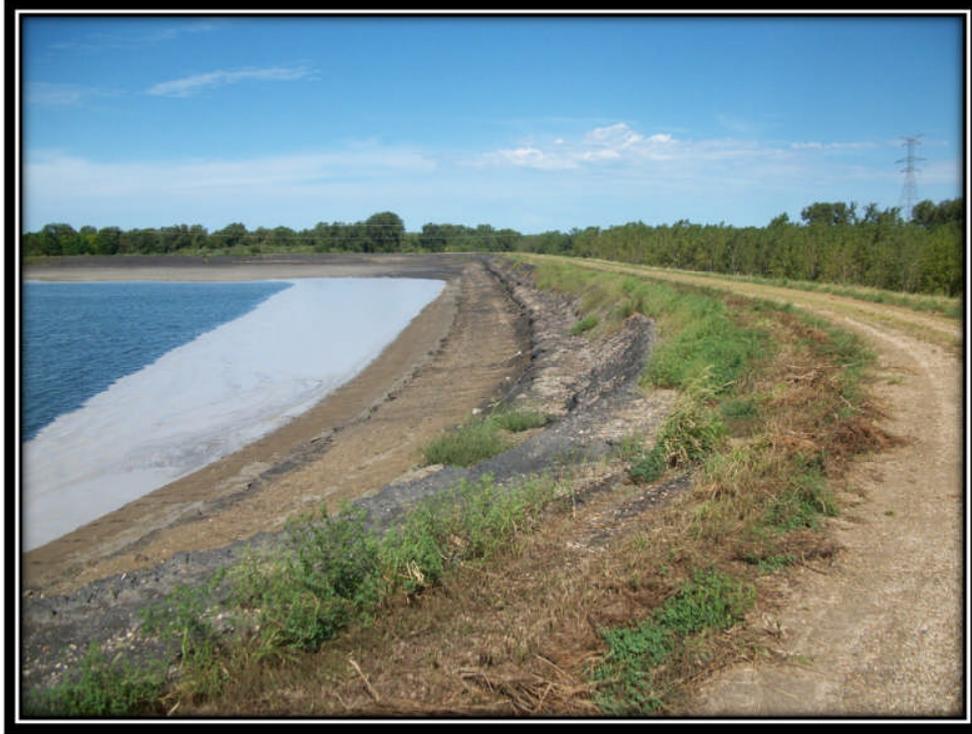
- The upstream slope was laid back at approximately 3H:1V, where visible. In locations where fly ash had accumulated on the slope, it appeared to be laid back at approximately 1.5H:1V.
- Grasses and woody bushes were observed on the upstream slope.
- Some possible wave erosion was evident in some locations.

Photo 19 – Typical Upstream Slope of Northern Embankment of Pond 2 Looking West

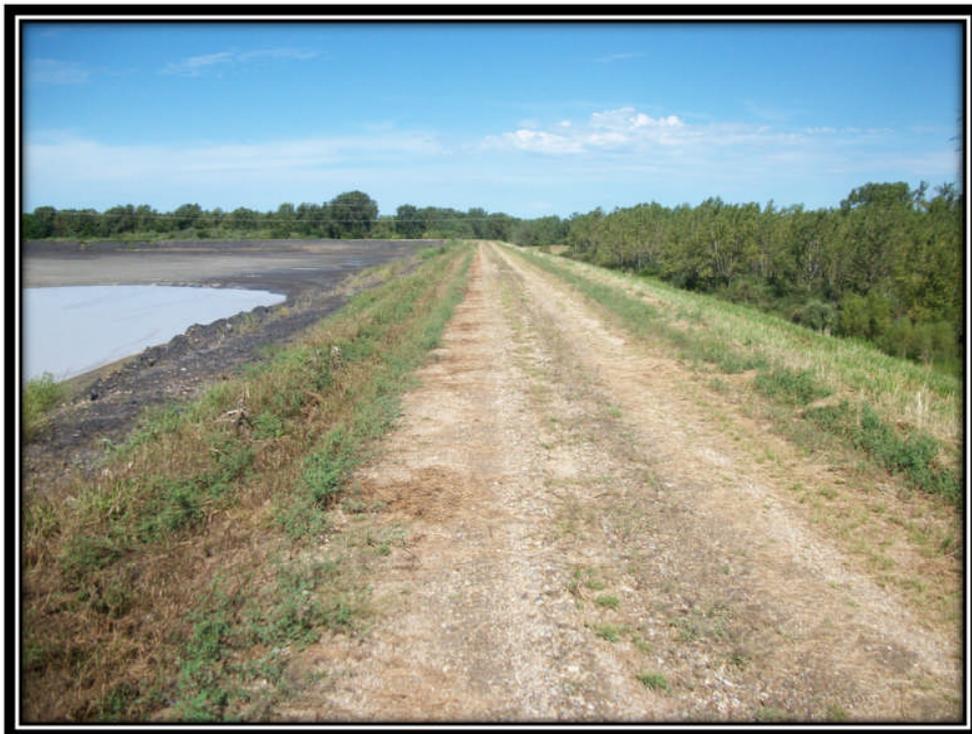
Photo 20 – Northern Embankment of Pond 2 Looking West Showing the Typical Crest Condition

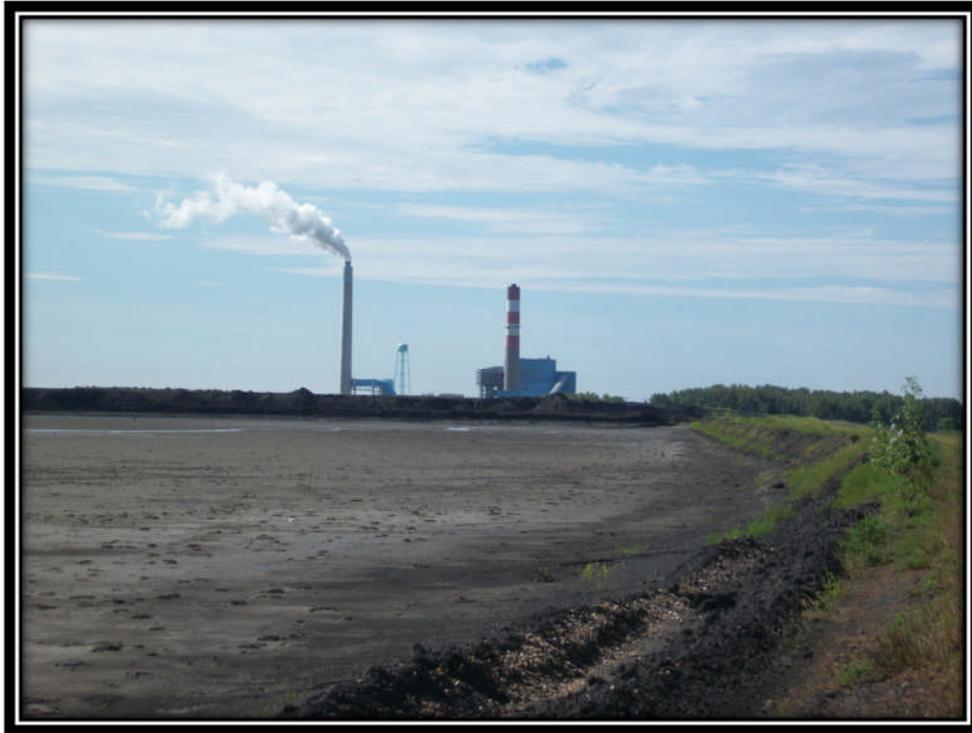
Photo 21 – Ash Pond 2 Looking South along the Western Upstream Embankment

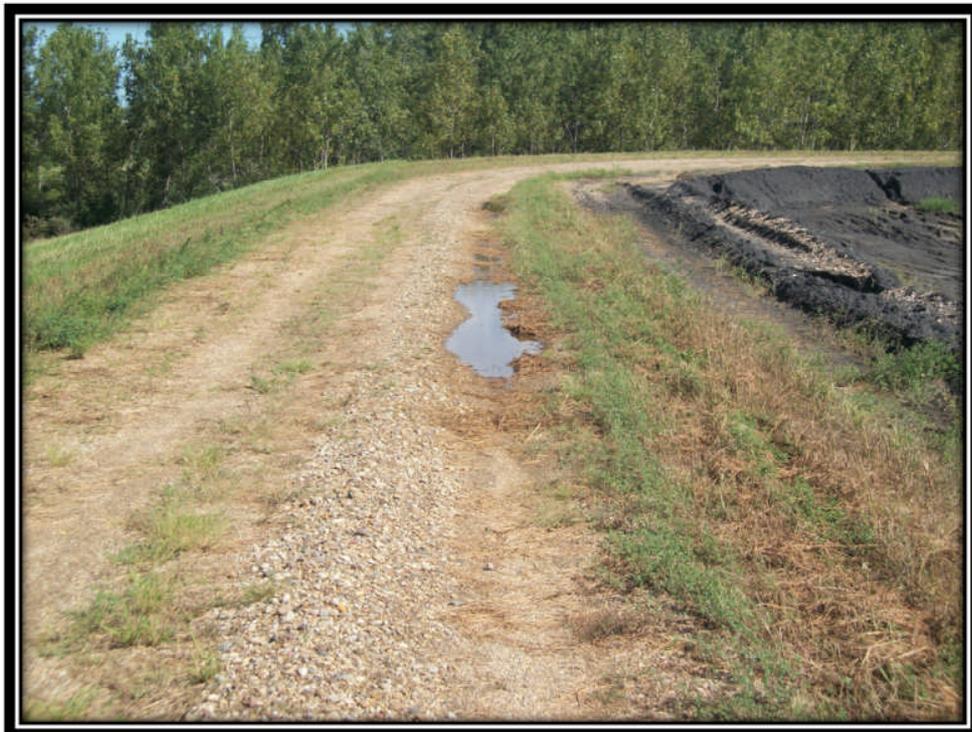
- The impoundment crest is a gravel road.
- Minor depressions or rutting, less than a few inches, were noted on the impoundment crest.
- Minor erosion was noted on crest in multiple locations. This erosion was typically less than six inches in depth and typically appeared on the edges of the crest where grade breaks occurred when transitioning to embankment slopes.

Photo 22 – Slight Rutting and Ponding of Storm Water on Western Crest of Pond 2

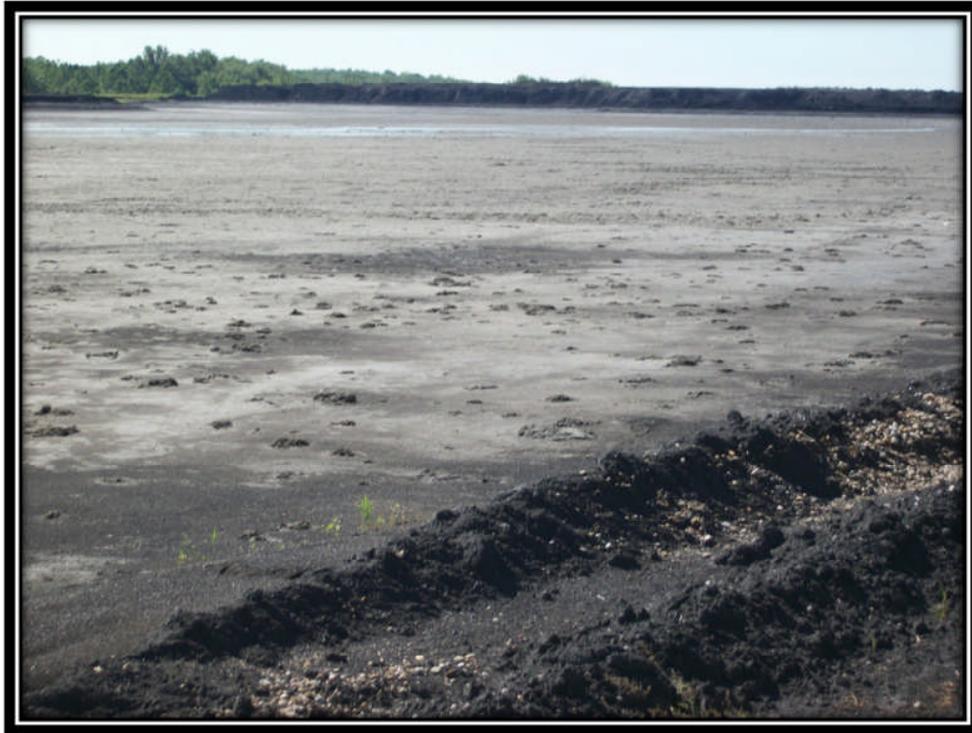
Photo 23 – Ash Pond 2 in the Process of being Drained and Decommissioned

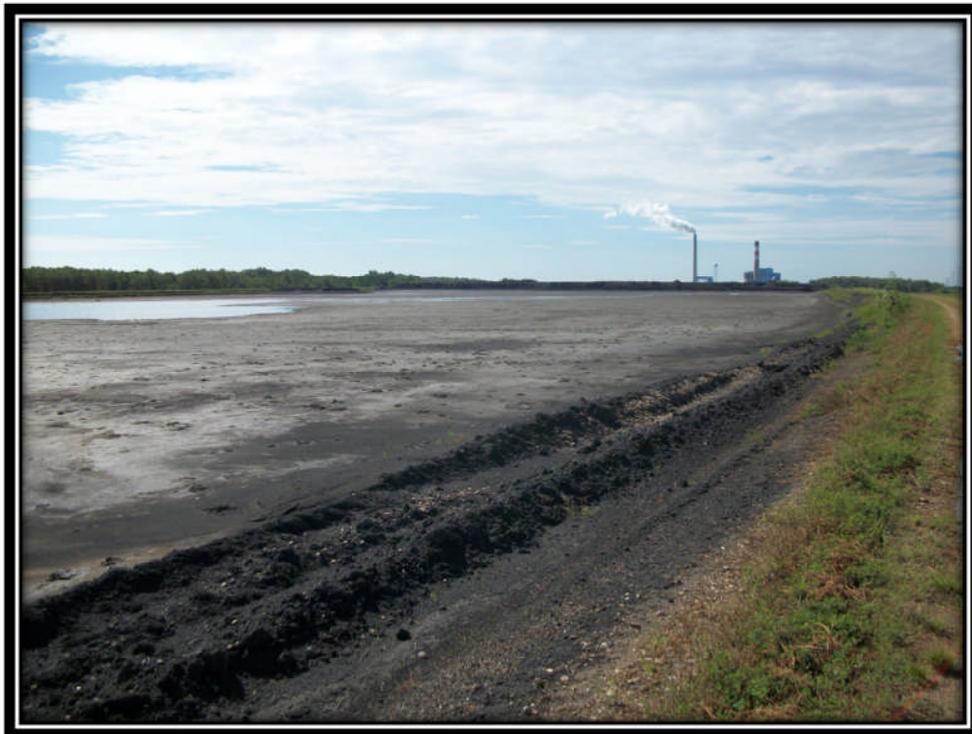
Photo 24 – Ash Pond 2 in the Process of being Drained and Decommissioned

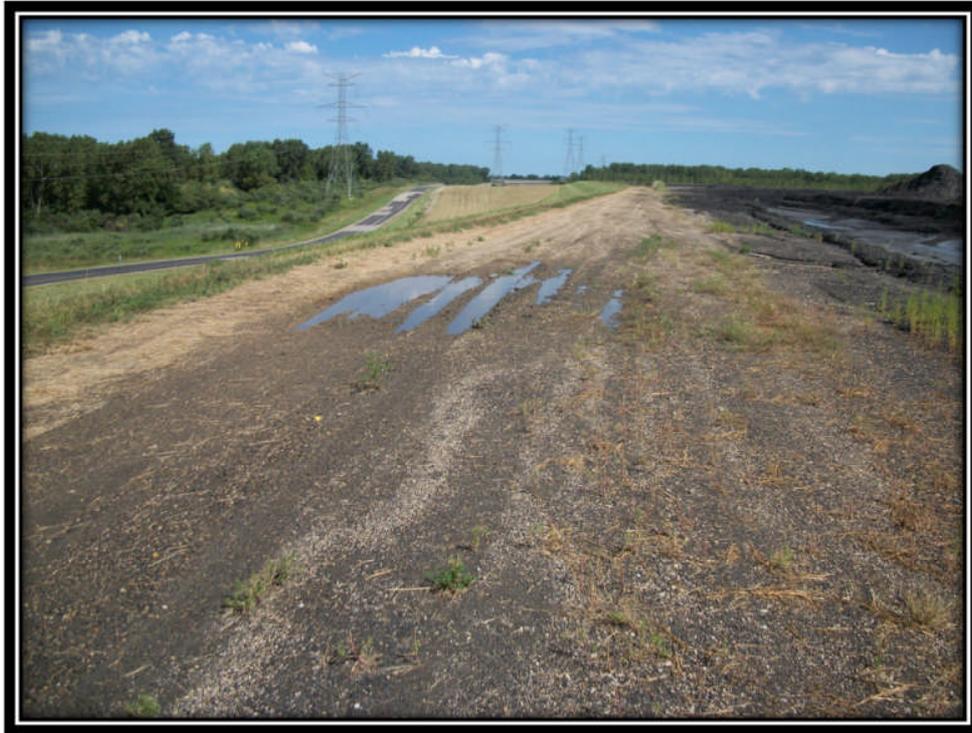
Photo 25 – Slight Rutting and Ponding of Storm Water on Western Embankment Crest (Typical)

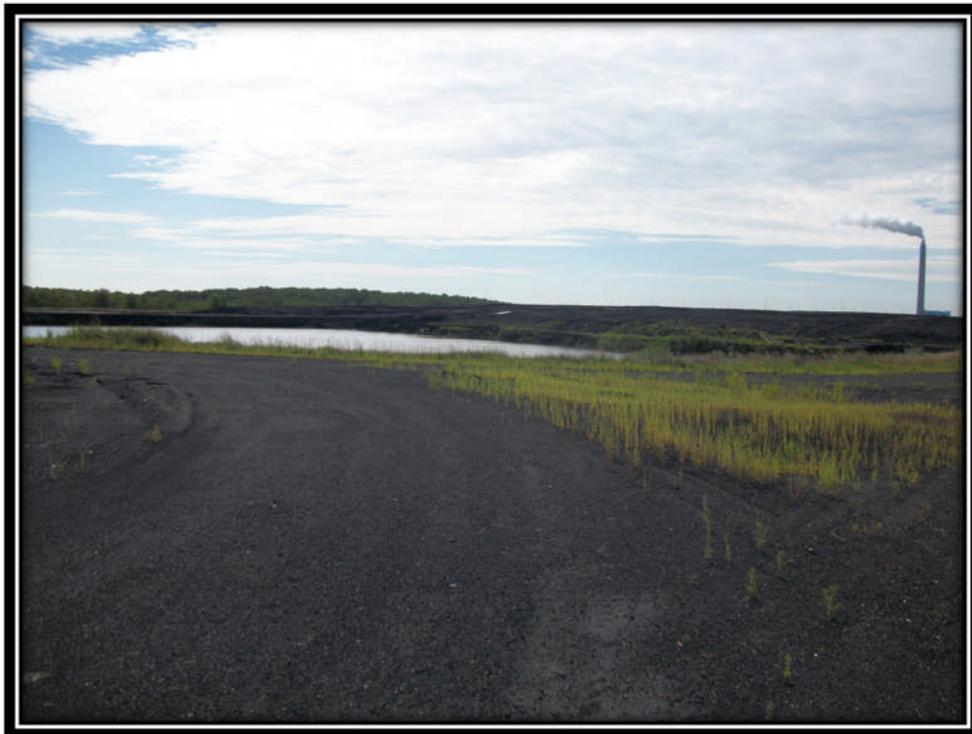
Photo 26 – Junction of Ash Ponds 1 and 2 Looking Southeast

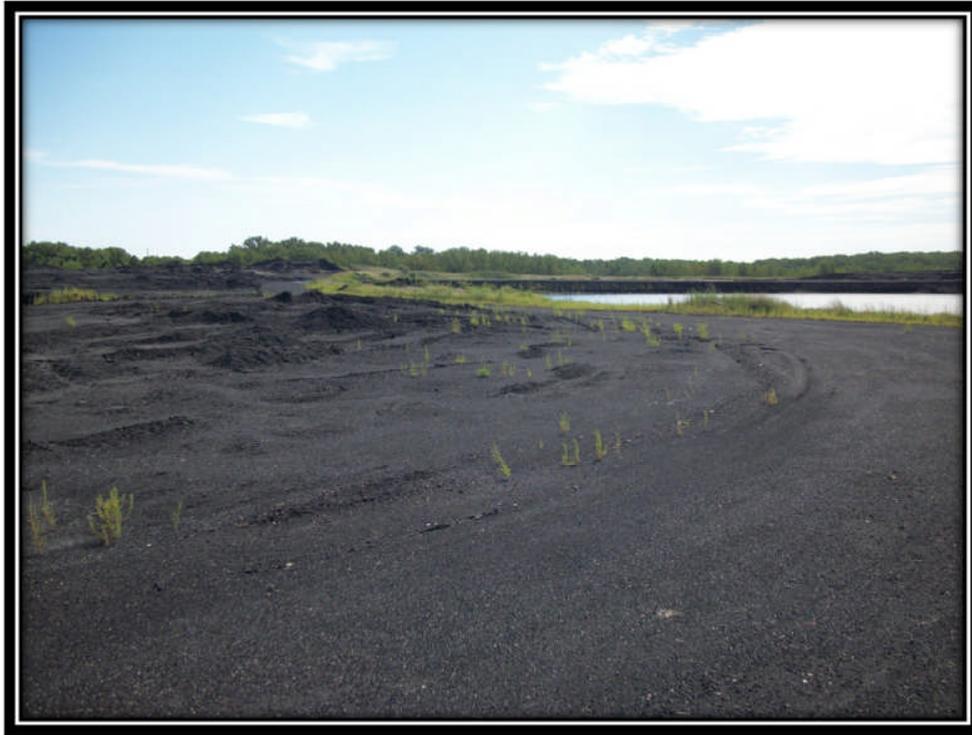
Photo 27 – Junction of Ash Ponds 1 and 2 Looking East

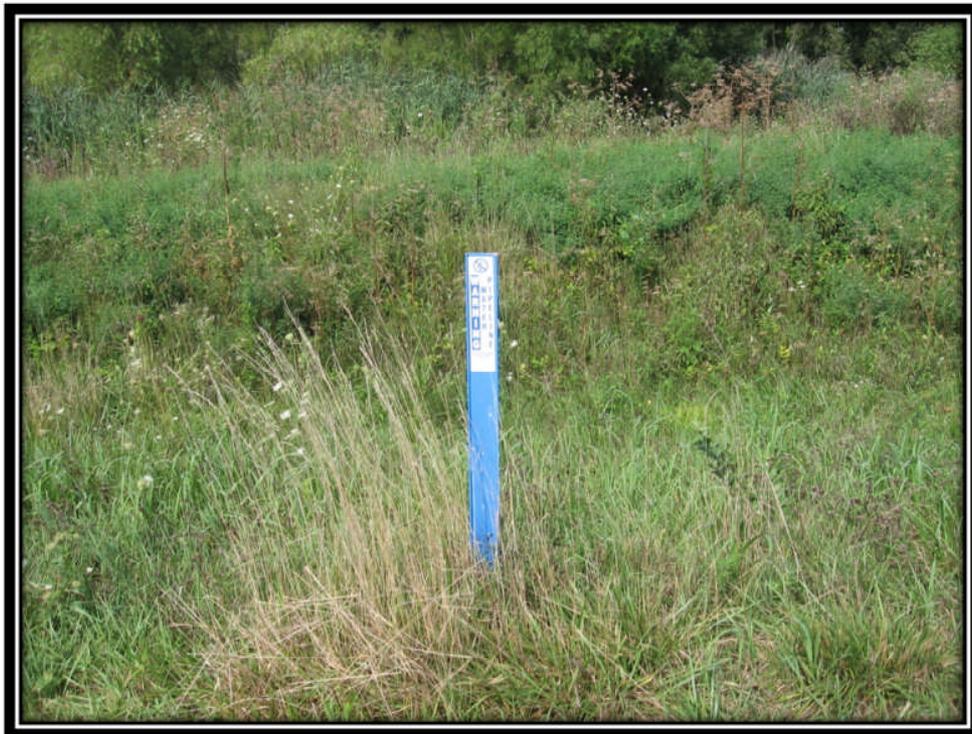
Photo 28 – Buried Water Line Marker at Junction of Ponds 1 and 2 at Toe of Western Embankment

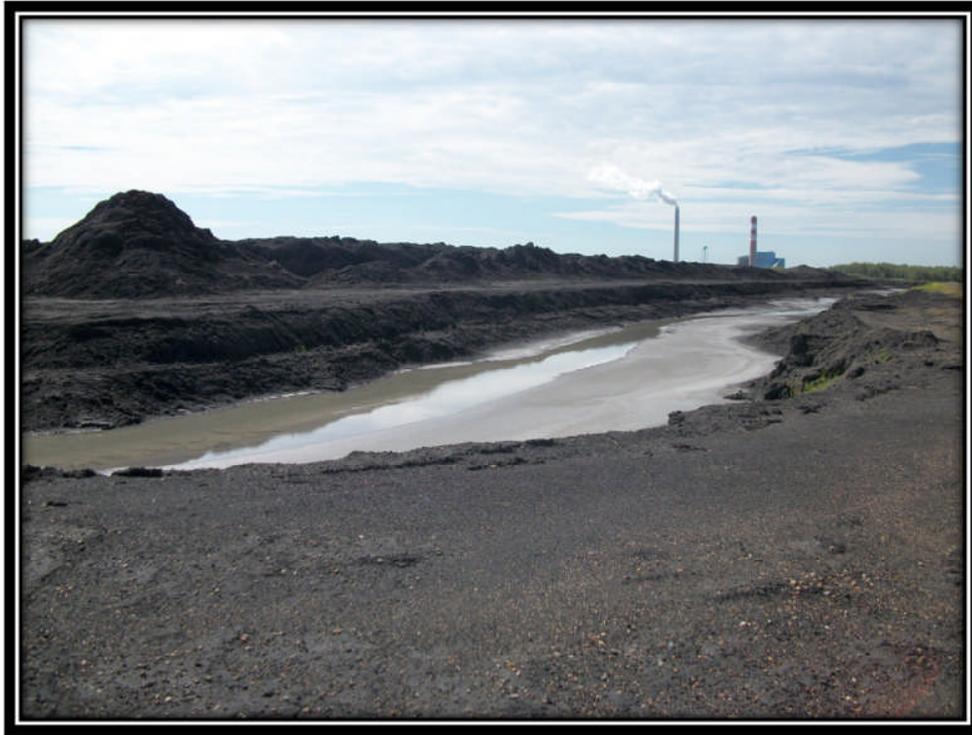
Photo 29 – Ash Pond 1 Settling Channel

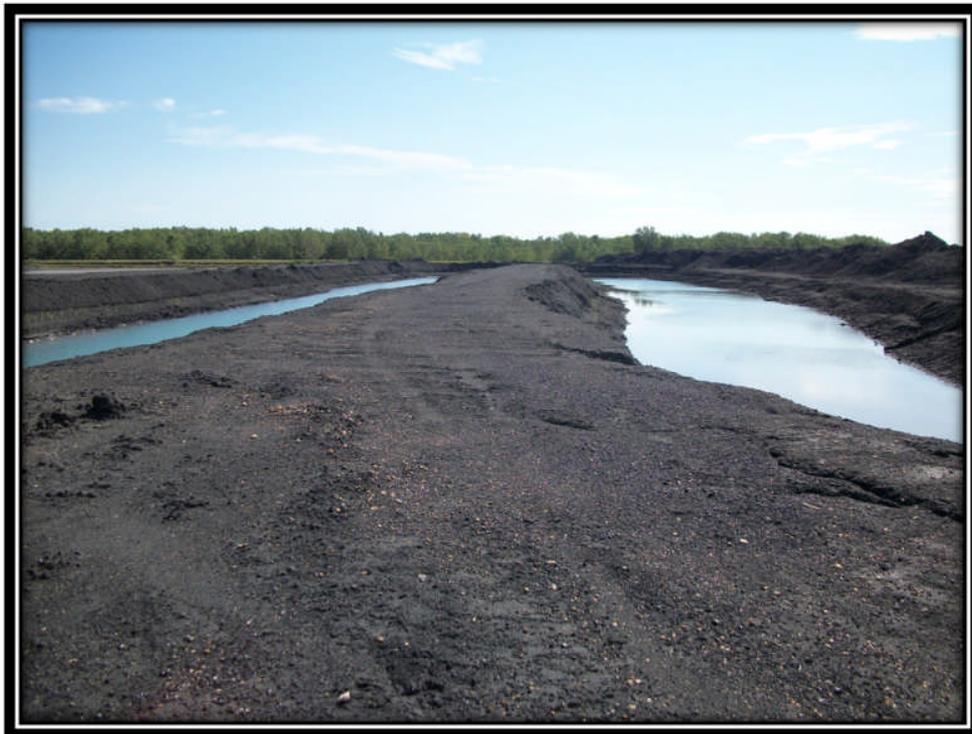
Photo 30 – Ash Pond 1 Settling Channel
