**COAL ASH IMPOUNDMENT
SITE ASSESSMENT DRAFT REPORT**

**Duck Creek Power Station
Ameren Energy Generating Company
Canton, Illinois**

KLEINFELDER PROJECT NUMBER 112618-5

September 16, 2010

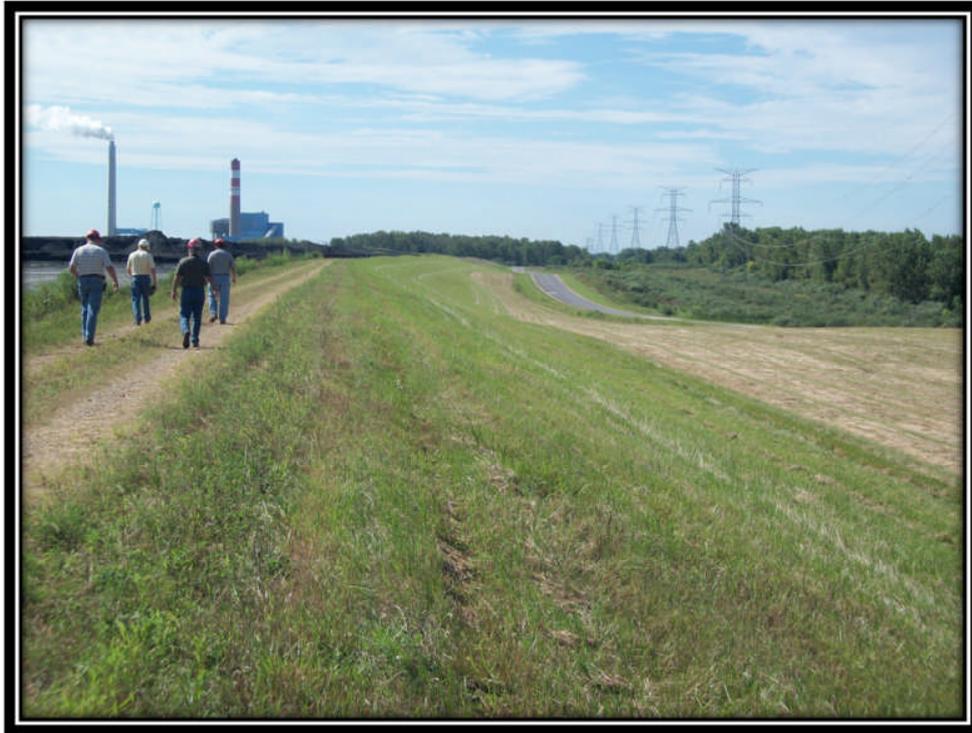
The toe areas of the embankment were in fair condition. See Photos 31, 35, 36, and 37 for the condition of these areas. Key features and observations of these areas include:

Photo 31 – Western Embankment Crest of Ponds 1 and 2 (Typical)

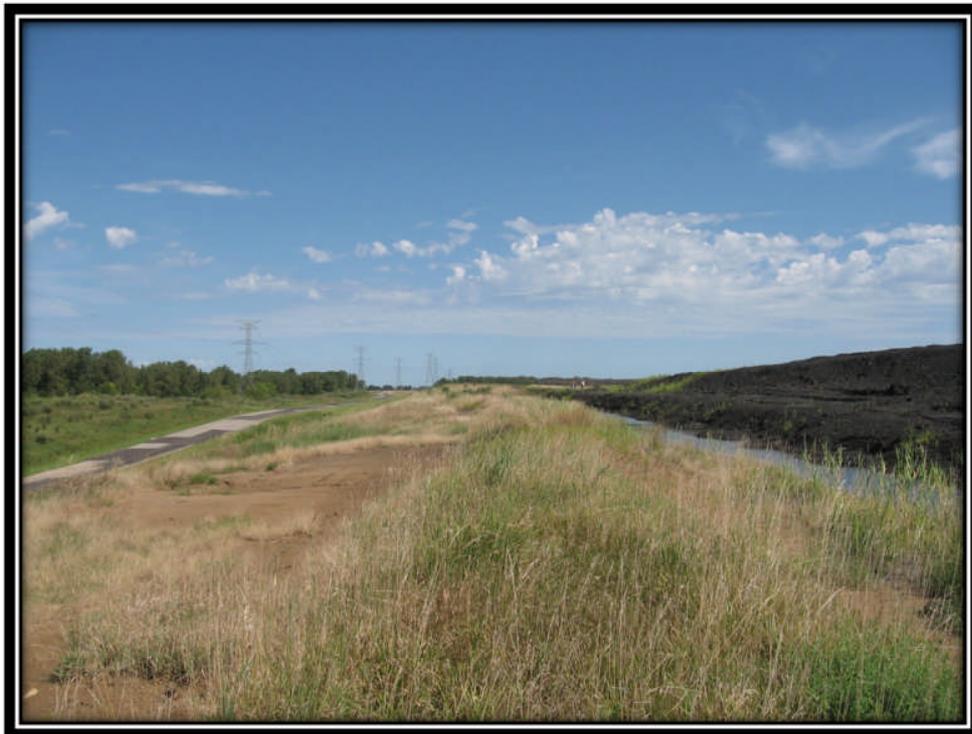
Overall, the crest of the impoundment was in good condition. Photos 32 and 34 in Appendix B show the condition of the crest. Specific observations include:

- Minor depressions or rutting, less than a few inches, were noted on the impoundment crest.
- Minor erosion was noted on crest in multiple locations. This erosion was typically less than six inches in depth and typically appeared on the edges of the crest where grade breaks occurred when transitioning to embankment slopes.

Photo 32 – Ash Pond 1 Crest and Settling Channel from Western Embankment Crest Looking North

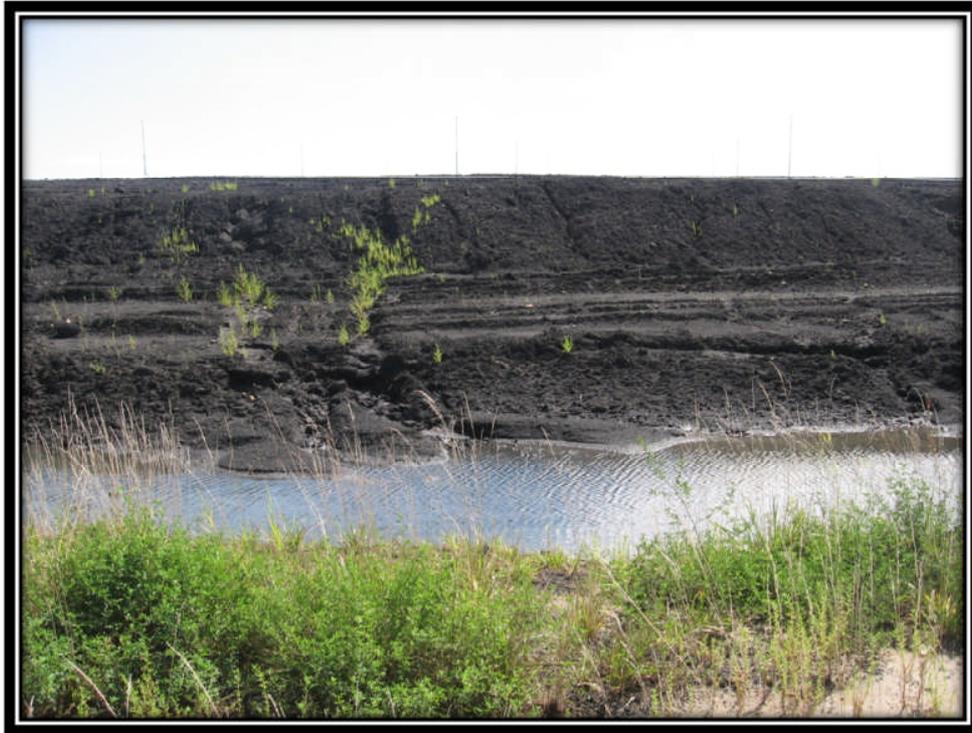
Photo 33 – Ash Pond 1 Settling Channel from Western Embankment Crest Looking East

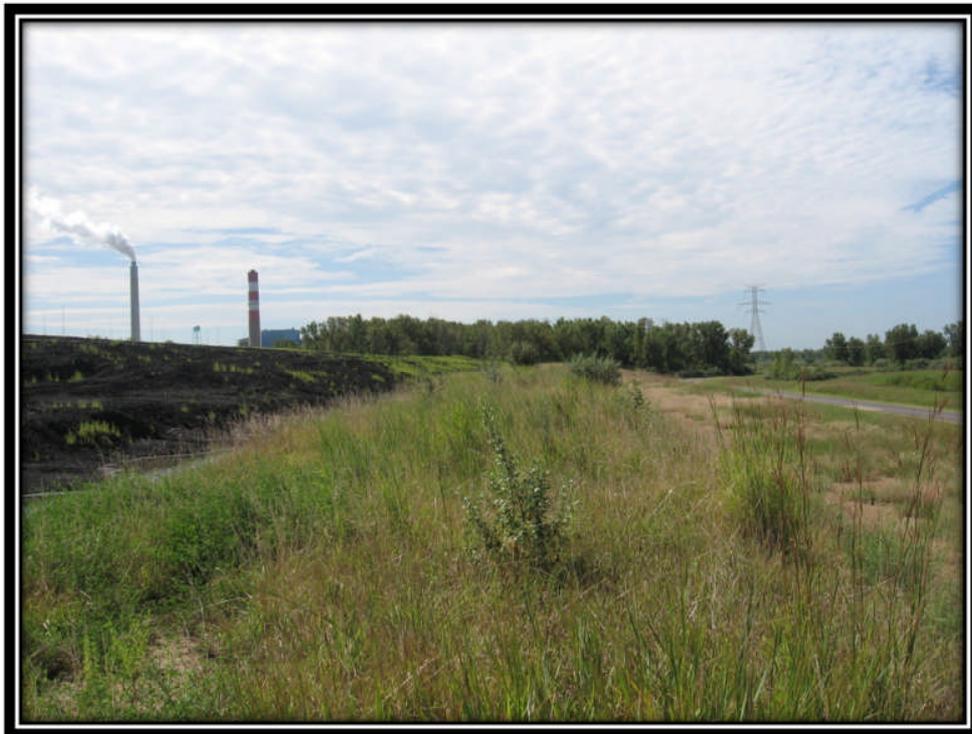
Photo 34 – Ash Pond 1 Crest and Settling Channel from Western Embankment Crest Looking South

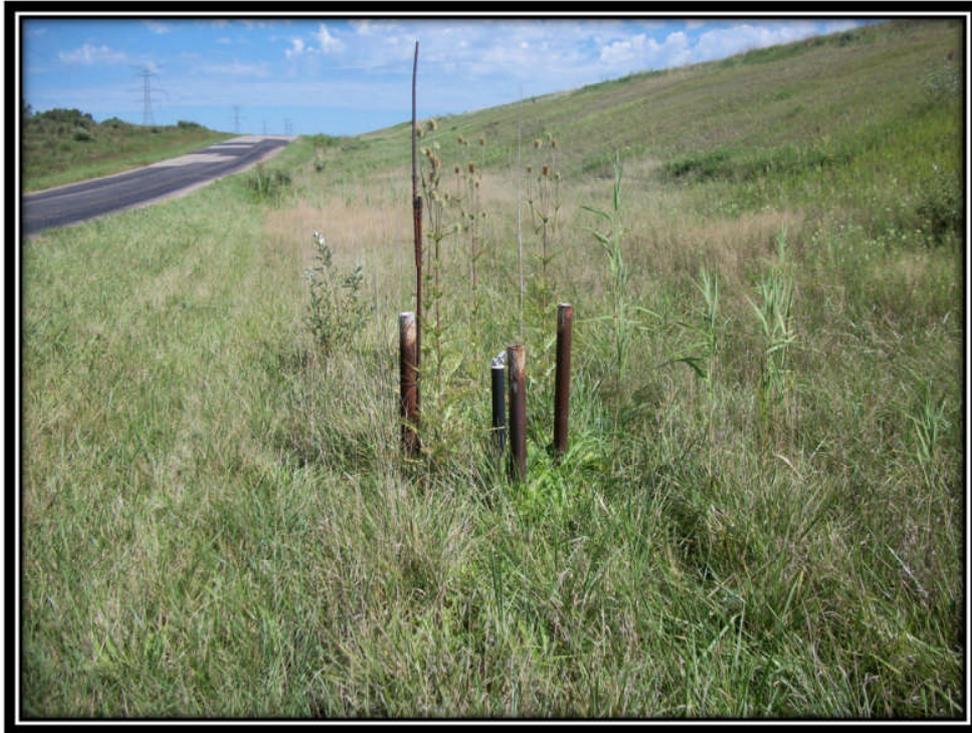
Photo 35 – Monitoring Well at the Downstream Toe of the Western Embankment of Pond 1

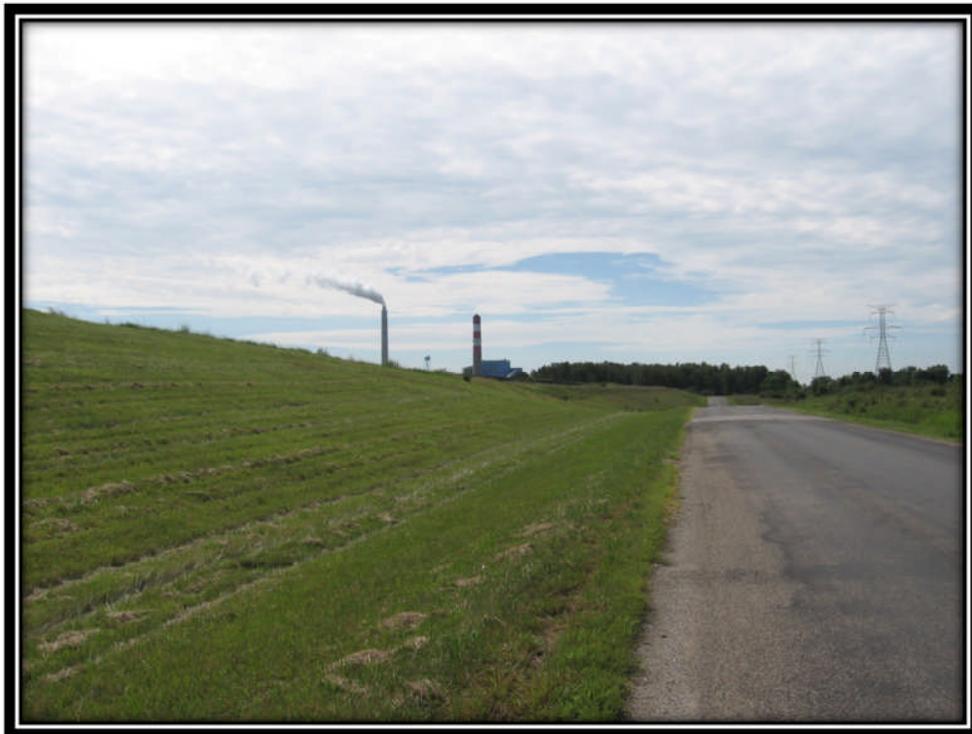
Overall, the downstream slope was in fair condition. Photos 36, 39, 40, 41, and 42 in Appendix B show the conditions of the downstream slope. Specific observations include:

Photo 36 – Typical Western Embankment of Ponds 1 & 2 Looking South

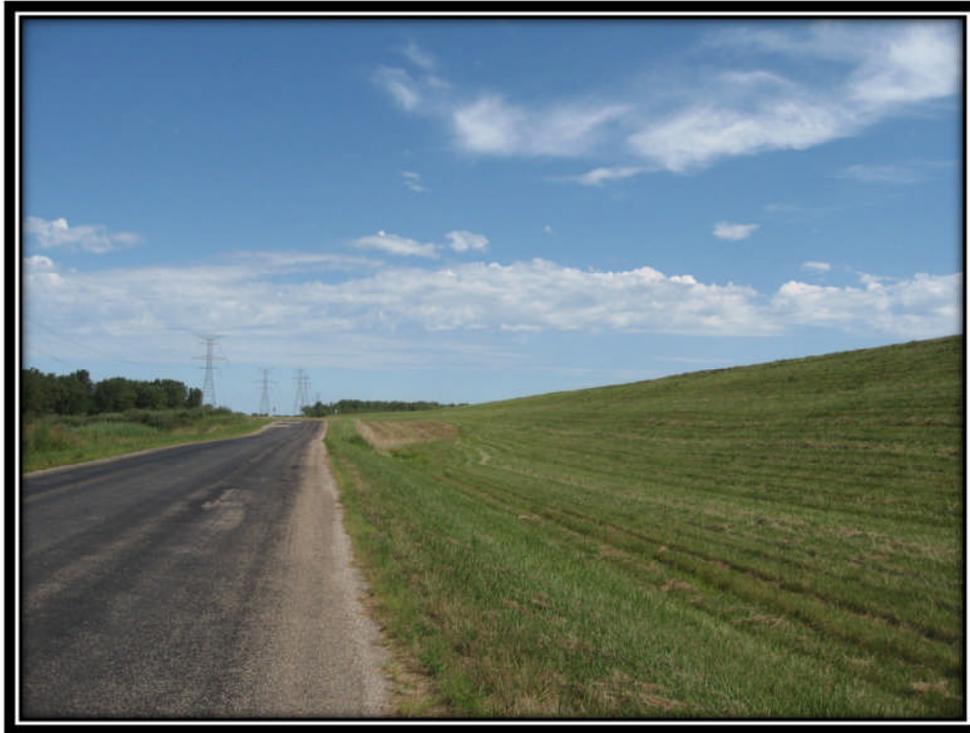
- Grasses, woody bushes, and large mature trees were observed on the downstream slope and at the toe of the embankment for the majority of the southern embankment.
- Some ponded water due to recent storm events was noted on the western embankment at the toe.

Photo 37 – Typical Western Embankment of Ponds 1 & 2 Looking North

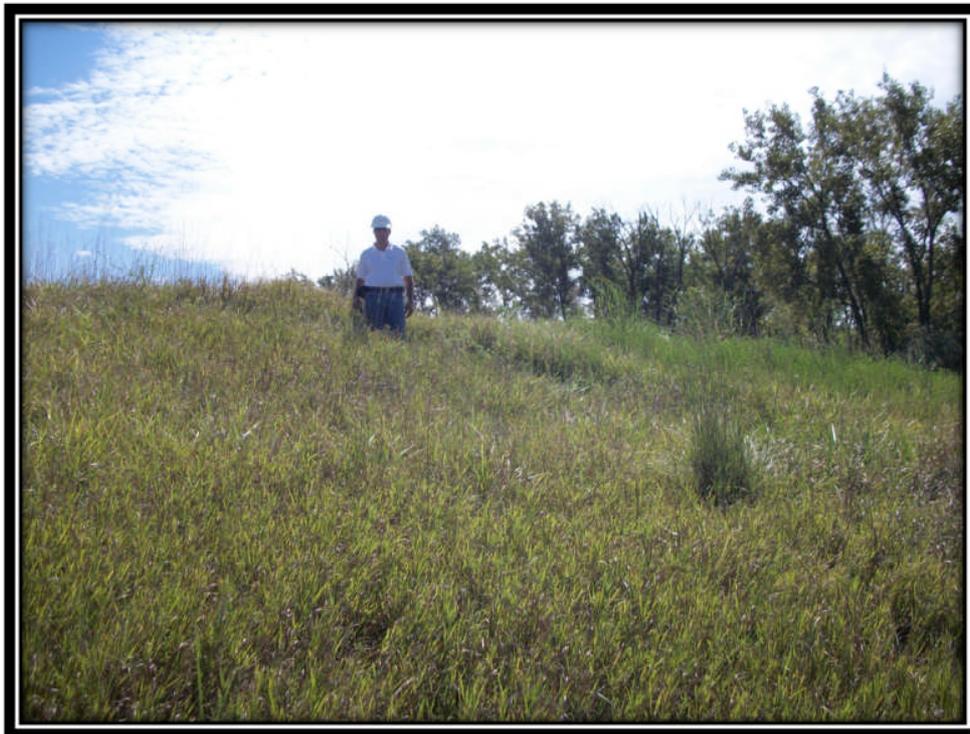
Photo38 – Surface Erosion Approximately 2' deep by 3' Wide on the Southwestern Corner of Pond 1

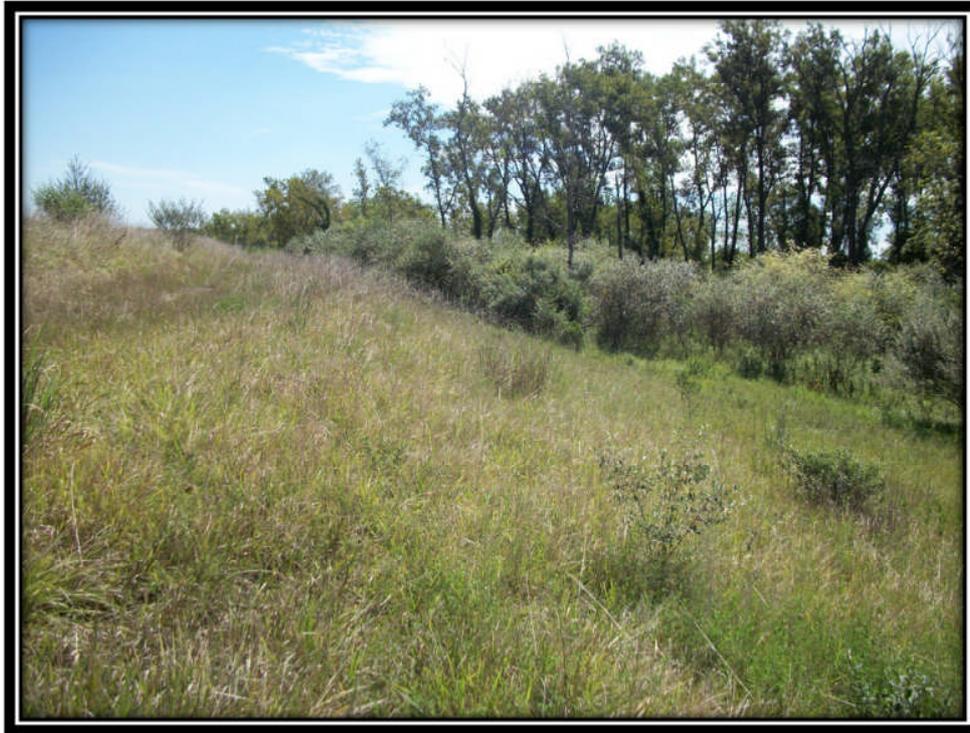
- Grasses, woody bushes, and large mature trees were observed on the downstream slope and at the toe of the embankment for the majority of the southern embankment.
- Typically the embankment was well maintained with what appears to be regular mowing operations.
- An erosion feature was noted at the southwest corner of the impoundment that was approximately 3 feet in depth.

- Large mature trees and other vegetation exist on the toe and slopes of a portion of Fly Ash Pond Number 1.
- An Emergency Action Plan (EAP) is not currently in place at the site to mitigate damage in the event of an emergency related to failure of the impoundment(s).

Photo 39 – Vegetation Greater than 1" in Diameter on the Southern Embankment of Pond 1 (Typical)

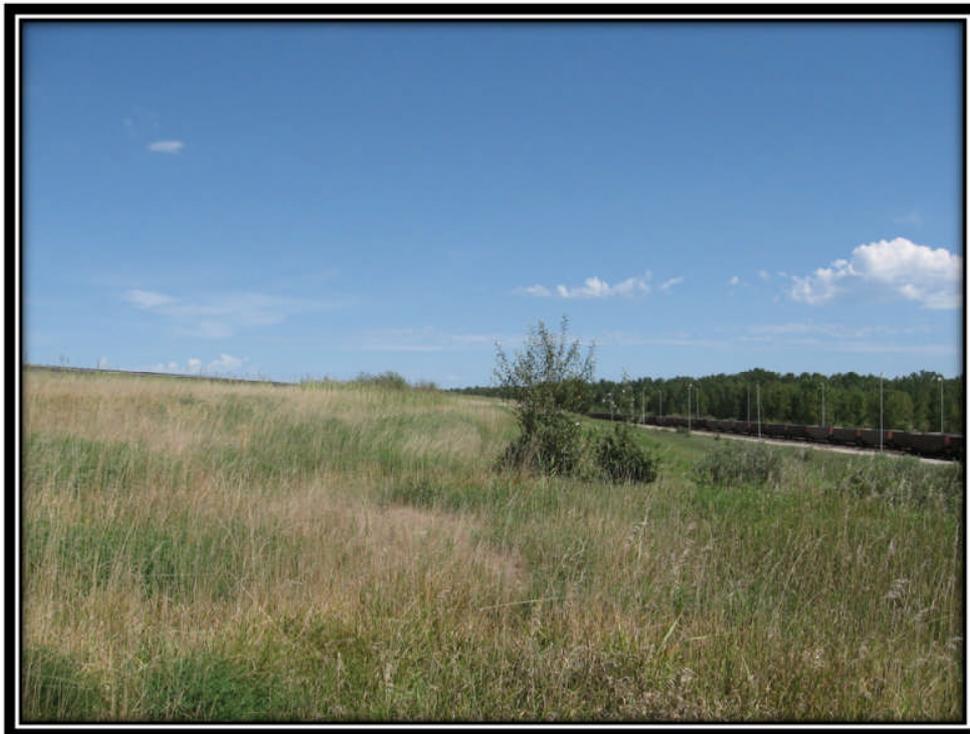
Photo 40 – Woody Vegetation on Eastern Slope of Pond 1 Embankment (Note Lack of Mowing)

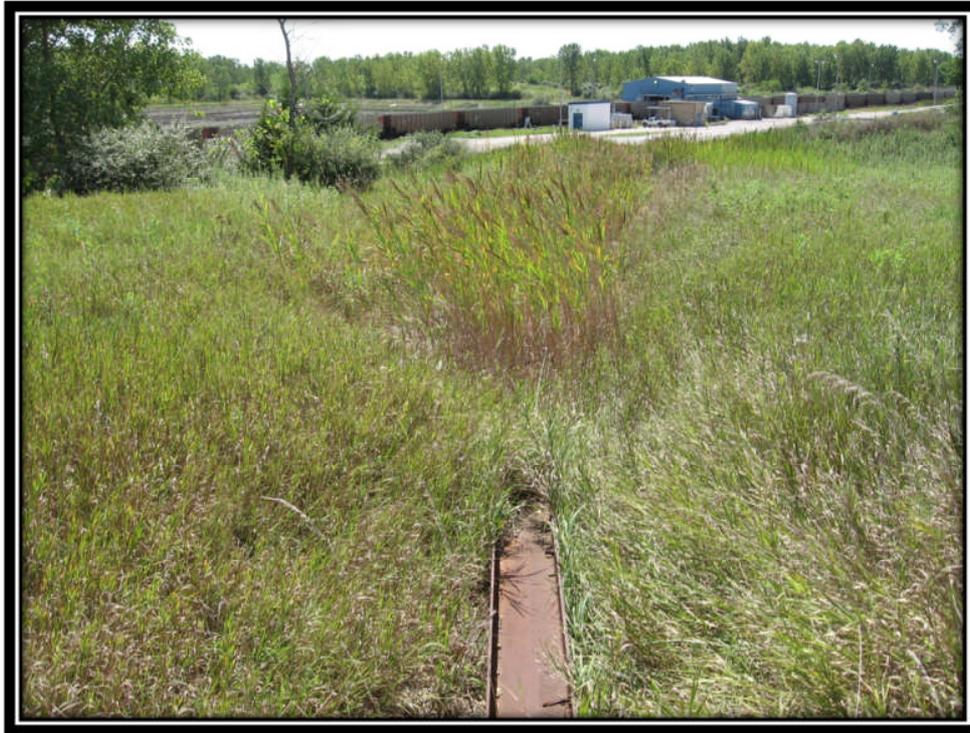
Photo 41 – Tall Grass and Similar Vegetation on Eastern Slope of Pond 1 Embankment (Note Debris)

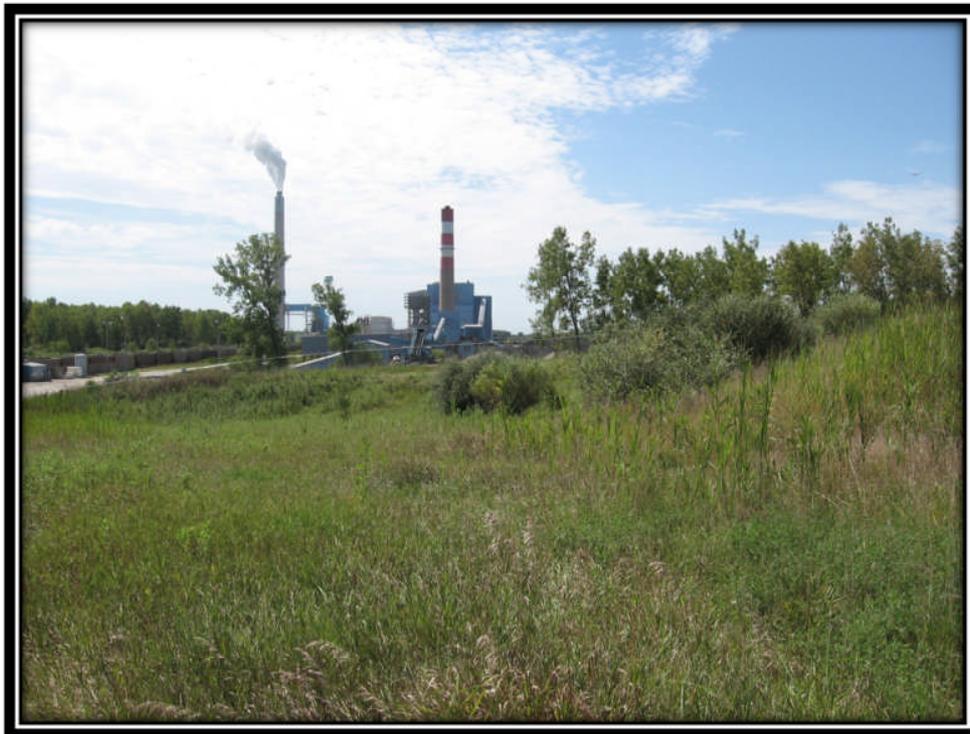
Photo 42 –Vegetation on Eastern Slope of Pond 1 Embankment (Note Lack of Mowing)
