**COAL ASH IMPOUNDMENT  
SITE ASSESSMENT FINALREPORT**

**Duck Creek Power Station  
Ameren Energy Generating Company  
Canton, Illinois**

**KLEINFELDER PROJECT NUMBER 112618-5**

**May 10, 2011**

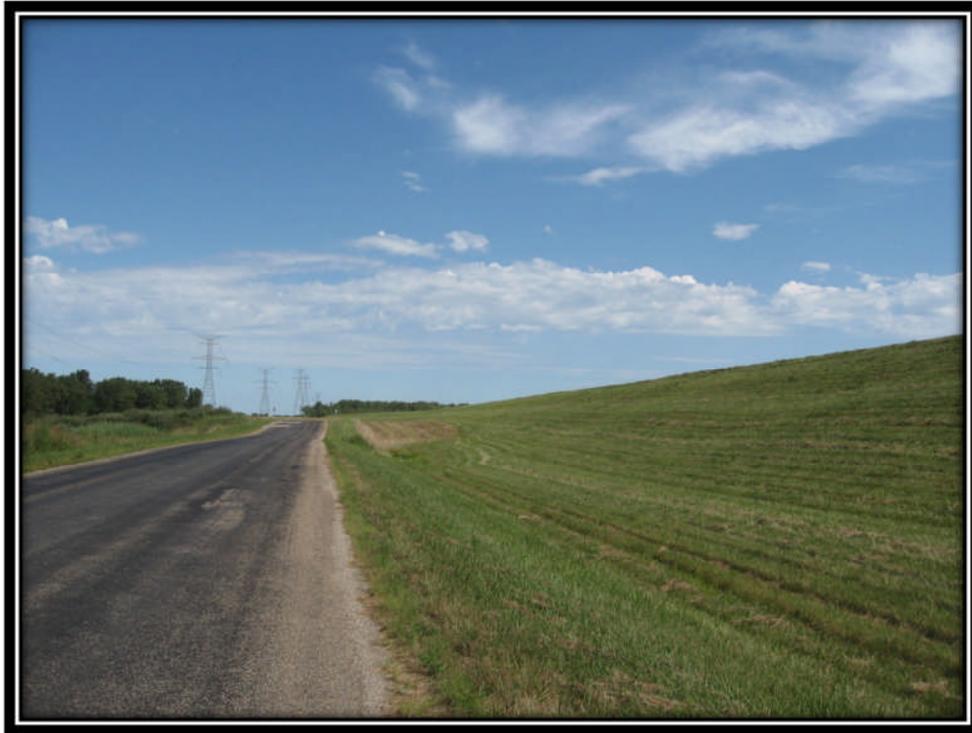
The toe areas of the embankment were in fair condition. See Photos 31, 35, 36, and 37 for the condition of these areas. Key features and observations of these areas include:

Photo 37 – Typical Western Embankment of Ponds 1 & 2 Looking North

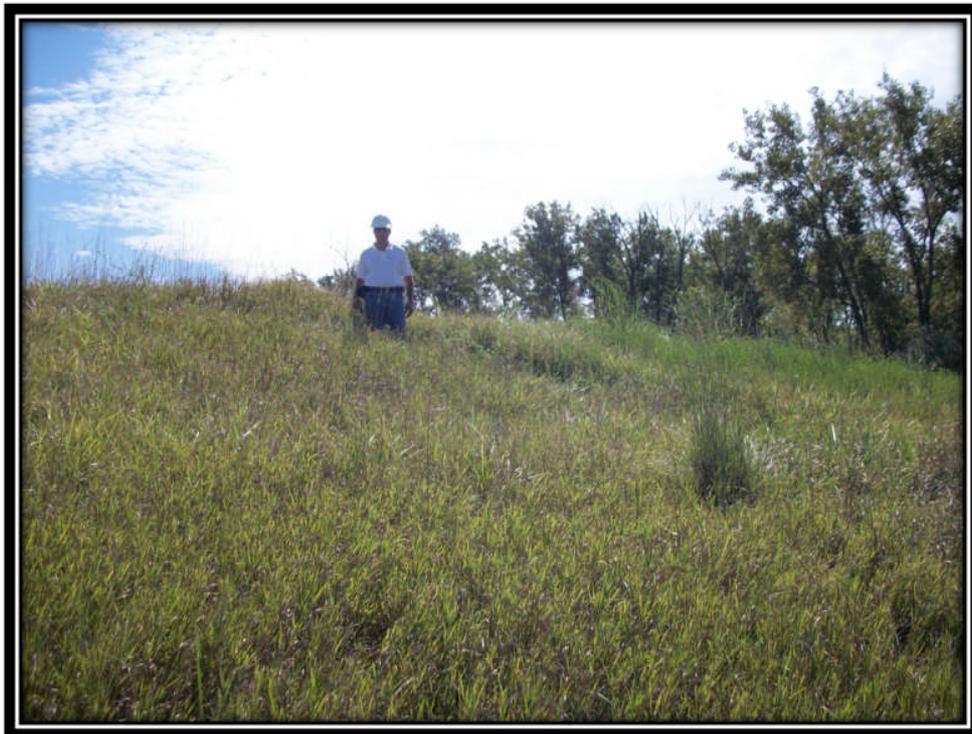
Photo38 – Surface Erosion Approximately 2' deep by 3' Wide on the Southwestern Corner of Pond 1

1. Develop an operations and maintenance manual for the facility and its impoundments.
2. Repair embankment erosion.
3. Maintain a log of maintenance and other activities at the fly ash impoundments and supporting facilities.
