**COAL ASH IMPOUNDMENT  
SITE ASSESSMENT DRAFT REPORT**

**E.D. Edwards Power Generating Station  
Ameren Energy Generating Company  
Bartonville, Illinois**

**KLEINFELDER PROJECT NUMBER 112618-2**

**September 20, 2010**

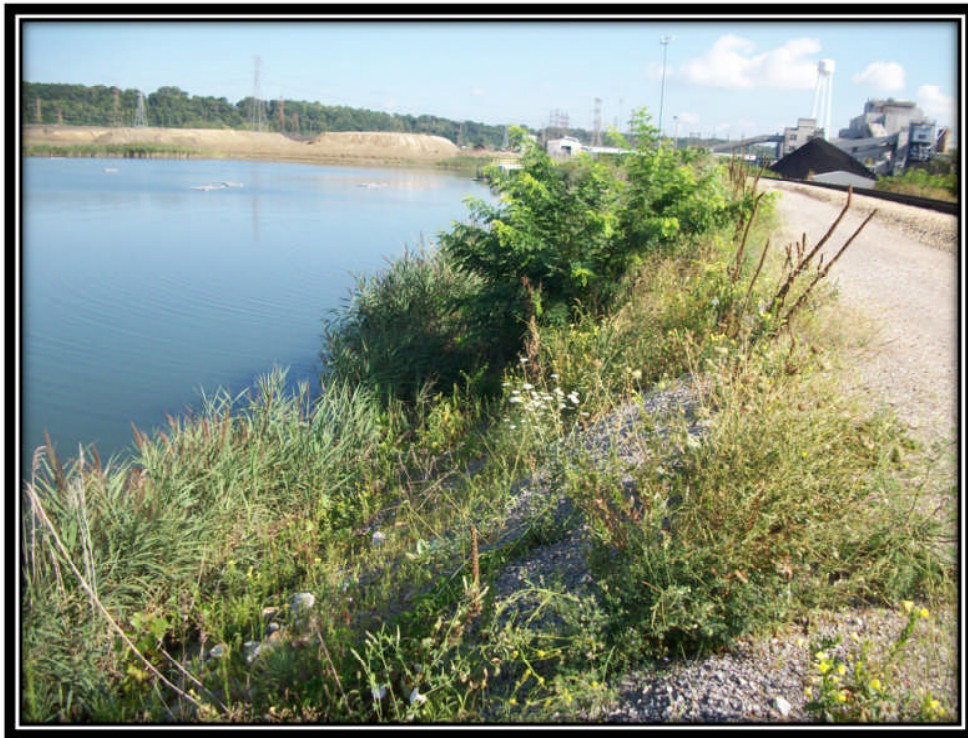
Photo 11 – Vegetation on Upstream Slope of Clarification Pond (Note Steep Slopes)

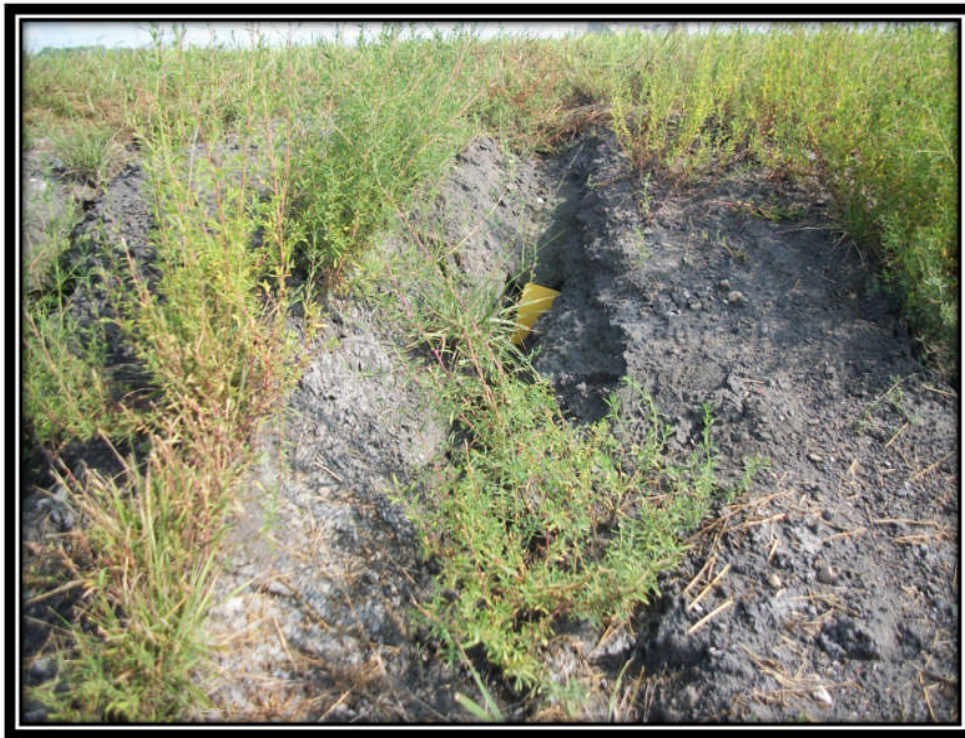
- There were areas of riprap slope protection present on the downstream slope. This riprap had been vegetated in some locations but was mostly clear of vegetation.
- Significant erosion, greater than 6 inches deep, was noted on some of the downstream slopes, particularly on the southern embankment of the impoundment.
- Grasses and woody bushes were observed on the downstream slope and at the toe of the embankment for the majority of the impoundment.
- Penetrations into the downstream slope included manholes and power line poles.

Photo 17 – Erosion Greater than 12 Inches Forming on Downstream Slopes of Southern Embankment

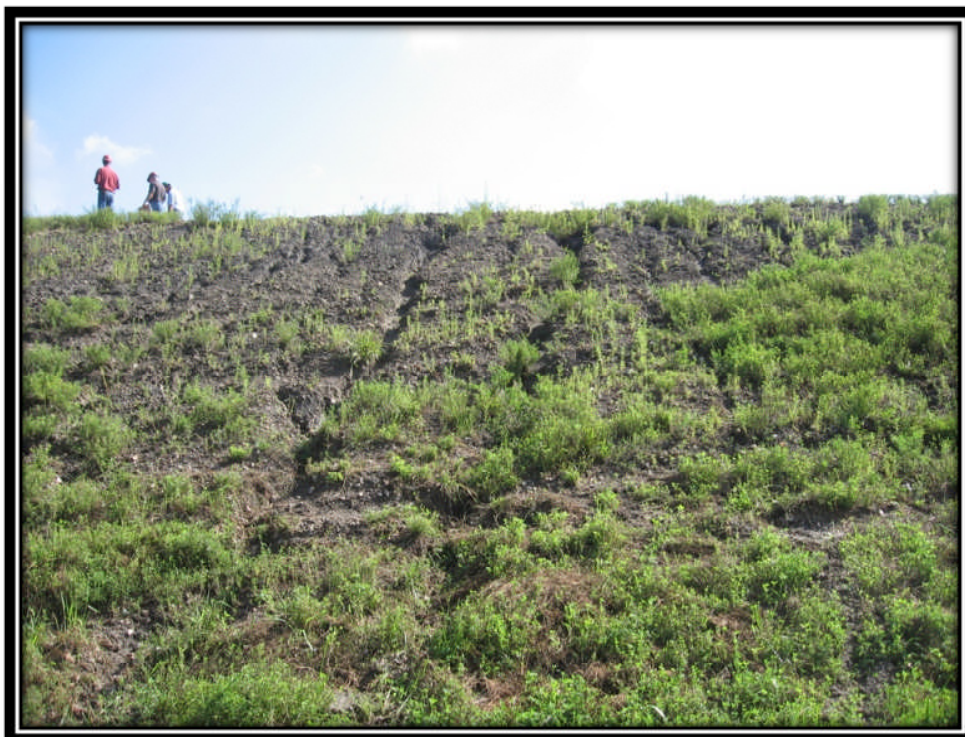
Photo 18 – Erosion and Sparse Vegetation on Downstream Slopes of Southern Embankment

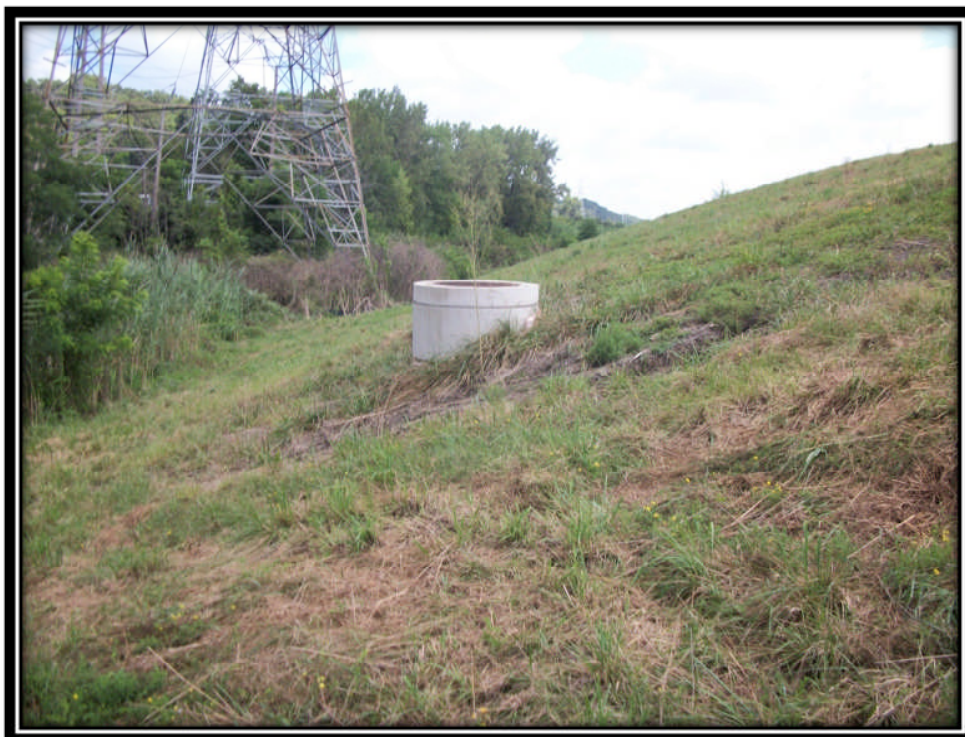
Photo 30 – Waste Water Sewer Line Manhole in Downstream Slope with Erosion Present

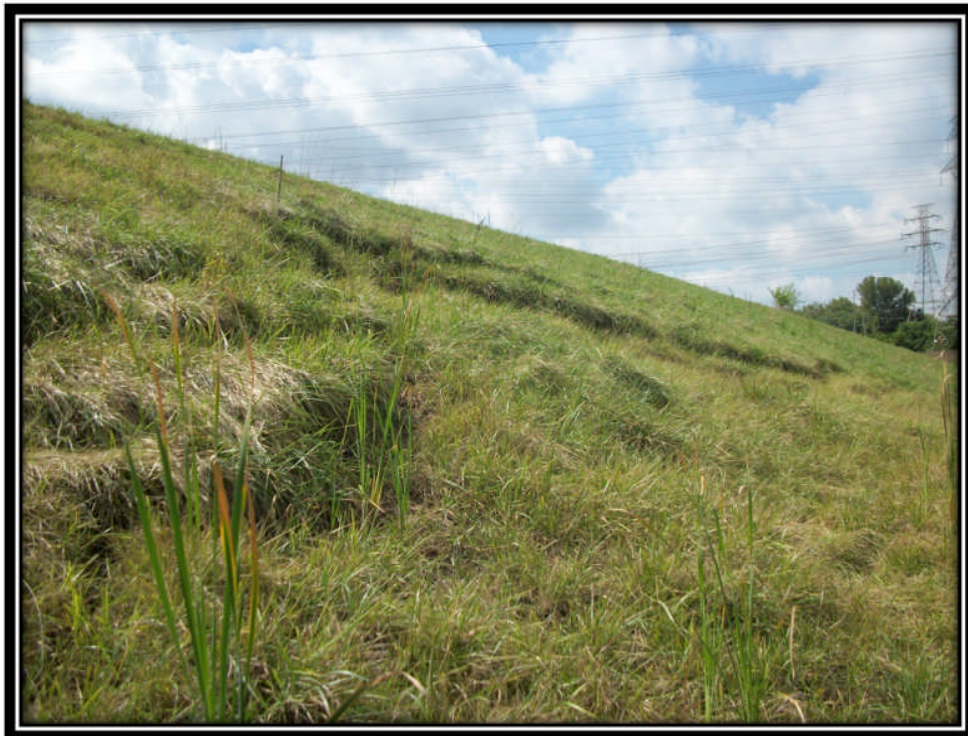
- Erosion, some areas greater than 6 inches, was noted on some of the downstream slope.
- Penetrations into the downstream embankment, including manholes, were present.
- A large scarp, approximately two feet in depth, was present for a significant portion of the western embankment slope.
- Grasses and woody bushes were observed on the downstream slope.

Photo 38 – Scarp on Western Pond 1 Downstream Slope

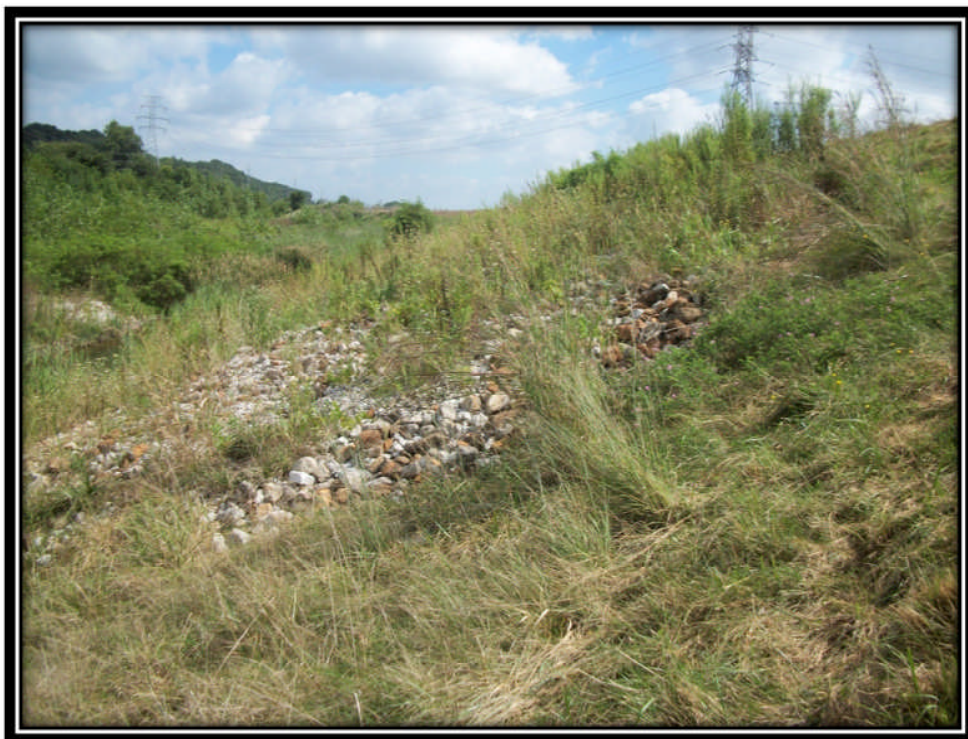
Photo 40 – Scarp that has Been Repaired on Western Pond 1 Downstream Slope
