**Re: Ameren Missouri
Labadie Power Station
Response to O'Brien & Gere Final Dam Safety Assessment of CCW Impoundment**

RE: Ash Pond Stability Recommendations
Labadie Power Station

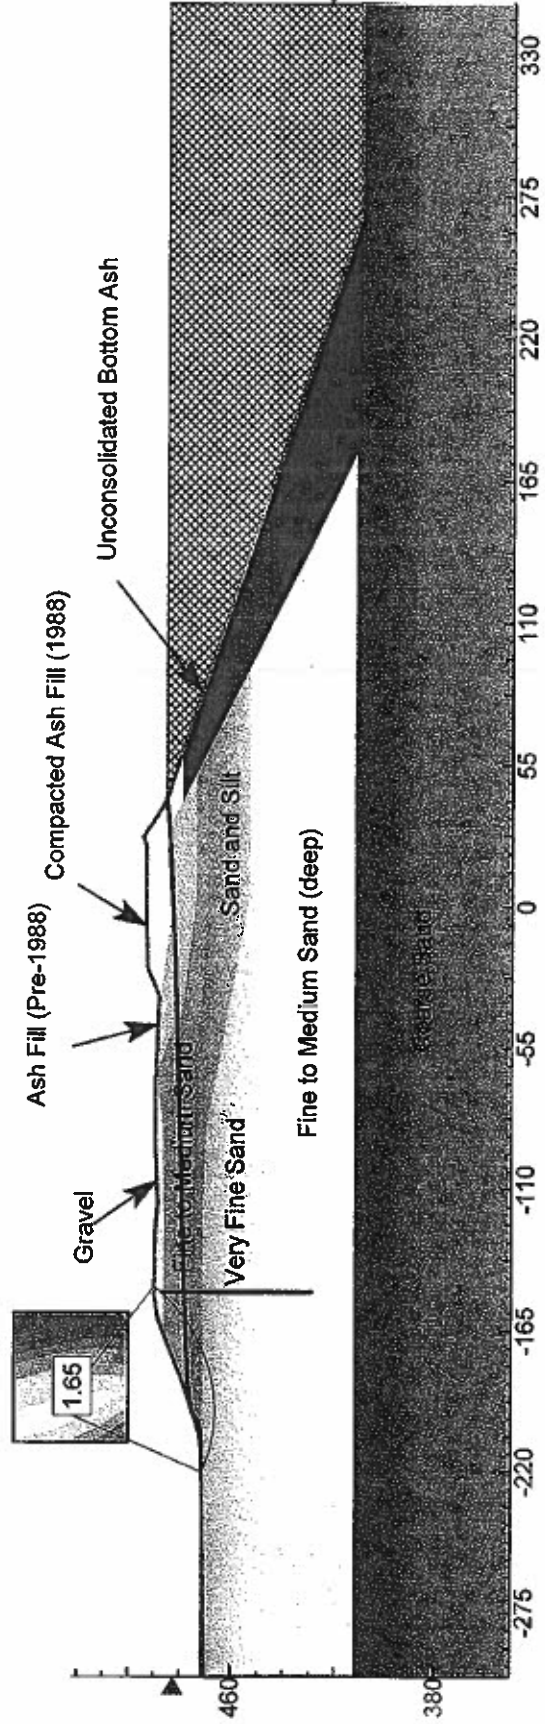
Labadie Power Station
 Steady Seepage, Full Reservoir
 Cross-section 5

Response – The result of stability analysis of cross section 5 for full pond, steady-state seepage, and long-term (drained) shear strength properties is depicted graphically and attached. Shown on the figure are the long-term shear strength properties used in the analysis. The analysis limited the search for failure surfaces to include “deep” failures surfaces or slope failures that would require significant effort to repair.

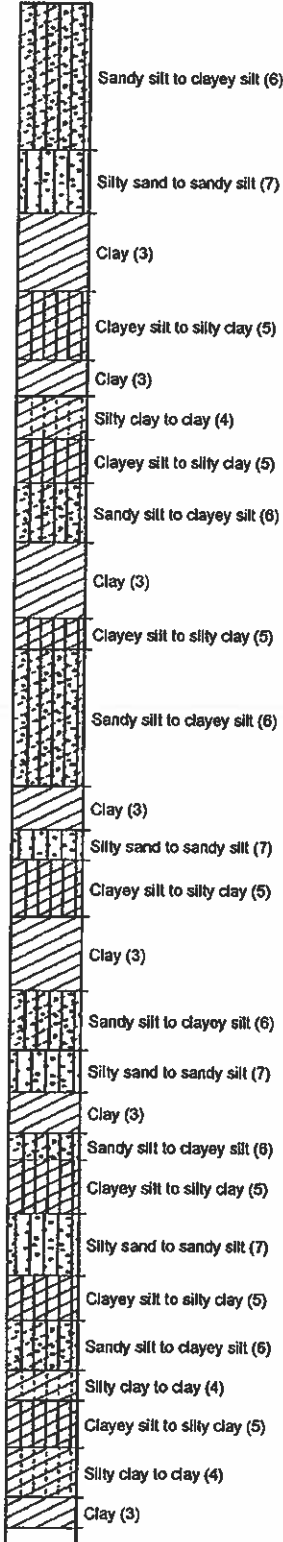
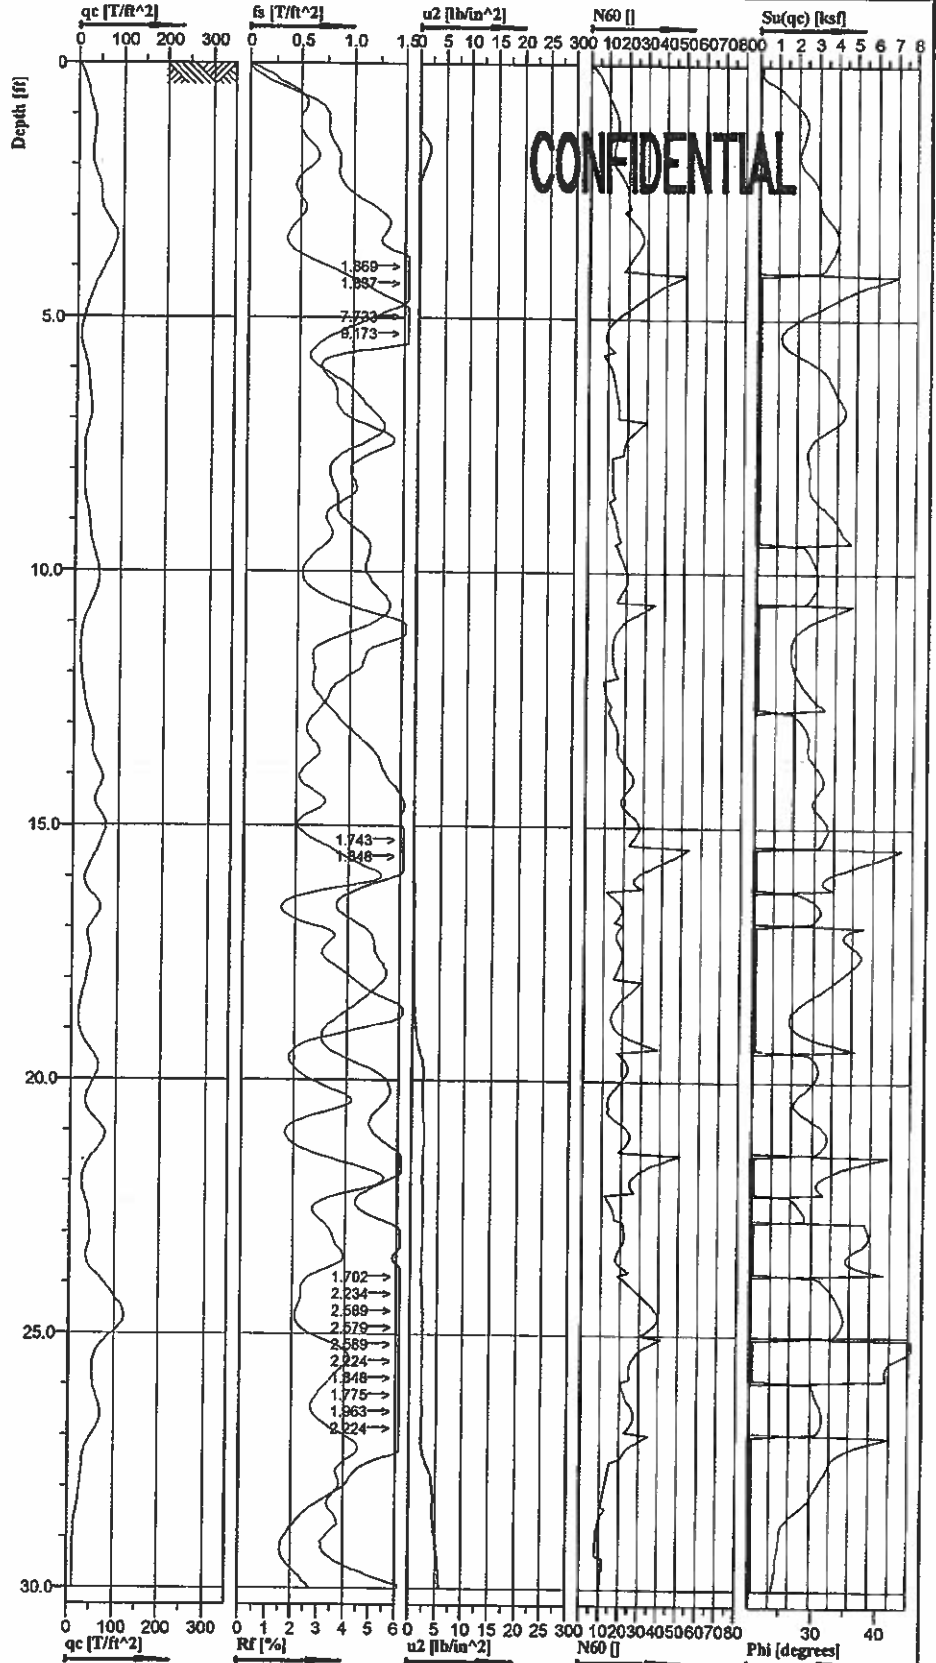
Location: Labadie Power Plant	Position: X: 726283.89 ft, Y: 992395.37 ft	Ground level: 492.49	Test no: P-3
Project ID: 2010012488	Client: AmerenUE	Date: 6/23/2010	Scale: 1 : 42
Project: Ash Pond Stability Analysis		Page: 1/1	Fig: 3-3
Revised 8/2/2011		File: P-3.cpd

Response - The water levels shown on soundings P-3 and P-4 are at elevation 476.5 and 487.3, respectively. These soundings were conducted in the crest of the embankment for the Fly Ash Pond which is lined with HDPE. The normal water level in the fly ash pond is estimated between elevations 475 to 480 feet based on weekly inspections. In the slope stability analysis presented in the November 2010 report it was assumed that the normal pool level was at elevation 484 feet,

While analyzing the CPT soundings it was concluded that the elevated pore pressures were the result of induced strains caused by advancing the CPT cone through unsaturated strata or due to thin, wet coarse grained strata bounded by impervious fine grained strata. Our conclusion that the water levels shown on the logs are not a true groundwater level was supported by the following observations:

- The measured tip pressure and sleeve friction do not support saturated soil behavior for the type of soil observed, above the assumed water level used in the analysis. The measured tip pressure at a depth of approximately 29 feet was lower in Soundings P-3 and P-4 than what was measured in the overlying strata. This behavior was also observed in Soundings P-2 and P-10

The water levels shown on CPT soundings P-3 and P-4 are assumed erroneous and have been removed from the revised logs which are attached.
