**Coal Combustion Waste Impoundment
Round 7 - Dam Assessment Report**

Meramec Power Station (Site #002)

***AmerenUE
St. Louis, Missouri***

Dewberry & Davis, LLC
Fairfax, Virginia

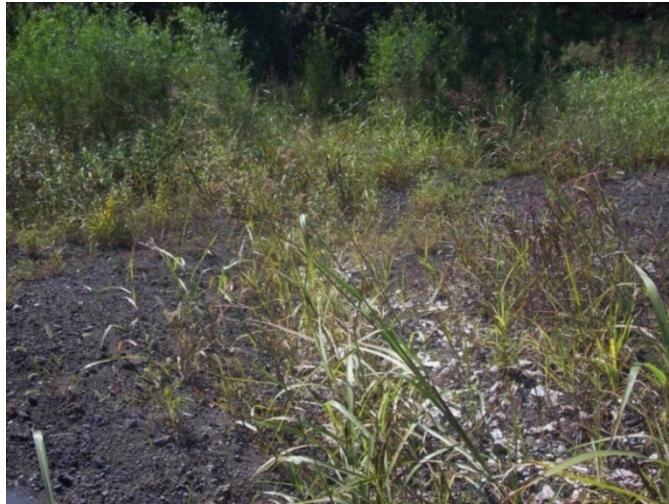
5. Repaired erosion area along levee embankment at Pond 8.

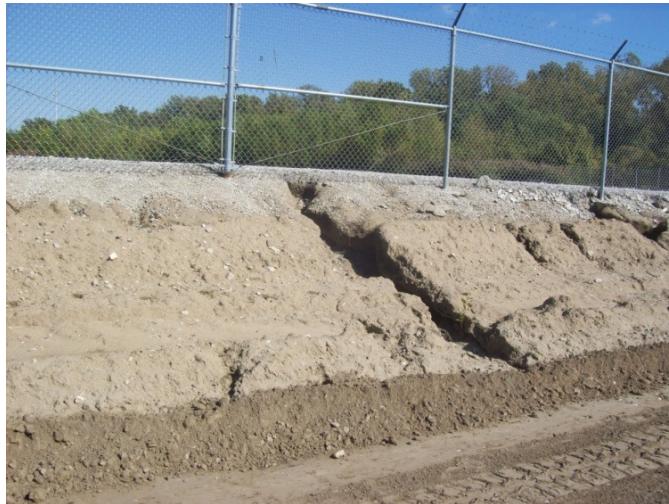
6. Looking at runoff erosion along top of levee embankment from runoff at Pond 2.

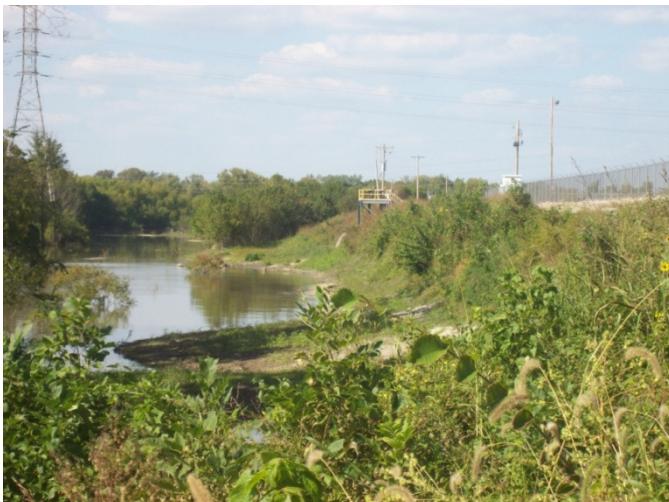
9. Looking northwest at outside slope of Pond 2 levee embankment. Note – High water was observed in the Meramec River during site visit. Perimeter access road was submerged.

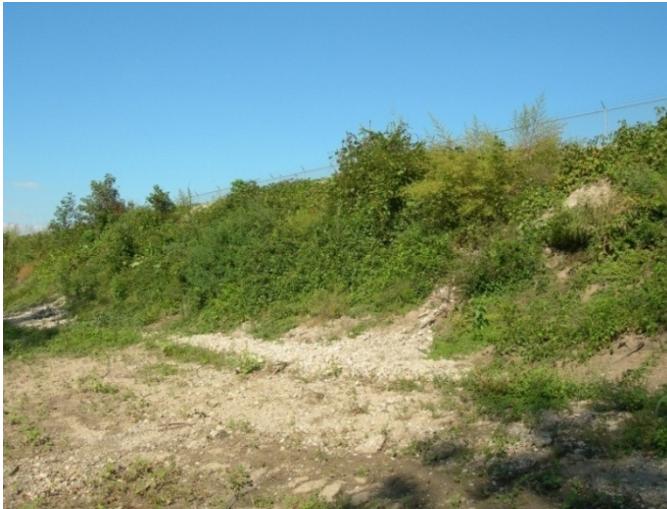
- 10. Outside slope of levee embankment at Pond 2. An unknown pipe was observed at the location, see Photo 14.**

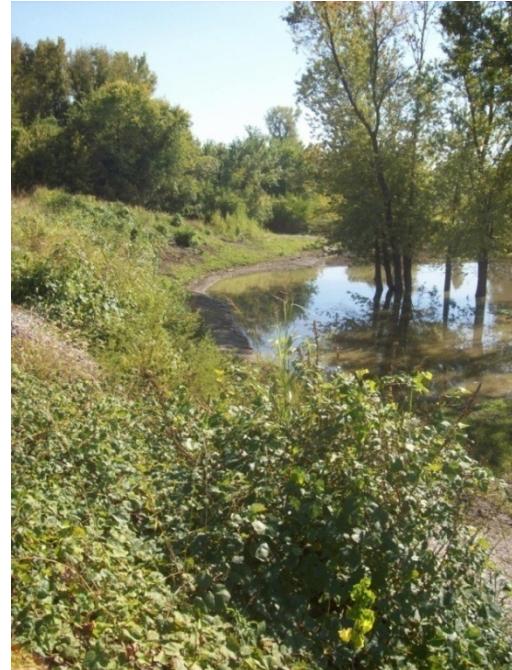
- 11. Looking southeast along outside slope of levee embankment of Pond 2. Note - High water was observed in the Meramec River during site visit.**

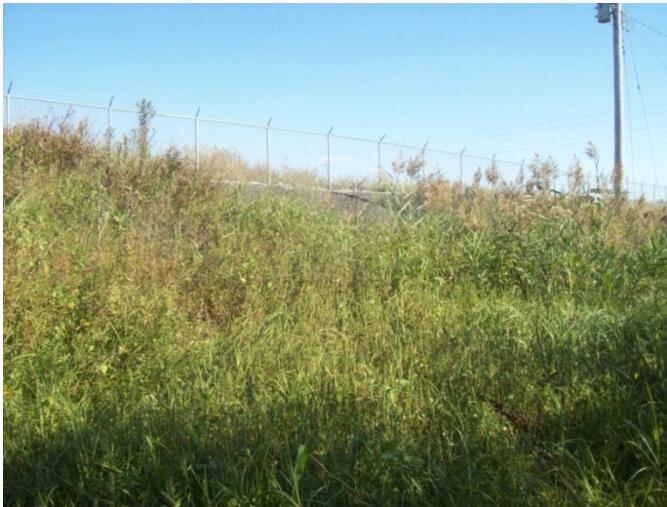
- 12. Looking at outside slope of levee embankment at Pond 8. Note - Repaired erosion area at edge of crest.**

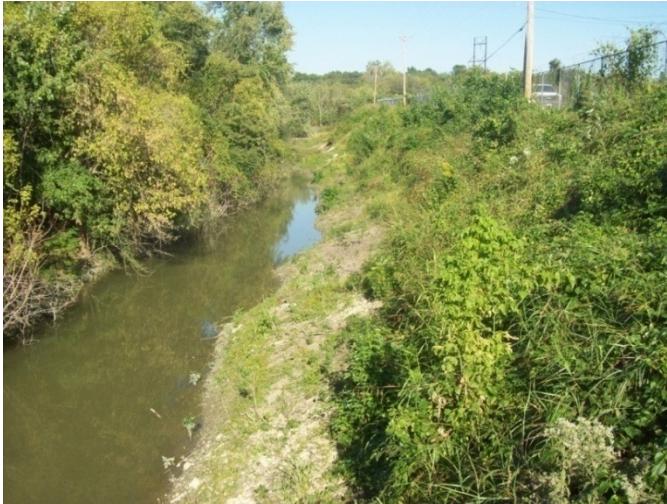
13. Looking northeast along outside slope and toe of the levee embankment along the tributary to Meramec River.

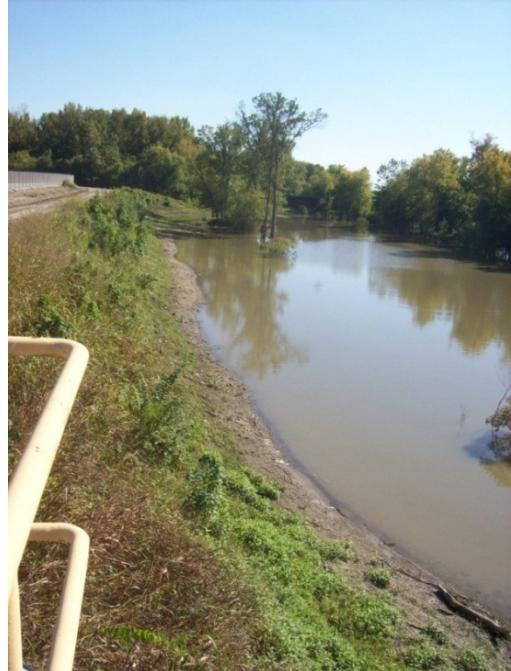
16. Looking southeast along perimeter levee embankment. Note - High water was observed in the Meramec River during site visit.

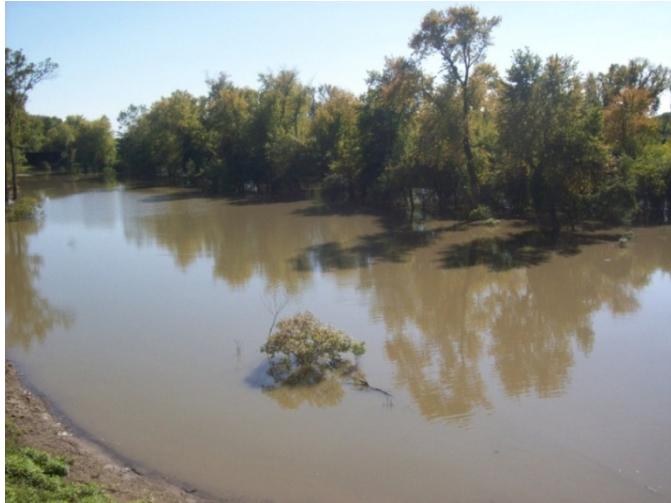
17. Looking southeast at tree line adjacent to submerged perimeter access road.

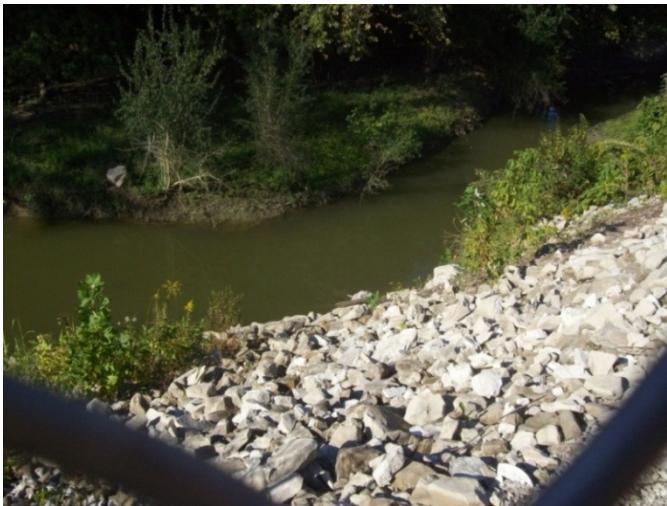
No evidence of major repairs to the embankments or prior releases was observed during the field assessment. Evidence of slope repair due to erosion on the outside slope of the perimeter levee was observed. Maintenance and methods of operation are adequate.

26. Evidence of repair to outside slope of levee embankment due to erosion.

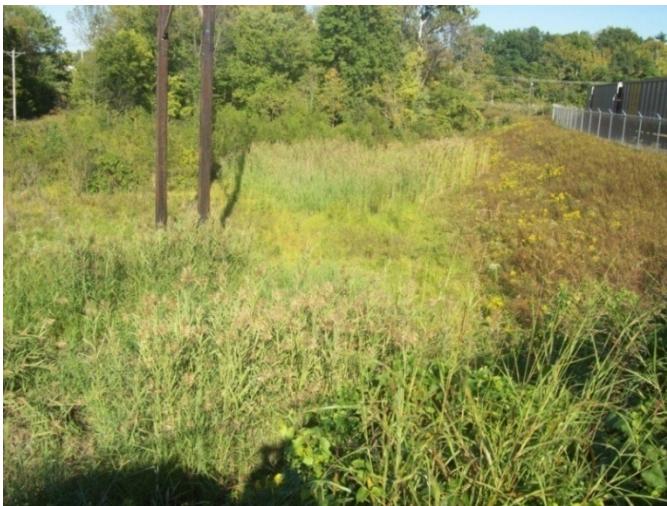
The embankment levee appeared maintained, safe, and structurally sound. There are no apparent indications of any unsafe conditions. The visible parts of the embankment levee and outlet structures were observed to have no signs of overstress, significant settlement, shear failure, or other signs of instability. Erosion on the inside slope and wooden retaining wall failure was observed at Pond 1. Runoff erosion was observed on the outside slope of the perimeter levee embankment. The outside slope of the levee embankment was observed to be covered in tall grass and brush. An indication of seepage was observed at the outside toe of Pond 4, although visual observations were severely hampered by the presence of tall vegetation. Runoff erosion is being managed through a maintenance program. The seepage area is being monitored and inspected per weekly inspection reports.

27. Looking towards Pond 4 (Bottom Ash Pond) at outside toe and slope of levee embankment. Note - Cat tails.

It is recommended that the seepage area observed at the outside toe of Pond 4 continue to be monitored for changed conditions.
