**COAL ASH IMPOUNDMENT  
SITE ASSESSMENT DRAFT REPORT**

**Newton Power Station  
Ameren Energy Generating Company  
Newton, Illinois**

**KLEINFELDER PROJECT NUMBER 112618-4**

**October 26, 2010**

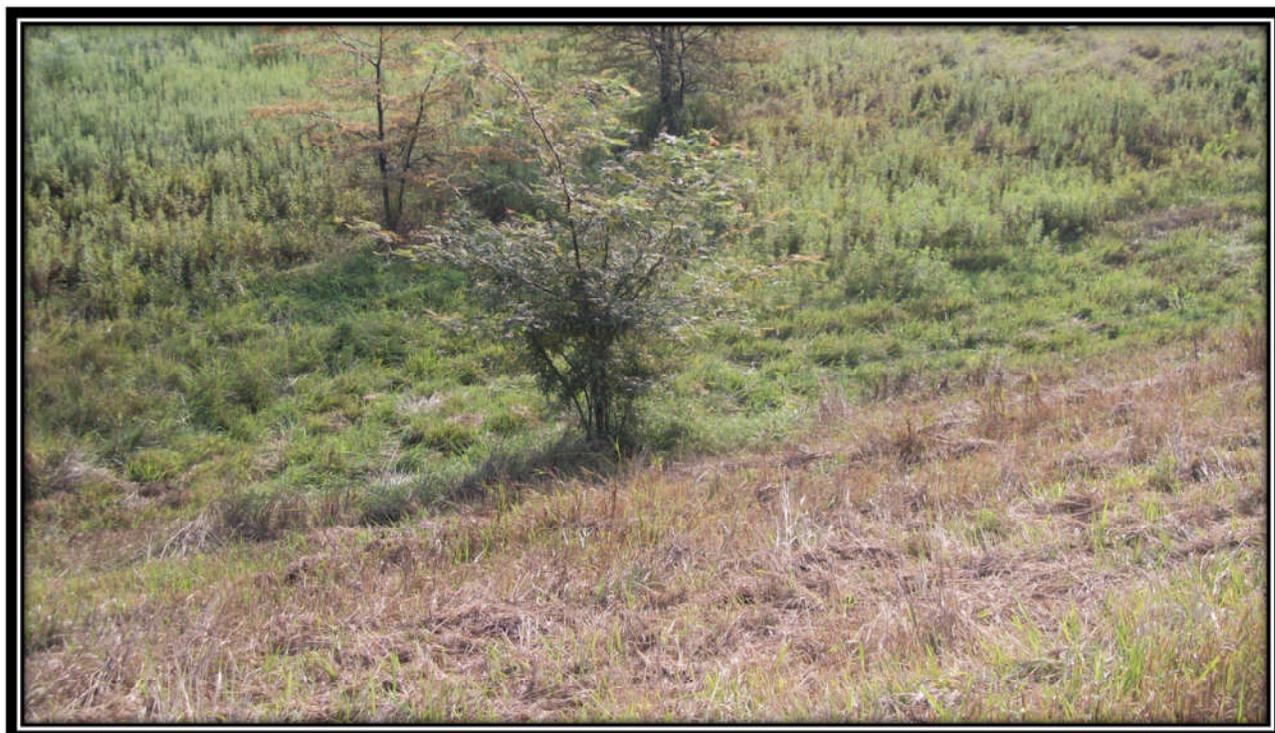
Photo 2 – Shrubs at downstream toe

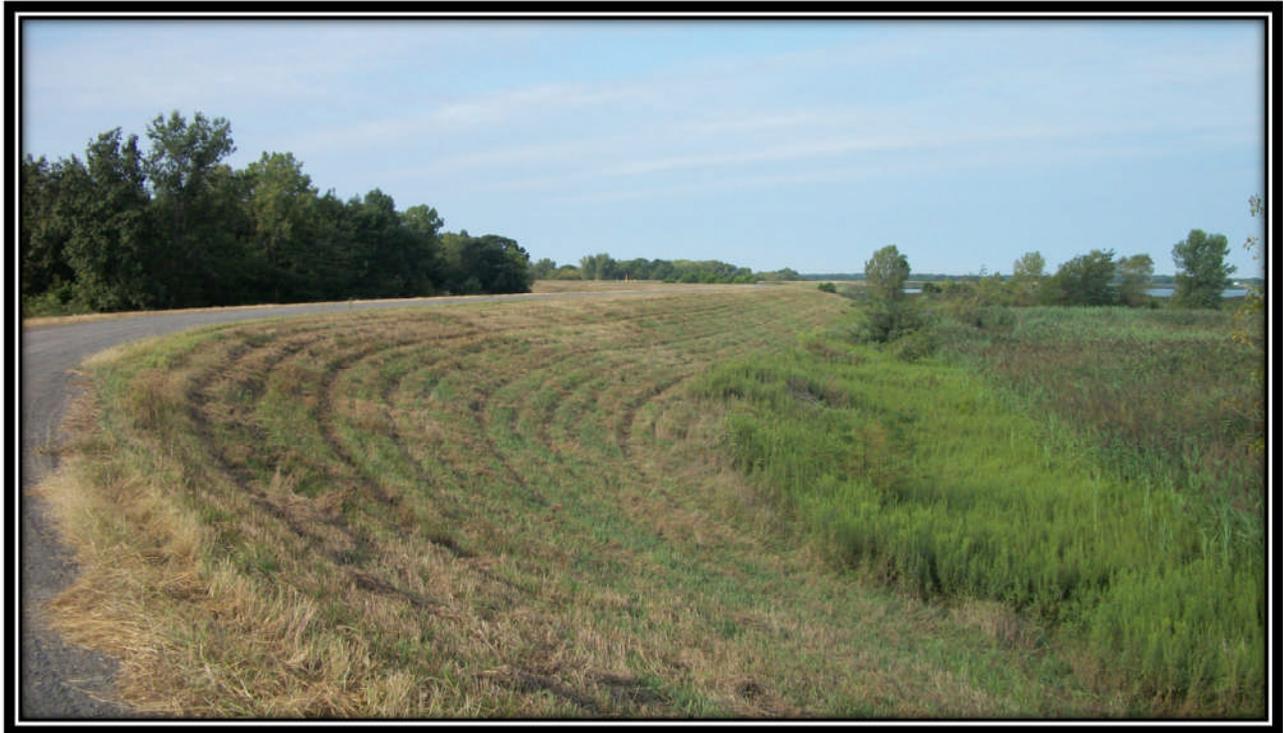
Overall, the upstream slope was in satisfactory condition. Photograph 3 in Appendix B shows typical conditions of the upstream slope. Specific observations include:

- The upstream slope was laid back at approximately 3H:1V, based on visual observations.
- Minor erosion rills, less than 6 inches deep, were noted on some of the upstream slopes.
- A few woody bushes were observed on the upstream slope, and a few trees were observed near the upstream toe of the embankment of the impoundment.
- Mowing/Vegetation control had been completed on the majority of the upstream slope.

Photo 3 – Looking South along East embankment, vegetation on upstream slope

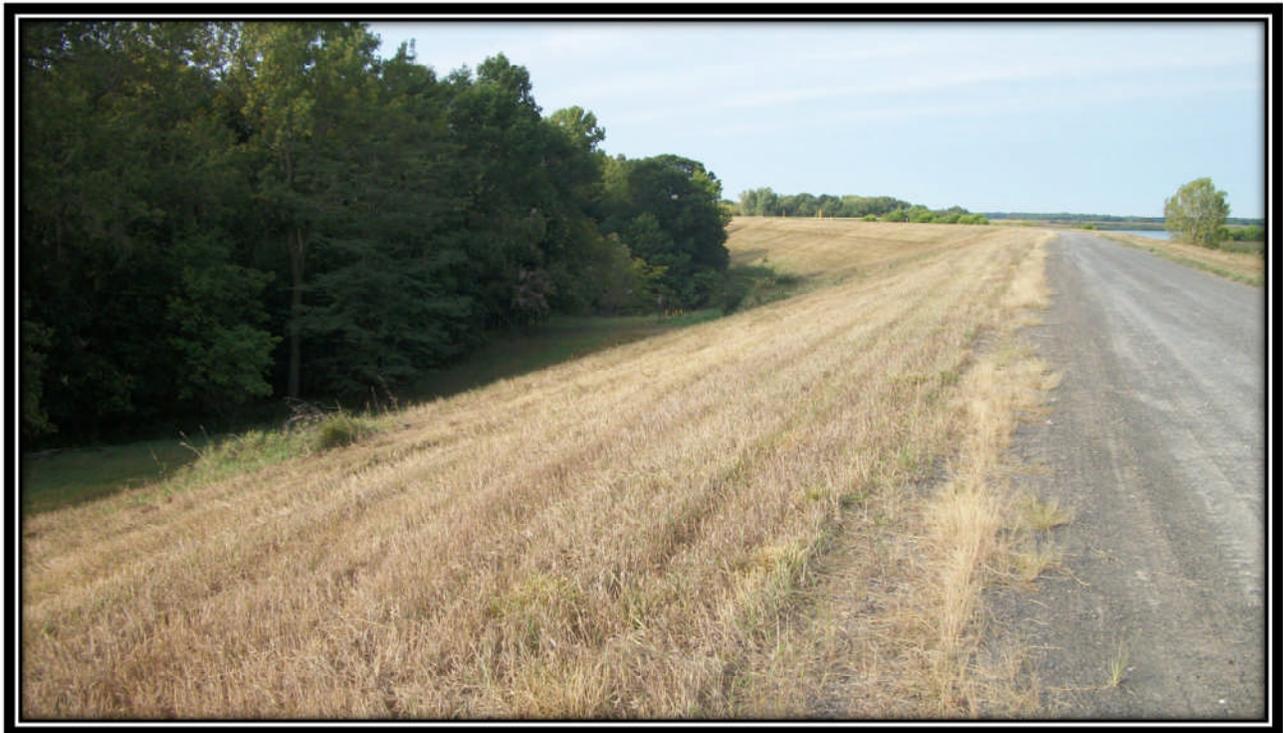
Overall, the downstream slope was in satisfactory condition. Photograph 4 shows typical conditions of the downstream slope. Specific observations include:

- Erosion rills up to 6 inches deep were noted on some downstream slopes.
- Grasses were observed on the downstream slope.

Photo 4 – Looking South along East embankment, vegetation on downstream slope

1. **Repair erosion of embankment.** Minor surface erosion was noted at both the Primary and Secondary Ash Ponds. Areas where erosion has occurred should be filled in and re-dressed with appropriate fill to prevent erosion from cutting further into the embankments.

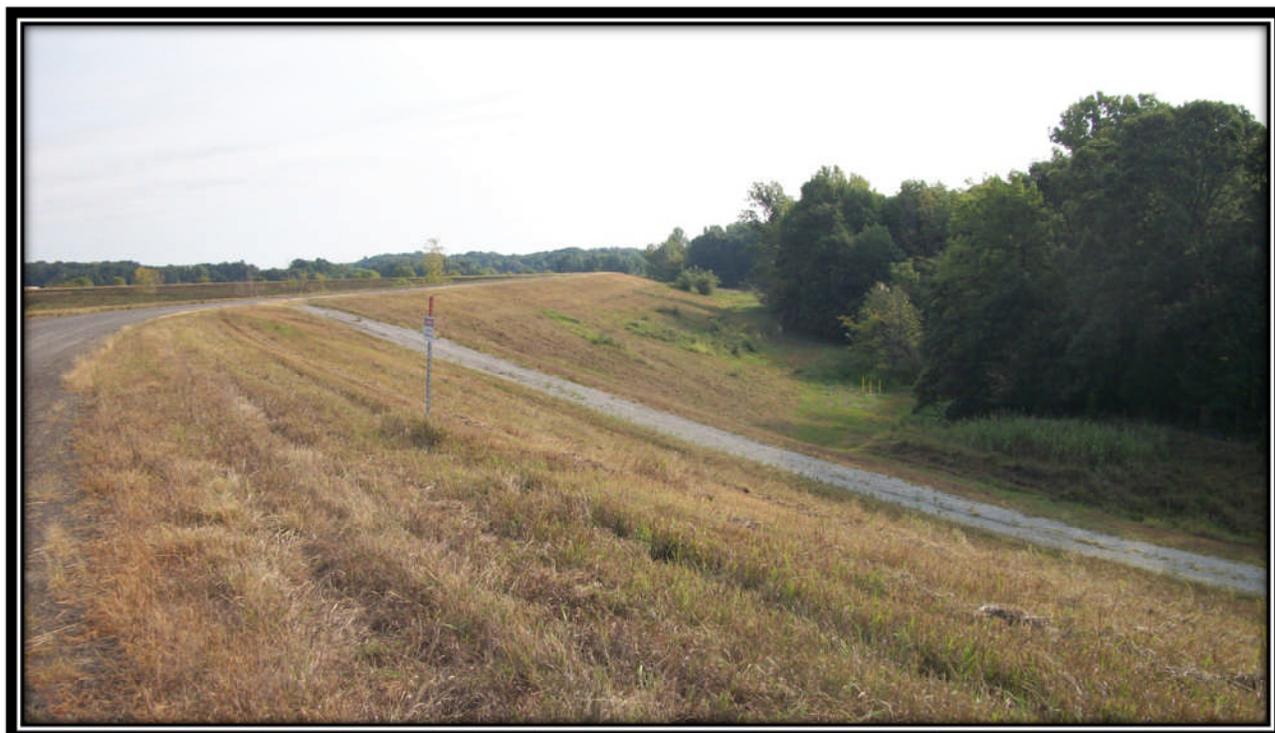
The toe areas of the embankment were in satisfactory condition. Photograph 6 shows typical conditions of these areas. Key features and observations of these areas include:

- Except for a few small bushes and trees, vegetation has been cut back at least 20 feet from the toe, leaving primarily grasses.
- Some hydrophilic vegetation was observed at seepage locations, but ponded water was not observed.

Photo 6 – Road up downstream slope to pump house

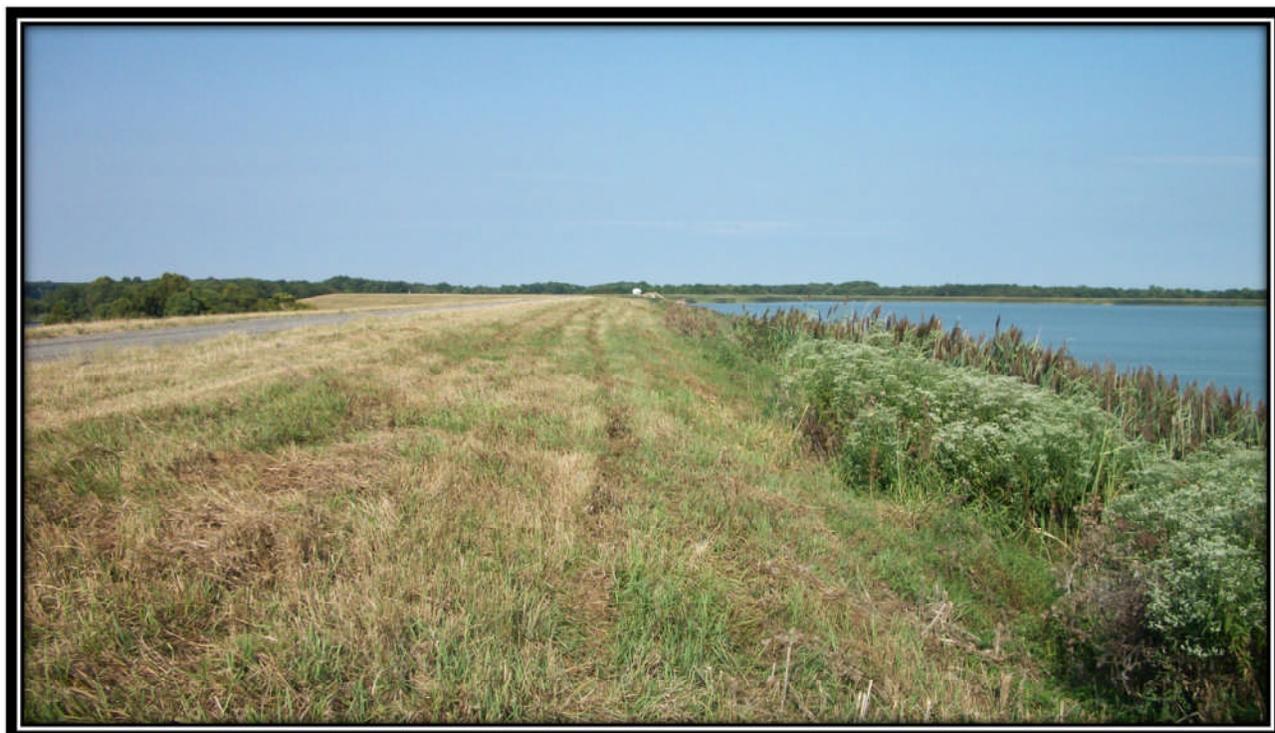
Photo 8 – Vegetation on upstream slope looking Southwest along East embankment

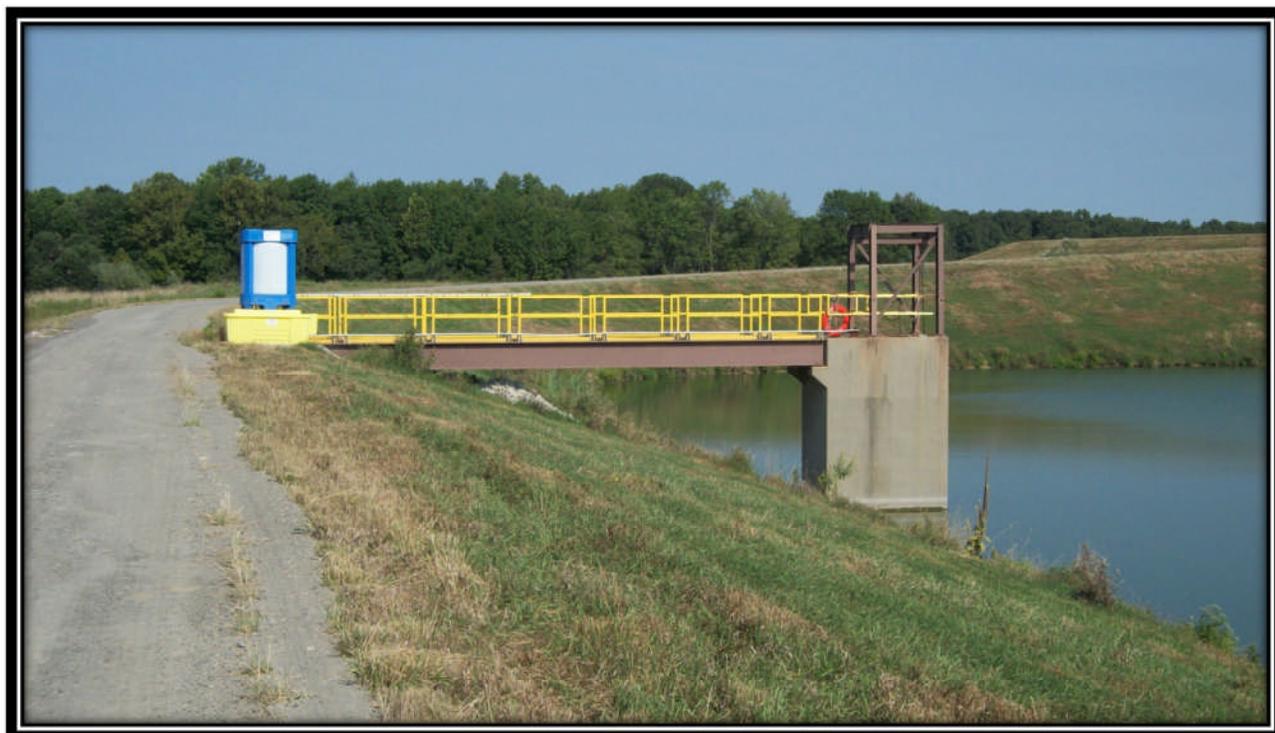
Overall, the upstream slope of the impoundment was in satisfactory condition. Photograph 14 in Appendix B shows the typical condition of the upstream slope. Specific observations include:

Overall, the crest of the impoundment was in satisfactory condition. Photograph 14 shows the typical condition of the crest. Specific observations include:

- The impoundment crest is a gravel road.
- Very sparse grasses were observed on the upstream side of the crest.

- No major depressions or rutting were noted on the impoundment crest.

Photo 14 – Secondary pond outlet

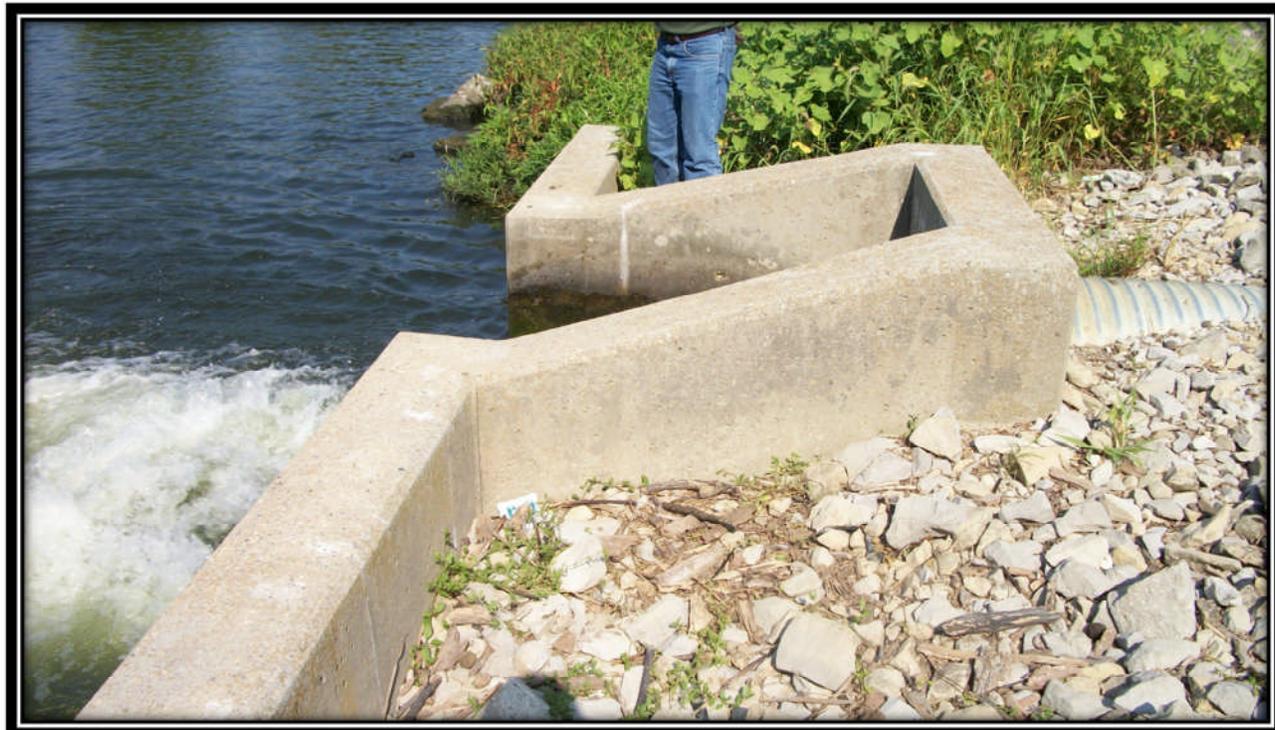
Photo 17 – CIPP lining slipped into CMP, discharging into Lake Newton

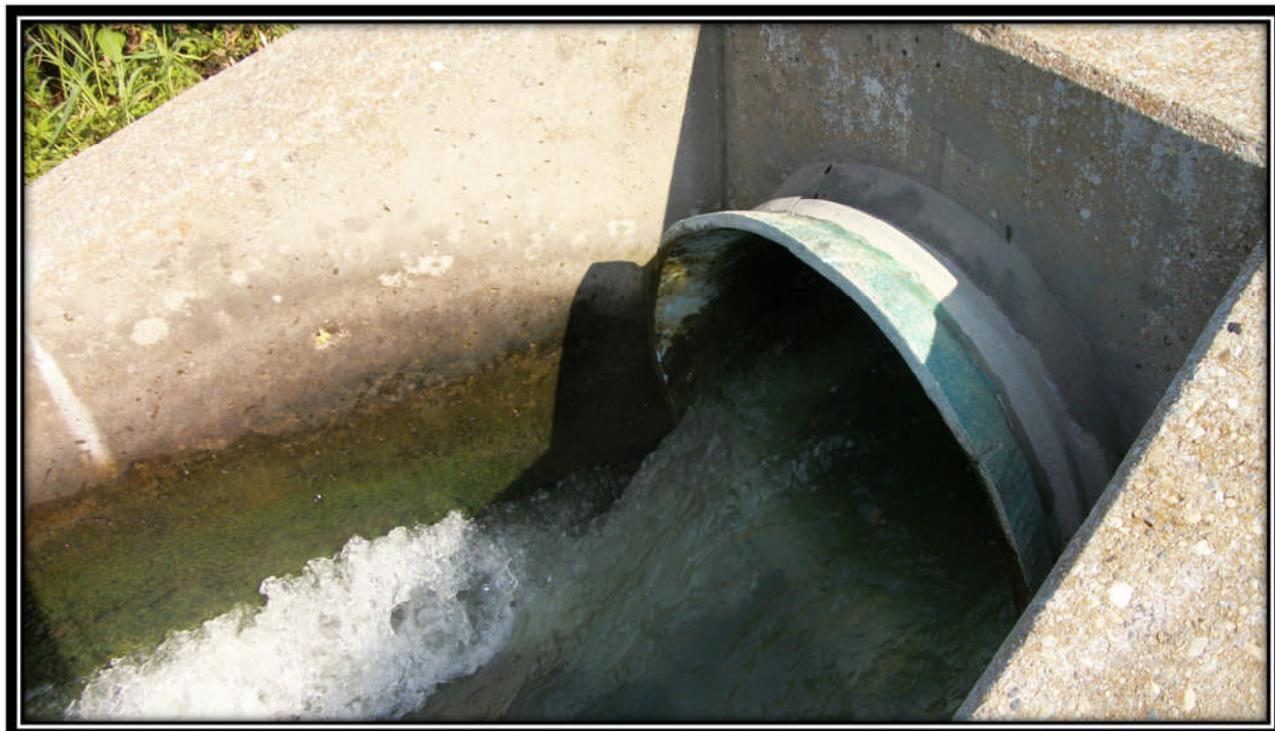
Photo 18 – CIPP lining slipped into CMP

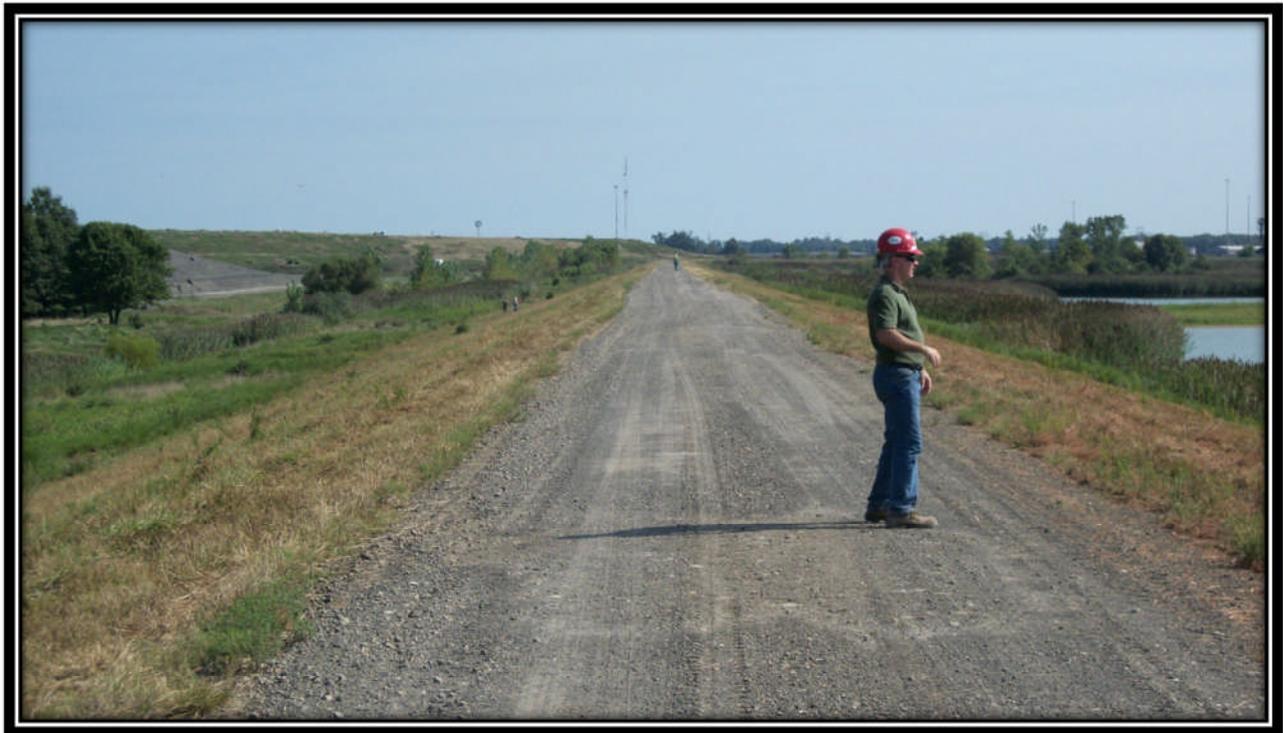
Overall, the crest of the impoundment was in satisfactory condition. Photograph 22 shows the typical condition of the crest. Specific observations include:

- The impoundment crest is a gravel road.
- Almost no grasses were observed on the crest.
- No major depressions or rutting were noted on the impoundment crest.

Photo 22 – Looking North along West embankment

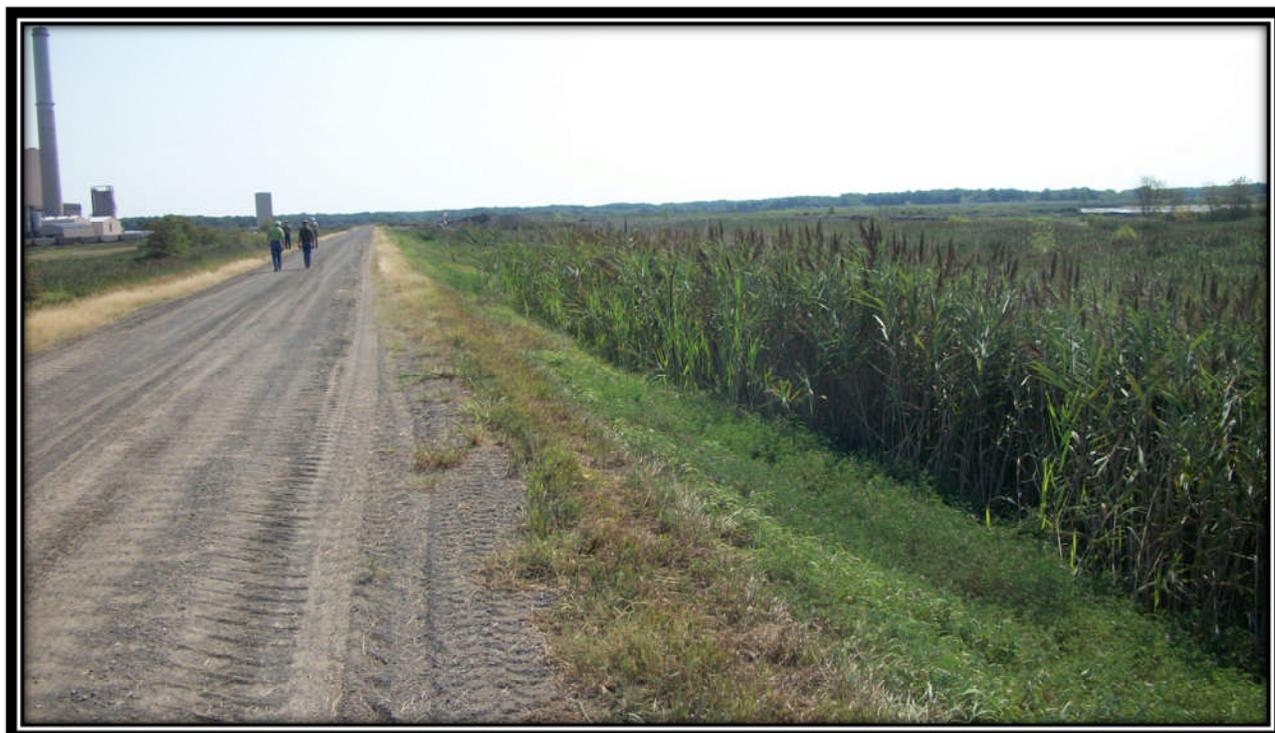
Photo 26 – Minor vegetation on upstream slope

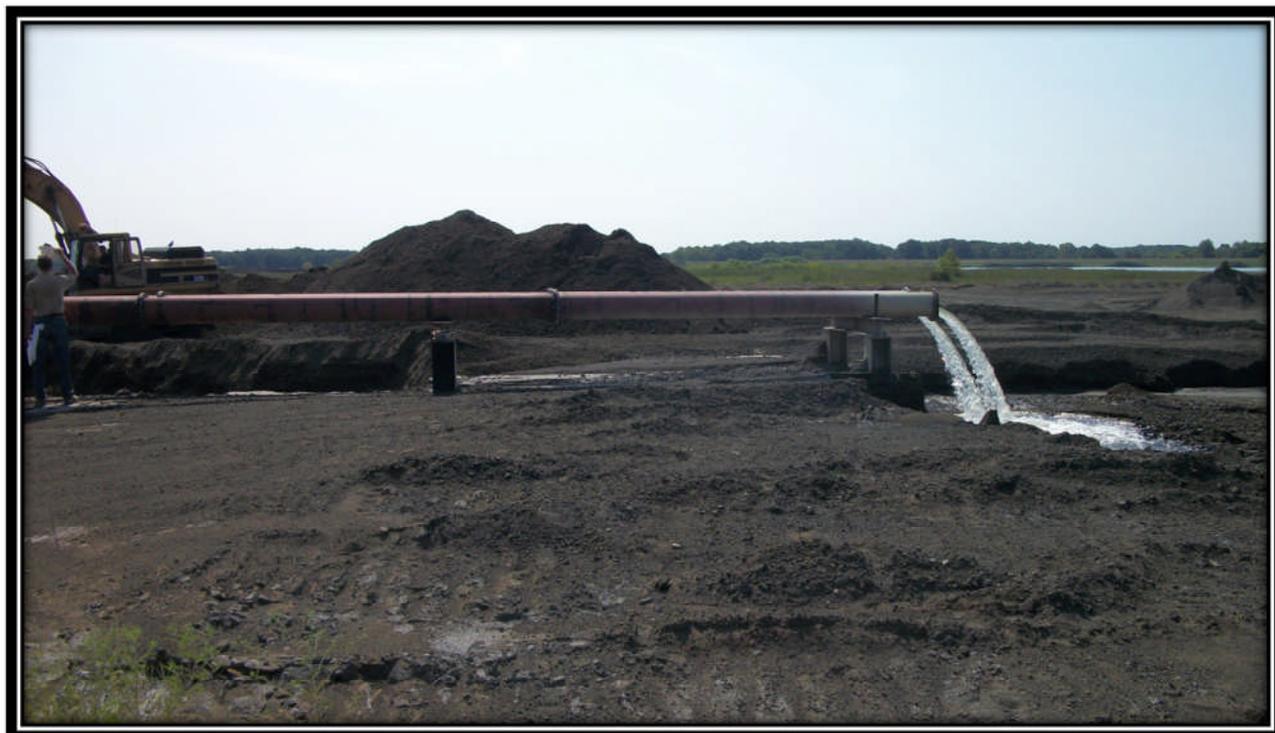
Inflow into the Primary Ash Pond includes metal pipes on the north side of the impoundment, as well as storm water runoff that flows naturally into the pond. Inlet pipes can be seen in Photograph 27 of Appendix B. The inlet pipe appears to be in satisfactory condition.

Photo 27 – Discharge pipes

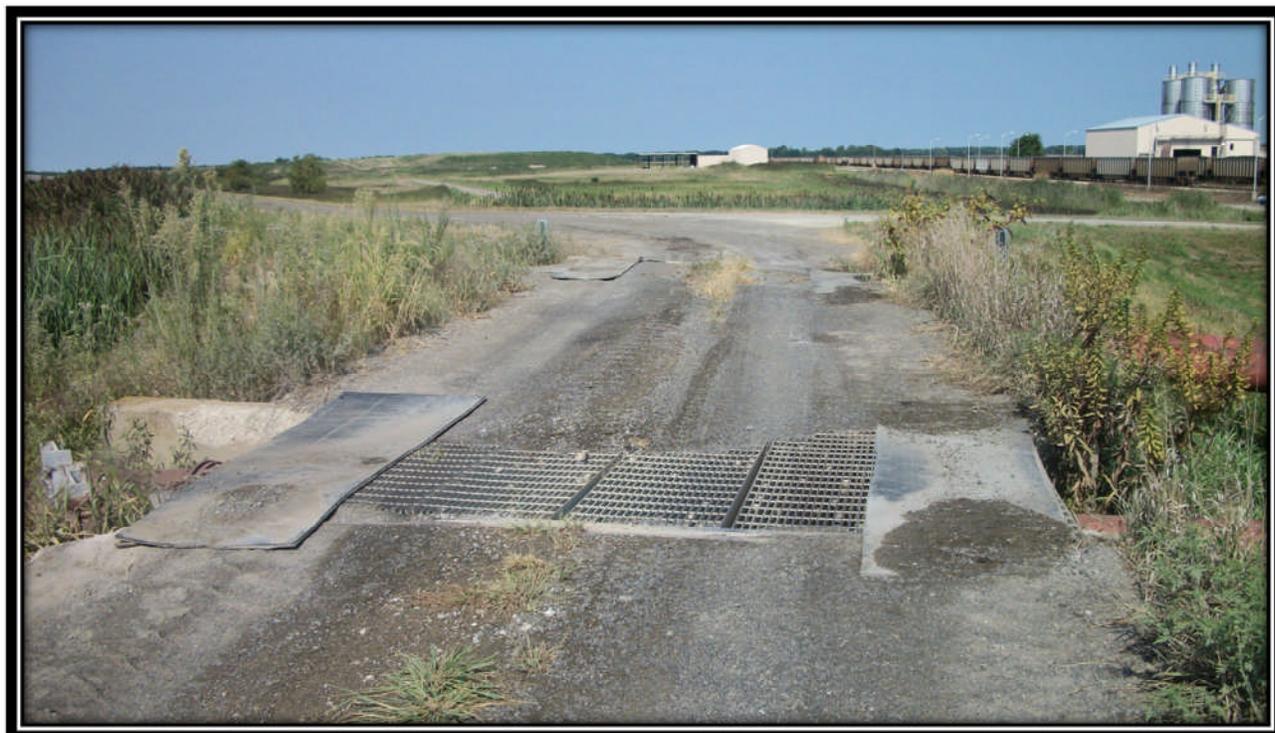
Photo 29 – Pipe crossing approximately 2 feet below grade
