**Coal Combustion Waste Impoundment**

**Round 7 - Dam Assessment Report**

***Rush Island Power Station (Site #003)***

***AmerenUE***  
**Festus, Missouri**

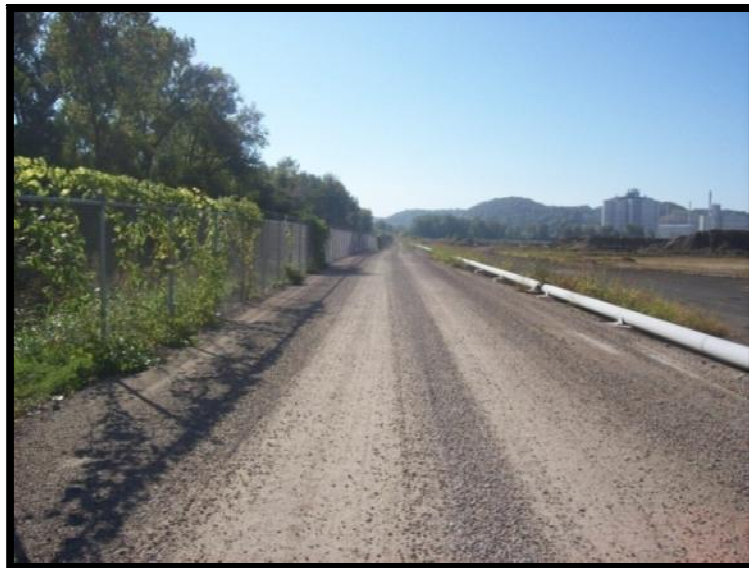
The crest of the ash pond showed no signs of significant depressions, tension cracks or other indications of settlement or shear failure. Figure 5.2.1-1 shows the typical crest condition of the embankment.

**Figure 5.2.1-1:** Typical crest condition of embankment, South.

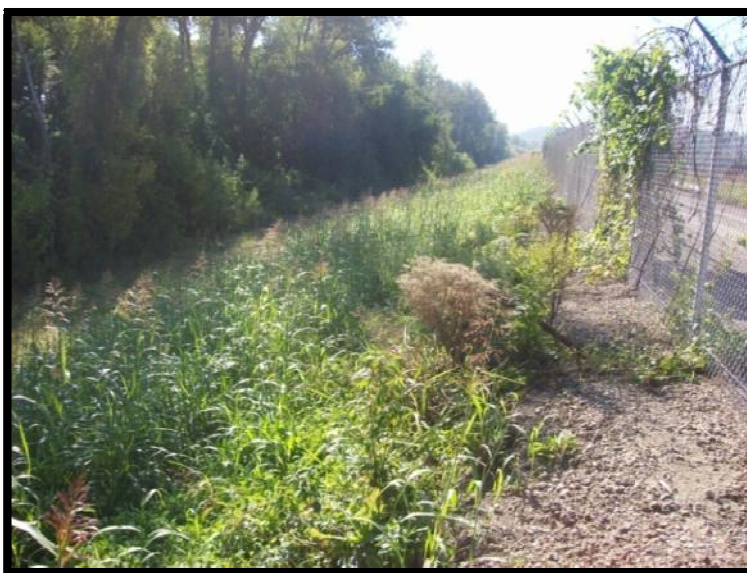
The external embankment has medium to heavy vegetative cover ranging from tall grass to trees. Some areas along the embankment were observed to have minimal grass cover and signs of minor erosion due to roadway runoff or the use of maintenance equipment. There were no scarps, sloughs, bulging, cracks or depressions observed along the embankment indicating slope instability. No evidence of spills, release or performance related problems could be found through field observations. The pond borders the Isle du Boise Creek on the southern portions of its embankment. A five foot bench between the banks of the creek and the toe of the pond embankment exists. This area was covered by medium to heavy vegetation. Figure 5.2.3-1 shows the conditions of the external embankment.

**Figure 5.2.3-2:** Ash pond external embankment with medium to heavy vegetative cover, Southeast.

A need for slope maintenance for the external embankment is necessary to limit the growth of vegetation and facilitate visual dam inspection. It should be noted that in 2006, the Corps of Engineers armored with rip-rap the entire length of the Isle du Boise Creek bank adjoining the ash pond. Careful consideration should be taken in monitoring signs of erosion of the ash pond external embankment due to flood waters of either the Isle du Bois Creek or the Mississippi River.

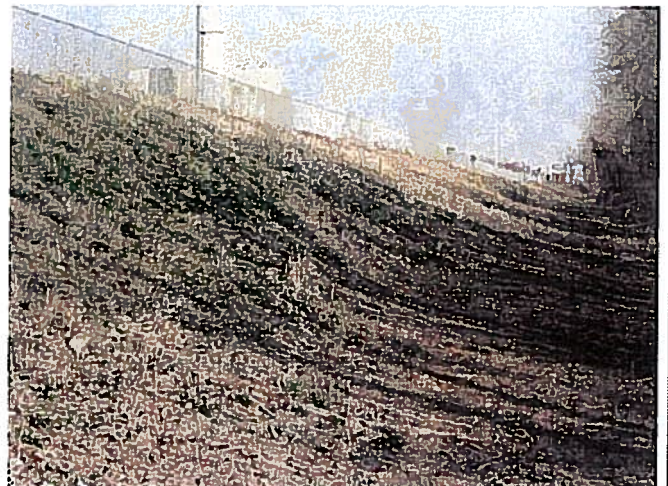
In the vicinity of station 30+00 the toe of the levee embankment slope has been eroded away to form a steep slope about 5 feet high. The surface has no erosion protection. This is shown in the photo to the right. In the event of a Mississippi river flood continued erosion could occur that would not be able to be observed through the flood waters, and the slope could fail. This eroded area needs to be rebuilt and rip-rapped. A similar section occurs about 80 feet south of the discharge platform bridge that also needs to be re-shaped and rip-rapped. The rock rip-rap should be placed on either a bedding layer, or a separation layer of non-woven filter fabric. The finish face of the entire slope should be built to

the original design slope.

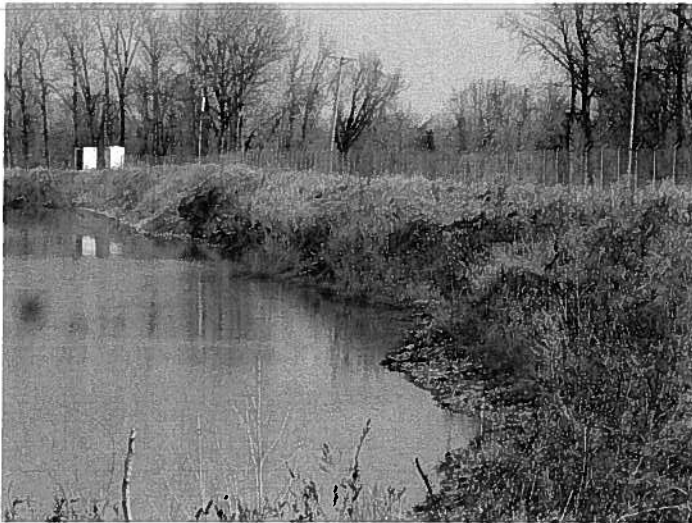
1H:1V, and along the east shore the erosion is within 10 feet of the edge of the roadway. A photo is shown on the left of this discussion.

The slope stability study has shown that the steady seepage condition is the most critical for the existing external slopes. The internal slopes have to be re-built with soils to a minimum 2H:1V slope to meet the seepage analysis assumptions. These slopes should also be rip-rapped after rebuilding to protect against recurrence of the wave erosion.

Reitz & Jens has been informed that plans are under way to perform this slope repair during the summer of 2010.

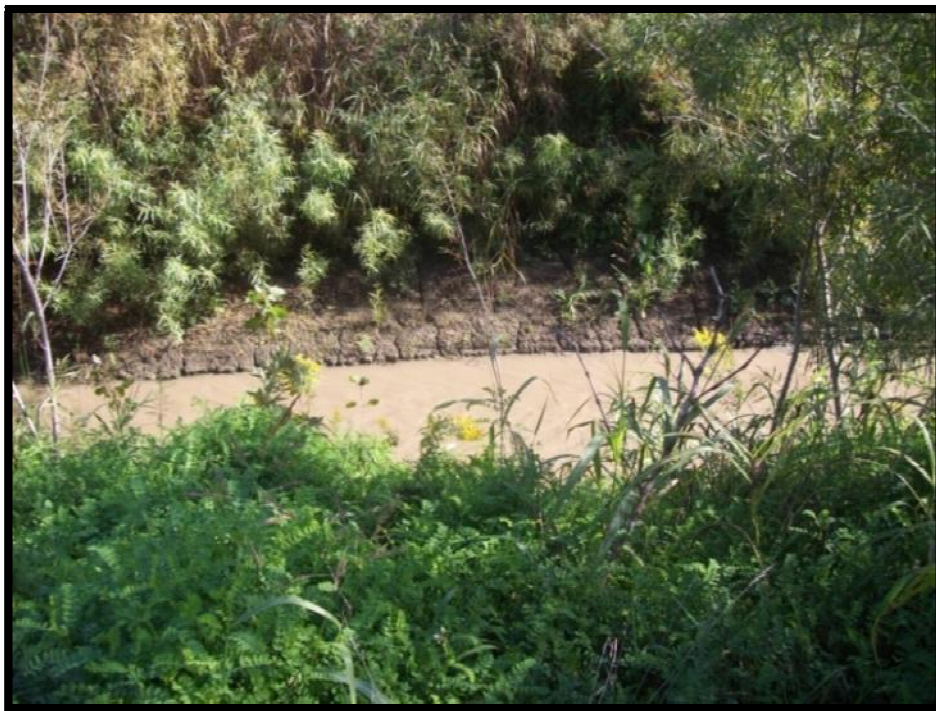
**Figure 15:** Downstream embankment of ash pond at Isle du Bois Creek. (High water noted during assessment. There is a 5' bench from toe of embankment to creek.)

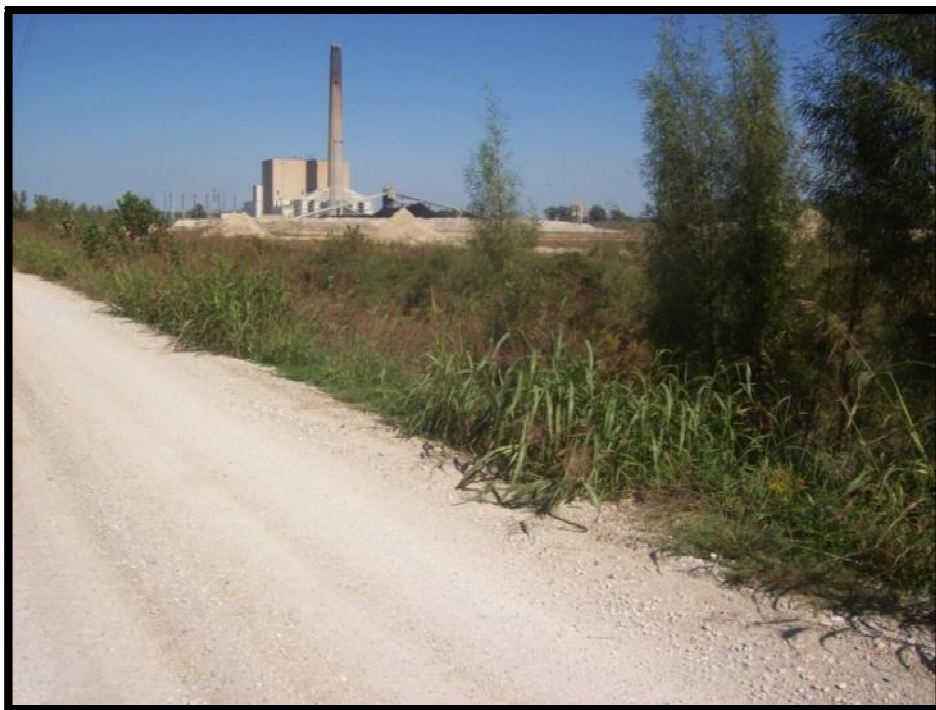
**Figure 16:** Vegetative growth adjacent to top of ash pond embankment, North. (A contract is in place to clear trees.)
