**DAM SAFETY INSPECTION
REPORT**

**GORGAS STEAM PLANT
WALKER COUNTY,
ALABAMA**

**PROJECT No. 09-4157
JULY 2009**

**DAM SAFETY INSPECTION REPORT
WILLIAM CRAWFORD GORGAS ELECTRIC
GENERATING PLANT
WALKER COUNTY, ALABAMA
PROJECT NO. 09-4157**

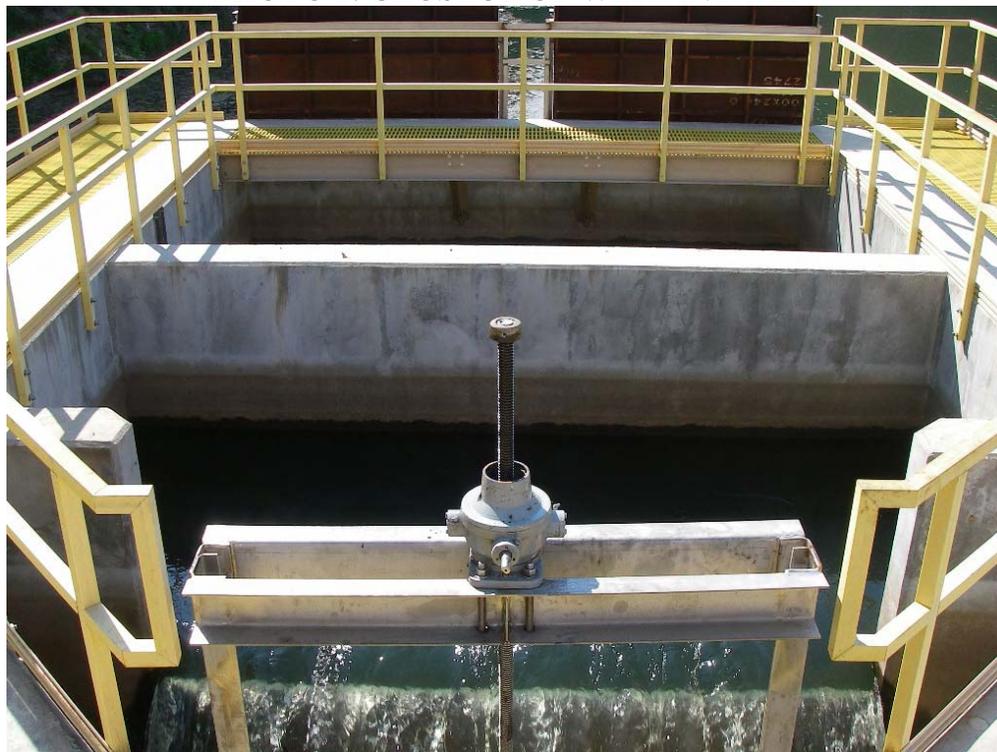
PHOTO 2: CLOSEUP OF WEIR INTAKE

The weir intake structure is a new reinforced concrete structure in excellent condition. This structure outlets into a 48-inch diameter corrugated metal pipe that carries decant water down the hill to the NPDES permitted release point. The release point is under water, therefore observation of the water at the point of discharge was not visible. Water at the point of entry was clear water. (See Photo 2).

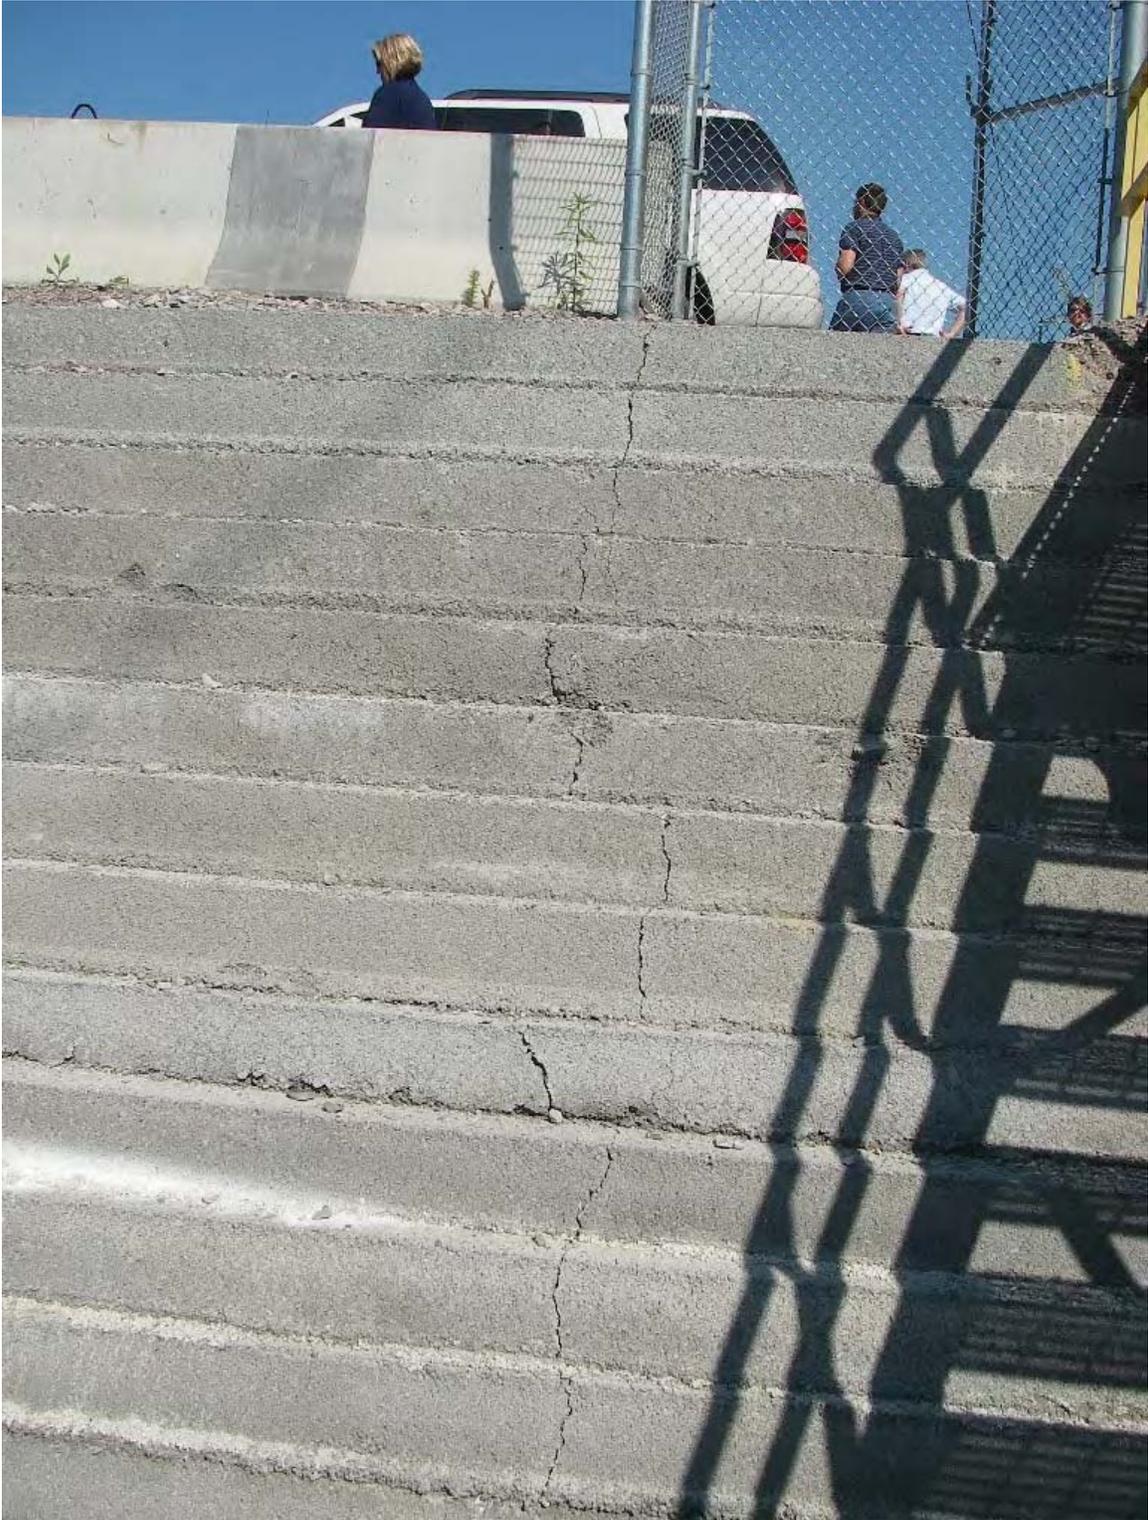
PHOTO 6: VERTICAL CRACKING IN RCC FACING BLOCK LEFT OF INTAKE STRUCTURE

Vertical cracking was noted in the upstream face of the RCC near the intake weir and right abutment. See Photo 6. According to APC personnel, no construction joints were placed in the RCC facing between the abutments – a distance of approximately 1300 feet. No area of concentrated vertical cracking was noted elsewhere on the RCC facing. The existing cracks should be monitored for change in size as part of the inspection program. The left abutment is flatter than the right abutment but may be subject to cracking due to future differential settlement. Observation of the front face of the RCC for cracking should be included in periodic inspection checklists.

It is recommended that cracks in the RCC facing block of Rattlesnake Dam be monitored as they develop, and that remedial measures such as caulking or grouting be considered to treat the cracks if they are deemed a risk to the embankment materials during normal conditions or high pool events.

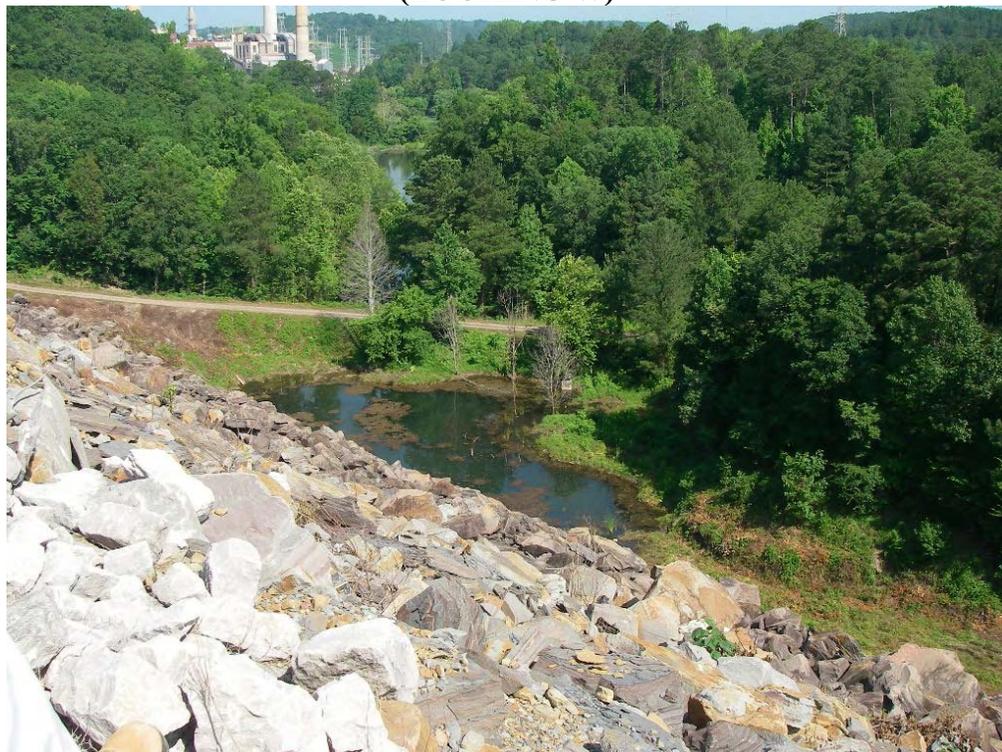
PHOTO 16: POOL AT DOWNSTREAM TOE OF RATTLESNAKE DAM (LOOKING W)

The downstream toe is generally grassed and clear of trees and heavy vegetation, with the exception of areas of tall brush in areas difficult to reach with tractor mowers. Seepage was noted below the toe in the left abutment area. The area around the pond in the center portion of the dam appears to be continuously wet from seepage and tailwater from the river. The pond was built during the initial dam construction. Wet areas and standing

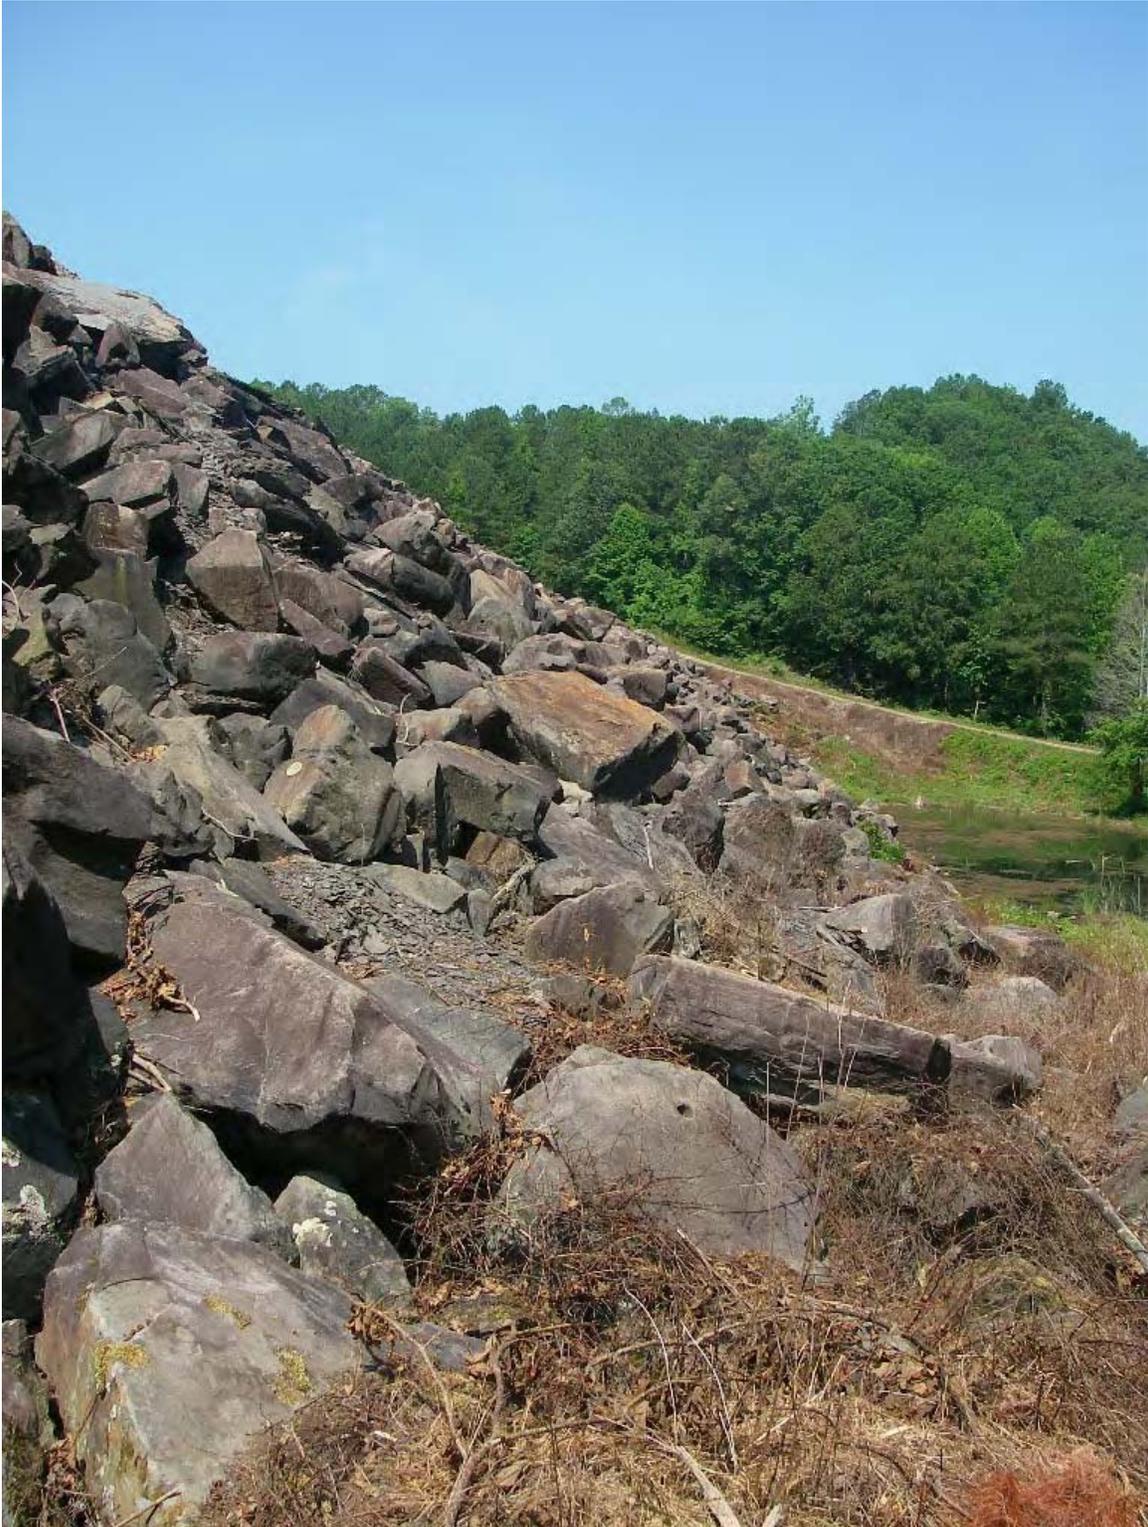
**PHOTO 19: APPROXIMATE SOURCE LOCATION OF SEEPAGE FROM
DOWNSTREAM TOE OF RATTLESNAKE DAM**

water in tractor ruts were noted in the cleared area downstream of the dam. All were seeps of clear water with no cloudiness or indication of soil movement and may have been hillside seepage from recent rainfall.

In conjunction with Recommendation No. 1, the existing weir box at the toe of the downstream slope of Rattlesnake Dam should be cleaned out and repositioned, or replaced with a larger weir if necessary, to collect the seepage flow along the downstream toe observed at the time of inspection. As much of the seepage currently visible should be collected as possible and the small ditch creating the current flow path should be kept as clear as possible to facilitate observations of changes in volume, turbidity, or location of new seeps. Such information, along with the flow measured at the box should be recorded as a part of Recommendation No. 1, so that seepage trends can be established and reviewed easily. In the event of increased seepage flows, the installation of additional instrumentation and a more involved monitoring program may be warranted.

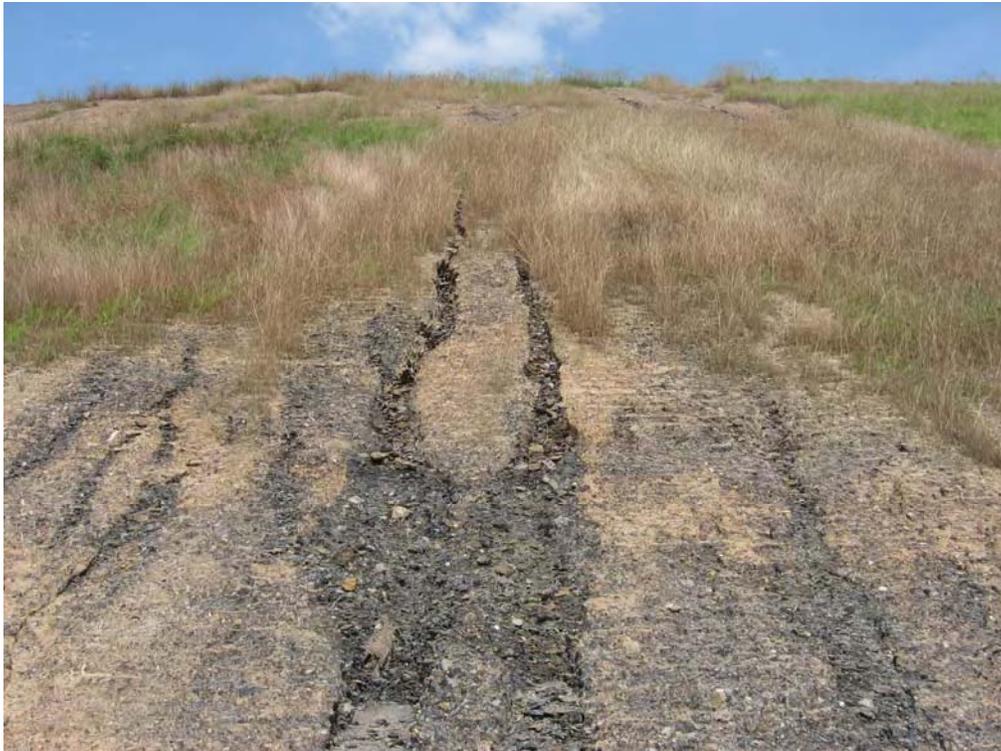
PHOTO 36: EROSION ON SLOPE BETWEEN ASH BASIN AND CLEAR POOL

The ponds were found to have smooth, even, well graded slopes with spotty vegetation on the exterior slopes. The lack of grass cover is attributed to the recent regional drought since the slopes were seeded after construction. This has resulted in areas of surface erosion on the slopes as shown in Photos 34, 35, and 36. According to Alabama Power personnel, repairs to the slope erosion and vegetation is scheduled for the near future. The erosion is not an immediate threat to the embankments, but should be addressed before it becomes a problem. The planned slope and vegetation repairs should help solve the threat.

It is recommended that the slopes between the gypsum storage cell and the clarification basins be reseeded or otherwise provided with good vegetative cover to prevent excessive raveling of the slopes. It is our understanding that Alabama Power has a plan in place to restore and establish cover on the slopes in the near future.

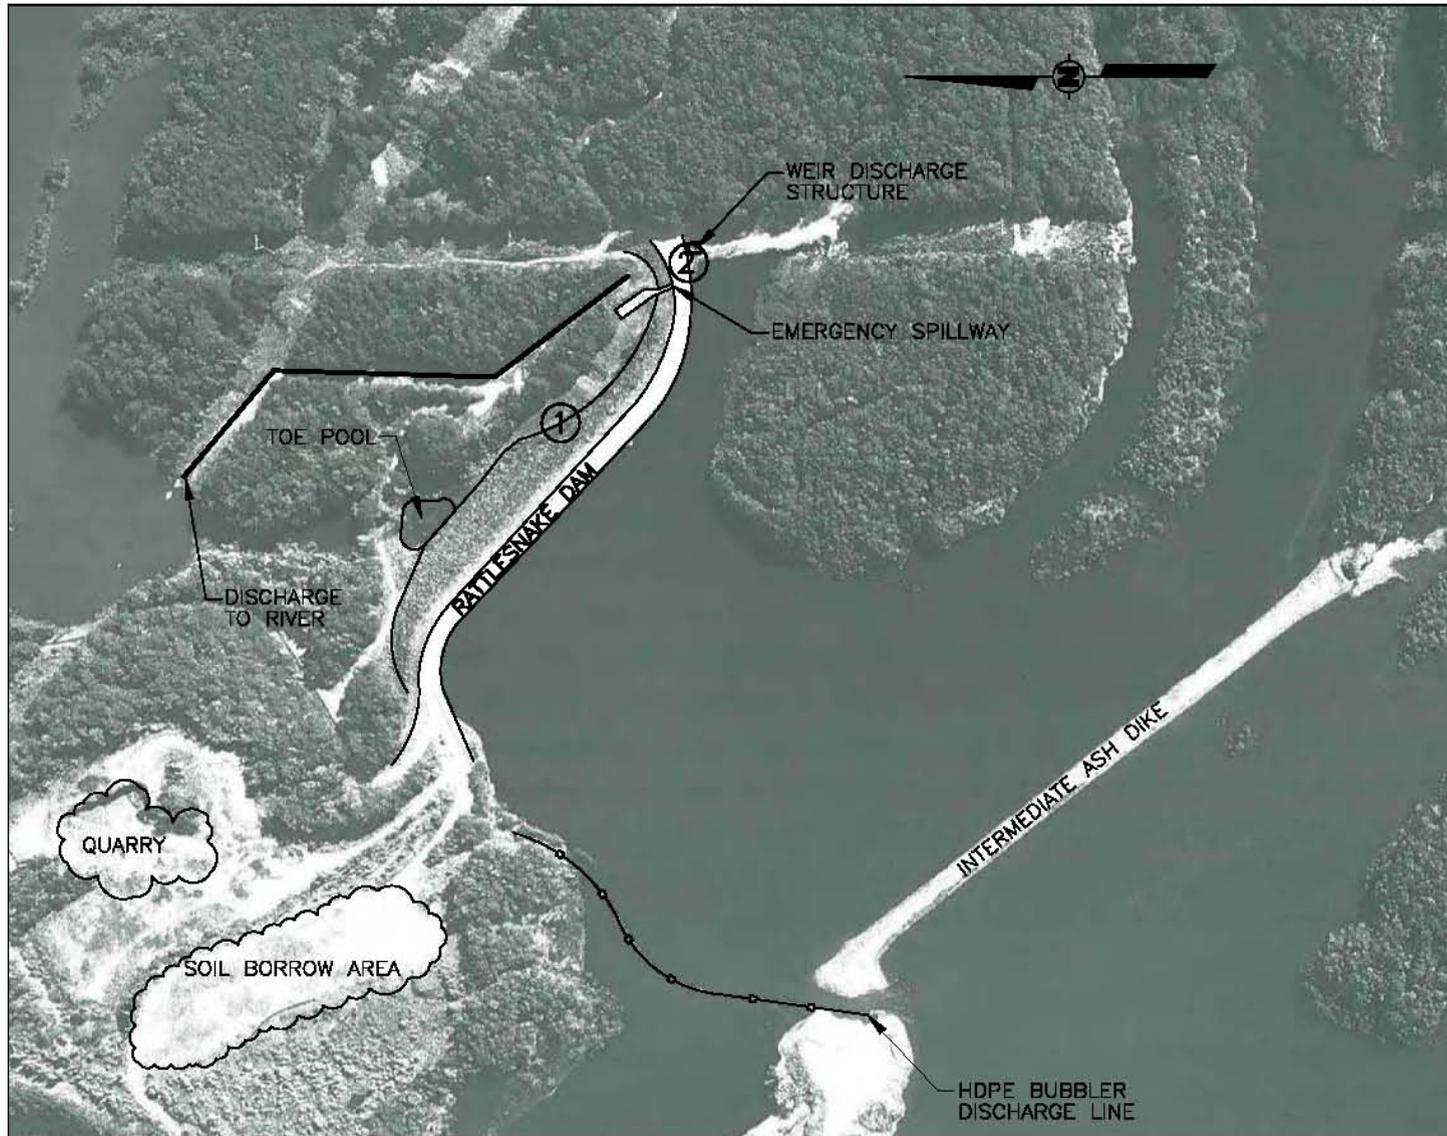
- ① APPROXIMATE LOCATION OF SEEPAGE FROM TOE.
- ② CRACKING IN RCC FACING BLOCK NOTED HERE.

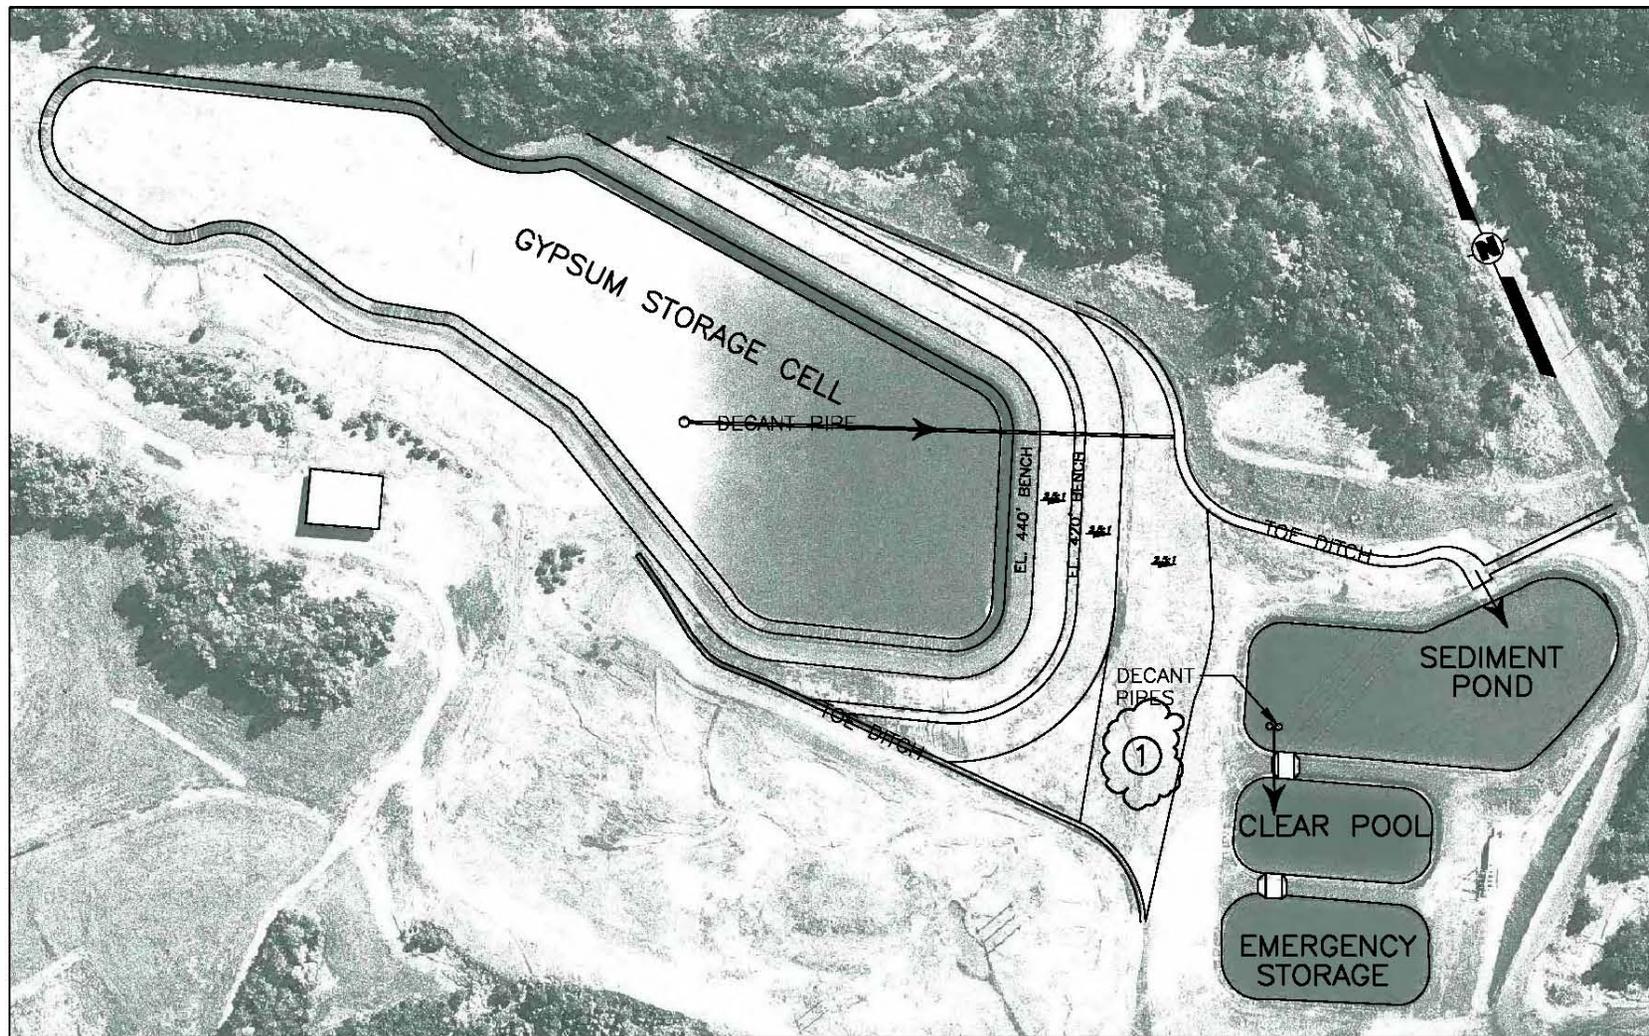
① AREA OF SLOPE EROSION CAUSED BY LACK OF VEGETATION.
