DRAFT FINAL
Coal Ash Impoundment
Specific Site Assessment
Report
Arizona Public Service
Cholla Power Plant

Submitted by:
GEI Consultants, Inc.
6950 South Potomac Street, Suite 300
Centennial, CO 80112

October 2009
Project 091330

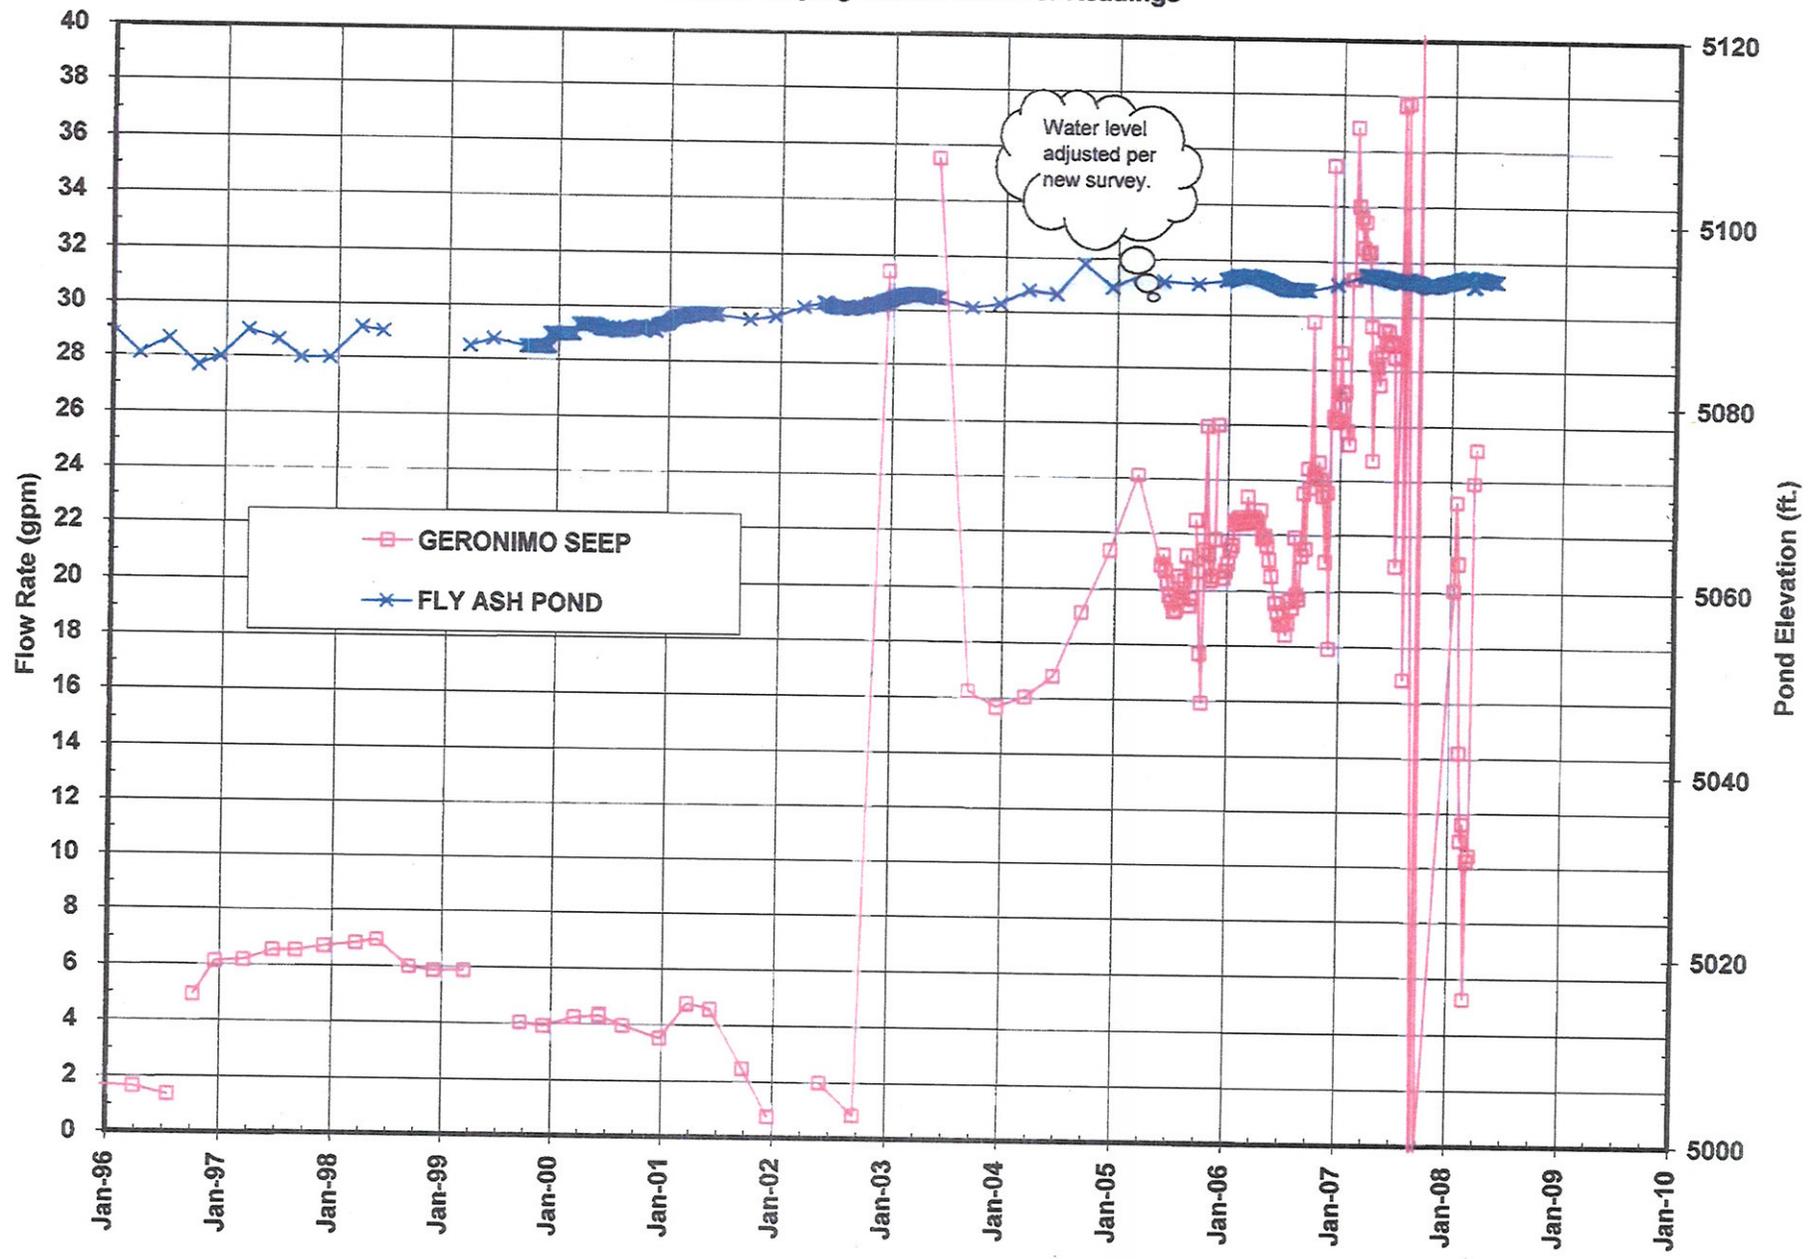
CHOLLA FLY ASH DAM

Seepage measured at the Geronimo totalizer was less than 8 gallons per minute (gpm) from the start of measurements in 1993 until 2003, when readings began to vary widely. After 2003, flows as high as 47 gpm were recorded, but the 2008 APS Dam Safety Inspection Report indicates that the equipment sometimes malfunctions and some of the readings are incorrect. A similar comment is made in the 1999 APS inspection report, which indicates that the totalizers will be replaced with more reliable mechanical flow meters. The situation does not appear to have been addressed. Similarly, the Hunt Seep Totalizer generally recorded less than 2 gpm from the start of measurements in 1997 until 2005, when its readings began to vary widely with seepage quantities up to 12 gpm recorded. However, APS personnel indicated that the Geronimo Seep readings are calculated based on the Hunt Seep readings, and therefore readings for both seeps may be affected when the totalizers malfunction.

The seepage totalizers at the Geronimo and Hunt Seeps show widely fluctuating readings with maximum seepage quantities up to 47 gpm at the Geronimo Seep and 12 gpm at the Hunt Seep. The Geronimo Seep is very close to the toe of the dam and therefore seepage quantities as high as 47 gpm could be of concern with regard to dam stability. APS should repair or replace the seepage totalizers as soon as possible to determine the actual quantity of seepage at the Geronimo Seep. If it is still relatively high, an investigation of the seepage origin should be undertaken and stability analyses completed in order to determine whether seepage of this magnitude could compromise dam stability. The turbidity measured in the Geronimo Seep has apparently been low since the equipment malfunction was corrected, but turbidity measurements should be closely monitored.

The instrumentation installed at the Fly Ash Pond Dam is thorough and considered adequate. The frequency of readings is also adequate. The totalizers at the Geronimo and Hunt Seeps should be repaired so they can again provide a reliable measure of seepage.

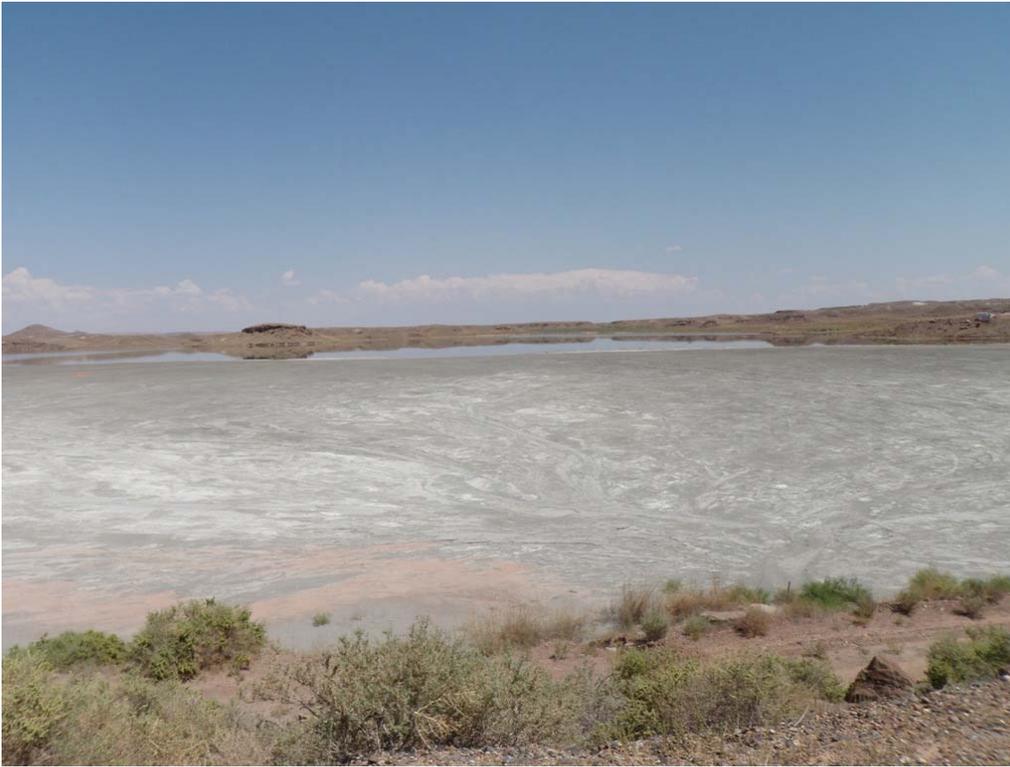
Field assessment of the Fly Ash Pond included driving around the pond and along the entire length of the embankment crest and toe, walking representative sections and closely investigating areas of interest. We saw no obvious signs of settlement or displacement. Several seepage locations were observed at and beyond the downstream toe of the dam. These are closely monitored by APS and are discussed further in Section 6.4.4. A general photo of the Fly Ash Pond is shown in Photo 1.

Photo 1 –Fly Ash Pond: Overview looking north from embankment. Note downstream fly ash beach.

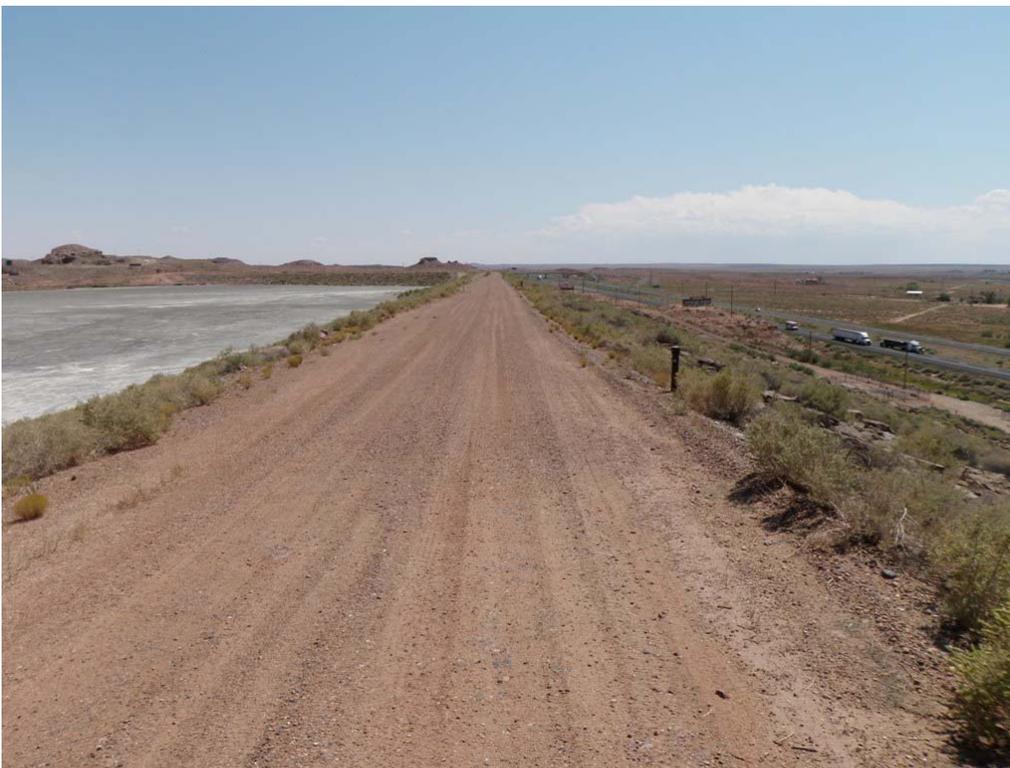
The embankment crest appeared to be in good condition (Photo 2). No signs of cracking or settlement were observed during the assessment. Occasional vegetation (brush) was present on the dam crest. This vegetation should be cleared in routine maintenance. Settlement monitoring points (Photo 3) and piezometers (Photo 4) are present along the dam crest.

Photo 2 –Fly Ash Pond Dam: Crest of embankment with dirt road, looking east.

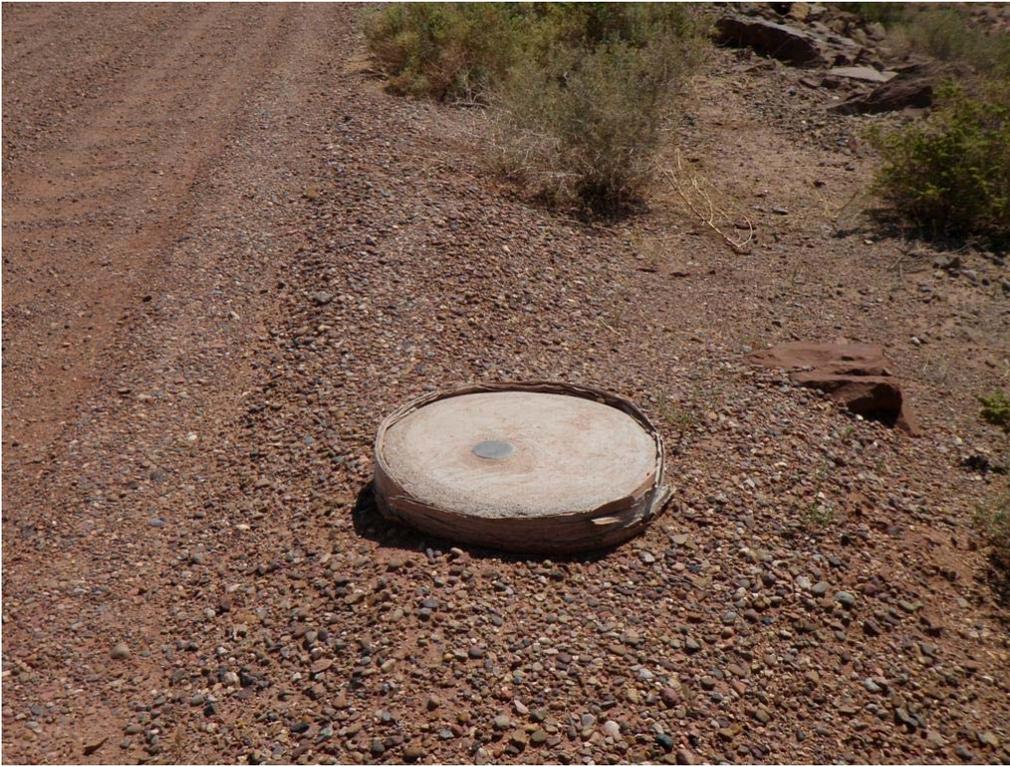
Photo 3- Movement monument on Fly Ash Pond Dam.

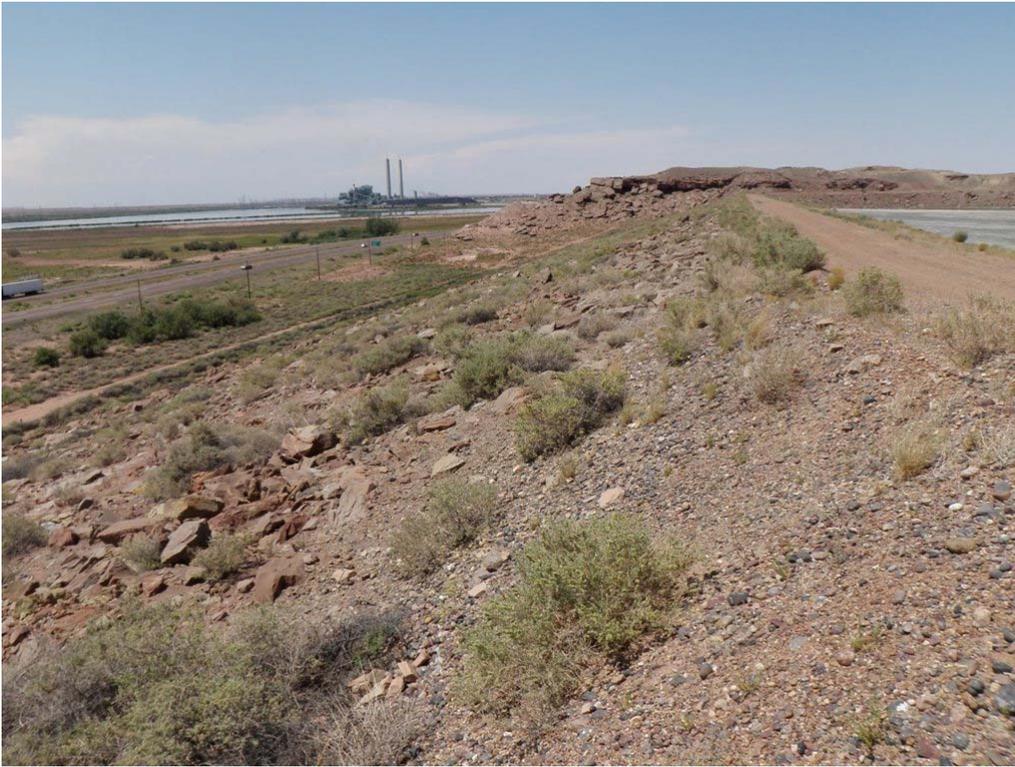
The downstream slope of the embankment is protected from erosion by riprap and appeared to be in good condition, though the riprap is eroding in some areas (Photo 7). Some vegetation was present on the downstream slope. The slurry discharge pipes traversing the downstream face are shown in Photo 8.

Photo 7 – Fly Ash Pond Dam: Downstream slope, looking west. Note vegetation and riprap erosion.

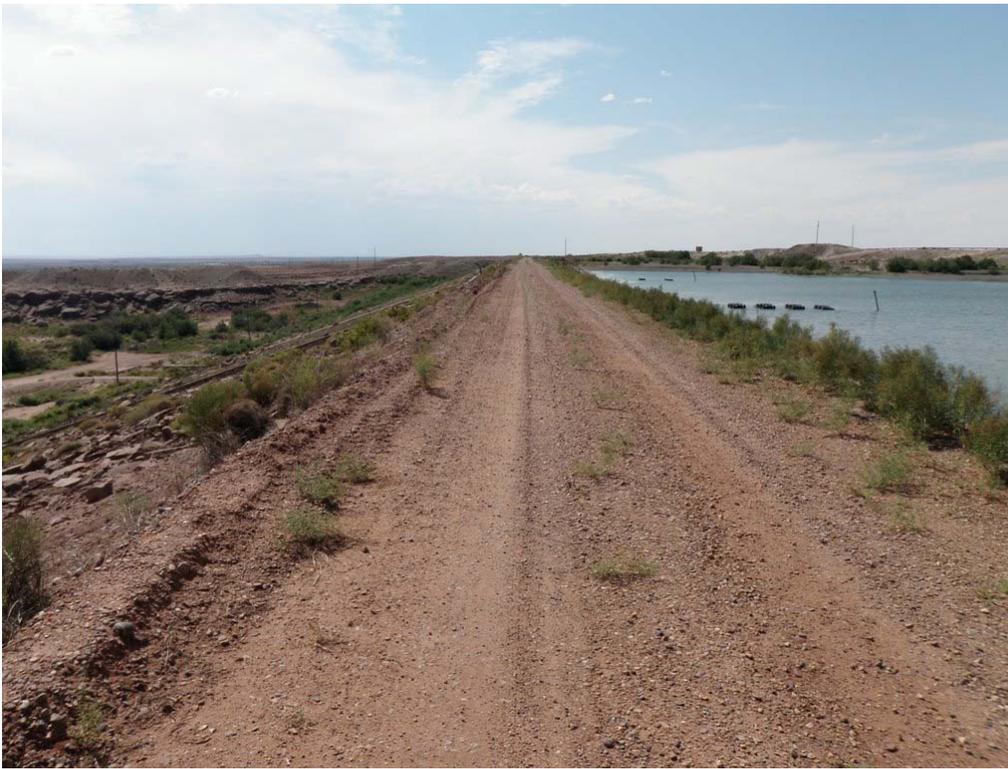
The embankment crest appeared to be in good condition (Photo 15). No signs of cracking or settlement were observed during the assessment. Occasional vegetation (brush) was present on the dam crest. This vegetation should be cleared in routine maintenance. The 3.3-foot dam crest raise that took place in 1993 is evident in Photo 16.

Photo 15 – Bottom Ash Pond Dam: Crest of embankment with dirt road, looking west.

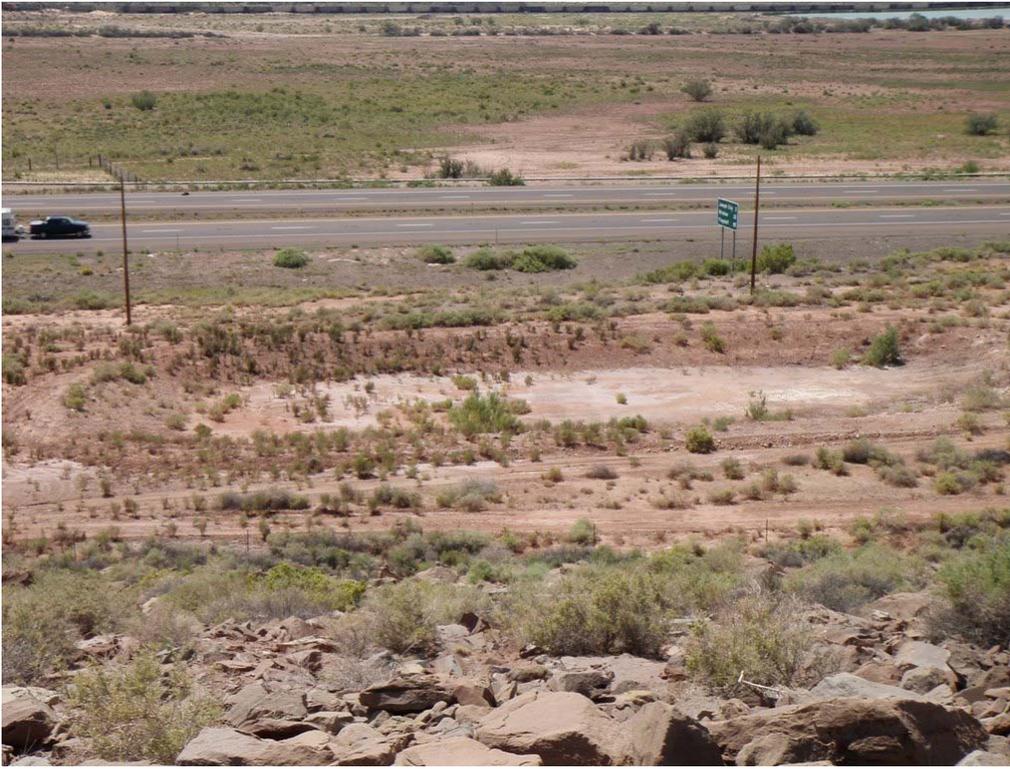
Photo 21 – Fly Ash Pond: Evaporation Pond for I-40 Seep.

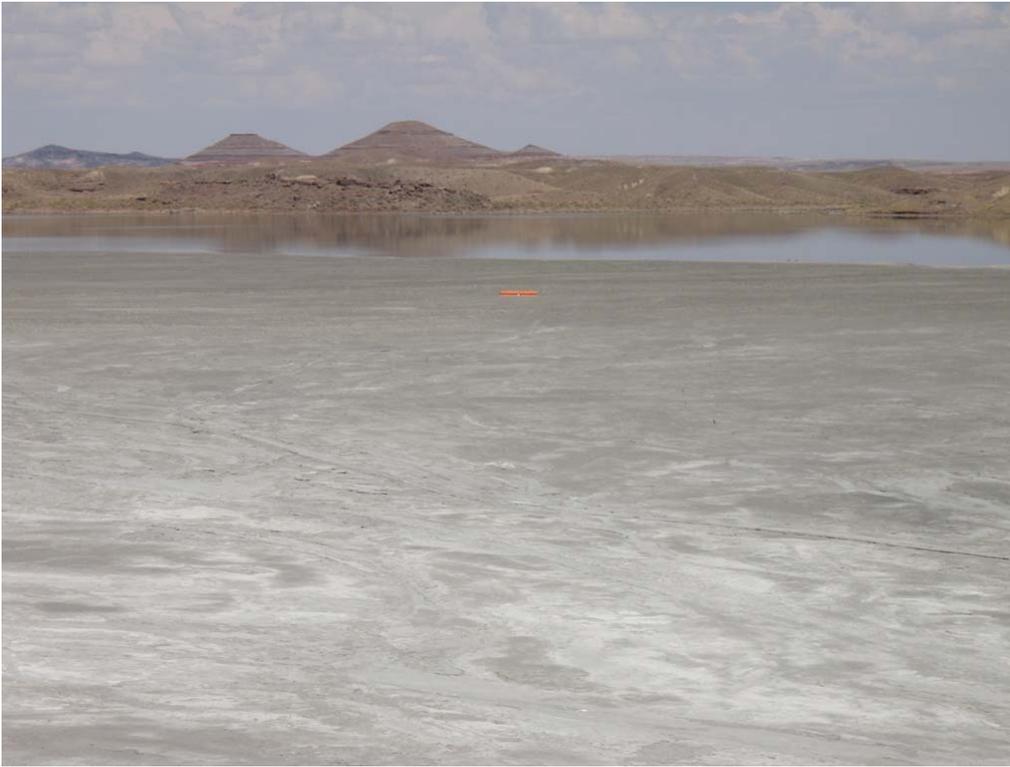
Photo 35 – Fly Ash Pond: Buoy marking 300-foot distance from area where cracks were observed in embankment crest. Fly ash beach must extend upstream of this distance.

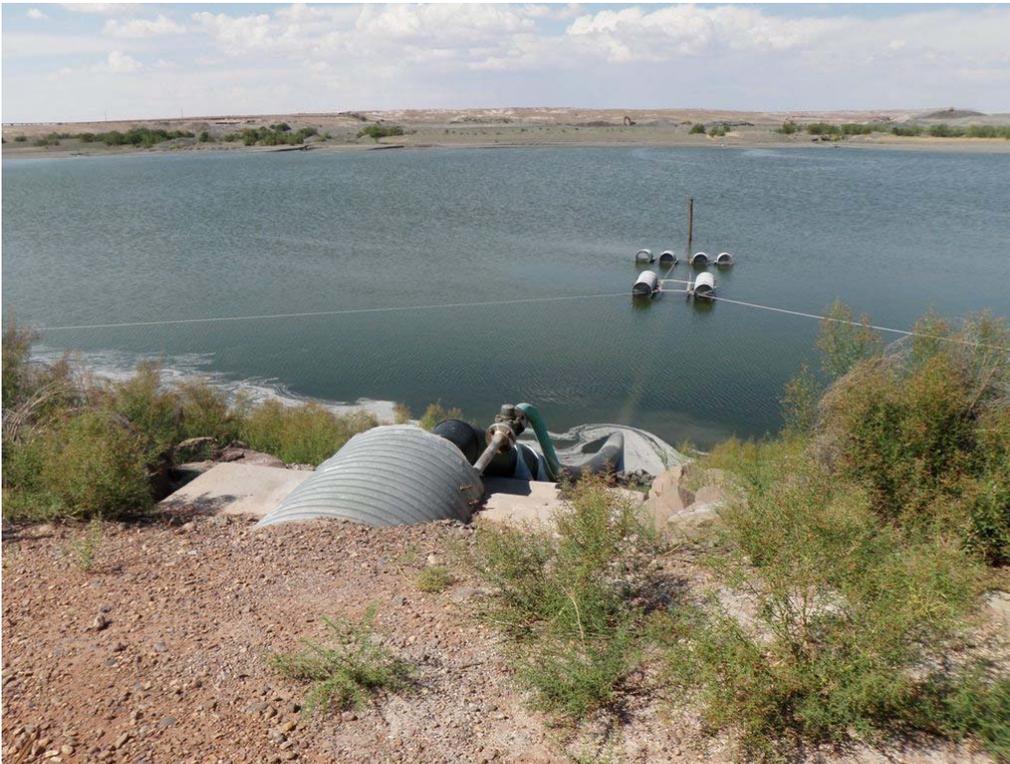
Photo 36 – Bottom Ash Pond: Floating siphon pipes to return water from main reservoir to power plant – upstream side of dam.
