**Specific Site Assessment for  
Coal Combustion Waste  
Impoundments at Basin  
Electric Leland Olds  
Generating Station**

**Stanton, North Dakota**

October 2010

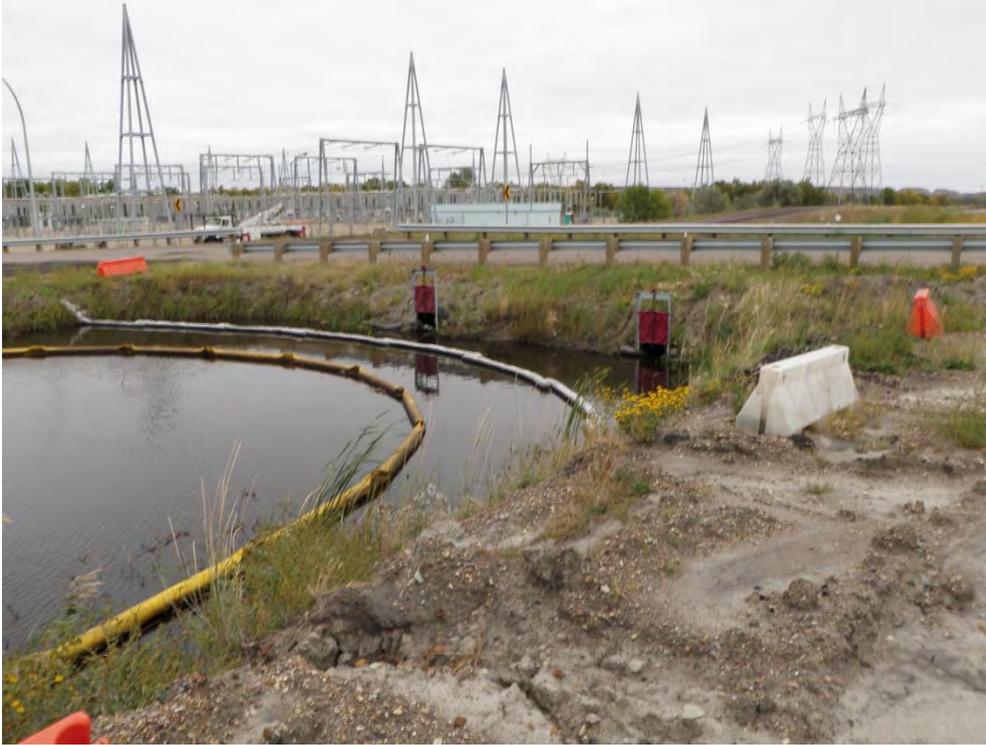
Photo 1: Coal Yard Stormwater Detention Pond, showing gates leading to Drainage Ditch.

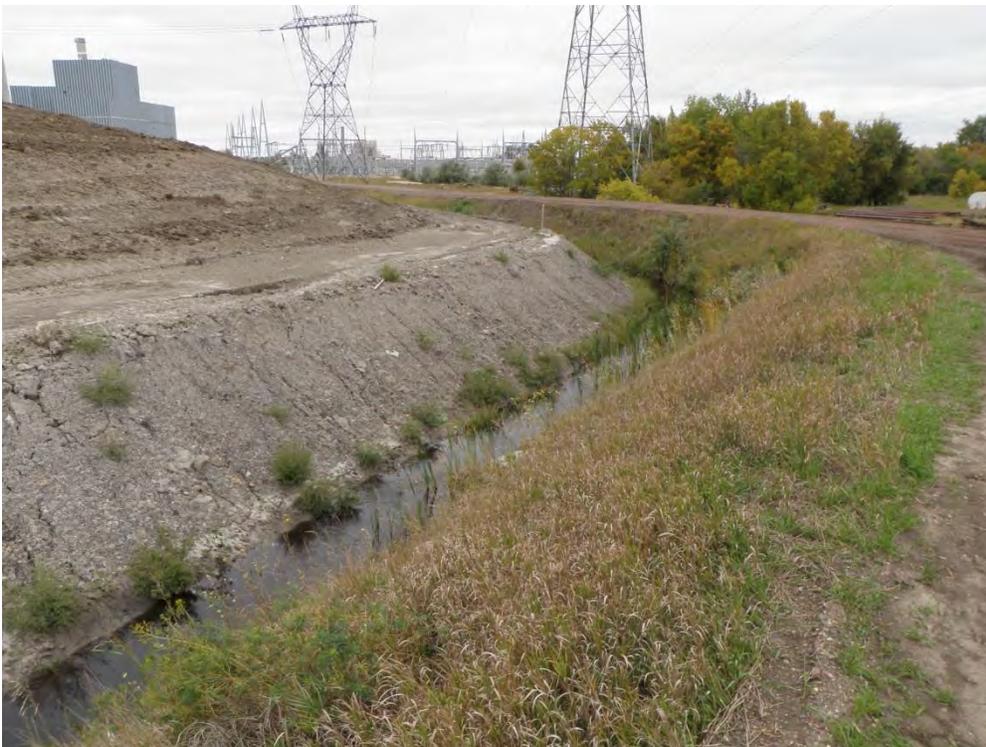
- The three CCW impoundments were generally observed to be in good condition in the field assessment.
- There is minor erosion of the north dike of Ash Pond #1 and currently does not have erosion protection installed.

Photo 2: Coal Yard Drainage Ditch showing north dike of Ash Pond #1 dry ash storage on left.

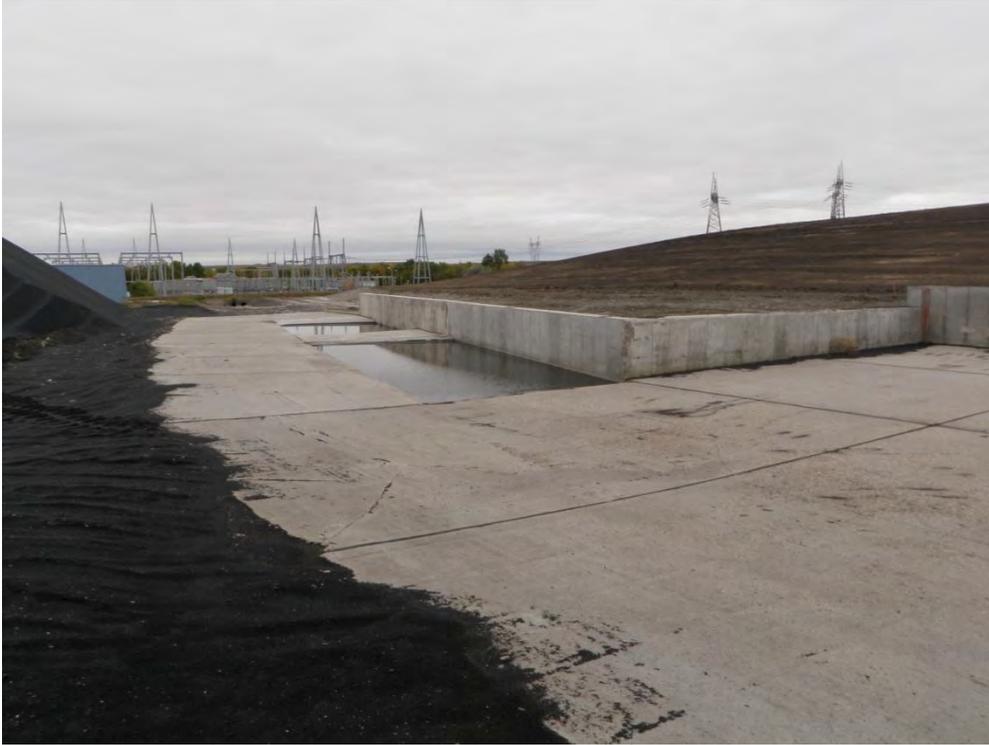
Photo 3: Ash Pond #1: Concrete containment structure for saleable dry ash.

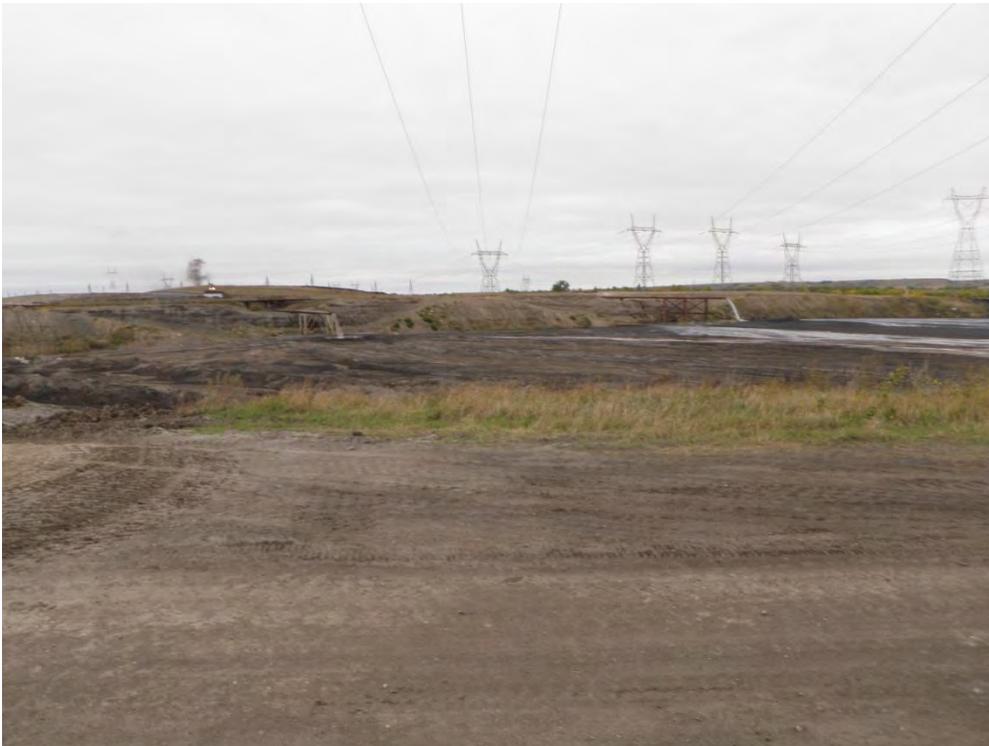
Photo 4: Ash Pond #2: Elevated pipes sluicing ash and water from plant into pond.

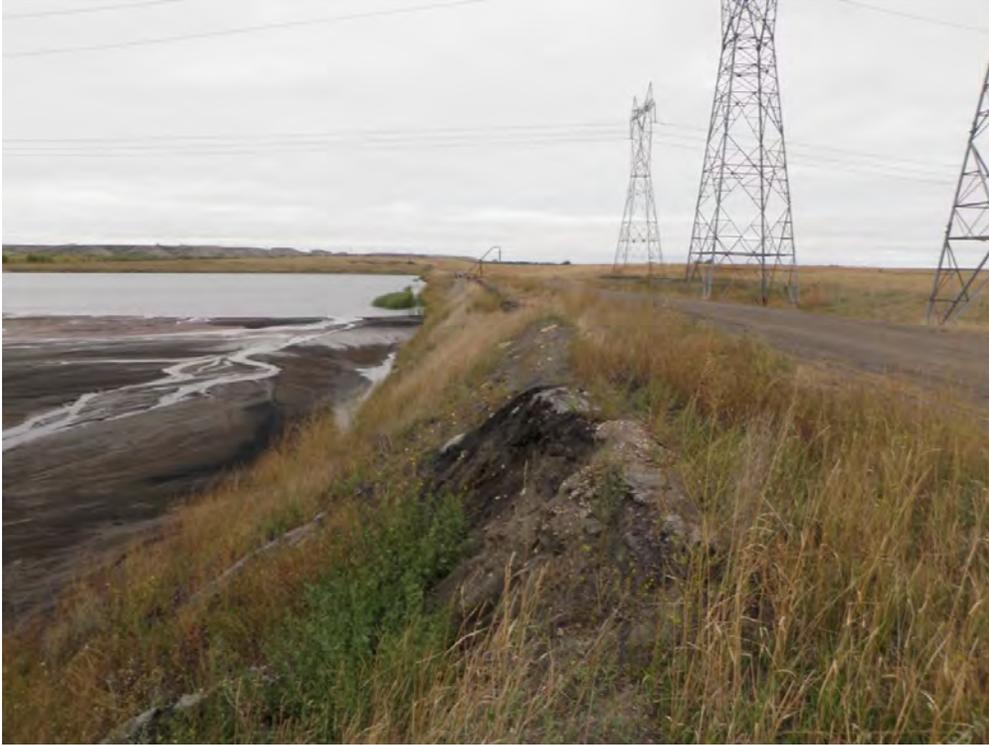
Photo 5: Ash Pond #2 – View of south perimeter dike looking east.

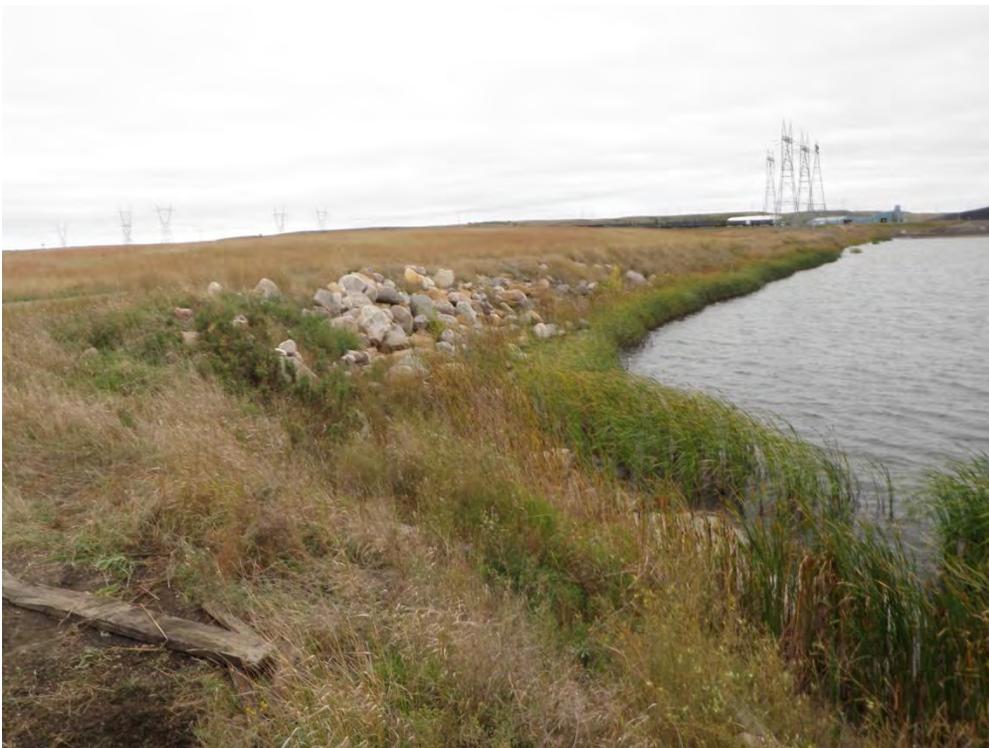
Photo 6: Ash Pond #2 – Grassy vegetation and riprap in southeast corner of pond.

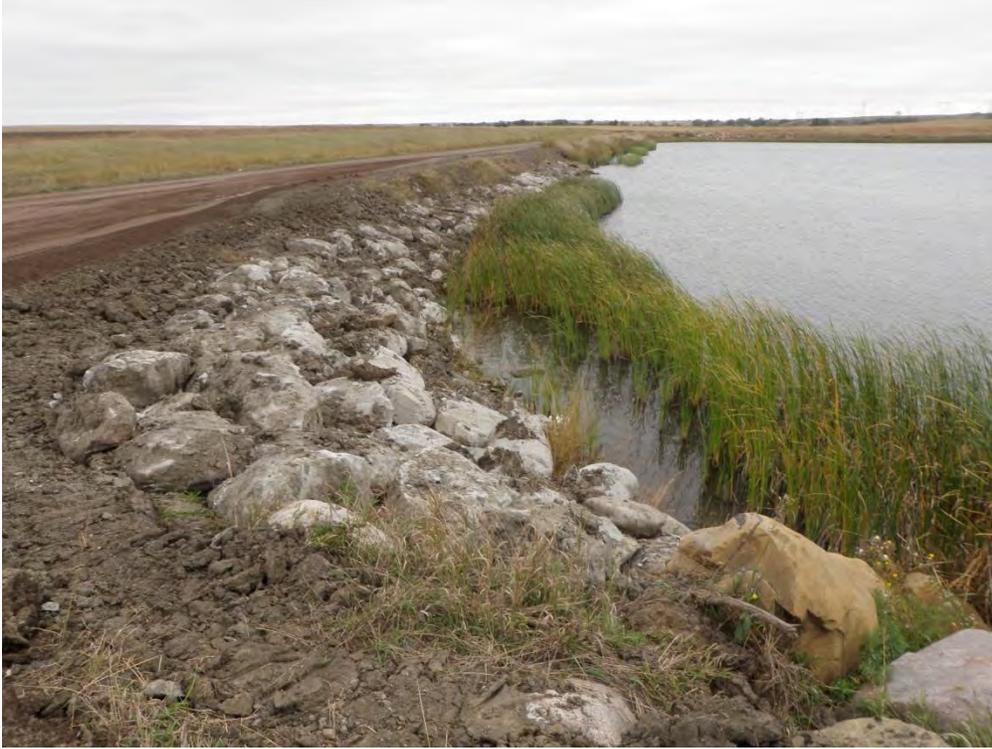
Photo 7: Ash Pond #2 – New riprap placed in northeast corner of pond.

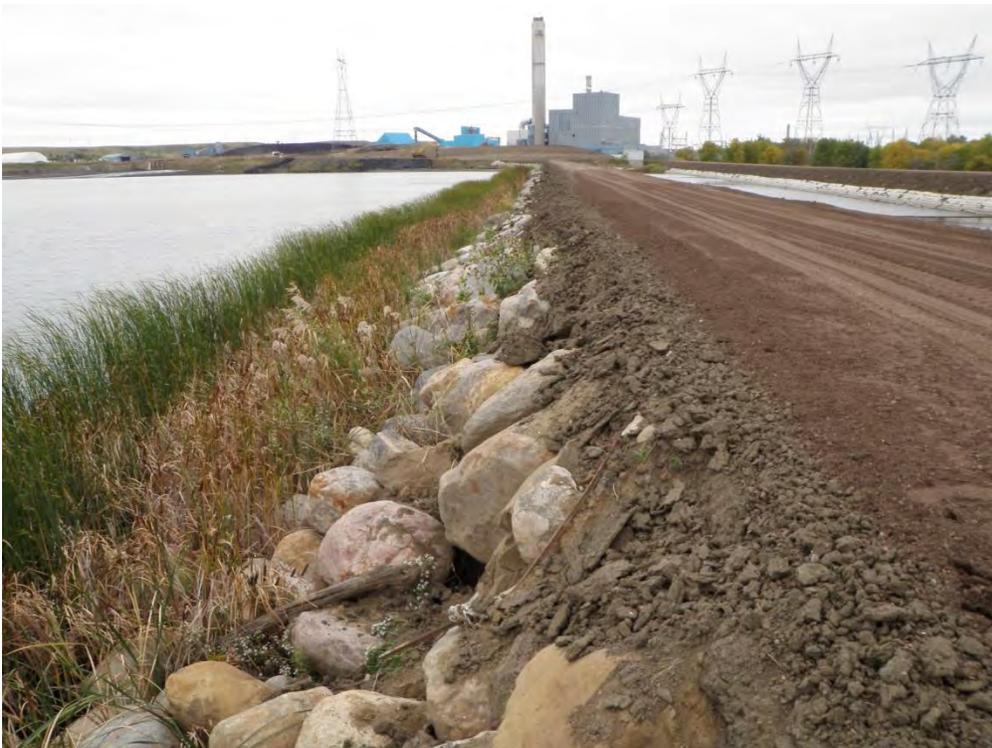
Photo 8: Ash Pond #2 – New riprap along north dike between Ash Ponds #2 and #3. Ash Pond #3 is shown on the right.

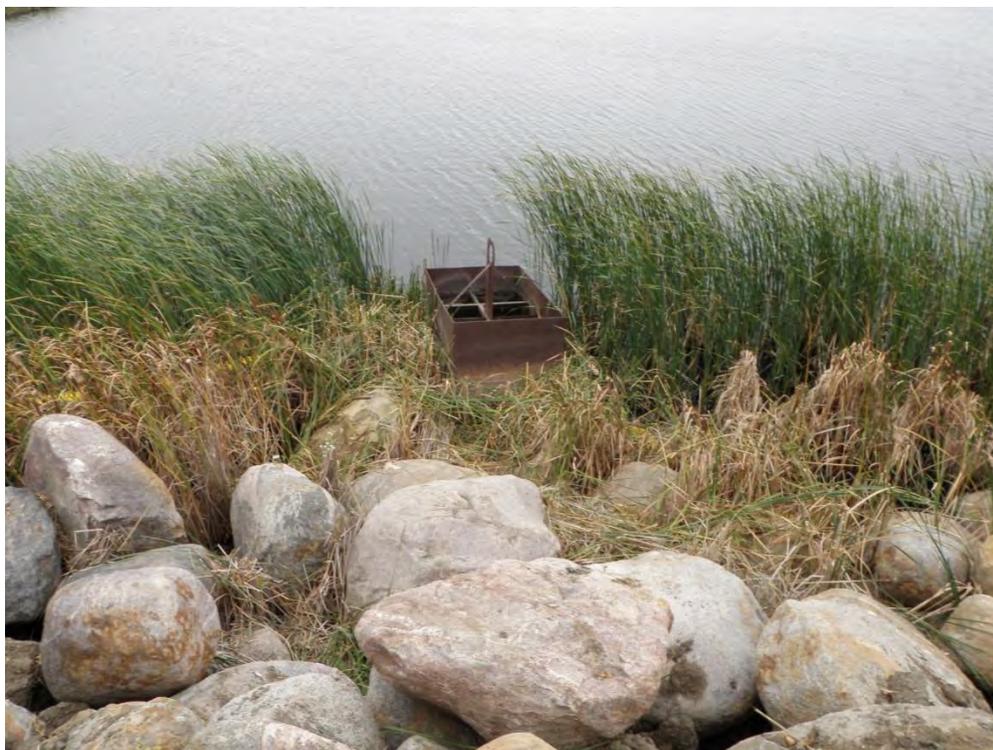
Photo 9: Ash Pond #2 – Decant structure on outlet pipe to Ash Pond #3.

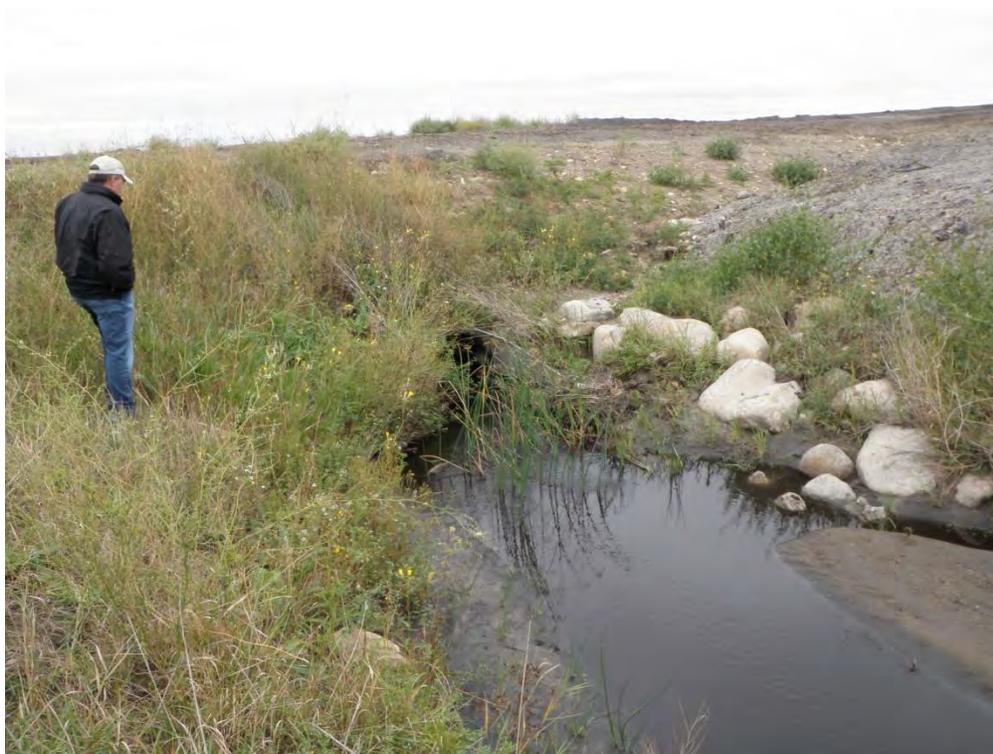
Photo 10: Ash Pond #2 – Outlet from Coal Yard Drainage Ditch to Ash Pond #2, showing drainage ditch in foreground.

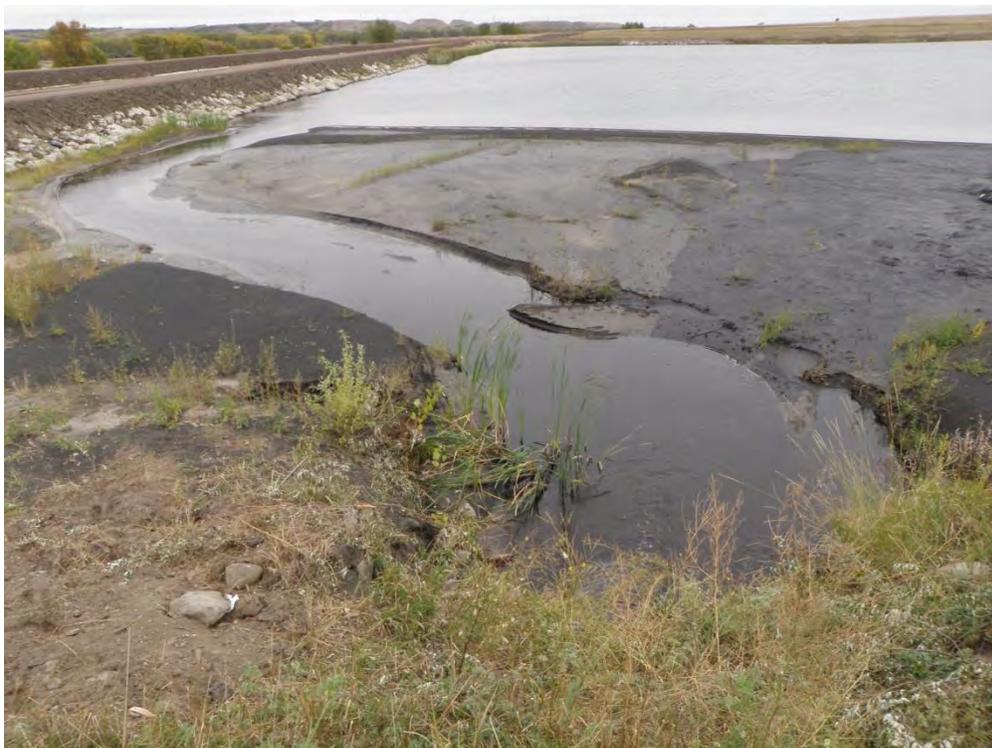
Photo 11: Ash Pond #2 – Outlet from Coal Yard Drainage Ditch to Ash Pond #2, showing northwest corner of Ash Pond #2.

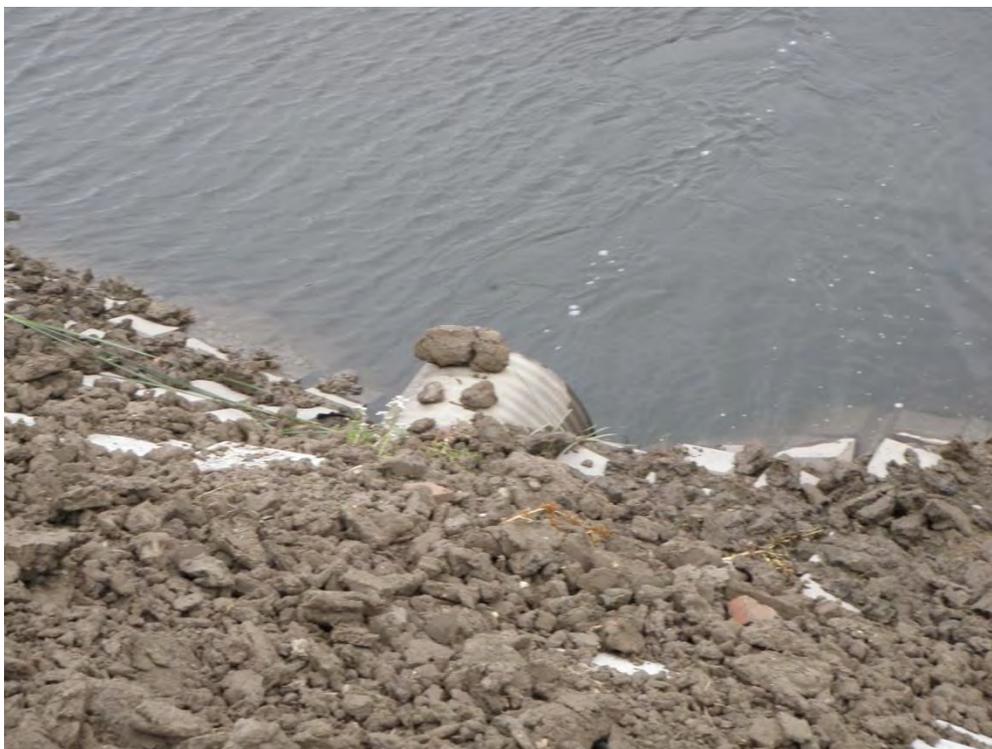
Photo 12: Ash Pond #3 – Outlet pipe from Ash Pond #2.

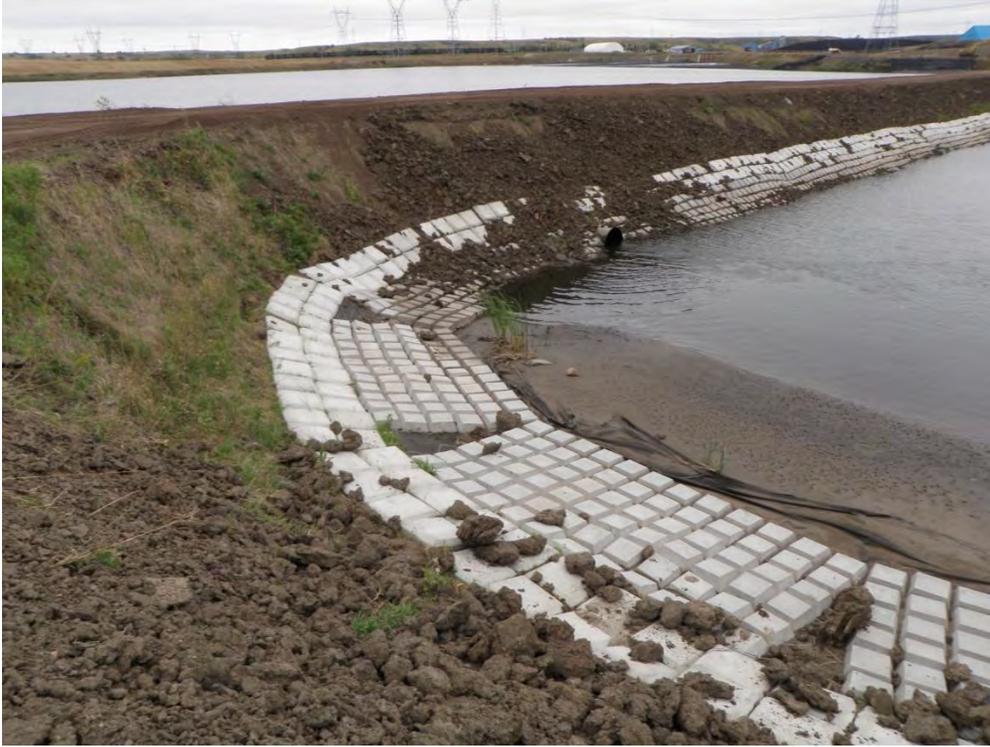
Photo 13: Ash Pond #3 – Cellular concrete mats installed at the upstream toe of the pond.

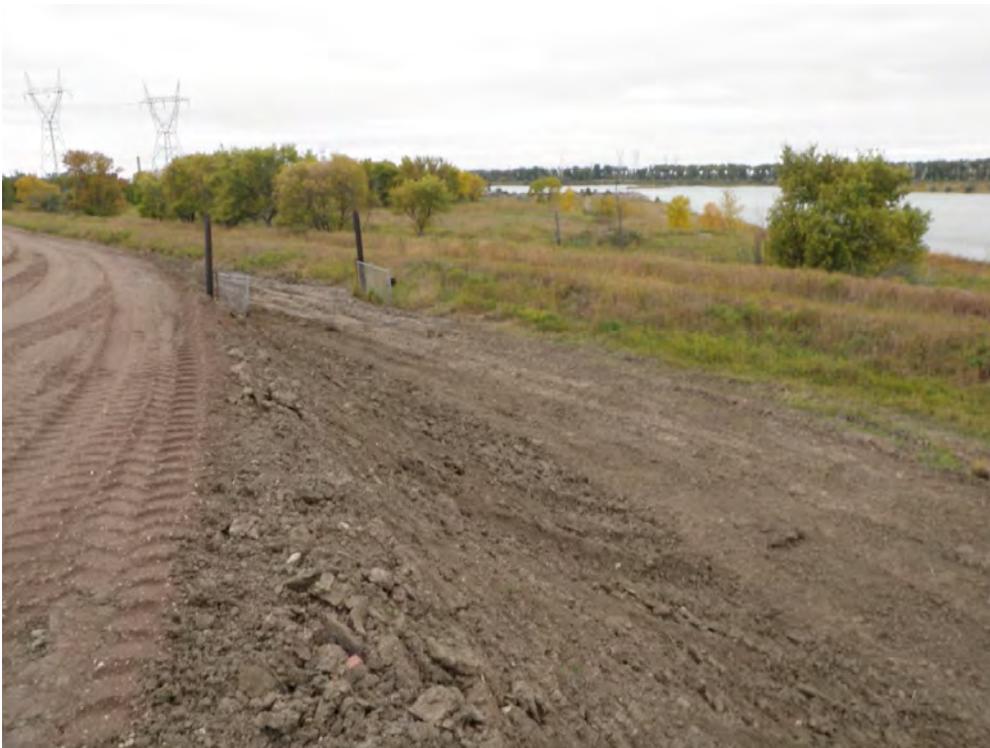
Photo 14: Ash Pond #3 – Re-graded perimeter dike at northeast corner of pond, showing Missouri River in background.

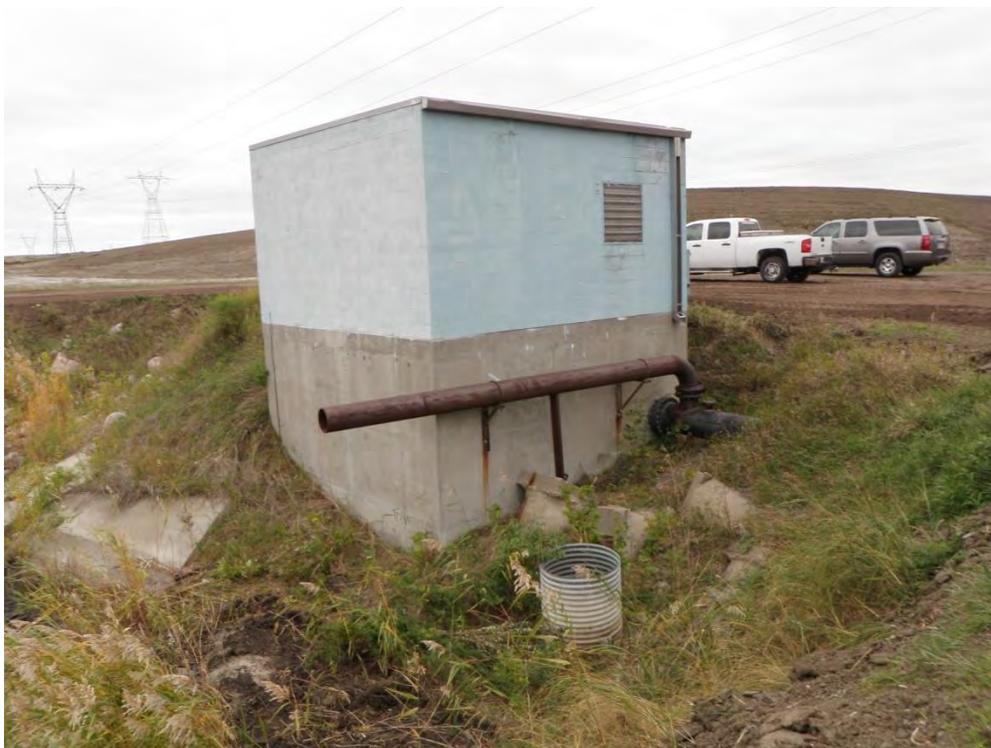
Photo 15: Ash Pond #3 – Pumphouse at the west edge of Ash Pond #3.

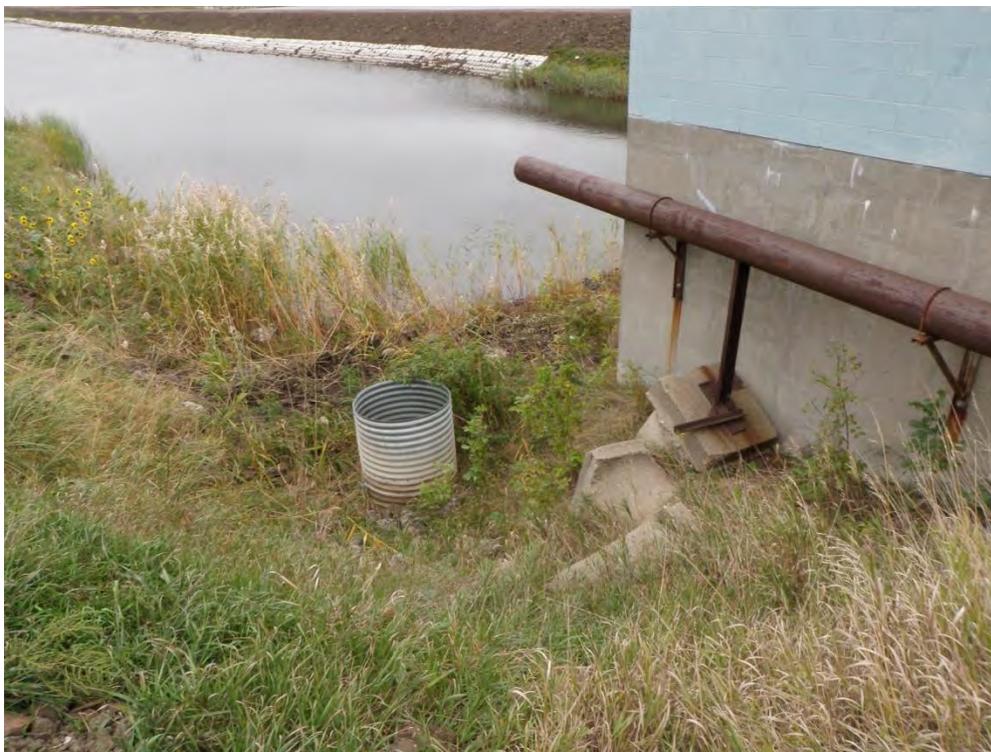
Photo 16: Ash Pond #3 – Decommissioned riser in northwest corner of pond, adjacent to pumphouse.
