**Dam Safety Assessment of CCW
Impoundments**

**Reid/Green/HMP&L Station II
Report**

**Lockheed Martin
Contractor for the USEPA**

December 2009

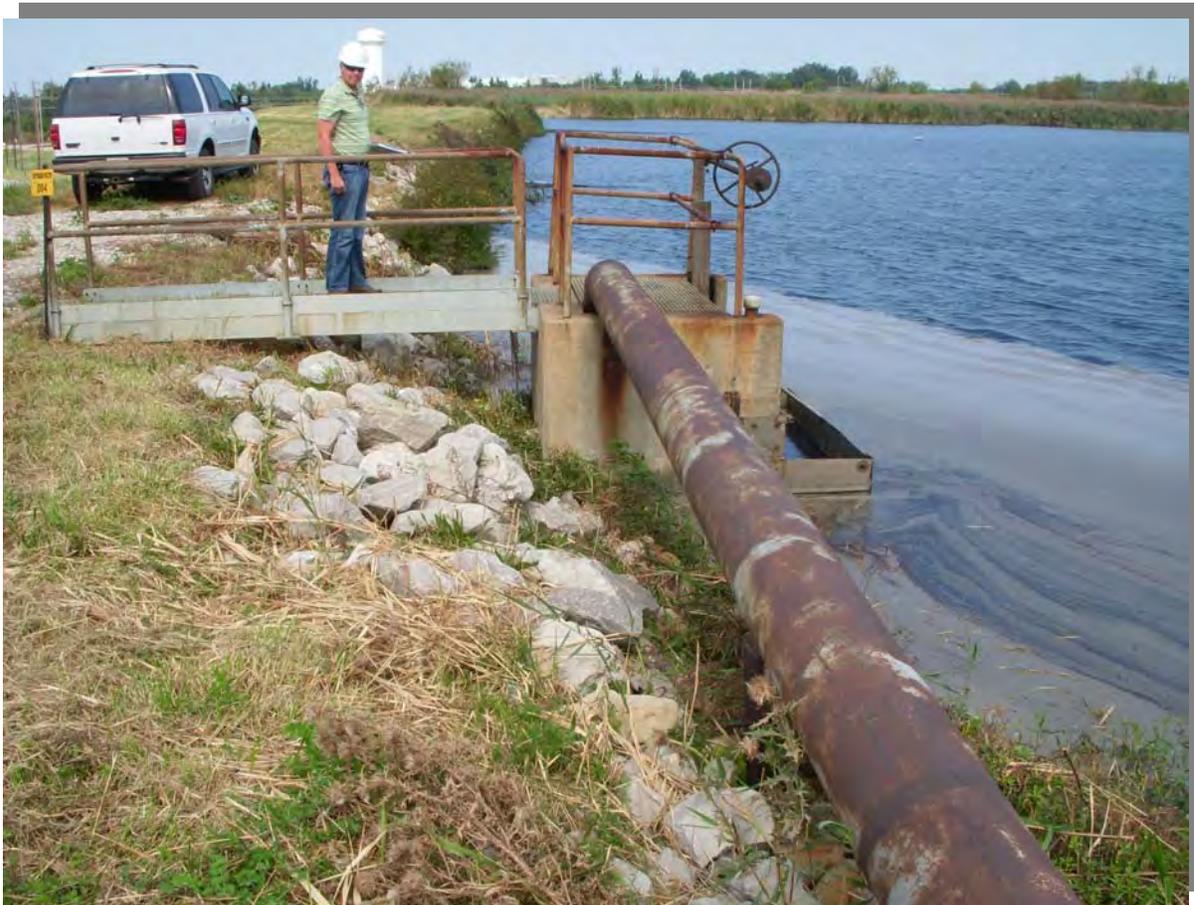
- Vegetative cover on the eastern outboard slope is poor, and is experiencing erosion problems, as a result. We also understand that portions of the eastern outboard slope along the cooling towers were excavated to a relatively steep grade to provide crane access between the cooling tower and the toe of slope (Appendix B – Photo 7).
- A mature willow tree is growing on the eastern crest and/or inboard slope.
- The outlet structure appeared to be in good condition and functioning normally (Appendix B – Photo 1).

Photo 1 – View of pond outlet structure

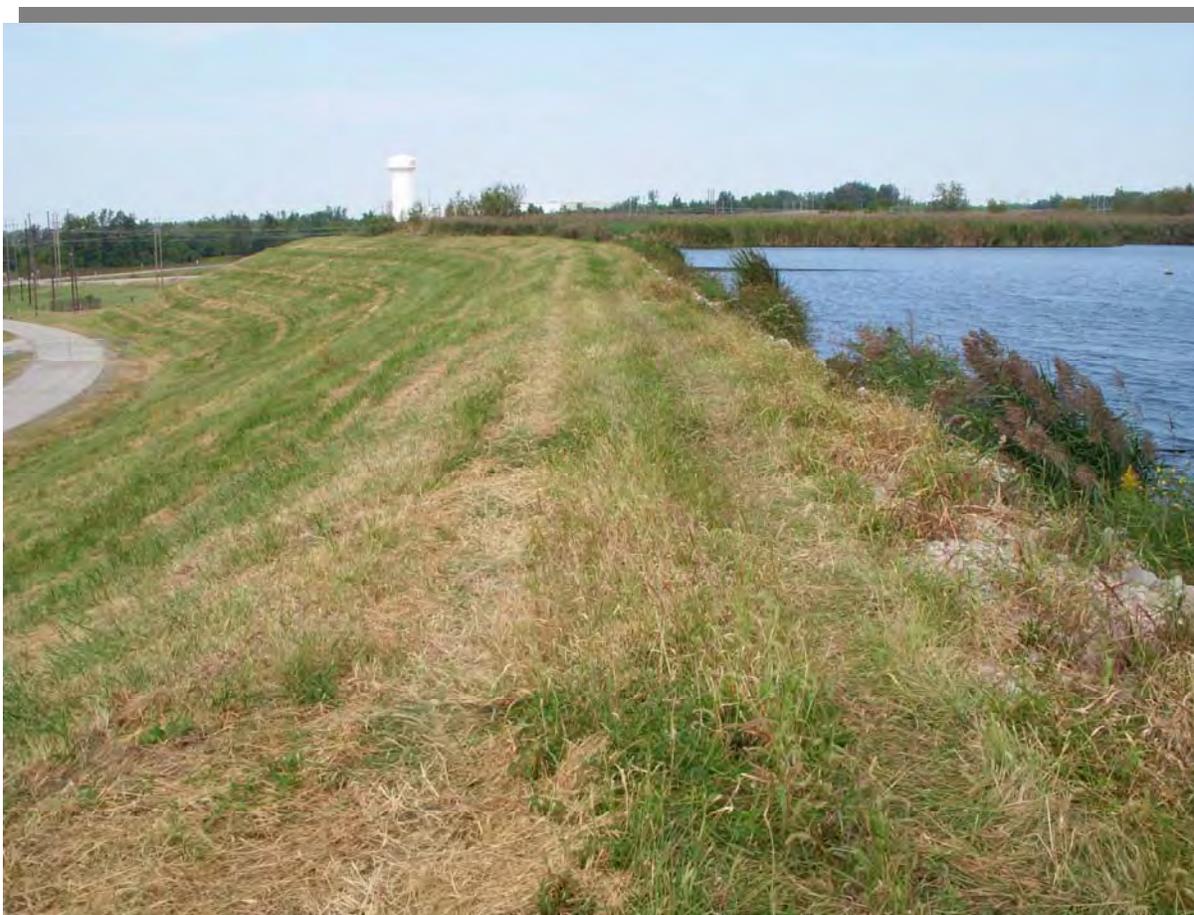
Photo 2 – View of south dike crest looking west.

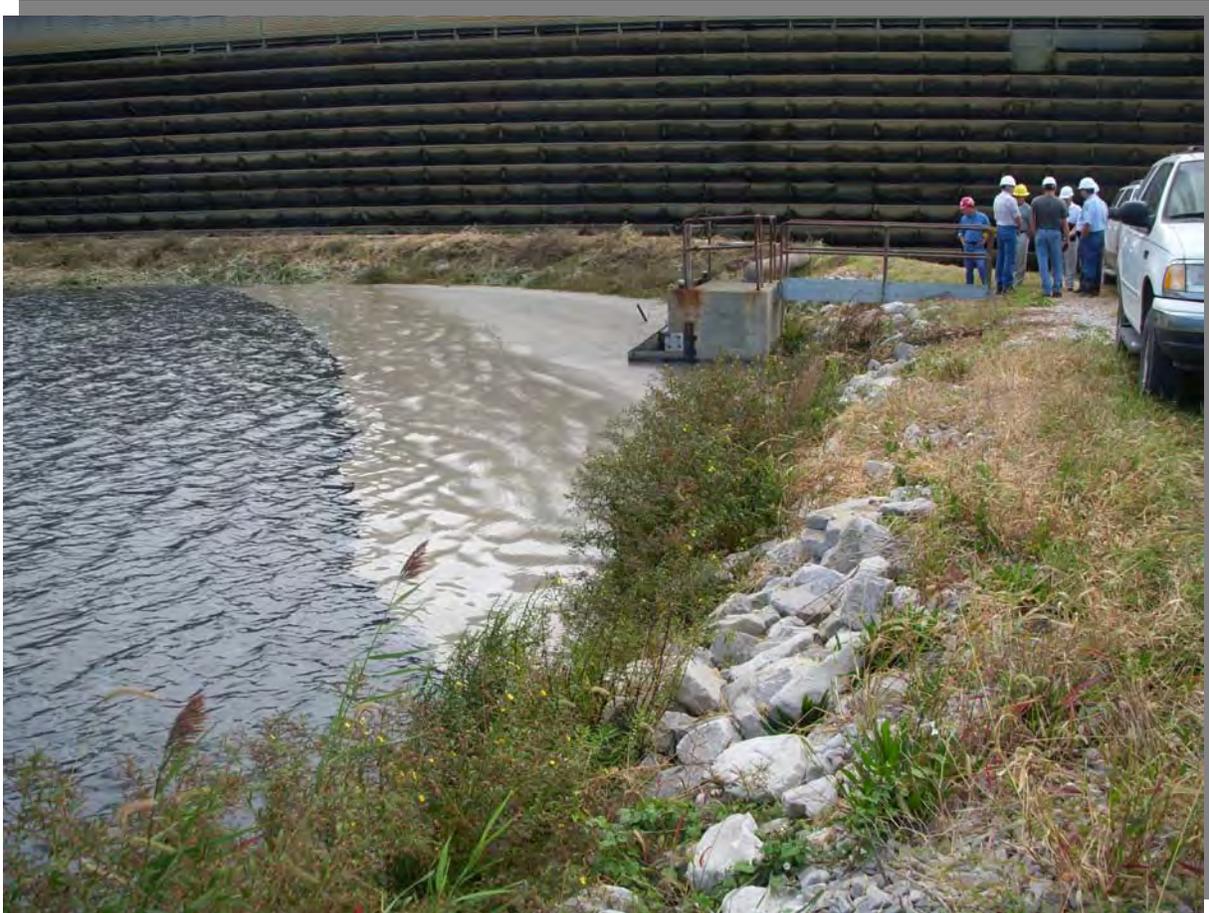
Photo 3 – View along inboard slope of south dike looking east. Note riprap armoring.

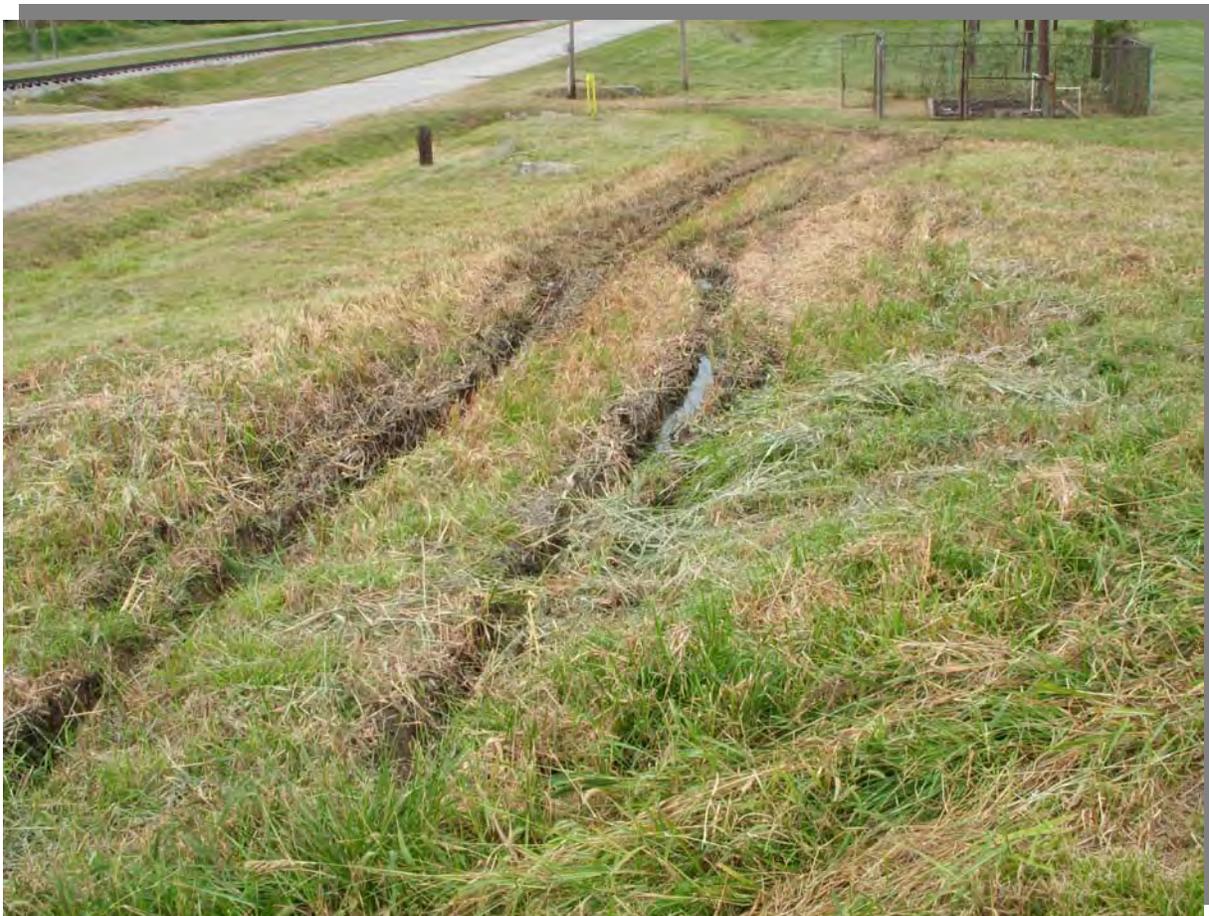
- The outboard slope and crest were covered with well maintained grass. The crest has been rutted by the mowing tractor in a few isolated locations.
- Minor seepage was evident along the toe of the outboard southern and western slopes. The seepage rate was very low with no discernible flow. Seepage was observed to accumulate in rutted areas at the toe of slope created by the mowing tractor. The seepage is believed to be controlled discharge from the sand toe drain.

Photo 4 – Seepage and rutting along south outboard toe.

- Outboard toe – re-grade the swale along the toe to improve drainage. The swale may need to be lined with alternate materials, such as crushed stone or concrete to alleviate the soft soil condition. Consider installing a V-notch weir to monitor seepage flow rate. Remove wooden poles and fill with compacted material consistent with the dike design. We understand that the utility is planning to re-grade the swale to improve drainage, and will consider installing a weir.

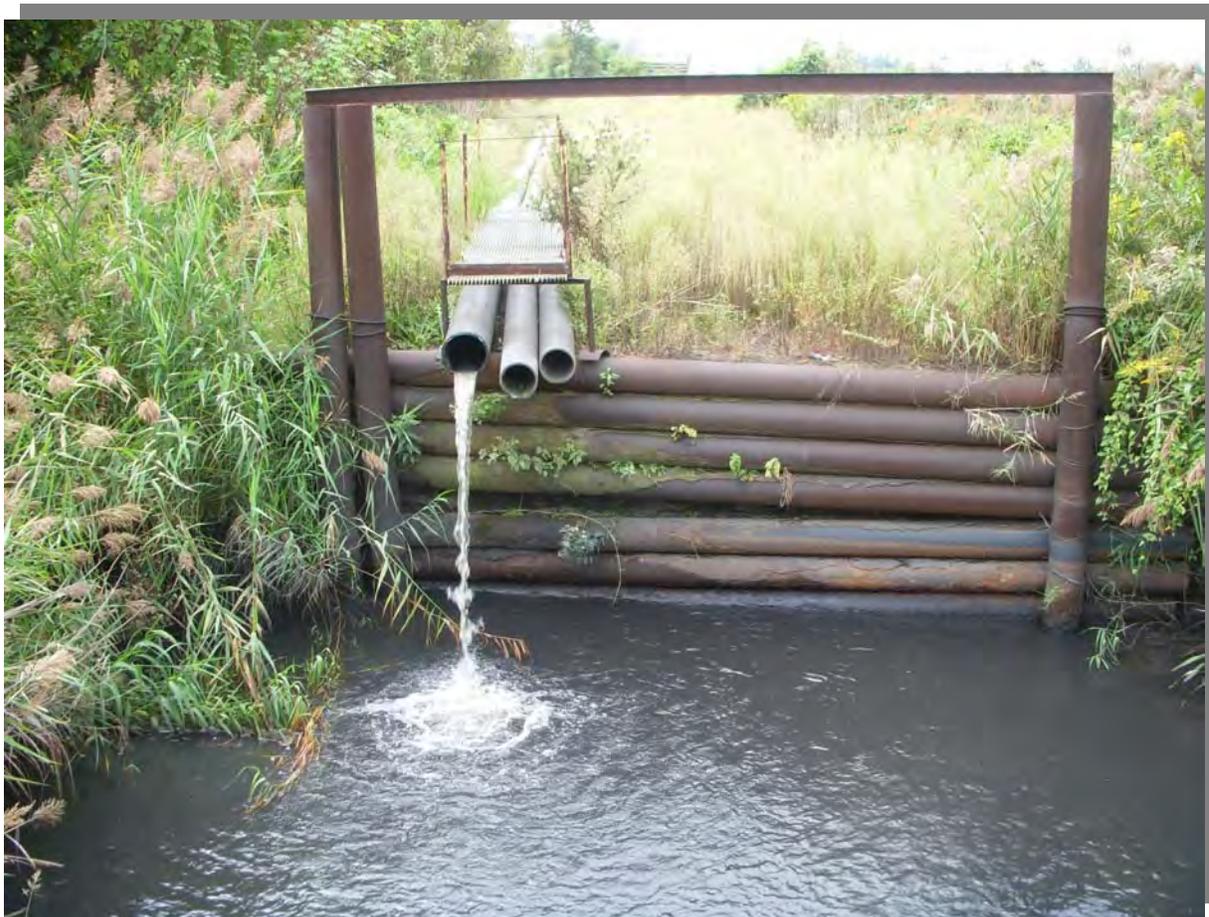
Photo 5 – Influent pipe discharging into northern ditch that parallels a portion of the northern inboard slope.

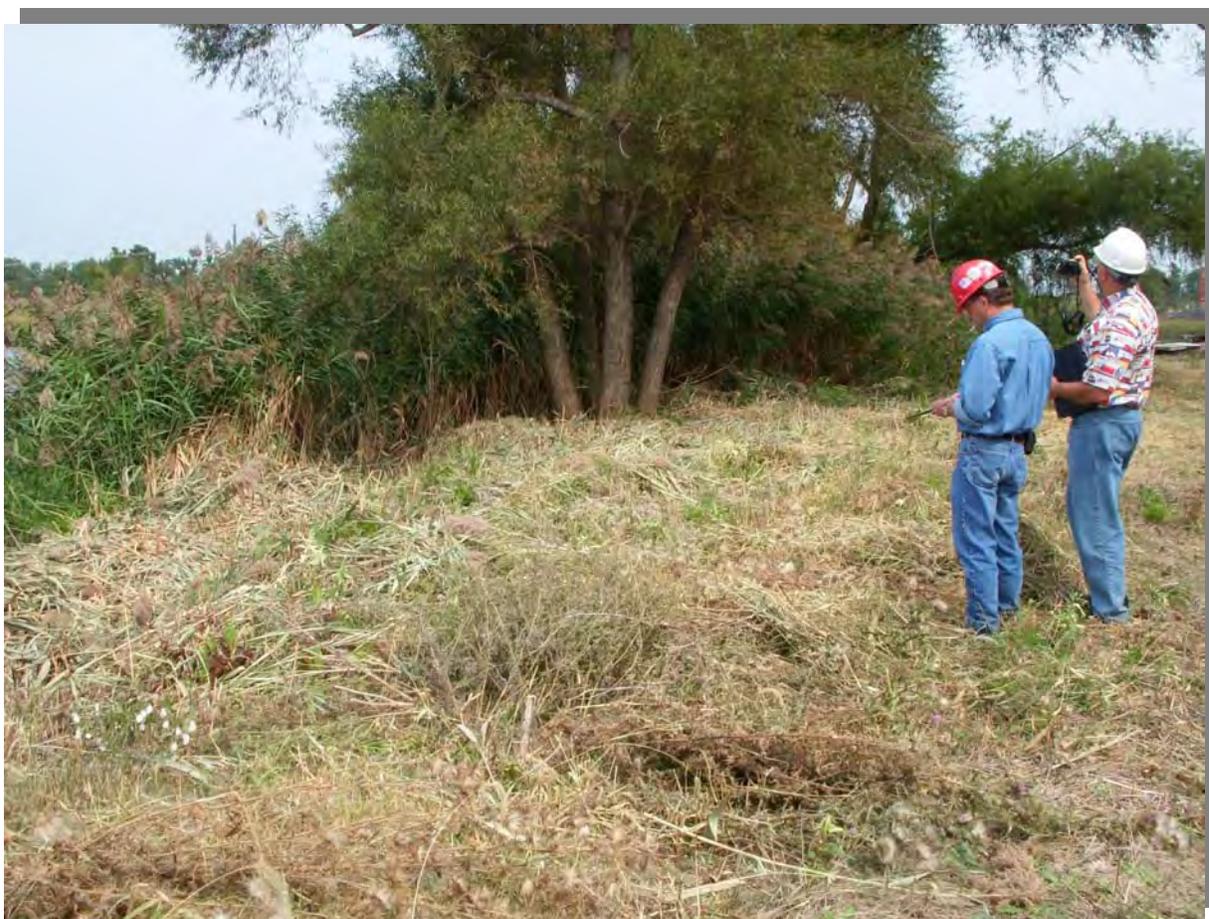
Photo 6 – East dike crest with willow tree.

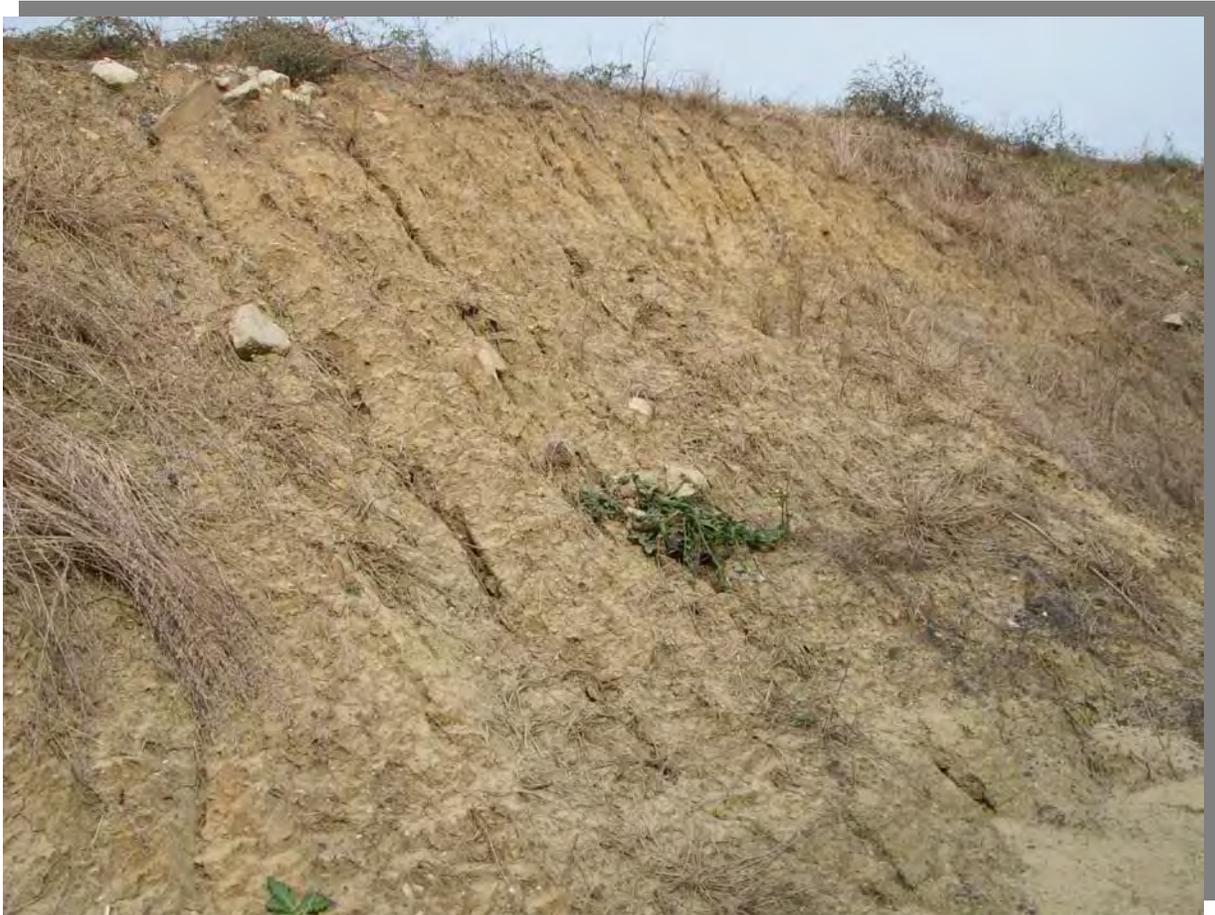
Photo 7 – East dike outboard slope impacted by excavation and erosion.

- Outboard slopes – restore the eastern slope to its design inclination and re-vegetate. The slope restoration should be performed in accordance with an engineered design with reference to the original design. Remove wooden poles embedded in slope and backfill with compacted fill consistent with the original design. We understand that an engineering specification for the slope repairs has been prepared and a solicitation for bids has been issued. The poles will be removed and the holes backfilled.

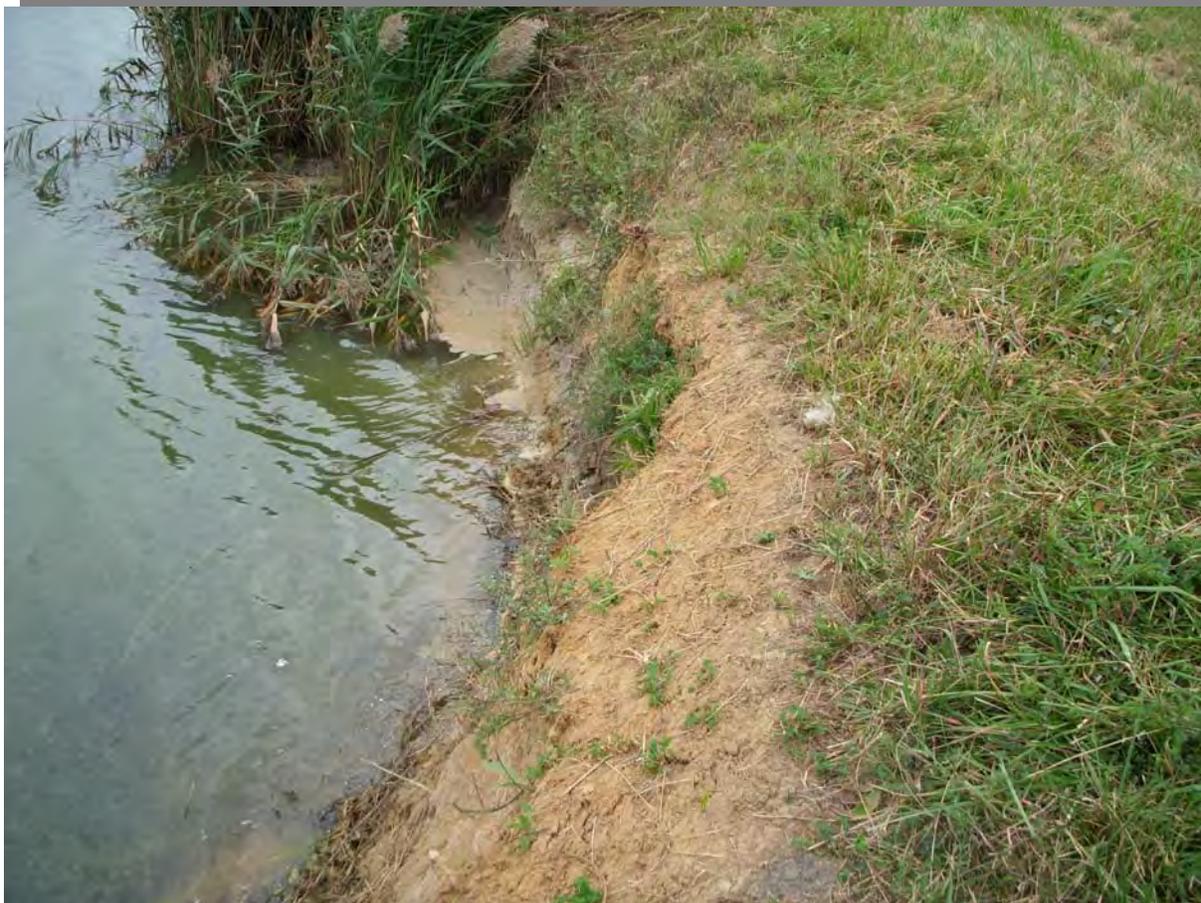
- The west inboard slope is experiencing erosion due to wave action.
- The emergency outlet pipes are deteriorated and obstructed at the downstream end.

Photo 1 – Typical erosion of inboard slope on west side of pond.

Inboard slopes – repair eroded inboard slopes. Repairs should be completed in accordance with an engineered design. Inspect and maintain erosion that may develop on freeboard section of all inboard slopes on a regular basis. Keep vegetation under control to allow for visual inspection of the exposed portion of the slope above the waterline. We understand that these issues are currently being evaluated by the utility’s engineering consultant.

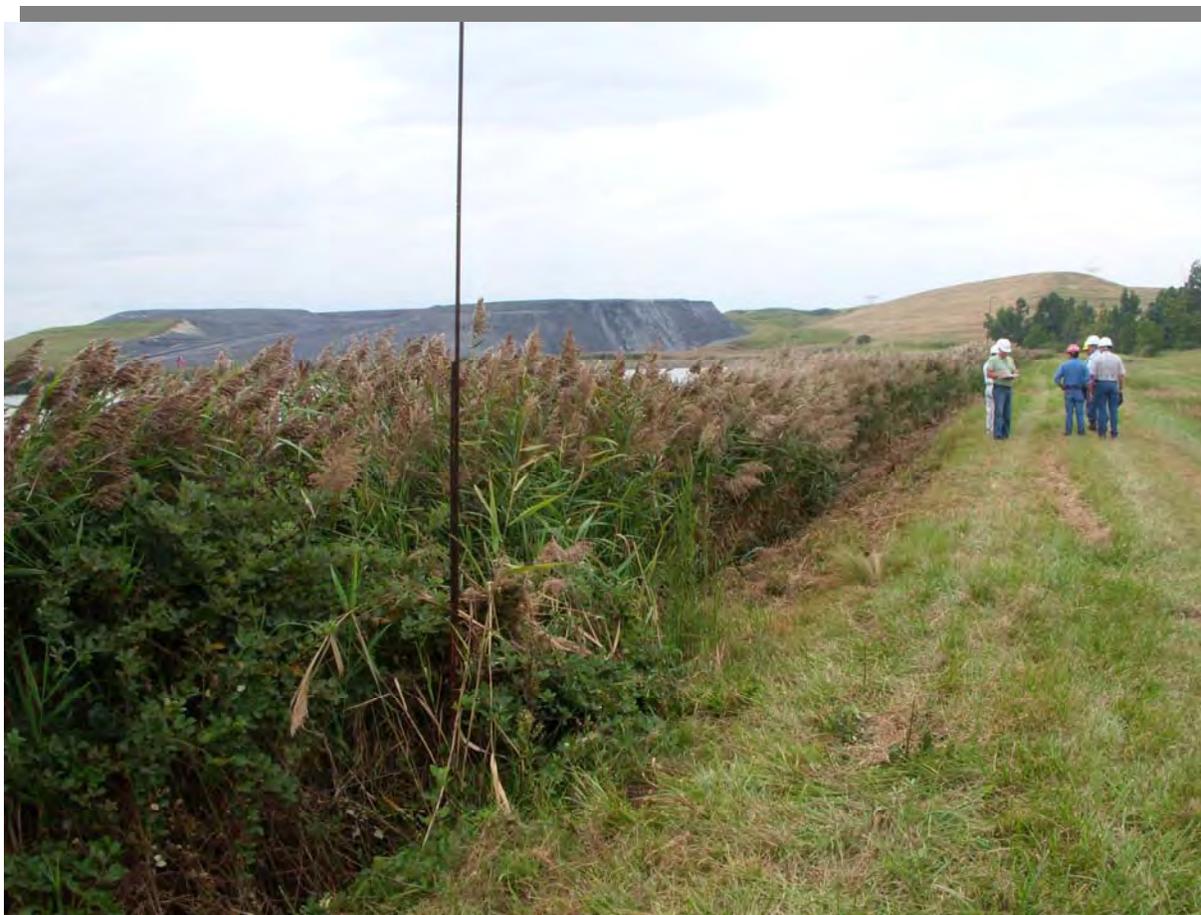
- The inboard slopes along portions of the pond were overgrown with reedy grasses such as fragmites (Appendix C – Photo 2).
- Some erosion of the exposed inboard slopes was observed along the west side of the pond.

Photo 2 – Crest of low west dike looking south. Note heavy vegetation on inboard slope.

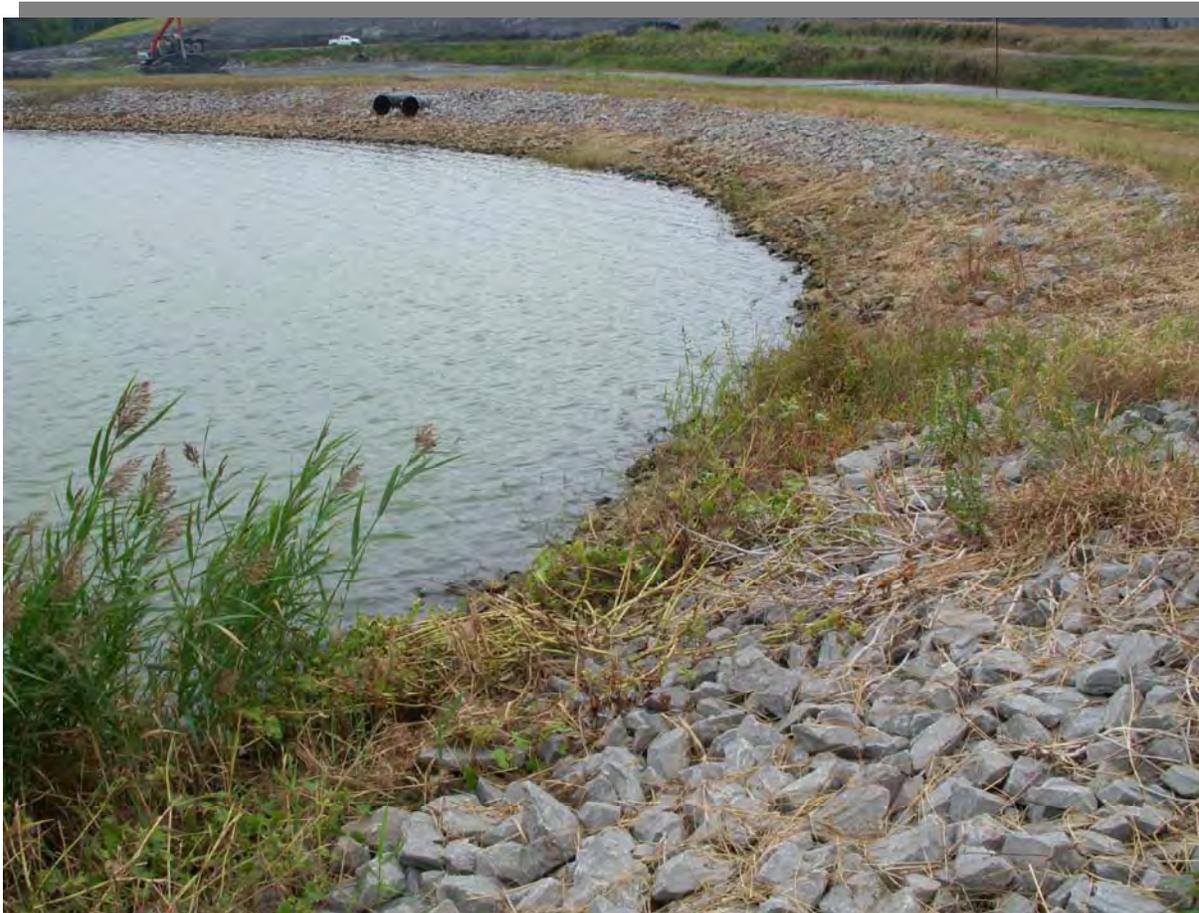
- The inboard slopes along the south end of the pond are armored with riprap to protect against wave action (Appendix C – Photo 3).
- Standing water (less than 6-inches deep) was observed within poorly drained swales along the western and southern embankment toe. The source of this water appears to be storm water and not seepage from the impoundment.

Photo 3 – Riprap-armored inboard slope of south dike. Note emergency overflow pipes in background.

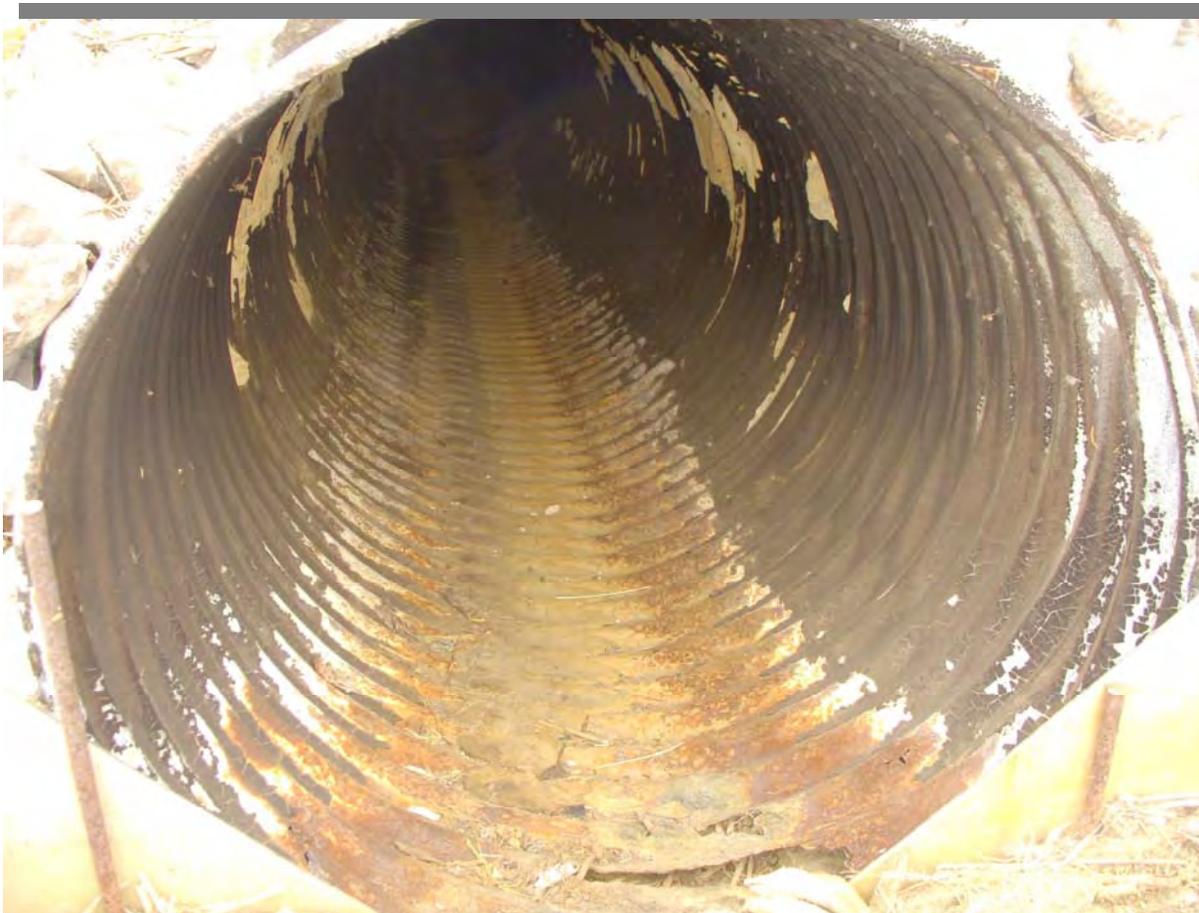
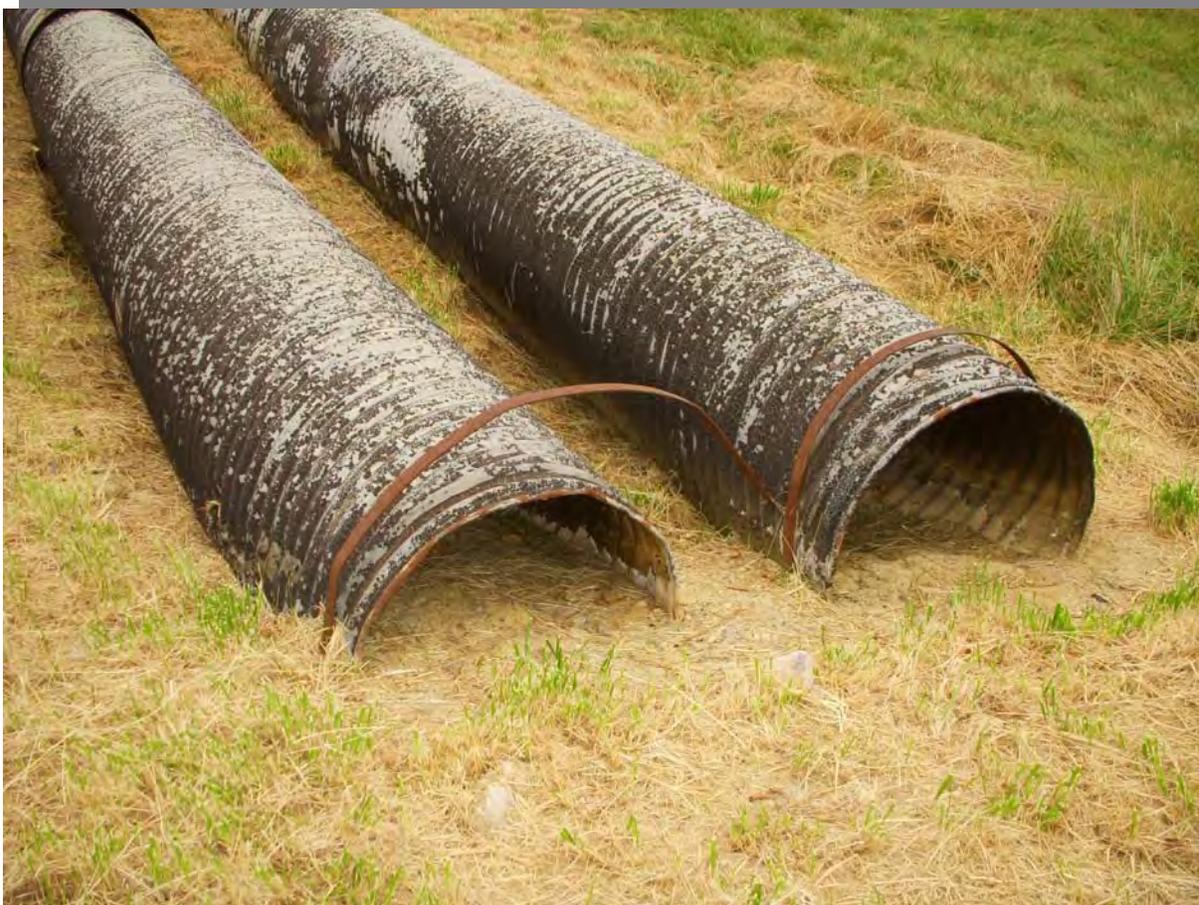
- The dual 30-inch emergency overflow pipes (CMP) located at the southwestern corner of the ash pond were observed to be deteriorated and damaged. These pipes were partially obstructed with silt at the discharge end. Our observations of the pipes indicated that they are rarely used (Appendix C – Photos 4 and 5).

Photo 4 – View of deteriorated 30-inch CMP emergency overflow pipe at upstream end.

Photo 5 – Downstream end of emergency overflow pipes. Note siltation of outlet.

- Emergency outlet – replace emergency overflow outlet pipes. Repairs should be completed in accordance with an engineered design. We understand that a repair design has been completed and bids are being solicited to complete the repairs, which is expected to be complete by the end of 2010.

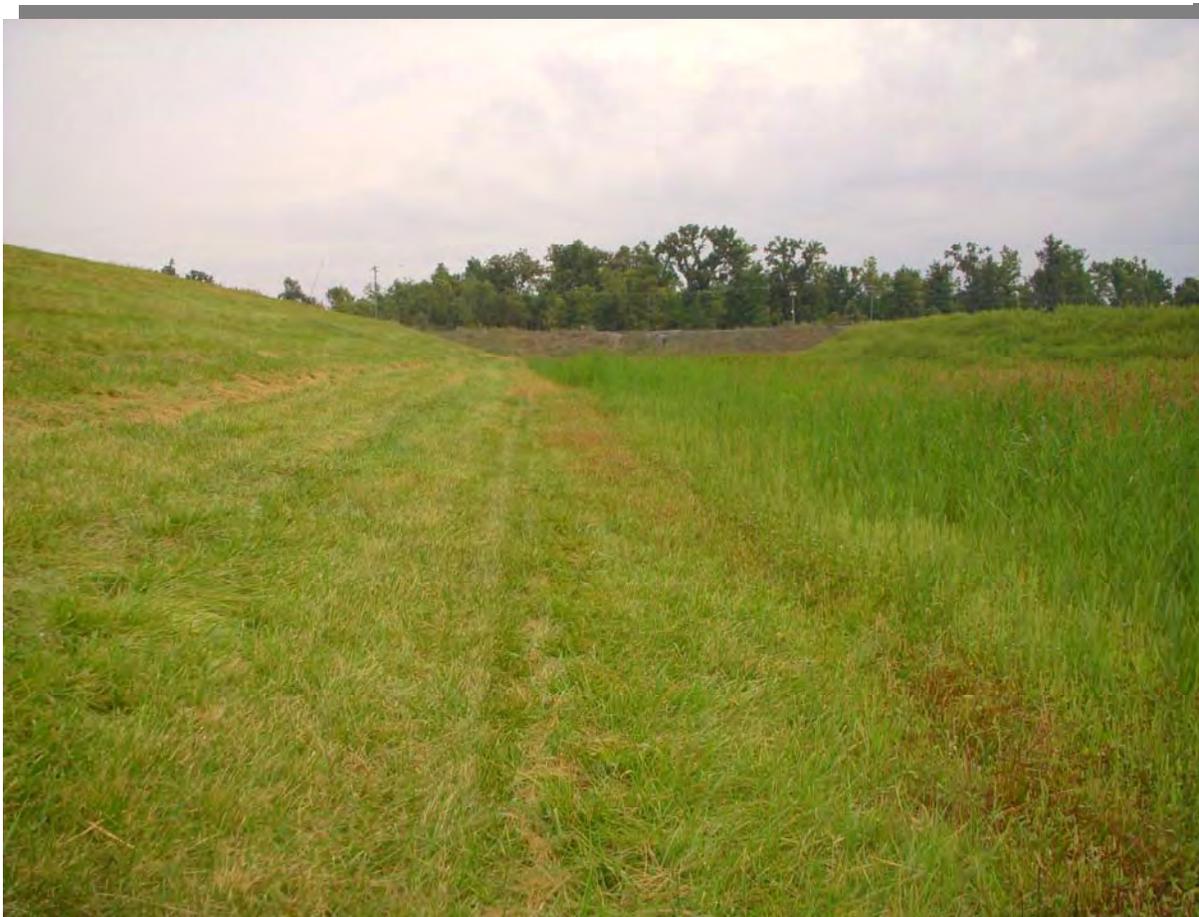
- The crest and outboard slopes appeared to be covered with well-maintained grass and in good condition (Appendix C – Photo 6).
- Bottom ash has accumulated above the normal pool elevation in much of the eastern portion of the pond. This area is used to stockpile excavated bottom ash which is allowed to drain, then loaded on trucks and hauled to the landfill located south of the ash pond. (Appendix C – Photo 7).

Photo 6 – View along outboard toe of south dike looking east. Note high vegetation in drainage swale beyond the toe.

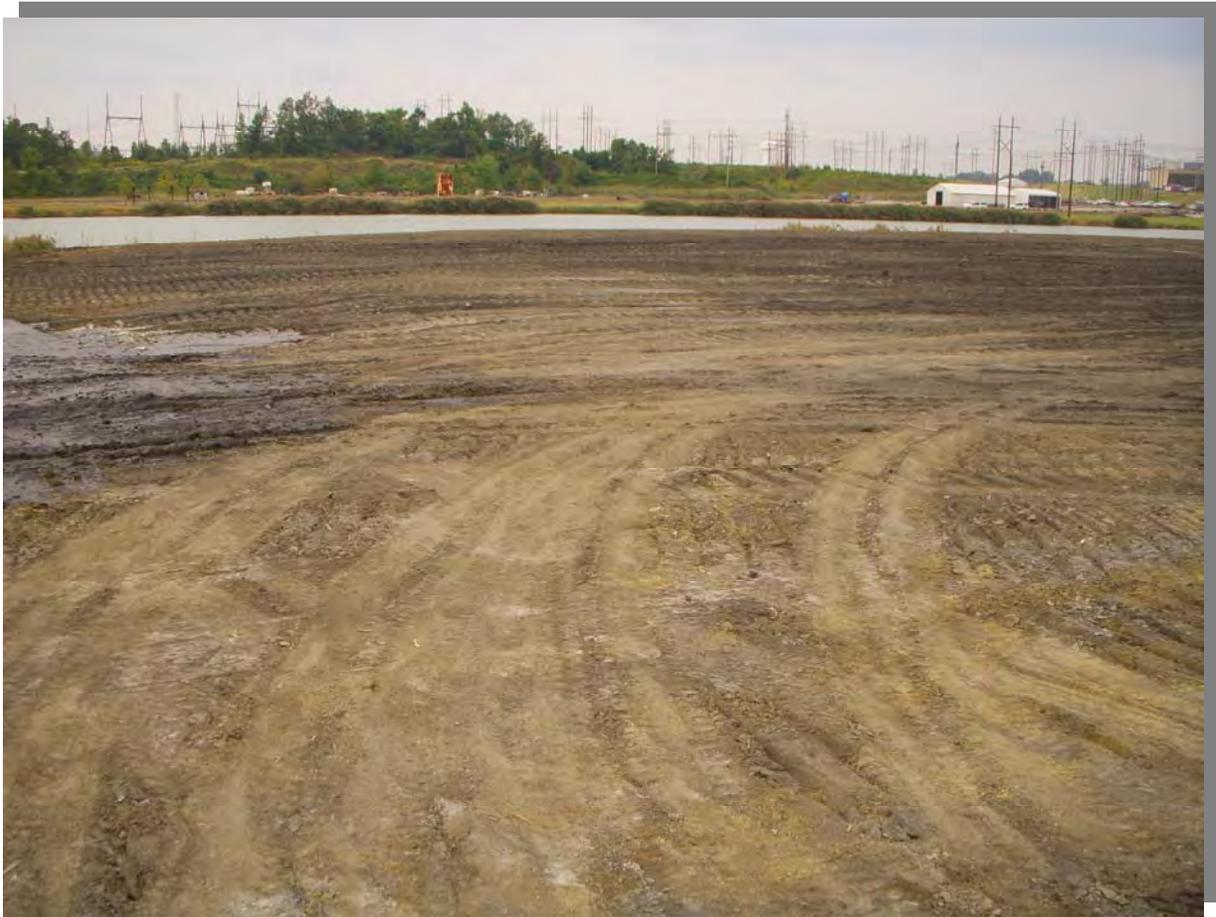
Photo 7 – View across the pond toward the west from the east side. Land in the foreground is former pond area that has been reclaimed with bottom ash.

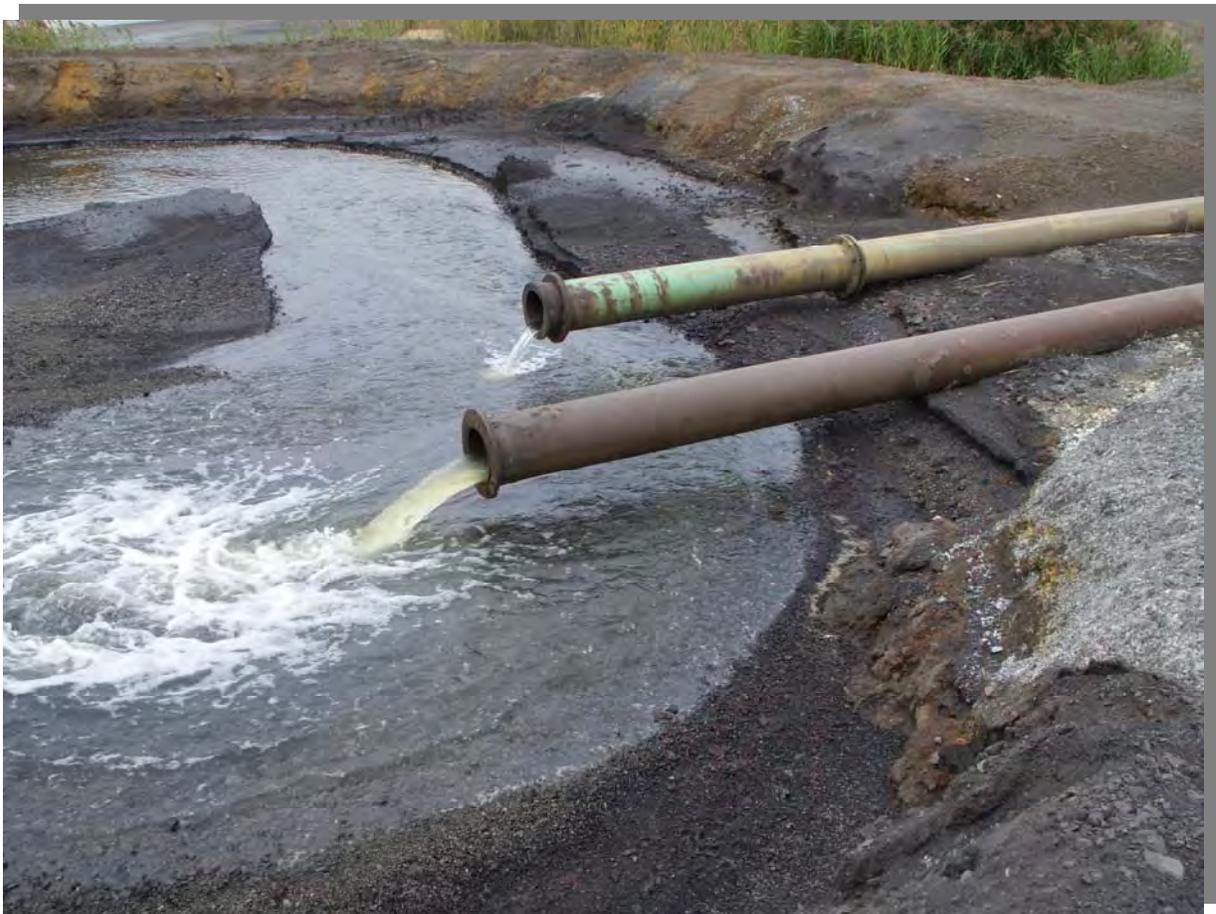
Photo 8 – Influent pipes discharging sluiced bottom ash into pond.

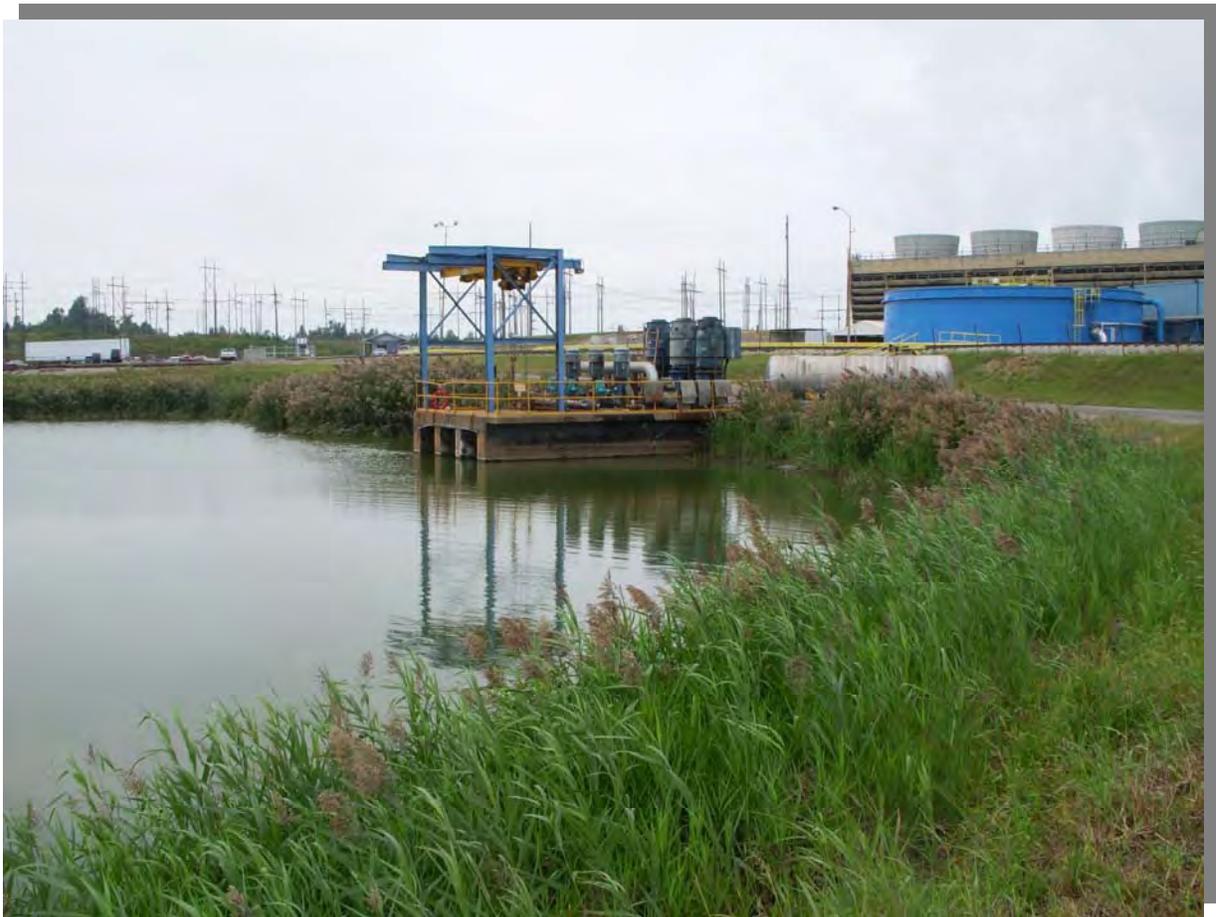
Photo 9 – View of pump station on incised inboard slope at the north end of the pond.
