**COAL ASH IMPOUNDMENT  
SITE ASSESSMENT FINAL REPORT**

**Dallman Power Station  
City of Springfield  
Springfield, Illinois**

**KLEINFELDER PROJECT NUMBER 112618-6**

**May 10, 2011**

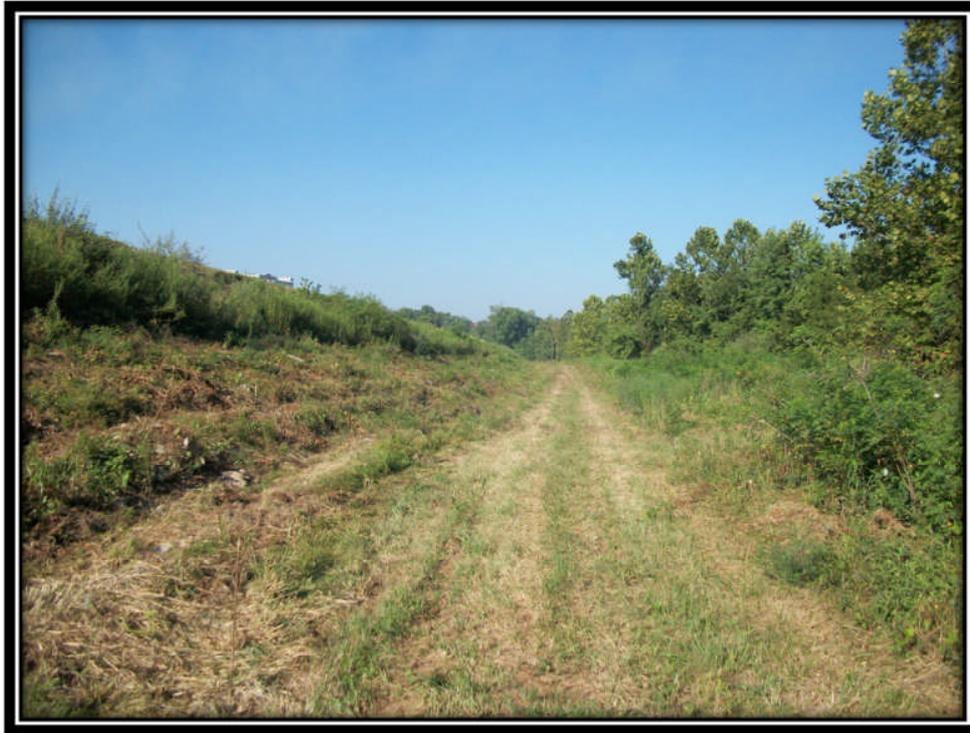
Photo 1 – Dallman Ash Pond Typical Northern Embankment Looking West (Note Uneven Slope Surface)

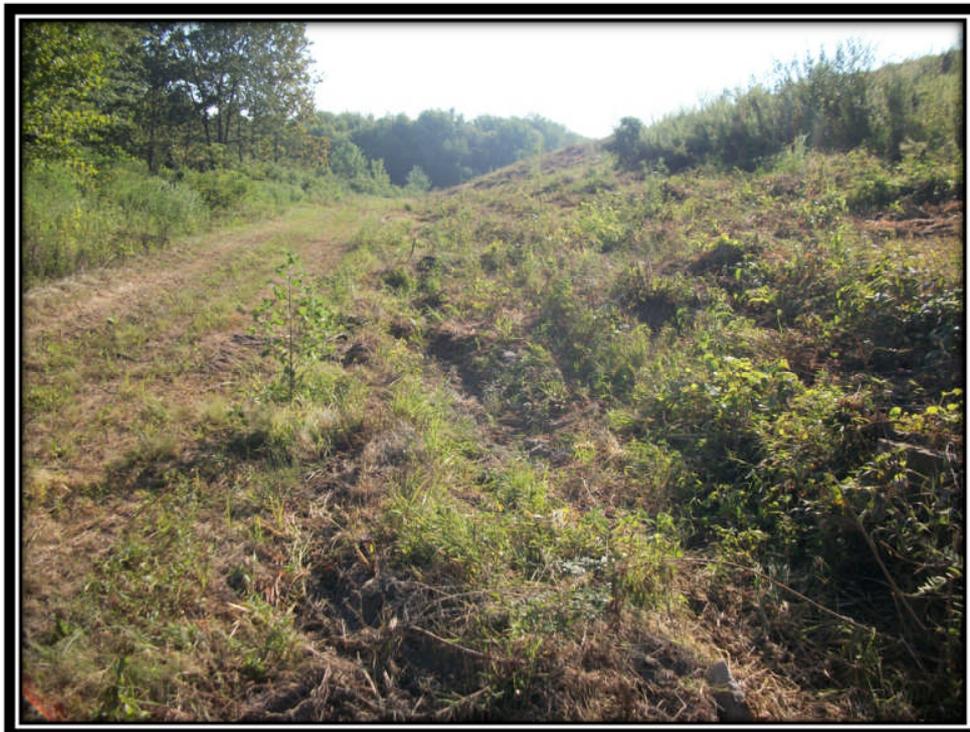
Photo 2 – Dallman Ash Pond Typical Northern Embankment Looking East (Note Vegetation on Slope)

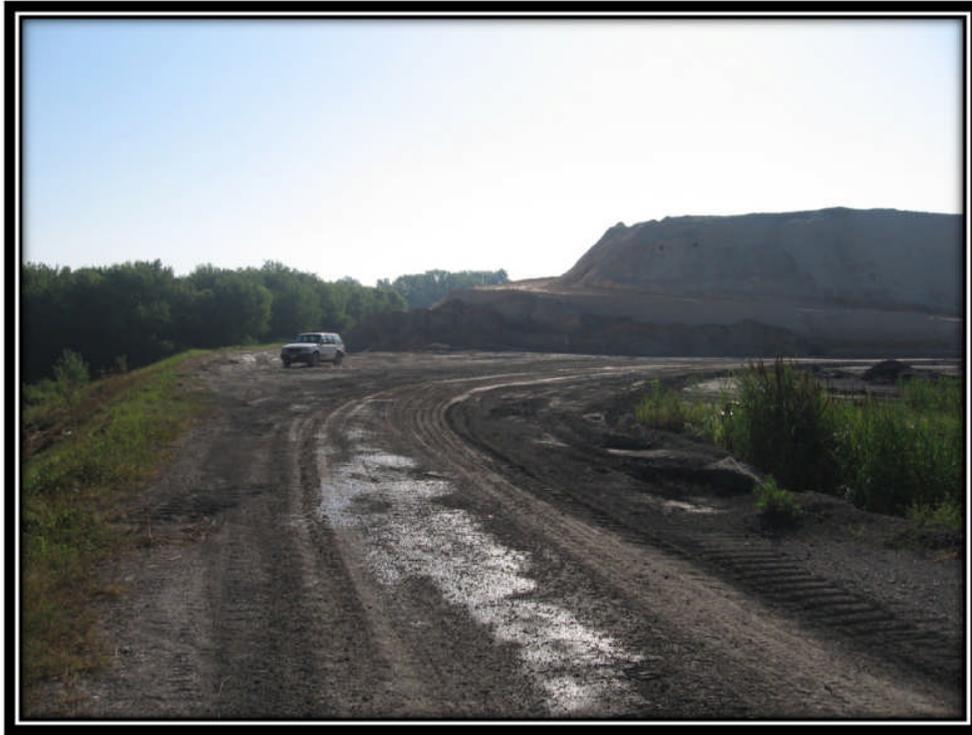
Overall, the crest of the impoundment was in satisfactory condition. Photograph 3 shows the condition of the crest. Specific observations include:

- The impoundment crest is a roadway.
- No major depressions or rutting were noted on the impoundment crest.
- Minor erosion was noted on crest in multiple locations. This erosion was typically less than six inches in depth and typically appeared on the edges of the crest, where grade breaks occurred when transitioning to embankment slopes.

Photo 3 – Dallman Ash Pond Typical Crest Condition Looking East

1. **Repair erosion of embankment on an as-needed basis.** Minor surface erosion was noted at various locations across the site. Areas where erosion has occurred should be filled in and re-dressed with appropriate fill in order to prevent erosion from cutting further into the embankments.

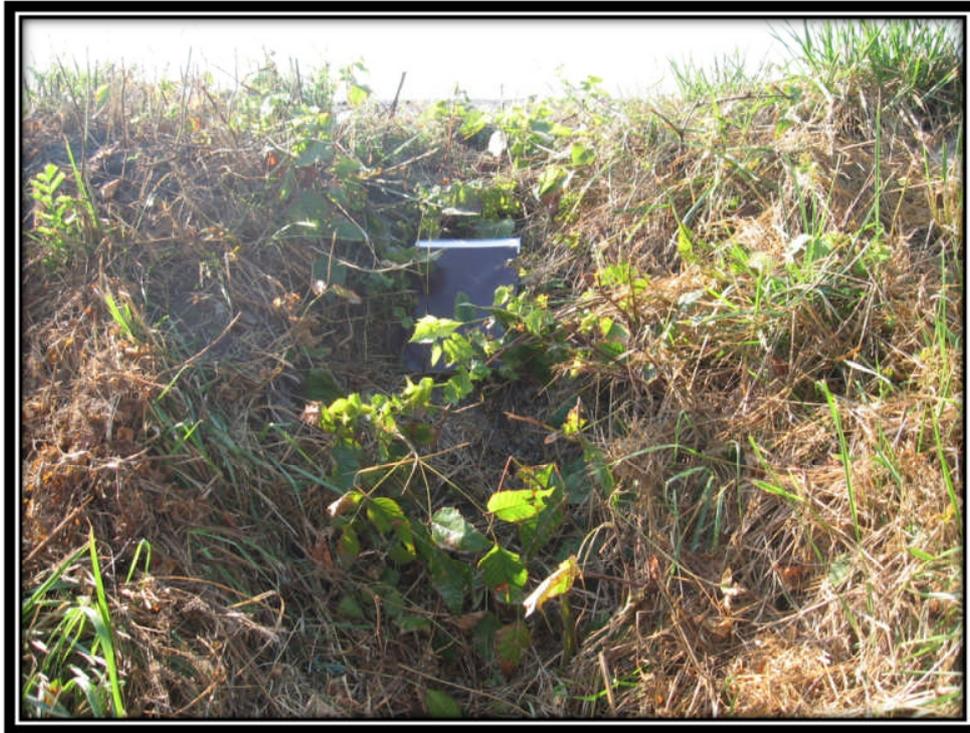
- Grasses and woody bushes were observed on the downstream slope and at the toe of the embankment for a large portion of the impoundment.
- Minor erosion was noted near the crest in multiple locations. This erosion was typically less than six inches in depth and typically appeared on the edges of the crest where grade breaks occurred when transitioning to embankment slopes. However, we noted some locations where the erosion was greater than 12 inches in depth as shown in Photograph 7.

Photo 7 – Surface Erosion Greater than 12” on Downstream Slope and Edge of Crest

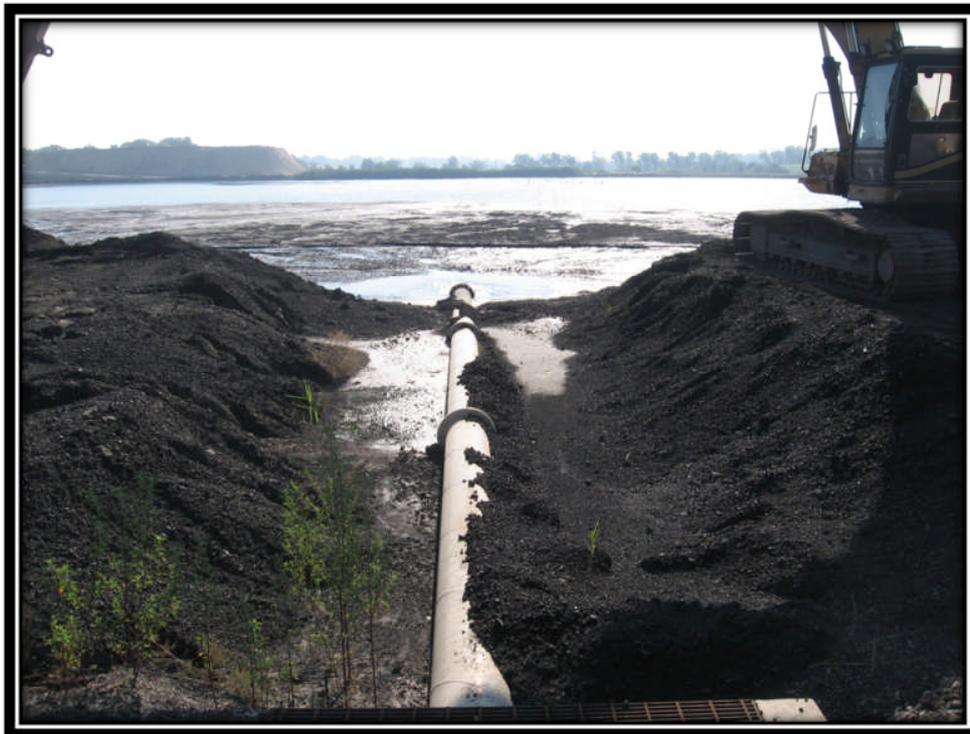
Photo 8 – Sluice Pipe Inlet into Dallman Ash Pond (Note Cut in Embankment)

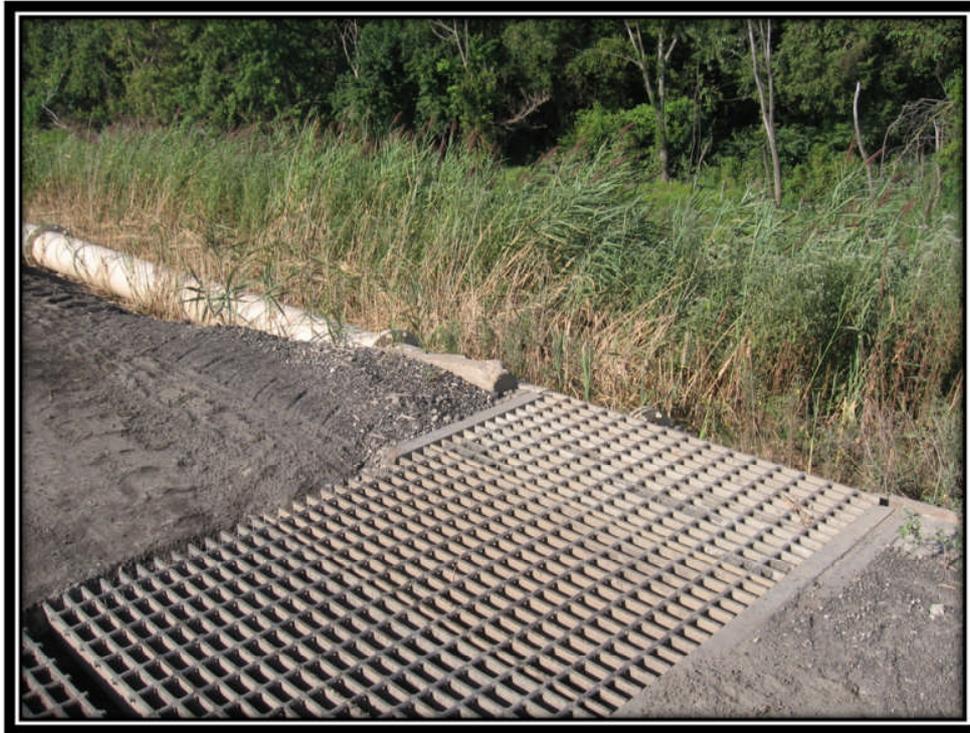
Overall, the downstream slope was in satisfactory condition. Photograph 9 shows the conditions of the downstream slope. Specific observations include:

Photo 9 – Grate on Crest Providing Roadway Access Over Sluice Pipe Inlet into Dallman Ash Pond

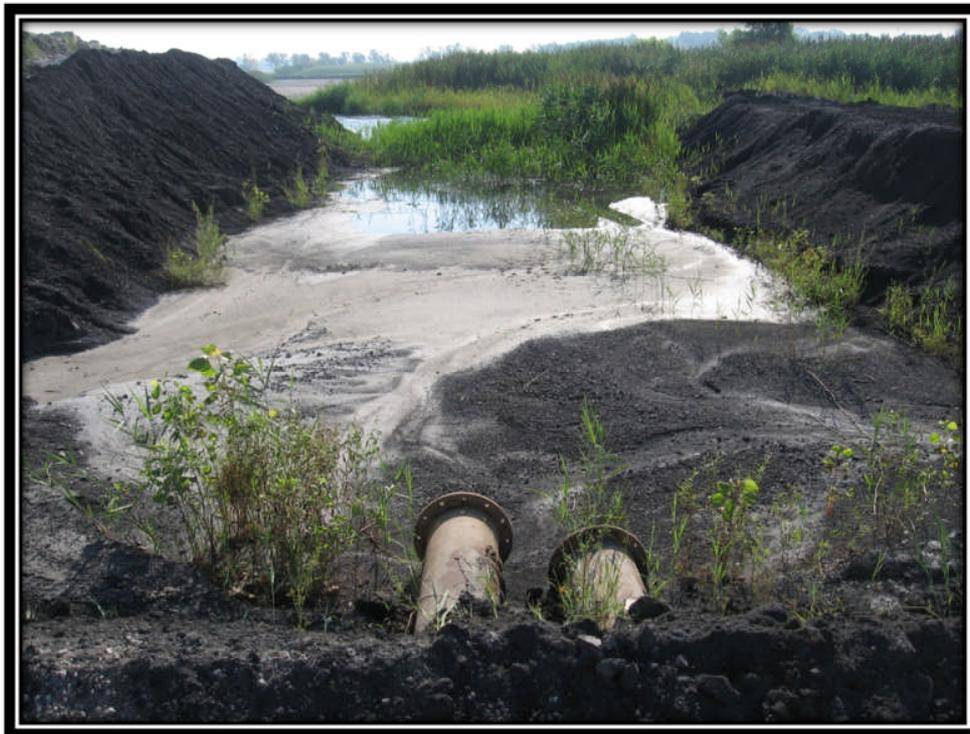
Photo 10 – Alternate Sluice Pipes (Not Active during Inspection, Note Cut in Embankment)

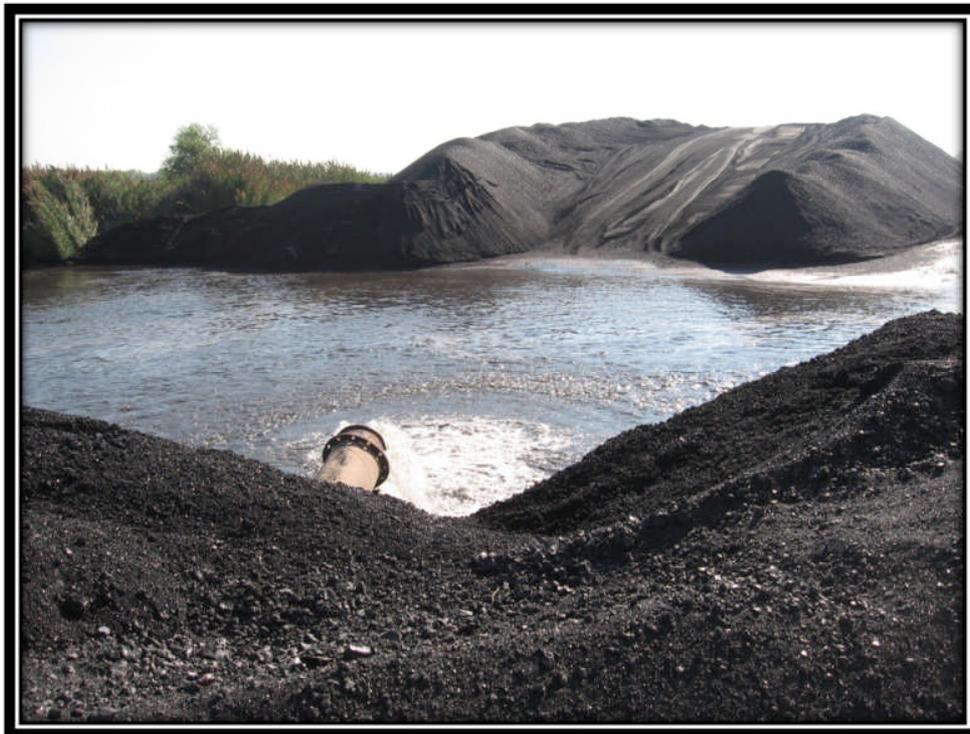
Photo 12 – Boiler Slag Sluice Pipe into Dallman Ash Pond (Note Backfilled Embankment)

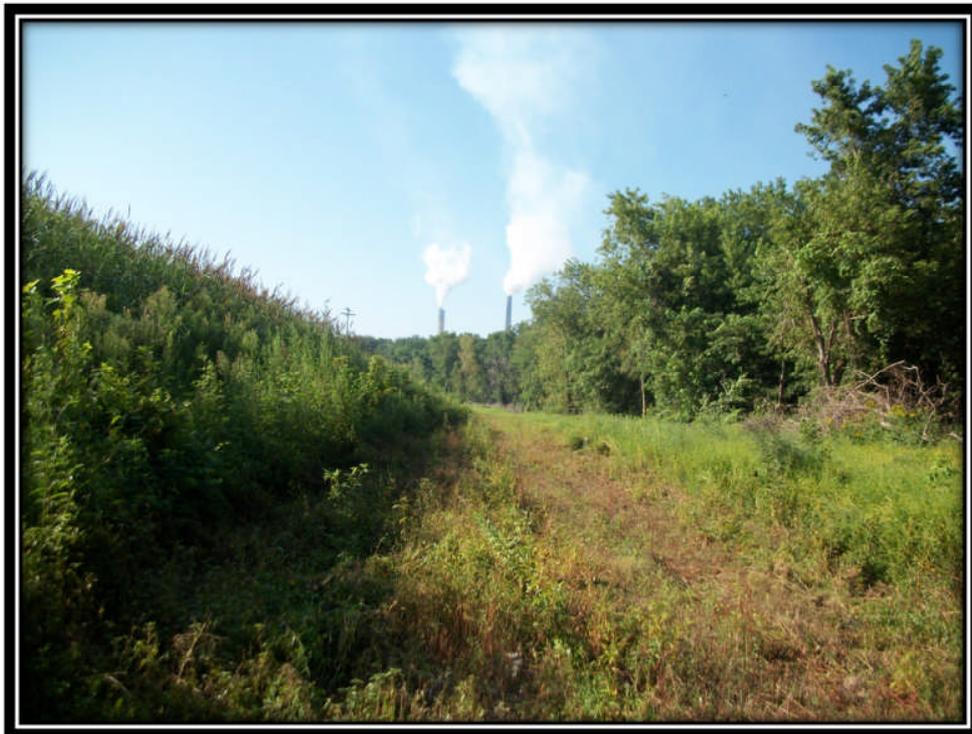
The toe areas of the embankment were in satisfactory condition. See Photographs 16 and 18 for the condition of these areas. Specific observations include:

Photo 16 – Dallman Ash Pond Typical Western Embankment Looking South

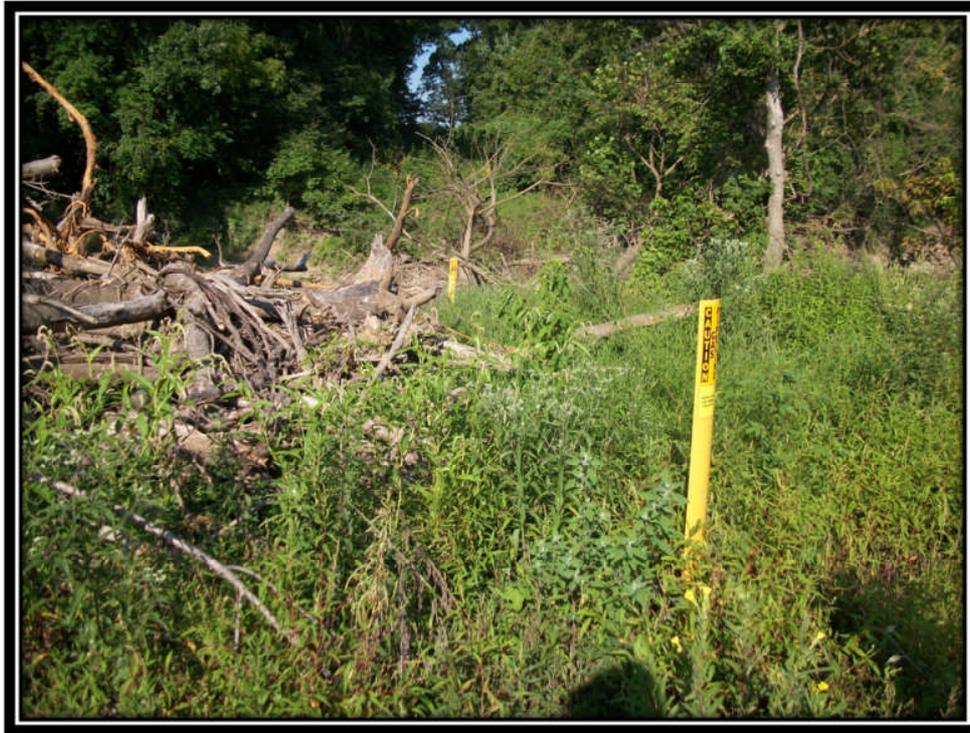
Photo 17 – Gas Pipeline Penetrating Embankment between Dallman Ash Pond & Clarification Pond

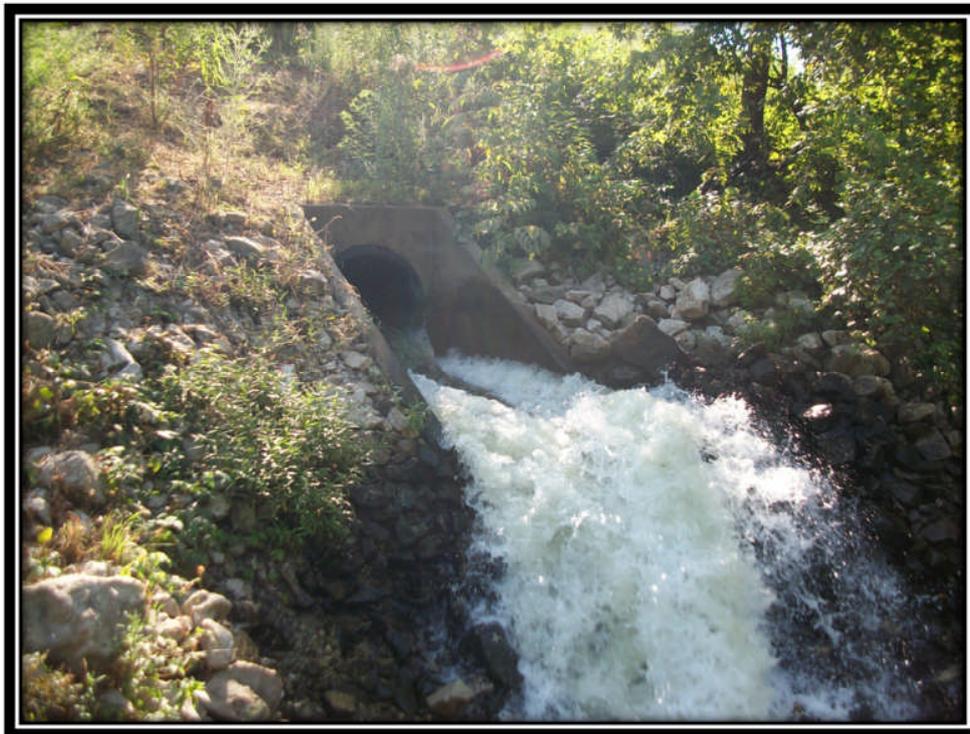
- A mature tree was noted at the toe of the embankment near the clarification pond outlet.

Photo 18 – Termination of Outlet Pipe for Clarification Pond (Note Mature Tree on Slope)

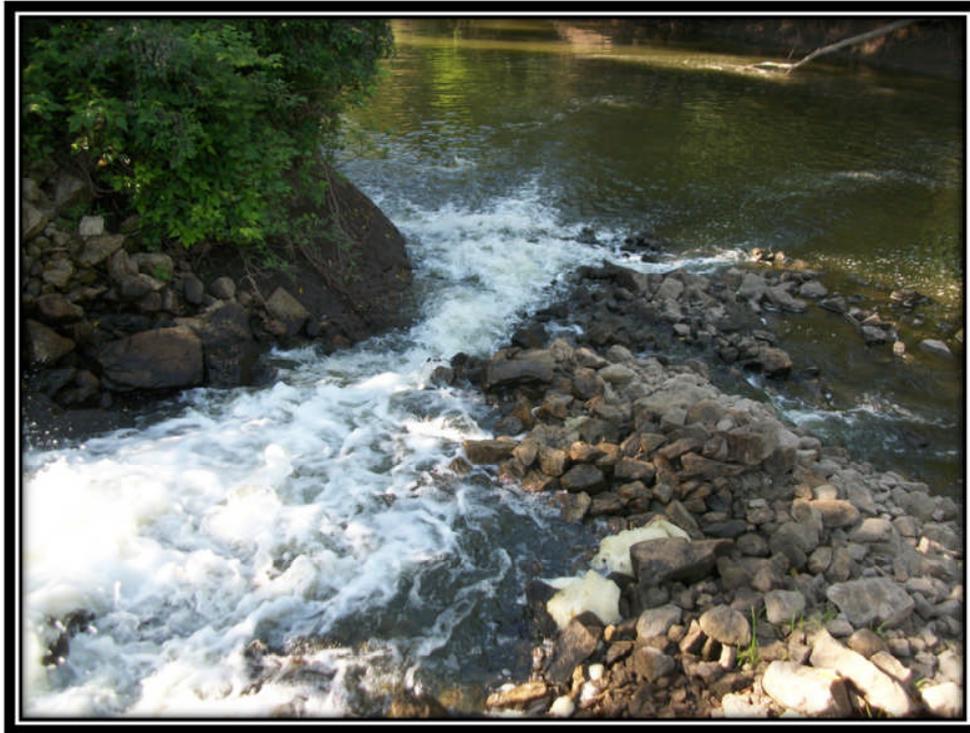
Photo 19 – Channel from Clarification Pond Outlet Piping (Note Riprapped Channel)

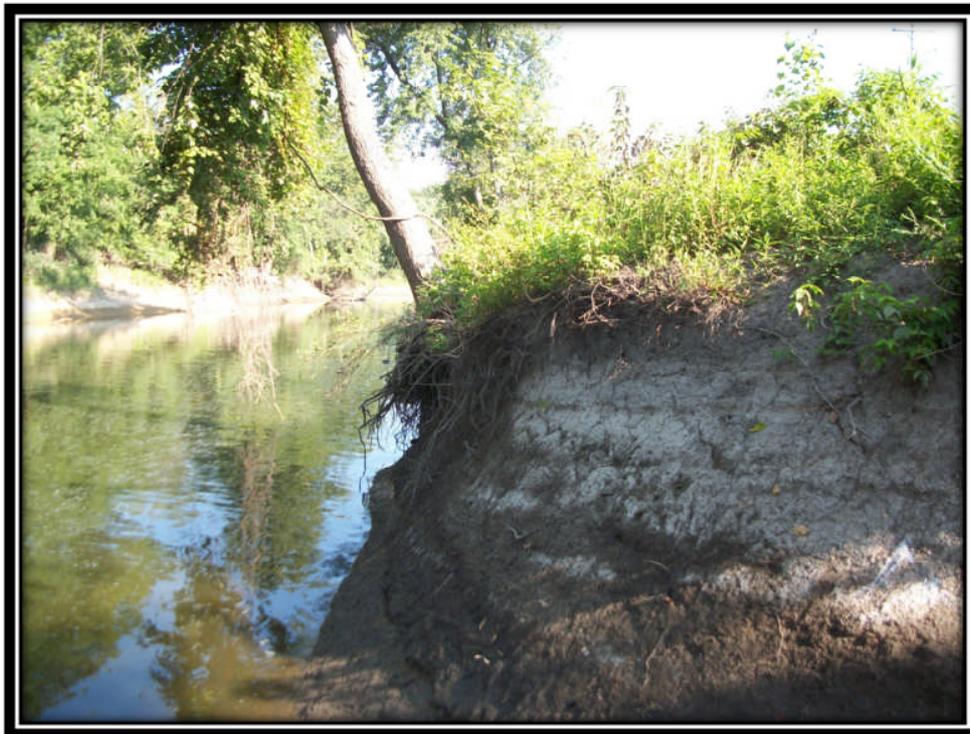
Photo 20 – Erosion of Creek Slopes Adjacent to Outlet Works Piping from Clarification Pond

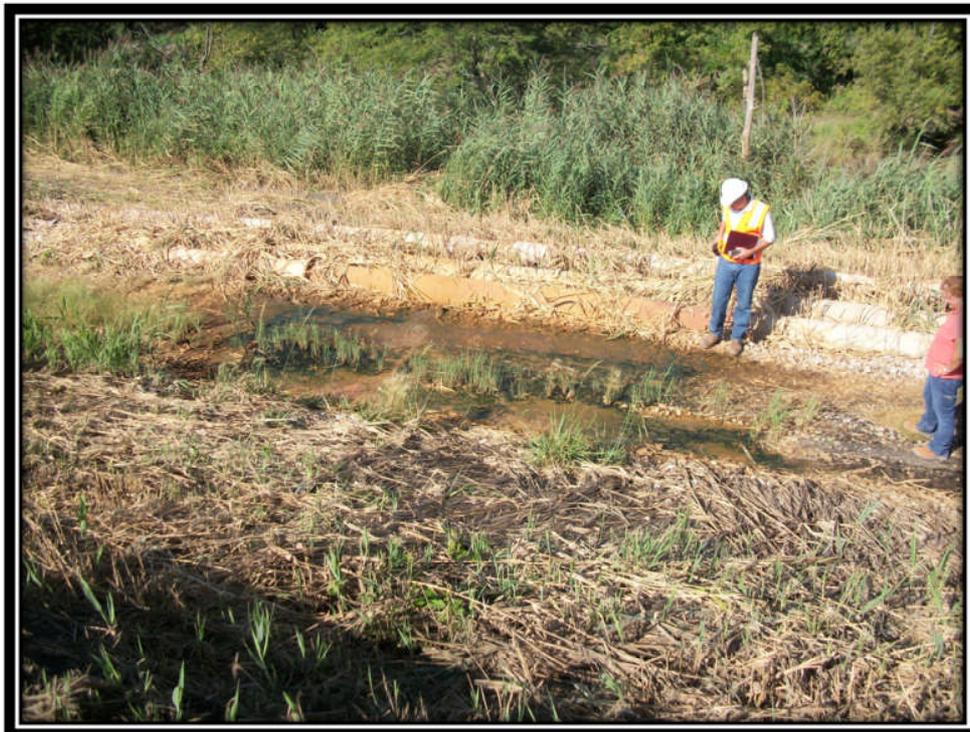
Regarding seepage, we understand that uncontrolled seepage has been observed at various locations on the downstream slope along the north and west sides of the Lakeside Ash Pond's vertical embankment extension by the City of Springfield and Hanson Professional Services at various times between 1992 and 2008. As a result, we understand that various modifications were made to limit uncontrolled seepage at the raised portion of the embankment, including installation of additional toe drains, inverted filters, and filter cake sludge seals. We noted visible uncontrolled seepage along the west side of the Lakeside Ash Pond during our recent visit as well. Based on the continued presence of uncontrolled seepage water, some type of monitoring system would be valuable to document changes in seepage rate or composition.

Photo 24 – Seepage Area Looking West from Crest

3. **Establish seepage and ground water monitoring program by 10/1/2011.** As discussed in Section 3.5, uncontrolled seepage water was observed on the west downstream slope of the Lakeside Ash pond. The presence of uncontrolled seepage water at the downstream embankment raises questions regarding the integrity and the stability of the embankment. Therefore, a detailed monitoring program should be established to quantify various important factors, including seepage quantities through the embankment, the amount of sediments carried by the seepage water, and the fluctuation of ground water levels.

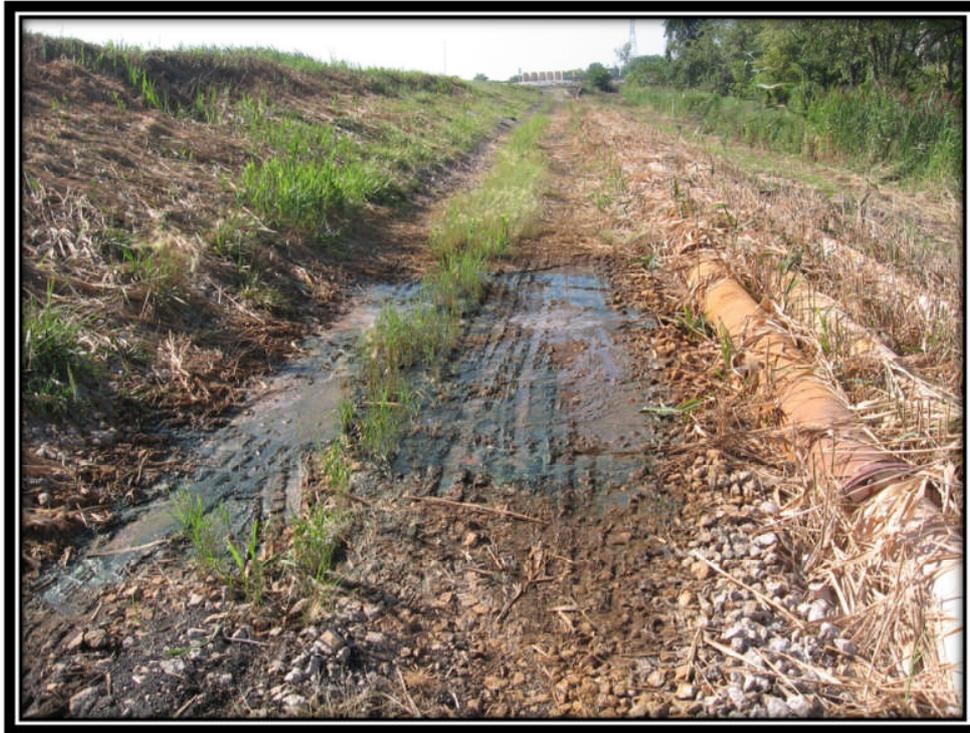
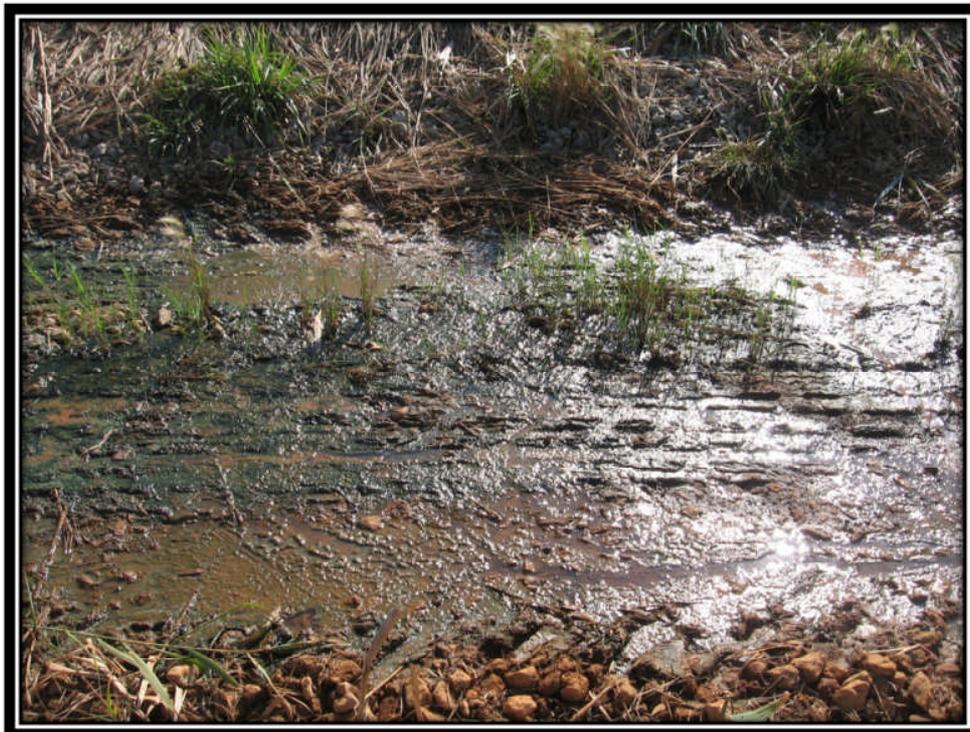
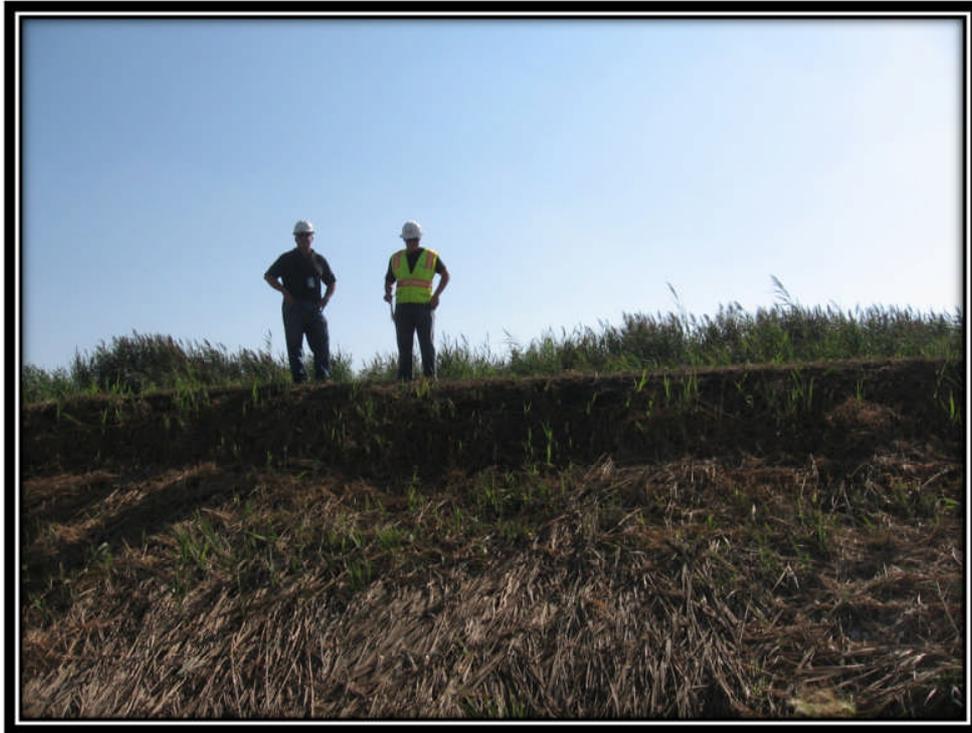
Overall, the downstream slope was in satisfactory condition. Photographs 25, 26, and 27 show the conditions of the downstream slope. Specific observations include:

- Uncontrolled seepage was noted on the west downstream slope near the juncture between the original top of embankment and the toe of the raised portion of the embankment. This area also serves as a vehicle access road.
- Portions of the downstream slopes were covered with thick vegetation.
- Sluice lines are located on the west downstream slope.

Photo 25 – Seepage Area Looking South

Photo 26 – Seepage Area at Base of Vertical Extension of Old Lakeside Ponds

Photo 27 – Seepage Area Looking East (Note Vertical Extension of Old Lakeside Ponds)

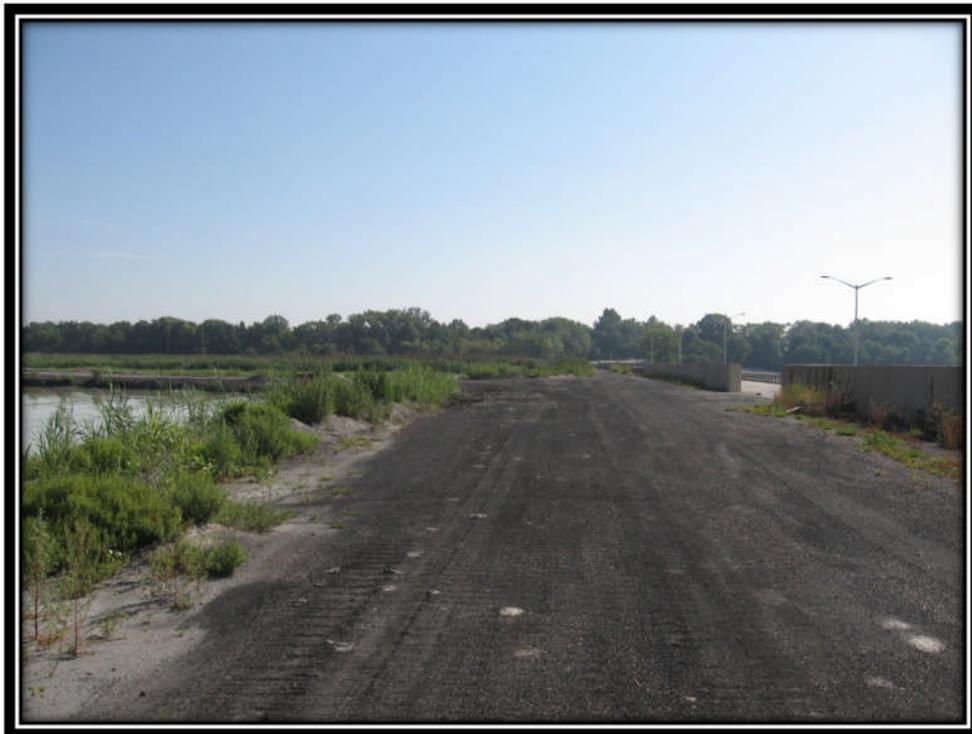
Overall, the crest of the impoundment was in satisfactory condition. Photograph 28 shows the condition of the crest where it abuts the crest of Spaulding Dam. Specific observations include:

- The impoundment crest is a roadway.
- No major depressions or rutting were noted on the impoundment crest.
- Minor erosion was noted on the crest in multiple locations. This erosion was typically less than six inches in depth and typically appeared on the edges of the crest, where grade breaks occurred when transitioning to embankment slopes.

Photo 28 – Southern Edge of the Old Lakeside Ponds Embankment Looking East

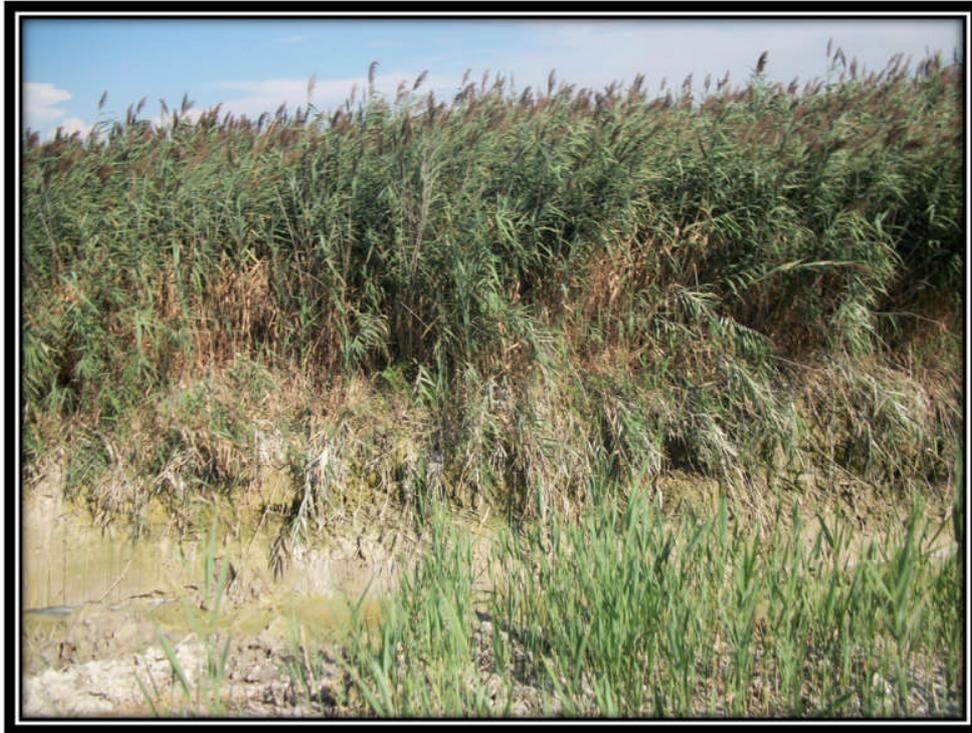
- Grasses and woody bushes were observed on the upstream slope for Cell Number 3.

Photo 31 – Old Lakeside Pond Cell Number 3 Overgrown and Currently Inactive

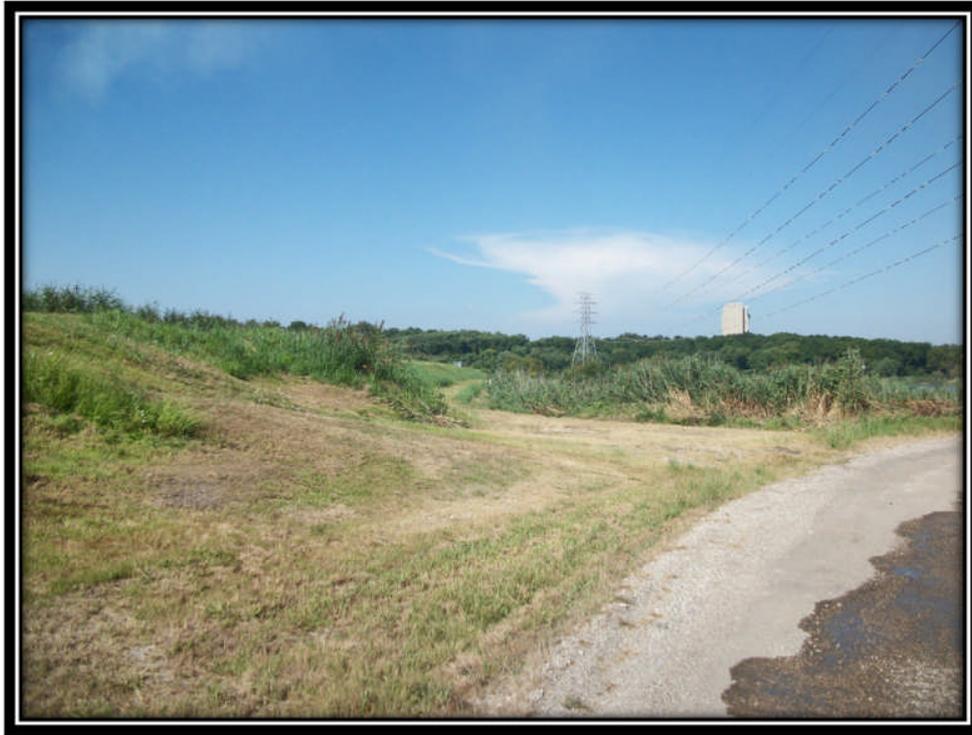
The toe areas of the embankment were in satisfactory condition. See Photograph 33 for the condition of these areas.

Photo 33 – Embankment Separating the Old Lakeside Ponds from the Clarification Pond
