Report of Dam Safety Assessment of Coal
Combustion Surface Impoundments
Dayton Power and Light Company
O.H. Hutchings Electric Generating Station
Miamisburg, OH

AMEC Project No. 3-2106-0177.0006

September 2010

Dayton Power and Light Company, O.H. Hutchings Electric Generating Station: East Primary Settling Pond, West Primary Settling Pond, and Secondary Settling Pond were assessed on August 18, 2010.

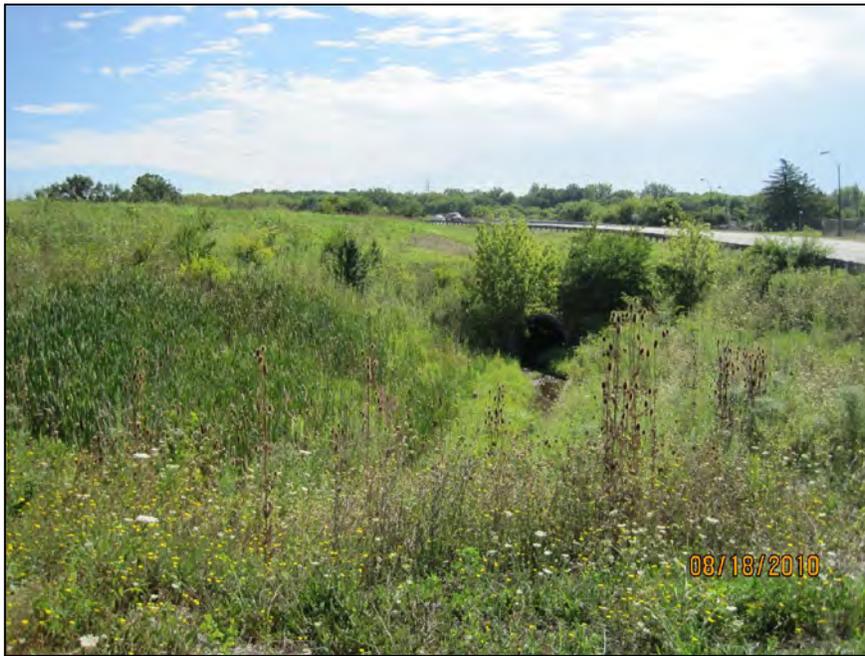
E-1

FROM ACCESS ROAD LOOKING EAST ALONG SOUTHERN DOWNSTREAM SLOPE

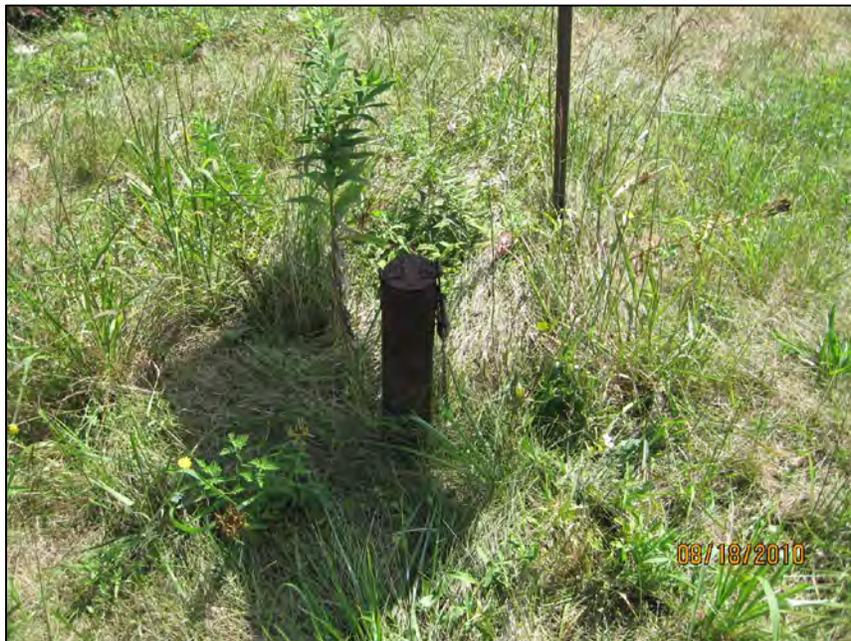
At the time of AMEC's site visit, one monitoring well was observed along the southern portion of the eastern crest of the East Primary Settling Pond (photo E-10). Site personnel indicated that additional monitoring wells were recently discovered, however, are not monitored.

E-10
MONITORING WELL AT CREST OF SOUTHEASTERN CORNER OF POND

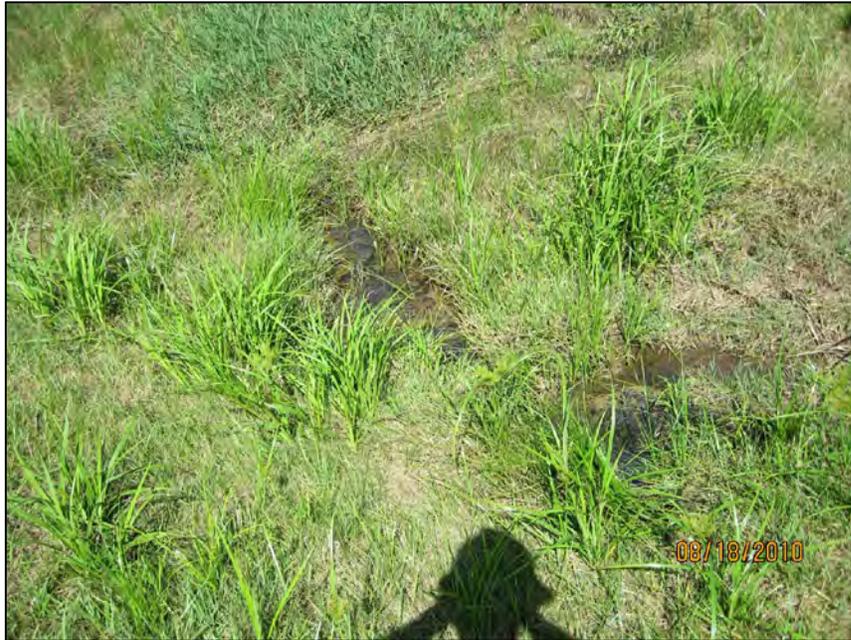
E-11
WET AREA ALONG SOUTHERN DOWNSTREAM TOE

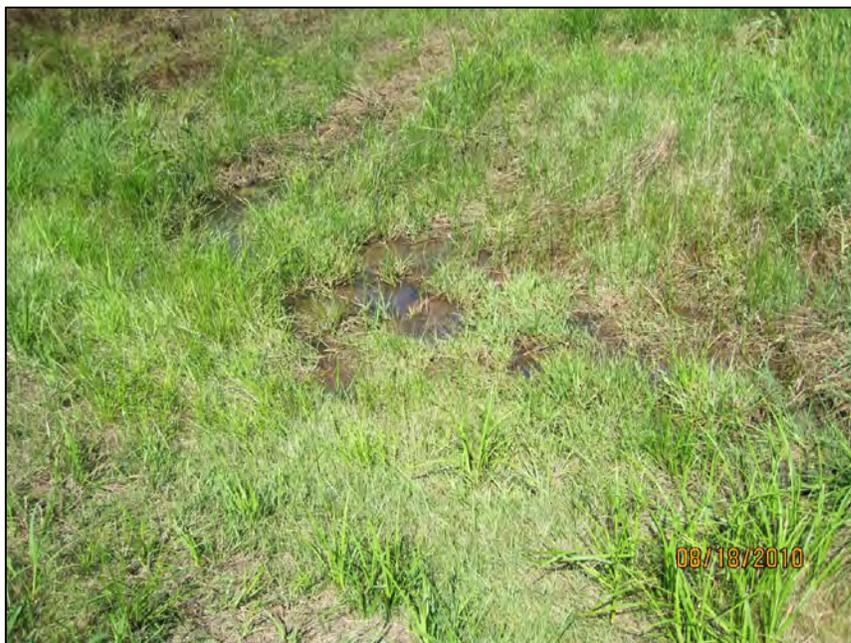
E-12
WET AREA ALONG SOUTHERN DOWNSTREAM TOE

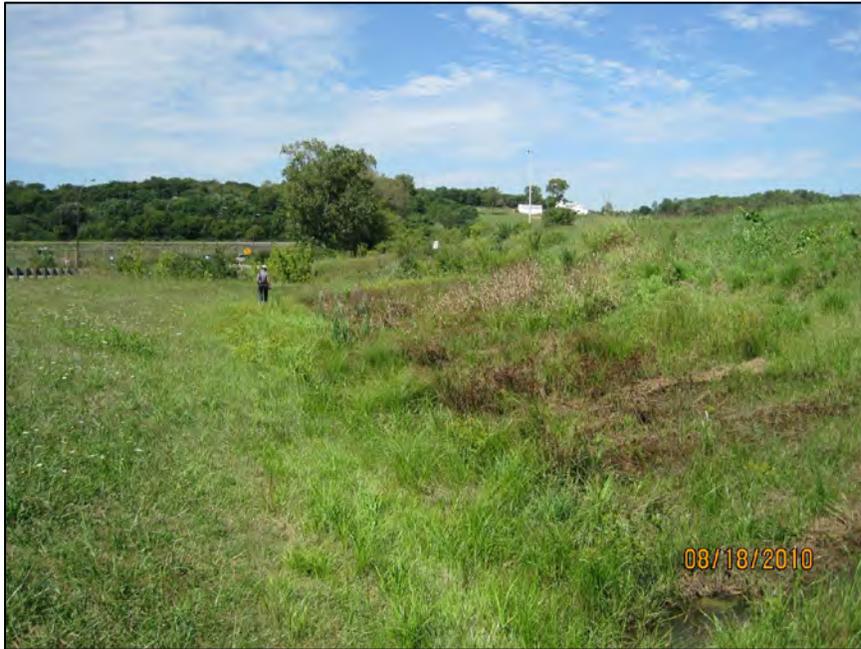
E-13

WET AREA ALONG SOUTHERN DOWNSTREAM TOE

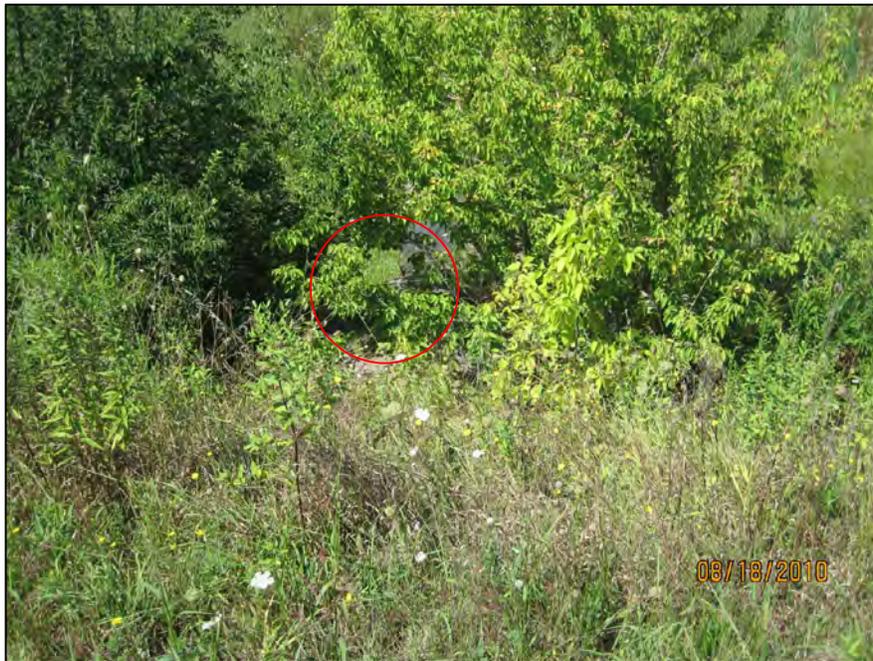
E-15

PIPE OUTLET LOCATED ALONG SOUTHERN DOWNSTREAM TOE

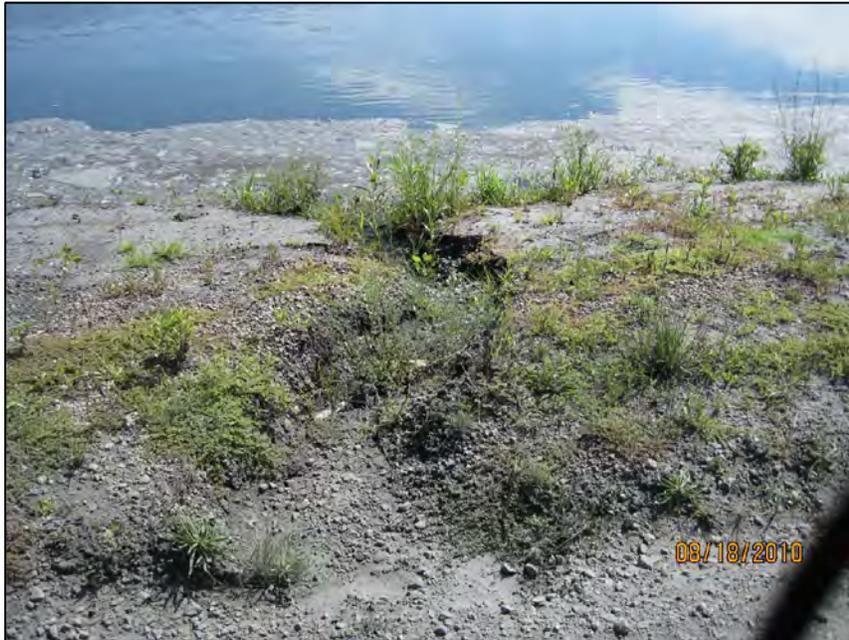
E-17
EROSION RILL ALONG WESTERN INTERIOR SLOPE

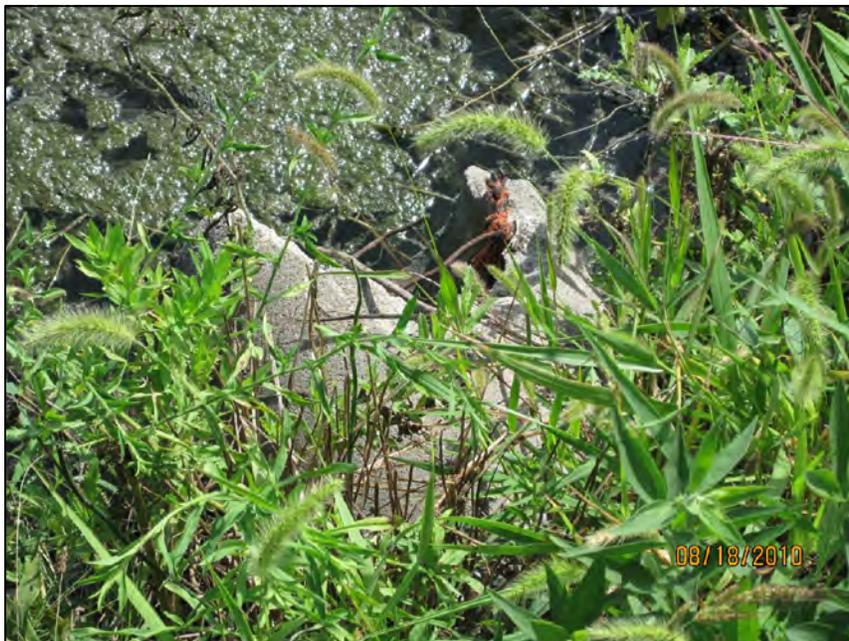
E-18
**EMERGENCY OVERFLOW BETWEEN WEST PRIMARY SETTLING POND AND EAST
 PRIMARY SETTLING POND**

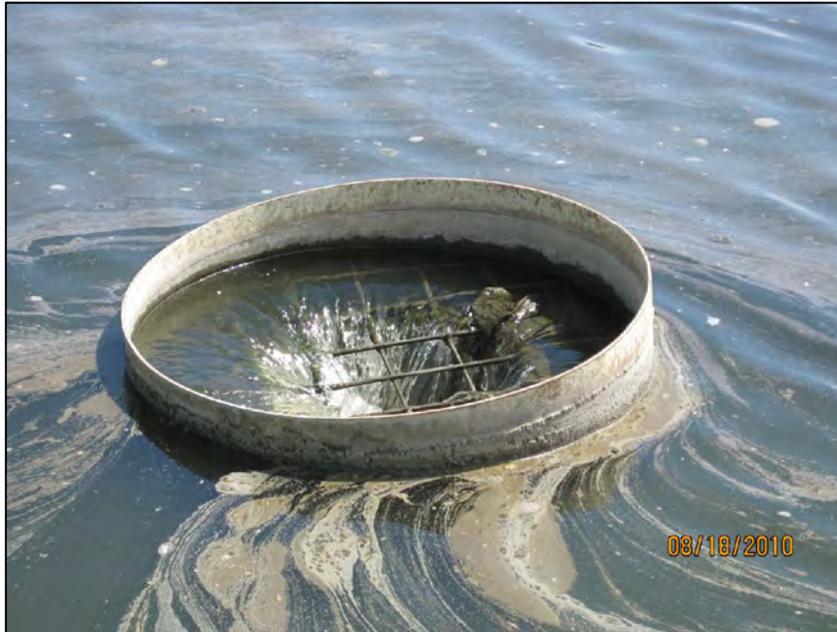
E-19

VERTICAL INLET STRUCTURE LOCATED IN NORTHWESTERN PORTION OF POND

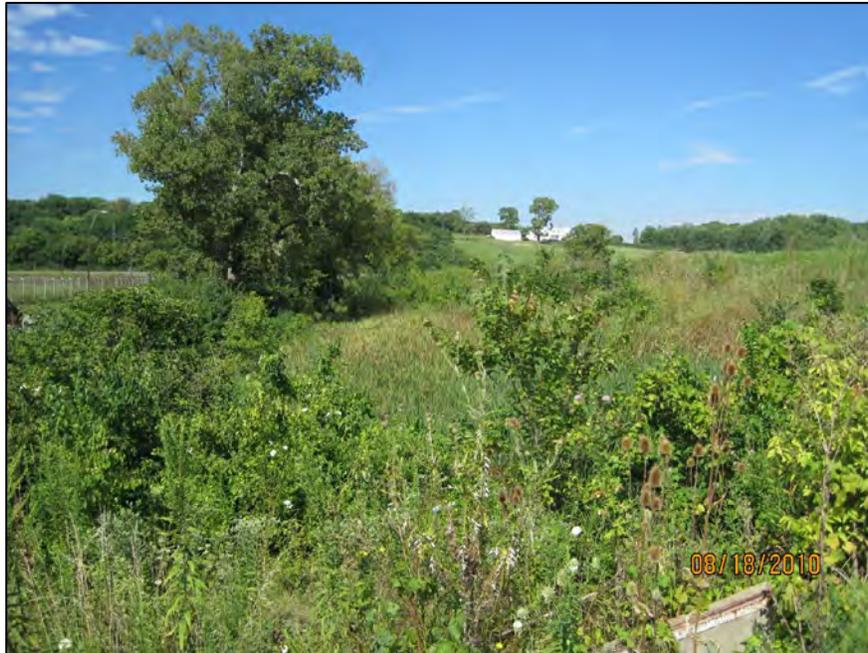
W-2

primarily surfaced with grass and heavy vegetation (photos W-2, W-5 and W-10). Heavy vegetation included grasses, brush, and trees up to 2 inches in diameter. The surface of the common dike is covered with an approximately 8-inch thick crushed stone surface (photo E-2). Several low spots and erosion rills which could affect freeboard were observed along the crest of the common dike (photo W-16). Erosion was noted along the southern interior slopes (photo W-11). Wet areas were suspected along the southern downstream toe due to wetland vegetation (cattails shown in photo W-13), however due to the density of the vegetation, could not be confirmed.

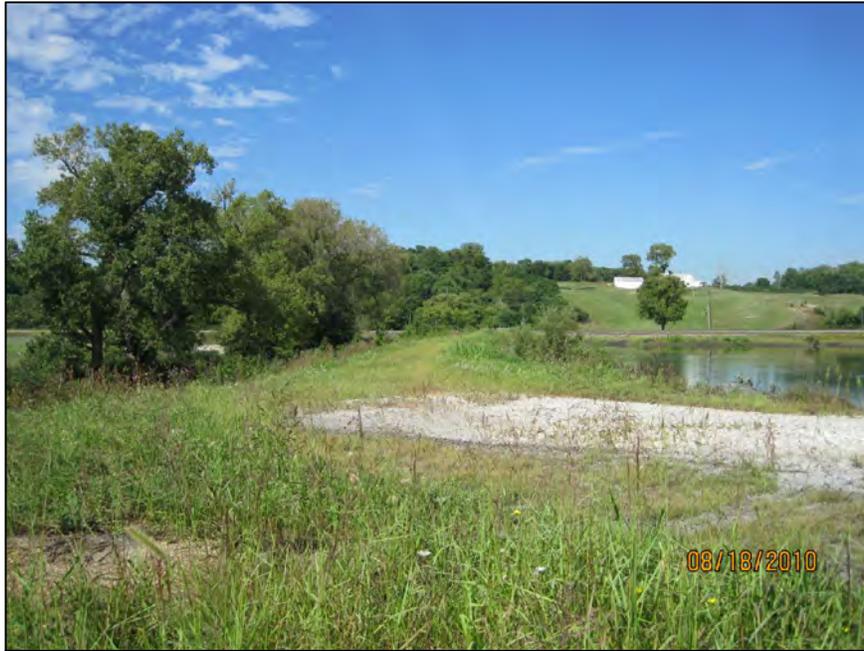
W-5

FROM ACCESS ROAD LOOKING WEST ALONG SOUTHERN CORNER

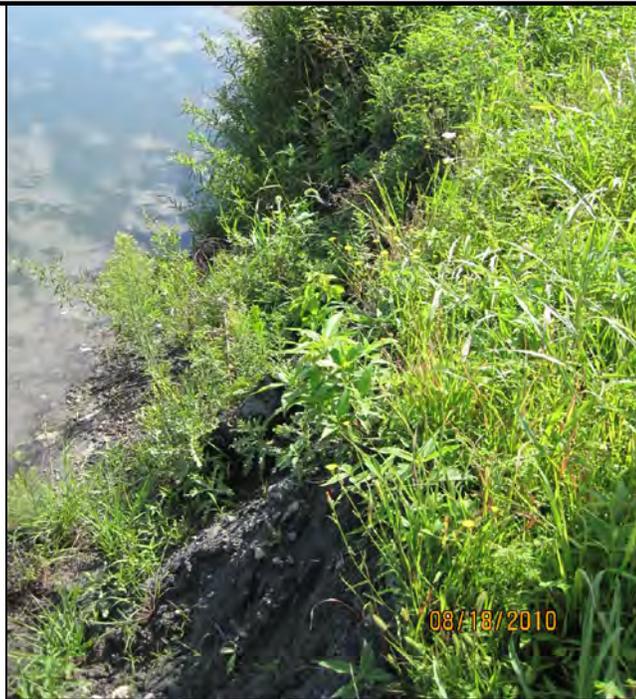
W-11
ERODED SOUTHERN INTERIOR SLOPES

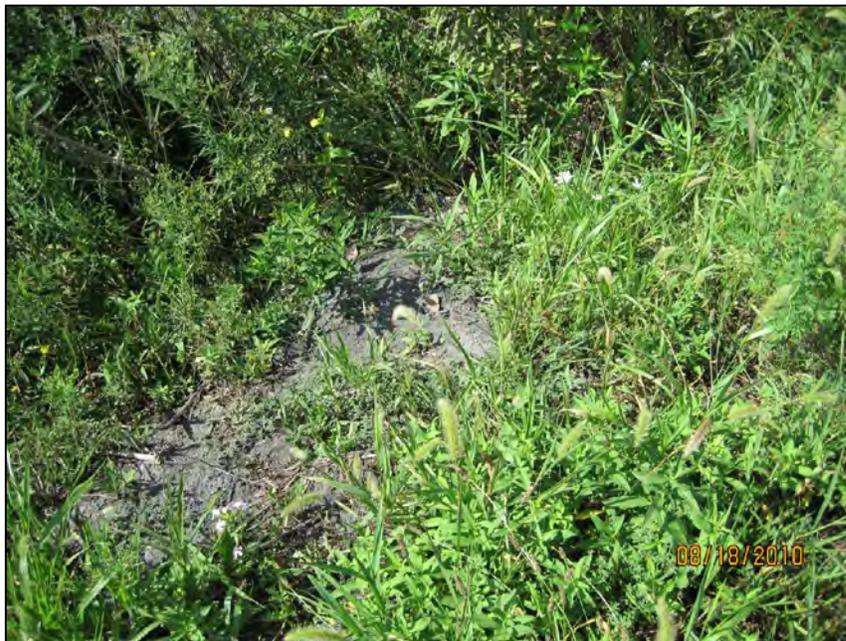
W-12
ASH NOTED ON SOUTHERN DOWNSTREAM SLOPE

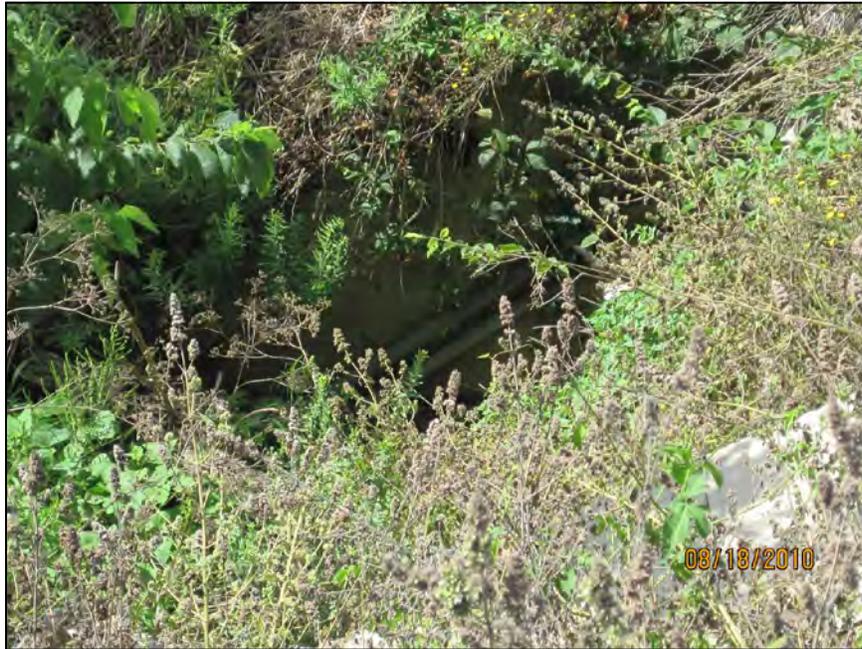
W-13

CULVERT LOCATED AT SOUTHWESTERN TOE

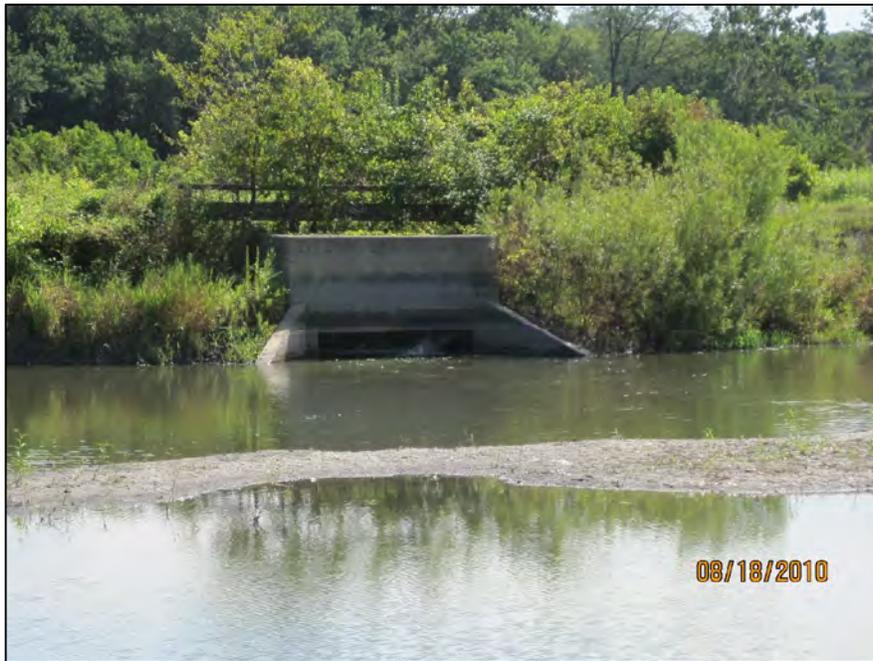
W-15

OVERFLOW STRUCTURE LOCATED ALONG EASTERN INTERIOR SLOPE, WATER NOTED TO BE FLOWING INTO THE POND FROM THE SECONDARY SETTLING POND

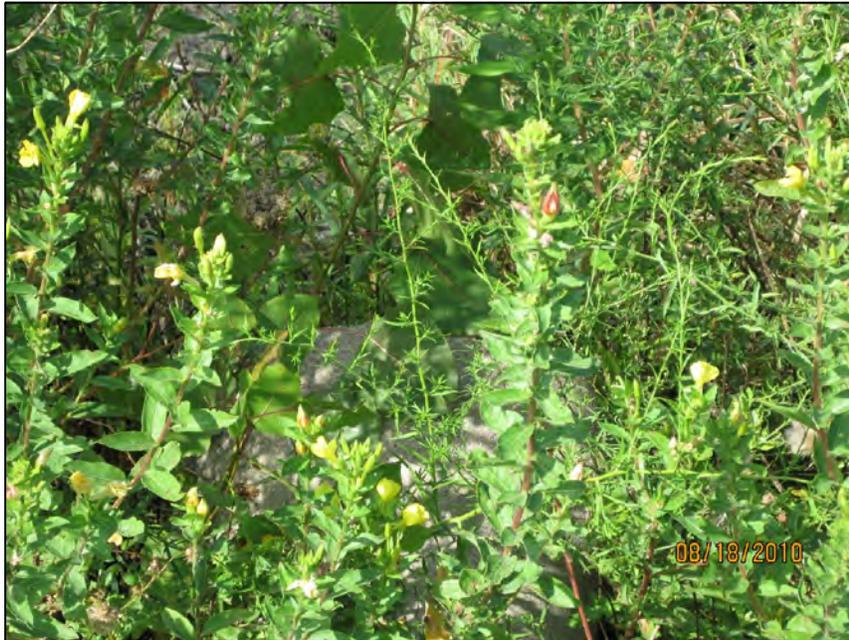
W-17

**EMERGENCY OVERFLOW BETWEEN WEST PRIMARY SETTLING POND AND EAST
PRIMARY SETTLING POND**

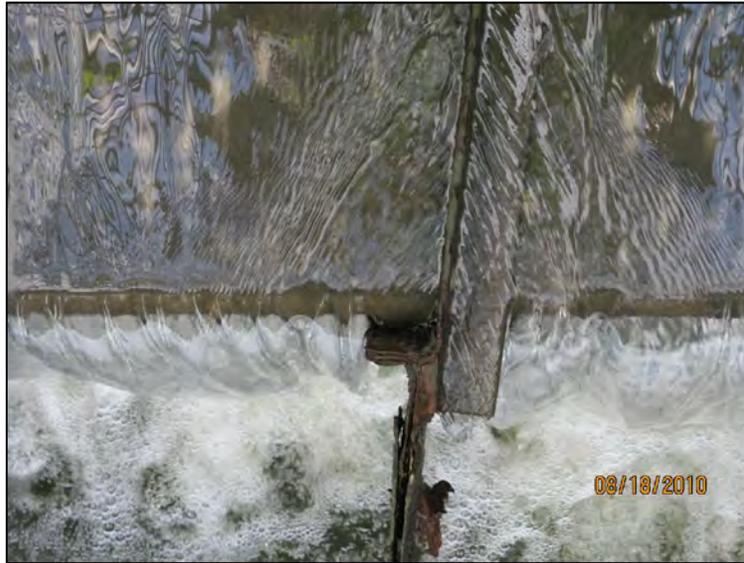
W-19

WATER FLOWING WITHIN OVERFLOW STRUCTURE INTO WEST PRIMARY SETTLING POND

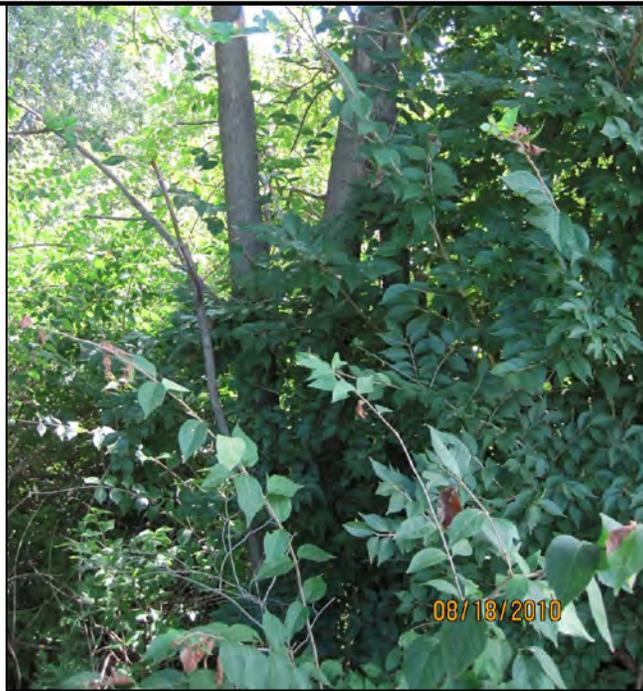
S-3

TYPICAL VEGETATION ALONG NORTHERN DOWNSTREAM SLOPE

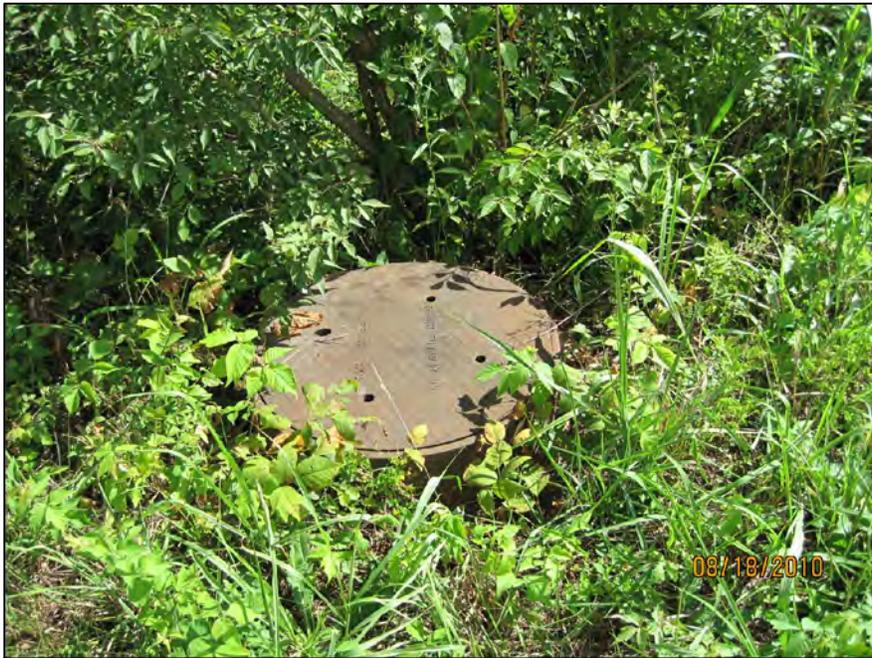
was observed flowing within the manhole that is located between the pond outlet and NPDES outlet along the Great Miami River (photos S-7 and S-8). Due to heavy vegetation the outlet along the Great Miami River was not observed.

MANHOLE LOCATED BETWEEN TREATMENT STATION AND FINAL OUTLET FOR SETTLING POND
