Report of Dam Safety Assessment of Coal
Combustion Surface Impoundments
Dayton Power and Light Company
O.H. Hutchings Electric Generating Station
Miamisburg, OH

AMEC Project No. 3-2106-0177.0006

April 2011

Dayton Power and Light Company, O.H. Hutchings Electric Generating Station: East Primary Settling Pond, West Primary Settling Pond, and Secondary Settling Pond were assessed on August 18, 2010.

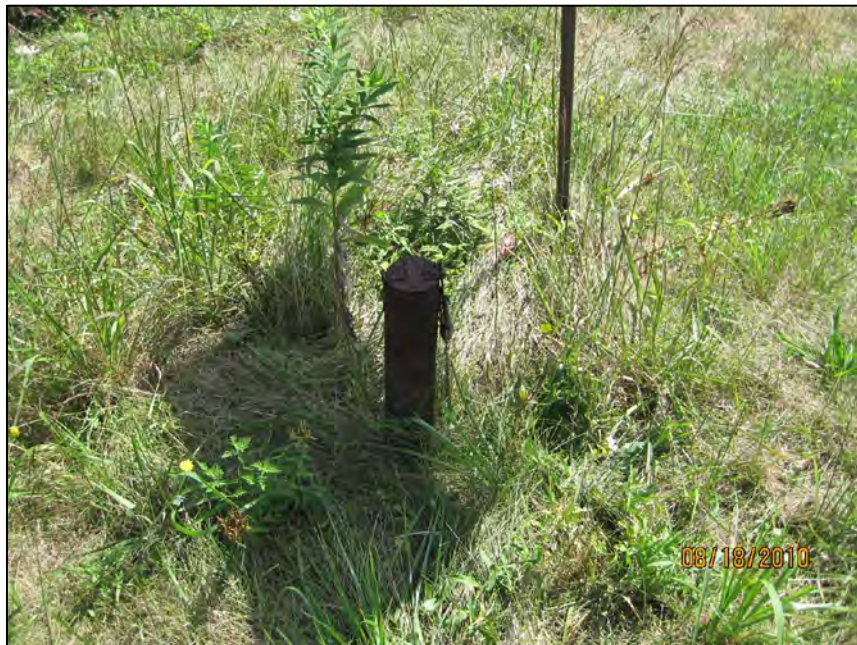
E-10

At the time of AMEC's site visit, one monitoring well was observed along the southern portion of the eastern crest of the East Primary Settling Pond (photo E-10). Site personnel indicated that additional monitoring wells were recently discovered, however, are not monitored.

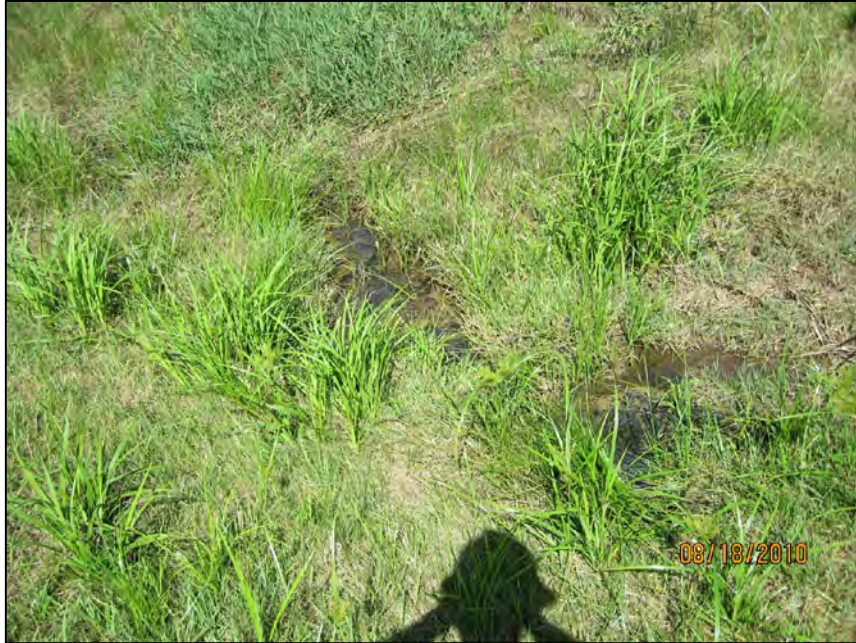
E-11
WET AREA ALONG SOUTHERN DOWNSTREAM TOE

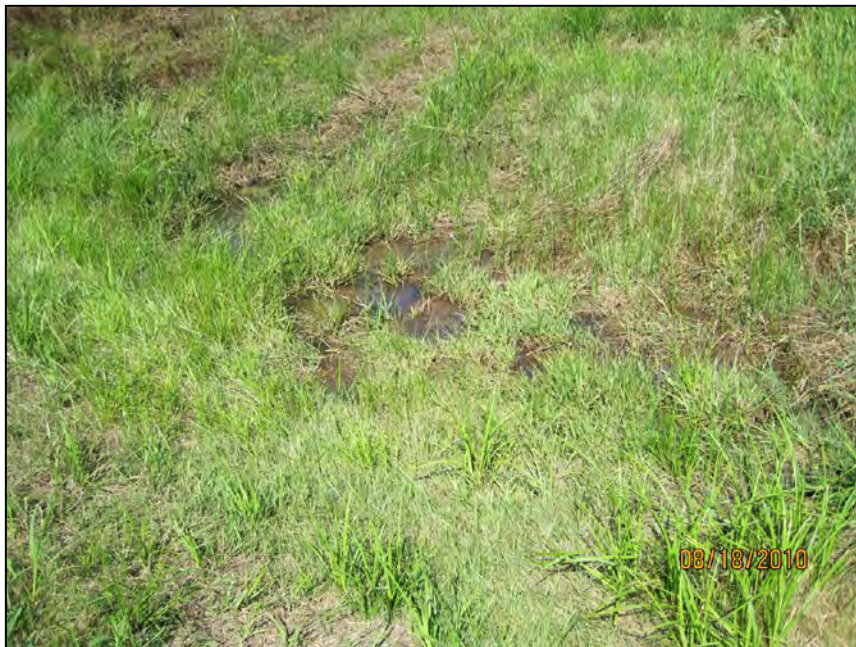
E-12
WET AREA ALONG SOUTHERN DOWNSTREAM TOE

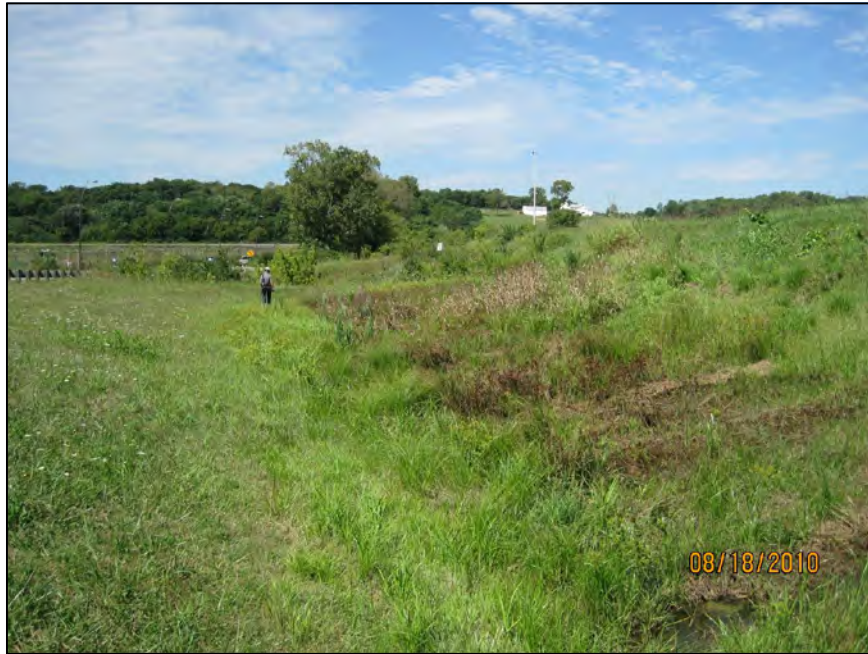
E-13

WET AREA ALONG SOUTHERN DOWNSTREAM TOE

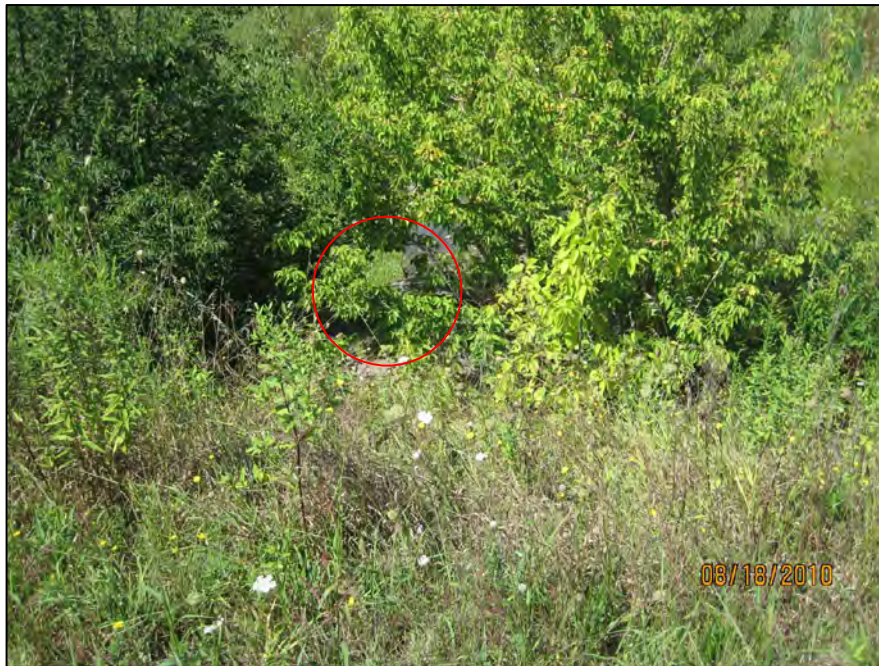
E-15

PIPE OUTLET LOCATED ALONG SOUTHERN DOWNSTREAM TOE

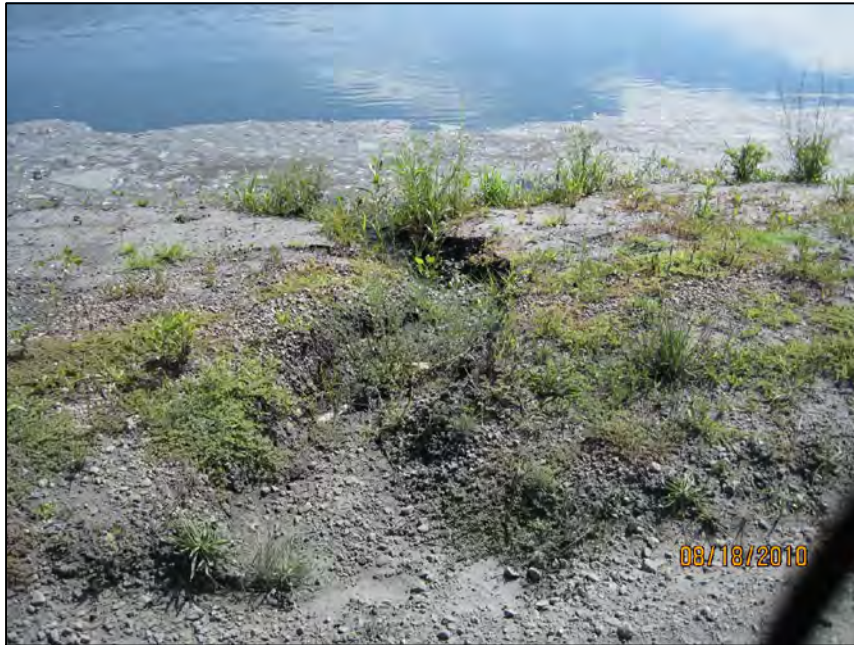
E-17
EROSION RILL ALONG WESTERN INTERIOR SLOPE

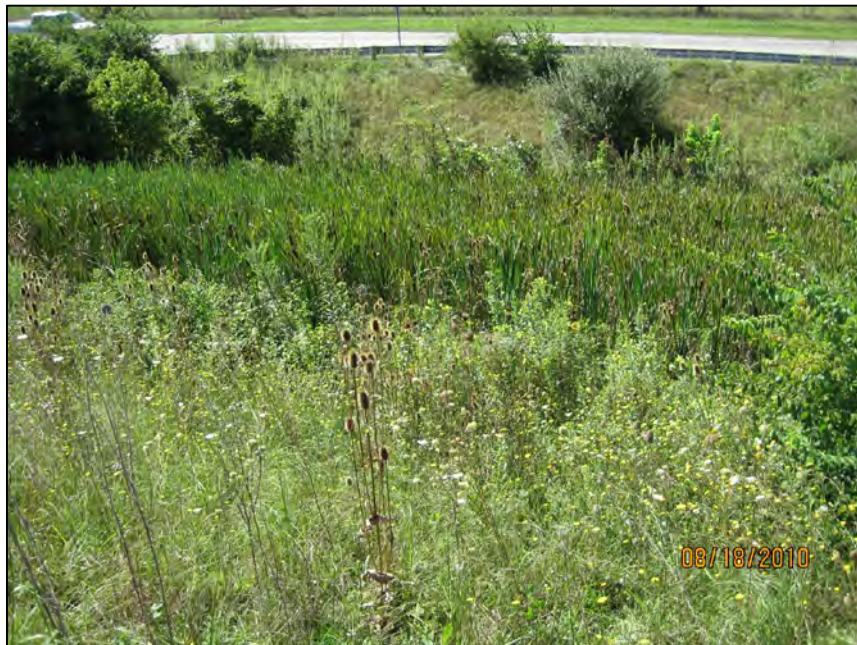
W-10

primarily surfaced with grass and heavy vegetation (photos W-2, W-5 and W-10). Heavy vegetation included grasses, brush, and trees up to 2 inches in diameter. The surface of the common dike is covered with an approximately 8-inch thick crushed stone surface (photo E-2). Several low spots and erosion rills which could affect freeboard were observed along the crest of the common dike (photo W-16). Erosion was noted along the southern interior slopes (photo W-11). Wet areas were suspected along the southern downstream toe due to wetland vegetation (cattails shown in photo W-10), however due to the density of the vegetation, could not be confirmed.

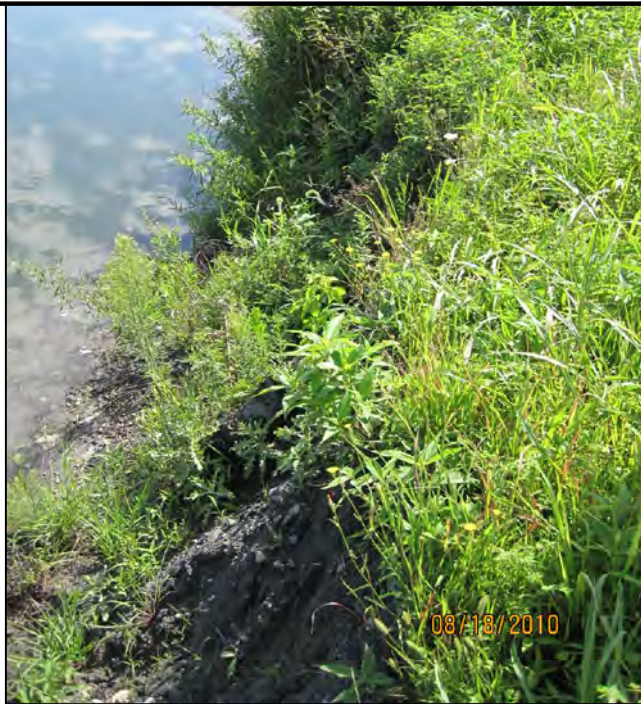
W-11
ERODED SOUTHERN INTERIOR SLOPES

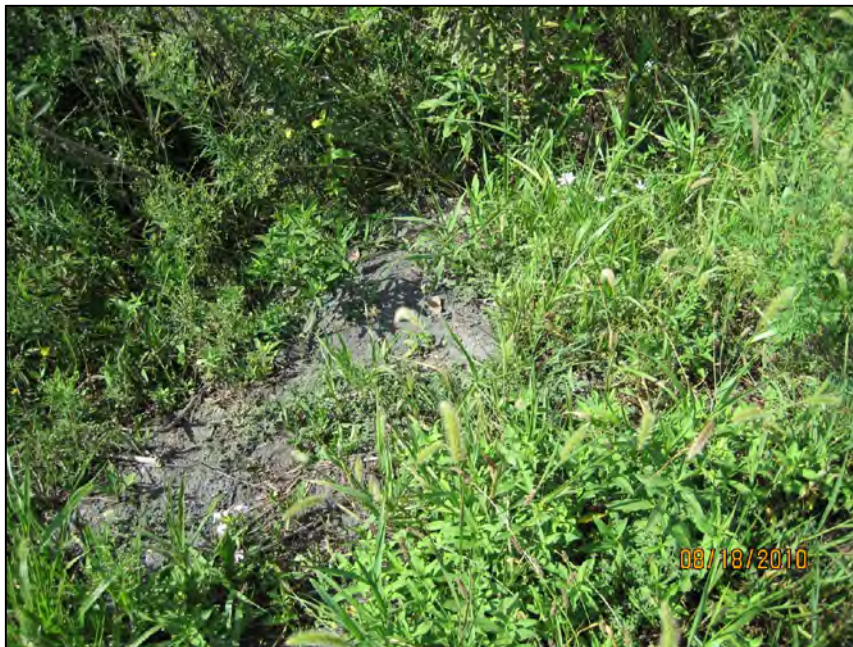
W-12
ASH NOTED ON SOUTHERN DOWNSTREAM SLOPE

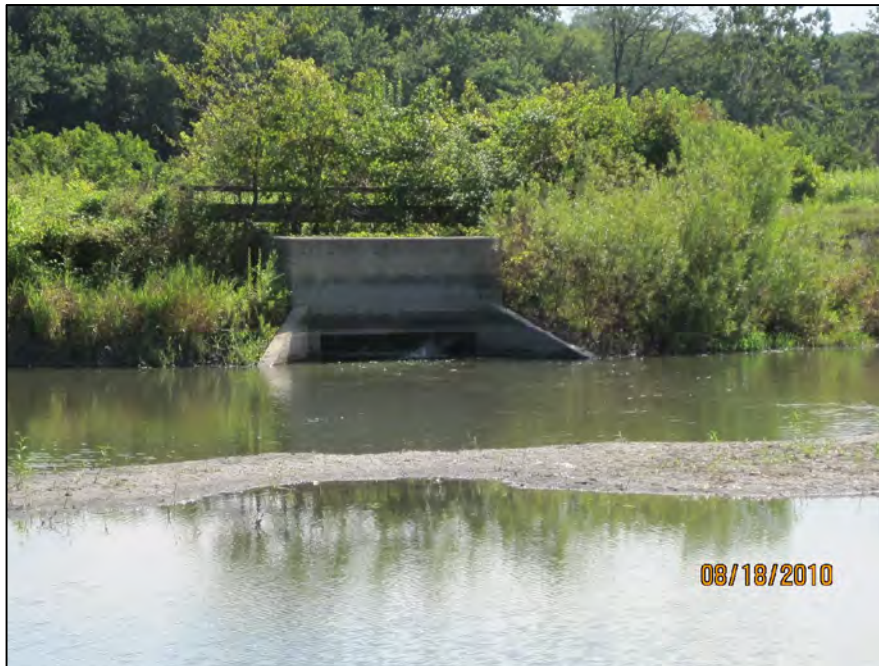
W-15

OVERFLOW STRUCTURE LOCATED ALONG EASTERN INTERIOR SLOPE, WATER NOTED TO BE FLOWING INTO THE POND FROM THE SECONDARY SETTLING POND

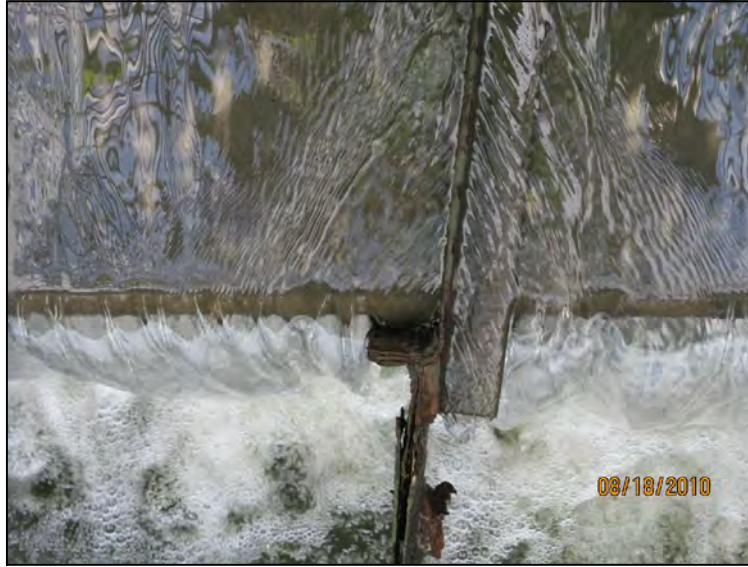
W-19

WATER FLOWING WITHIN OVERFLOW STRUCTURE INTO WEST PRIMARY SETTLING POND

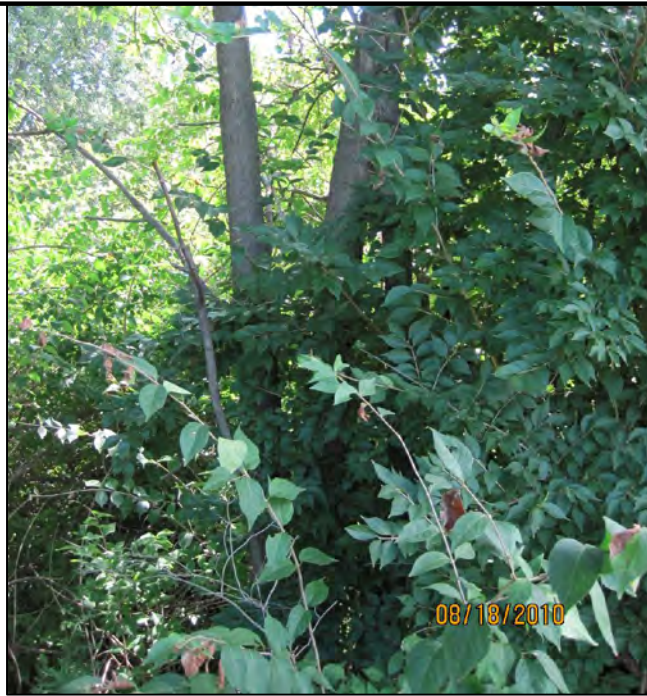
S-3

The Secondary Settling Pond has a diked configuration. Because survey data was not available and gauges are not located within the pond, freeboard was not able to be determined. The crest and dikes (upstream and downstream) of the dam are primarily surfaced with grass and/or heavy vegetation (photos S-1, S-3, S-4, S-5, and S-6). Heavy vegetation included grasses, brush, and trees up to 6 inches in diameter. An irregular surface was noted along the northern downstream toe.

TYPICAL VEGETATION ALONG NORTHERN DOWNSTREAM SLOPE

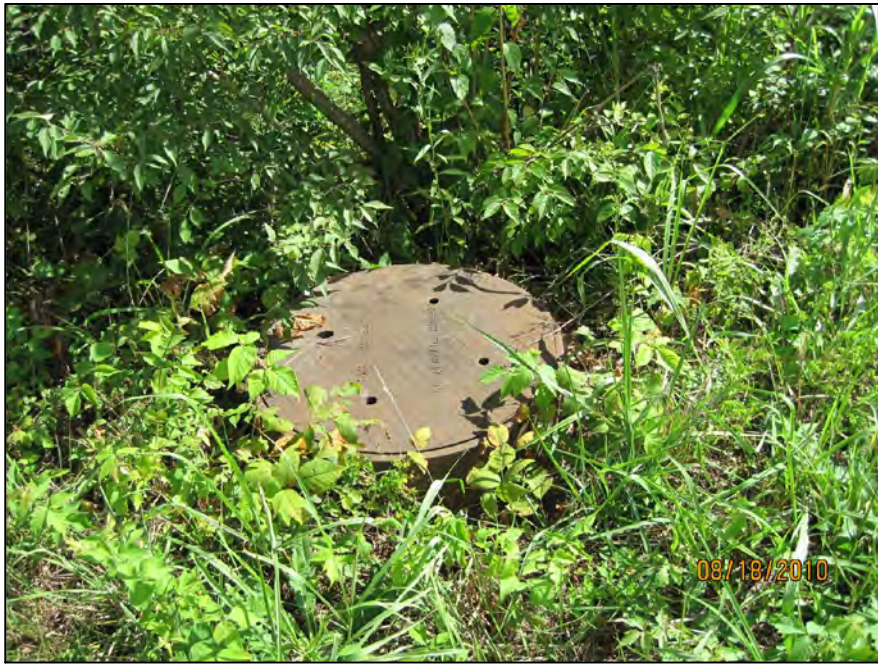
was observed flowing within the manhole that is located between the pond outlet and NPDES outlet along the Great Miami River (photos S-7 and S-8). Due to heavy vegetation the outlet along the Great Miami River was not observed.

MANHOLE LOCATED BETWEEN TREATMENT STATION AND FINAL OUTLET FOR SETTLING POND
