# **Dam Safety Assessment of CCW Impoundments**

## **Possum Point Power Station**

June 9, 2010

**O'BRIEN & GERE**  
[www.obg.com](http://www.obg.com)

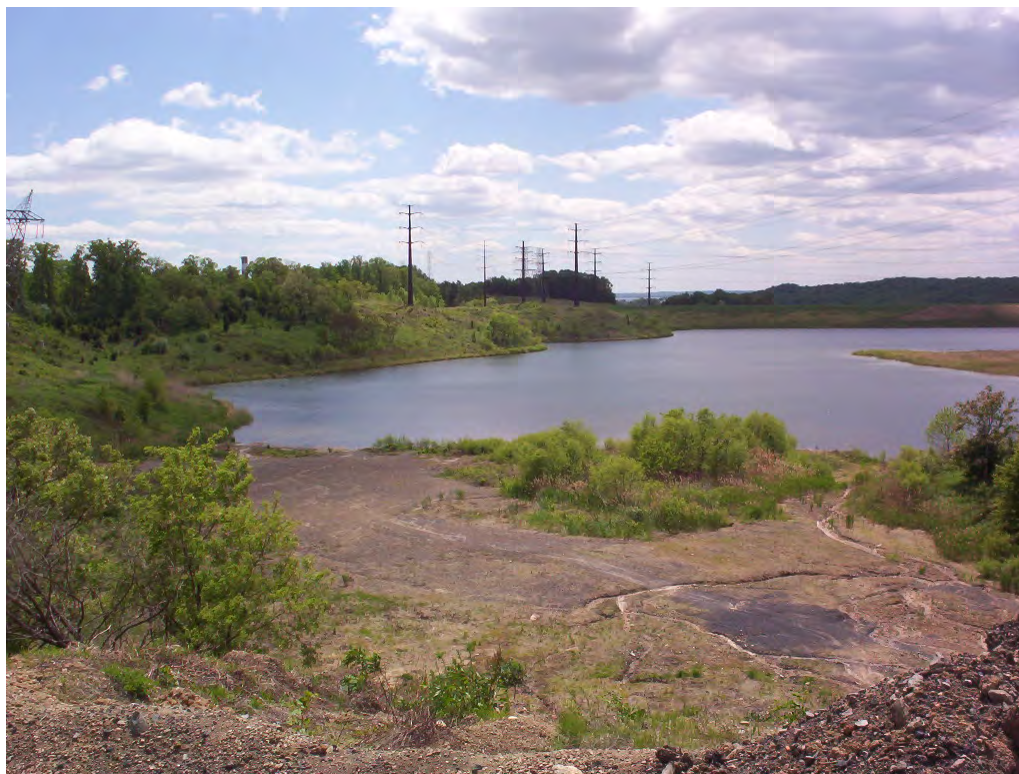
Photo Number:  
1

Description:  
Reservoir from  
north bank.  
Note dredged  
material in  
foreground of  
picture

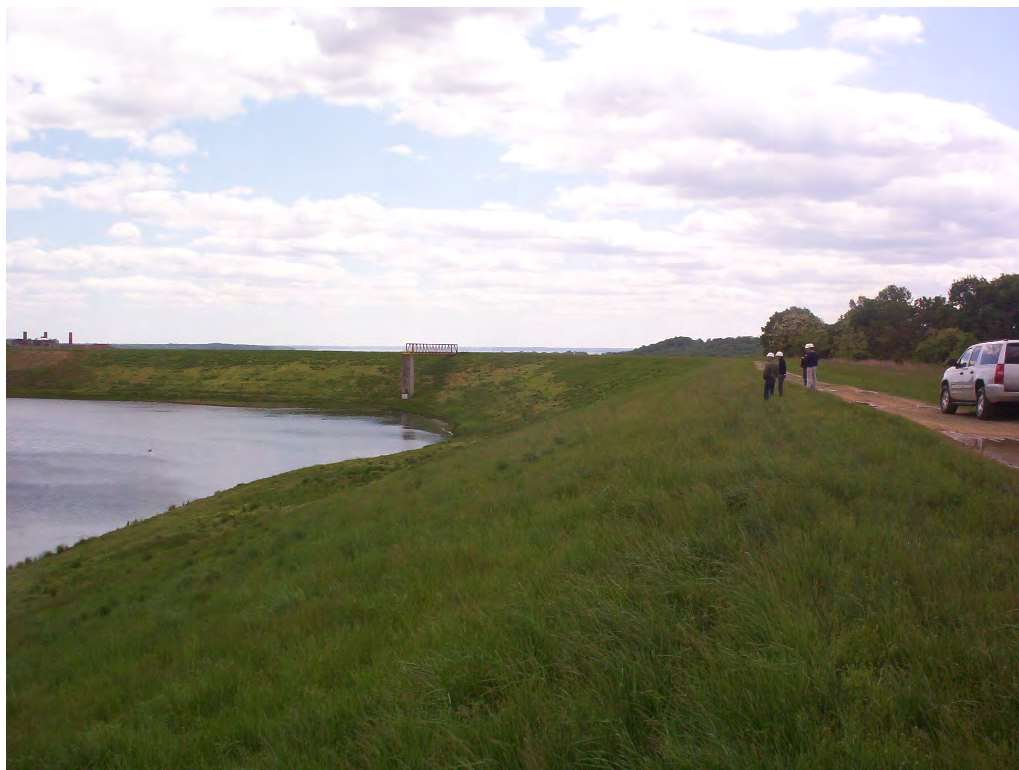
Photo Number:  
2

Description:  
Crest of dam  
looking  
upstream face.

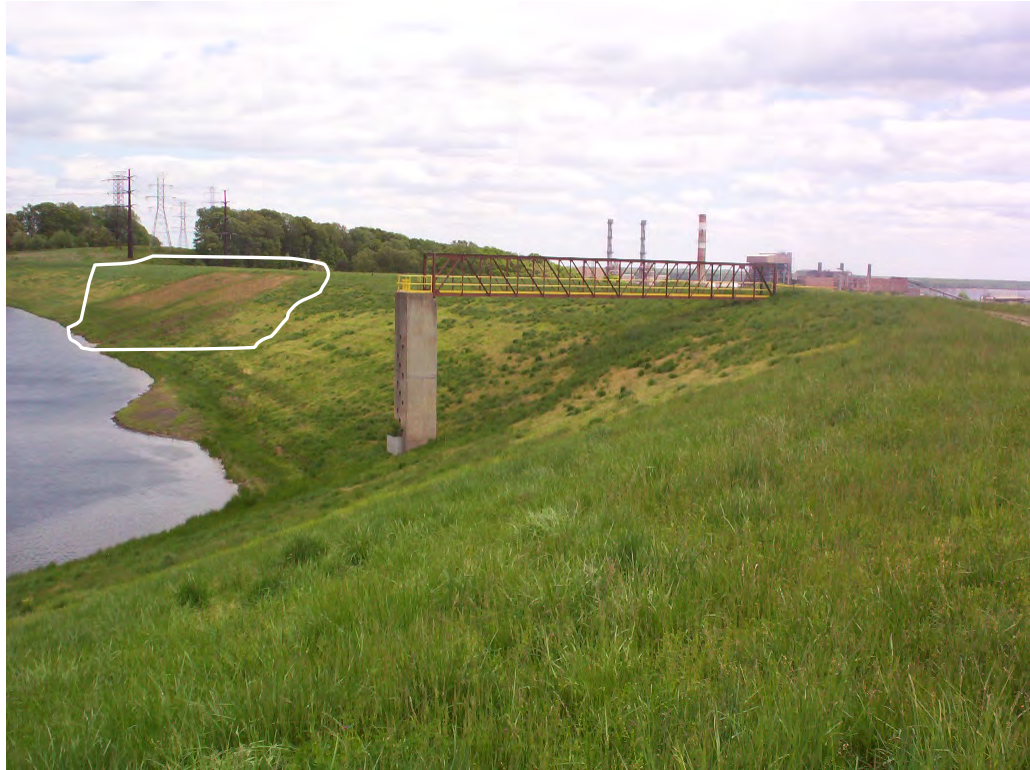
- The upstream slope of the embankment is covered with well-tended grass, which is mowed 2-3 times per year (Appendix B – Photo 2 and 3).
- As noted in the review of the documents, Dominion Power personnel reported that a 24-inch thick clay liner had been installed on the upstream slope of the dam. Apparently, a large amount of rain fell last year and caused minor sloughing of the slope. Ongoing repairs have included regrading and hydroseeding of the slope. At the time of the site visit, the grass had not been reestablished on the slope. This area can be seen on the left side of Photo 3 (Appendix B).

Upstream slope of dam and decant tower. Note area of bare soil toward middle of the dam which has recently been repaired due to sloughing of soil on top of clay layer.

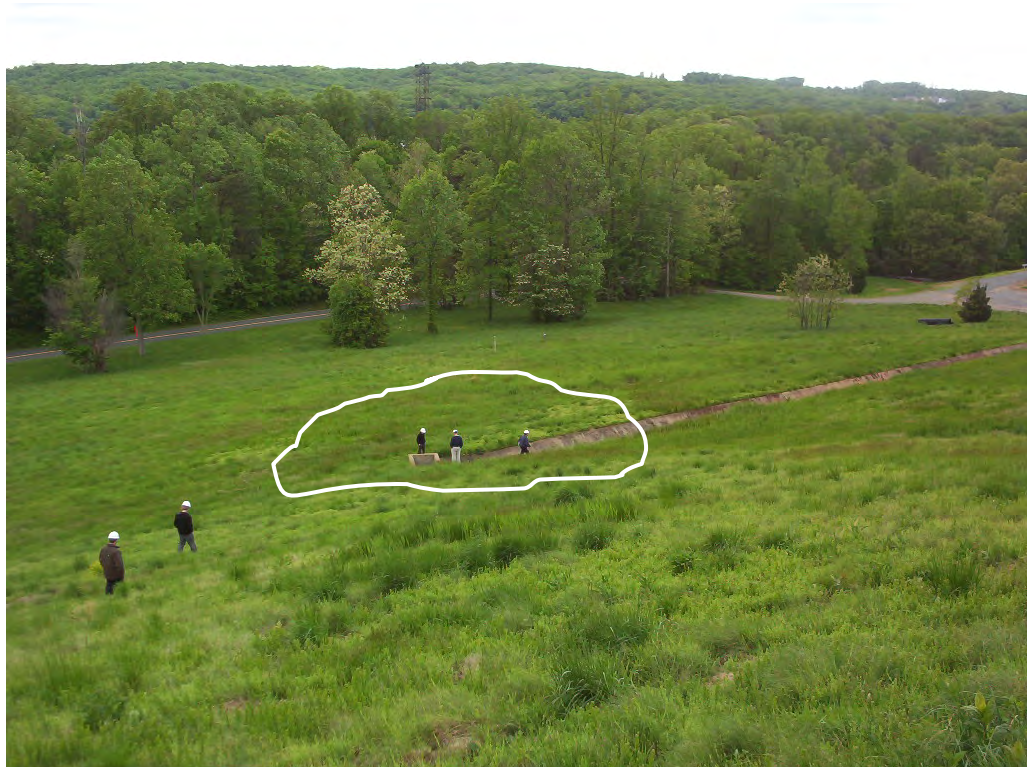
- On the downstream slope, there is an area of seepage along the southwestern portion of the embankment that appears to be below the pond water level. Dominion Power operators stated that this area is wet throughout the year, which results in difficulty in mowing because the tractors get stuck. Dominion Power also noted that this area was wet prior to the construction of the dam and it appears to be a perched groundwater condition at the interface between the embankment and natural ground. The area of saturation is shown by the taller grasses in Appendix B – Photo 4 and Photo 7.

Downstream slope of dam and drainage outfall structure and concrete channel. Approximate area of wetness highlighted.

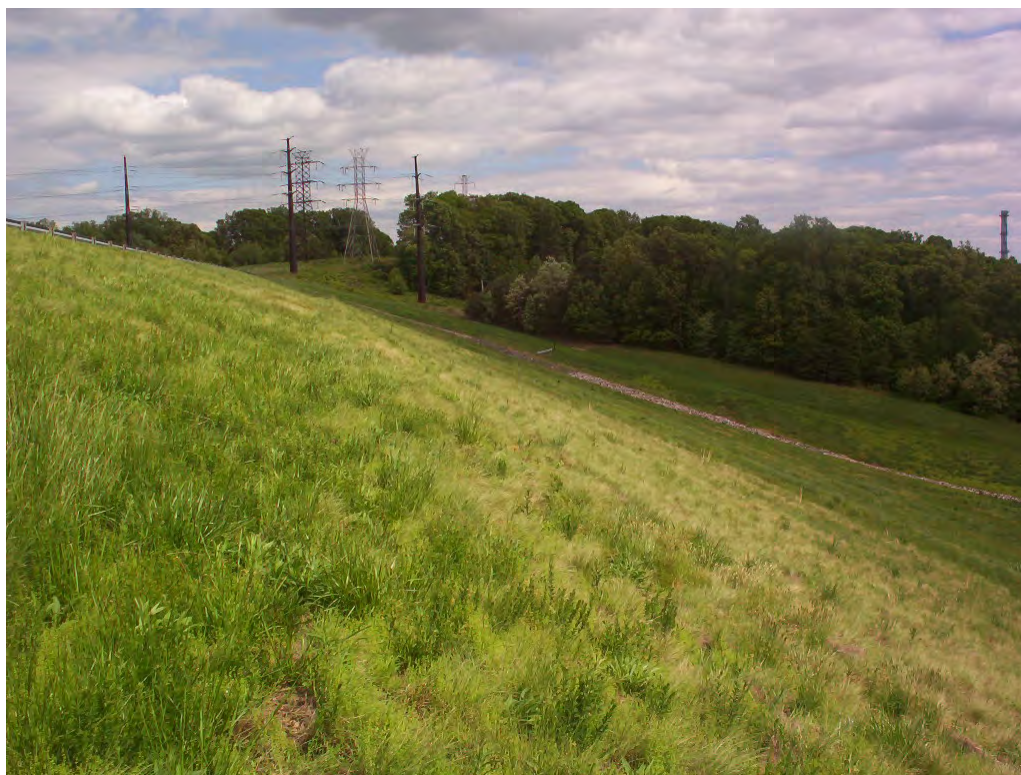
Photo Number:  
5

- The downstream slope of the dam is well maintained, although there are some minor erosion gullies visible. (Appendix B – Photo 5). There are also several locations where sloughing occurred after construction. These areas have been repaired by filling with large riprap. A close examination of these areas showed no visible signs of continued movement.

Description:  
Downstream  
slope of dam.

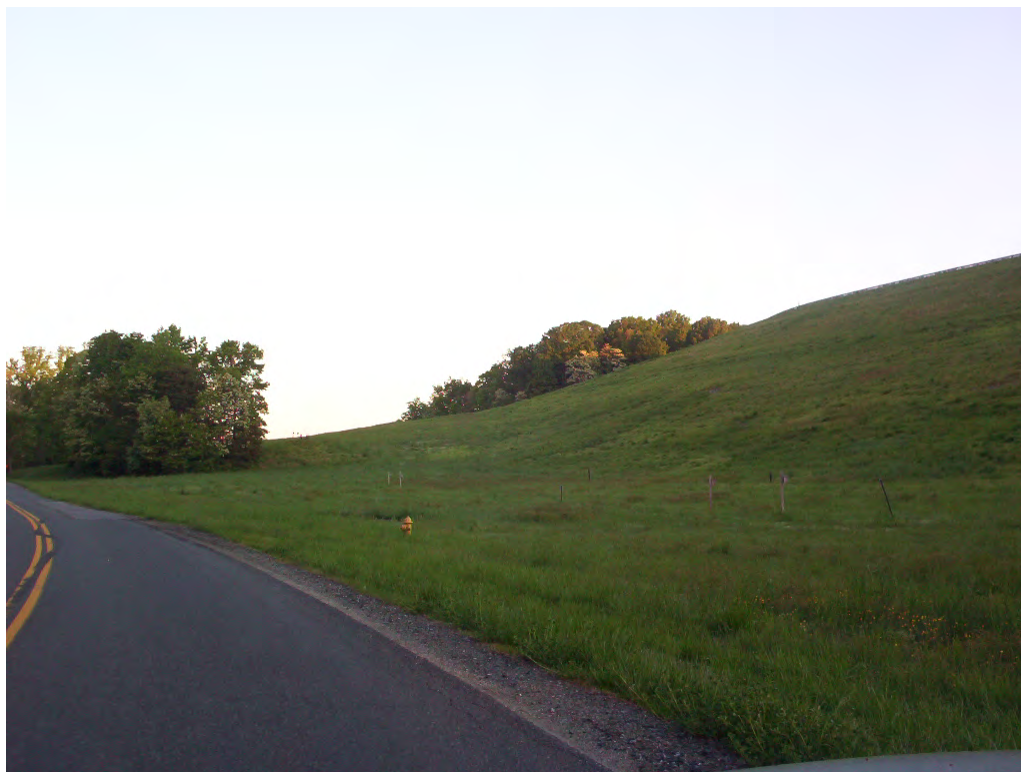
Photo Number:  
6

Description:  
Downstream  
slope of dam.  
Toe-drainage  
structure near  
fire-hydrant in  
fore-ground

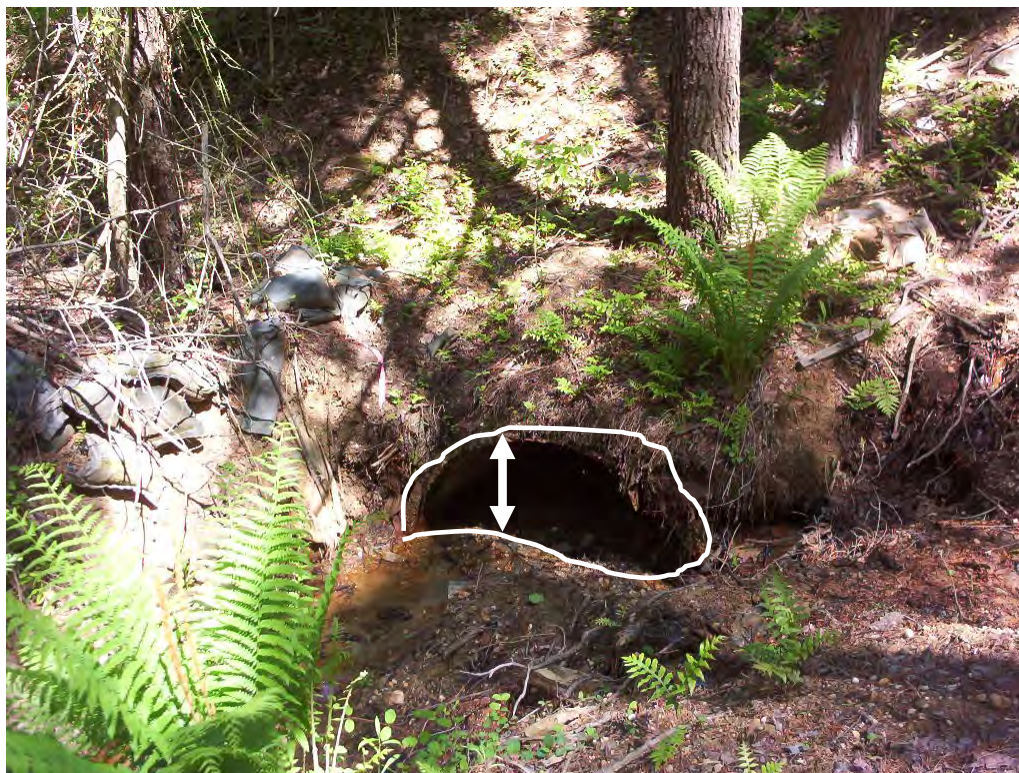
Toe-drain outlet pipe. Note, sediment in ditch only provide 2.25' opening in 6-foot pipe.

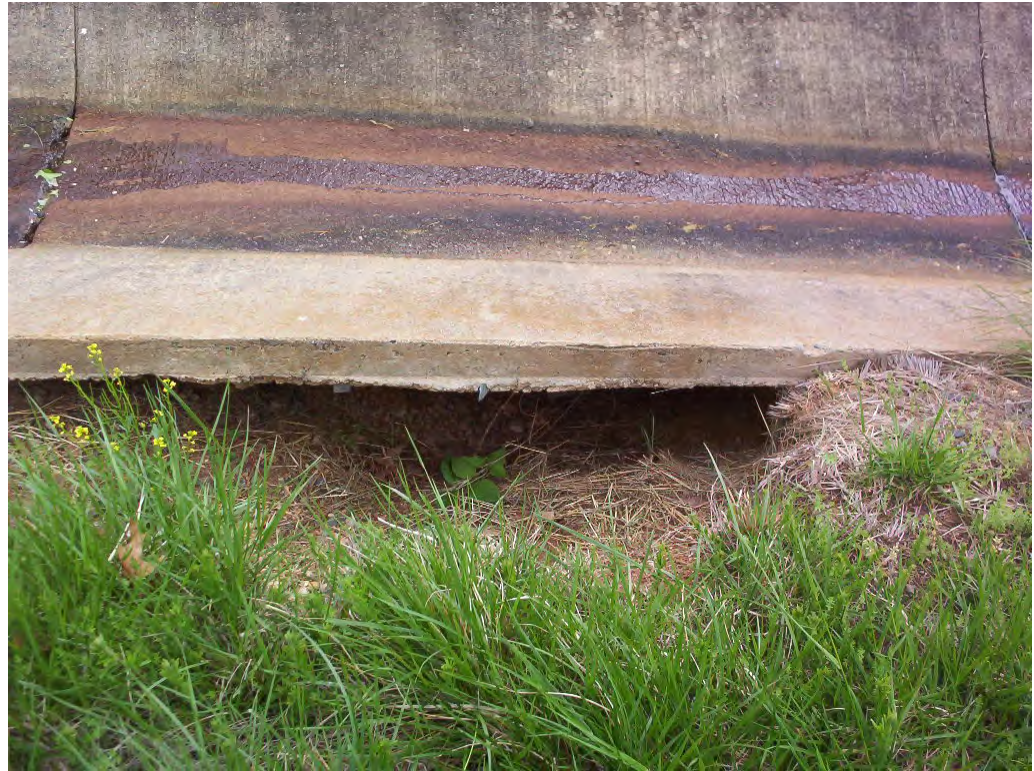
Photo Number:  
9

Description:  
Erosion at  
downstream  
concrete lined  
channel from  
Ash Pond D to  
Ash Pond E

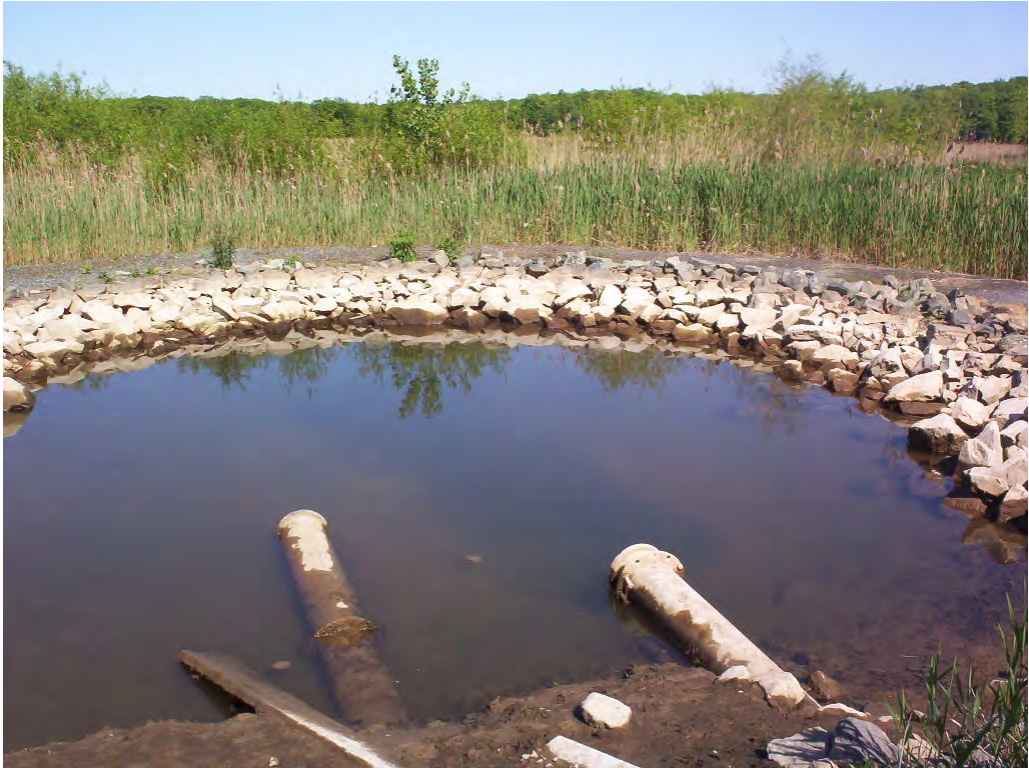
Photo Number:  
1

Description:  
Photo of stilling basin as pipes enter Ash Pond E

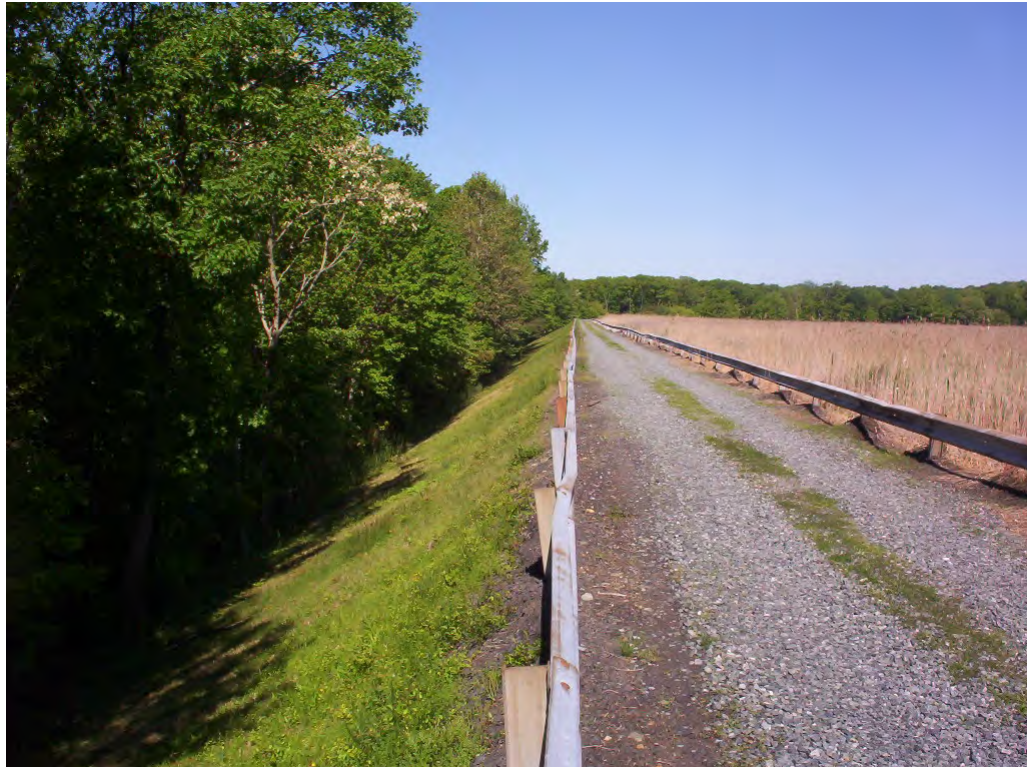
Photo Number:  
2

Description:  
Crest of dam looking West

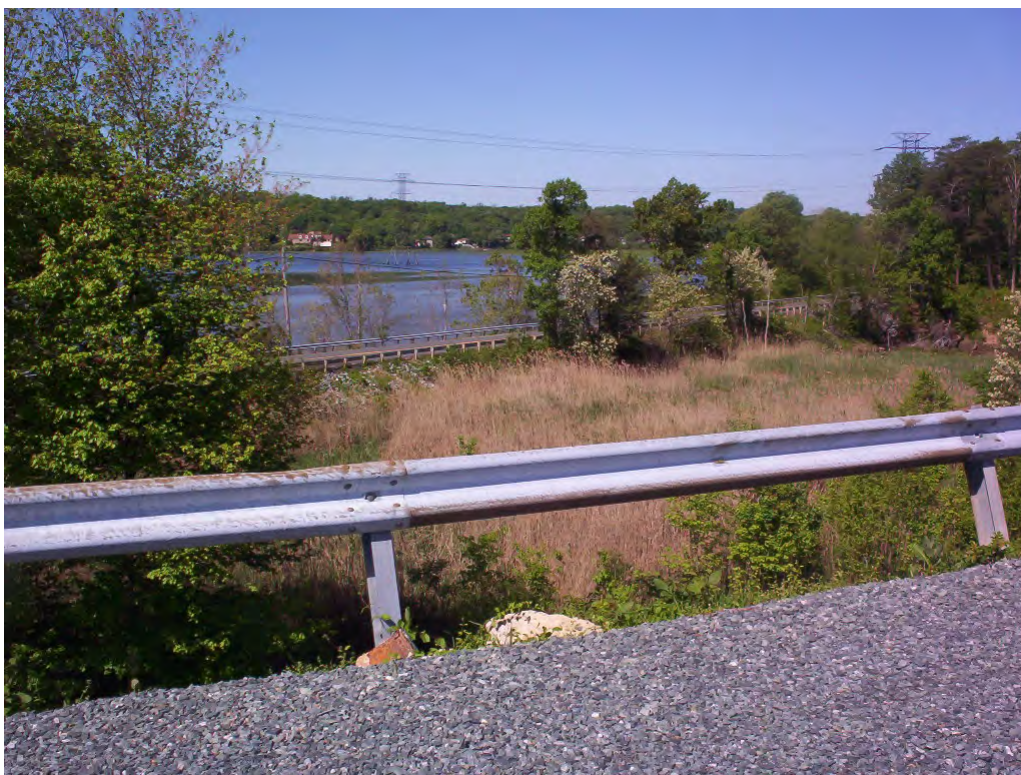
Photo Number:  
5

Looking at  
marsh area  
downstream of  
dam and close  
proximity to  
Quantico Creek  
(bay).

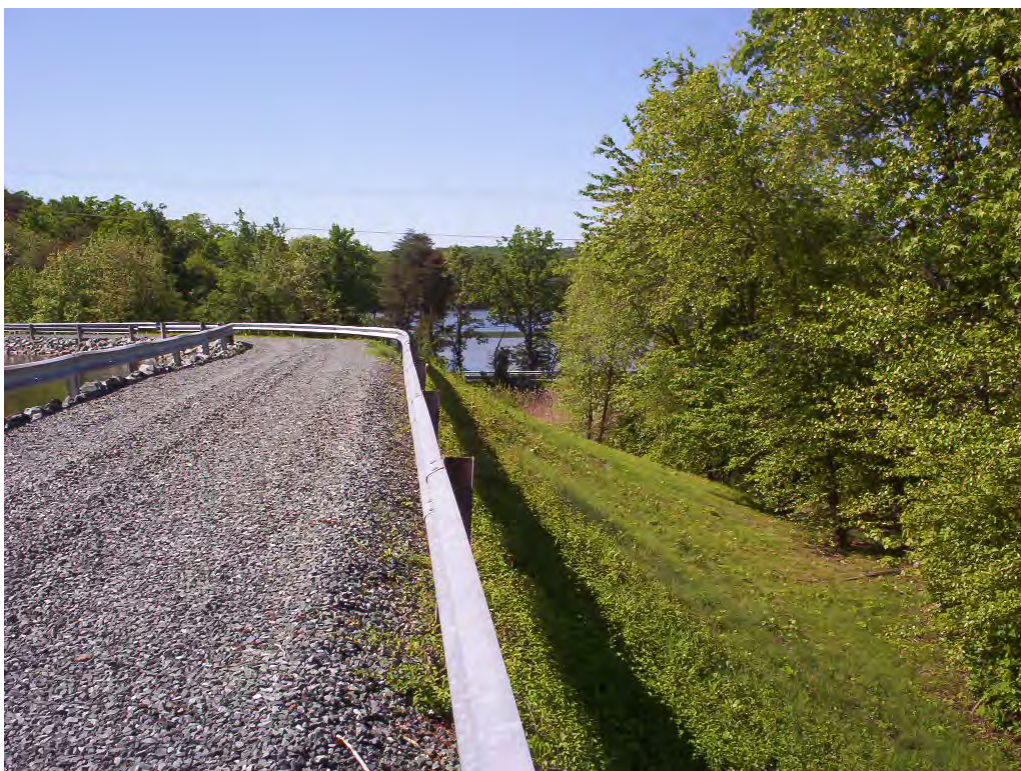
Photo Number:  
6

Description:  
Crest of dam  
looking at  
downstream  
slope. Notice  
trees  
encroaching on  
toe of dam.

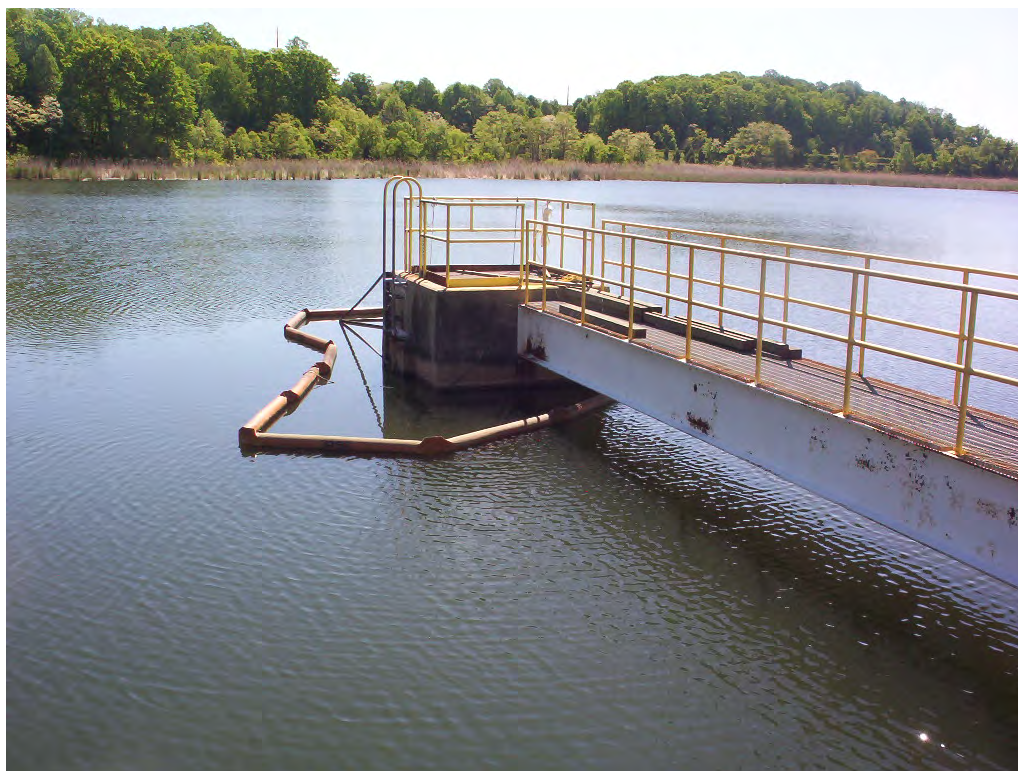
- The outlet structure appeared to be in good condition and functioning normally (Appendix C – Photo 7 and Photo 8). However, the operators adjust the pond elevation by inserting or removing stop logs at the spillway drop inlet and it could not be determined if there is adequate freeboard between the maximum pool elevation and the low point on the crest of the embankment.

Decant

structure. Note boom on surface to prevent floatables from entering discharge pipe.

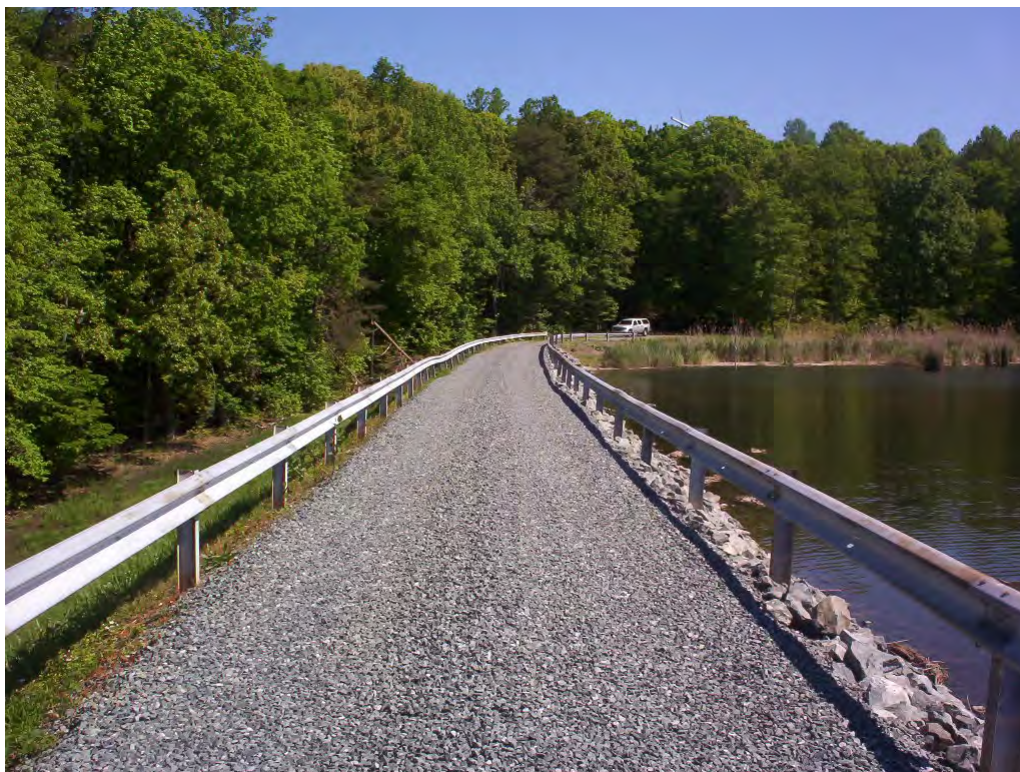
Crest of dam.  
Noted gravel  
driving surface  
and rip-rap on  
upstream face  
of dam.

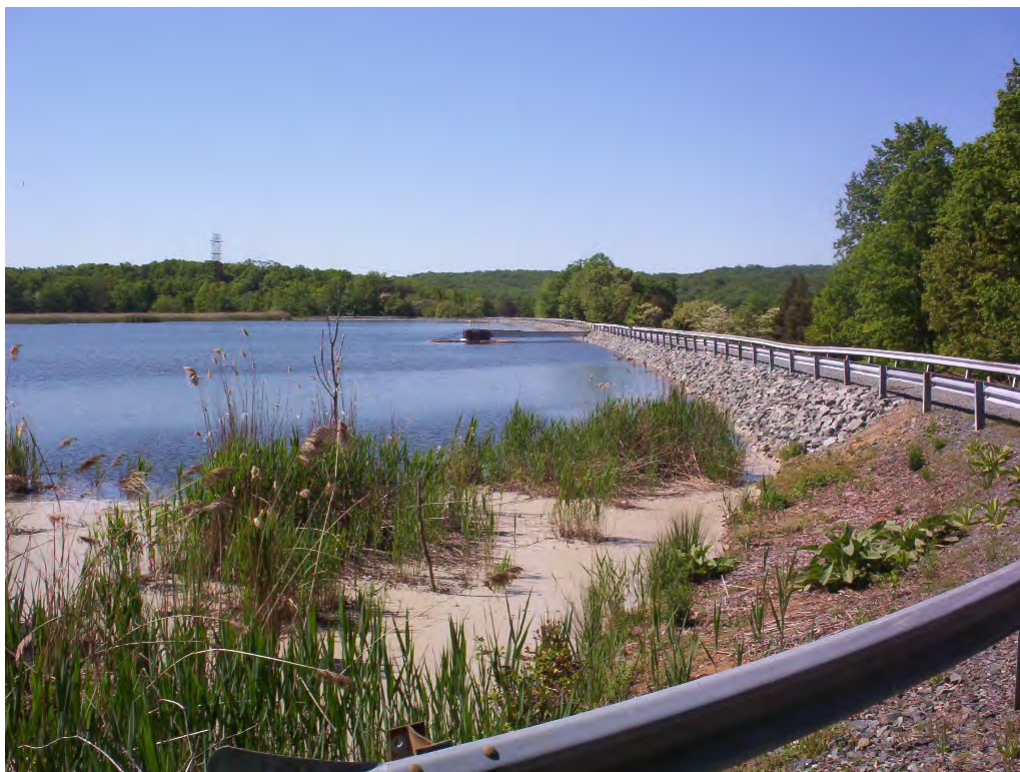
Upstream face  
of dam.
