**Coal Combustion Waste Impoundment
Round 6 - Dam Assessment Report**

East Bend Station (Site # 002)

Fly Ash Dike
Duke Energy
Boone County, KY

August 2010

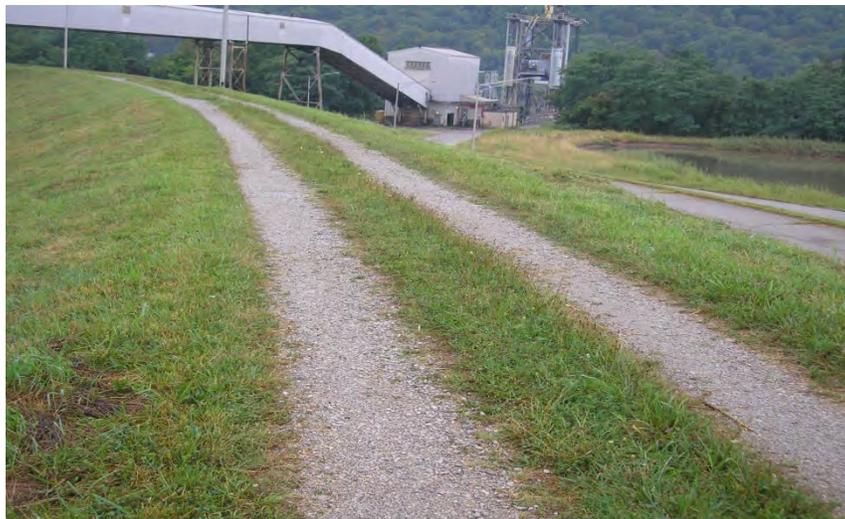
The crest of the embankment had no signs of significant depressions, tension cracks or other indications of settlement or shear failure. Figure 5.2.1-1 shows the typical crest conditions. Photographs 1 and 2, Appendix B provide additional views of the embankment crest.

Figure 5.2.1-1: Photograph of Impoundment Dike Crest View to East

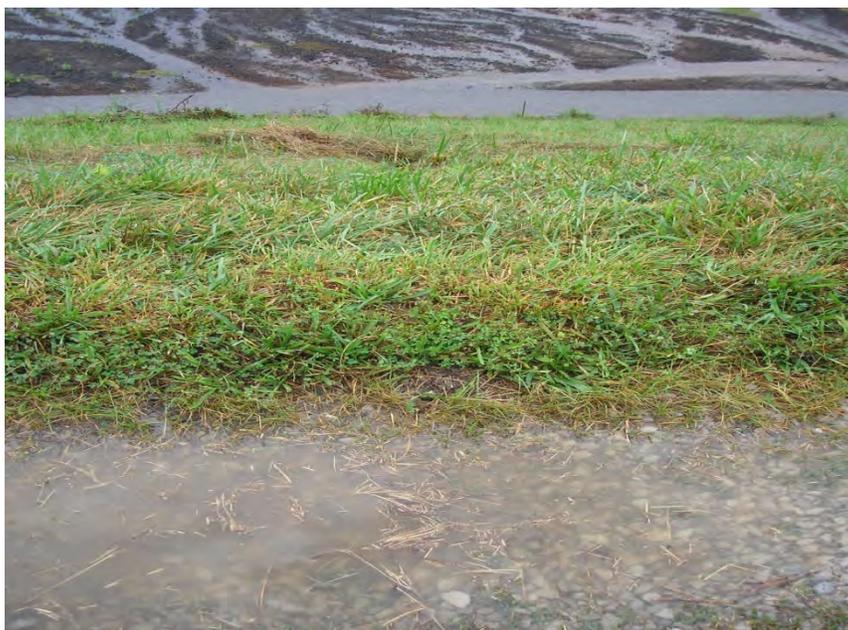
In scattered areas vehicle traffic along the crest has caused depressions in the gravel tracks allowing water to pond. Overflow from these small ponding areas is causing small erosion rills on both the up-gradient and down-gradient slopes of the embankment. Figure 5.2.1-2 shows a small area of ponding in the gravel travel track along the embankment crest.

Figure 5.2.1-2: Water Ponding in Small Depression in Gravel Travel Track along Embankment Crest.

- Add rip rap armoring to toe of embankment up-gradient slope in areas susceptible to erosion caused by wave action
- Grade depressed traffic tracks along the crest to prevent water ponding and reduce erosion rills
- Repair erosion rills on both the up-gradient and down-gradient slopes
- Increase frequency of mowing dike embankments to improve effectiveness of daily observations and monthly inspections.

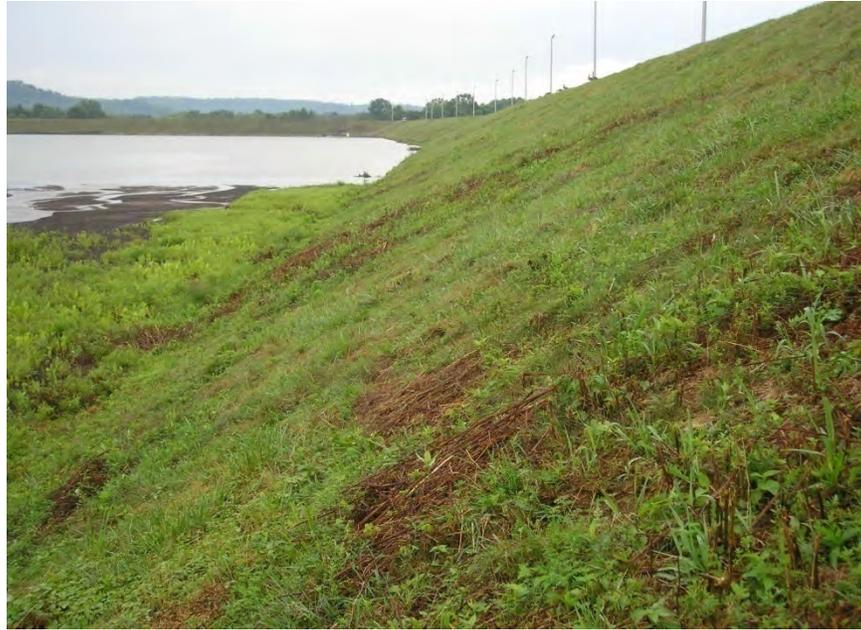
The up-gradient slope of the embankment is vegetated with various species of tall grass and weeds. There were no observed scarps, sloughs, bulging, cracks, depressions or other indications of slope instability. Figure 5.2.2-1 shows a representative section of the up-gradient slope of the embankment.

Figure 5.2.2-1: Photo of Embankment Up-gradient Slope View to East

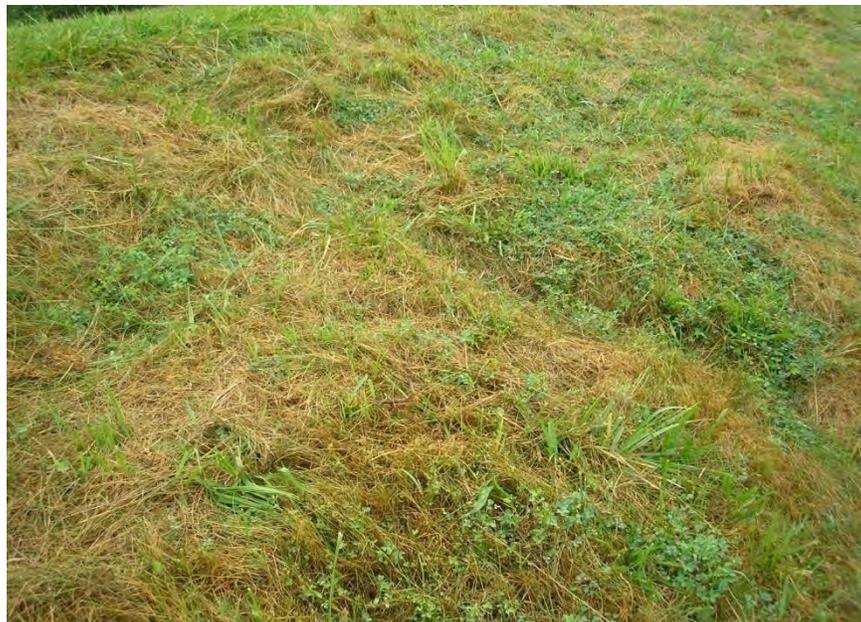
Small areas of sloughing or erosion were observed along the up-gradient slope. There was also evidence of animal burrows. Figures 5.2.2-2 and 5.2.2-3 show the conditions observed.

Figure 5.2.2-2: Photo of Small Erosion Rill on Up-gradient Slope

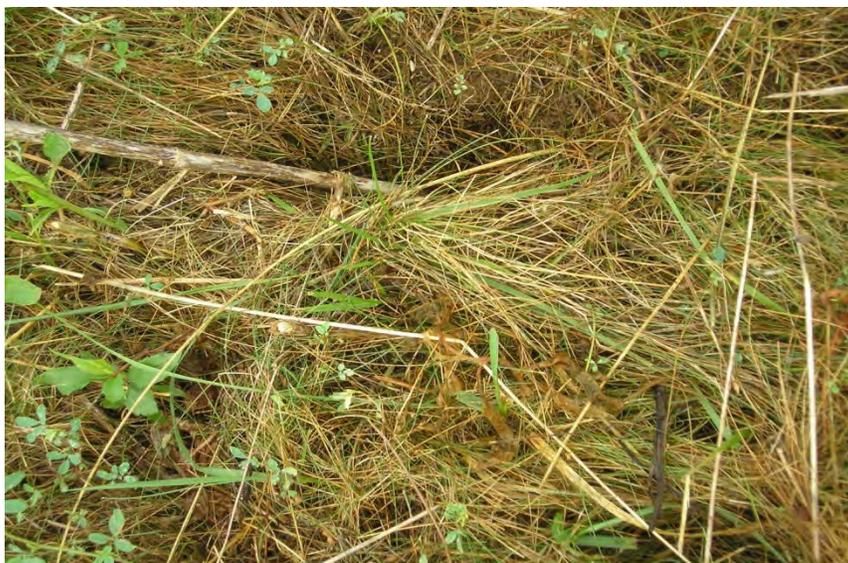
Figure 5.2.2-3: Evidence of Animal Burrow on Up-Gradient Slope

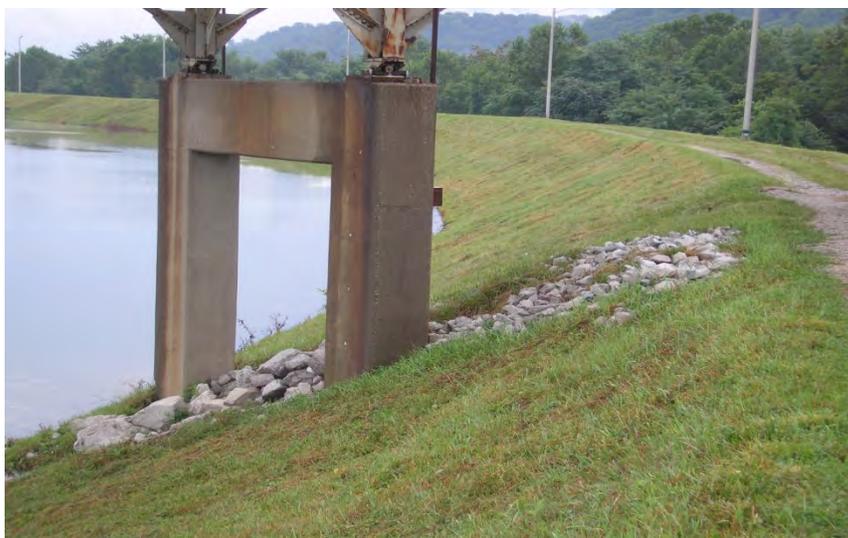
Areas of erosion repairs to the up-gradient slope were observed. The largest of the repairs were near the coal conveyor crossing. Storm water from broken gutters on the coal conveyor crossing caused areas of erosion beneath the conveyor. Figure 5.2.3-4 shows a typical repair area.

Figure 5.2.2-4: Erosion Repairs beneath Coal Conveyor Structure

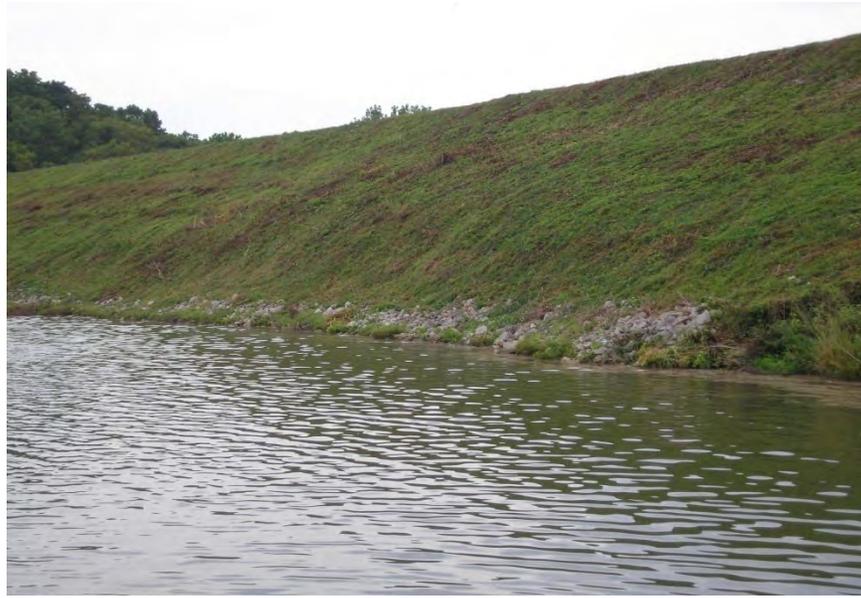
A section of up-gradient embankment toe along the eastern edge of the impoundment has been armored with rip rap to protect against erosion. Figure 5.2.2-5 shows the protected toe area.

Figure 5.2.2-5: Rip Rap Armoring to Protect against Wave Erosion

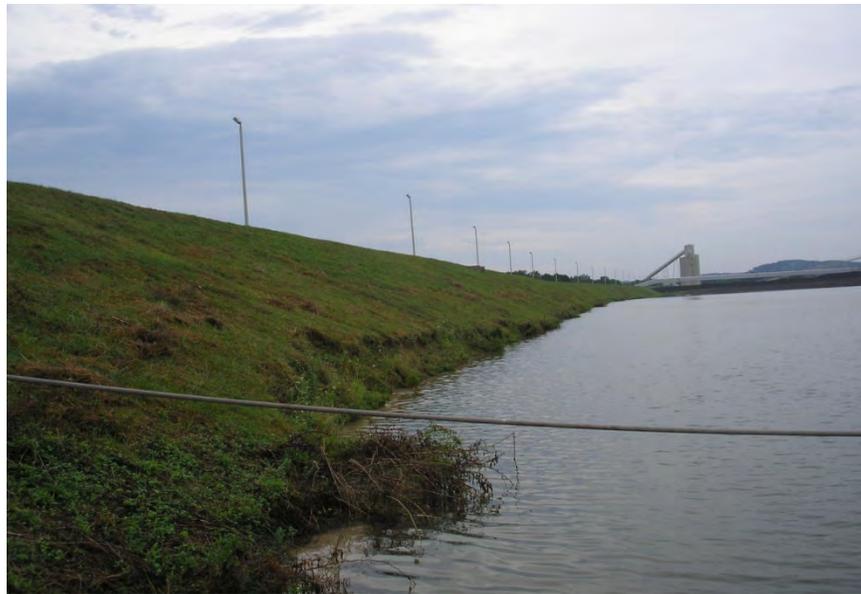
Observations at the site indicate other areas of wave erosion that warrant armoring, including the areas adjacent to the previously installed rip rap. Figure 5.2.2-6 shows an area of wave erosion near the primary spillway riser.

Figure 5.2.2-6: Up-gradient Embankment Toe Wave Erosion near Primary Spillway Structure

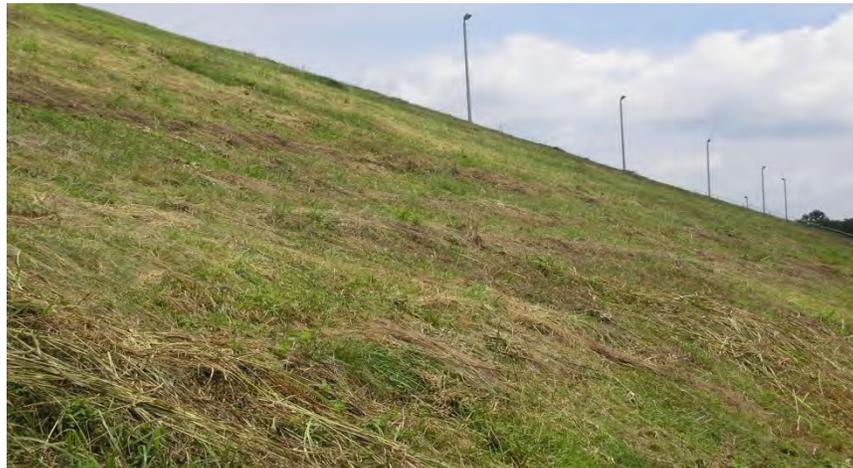
The down-gradient slope of the embankment is vegetated with various species of tall grass and weeds. No major scarps, sloughs, bulging, cracks, depressions or other indications of slope instability or signs of uncontrolled seepage were observed. Figure 5.2.3-1 shows a representative section of the down--gradient slope of the embankment.

Figure 5.2.3-1: Photo of Embankment Down-gradient Slope View to East

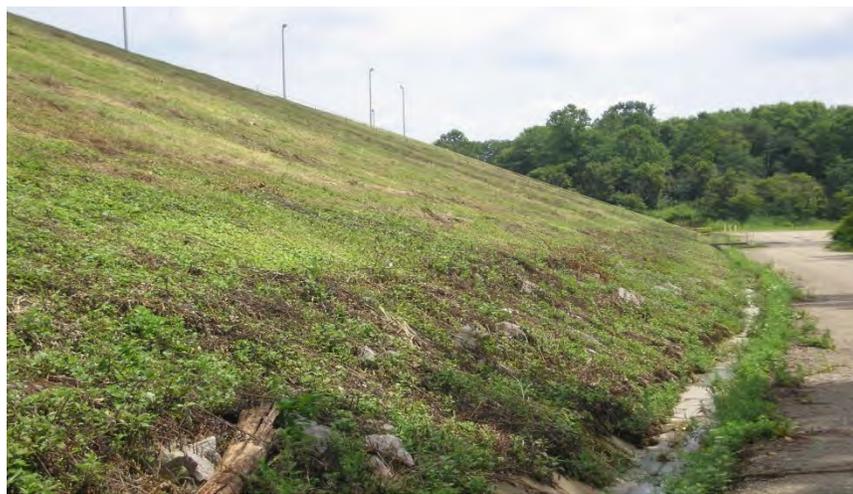
The bottom portion near the east end of the down-gradient embankment is armored with rip rap as protection from erosion during flooding of the Ohio River. Figure 5.2.3-2 shows the rip rap armoring. The observed armoring is indicated on the drawings as part of the original design (See Appendix A – Doc 03)

Figure 5.2.3-2: Rip-Rap Protection at Bottom of Down-gradient Slope

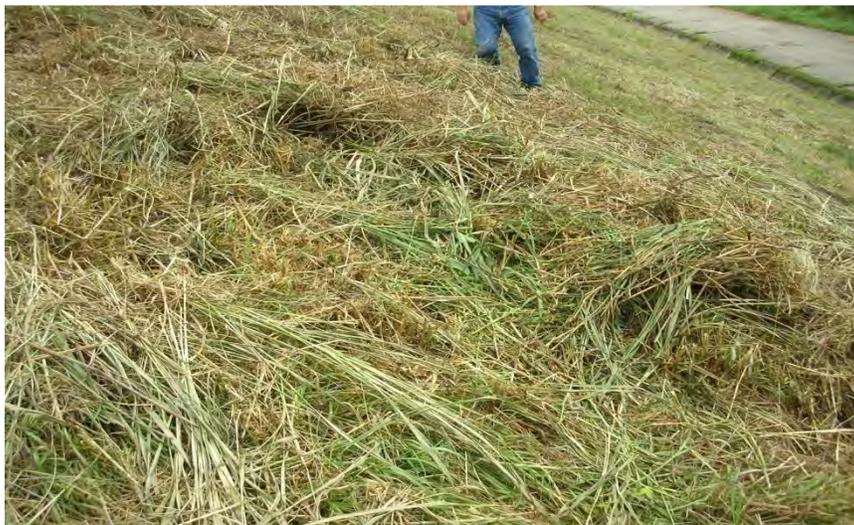
Small areas of sloughing and small erosion rills were observed along the down-gradient embankment slope. Figure 5.2.3-2 shows a slough area.

Figure 5.2.3-2: Photo of Local Slough Area on Down-gradient Slope

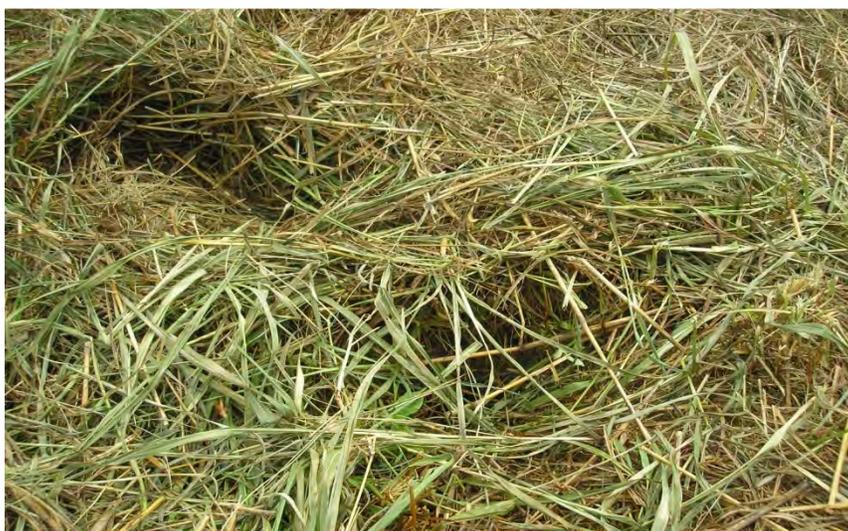
Evidence of animal burrows was observed along the down-gradient slope. Animal burrowing activity on the down-gradient slope appeared to be higher than on the up-gradient slope. Figure 5.2.3-3 shows twin burrows observed on the down-gradient slope.

Figure 5.2.3-3: Photo of Adjacent Animal Burrows on the Down-gradient Slope

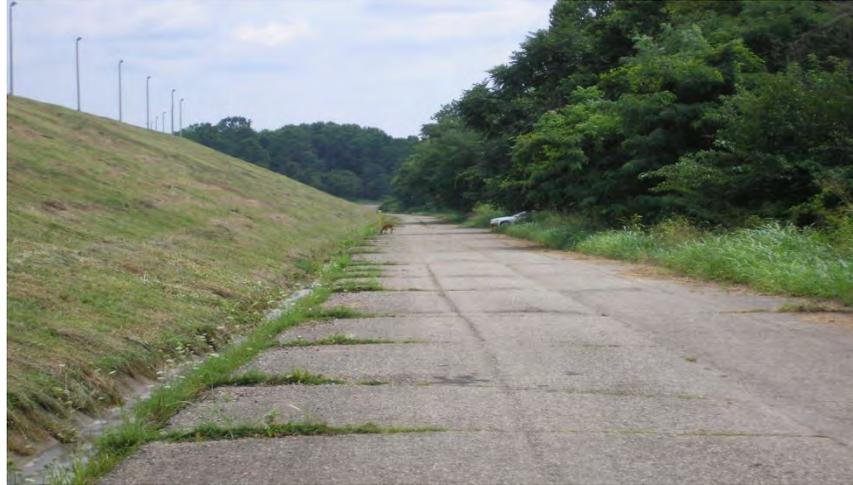
No areas of seepage or soft soils were observed along the toe of the down-gradient slope. There is a concrete lined ditch and adjacent paved roadway along the down-gradient toe of the main embankment section. Figure 5.2.3-4 shows a section of the down-gradient embankment toe.

Figure 5.2.3-4: Photo of Down-gradient Embankment Toe with Drainage Ditch and Adjacent Pavement

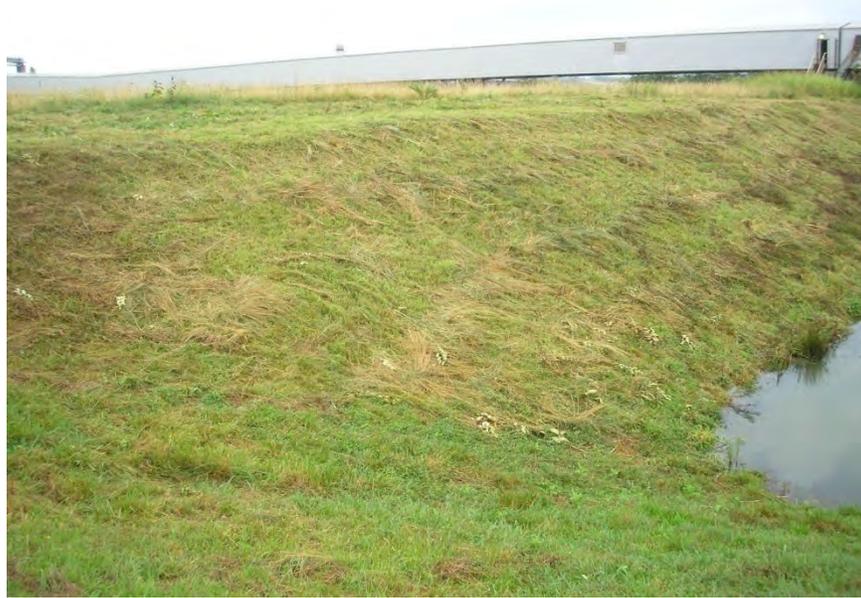
Neither erosion nor uncontrolled seepage was observed along the groins or abutments. Groin slopes and abutments are protected with the same vegetative cover as the adjoining slopes. Figures 5.2.4-1 and 5.2.4-2 show typical conditions observed at the groins and abutments.

Figure 5.2.4-1: Photo of Interior Groin at Southwest Corner of Impoundment

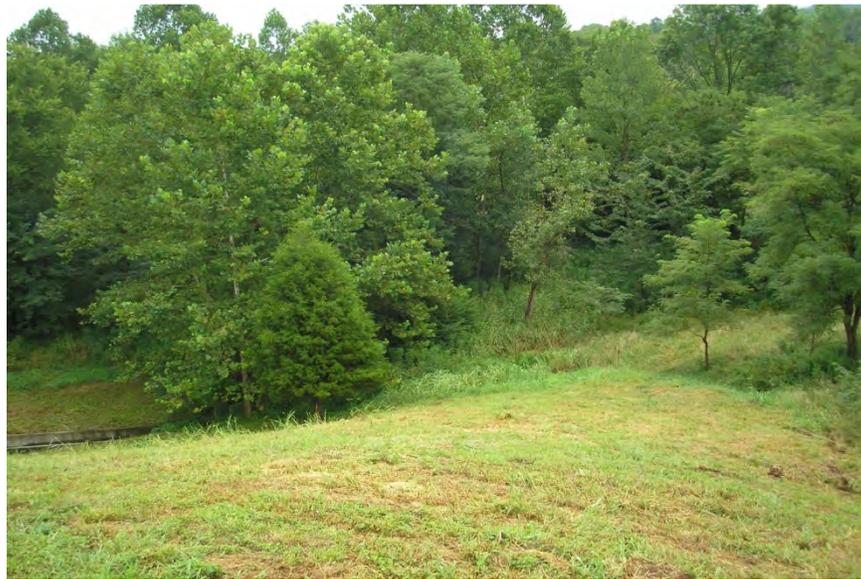
Figure 5.2.4-1: Photo of Embankment Crest at Northeast Corner Abutment

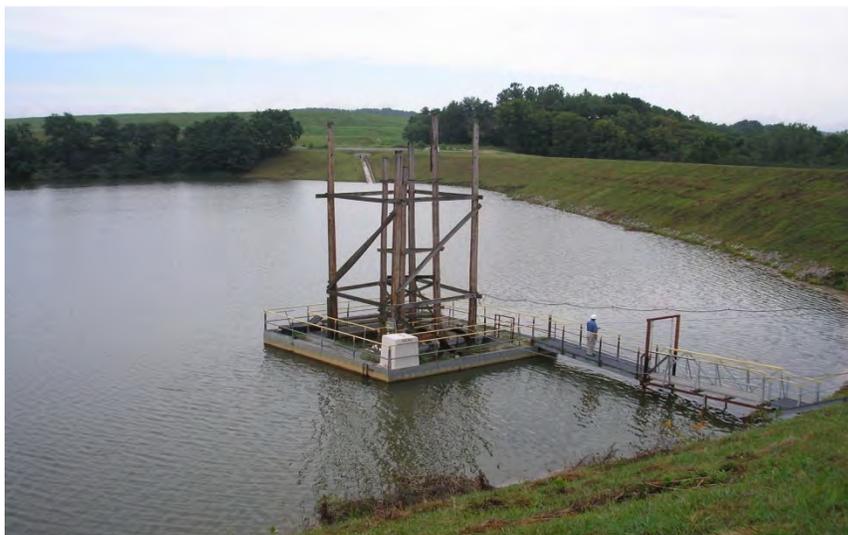
The impoundment overflow structure is located in the southeast corner of the impoundment. The original overflow structure consists of a 48-inch diameter corrugated metal riser protected by a timber frame. In the early 1990s a 40-inch diameter liner was installed in the original riser. The riser invert elevation is 485.5 ft. Access to the riser is provided by a fixed walkway. Outlet flow can be controlled by means of a manually operated valve. Figures 5.3.1-1 and 5.3.102 shows the primary spillway riser structure and riser invert (Also see photos 6 and 7, Appendix B).

Figure 5.3.1-1: Photo of Primary Spillway Riser Structure

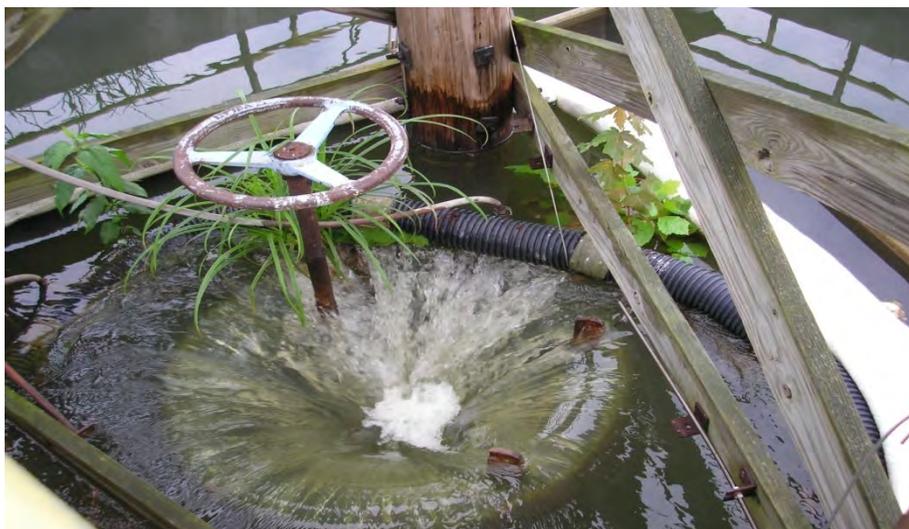
Figure 5.3.2-2: Photo of Primary Spillway Pipe Invert

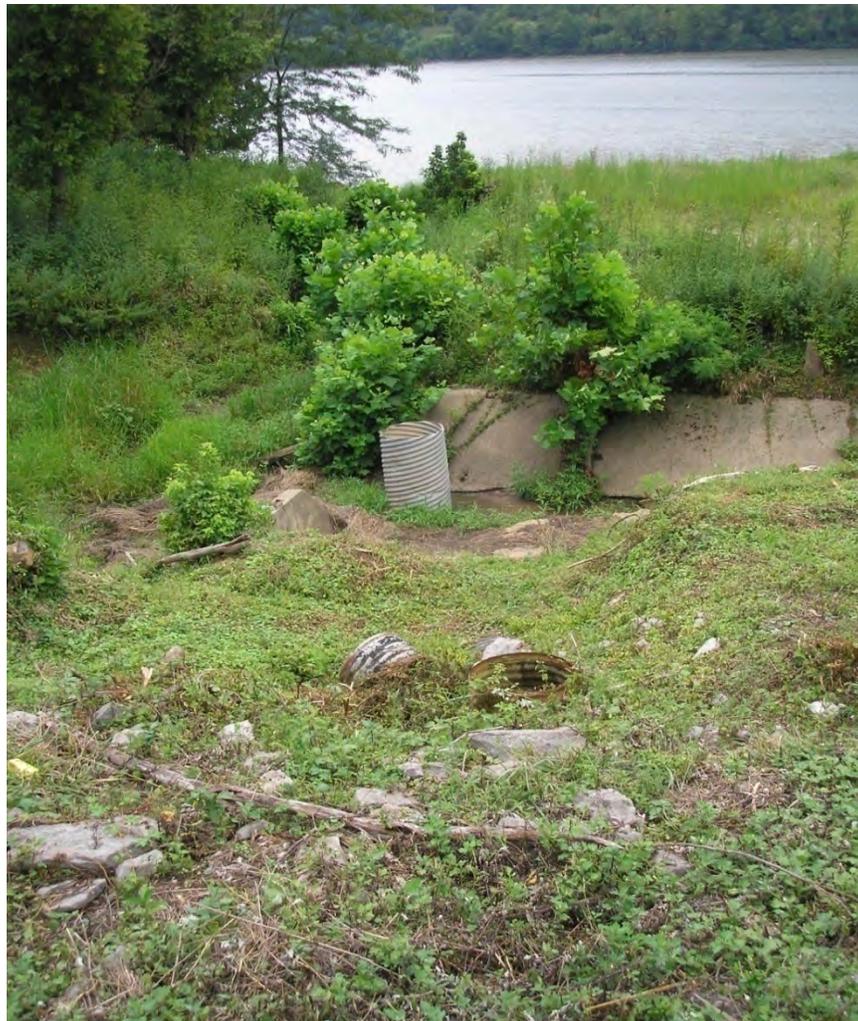
The original outfall pipe is a 36-inch diameter corrugated metal pipe. As part of the early 1990s work, a 28-inch diameter liner was installed in the outfall pipe. The outfall pipe is located in natural ground beneath the embankment. The outfall pipe remains below ground until discharging into the Ohio River. The outfall invert elevation is 441.6 ft which is approximately 12.6-ft. below the Ohio River normal pool elevation of 454.25 ft. There are two vent risers along the spillway outfall pipe between the toe of the embankment and the Ohio River. Observations in the vent pipes showed water to be flowing clear and unobstructed. Figure 5.3.2-1 shows outlet pipe vent pipe locations.

Figure 5.3.2-1: Photo of Primary Spillway Outlet Pipe Vents

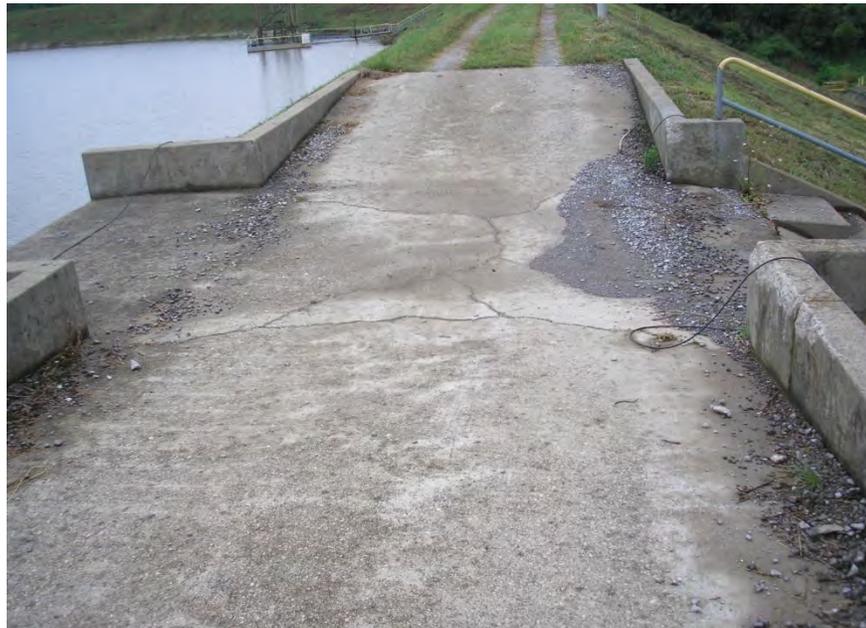
The emergency spillway consists of a 12ft. wide, 1 ft. deep concrete lined open channel crossing the embankment crest near the southeast corner of the impoundment. The invert elevation of the emergency spillway is 518.15. The emergency spillway discharges into the concrete lined drainage ditch at the toe of the embankment. Figure 5.3.3-1 shows the emergency spillway invert. Figure 5.3.3-2 shows the emergency spillway along the down-gradient slope of the embankment.

Figure 5.3.3-1: Photo of Emergency Spillway Invert.

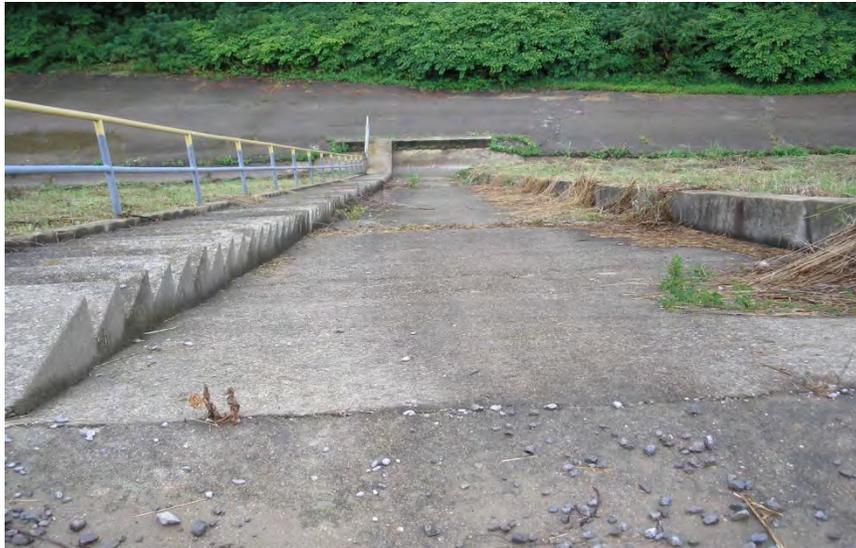
Figure 5.3.3-2: Photo of Emergency Spillway on Down-gradient Slope of Embankment

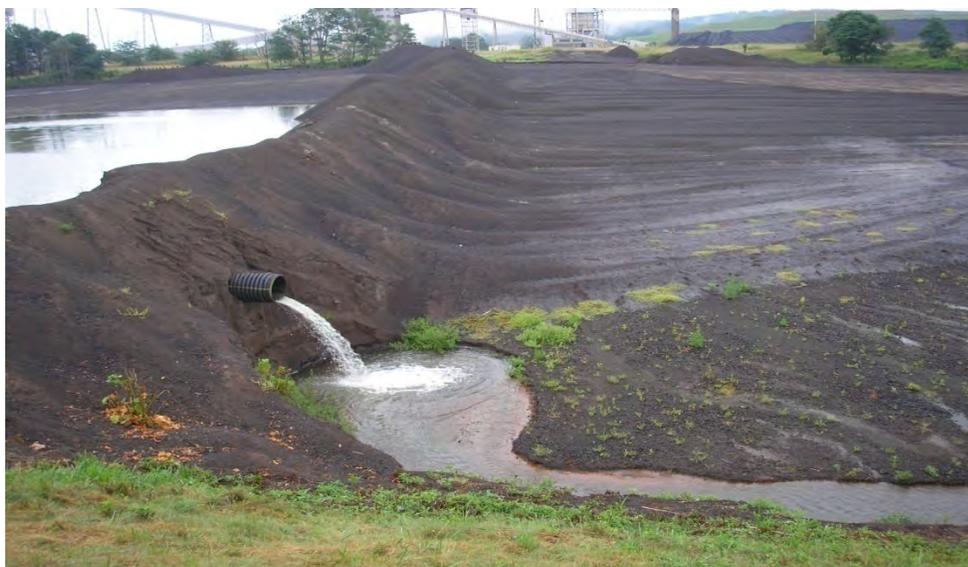
The facility is operated for the storage of wet fly ash as well as water from other plant sources including storm runoff from the plant landfill and coal pile, cooling tower blowdown water, and water from miscellaneous plant drains. Coal combustion waste process water discharges into the west side of the impoundment which is separated from the east section by a fly ash dike. The west side of the impoundment is the primary sedimentation area. Decant water flows by gravity to the east section of the impoundment through a pipe in the fly ash dike. Figure 8.1-1 shows the fly ash dike and drain pipe.

Figure 8.1-1: Photo of Decant Water from West to East Sections of Impoundment

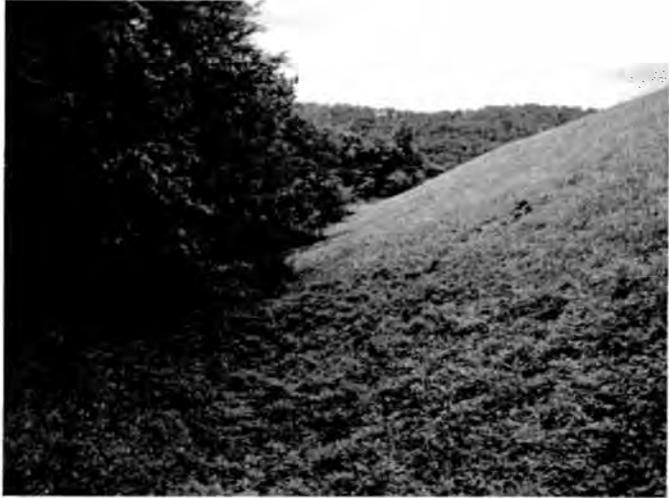
<p>Photo 8 Standing water east of downstream slope of east embankment.</p>

- Grade observed wet areas along the toe of the east embankment to promote positive drainage, and monitor areas after re-grading
- Remove scrap pipe along toe of east embankment
- Clean out vegetation from the concrete ditch along the down-gradient toe of the embankment and the emergency spillway
- Fill erosion channels on the up-gradient slopes with rip rap.
- Monitor ash divider dike for seepage and instability
- Re-grade low lying area on down-gradient west embankment slope adjacent to the crest
- Continue regular mowing embankments and down-gradient areas.

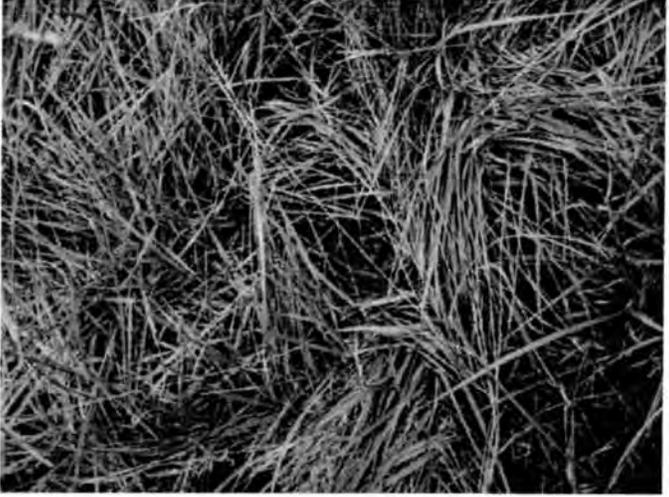
<p>Photo 9 Existing scrap pipe located near toe of the east embankment.</p>

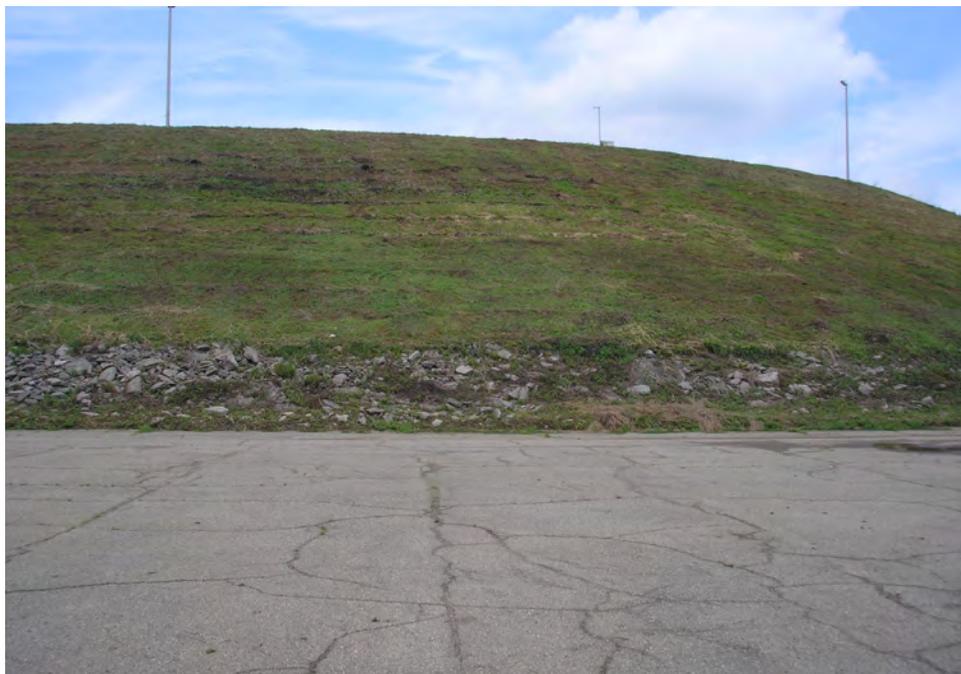
Photograph 3, Appendix B provides an additional view of the down-gradient embankment and toe.

Photograph 3: Toe Rip Rap Armoring – East Section Down Gradient Slope

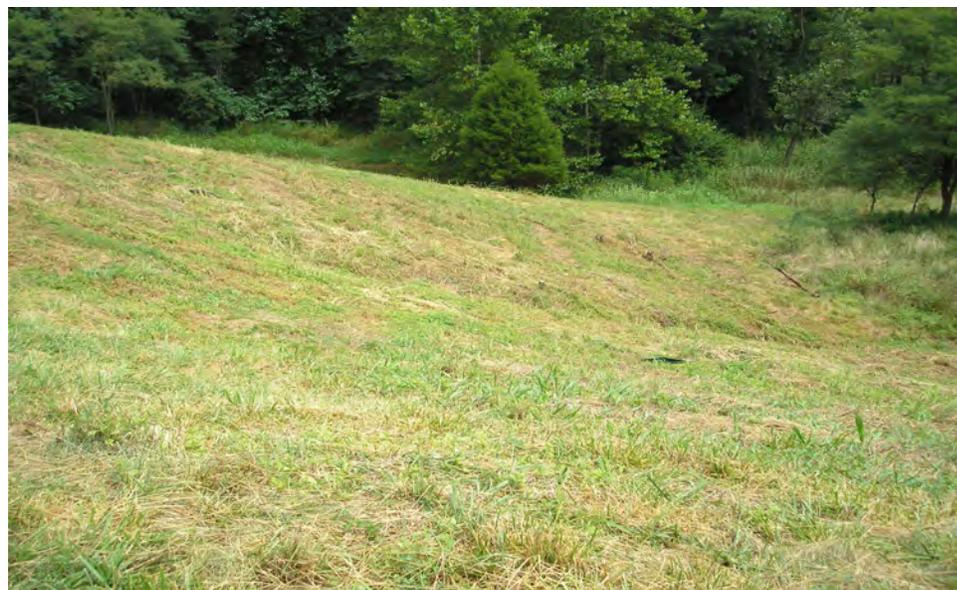
Photograph 4: Down Gradient Slope @ Northeast Abutment

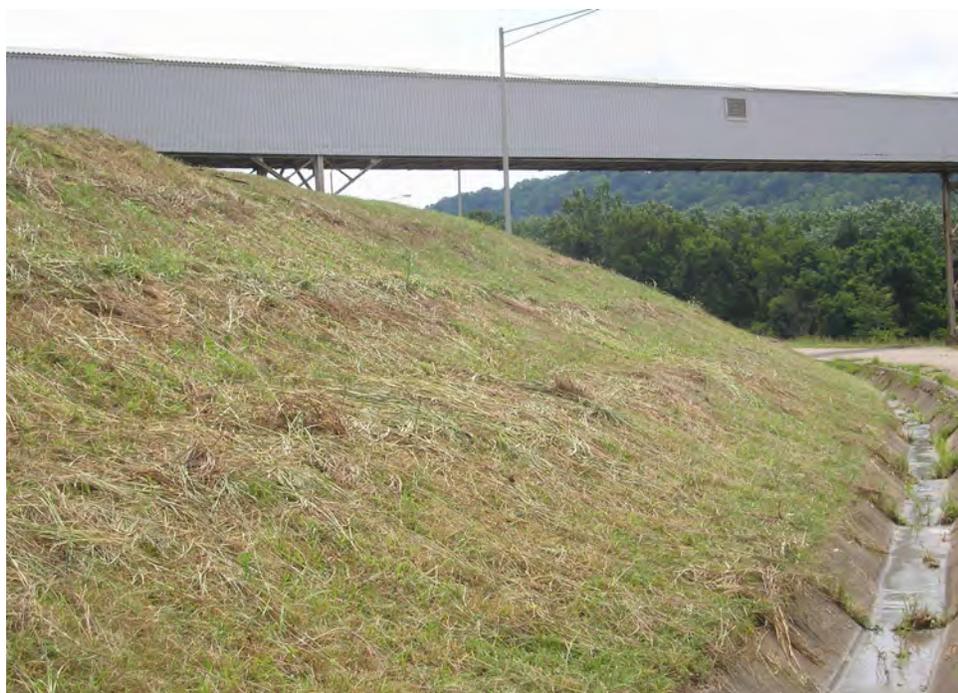
Photograph 5: Down Gradient Slope @ Southwest Groin

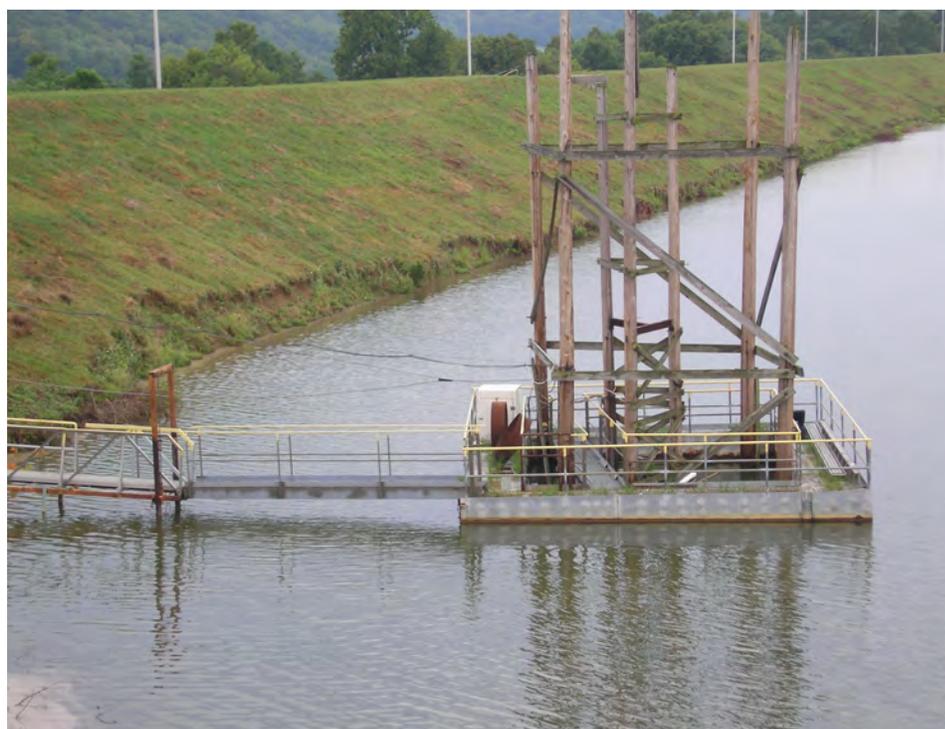
Photograph 6: Primary Spillway Riser Structure

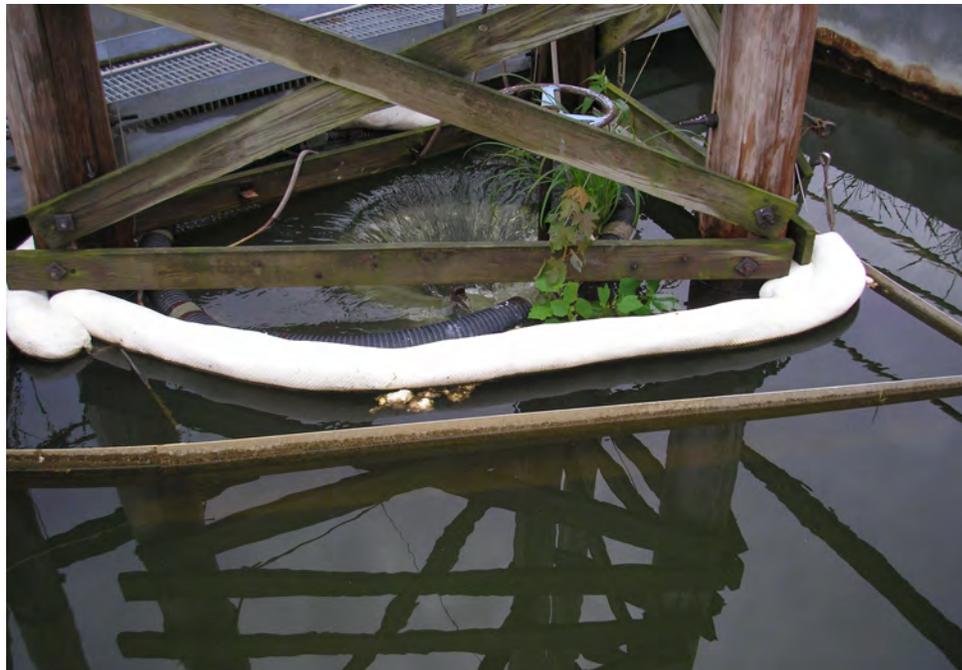
Photograph 7: Skimmer Boom at Primary Riser Spillway

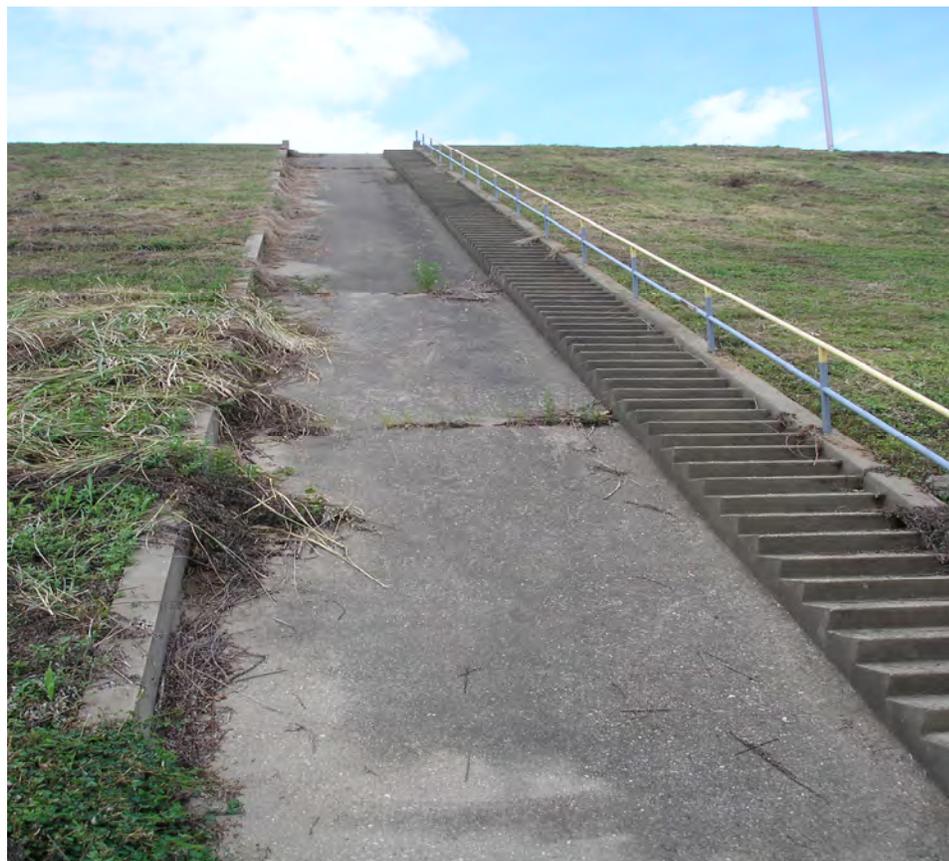
Photograph 8: Emergency Spillway View from Down Gradient Toe
