**Coal Combustion Waste Impoundment
Round 6 - Dam Assessment Report**

East Bend Station

Coal Combustion Surface Impoundment
Duke Energy
Boone County, KY

March 2011

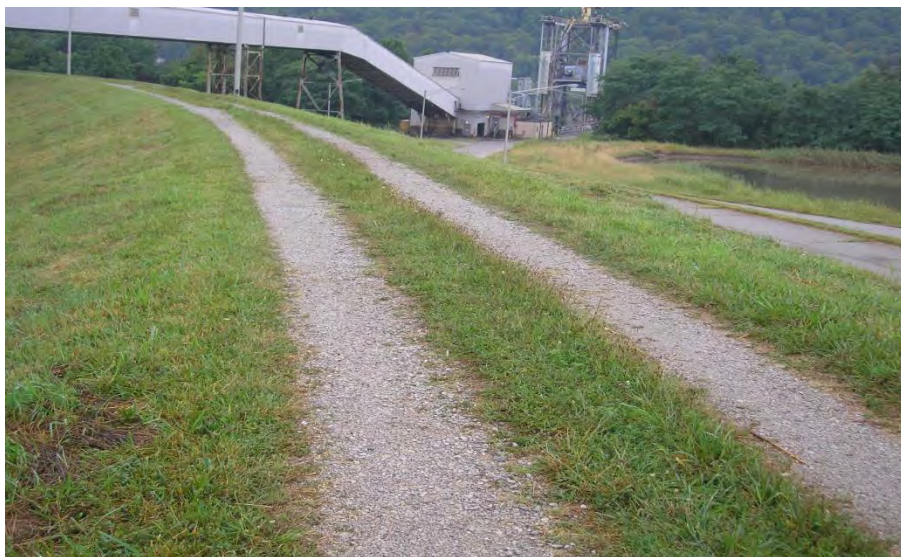
The crest of the embankment had no signs of significant depressions, tension cracks or other indications of settlement or shear failure. Figure 5.2.1-1 shows the typical crest conditions.

Figure 5.2.1-1: Photograph of Impoundment Dike Crest View to East

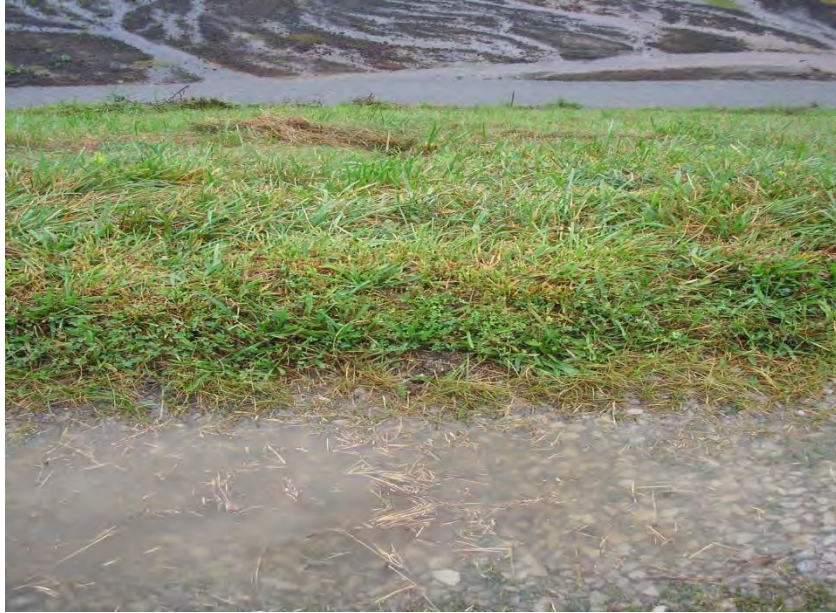
In scattered areas vehicle traffic along the crest has caused depressions in the gravel tracks allowing water to pond. Overflow from the small ponding areas is causing small erosion rills on both the up-gradient and down-gradient slopes of the embankment. Figure 5.2.1-2 shows a small area of ponding in the gravel travel track along the embankment crest.

Figure 5.2.1-2: Water Ponding in Small Depression in Gravel Travel Track along Embankment Crest.

- Add rip rap armoring to toe of embankment up-gradient slope in areas susceptible to erosion caused by wave action
- Grade depressed traffic tracks along the crest to prevent water ponding and reduce erosion rills
- Repair erosion rills on both the up-gradient and down-gradient slopes
- Increase frequency of mowing dike embankments to improve effectiveness of daily observations and monthly inspections.

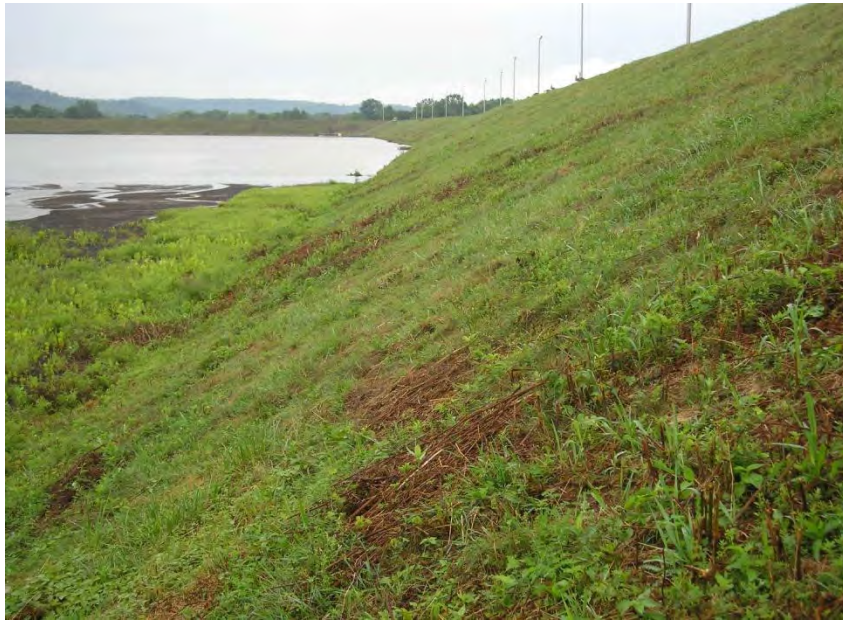
The up-gradient slope of the embankment is vegetated with various species of tall grass and weeds. There were no observed scarps, sloughs, bulging, cracks, depressions or other indications of slope instability. Figure 5.2.2-1 shows a representative section of the up-gradient slope of the embankment.

Figure 5.2.2-1: Photo of Embankment Up-gradient Slope View to East

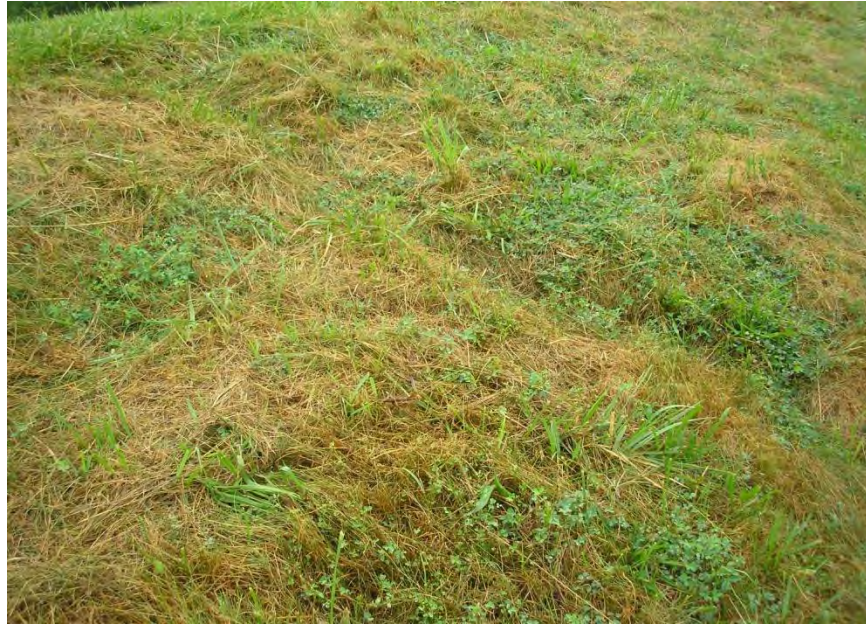
Small areas of sloughing or erosion were observed along the up-gradient slope as evidence of animal burrows. Figures 5.2.2-2 and 5.2.2-3 show the conditions observed.

Figure 5.2.2-2: Photo of Small Erosion Rill on Up-gradient Slope

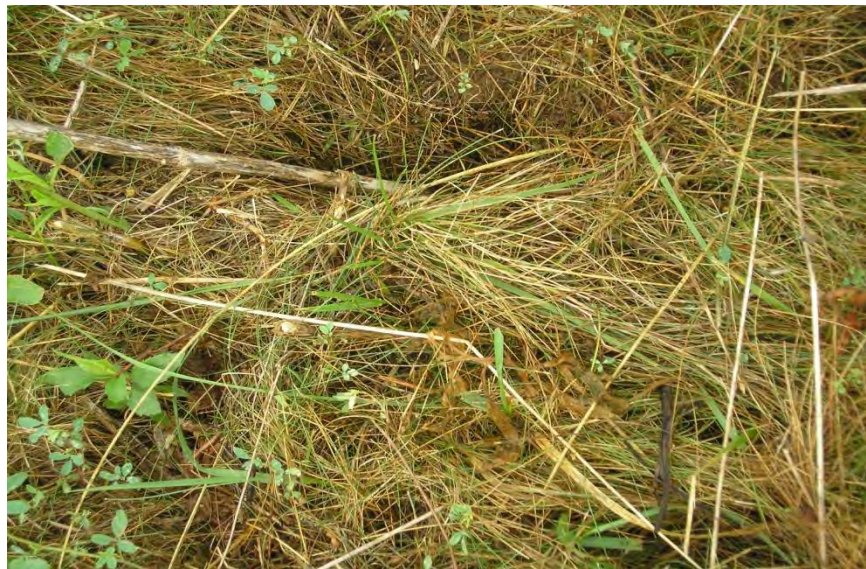
Figure 5.2.2-3: Evidence of Animal Burrow on Up-Gradient Slope

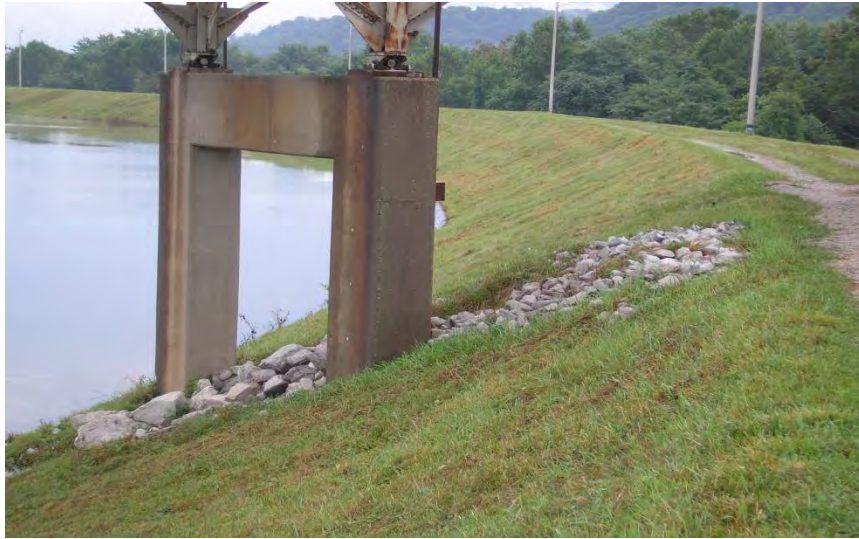
Areas of erosion repairs to the up-gradient slope were observed. The largest of the repairs were near the coal conveyor crossing. Storm water from broken gutters on the coal conveyor crossing caused areas of erosion beneath the conveyor. Figure 5.2.3-4 shows a typical repair area.

Figure 5.2.2-4: Erosion Repairs beneath Coal Conveyor Structure

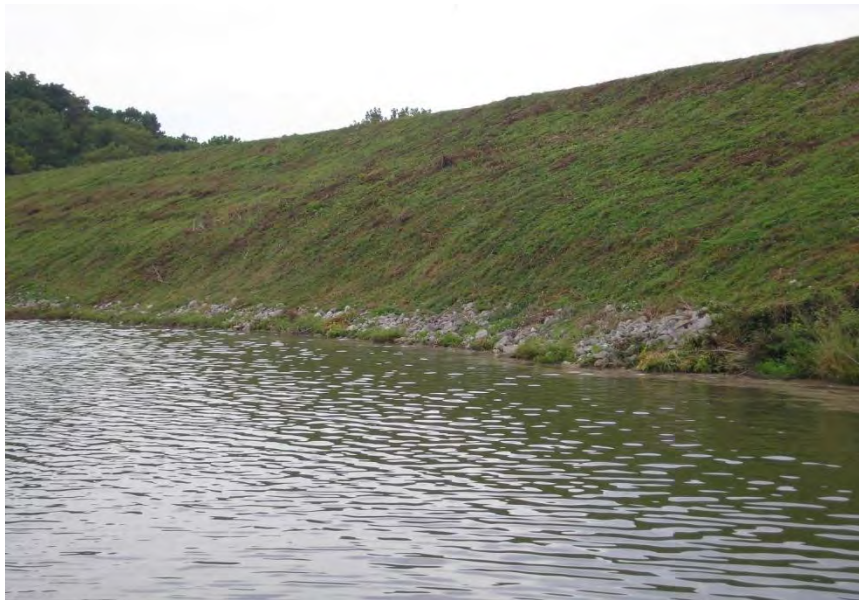
A section of up-gradient embankment toe along the eastern edge of the impoundment has been armored with rip rap to protect against erosion. Figure 5.2.2-5 shows the protected toe area.

Figure 5.2.2-5: Rip Rap Armoring to Protect against Wave Erosion

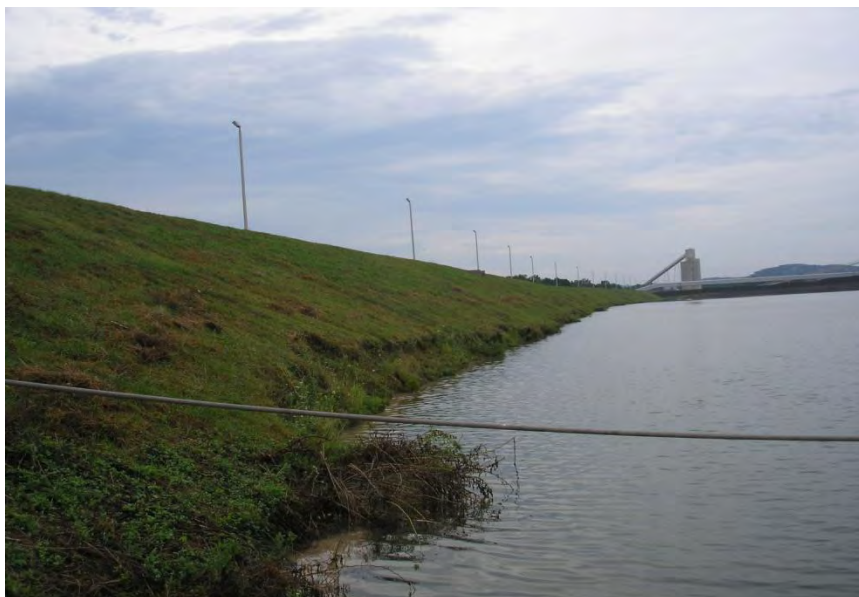
Observations at the site indicate other areas of wave erosion that warrant armoring, including the areas adjacent to the previously installed rip rap. Figure 5.2.2-6 shows an area of wave erosion near the primary spillway riser.

Figure 5.2.2-6: Up-gradient Embankment Toe Wave Erosion near Primary Spillway Structure

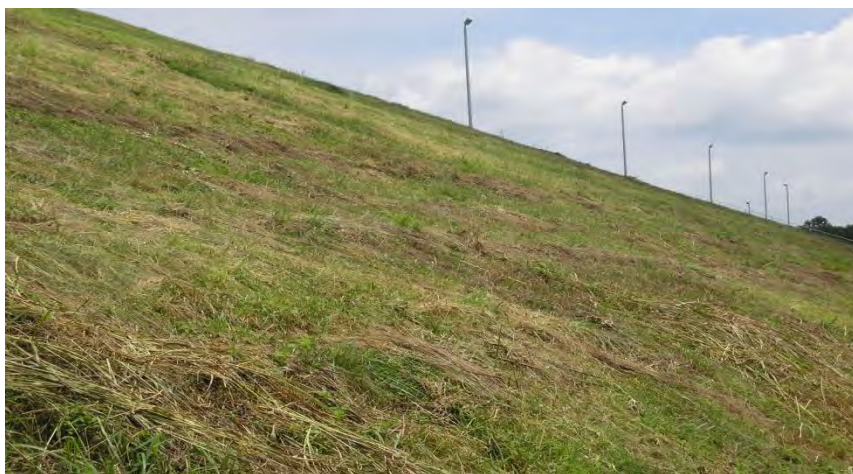
The down-gradient slope of the embankment is vegetated with various species of tall grass and weeds. No major scarps, sloughs, bulging, cracks, depressions or other indications of slope instability or signs of uncontrolled seepage were observed. Figure 5.2.3-1 shows a representative section of the up-gradient slope of the embankment.

Figure 5.2.3-1: Photo of Embankment Down-gradient Slope View to East

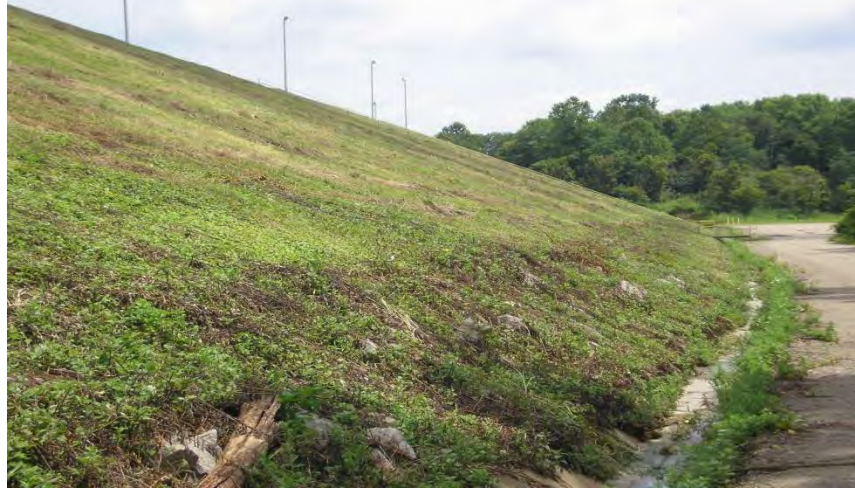
The bottom portion near the east end of the down-gradient embankment is armored with rip rap as protection from erosion during flooding of the Ohio River. Figure 5.2.3-2 shows the rip rap armoring. The observed armoring is indicated on the drawings as part of the original design (See Appendix A – Doc 03)

Figure 5.2.3-2: Rip-Rap Protection at Bottom of Down-gradient Slope

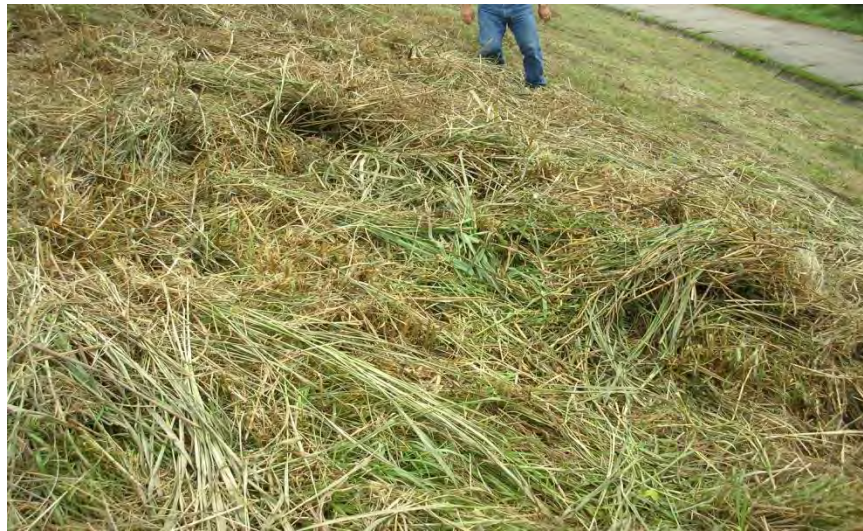
Small areas of sloughing and small erosion rills were observed along the down-gradient embankment slope. Figure 5.2.3-2 shows a slough area.

Figure 5.2.3-2: Photo of Local Slough Area on Down-gradient Slope

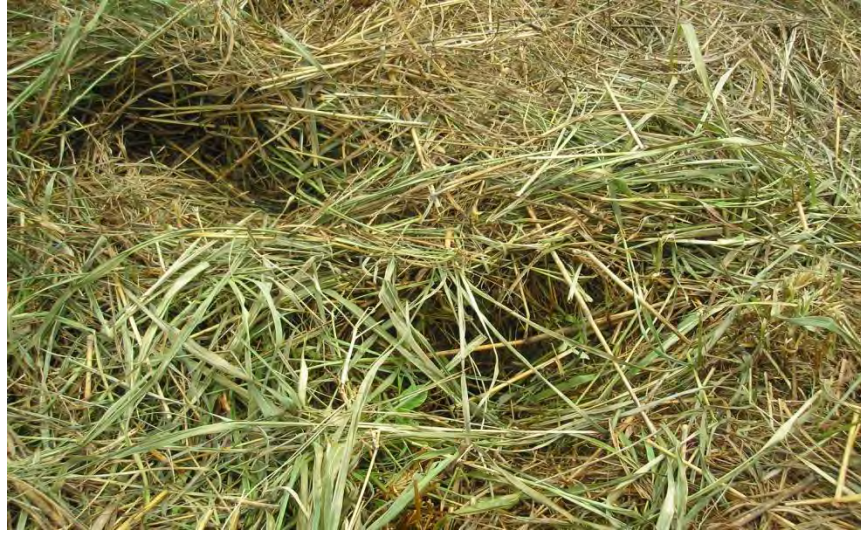
Evidence of animal burrows was observed along the down-gradient slope. The activity on the down-gradient slope appeared to be higher than on the up-gradient slope. Figure 5.2.3-3 shows twin burrows observed on the down-gradient slope.

Figure 5.2.3-3: Photo of Adjacent Animal Burrows on the Down-gradient Slope

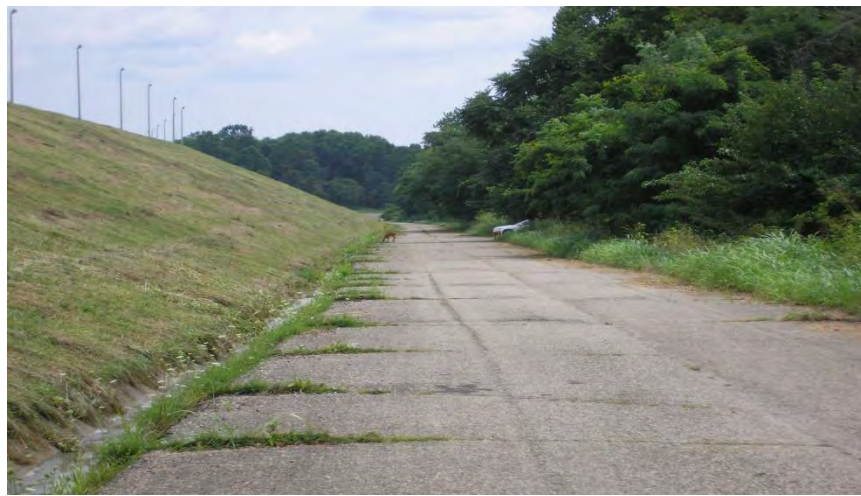
No areas of seepage or soft soils were observed along the toe of the down-gradient slope. There is a concrete lined ditch and adjacent paved roadway along the down-gradient toe of the main embankment section. Figure 5.2.3-4 shows a section of the down-gradient embankment toe.

Figure 5.2.3-4: Photo of Down-gradient Embankment Toe with Drainage Ditch and Adjacent Pavement

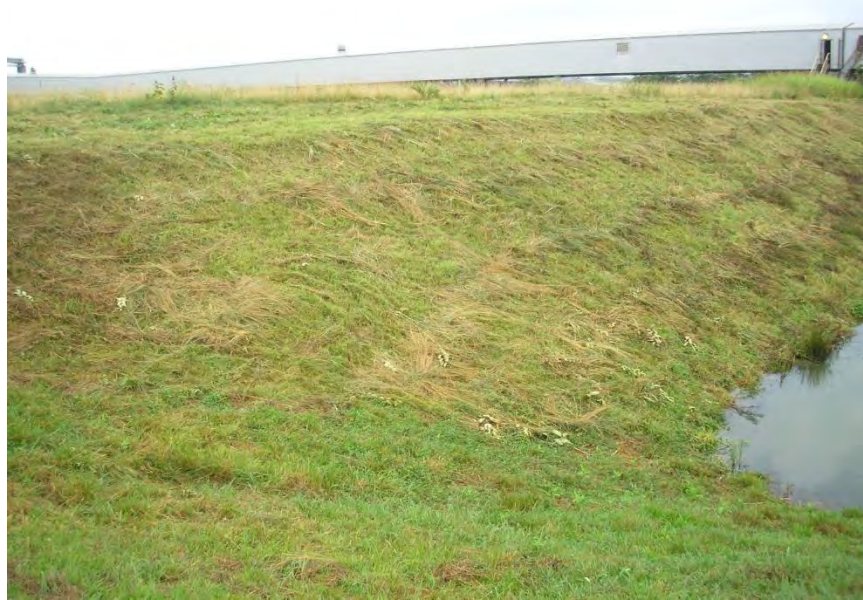
Neither erosion nor uncontrolled seepage was observed along the groins or abutments. Groin slopes and abutments are protected with the same vegetative cover as the adjoining slopes. Figures 5.2.4-1 and 5.2.4-2 show typical conditions observed at the groins and abutments.

Figure 5.2.4-1: Photo of Interior Groin at Southwest Corner of Impoundment

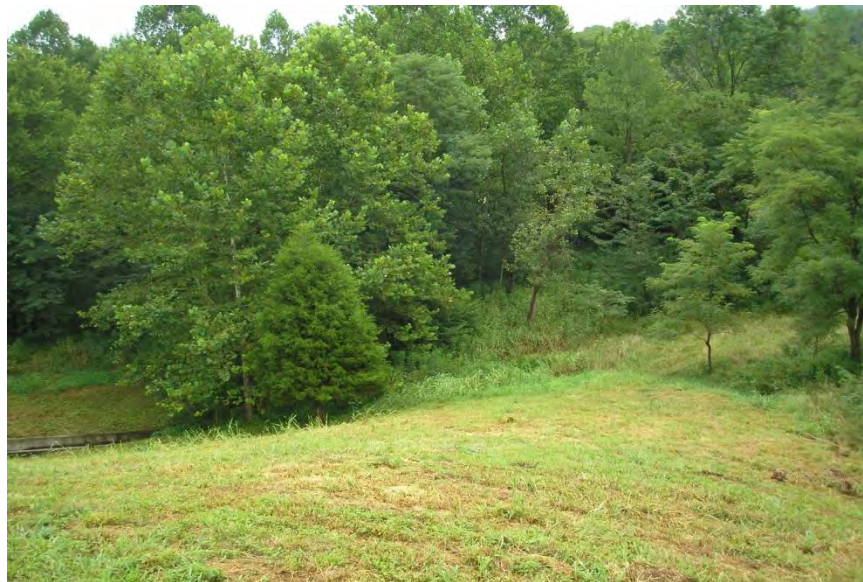
Figure 5.2.4-1: Photo of Embankment Crest at Northeast Corner Abutment

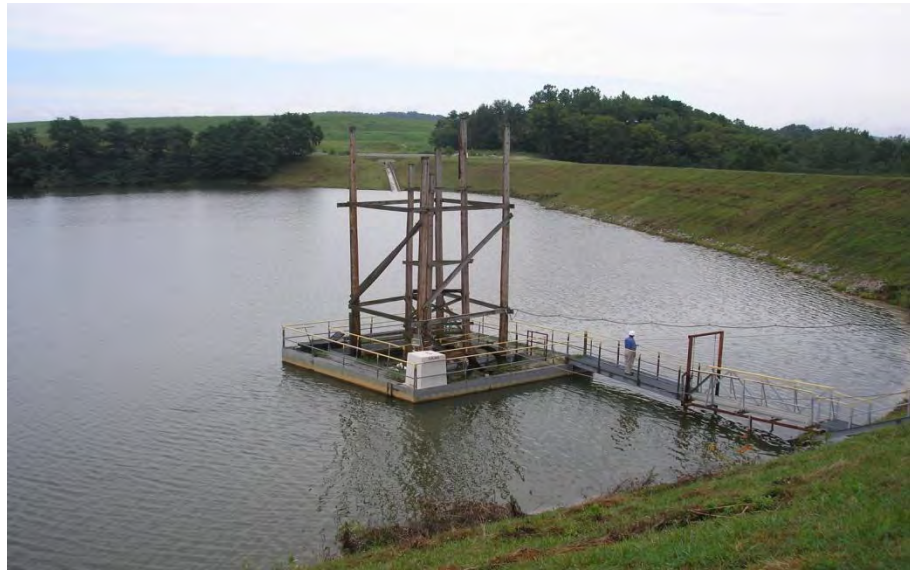
Figure 5.3.1-1: Photo of Primary Spillway Riser Structure

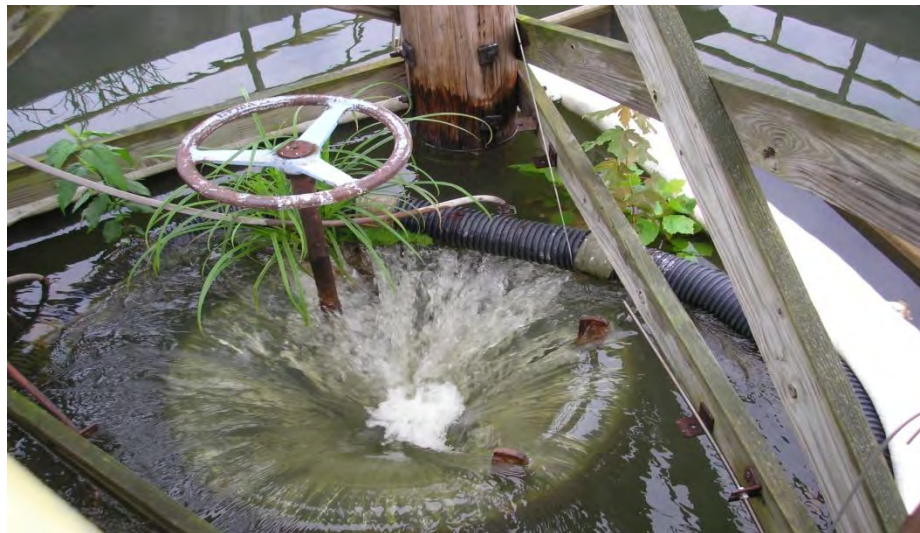
Figure 5.3.2-2: Photo of Primary Spillway Pipe Invert

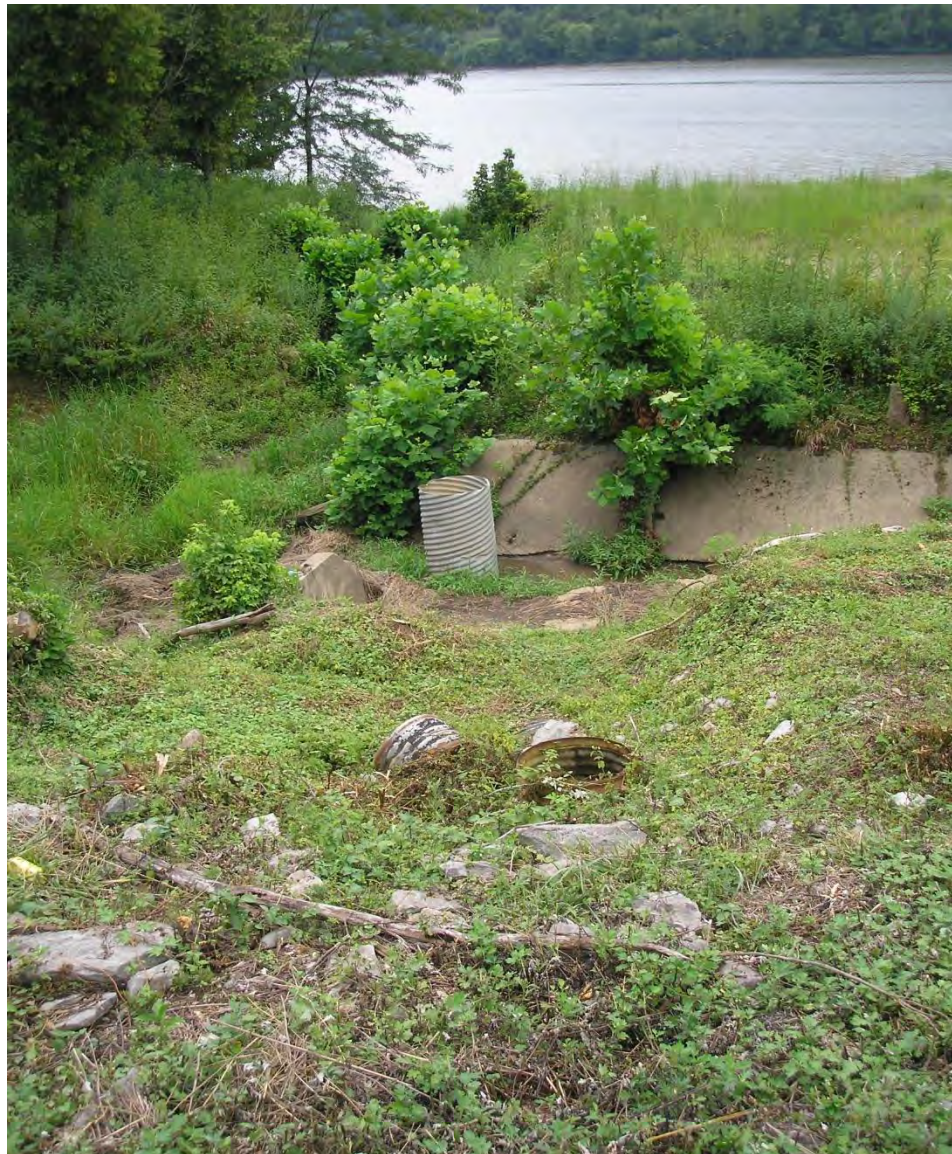
approximately 12.6-ft. below the Ohio River normal pool elevation of 454.25 ft. There are two vent risers along the spillway outfall pipe between the toe of the embankment and the Ohio River. Observations in the vent pipes showed water to be flowing clear and unobstructed. Figure 5.3.2-1 shows outlet pipe vent pipe locations.

Figure 5.3.2-1: Photo of Primary Spillway Outlet Pipe Vents

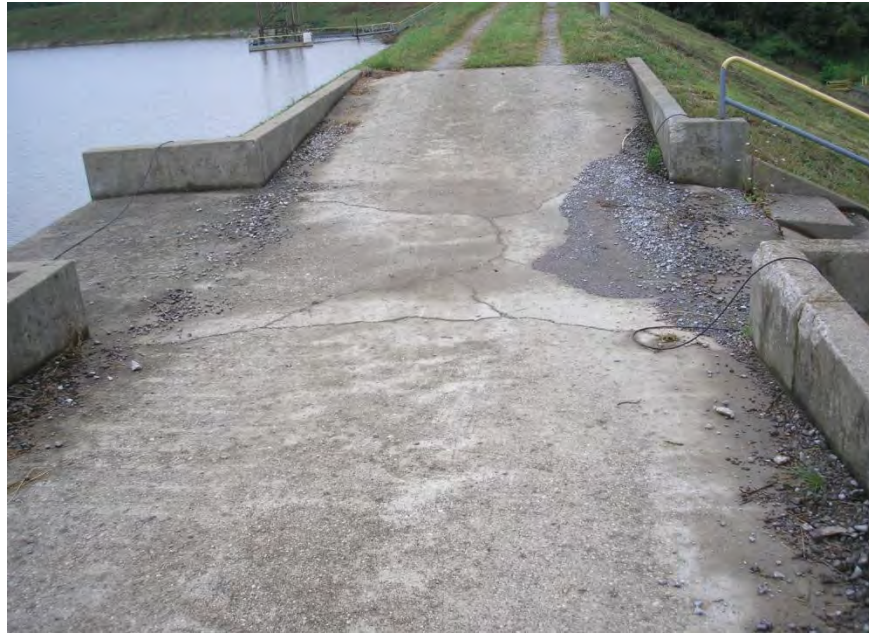
Figure 5.3.3-1: Photo of Emergency Spillway Invert.

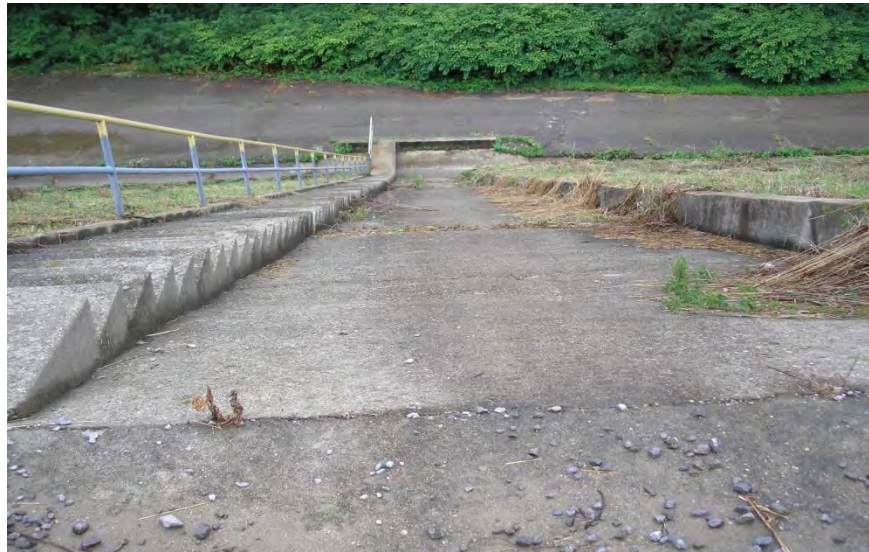
Figure 5.3.3-2: Photo of Emergency Spillway on Down-gradient Slope of Embankment

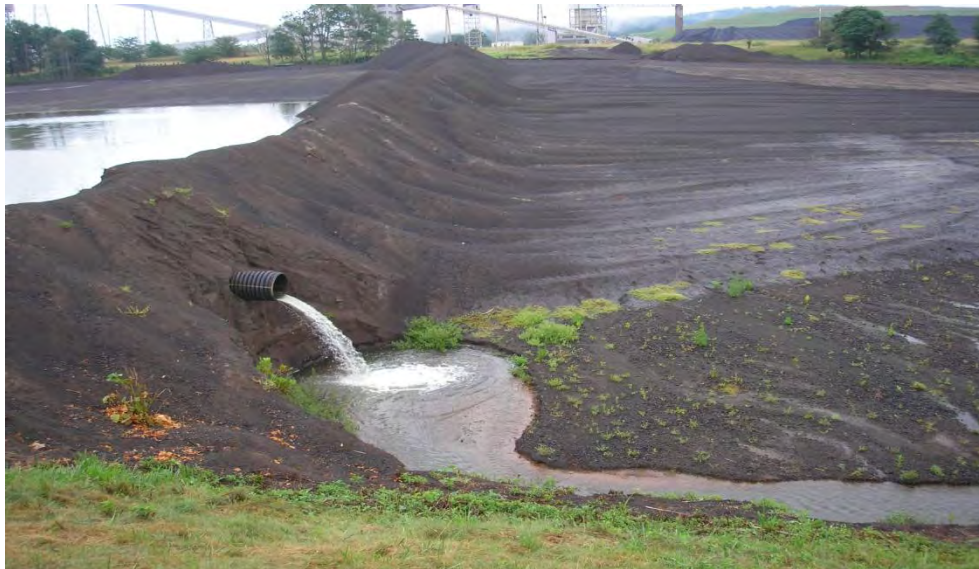
Figure 8.1-1: Photo of Decant Water from West to East Sections of Impoundment

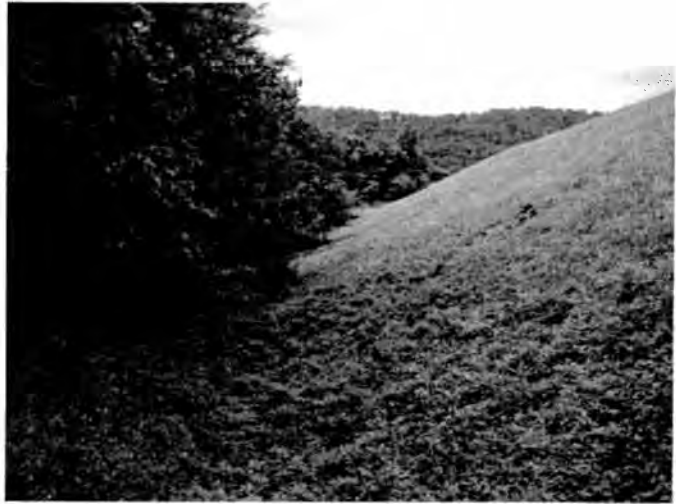
<p>Photo 8 Standing water east of downstream slope of east embankment.</p>

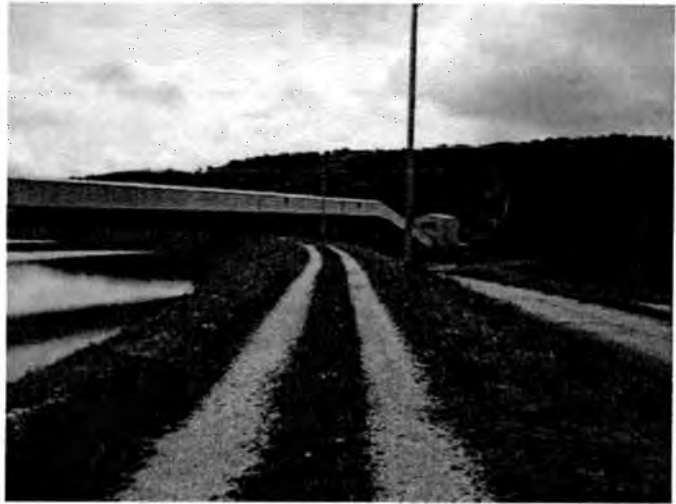
<p>Photo 44 Low area on the downstream slope of west embankment, photo facing southeast.</p>
