DRAFT REPORT

Dam Safety Assessment of CCW Impoundments

Gallagher Generating Station

October 6, 2010

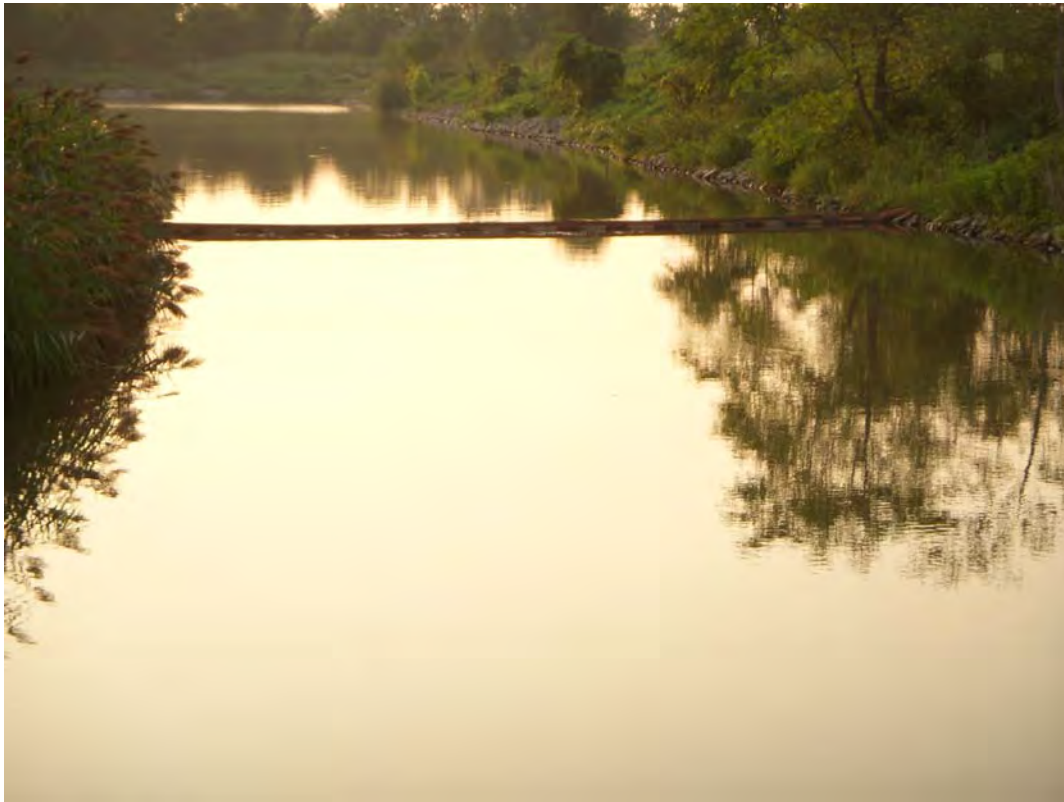
Photo Number:
1

Description:
Flow control
weir on Primary
Pond outlet
channel (inlet
to Ash Pond A)

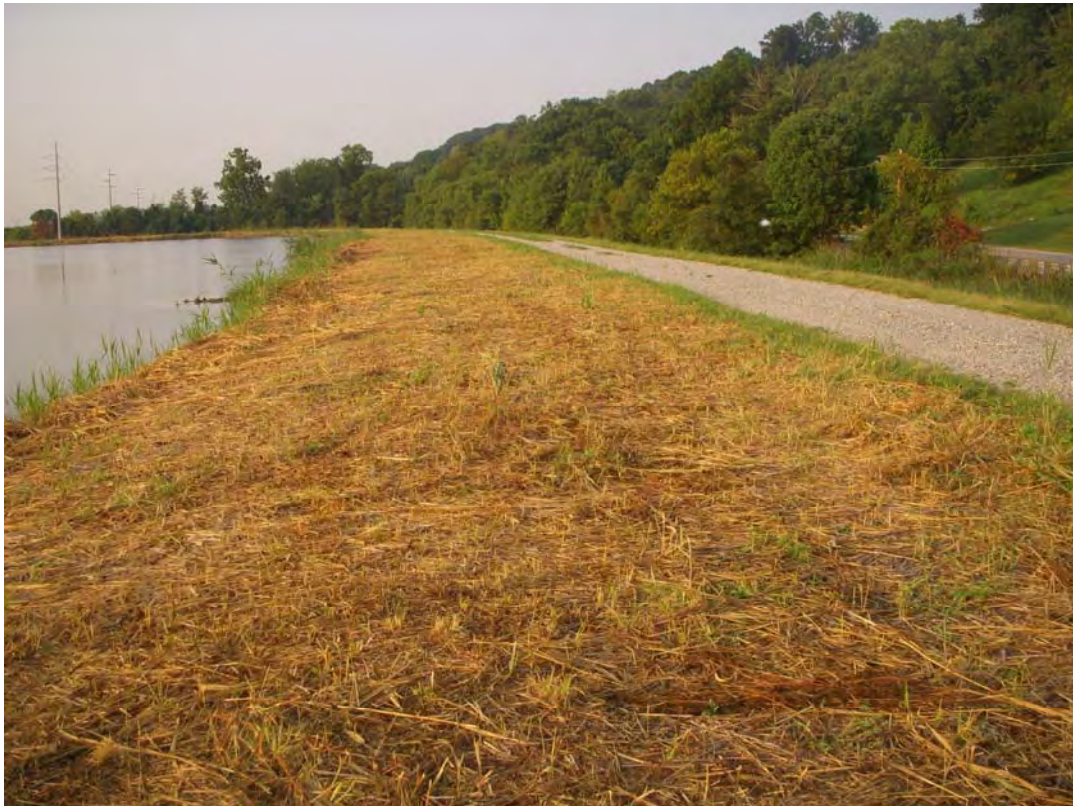
Photo Number:
2

Description:
Inboard side of
western
embankment of
Ash Pond A

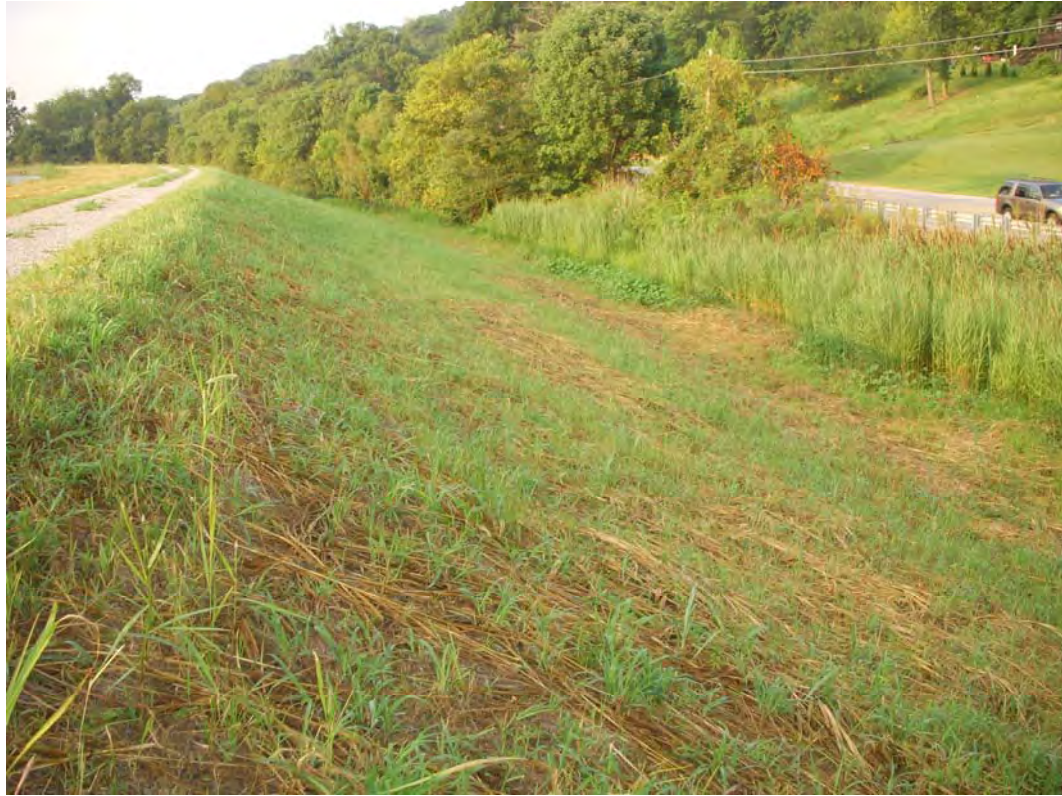
Outboard slope of western embankment of Ash Pond A

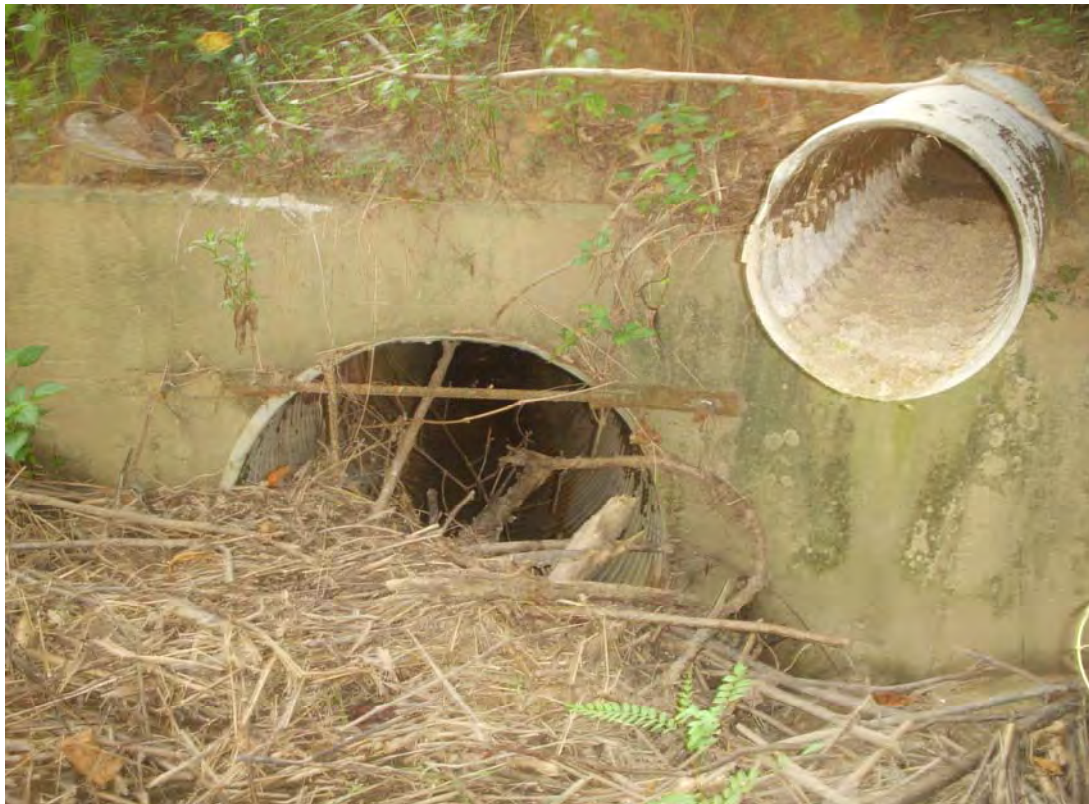
Outlet pipe for the drainage channel at the southwestern corner of Ash Pond A

- The slope of the drainage channel along the outboard toe of the western embankment should be investigated to establish if regrading of the channel would allow the standing water to drain more freely to the outlet pipe. Once the channel is regraded (if feasible), the reedy vegetation should be removed from the channel.
- Based on the hydrologic/hydraulic analyses recommended above, a design crest elevation should be established for the embankments and low spots in the crest should be filled/raised to create a uniform crest elevation around Ash Pond A (except in the area of the landfill leachate/drain pipes).

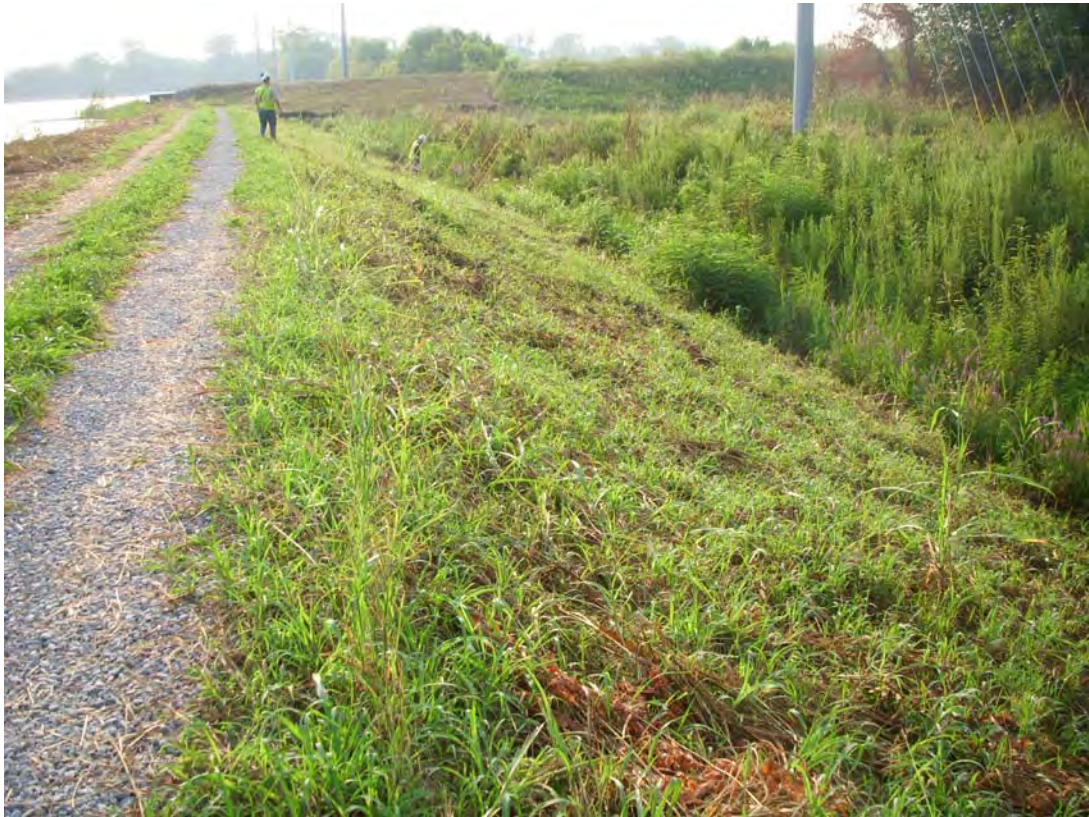
Photo Number:
5

Description:
Southern
embankment of
Ash Pond A

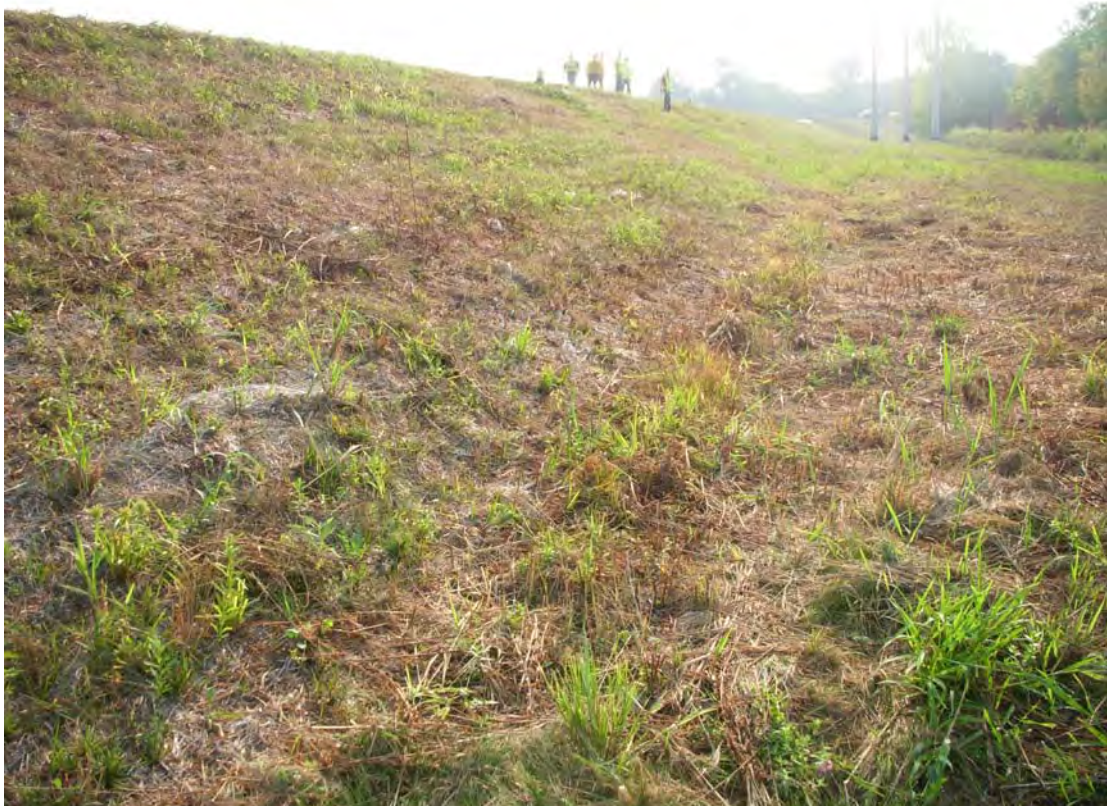
Photo Number:
6

- The outboard slope of the southern embankment ties into an abandoned road embankment (Old River Road). For the purposes of this report, the tie-in point is considered to be the outboard toe of the embankment; however, it should be noted that the abandoned road embankment slopes down to a lower elevation beyond the Ash Pond A embankment (Appendix B – Photos 6 and 7).

Description:
Outboard
slope of
southern
embankment of
Ash Pond A

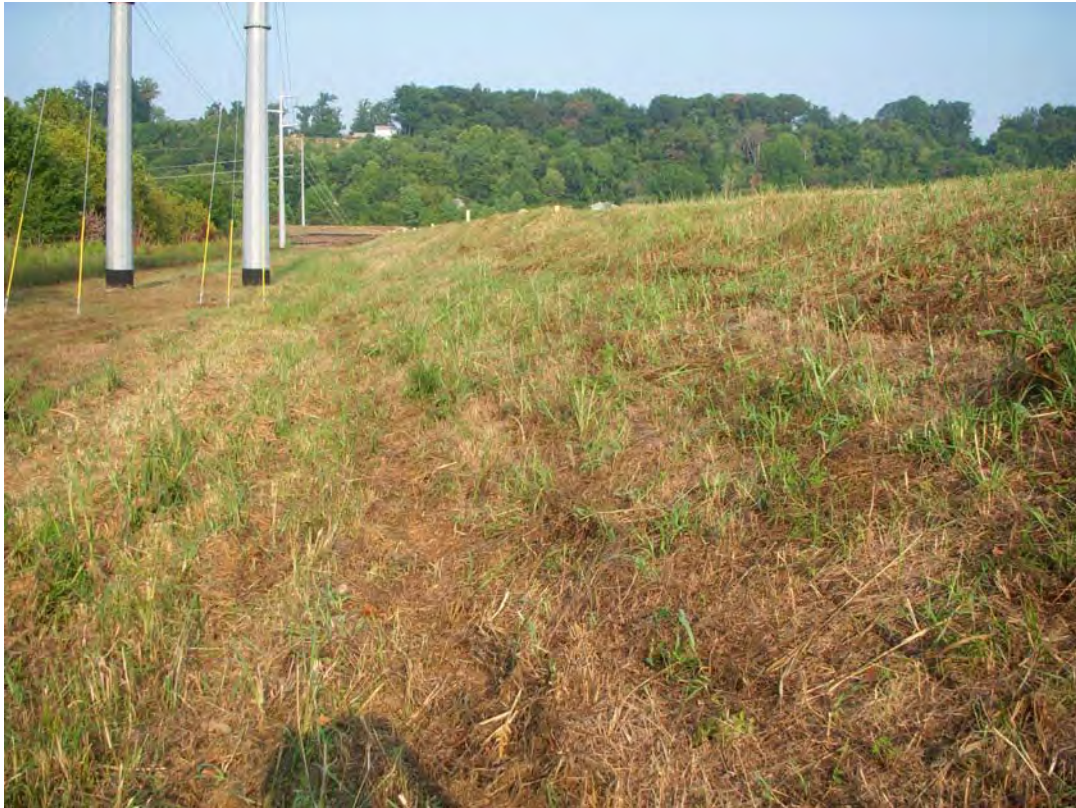
Photo Number:
7

Description:
Outboard
slope of
southern
embankment of
Ash Pond A

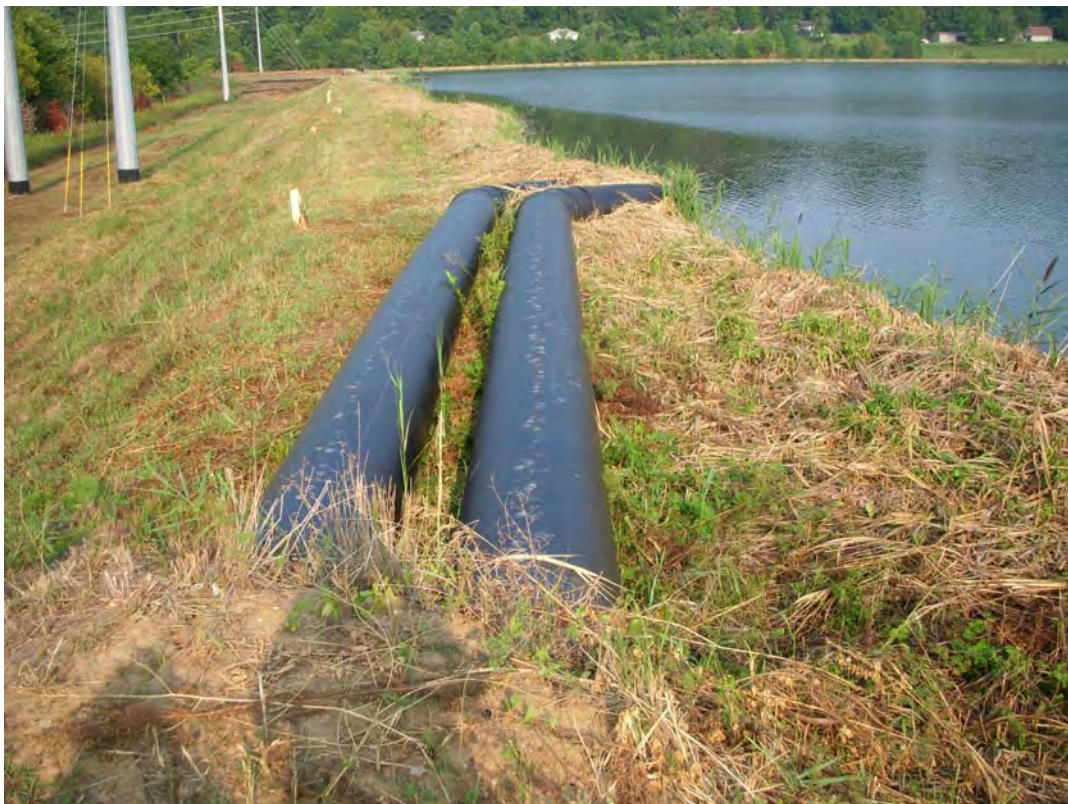
Photo Number:
8

Description:
Landfill storm
water and
leachate
effluent pipes
into Ash Pond A

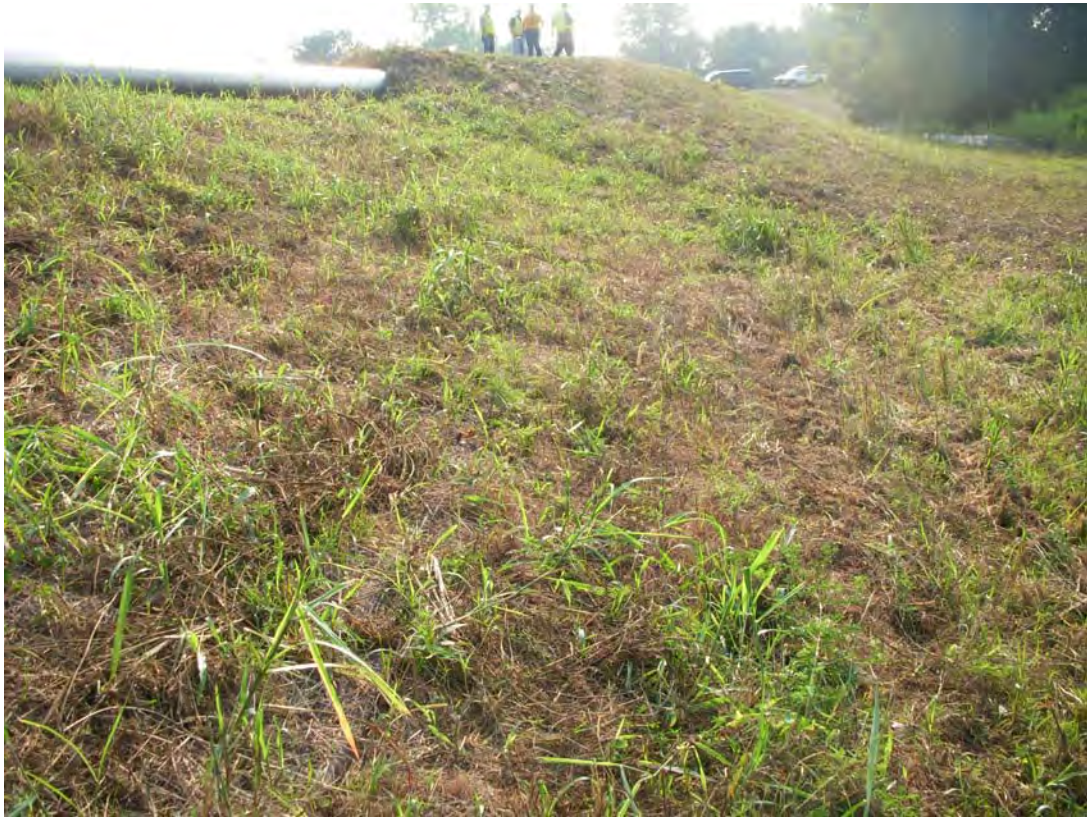
Photo Number:
9

Description:
Raised section
of southern
embankment of
Ash Pond A for
landfill pipe
cover

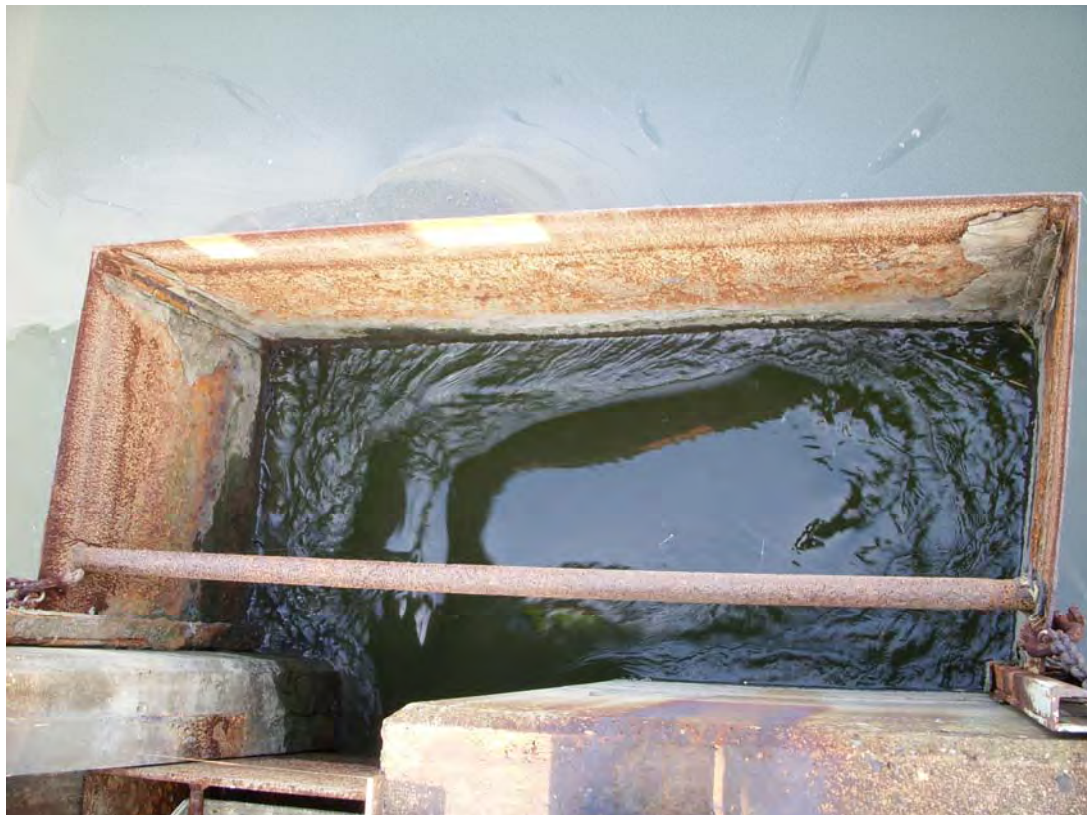
Photo Number:
10

- Weir boxes (rather than trash racks) have been installed to prevent floating debris from entering both the principal and emergency spillways (Appendix B – Photos 10 and 11). The principal spillway appears to be in good condition and functioning as designed, with flow occurring into the Secondary Pond on the date of the inspection. Stop logs are used to adjust the overflow elevation of the principal spillway, as necessary.

Description:
Weir box for
principal
spillway inlet at
southeastern
corner of Ash
Pond A

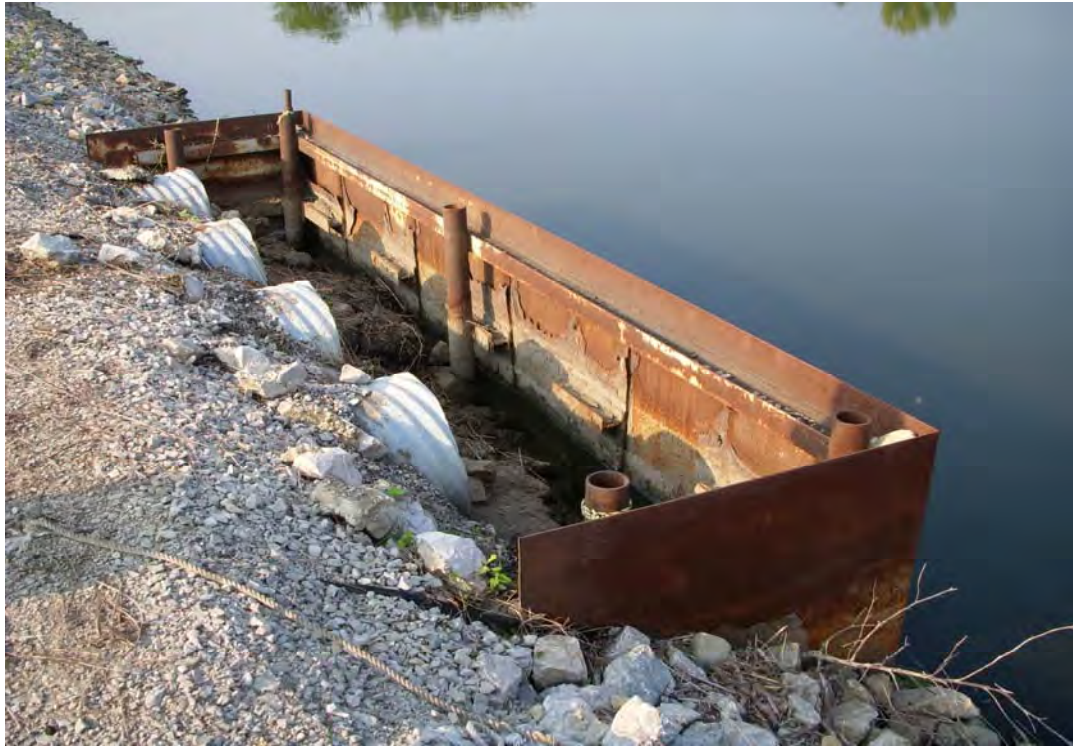
Weir box for emergency spillway outlet pipes from Ash Pond A to the Secondary Pond

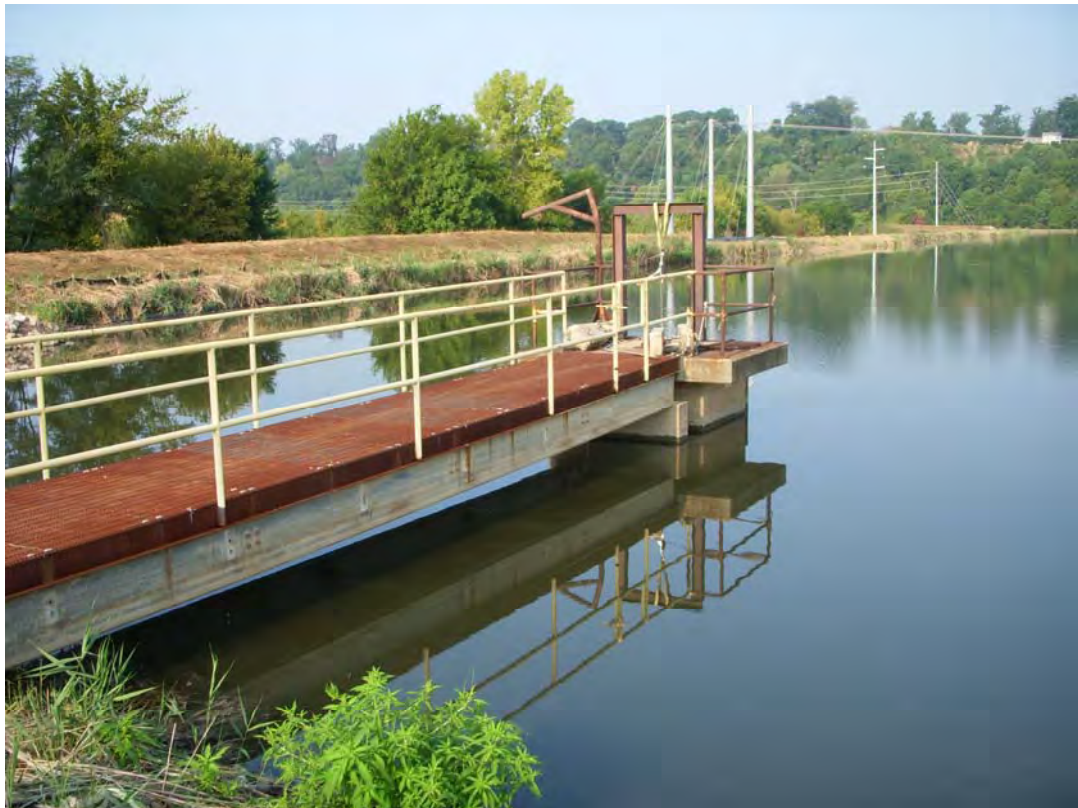
Access bridge and operating platform for Ash Pond A principal spillway

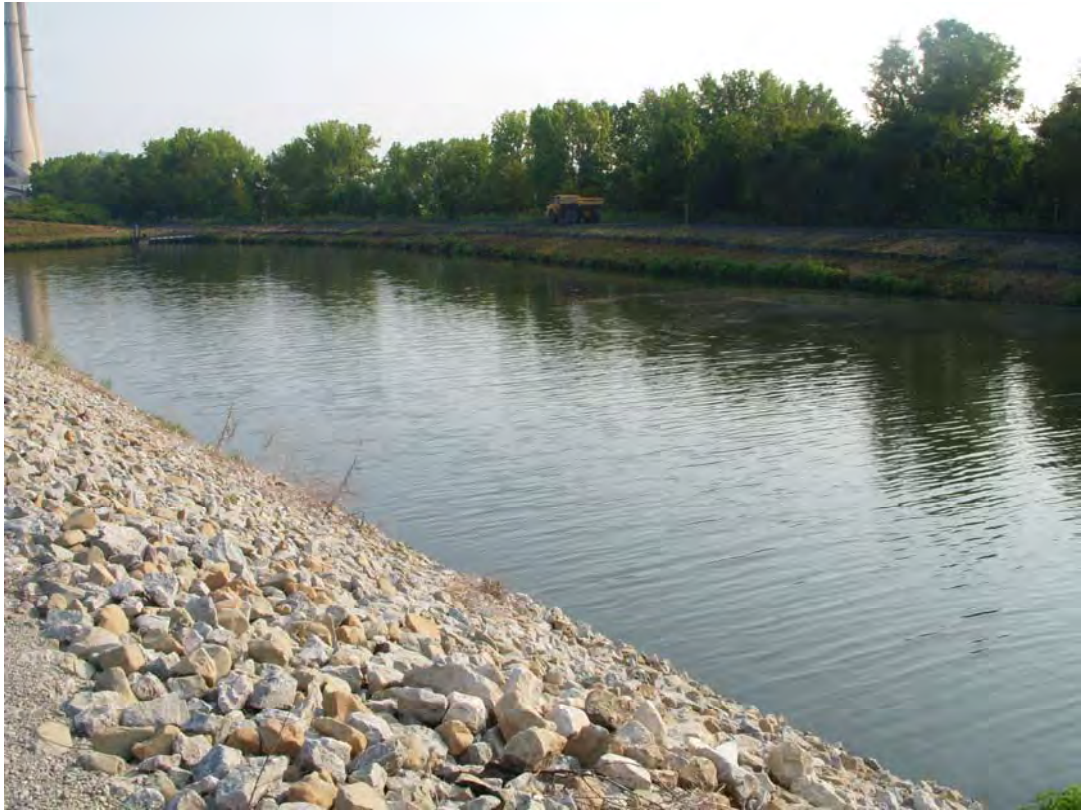
- The eastern embankment divides Ash Pond A from the Secondary Pond, but the Secondary Pond water elevation was significantly lower than the Ash Pond A water elevation such that most of the outboard slope was visible (Appendix B – Photo 13). This slope is lined with rock fill and appears to be in stable condition.

Eastern slope of separation dike (eastern embankment of Ash Pond A)

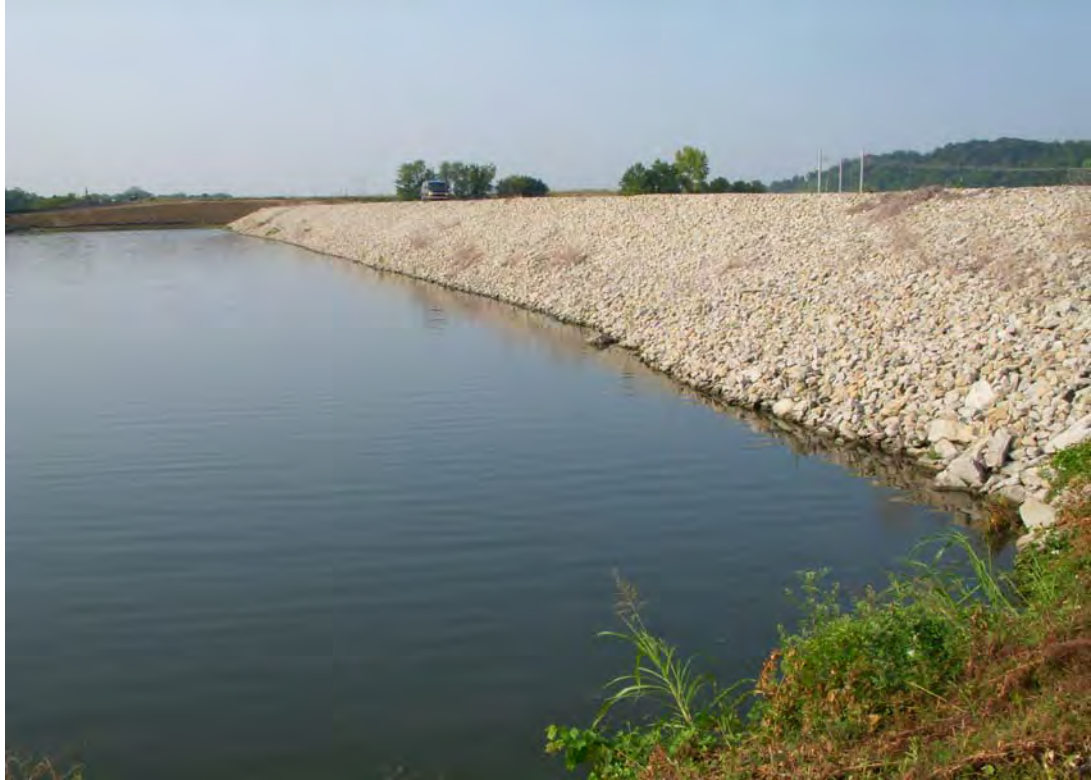
Photo Number:
1

- As noted above, the dike that separates Ash Pond A and the Secondary Pond serves as the western embankment of the Secondary Pond (Appendix C – Photo 1). The Ash Pond A principal spillway outlet pipe is located through the separation dike and, on the date of the inspection, water was discharging into the Secondary Pond. The pool elevation of the Secondary Pond was considerably lower than the Ash Pond A elevation. According to the ATC report, the normal pool elevation of the Secondary Pond is El. 427.

Eastern slope of separation dike (inboard slope of western embankment of Secondary Pond

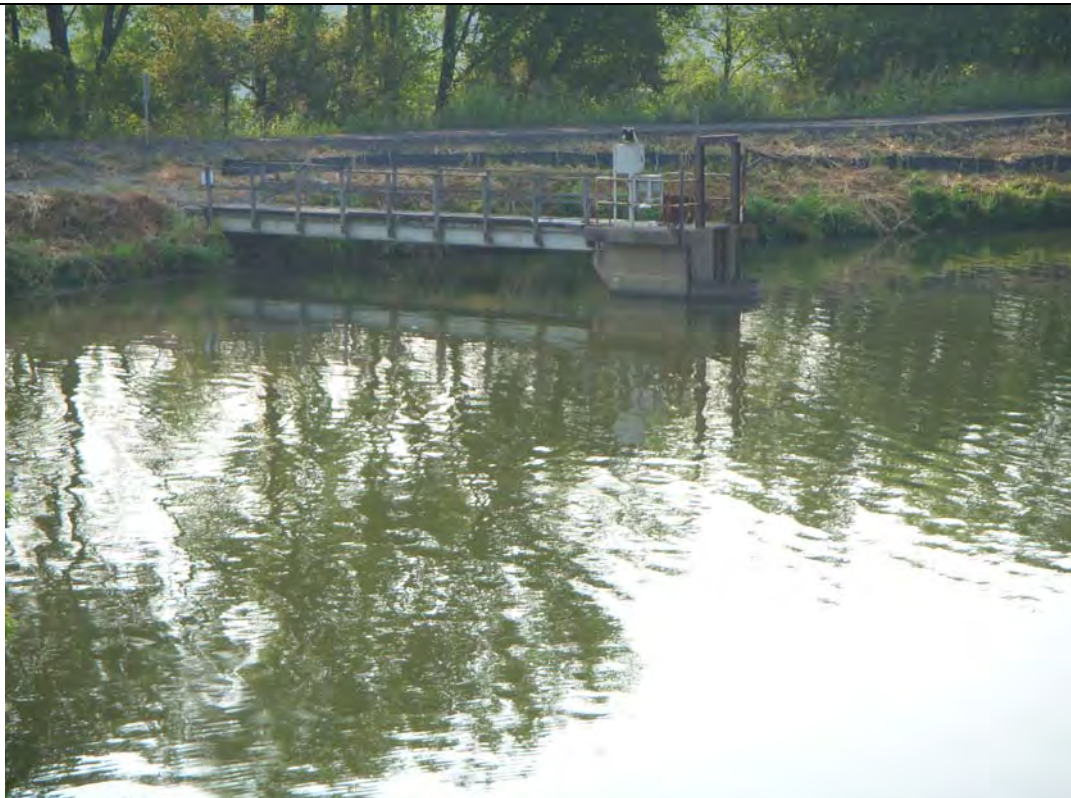
Photo Number:
2

Principal spillway outlet structure for Secondary Pond

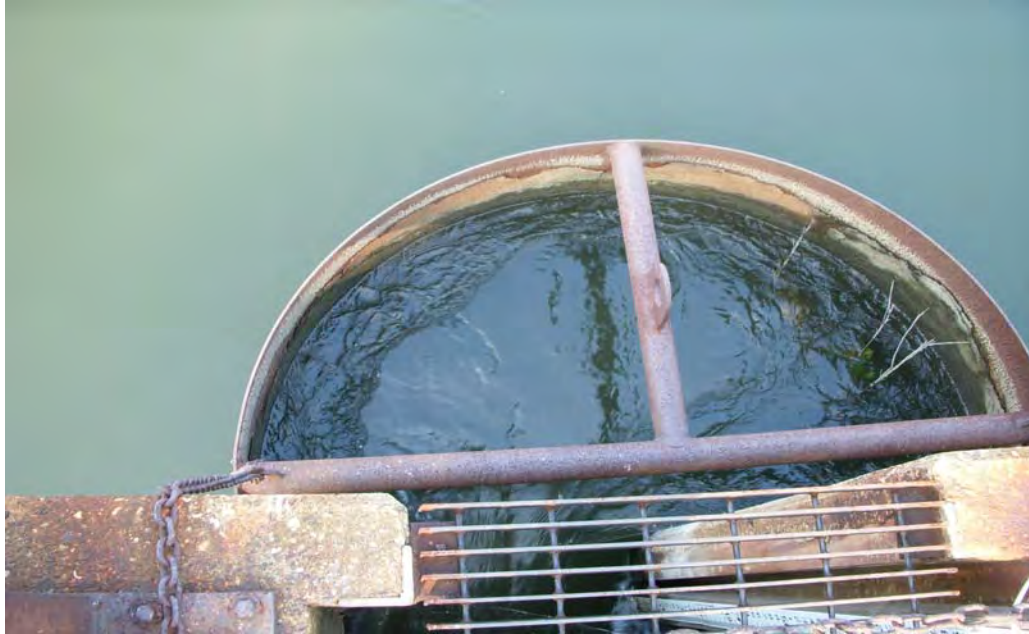
Photo Number:
3

Description:
Principal
spillway inlet
for the
Secondary Pond

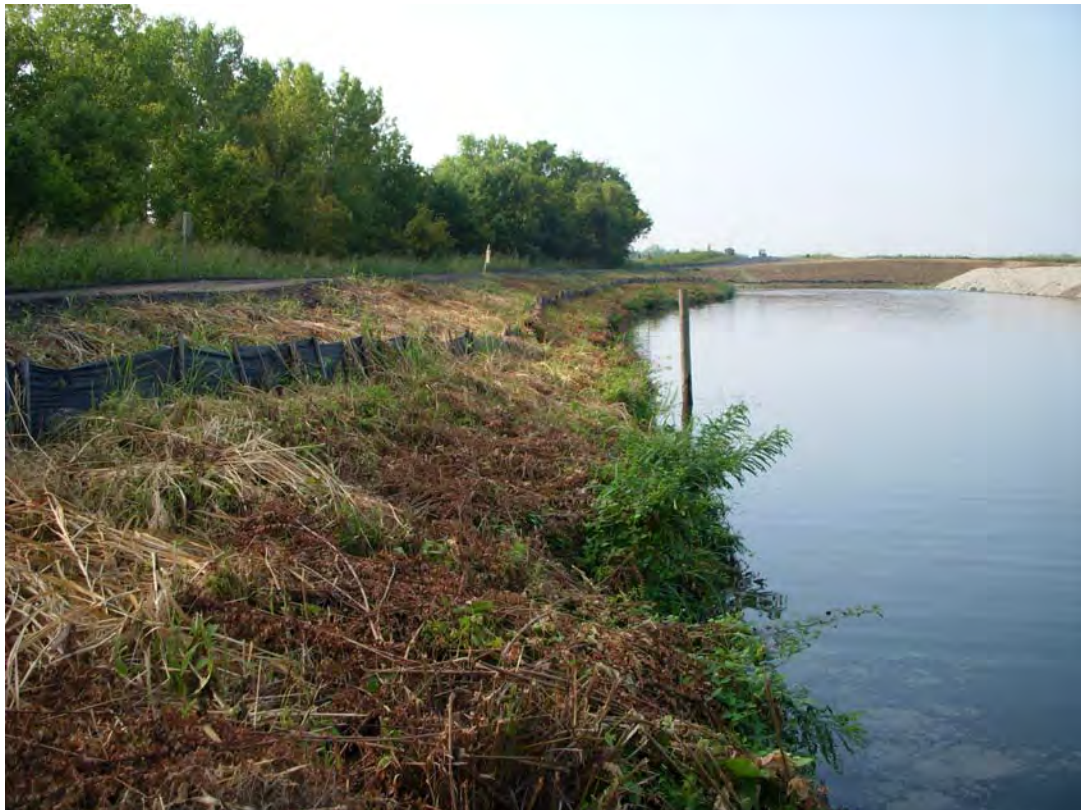
Photo Number:
4

Description:
Inboard slope
of the eastern
embankment of
the Secondary
Pond

- Based on the hydrologic/hydraulic analyses recommended above, an appropriate crest elevation should be established for the eastern embankment of the Secondary Pond. The embankment crest should then be regraded to a uniform elevation to eliminate the significant variation that currently exists in the crest elevation.

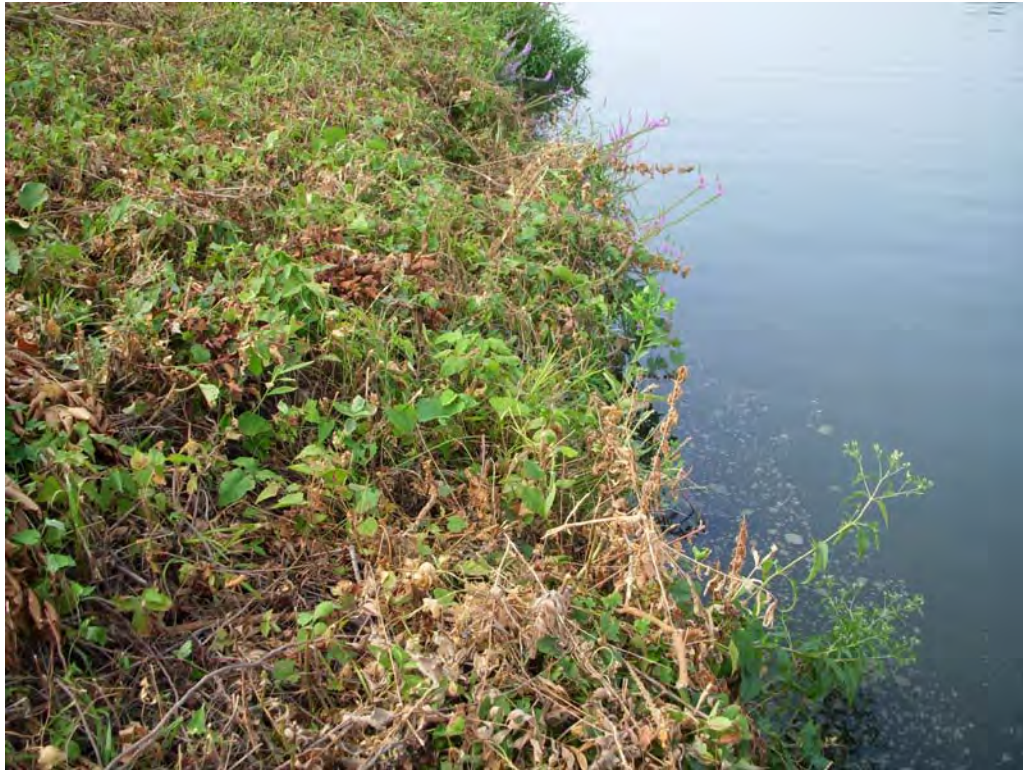
Photo Number:
5

Cut vegetation along the inboard slope of the eastern embankment of the Secondary Pond

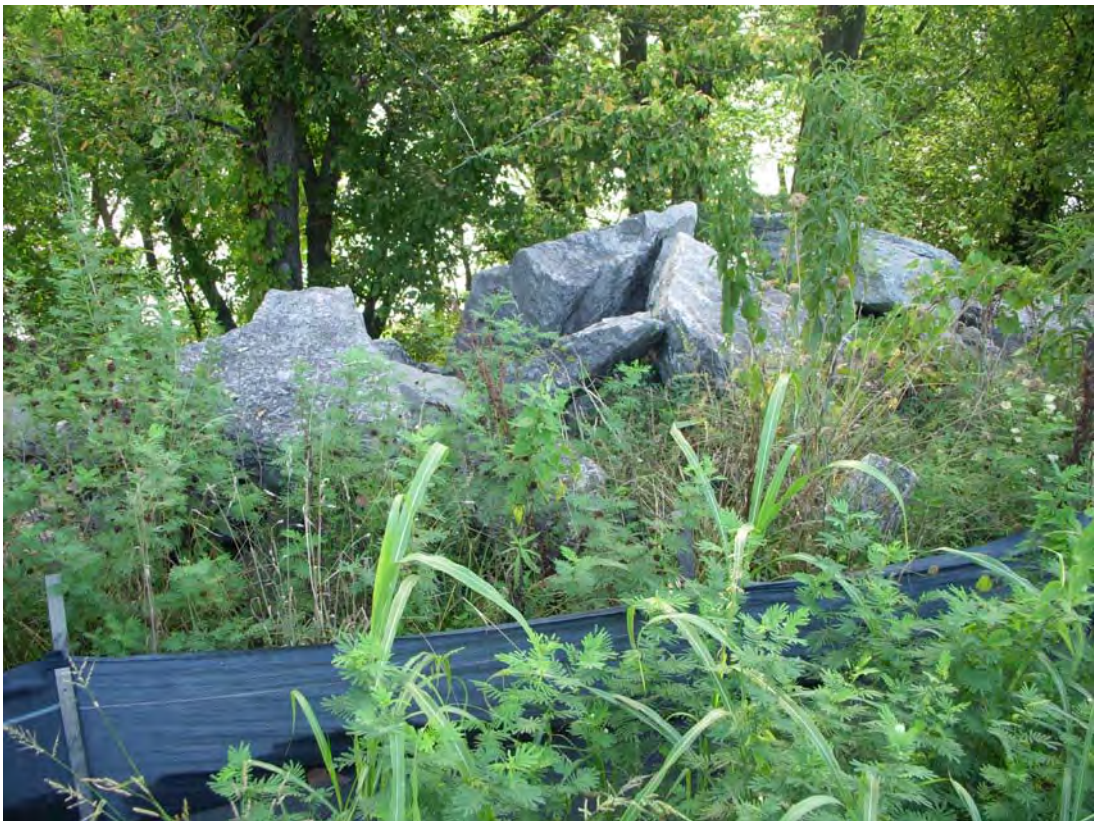
Photo Number:
6

Large riprap and overgrowth of trees on outboard slope of eastern embankment (Ohio River bank) of Secondary Pond

- Standard dam safety practice typically recommends the removal of trees from earth embankment sections, due to the potential for uprooting of the trees during storm events and the resulting damage to the embankment. However, since the outboard slope of the eastern embankment also serves as the Ohio River bank, the large trees growing on the slope may reduce the erosion potential from high river flows and, therefore, we recommend that these trees be left in place. However, it would be advisable to perform periodic inspections of this slope, particularly after major storm events, to identify any trees that may have been uprooted and damaged the embankment.

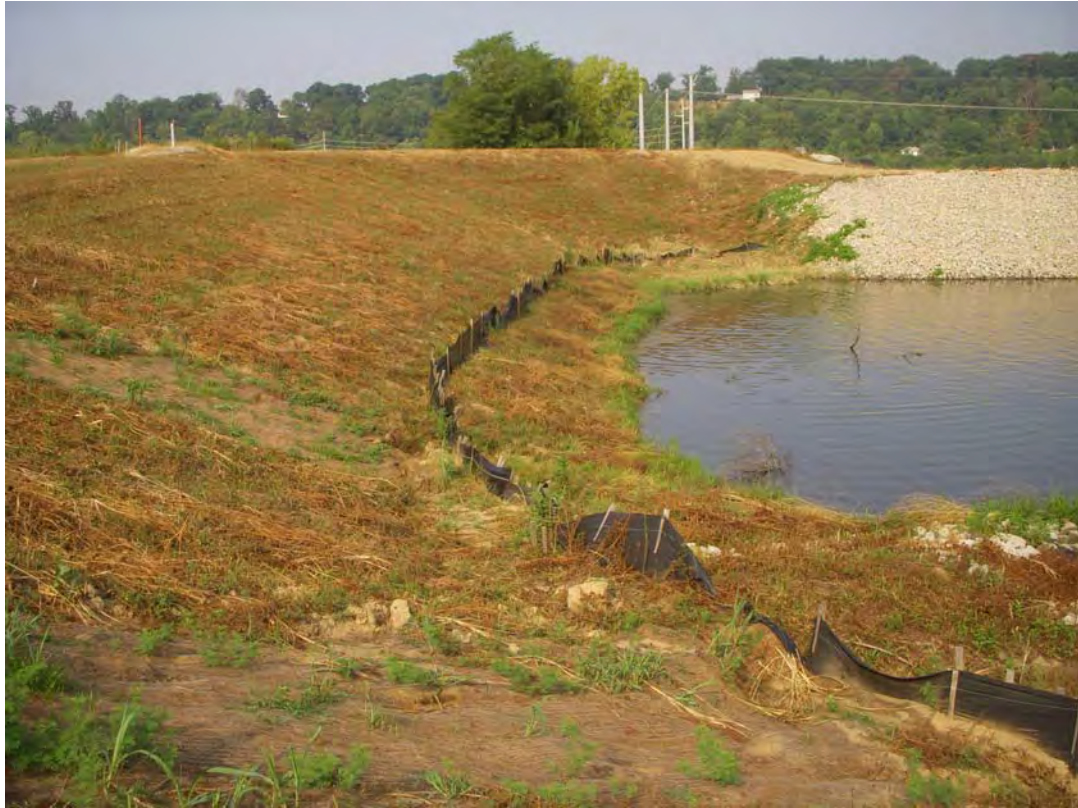
Photo Number:
7

Description:
Tie-in of separation dike and eastern embankment to natural ground at south end of the Secondary pond

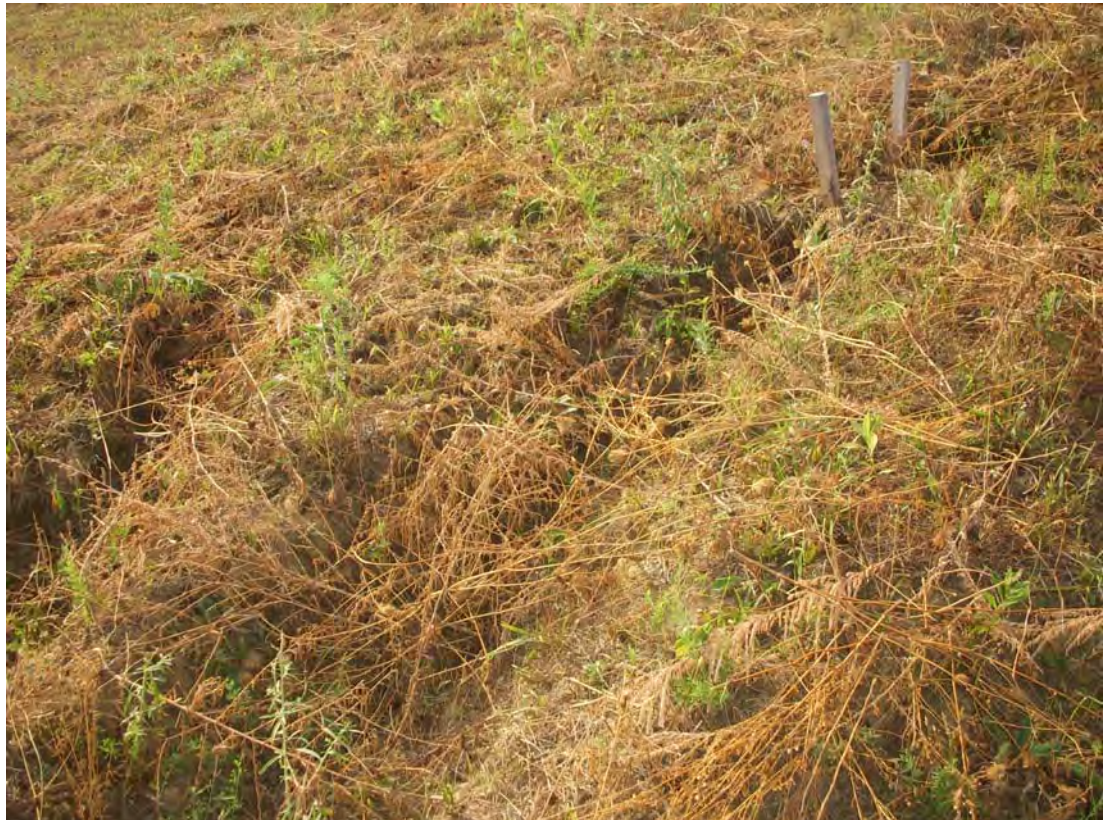
Photo Number:
8

Description:
Runoff erosion rills along the natural ground slope at the south end of the Secondary Pond
