DRAFT

**Specific Site Assessment for
Coal Combustion Waste
Impoundments at Duke Energy
Indiana (DEI) Gibson
Generating Station**

Owensville, Indiana

May 2010
Project 092880

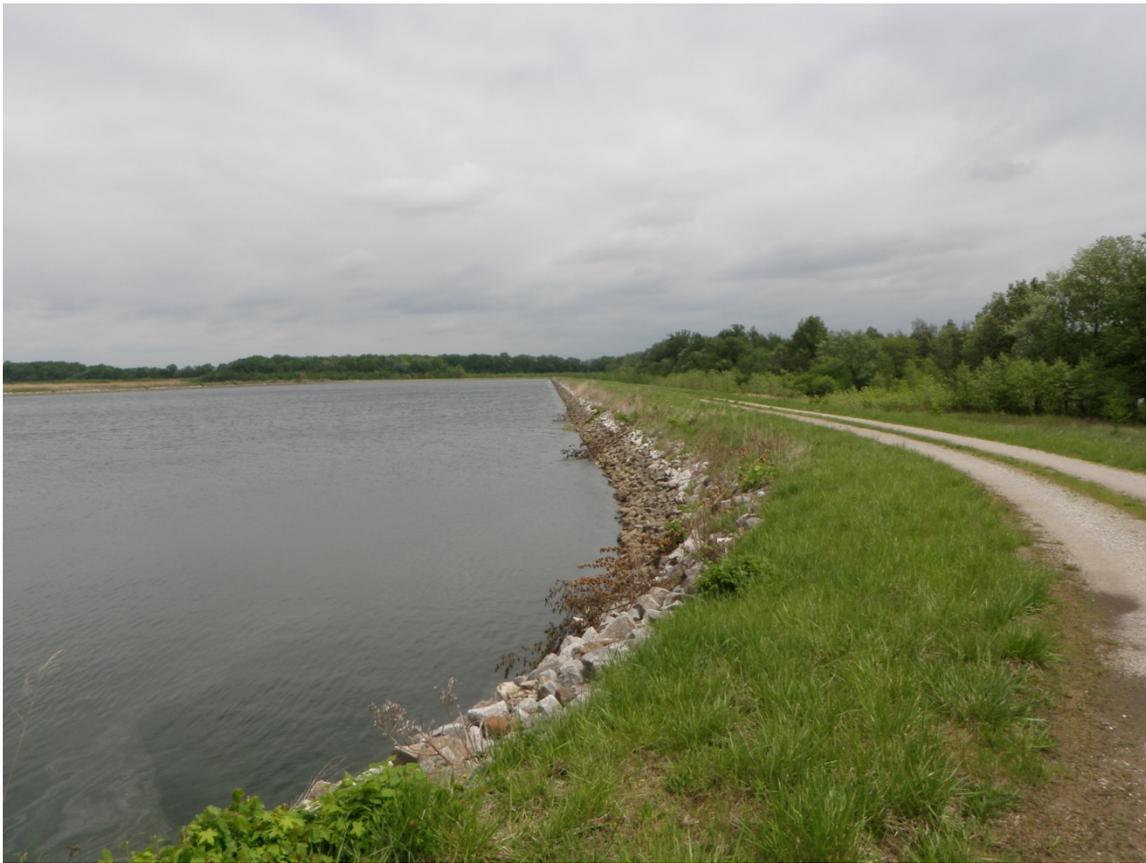
Photo 1: East Settling Basin - South dike upstream slope, looking east from south west corner.

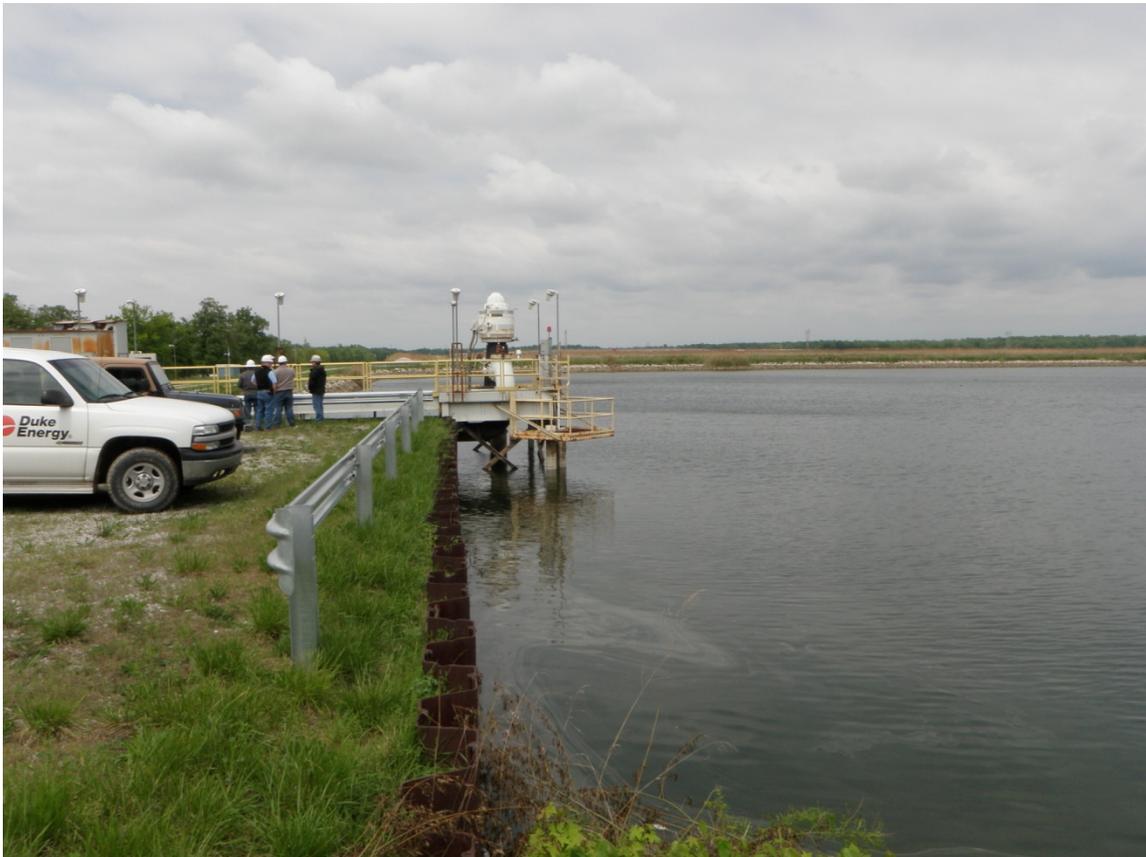
Photo 2: East Settling Basin –Pump intake that discharges to the Cooling Pond, looking north.

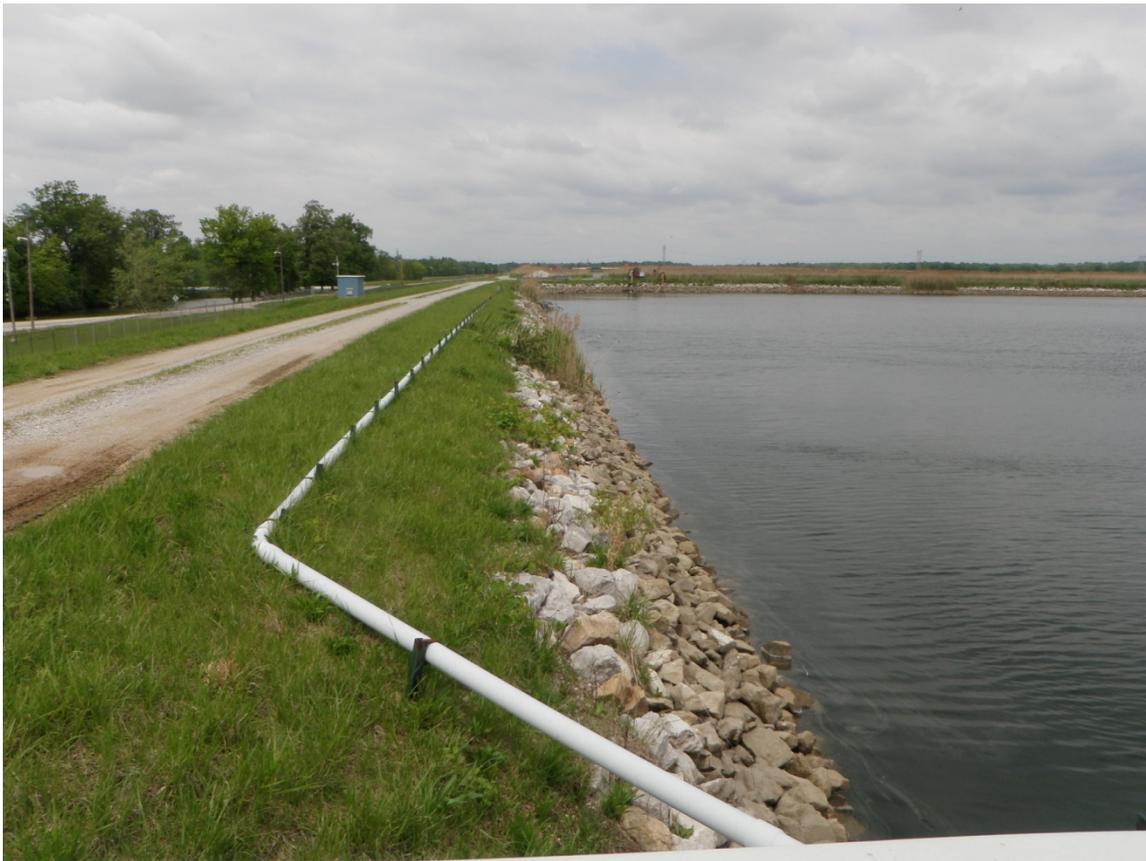
Photo 3: East Settling Basin – West dike upstream slope, looking north.

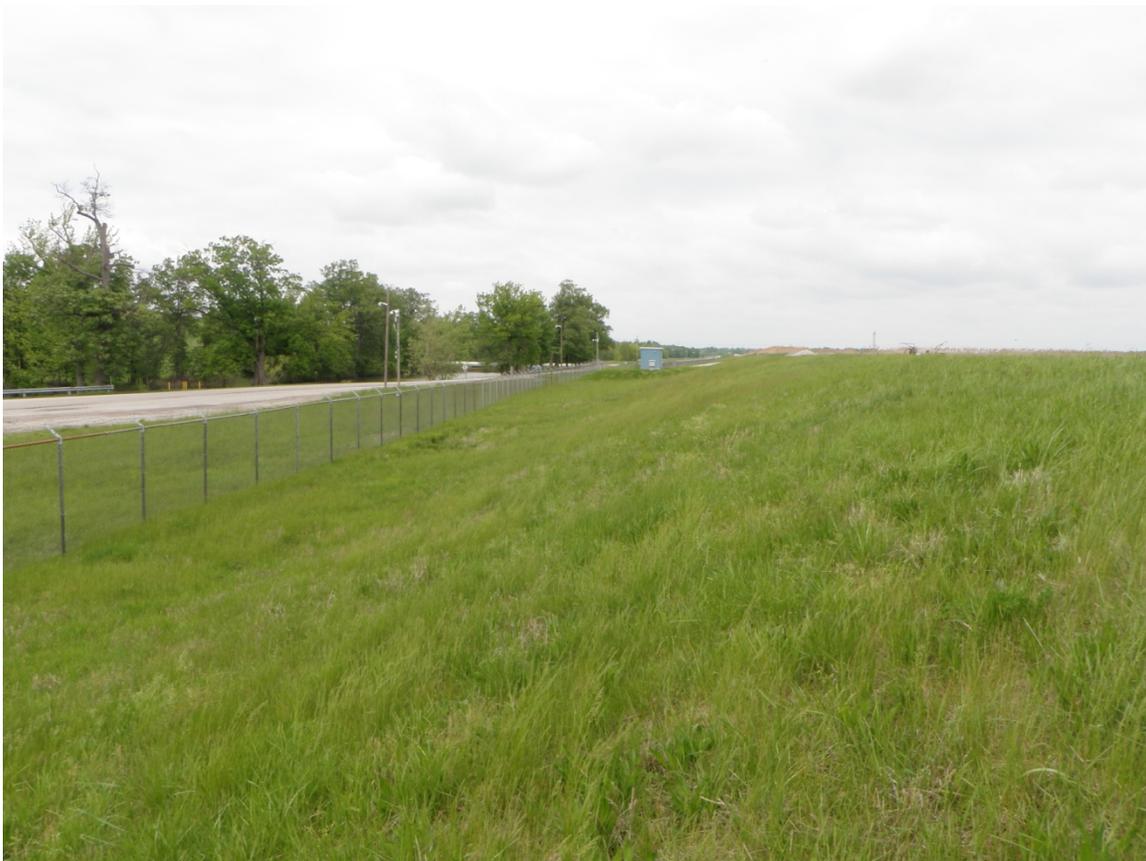
Photo 4: East Settling Basin – West dike downstream slope, looking north.

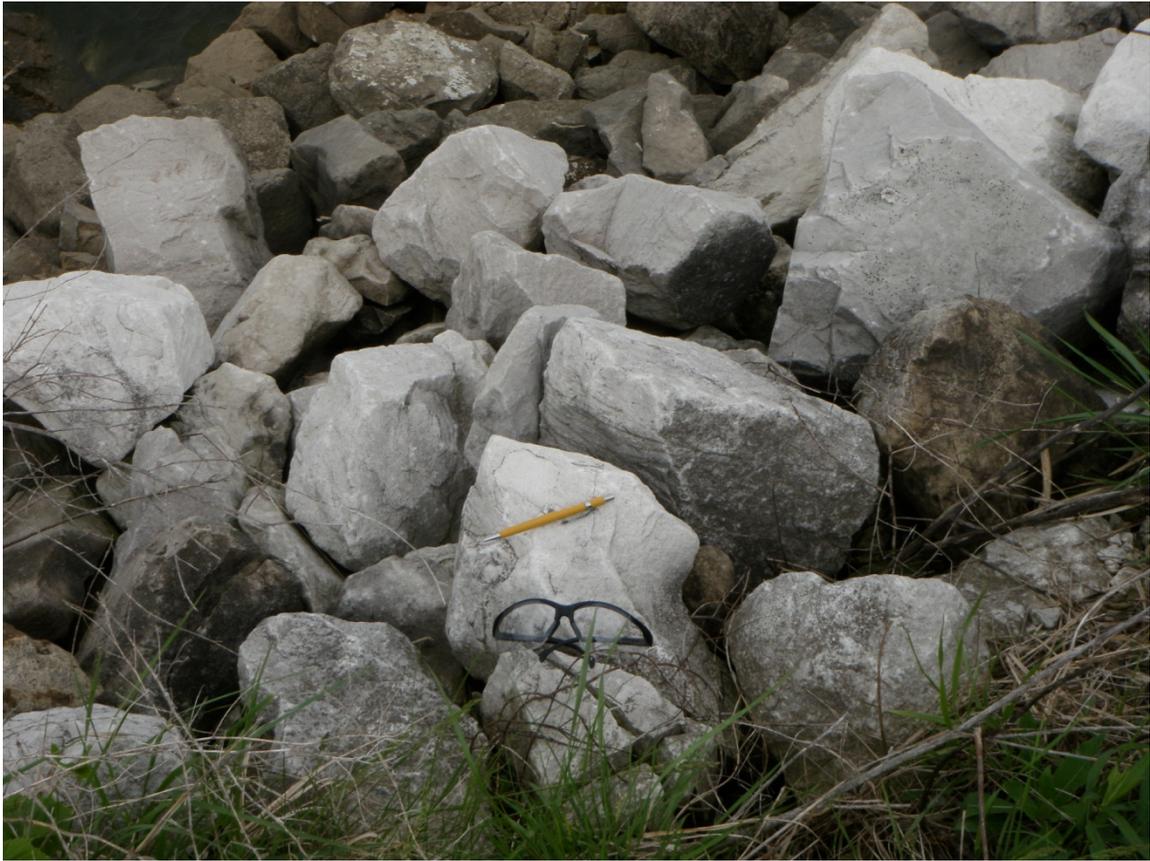
Photo 5: East Settling Basin – South dike upstream slope protection detail.

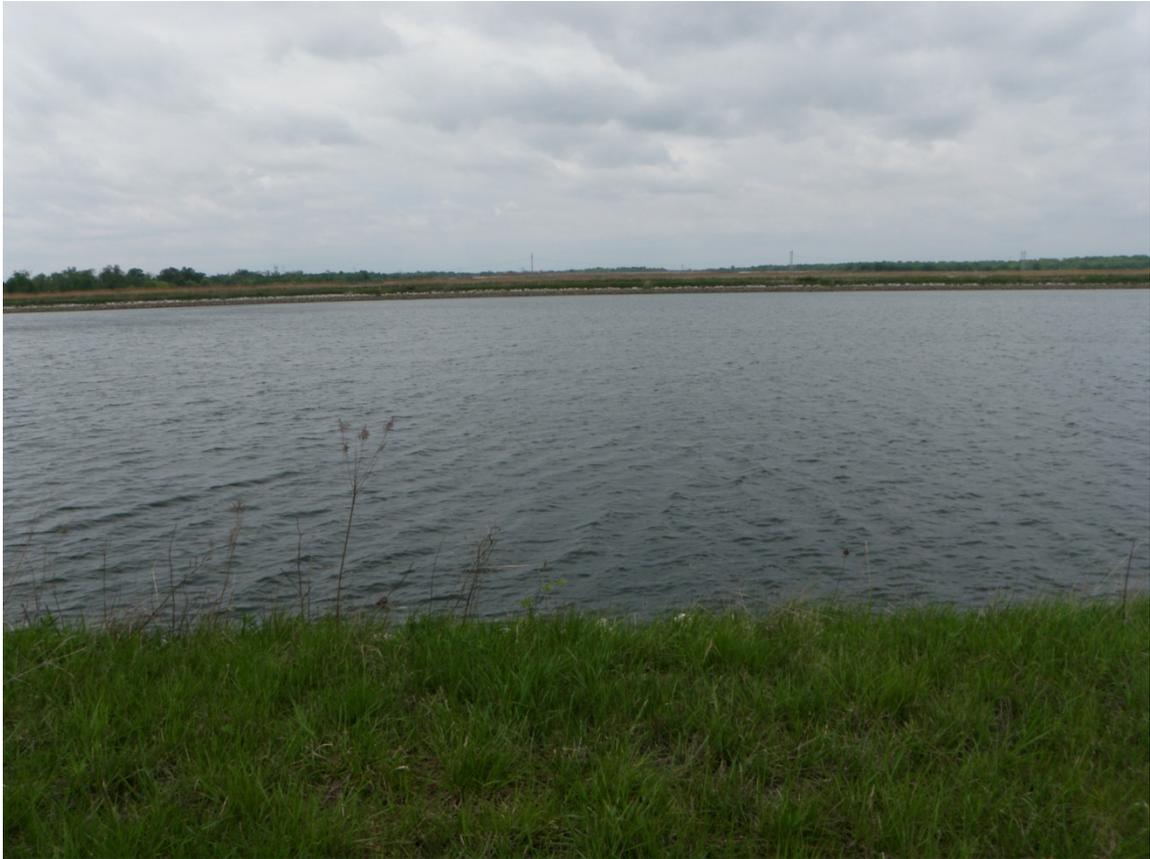
Photo 6: East Settling Basin – Reservoir area from south dike, looking north.

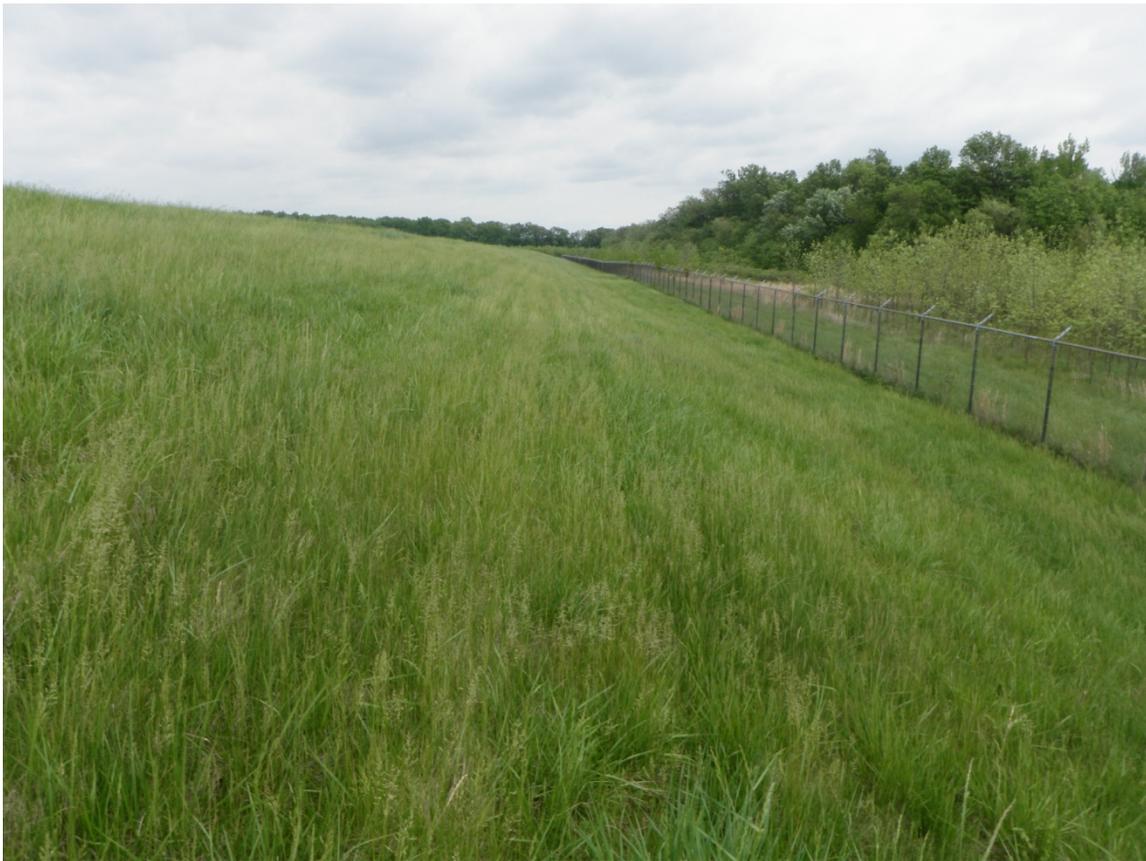
Photo 7: East Settling Basin – South Dike downstream slope, looking west.

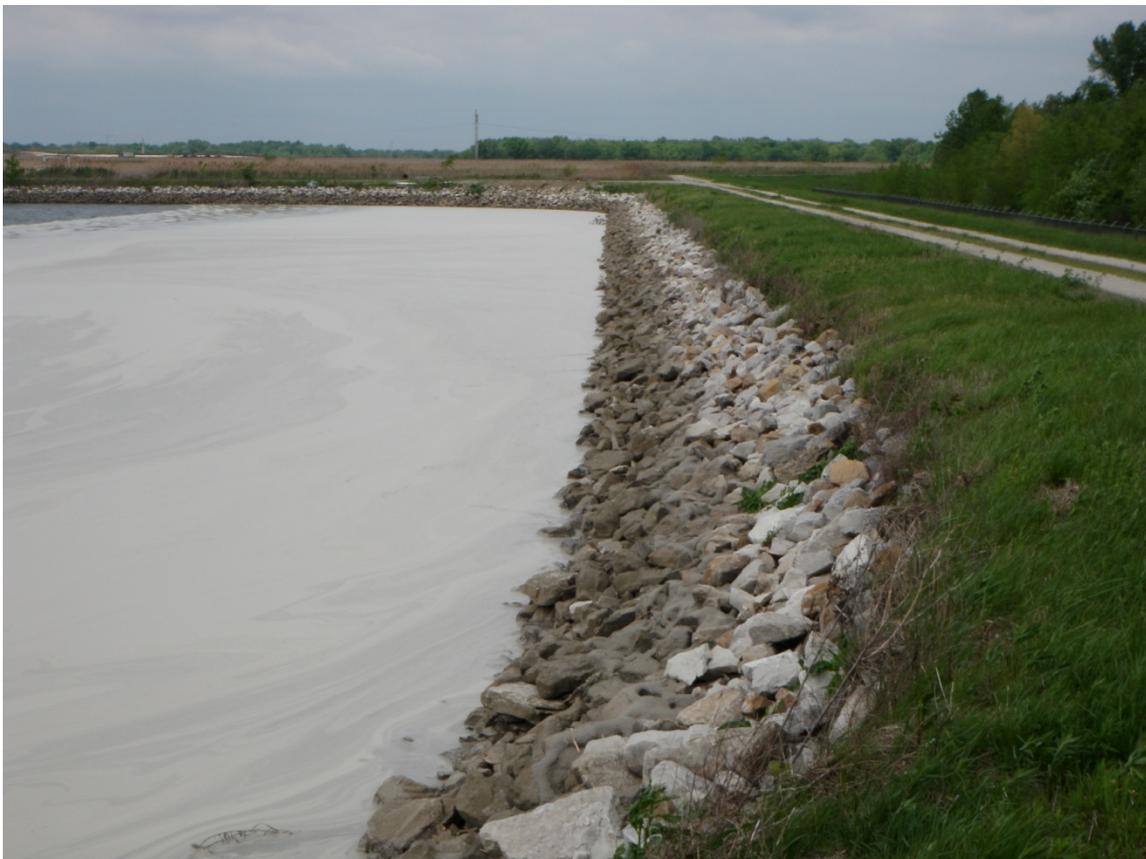
Photo 8: East Settling Basin – East Dike upstream slope, looking north.

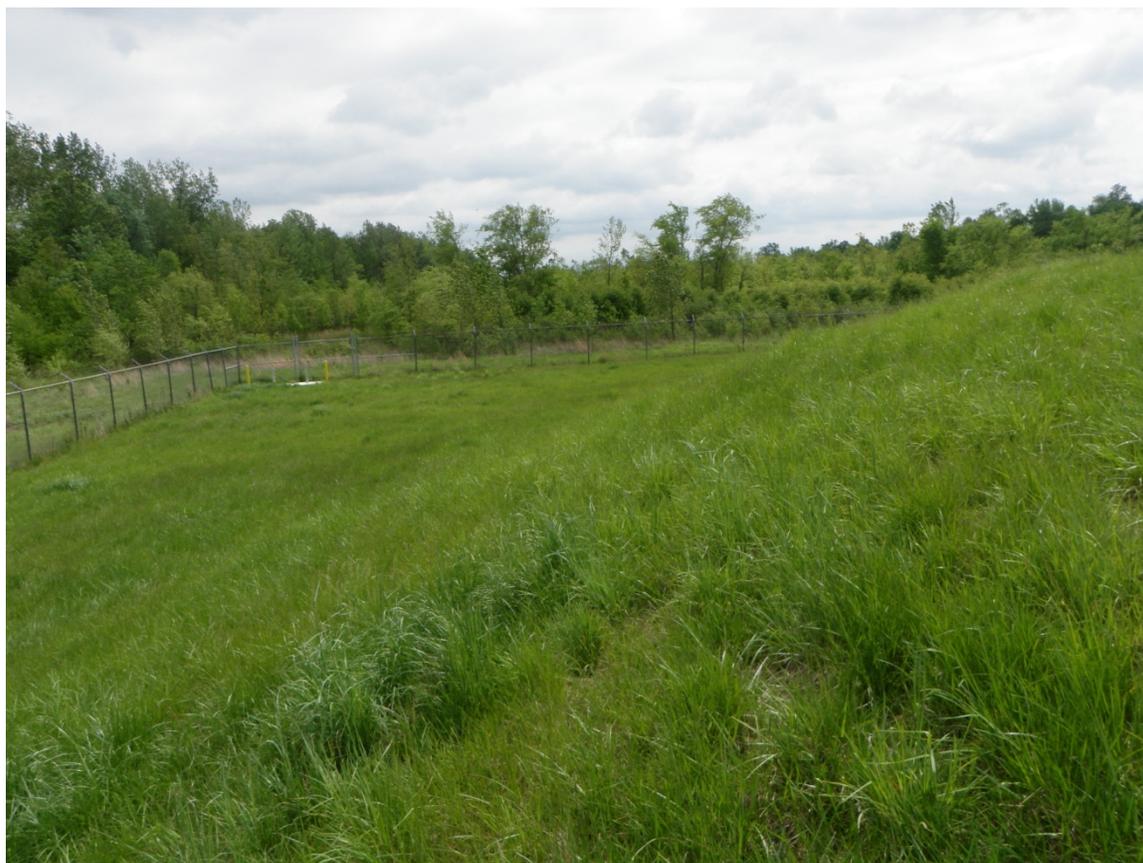
Photo 9: East Settling Basin – East and south dike downstream corner, looking south.

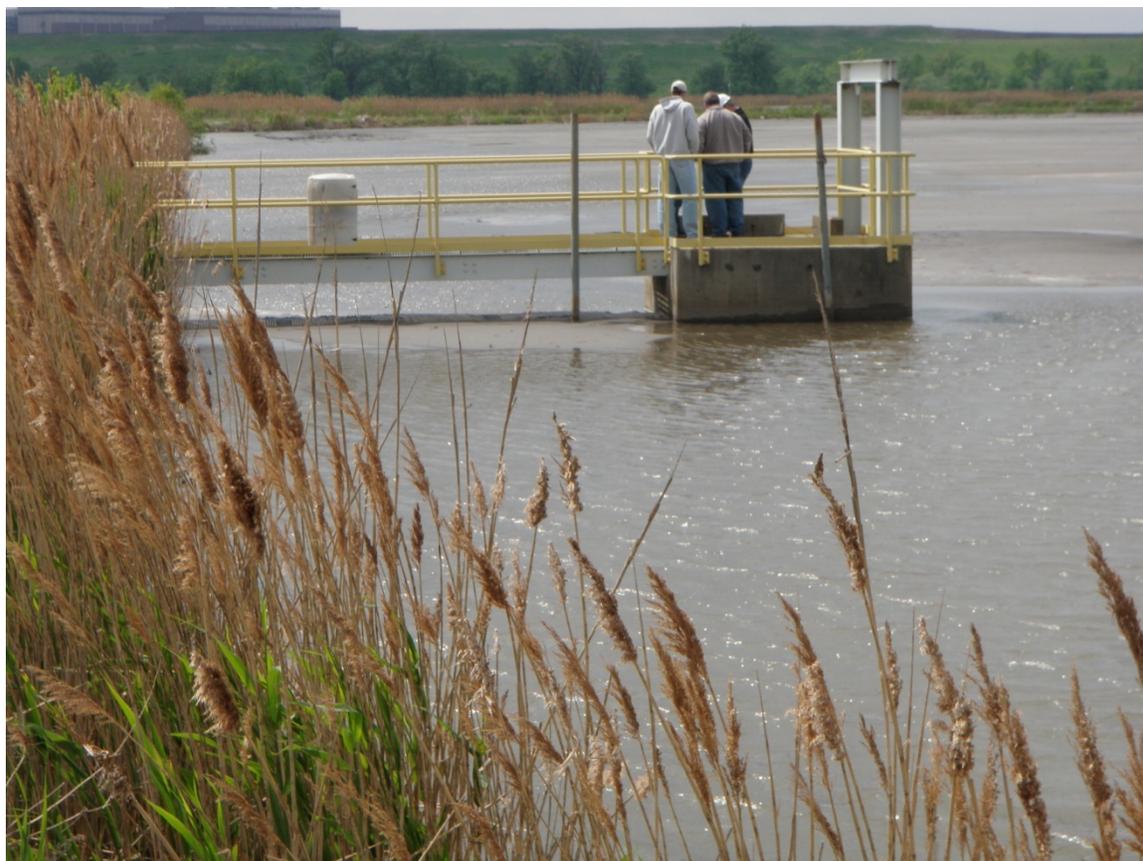
Photo 10: East Ash Pond #1 – Intake structure near southeast corner of EAP #1 that discharges to Settling Basin, looking west.

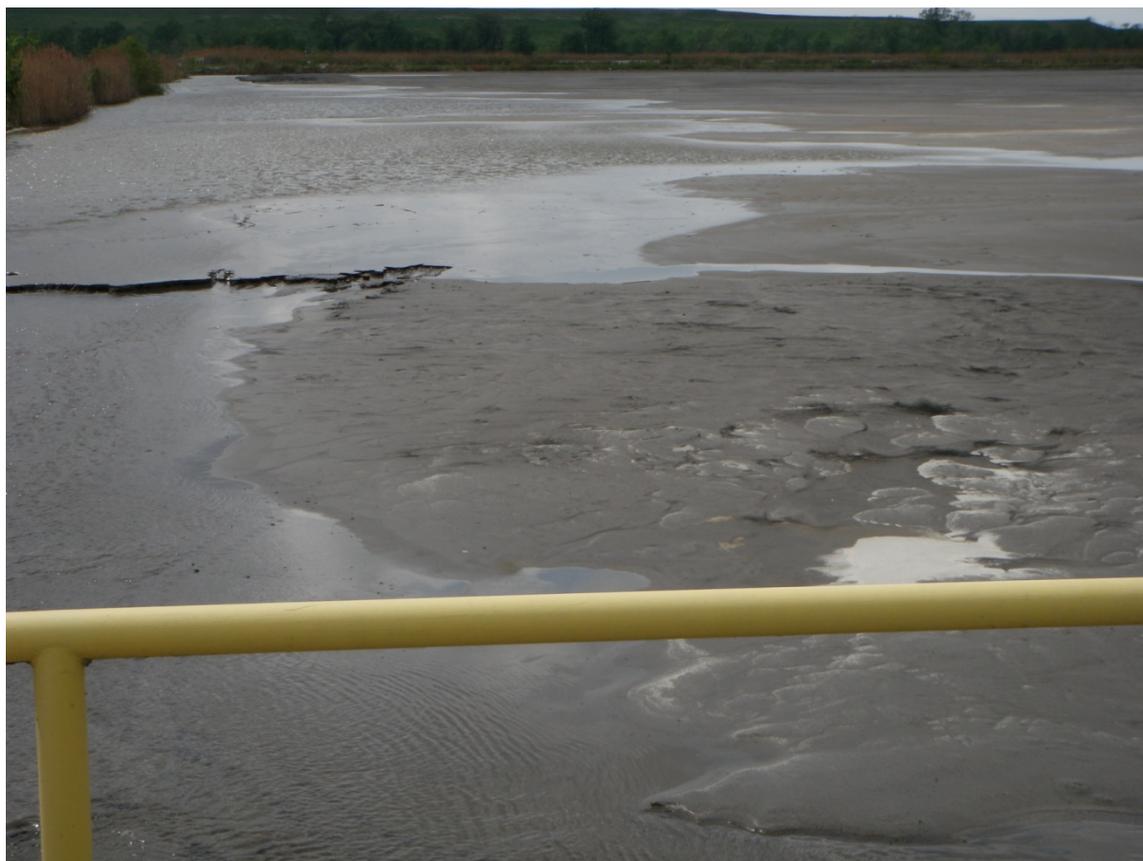
Photo 11: East Ash Pond #1 – EAP #1 reservoir area, approximately 95% full of CCW, looking west.

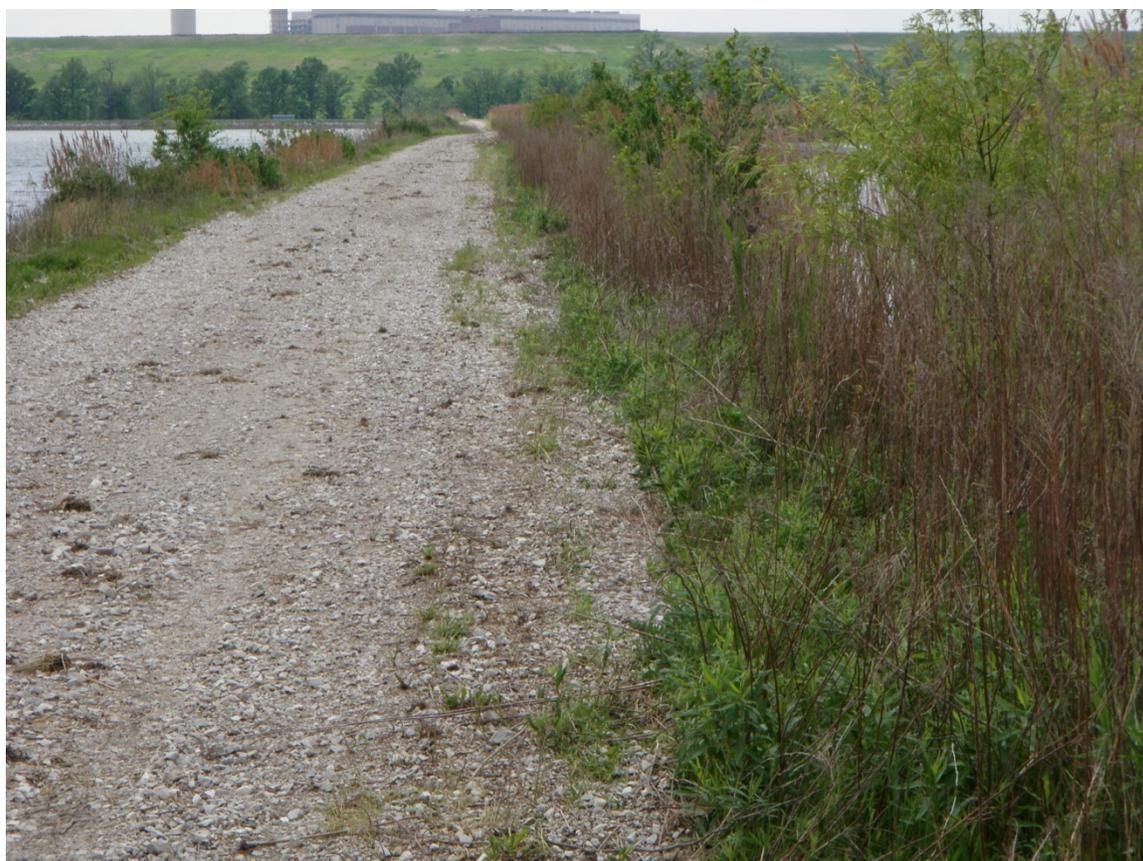
Photo 12: East Ash Pond #1 – Interior dike crest between EAP #1 and Settling Basin, looking west, notice several small trees.

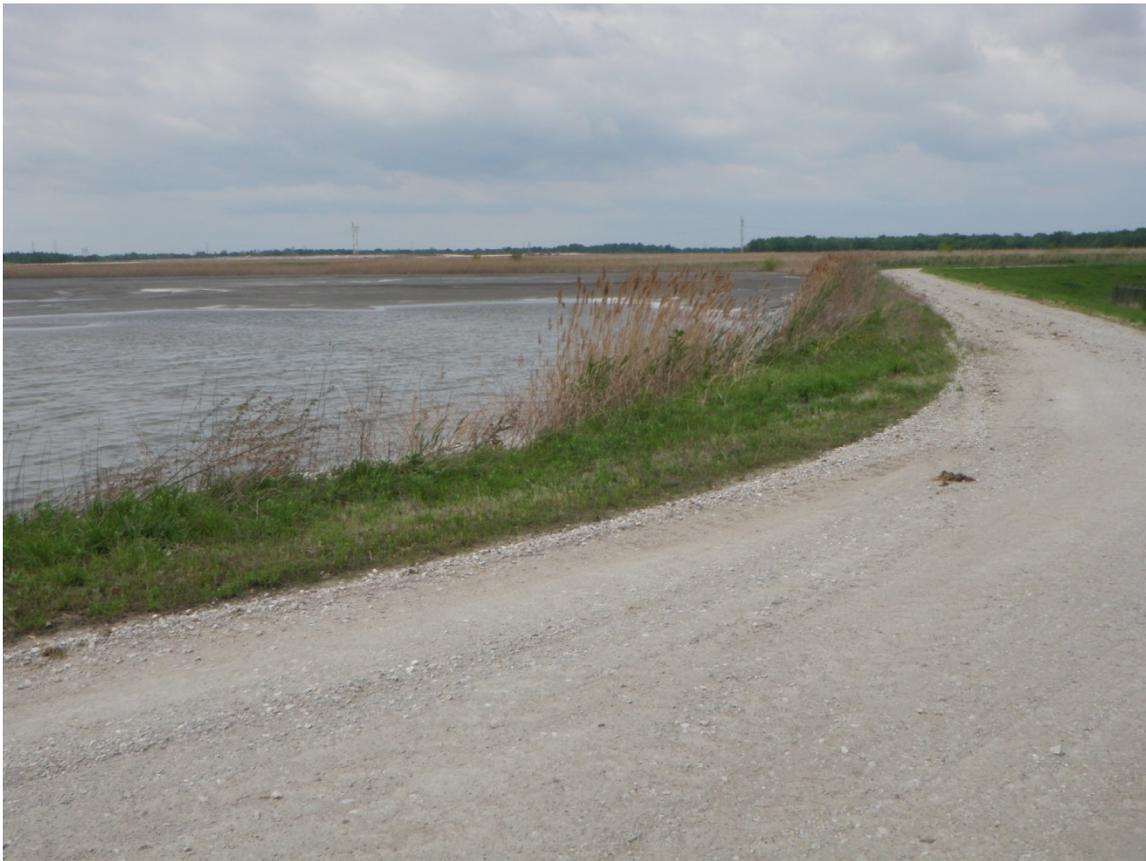
Photo 13: East Ash Pond #1 – East Dike crest, road, and reservoir area, looking north from SE corner.

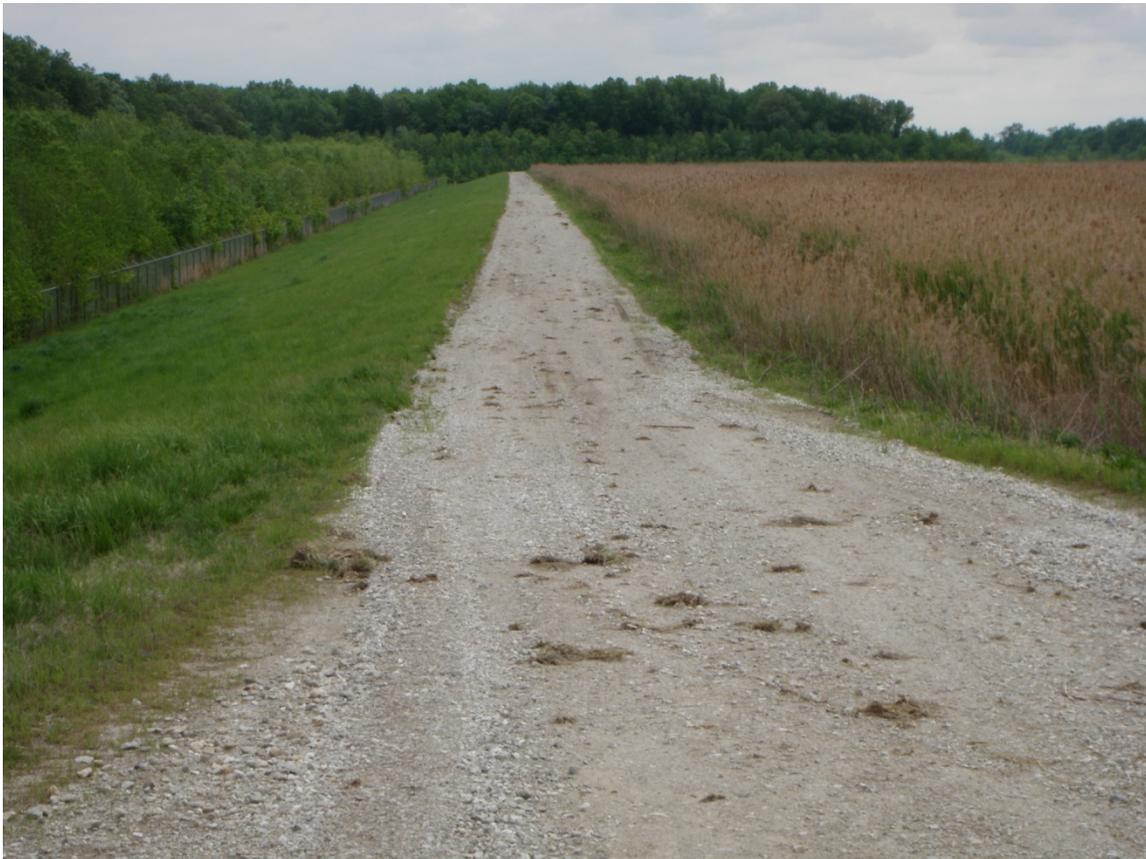
Photo 14: East Ash Pond #1 – East Dike crest and road, looking south from NE corner.

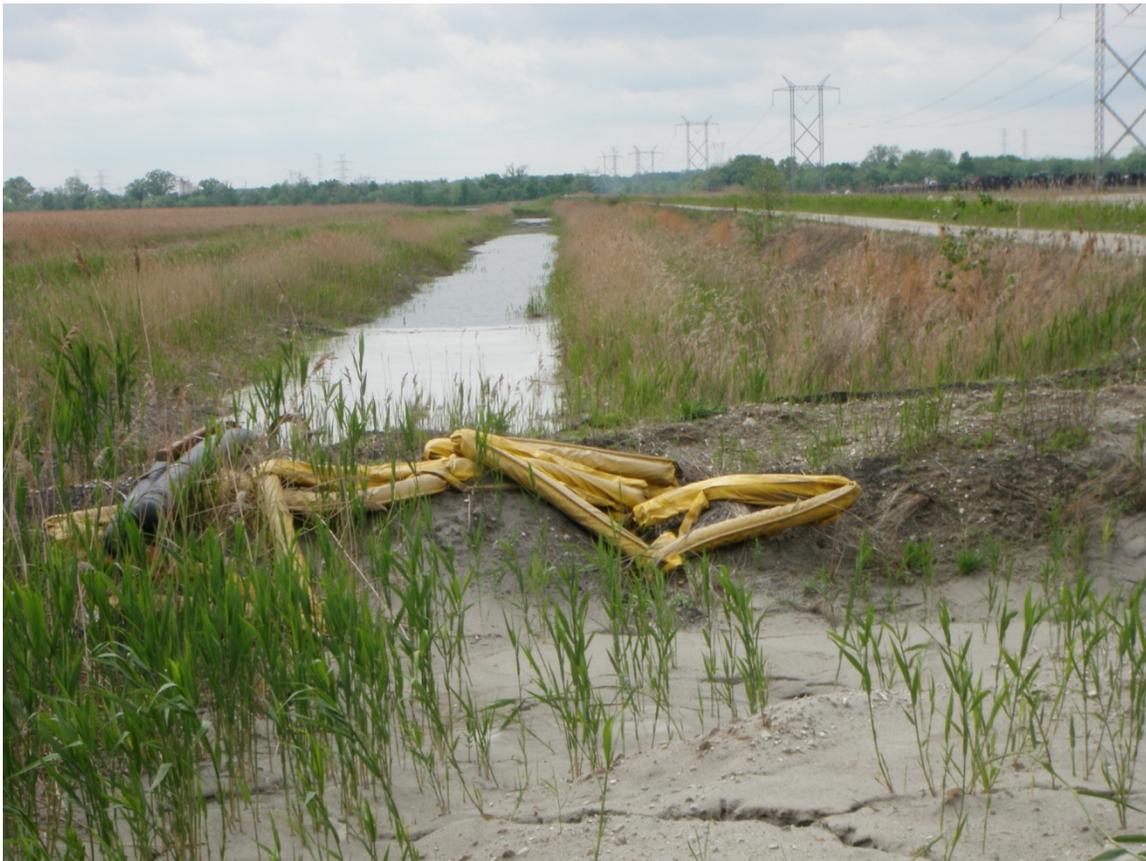
Photo 15: East Ash Pond #1 – Drainage swell on north side of EAP #1 that discharges to EAP #2, looking west.

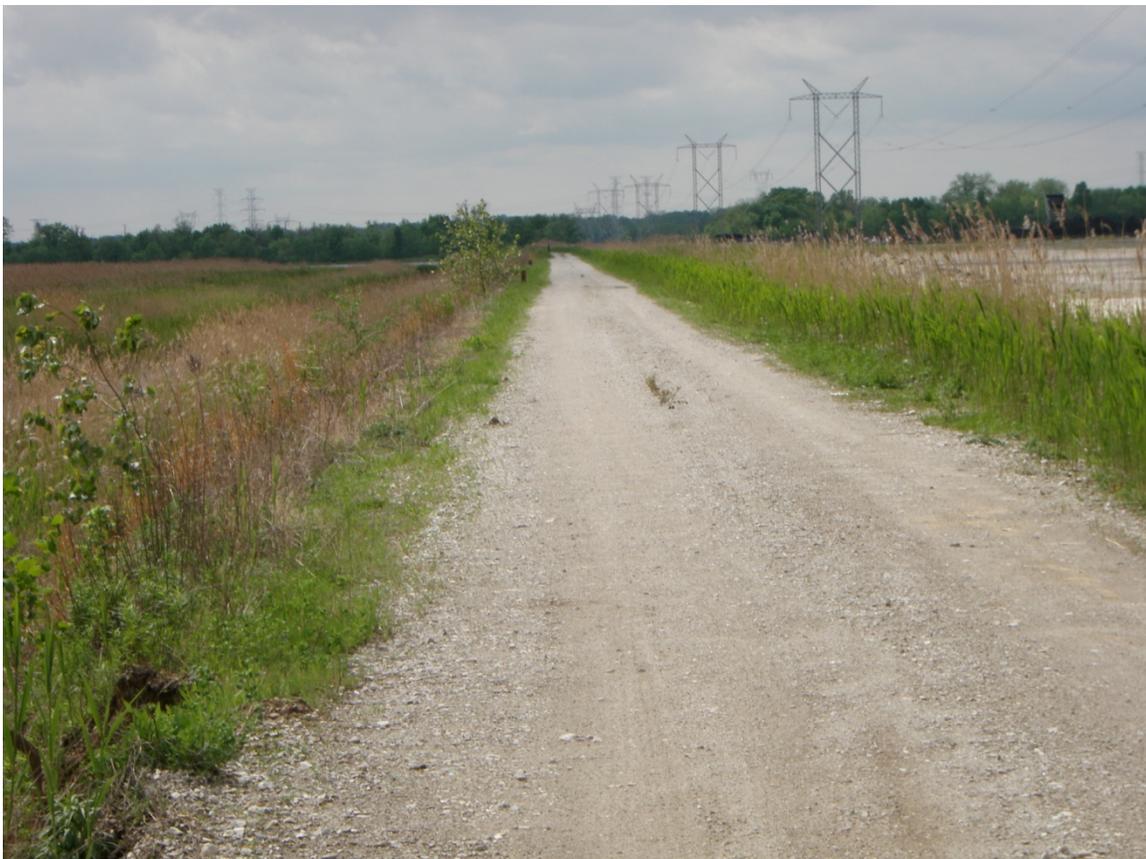
Photo 16: East Ash Pond #3 – Interior dike crest and road between EAP #1 and EAP #3, looking west.

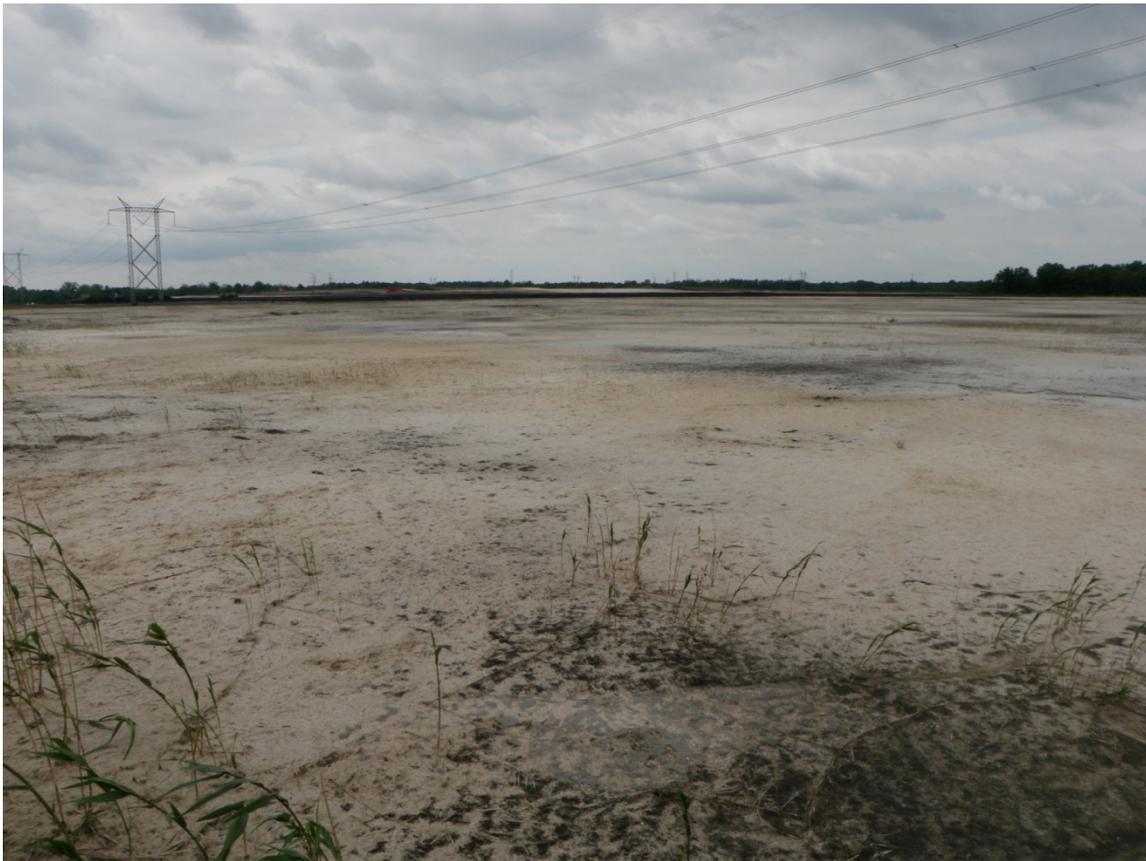
Photo 17: East Ash Pond #3 – EAP #3 reservoir area, about 95% full, in close out phase, looking northwest.

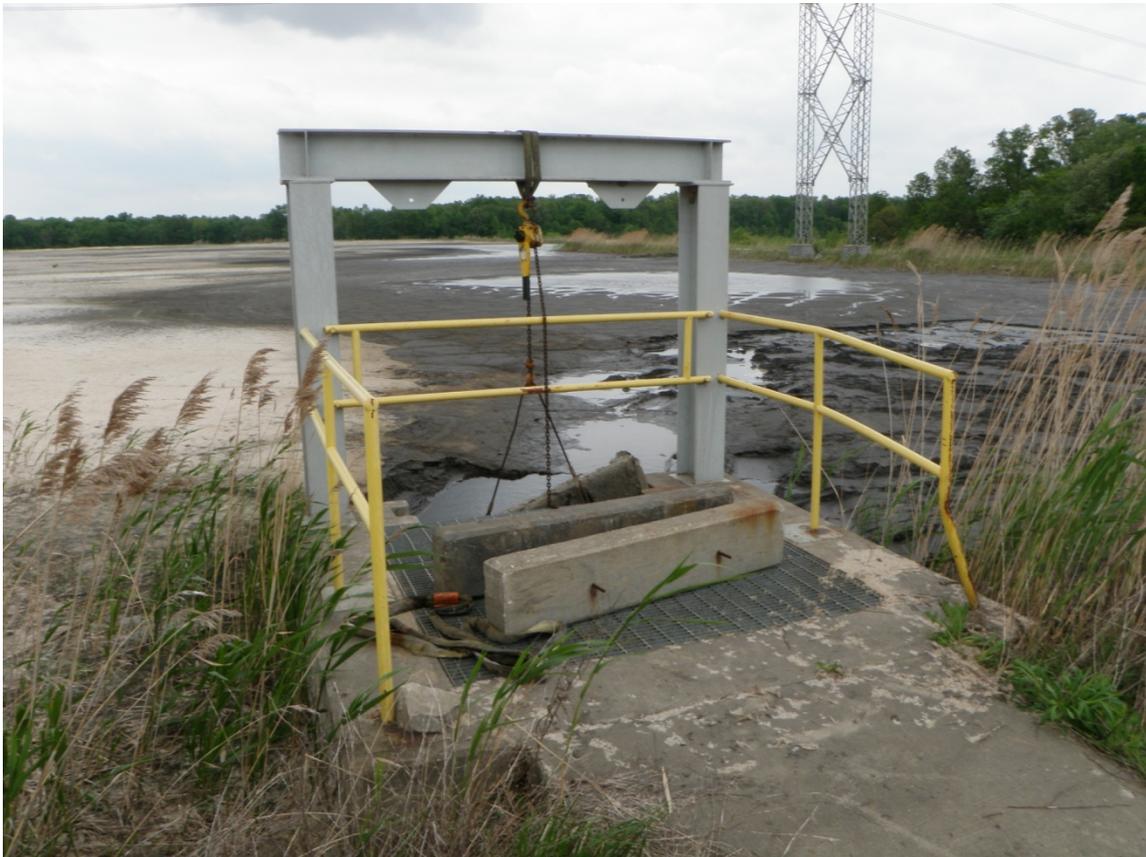
Photo 18: East Ash Pond #3 – EAP #3 Intake structure, looking north from interior dike between EAP #1 and EAP #3.

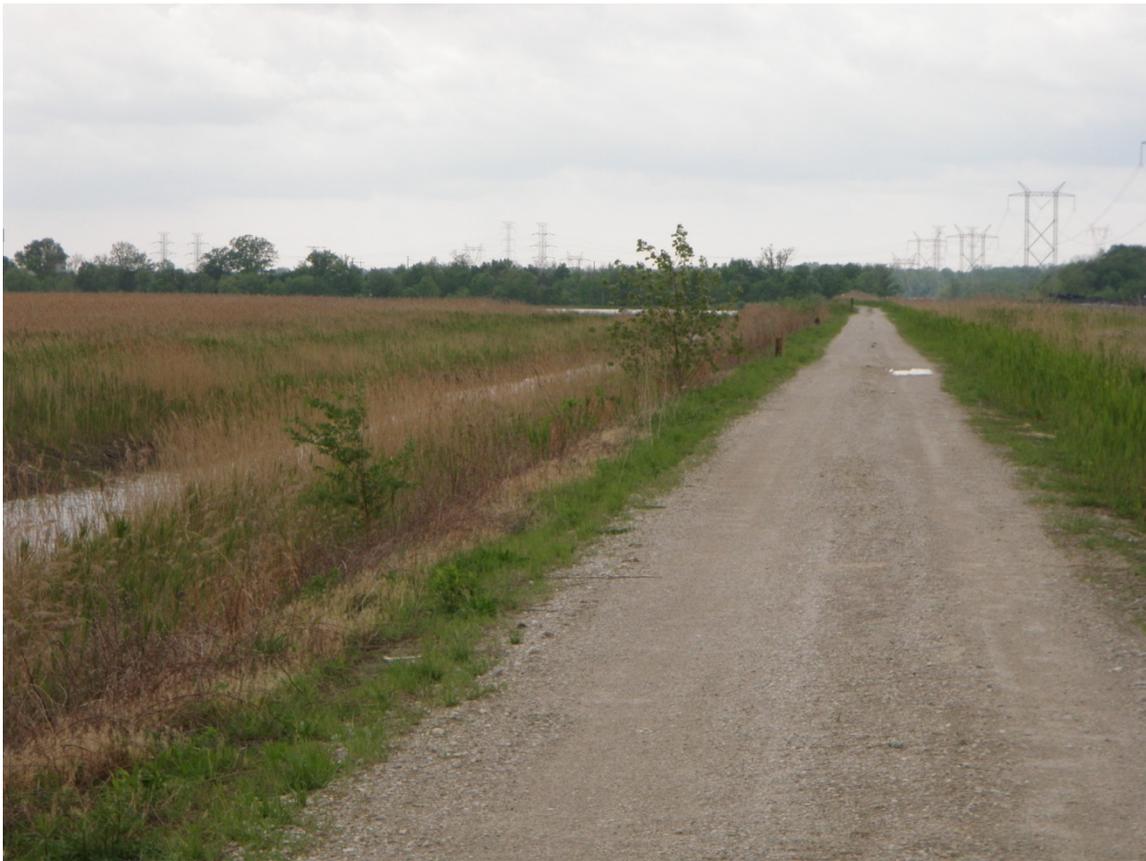
Photo 19: East Ash Pond #3 – Interior dike between EAP #1 and EAP #3, looking west, notice trees along dike.

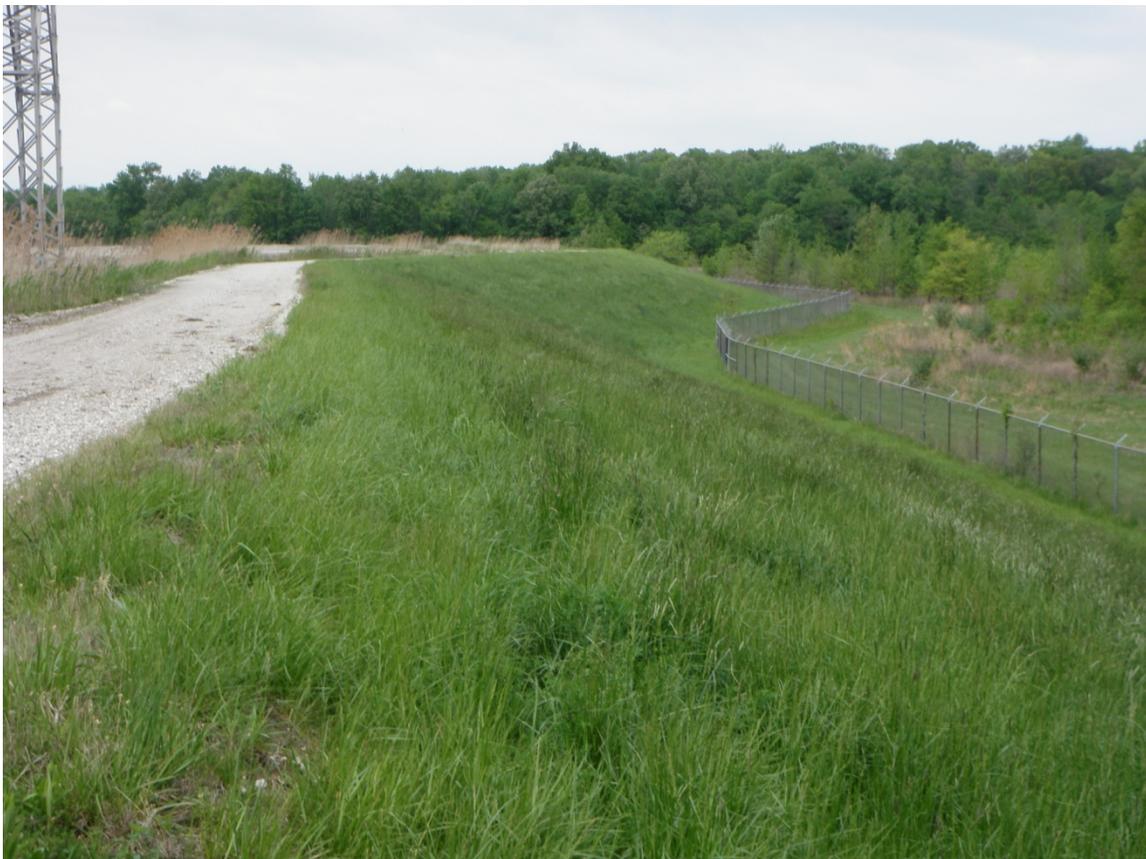
Photo 20: East Ash Pond #3 – East dike downstream slope, looking north from the corner of EAP #1 and EAP #3 interior dike.

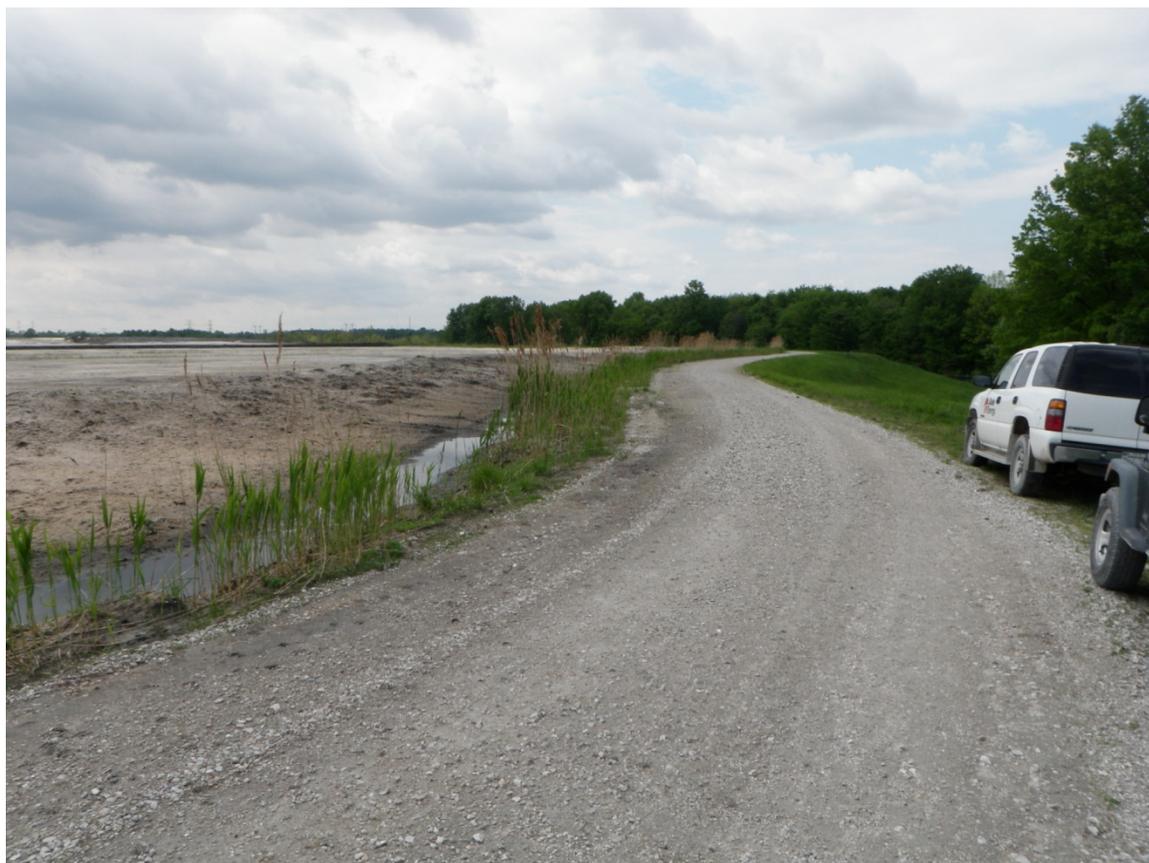
Photo 21: East Ash Pond #3 – North dike crest and reservoir area, looking northwest from northeast corner of EAP #3.

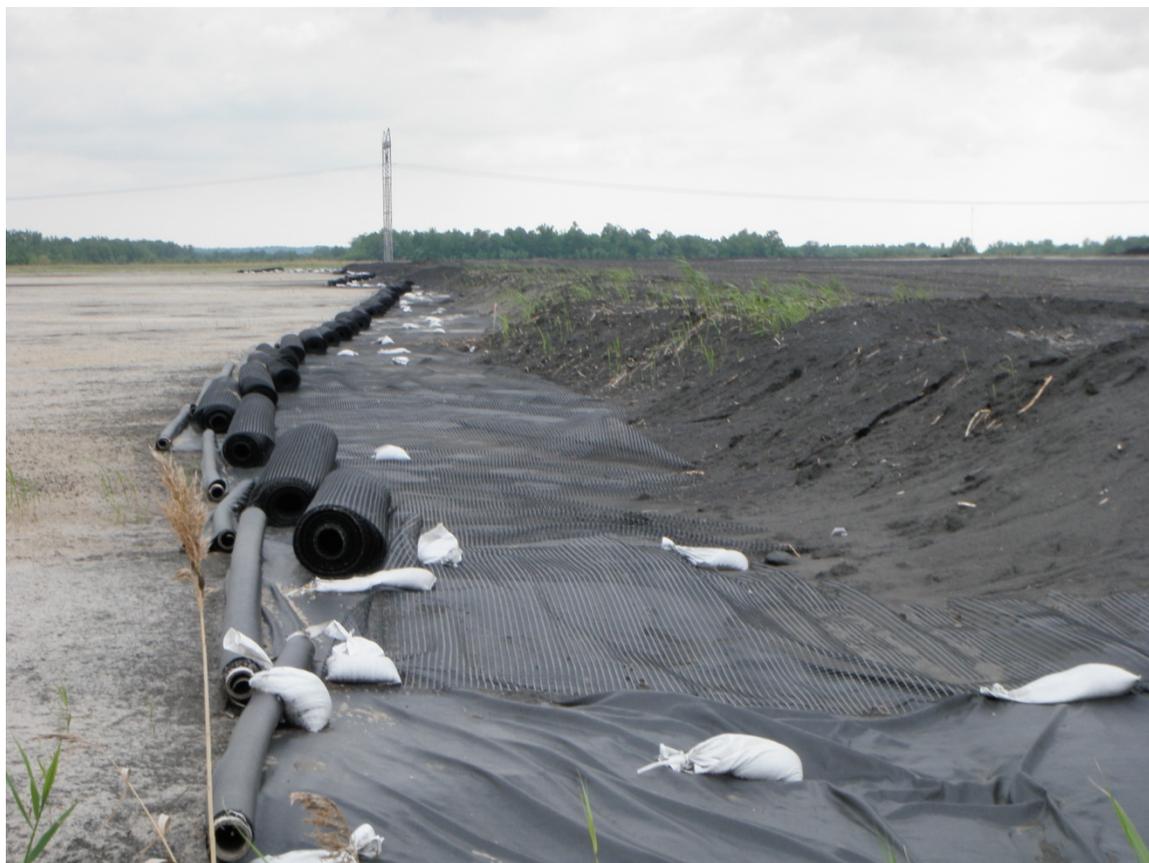
Photo 22: East Ash Pond #3 – EAP #3 capping construction, notice geofabric and geogrid, looking south from north dike.

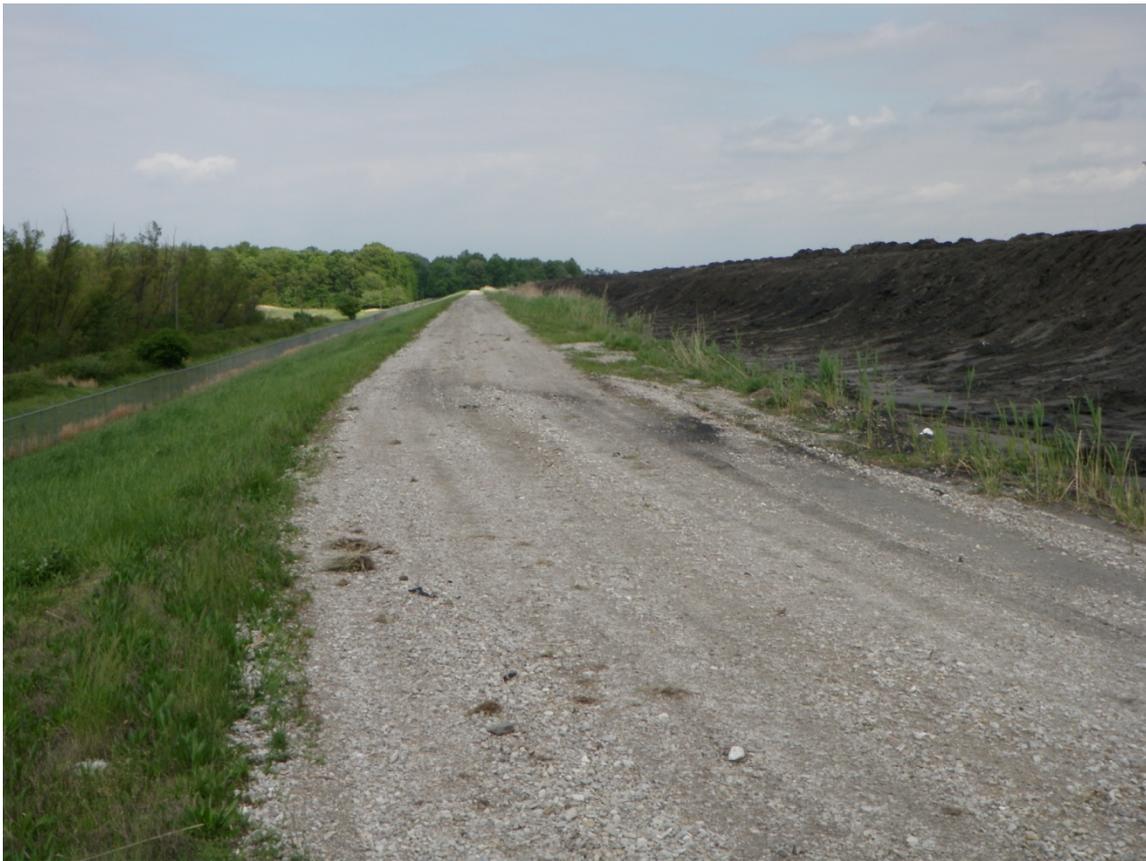
Photo 23: East Ash Pond #3 – North dike crest and capping material, looking east from northwest corner of EAP #3.
