DRAFT

**Specific Site Assessment for
Coal Combustion Waste
Impoundments at Duke Energy
Indiana (DEI) Gibson
Generating Station**

Owensville, Indiana

May 2010
Project 092880

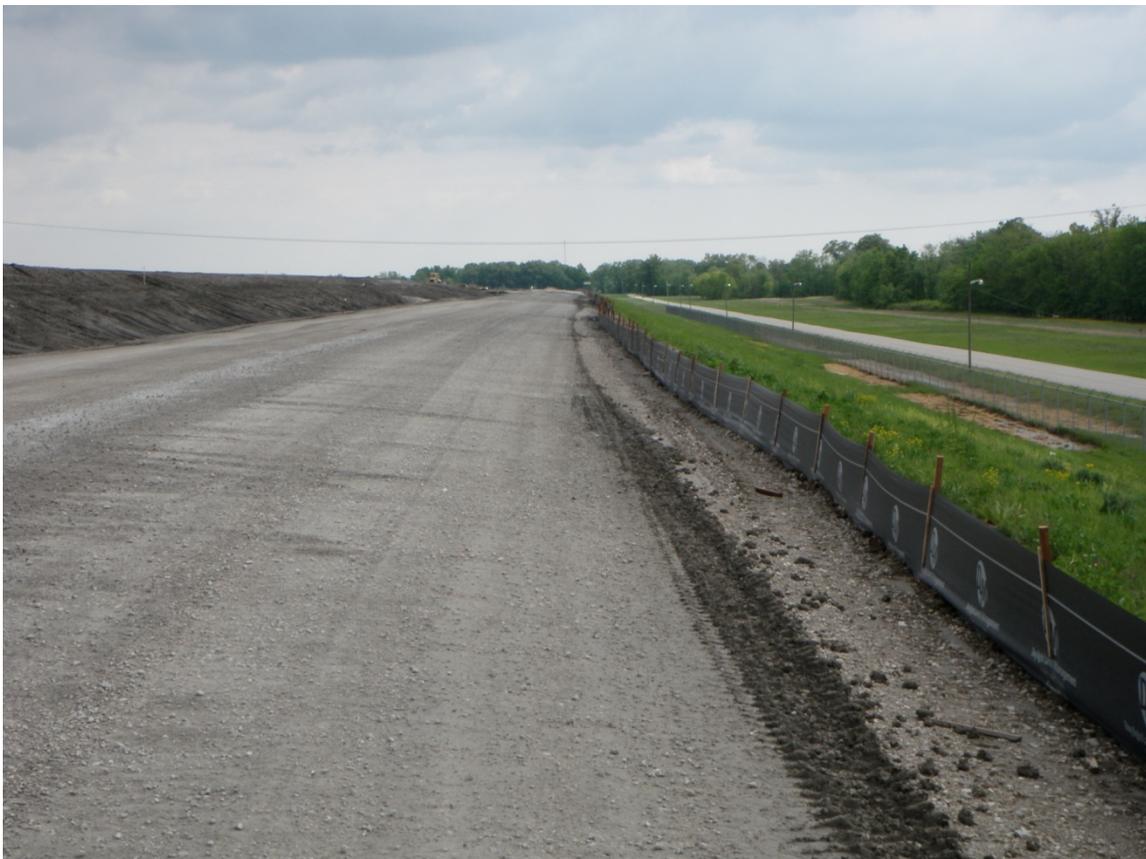
Photo 24: East Ash Pond #3 – West dike crest and road, looking south, notice county road to the west.\

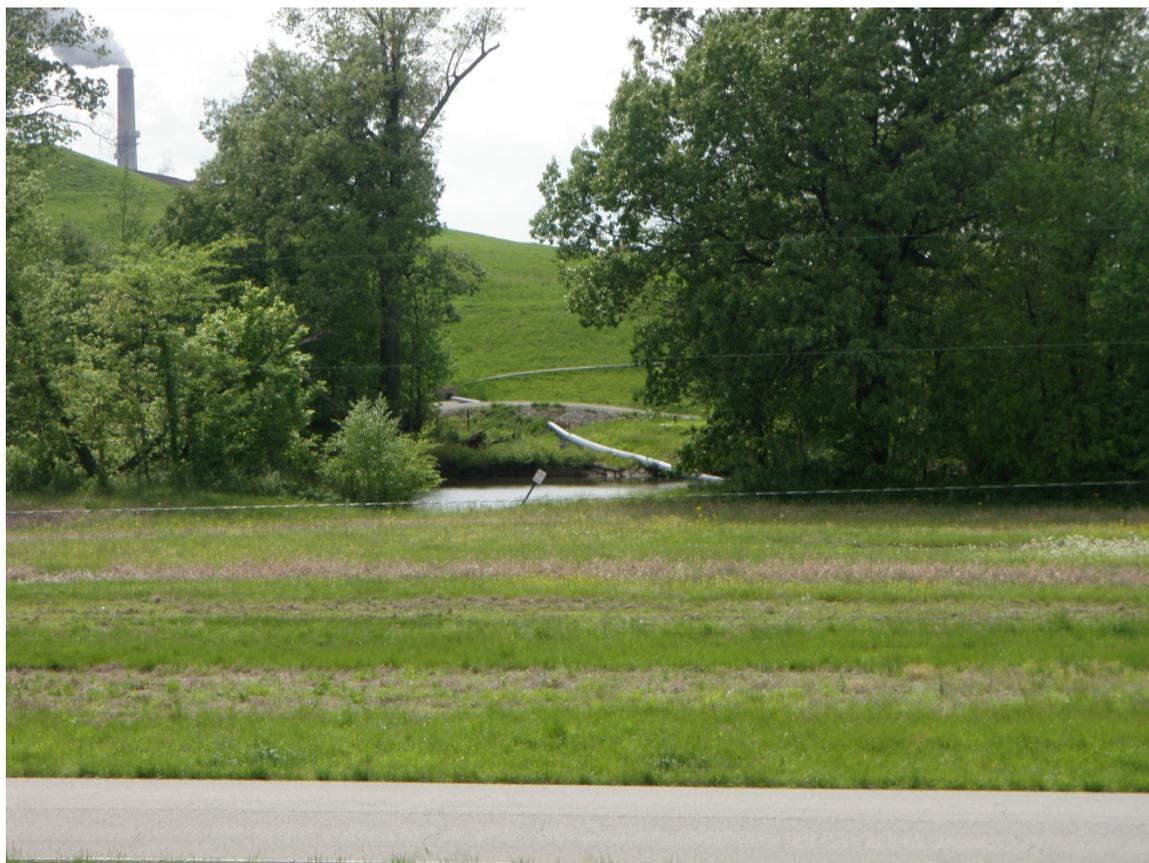
Photo 25: East Ash Pond #2 – CCW discharge line crossing Coon Creek, downstream of west dike, looking west.

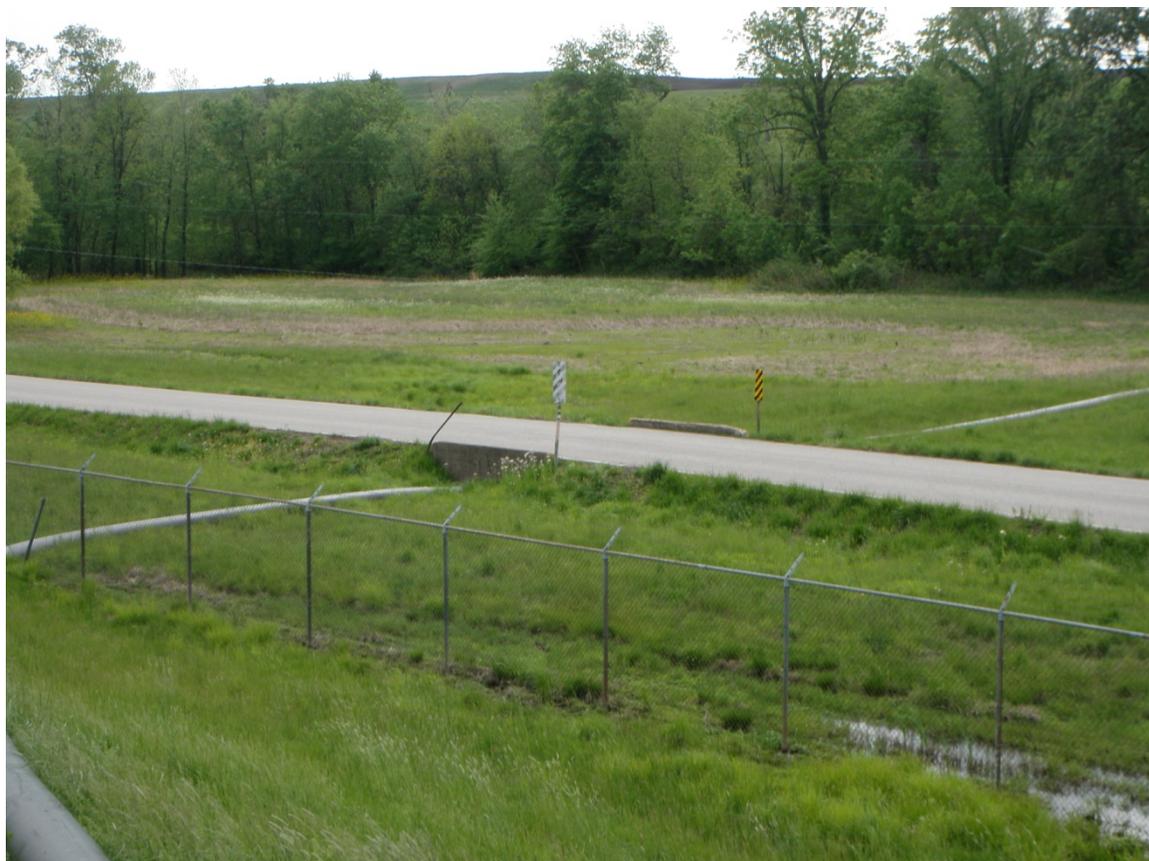
Photo 26: East Ash Pond #2 – CCW discharge line crossing under county road, looking southwest from west dike.

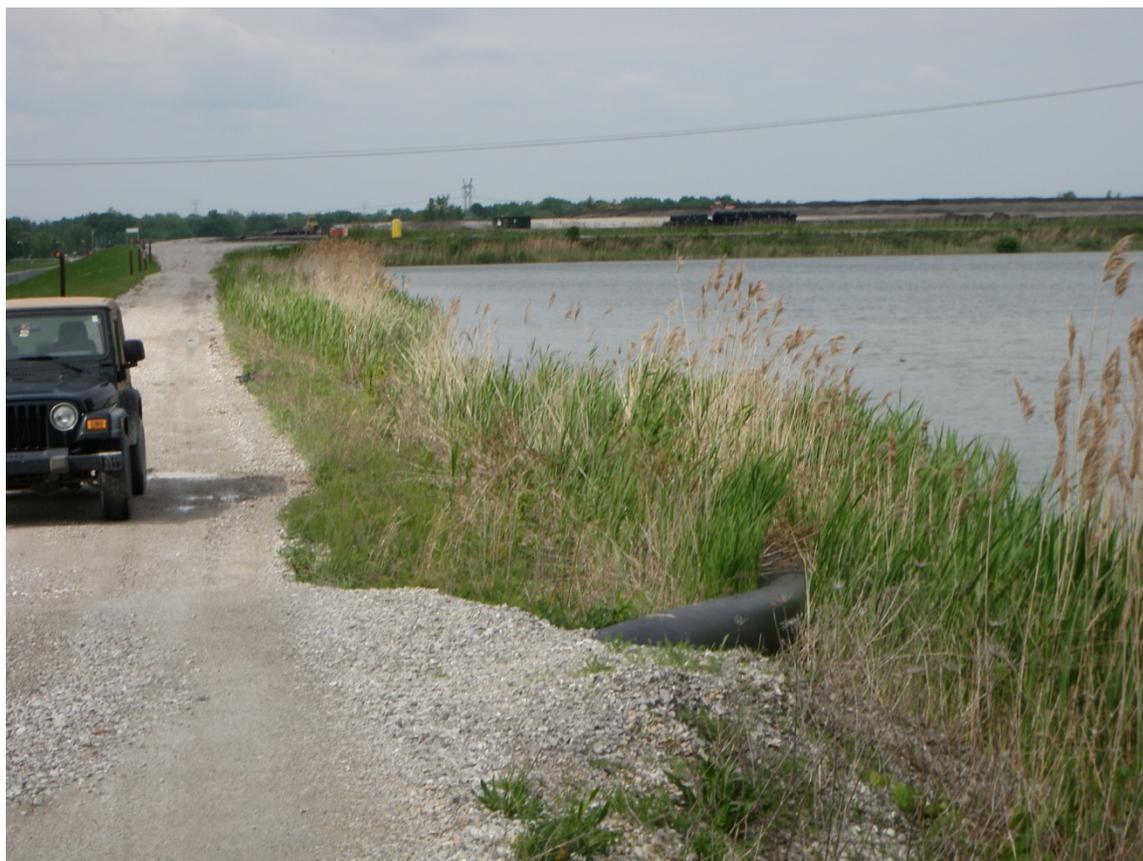
Photo 27: East Ash Pond #2 – CCW discharge line crossing west dike dam crest, looking north.

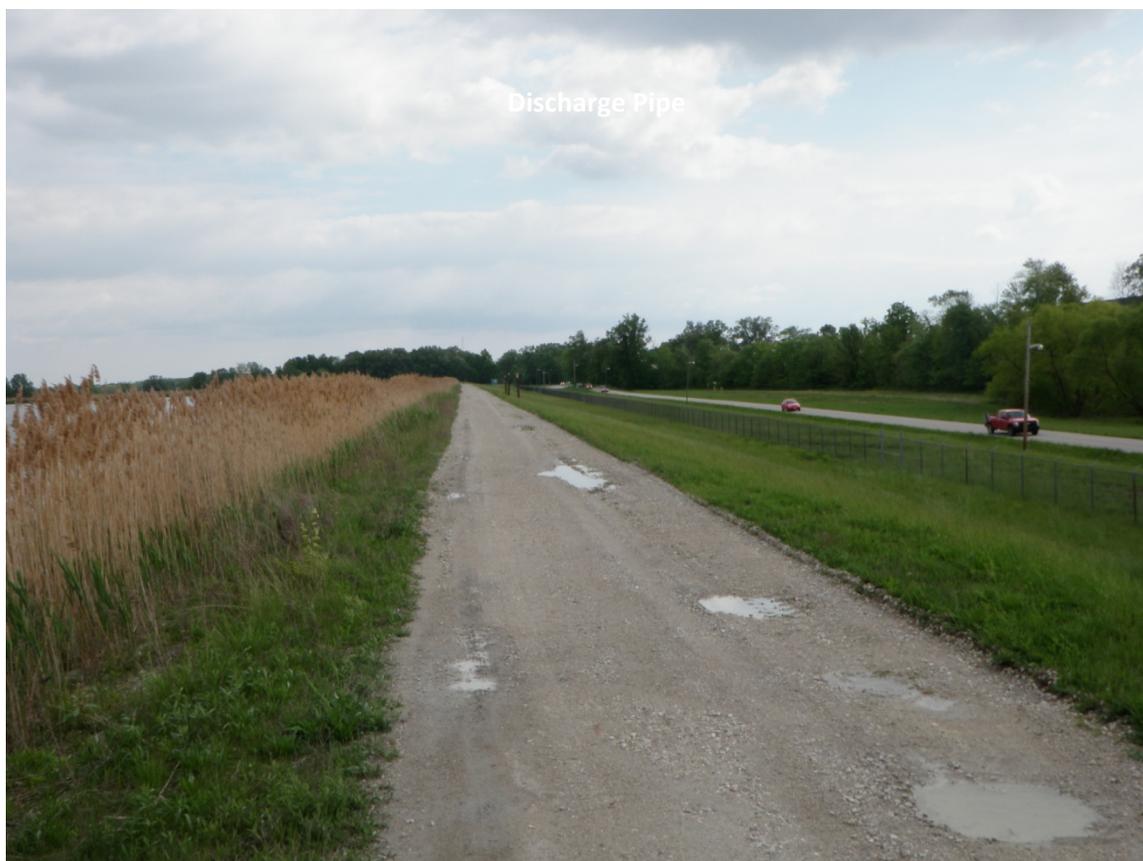
Photo 28: East Ash Pond #2 – EAP #2 west dike crest, looking south.

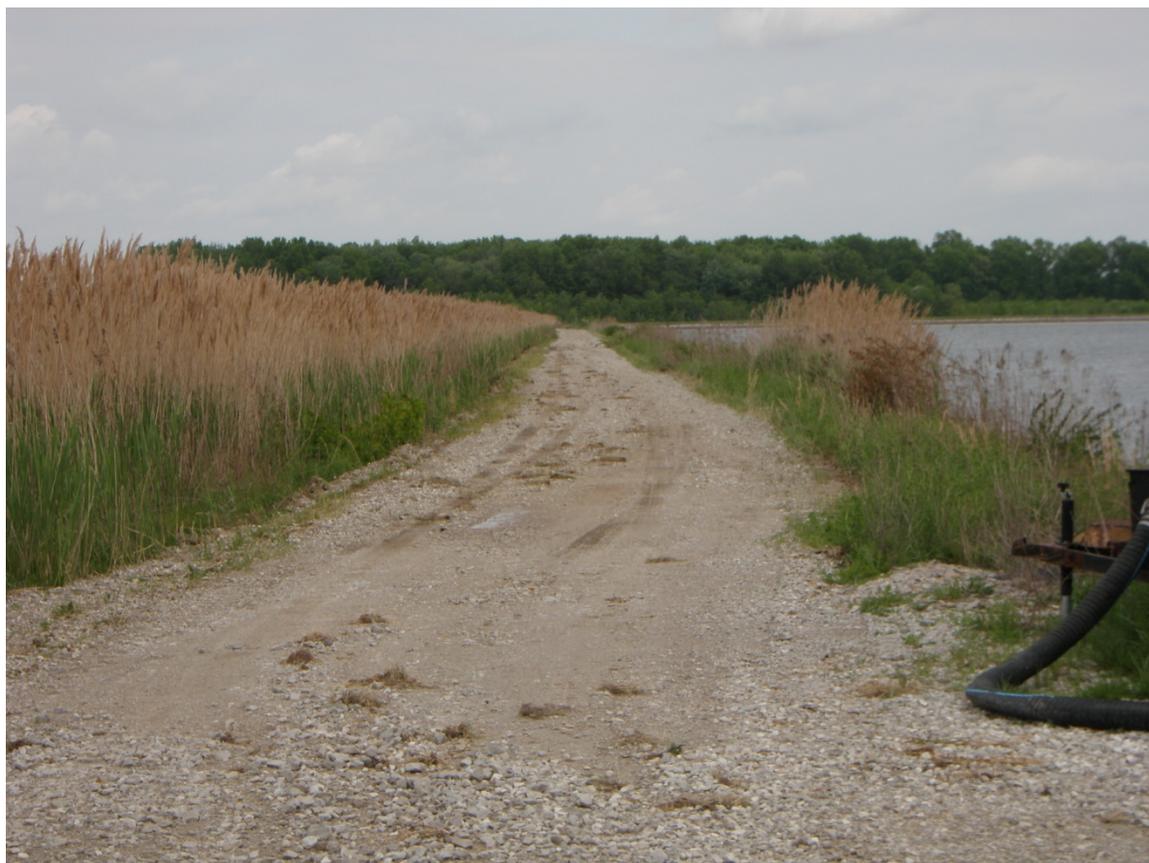
Photo 29: East Settling Basin – Interior dike crest between East Settling Basin and EAP #2, looking east.

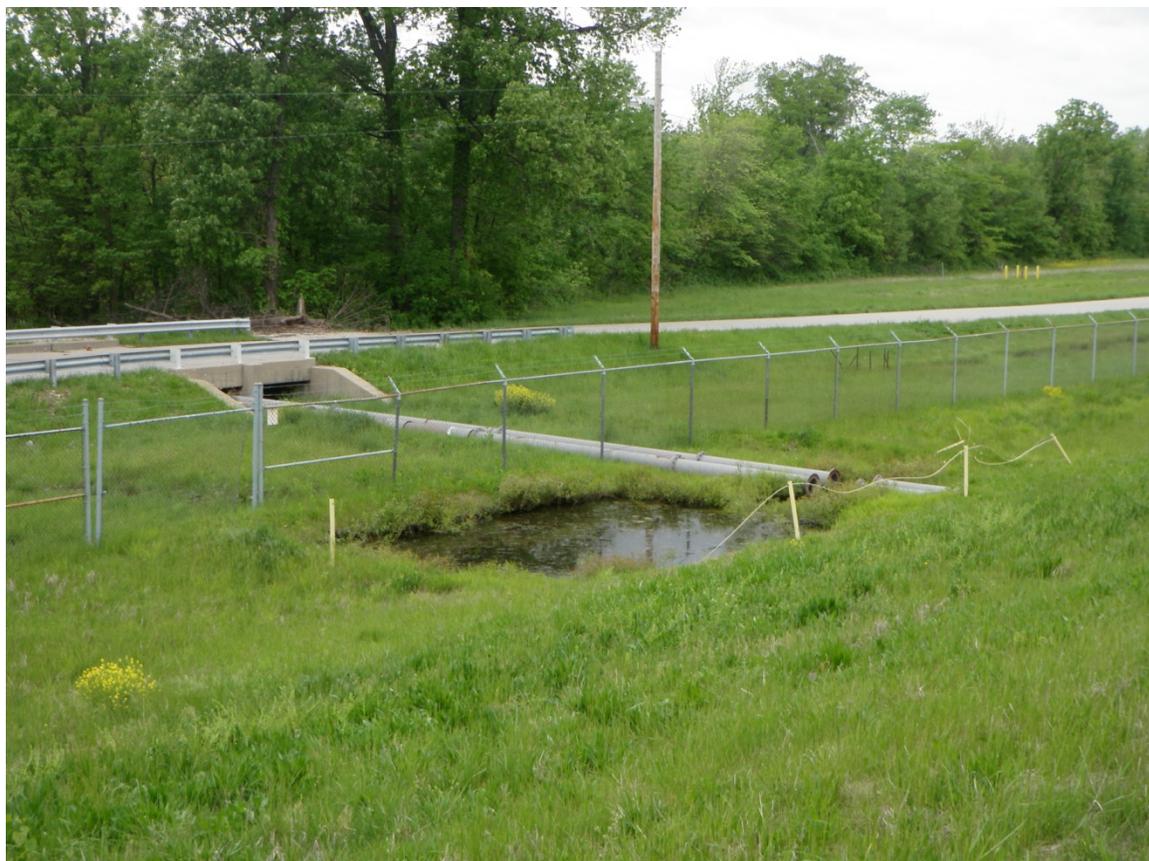
Photo 30: East Ash Pond #2 - EAP #2 downstream slope, abandoned discharge lines and drainage sump, looking northwest.

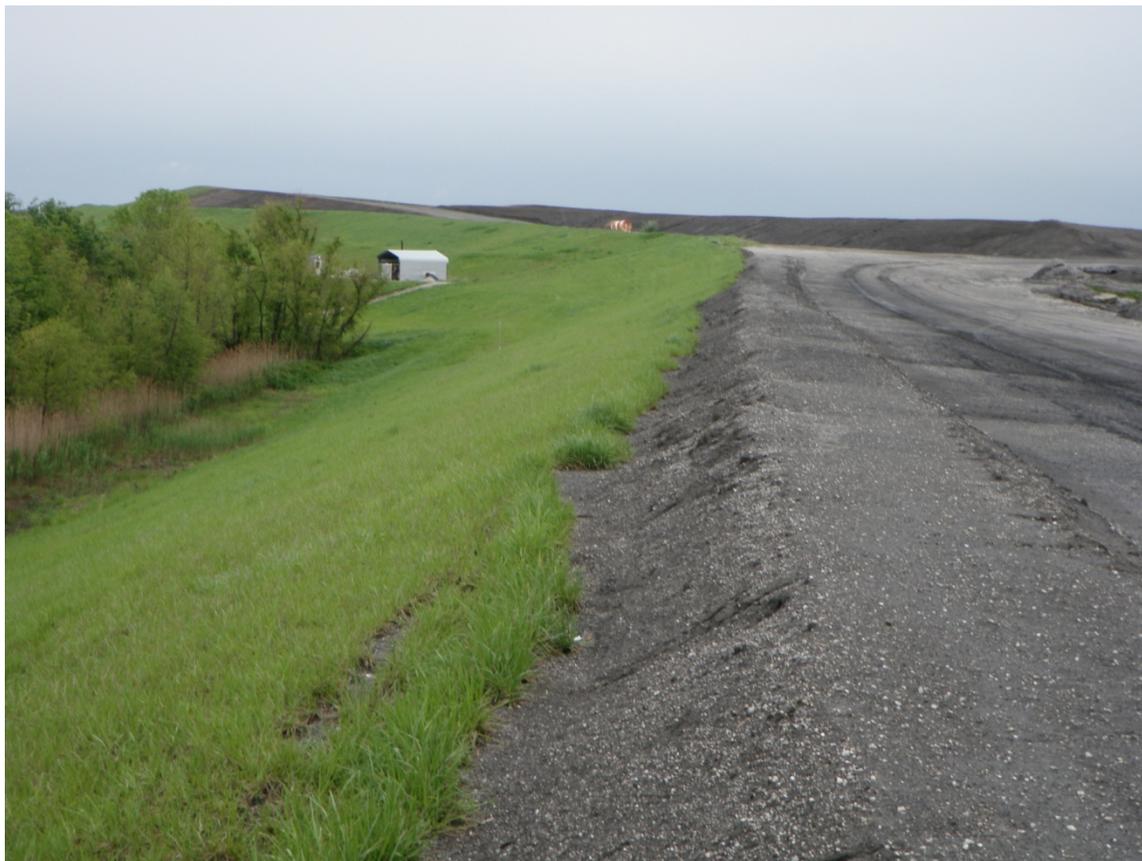
Photo 31: North Ash Pond – Downstream slope and crest of northeast dike, looking southeast.

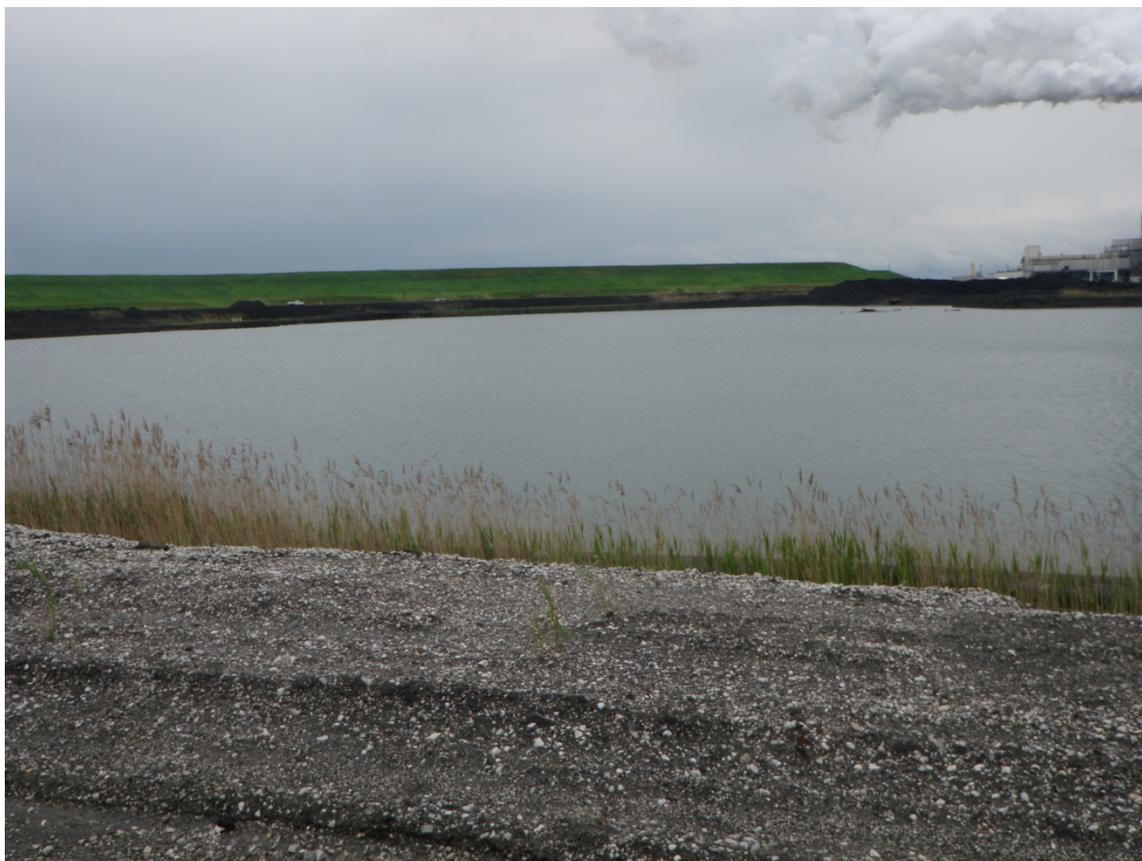
Photo 32: North Ash Pond – North Ash Pond reservoir area, looking south towards FSS landfill from northeast dike.

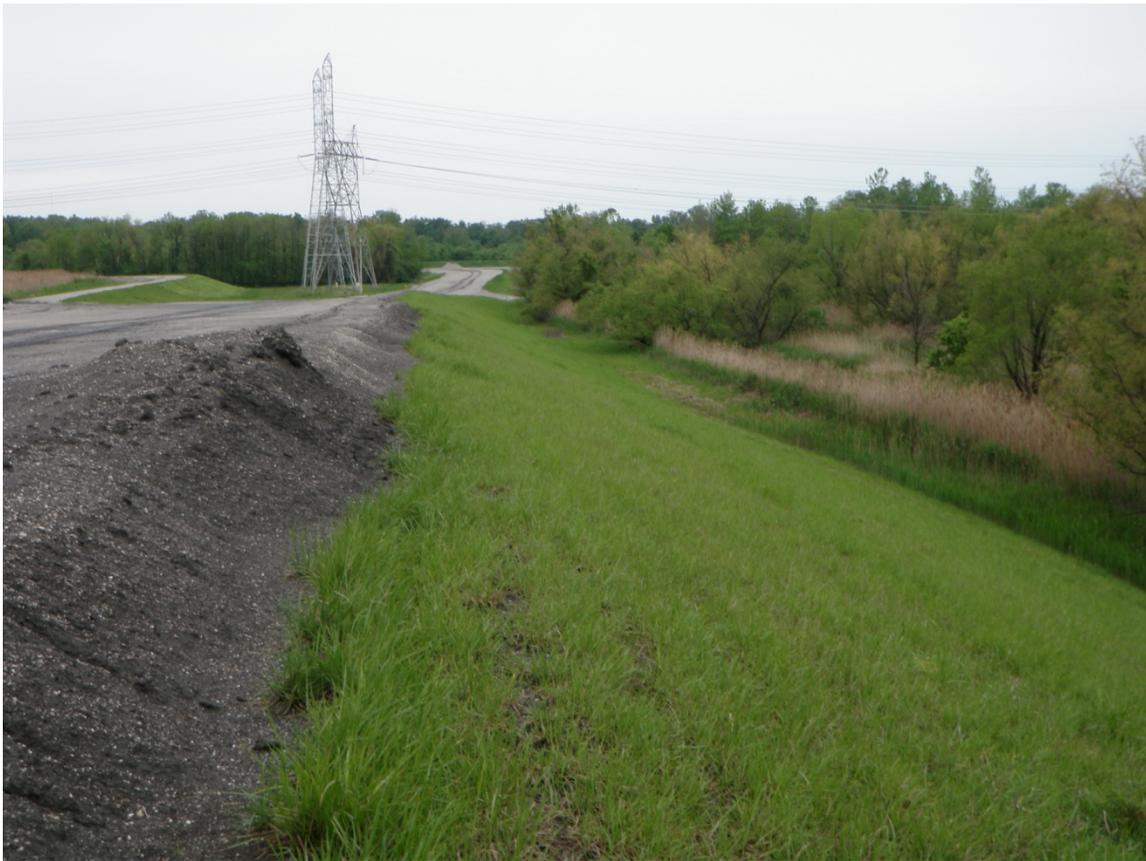
Photo 33: North Ash Pond – Downstream slope and crest of northeast dike, looking northwest.

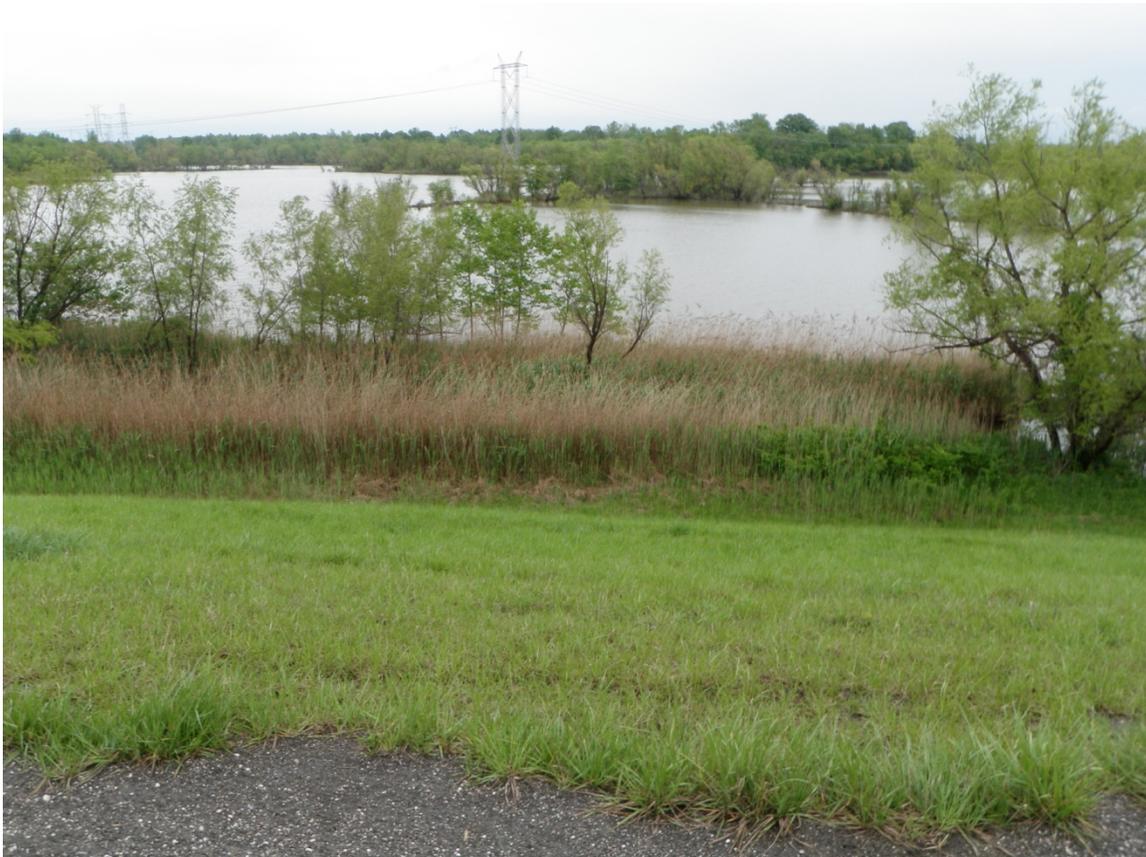
Photo 34: North Ash Pond – Downstream slope of northeast dike looking northeast at wetlands area from crest.

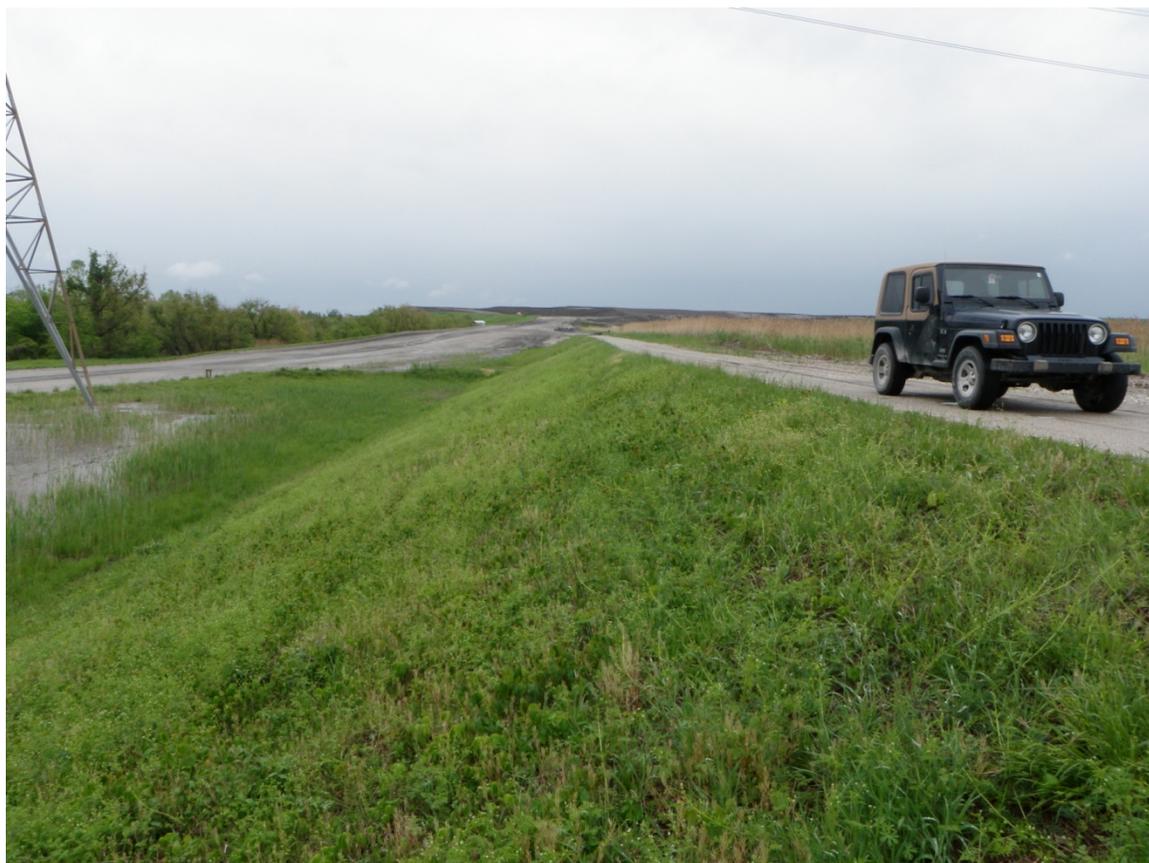
Photo 35: North Ash Pond – North dike downstream slope, looking southeast at northeast dike.

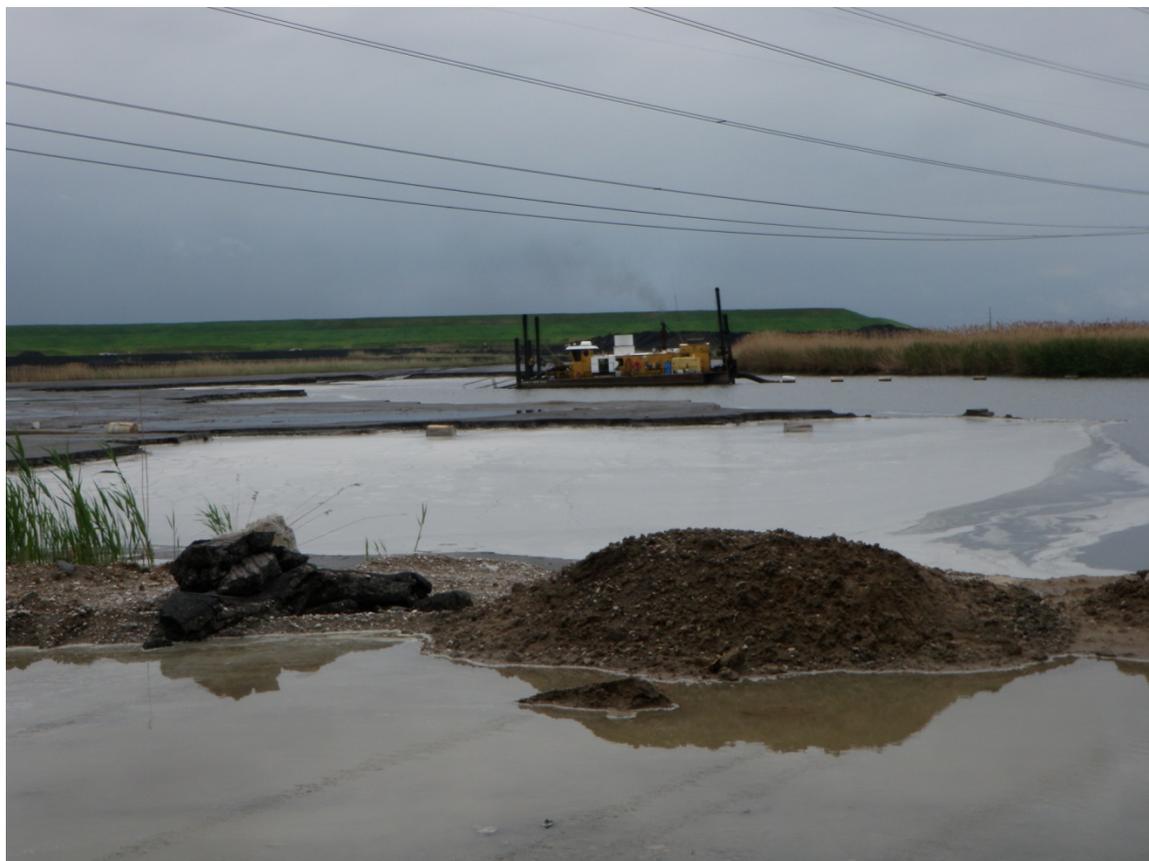
Photo 36: North Ash Pond – North Ash Pond reservoir area and dredging equipment, looking southeast from north dike.

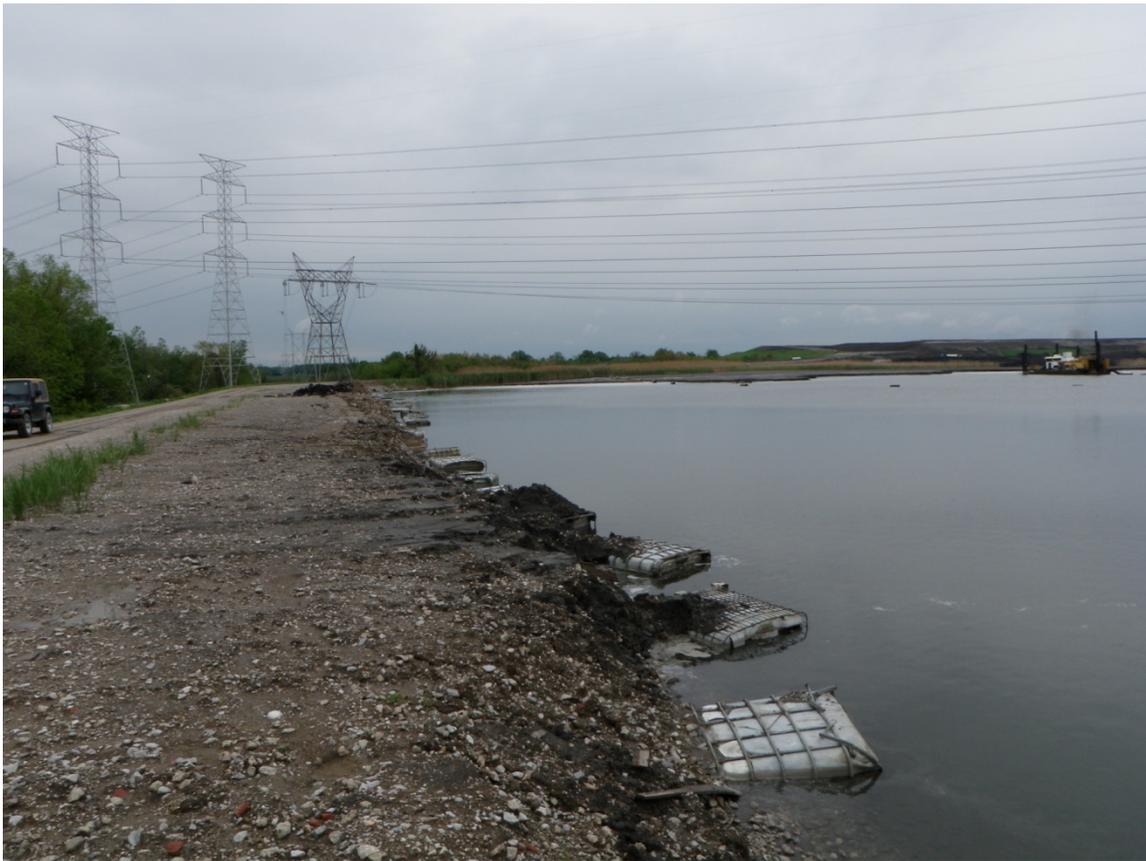
Photo 37: North Ash Pond – North Ash Pond reservoir area, looking east, notice upstream slope extended into reservoir.

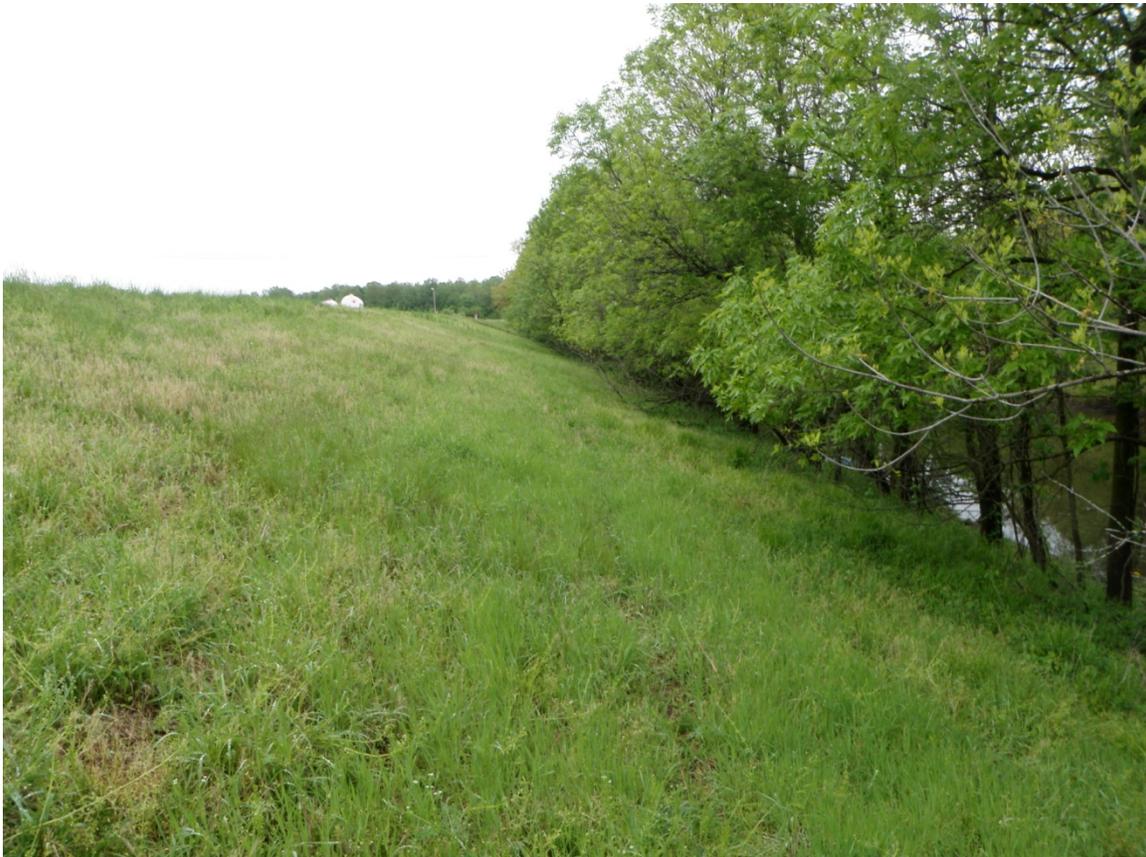
Photo 38: North Ash Pond – North dike downstream slope, looking west, notice large trees in wetland at toe of slope.

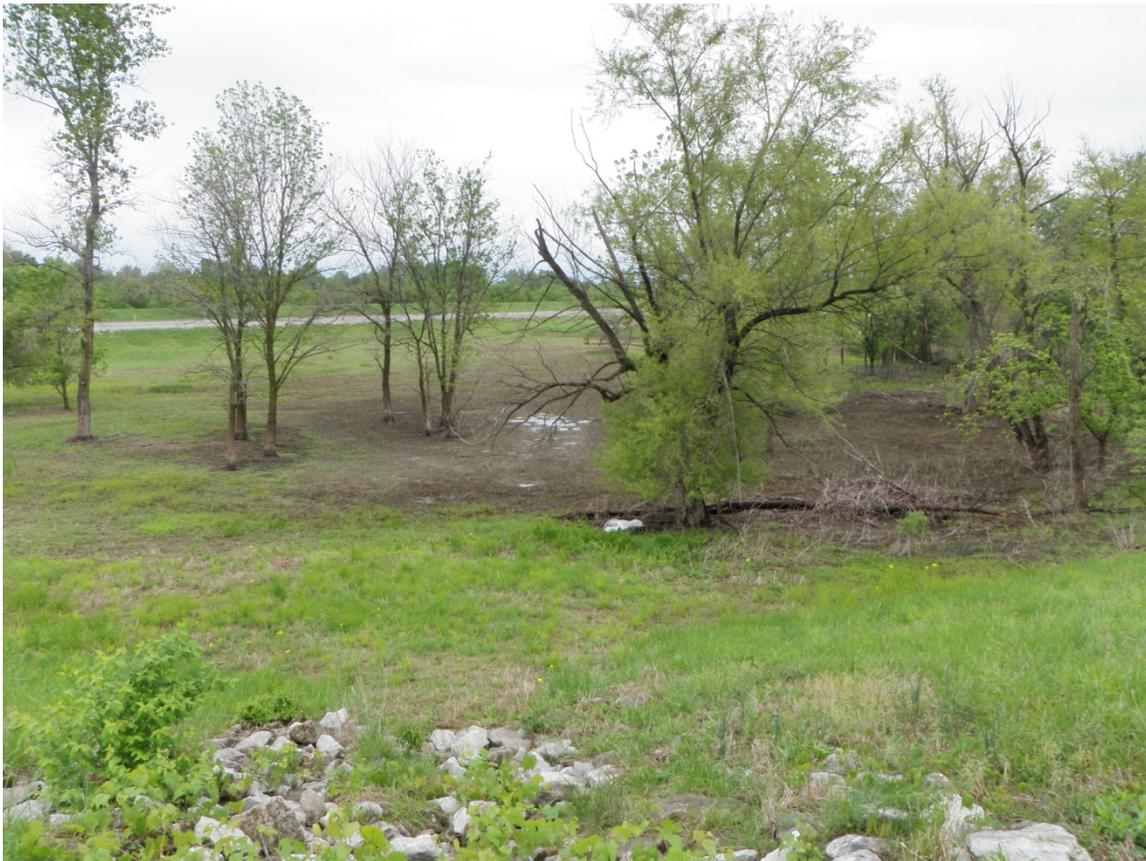
Photo 39: North Ash Pond – Wetlands area downstream of north dike, looking north from interior dike between NAP and NSB.

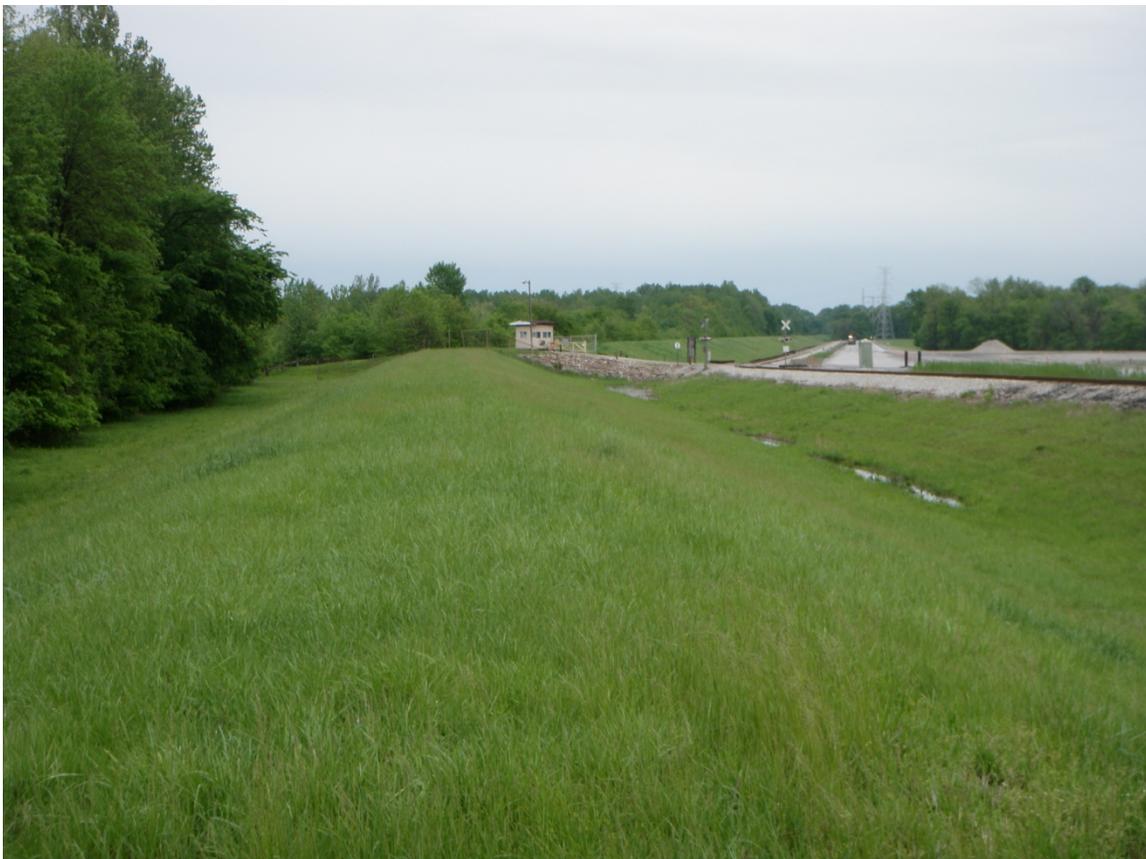
Photo 40: North Settling Basin – USACE Levee, looking northeast from levee crest.

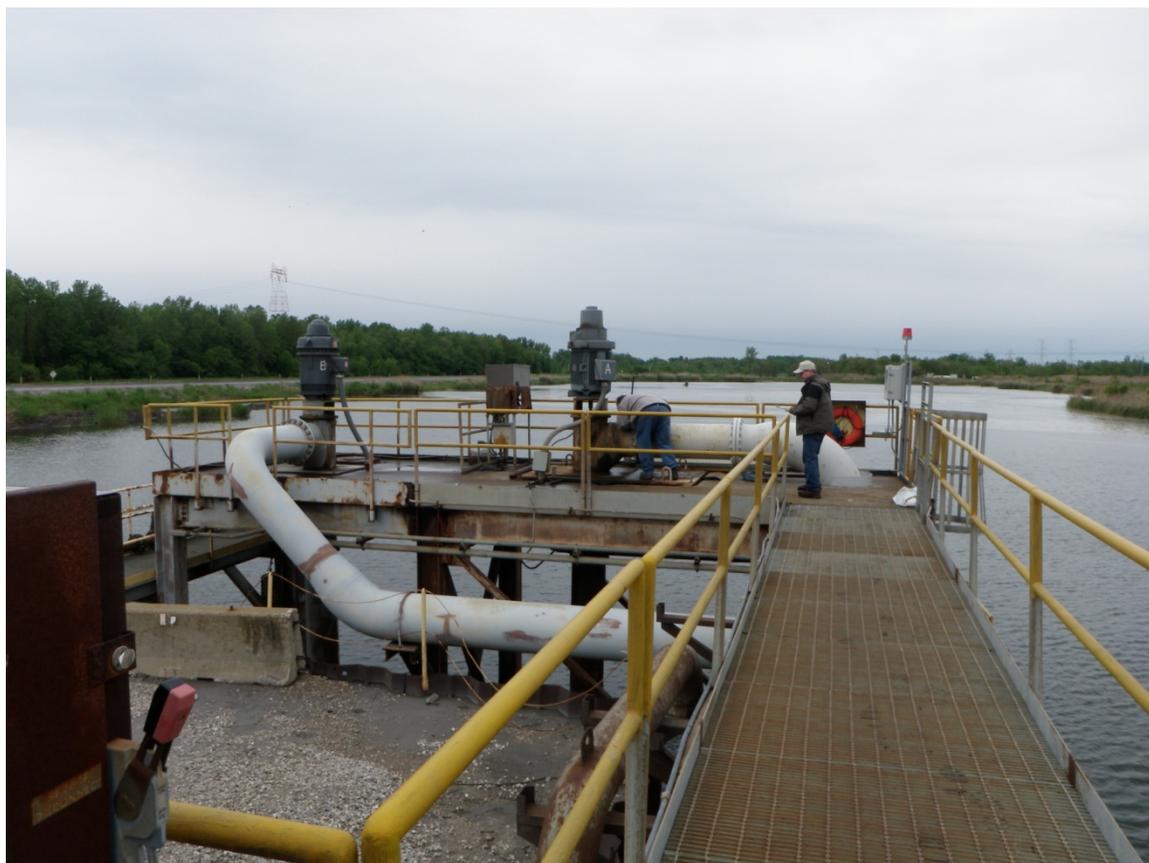
Photo 41: North Settling Basin – Pump intake structure that discharges to cooling pond, looking northeast.

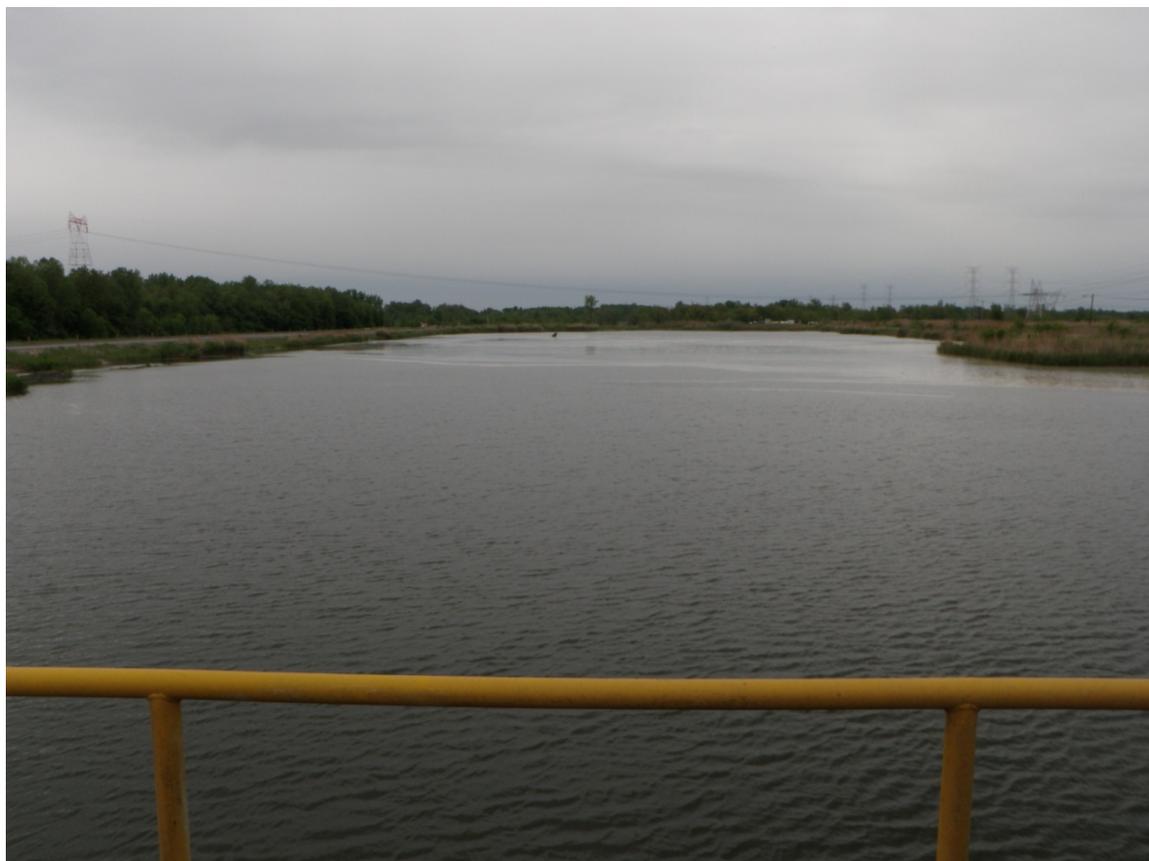
Photo 42: North Settling Basin – Reservoir area looking northeast from pump intake structure.

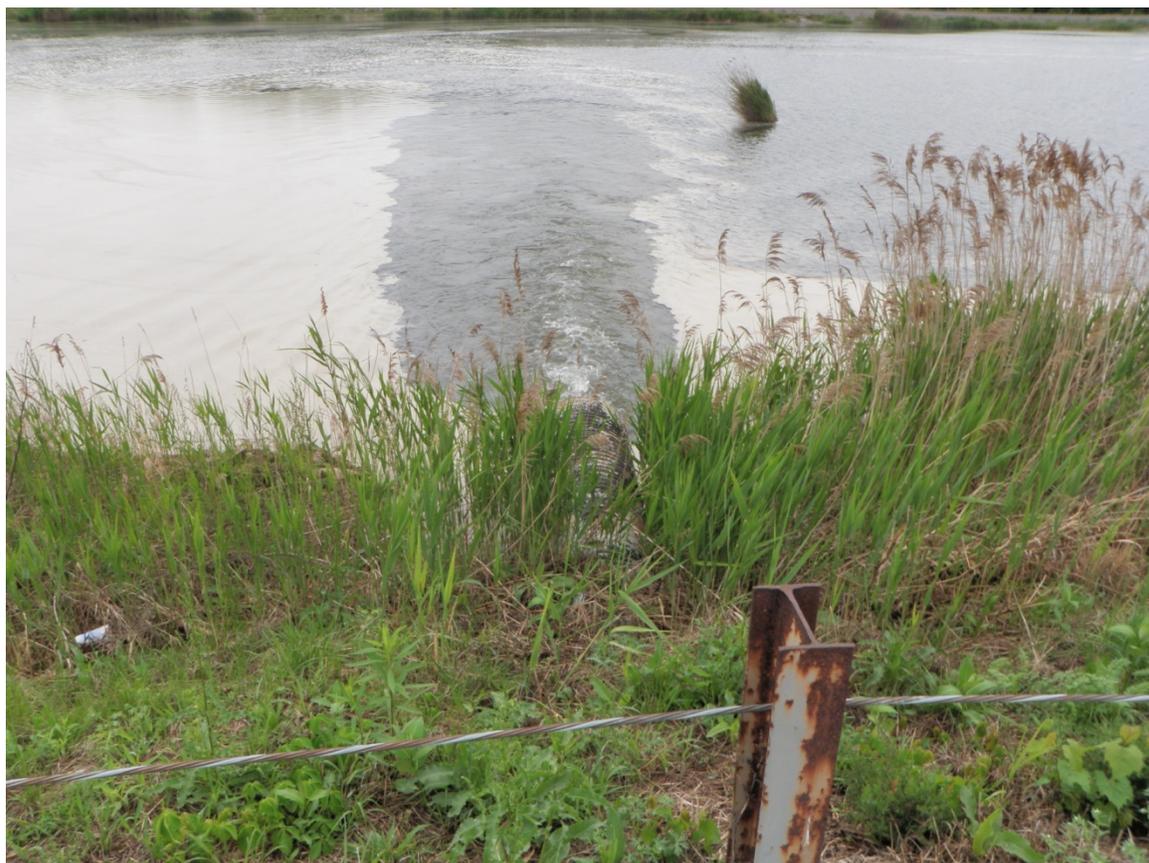
Photo 43: North Settling Basin – Discharge into settling basin, looking northwest from interior dike between NAP and NSB.

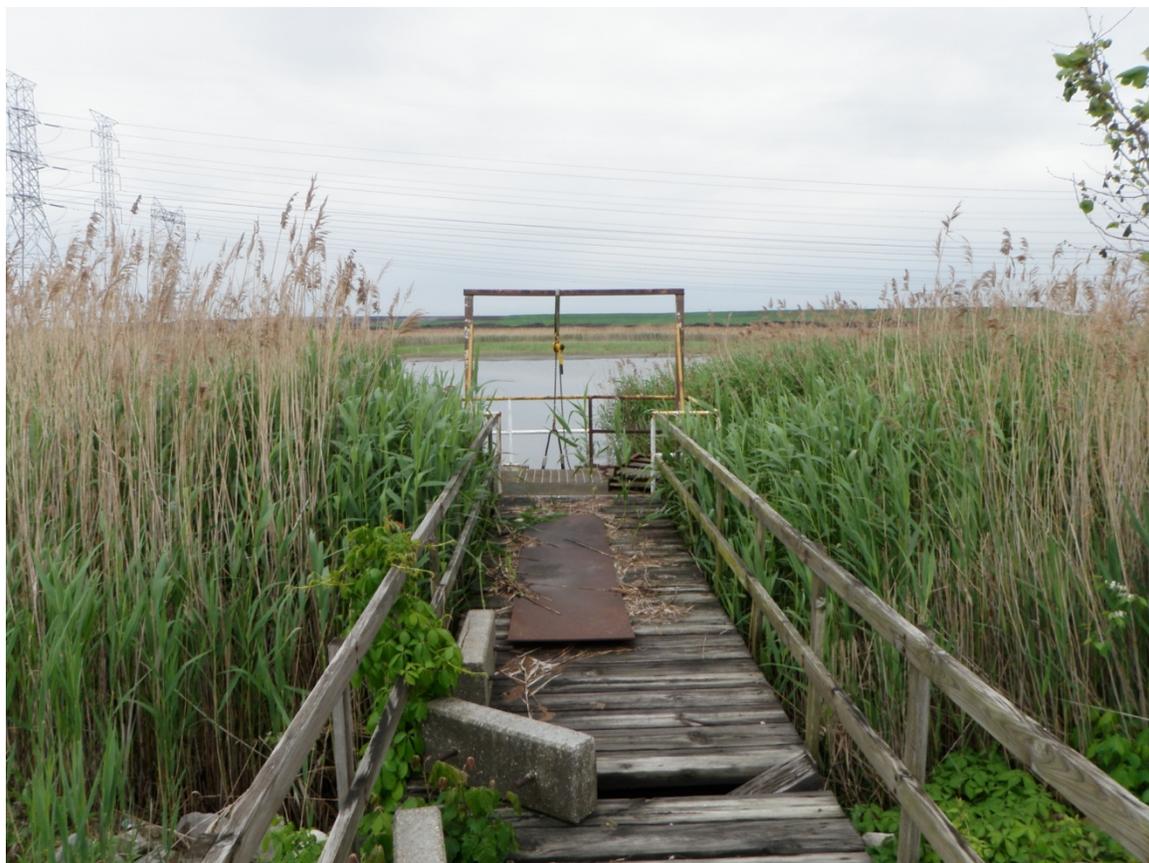
Photo 44: North Ash Pond – Intake structure in NAP that discharges into NSB, looking southeast from interior dike.

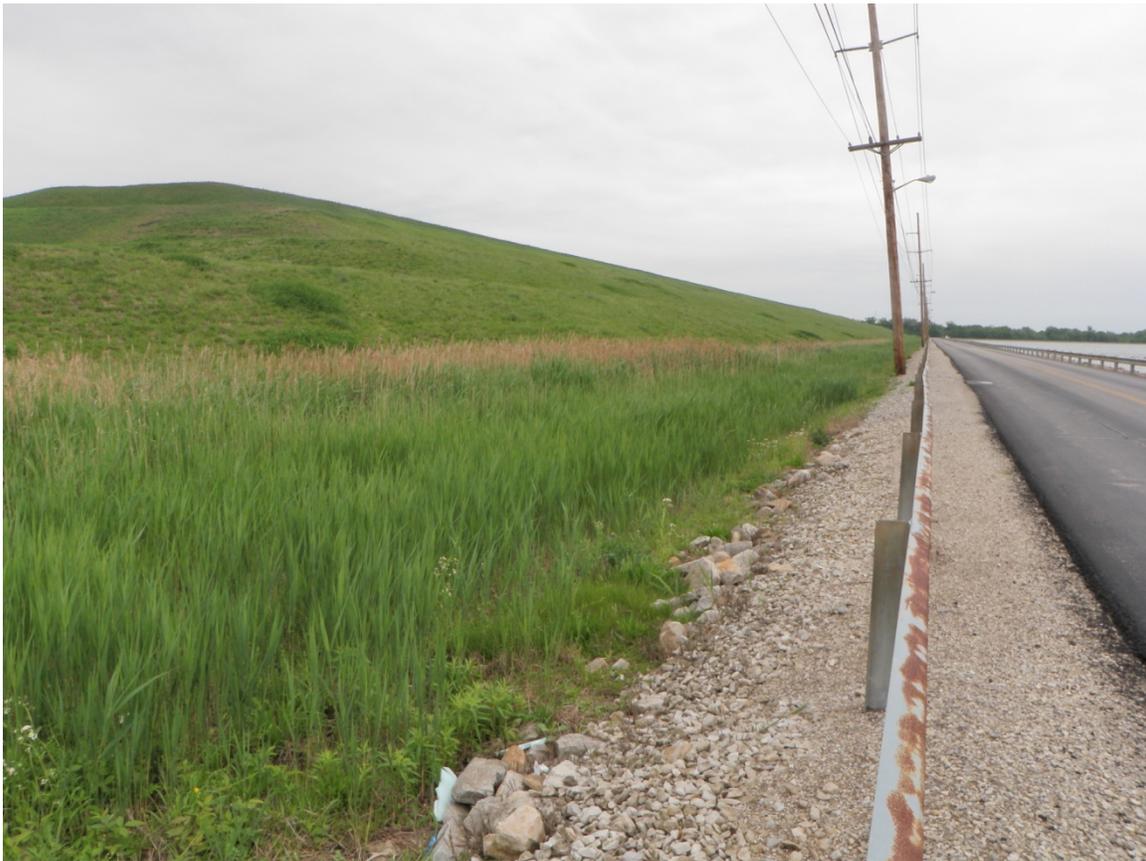
Photo 45: North Ash Pond – Southeast dike upstream slope, crest and road, looking southeast from crest.
