DRAFT

**Specific Site Assessment for
Coal Combustion Waste
Impoundments at Duke Energy
Indiana (DEI) Gibson
Generating Station**

Owensville, Indiana

May 2010
Project 092880

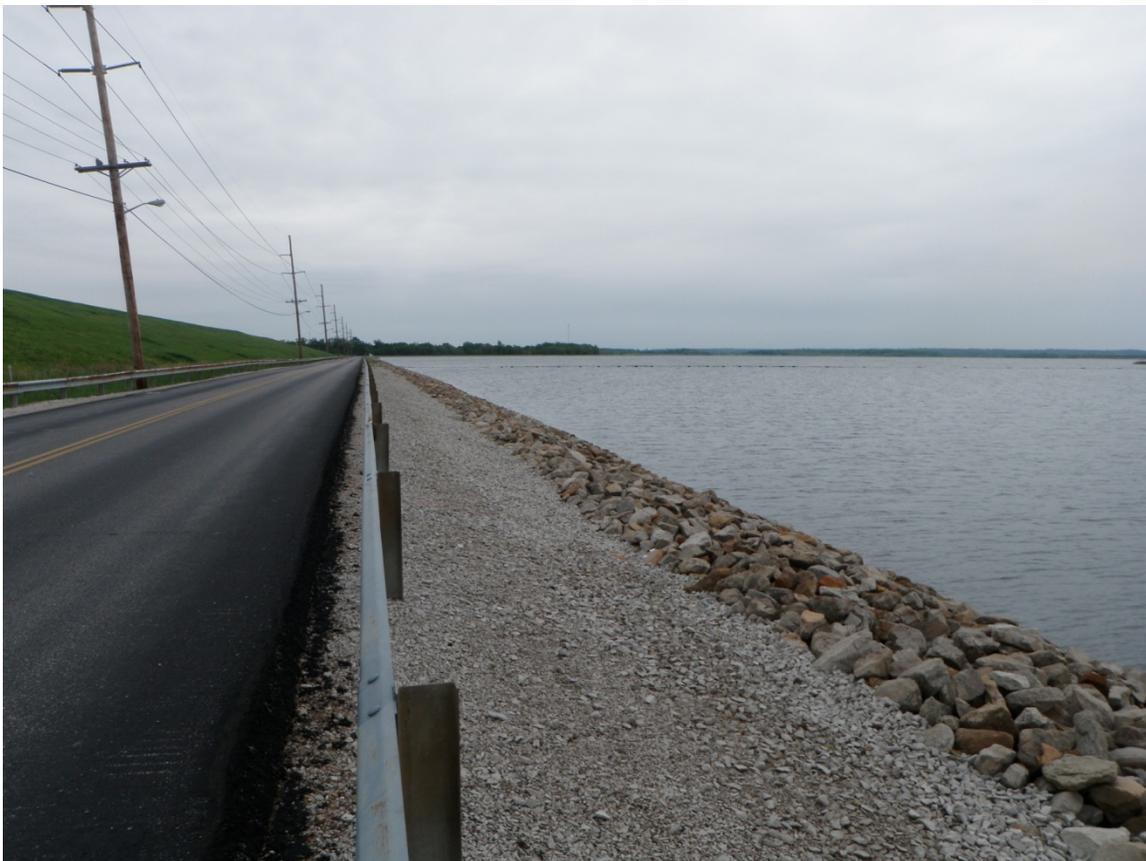
Photo 46: North Ash Pond – Southeast dike downstream, crest and cooling pond reservoir area, looking southeast.
