DRAFT REPORT

Dam Safety Assessment of CCW Impoundments

WH Zimmer Station

June 2010

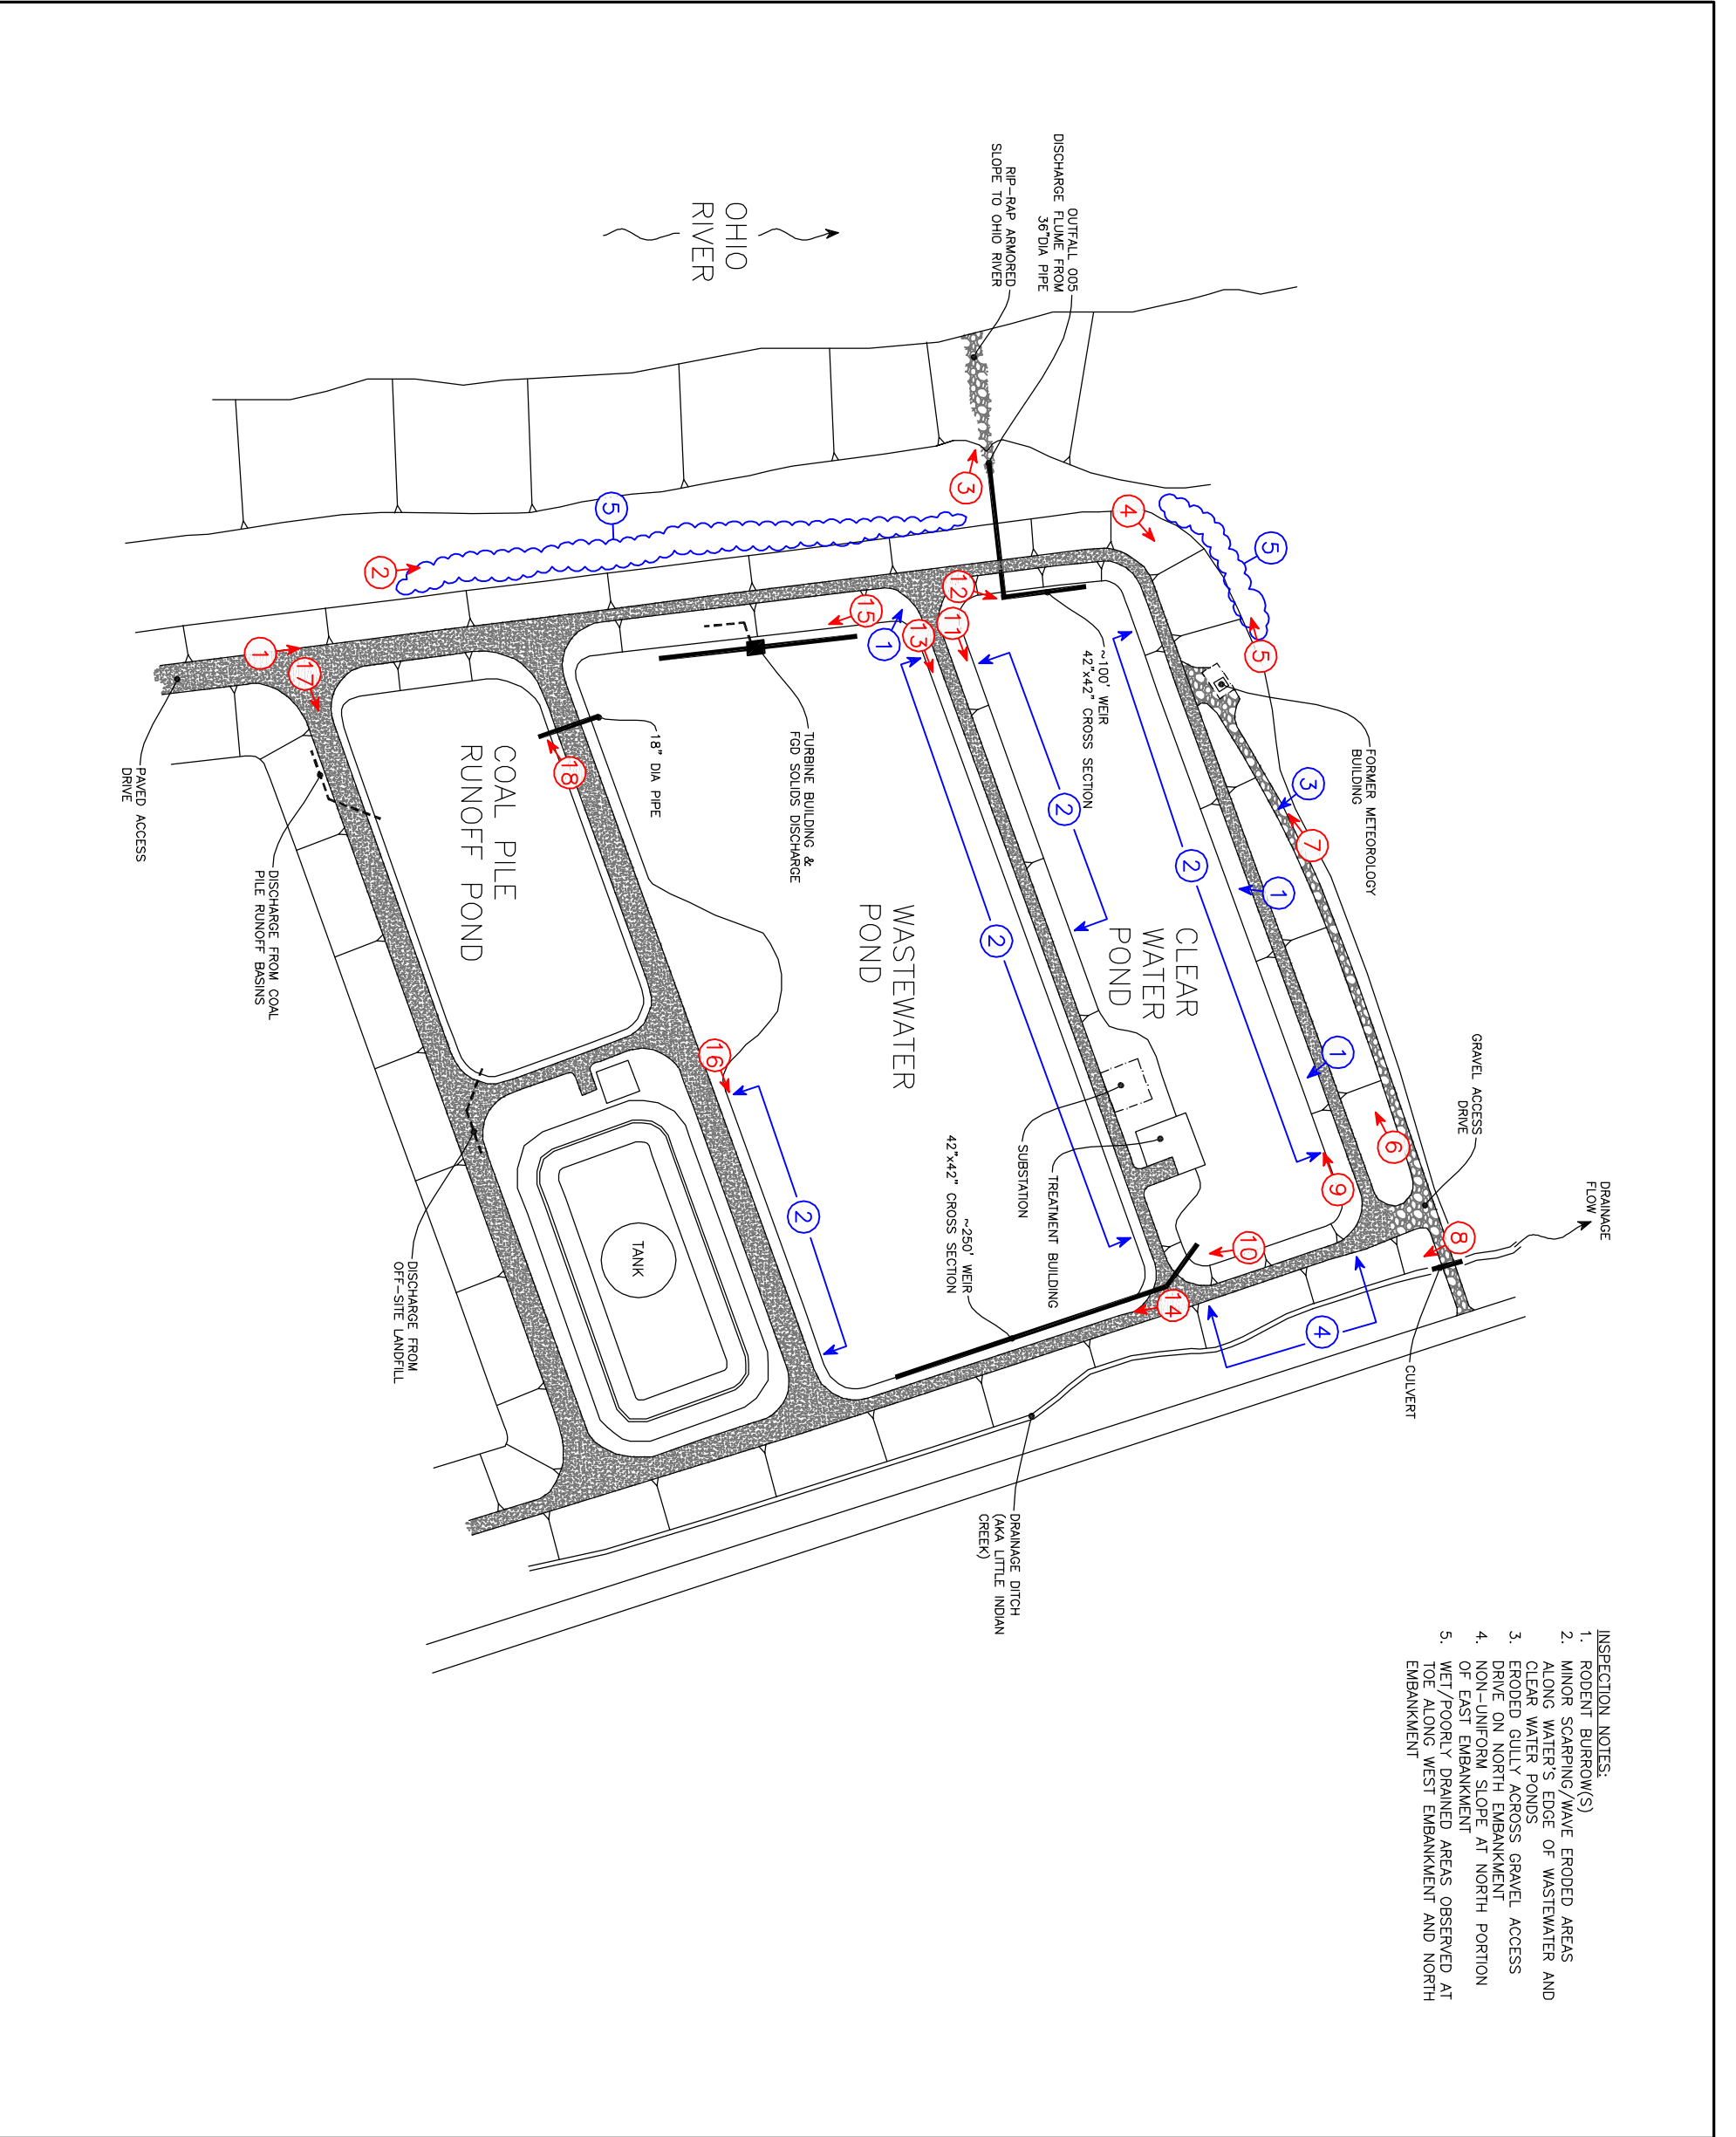
- INSPECTION NOTES:**
1. RODENT BURROW(S)
 2. MINOR SCARPING/WAVE ERODED AREAS ALONG WATER'S EDGE OF WASTEWATER AND CLEAR WATER PONDS
 3. ERODED GULLY ACROSS GRAVEL ACCESS DRIVE ON NORTH EMBANKMENT
 4. NON-UNIFORM SLOPE AT NORTH PORTION OF EAST EMBANKMENT
 5. WET/POORLY DRAINED AREAS OBSERVED AT TOE ALONG WEST EMBANKMENT AND NORTH EMBANKMENT

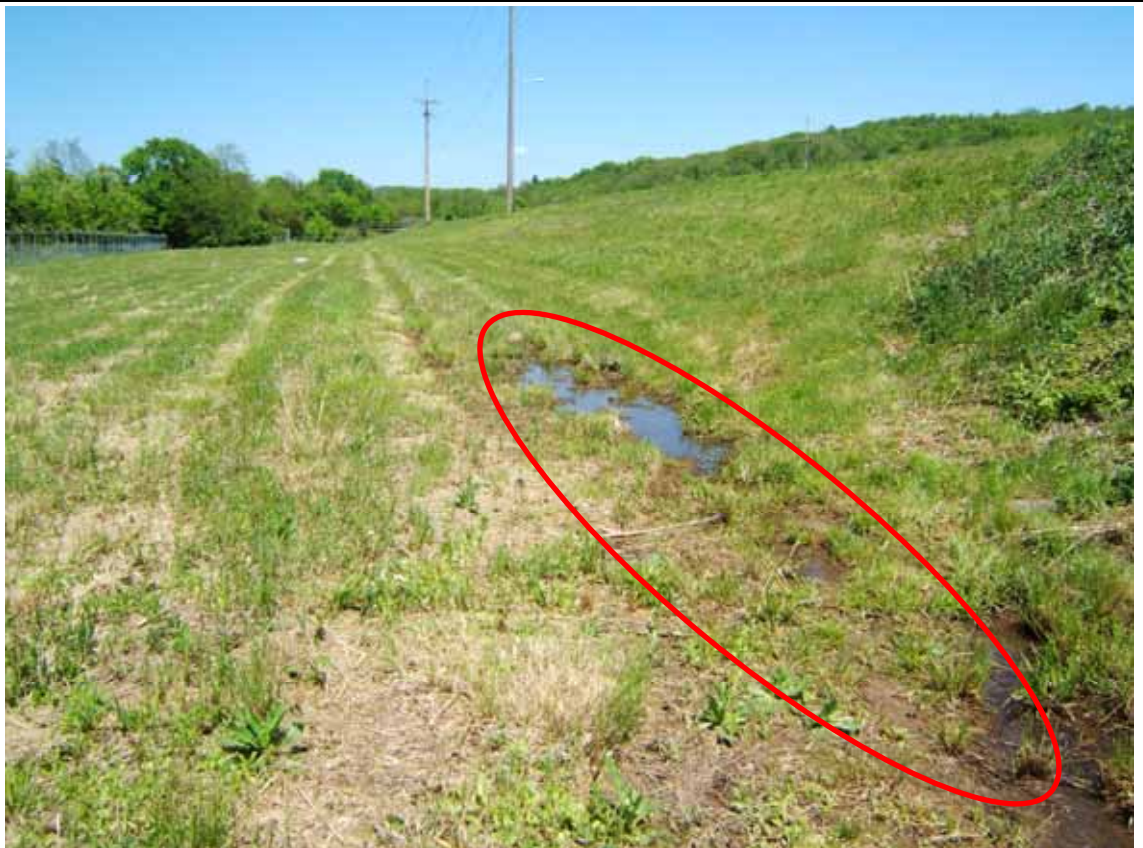
Photo Number:
2

- Ponded water was observed at the toe of the slope along the majority of the west embankment and western portion of the north embankment. The ponded water was reportedly due to recent heavy rains and poor local surface drainage and is expected to dry up in time. As a result it is not believed to be seepage from the Wastewater Pond Complex.

Description:
View along west
embankment

Note ponded
water at toe,
suspected to be
poor surface
drainage from
recent heavy
rain, not
seepage

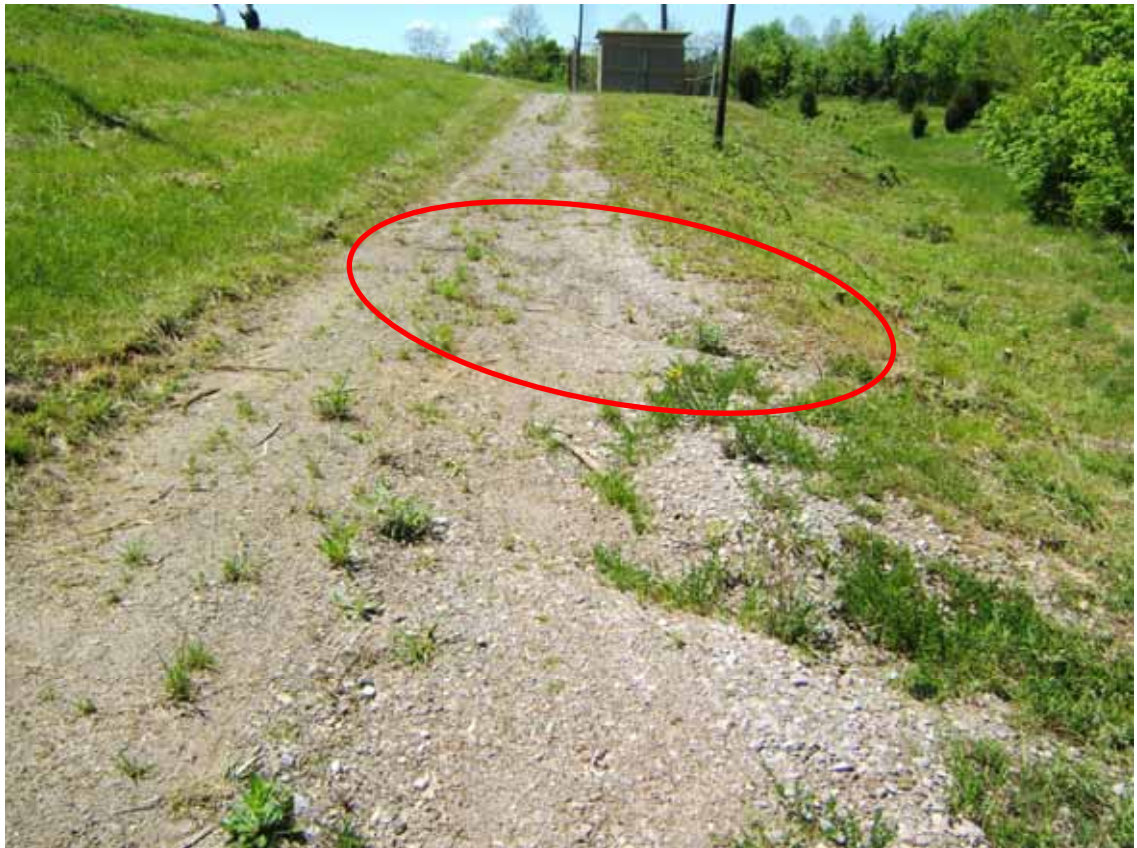
Photo Number:
7

- Erosion was observed across the secondary access road on the north embankment.
- A non-uniform slope was observed at the north end of the east embankment. This departure from the design slope was reported to be a result of fill placed to create an access ramp on the slope for maintenance activity related to the adjacent highway.

Description:
Erosion on
access road to
former
meterological
station on
North
embankment

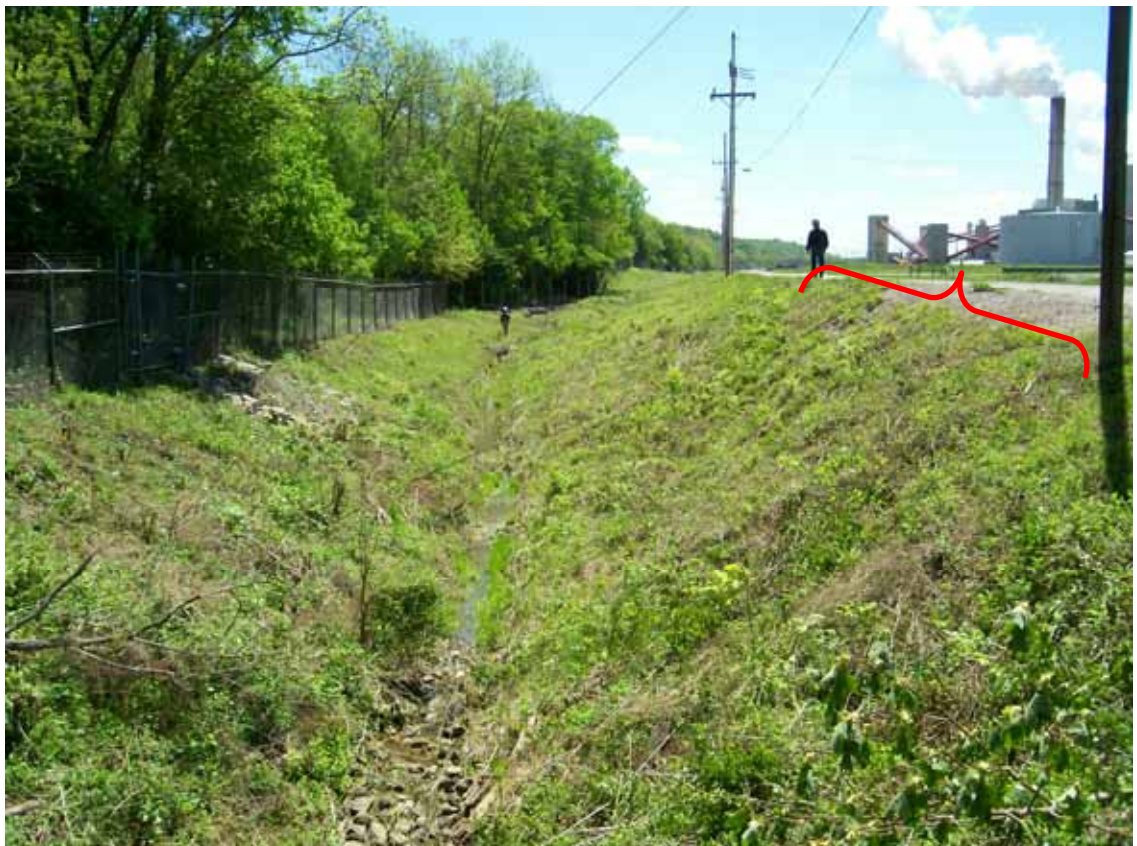
Photo Number:
8

| Checklist Number | Description/Notes |
|---|---|
| 18 | A non uniform slope was observed at the north end of the east embankment. This non uniform slope did not appear to be due to significant sloughing or bulging of the embankment, but rather possibly a result of overfilling during original construction or another unrelated project. |

Description:
View along east
embankment

Note section of
embankment
with non-
uniform slope

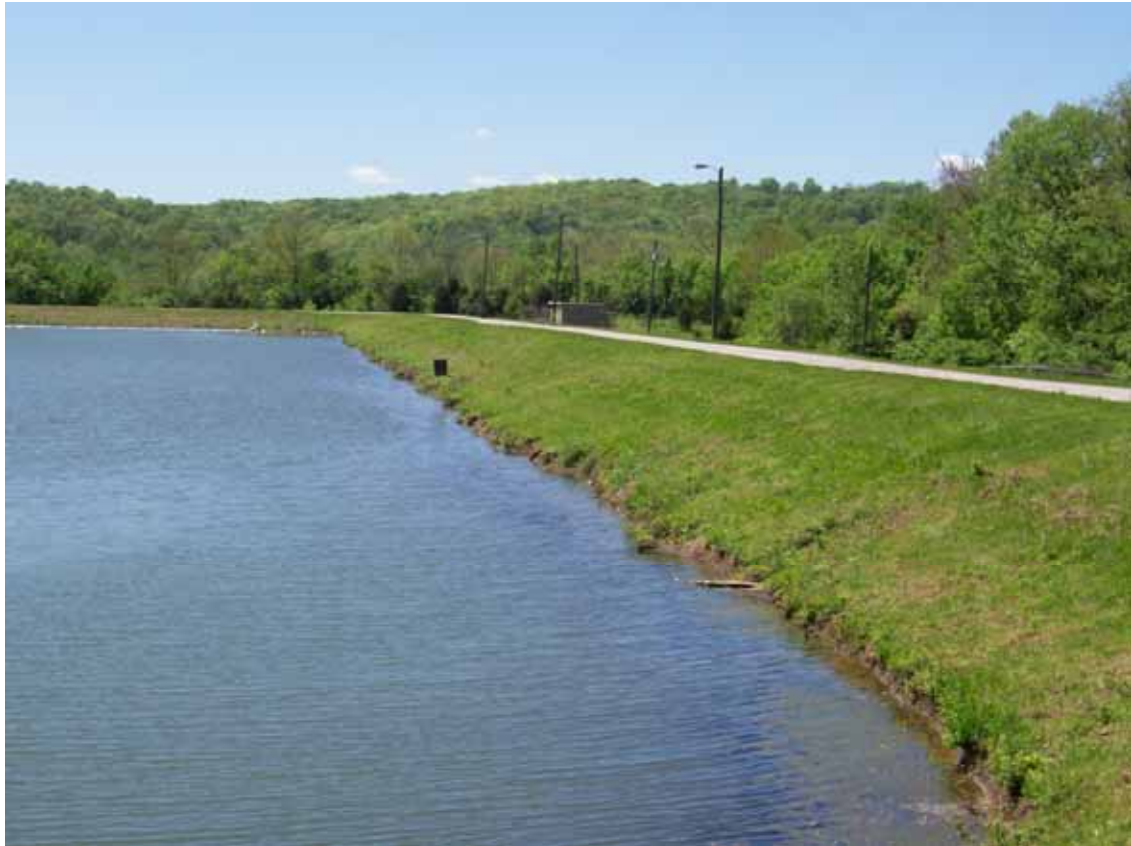
Photo Number:
9

Description:
Inboard slope of
north
embankment
along Clear
Water Pond

Note minor
scarping along
length of
water's edge

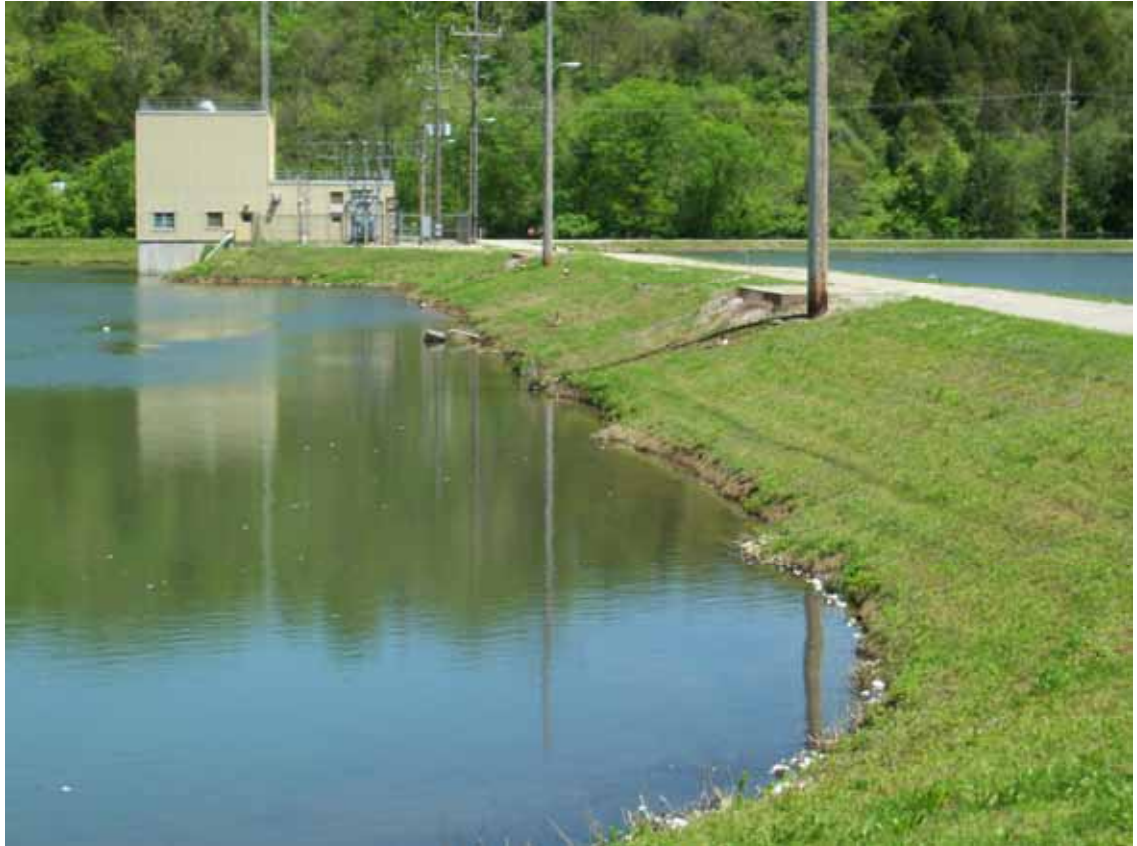
View of south inboard slope of Clear Water Pond

Note minor scarping along length of water's edge

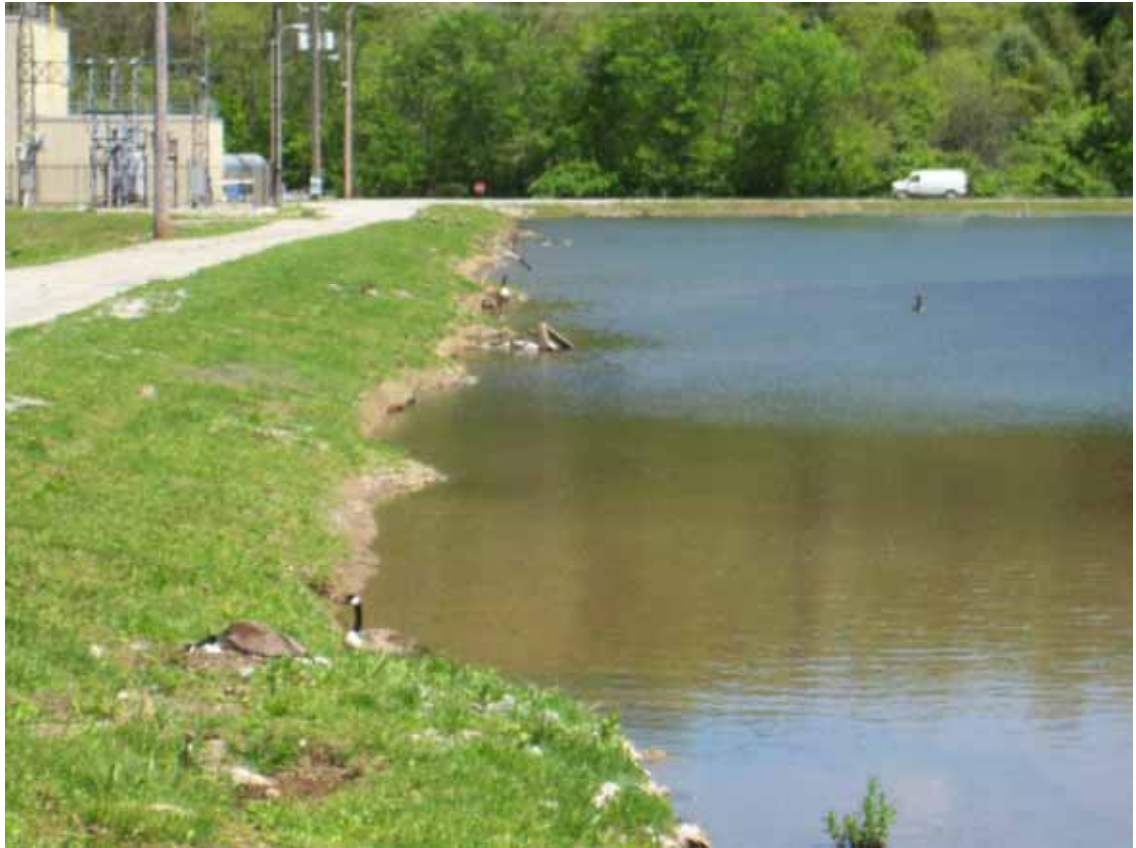
View of north inboard slope of Wastewater Pond

Note minor scarping along length of water's edge

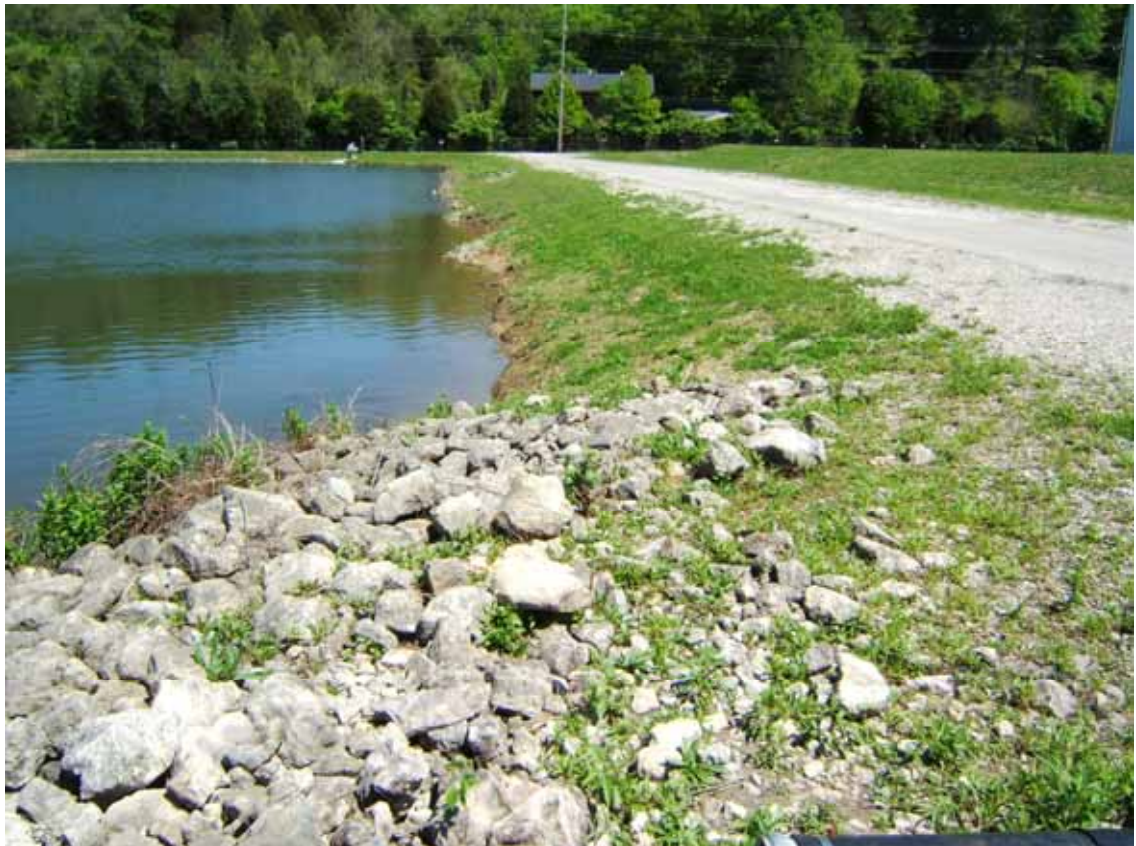
Photo Number:
16

Description:
View of south
inboard slope of
Wastewater
Pond

Note minor
scarping along
length of
water's edge
