Dam Safety Assessment of CCW Impoundments

WH Zimmer Station

September 27, 2010

O'BRIEN & GERE
www.obg.com

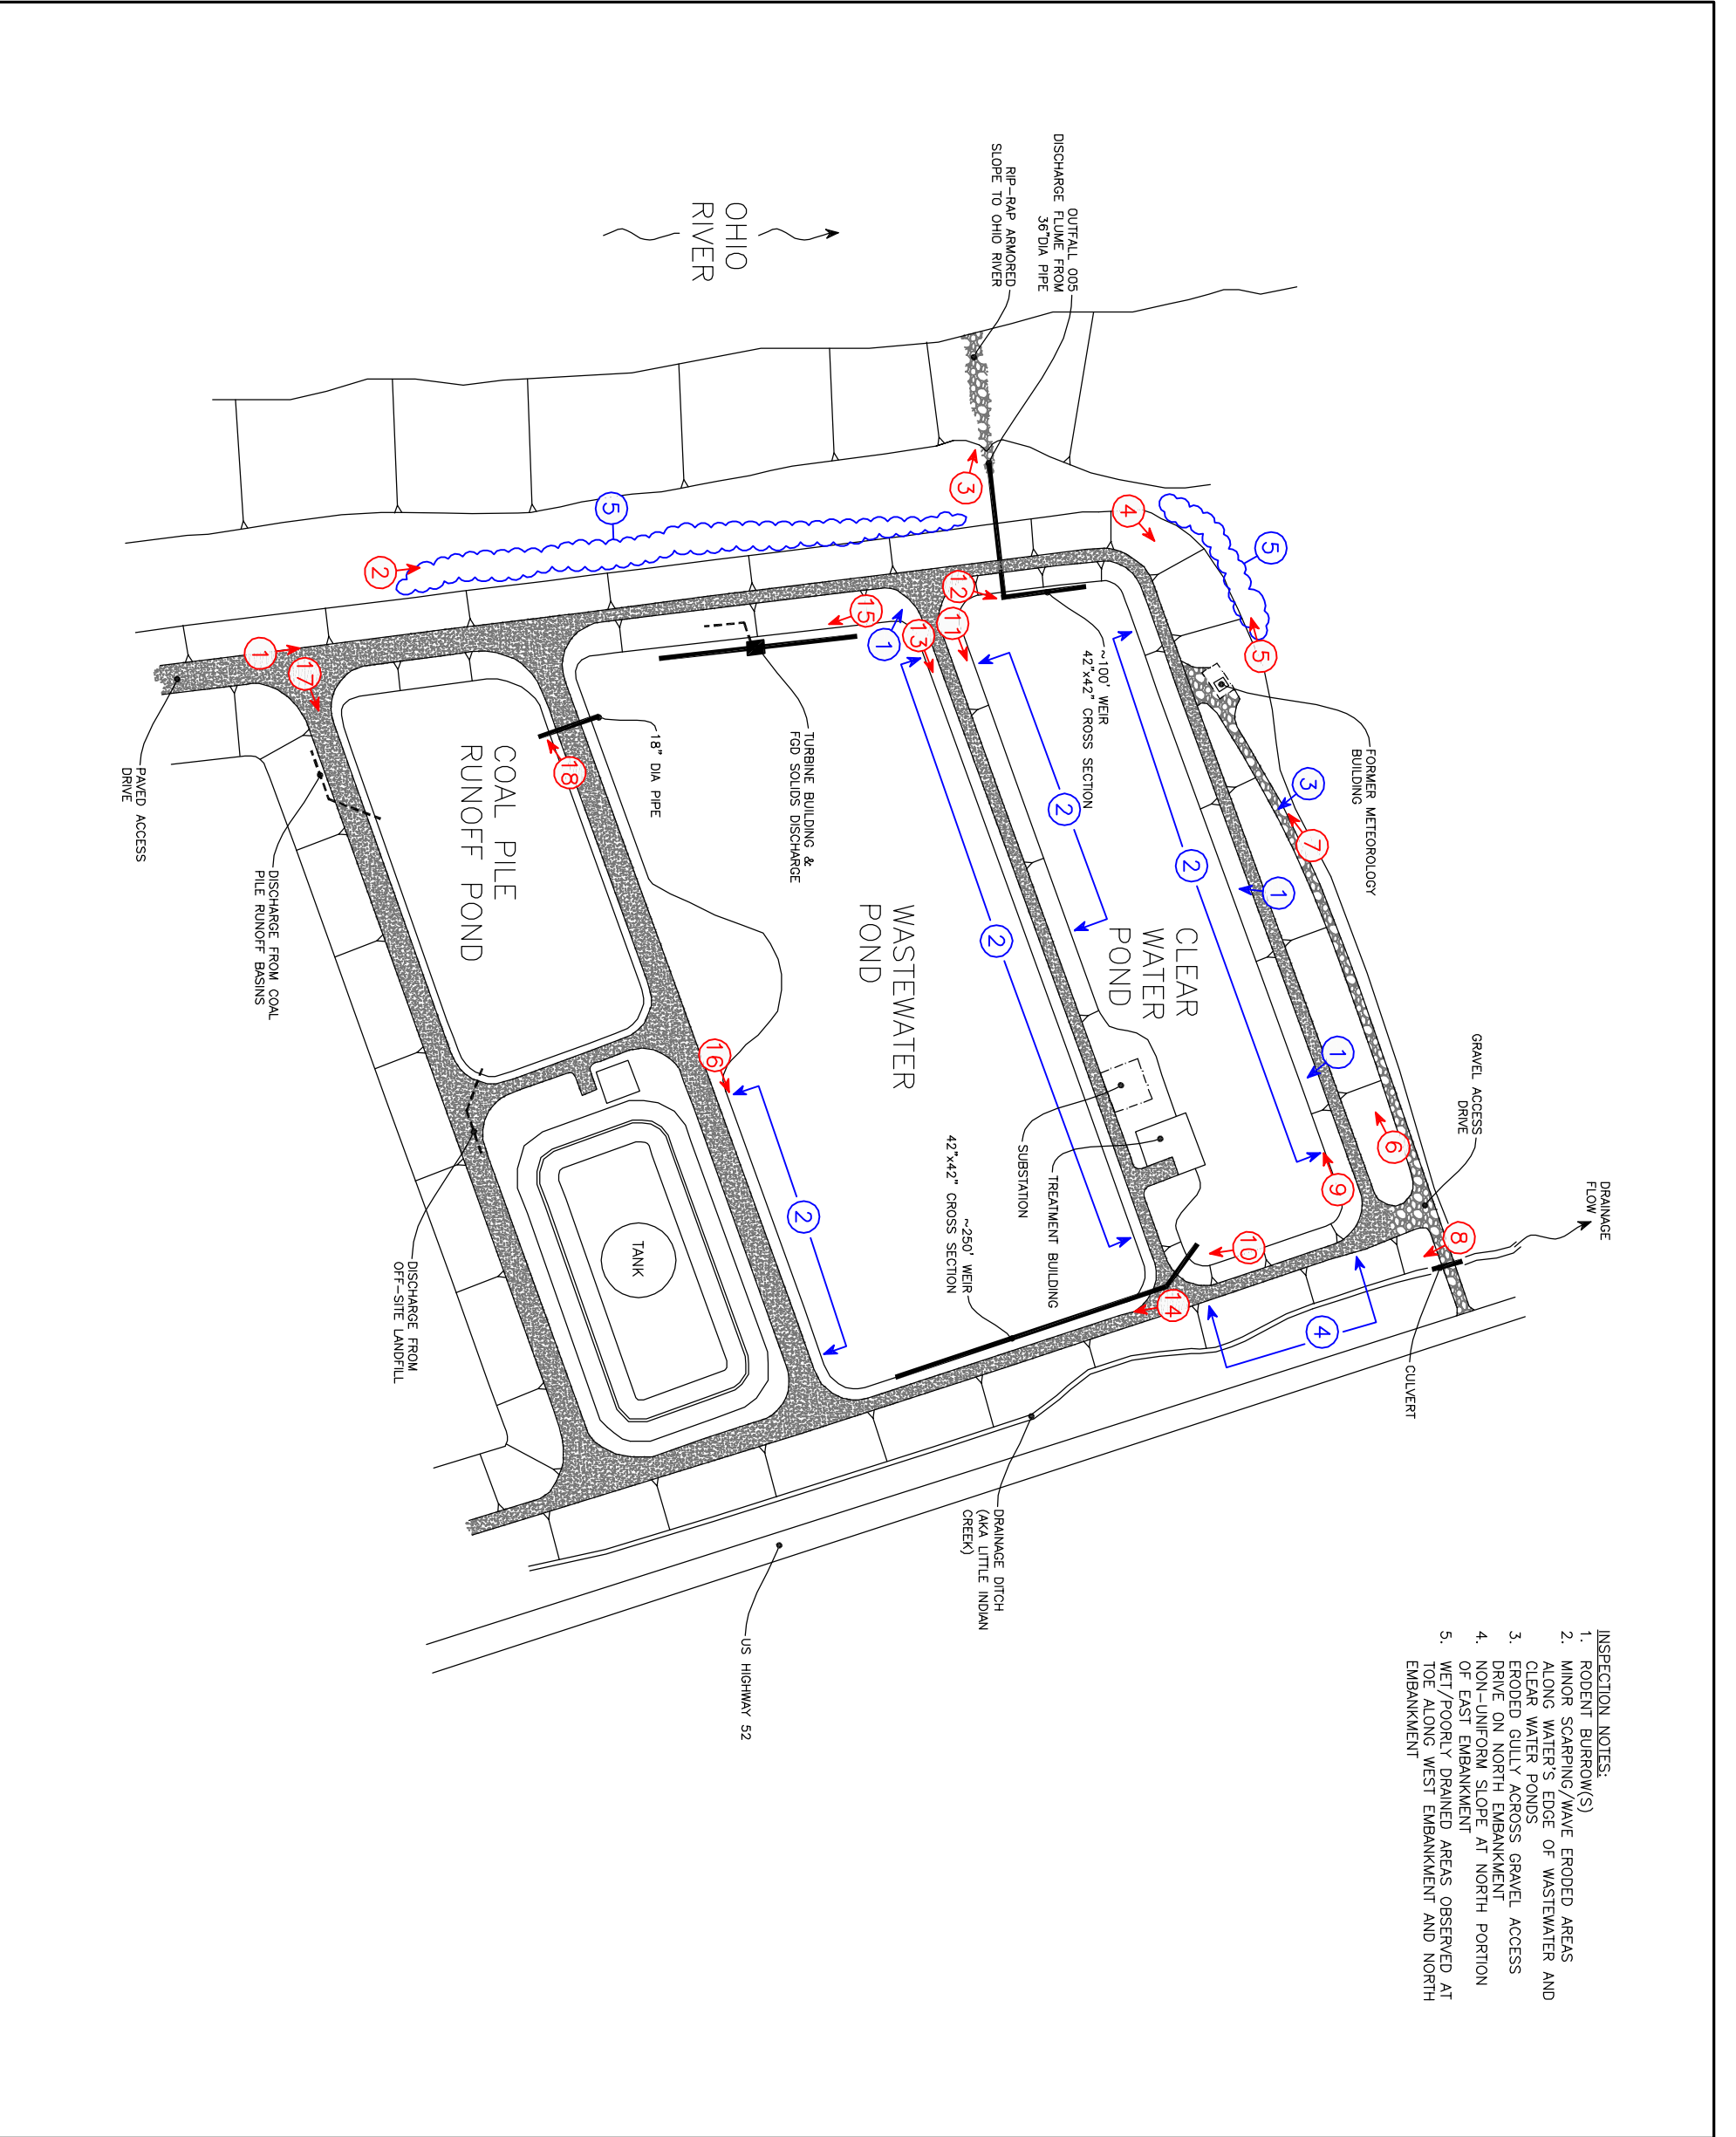
FIGURE 3

- INSPECTION NOTES:**
1. RODENT BURROW(S)
 2. MINOR SCARPING/WAVE ERODED AREAS ALONG WATER'S EDGE OF WASTEWATER AND CLEAR WATER PONDS
 3. ERODED GULLY ACROSS GRAVEL ACCESS DRIVE ON NORTH EMBANKMENT
 4. NON-UNIFORM SLOPE AT NORTH PORTION OF EAST EMBANKMENT
 5. WET/POORLY DRAINED AREAS OBSERVED AT TOE ALONG WEST EMBANKMENT AND NORTH EMBANKMENT

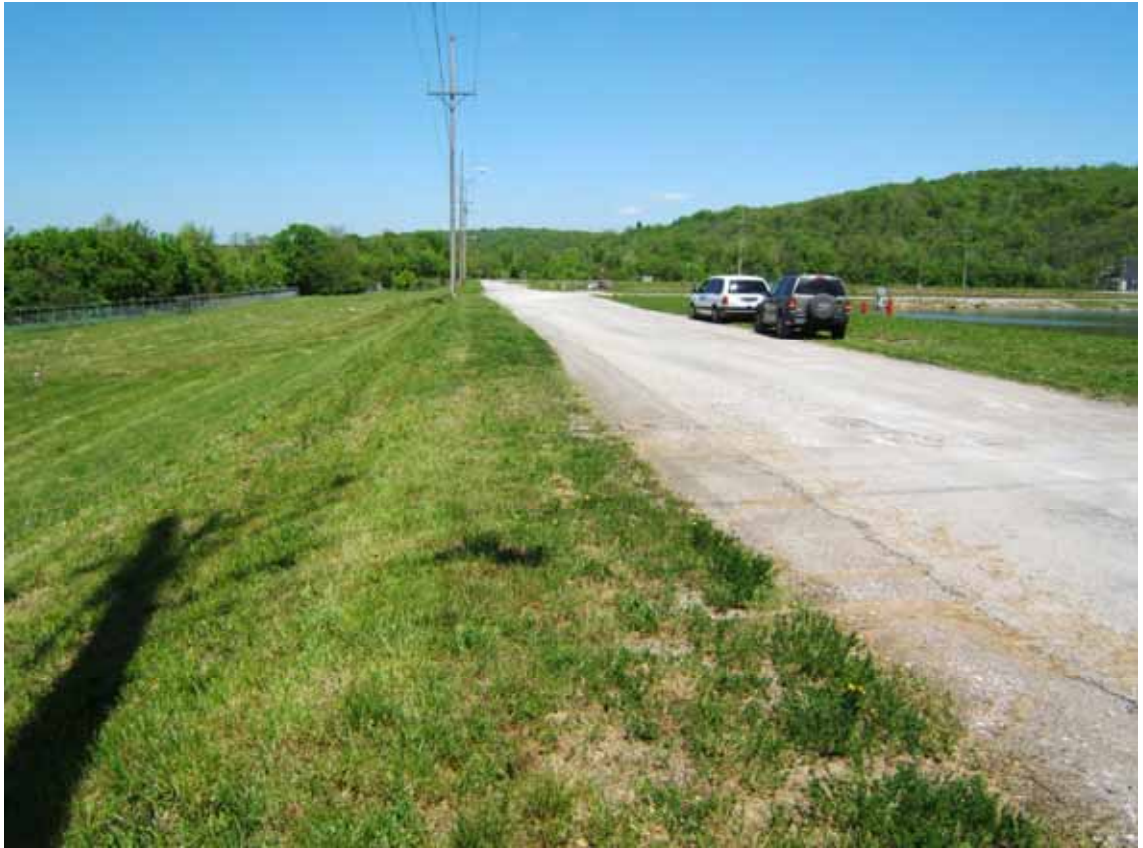
Photo Number:
1

Description:
View along west
embankment

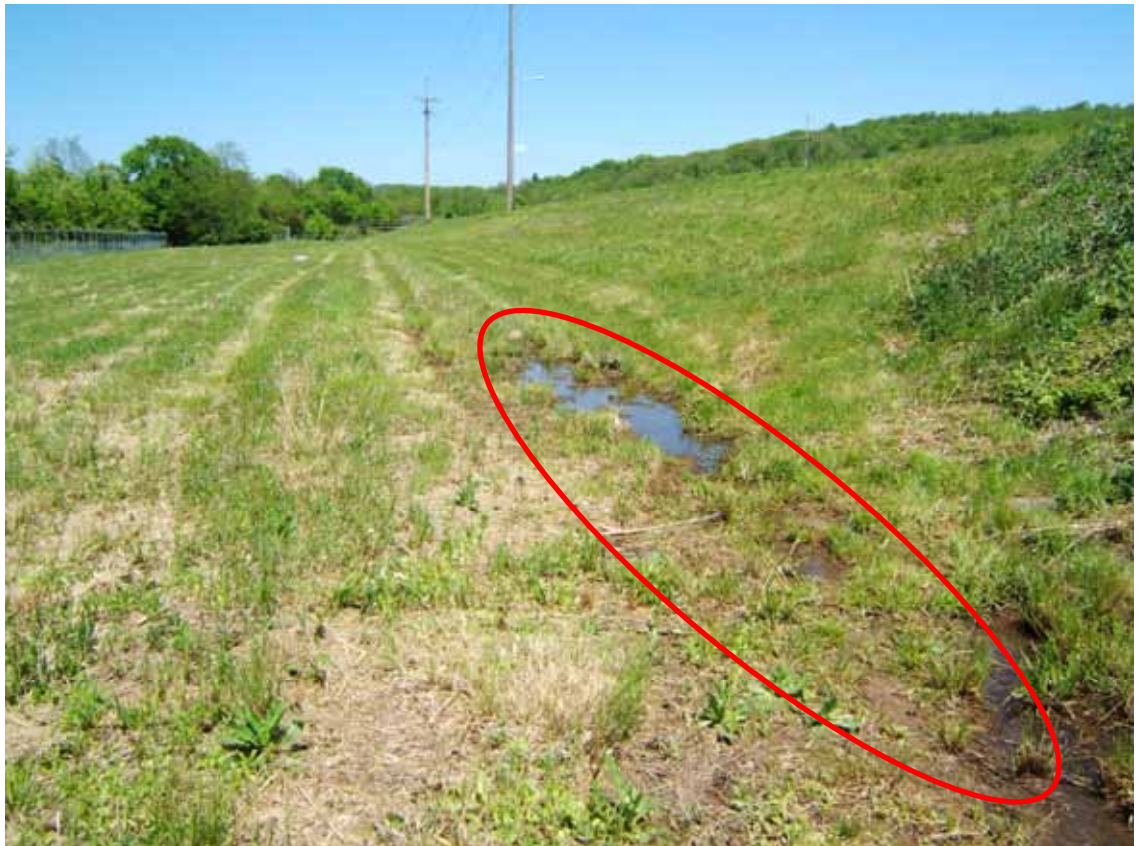
Photo Number:
2

- Ponded water was observed at the toe of the slope along the majority of the west embankment and western portion of the north embankment. The ponded water was reportedly due to recent heavy rains and poor local surface drainage and is expected to dry up in time. As a result it is not believed to be seepage from the Wastewater Pond Complex.

Description:
View along west
embankment

Note ponded
water at toe,
suspected to be
poor surface
drainage from
recent heavy
rain, not
seepage

O'Brien & Gere also recommends that the long term improvements noted in Section 6.2 above be completed by the end of calendar year 2011. Should the wet areas along the toe return upon completion of regrading, further investigation may be necessary to verify if seepage is an issue.

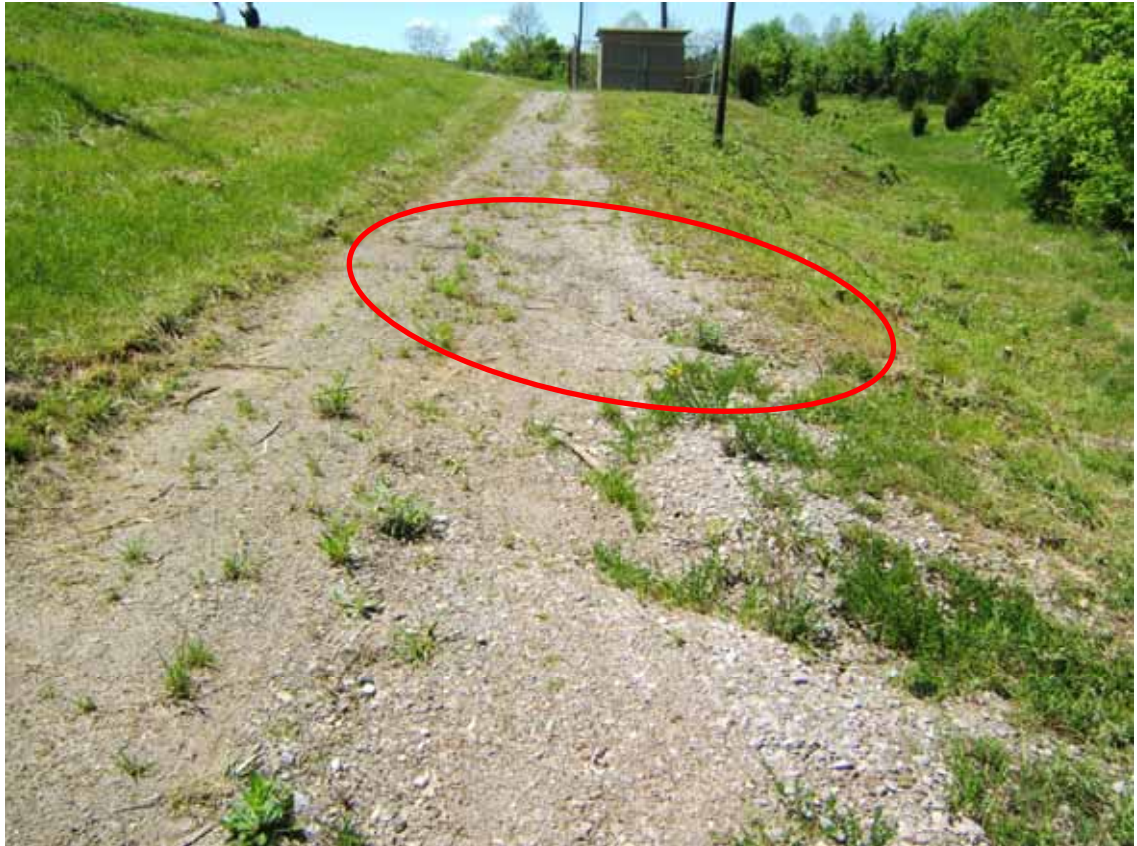
Photo Number:
7

- Erosion was observed across the secondary access road on the north embankment.
- A non-uniform slope was observed at the north end of the east embankment. This departure from the design slope was reported to be a result of fill placed to create an access ramp on the slope for maintenance activity related to the adjacent highway.

Description:
Erosion on
access road to
former
meterological
station on
North
embankment

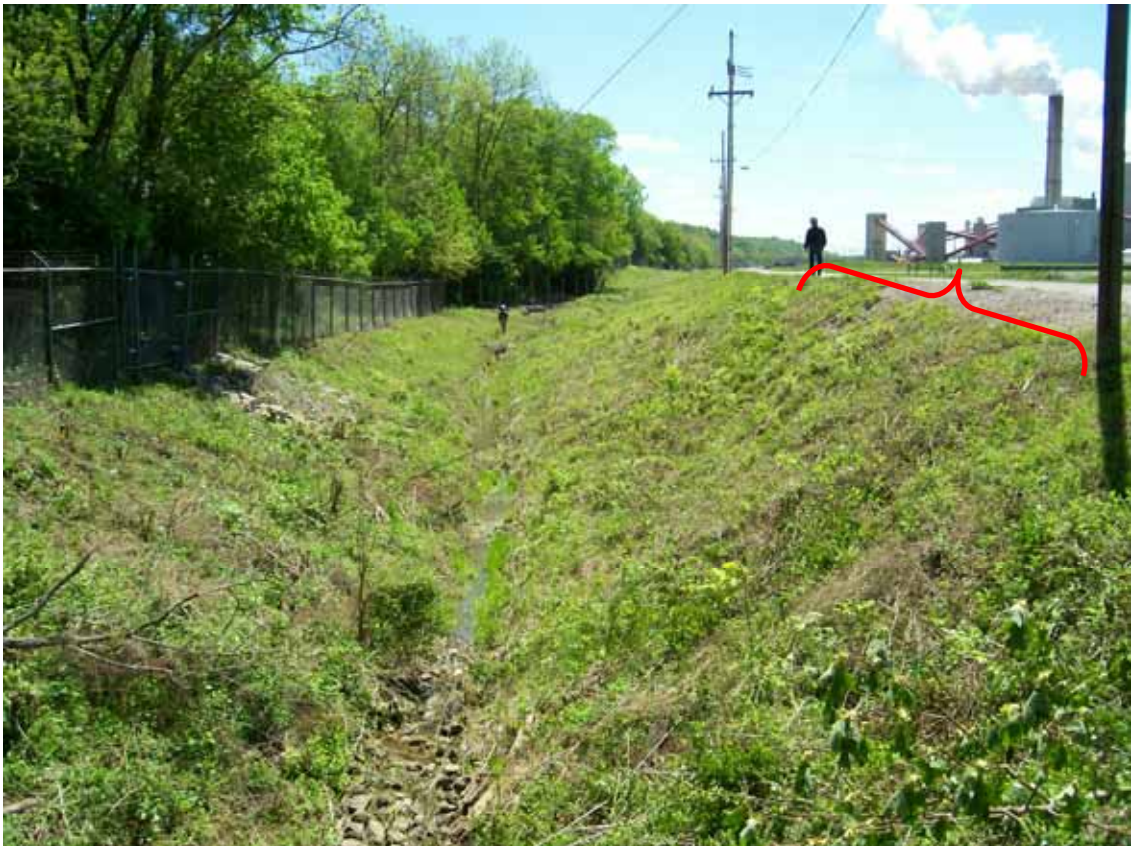
Photo Number:
8

18	A non uniform slope was observed at the north end of the east embankment. This non uniform slope did not appear to be due to significant sloughing or bulging of the embankment, but rather possibly a result of overfilling during original construction or another unrelated project.
21, 23	Ponded water was observed at the toe of the slope along a majority of the west and north embankments. Based on historical inspections and reports from the site walk escorts, these areas are normally dry. It is estimated that the ponded water observed during this inspection was due to heavy rains within the week prior to the site visit.

Description:
View along east
embankment

Note section of
embankment
with non-
uniform slope
