Subject: EPA Comments on Dynegey Midwest Generation Inc. – Baldwin Power Station,
Baldwin, IL
Round 10 Draft Assessment Report

Comments on Draft Report
Dynergy Midwest Generation – Baldwin Energy Complex
By Paul Mauer, Jr., P.E.
Senior Engineer
Illinois Dam Safety Program

RE: DMG Comments on Draft Assessment of Dam Safety of Coal Combustion Surface Impoundments at the Baldwin Energy Complex, dated March 15, 2012

Baldwin Energy Complex Ash Pond System

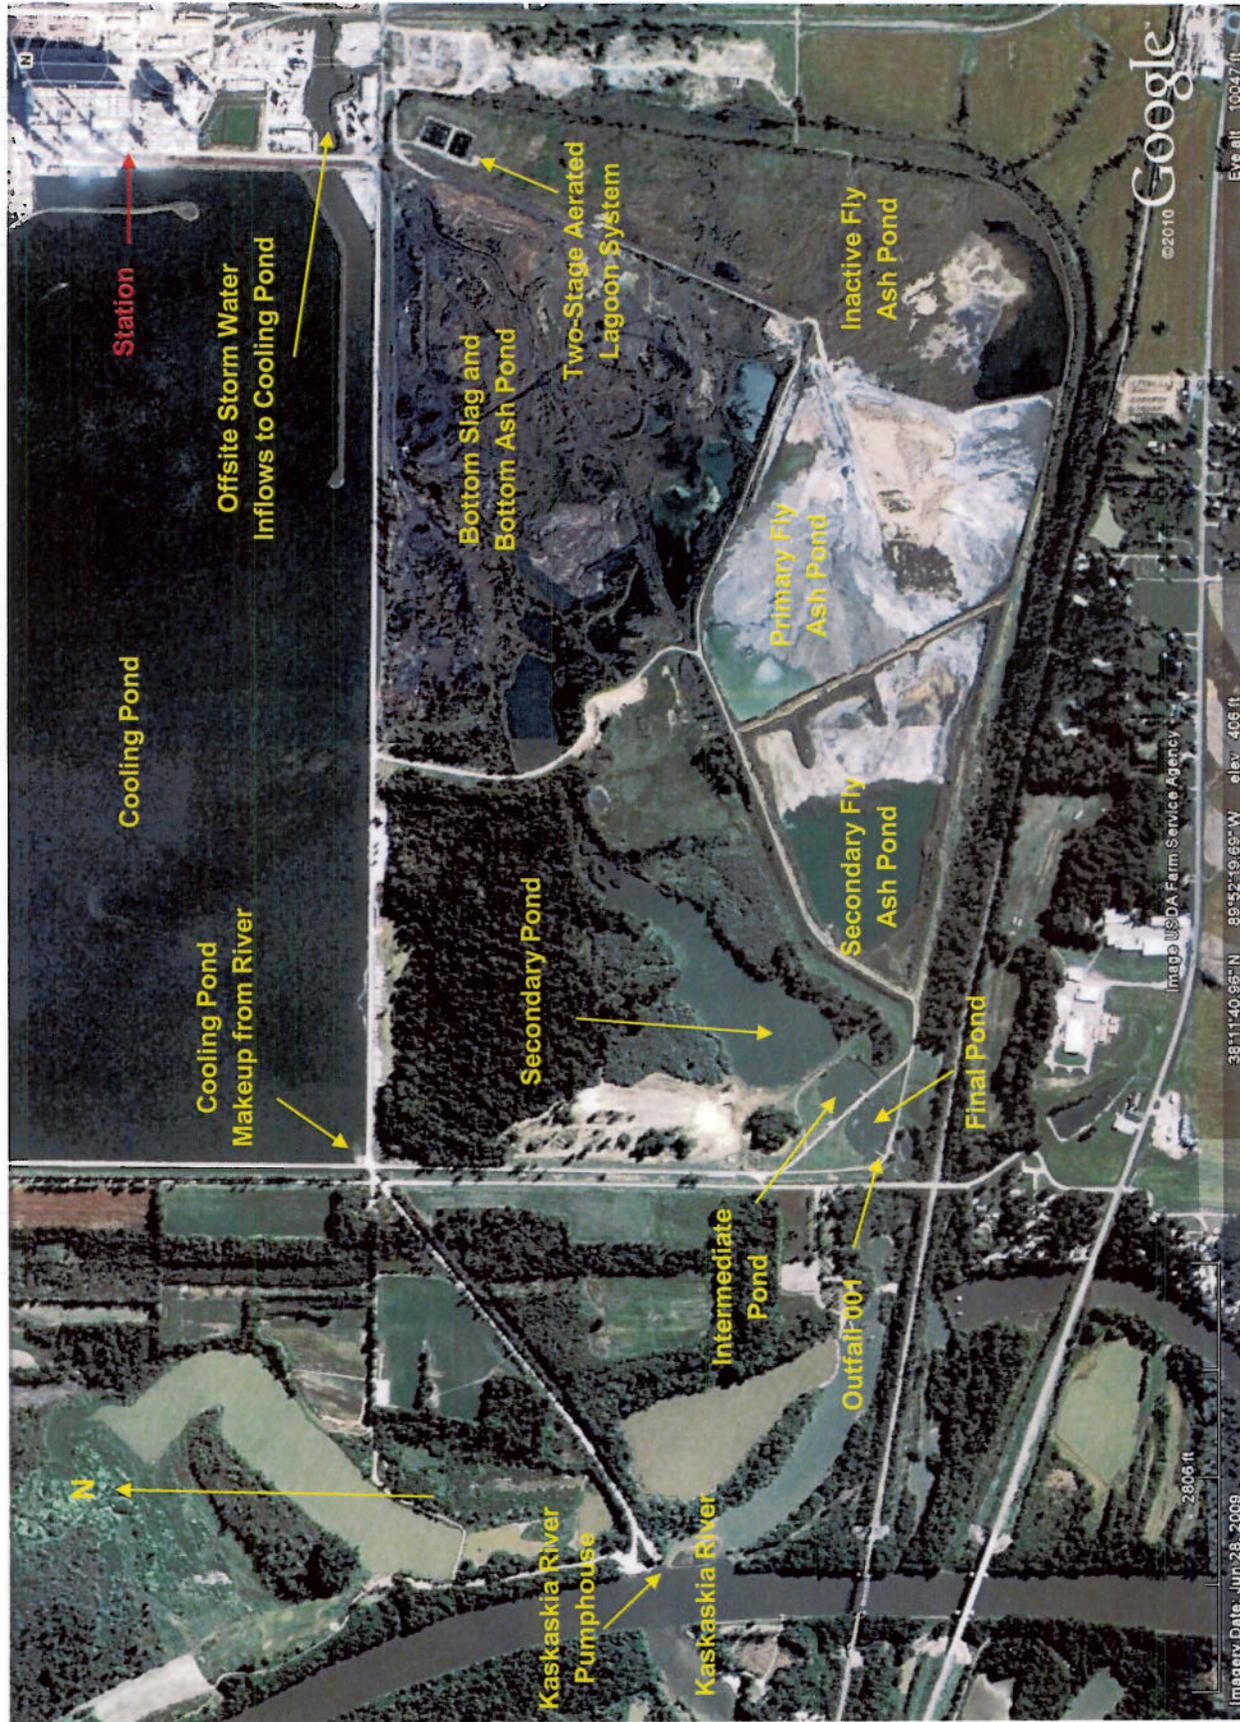
1. To avoid confusion and for consistency with formal documents that already exist in the public domain, such as permit applications, groundwater report submittals, etc., DMG recommends that the ash pond designations on the attached figure, labeled as the Baldwin Energy Complex Ash Pond Systems, be used in the assessment report and associated figures.

5. Referring the attached figure, labeled as the Baldwin Energy Complex Ash Pond Systems, the inactive fly ash pond and the primary fly ash pond are essentially inactive and do not impound surface water. DMG also understands that the scope of the assessment, as stated by the USEPA, includes "the assessment of closed units that no longer receive coal combustion residues or by-products but still contain free liquids". GZA has apparently assumed that these two inactive surface impoundments contain free liquids, without performing a paint filter (free liquid) test. DMG recommends that a paint filter (free liquid) test be conducted, to determine the presence of free liquids, before the report is finalized.
