DRAFT
Specific Site Assessment for
Coal Combustion Waste
Impoundments at Empire
District Electric Company,
Riverton Generating Station
Riverton, Kansas

November 2010
Project 092883

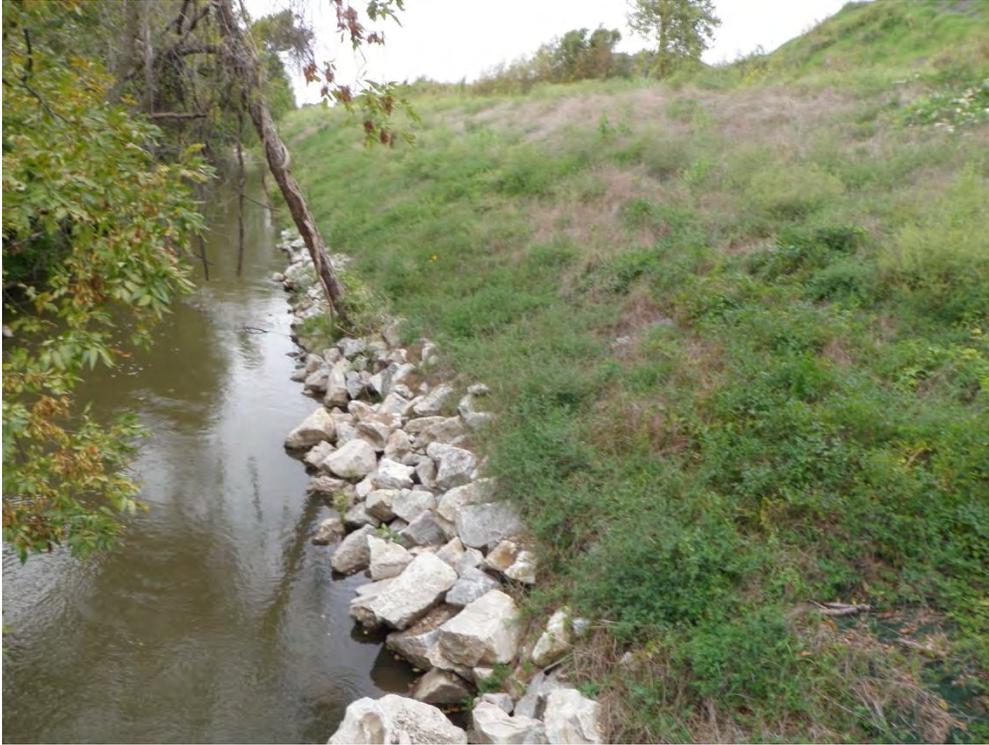
The downstream slopes of the CCW impoundment have well-established stands of grass, which provides some erosion protection. No scarps, sloughs, depressions or other indications of slope instability or signs of erosion were observed during the inspection of the CCW impoundment, however the heavy vegetation limited much of the visual inspections of the downstream slopes. Based on an Anderson Engineering Preliminary Visual Slope Stability Assessment dated April 13, 2009, minor sloughing and shallow slope failures were observed at locations along the downstream toe of the perimeter dike. A deep failure was also identified in the report, located at the toe of the east perimeter dike in the cooling water discharge channel.

Photo 1: Riprap at downstream toe of the perimeter dike in the cooling water discharge channel.

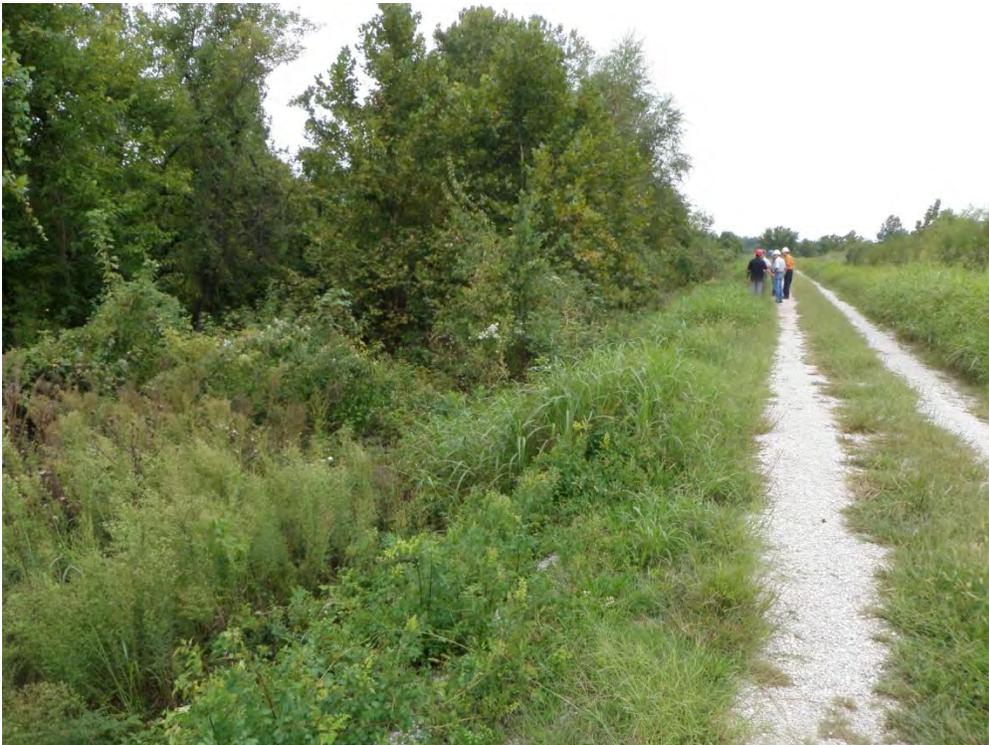
Tree growth was observed at the toe of the downstream slope around the entire perimeter dike. Dense growths of trees are located along the east perimeter dike in the cooling water channel, where some trees are also growing out of the downstream slope, and along the west and north perimeter dikes. Several trees (up to 1-foot-diameter) were observed in these dense growths of trees. The south perimeter dike contains sparse tree growth and is contained within the Spring River flood plain.

Photo 2: Heavy vegetation and large trees in downstream slope of east perimeter dike, East Cell.

1. A thick growth of trees, many up to 1 feet in diameter, was observed on the East Cell east perimeter dike downstream slope and at the toe in the cooling water channel. The trees should be removed to prevent root systems from creating seepage paths through the embankment slopes. Removal of root balls of large trees can cause additional damage to a dike and is not recommended without proper engineering planning and consideration.

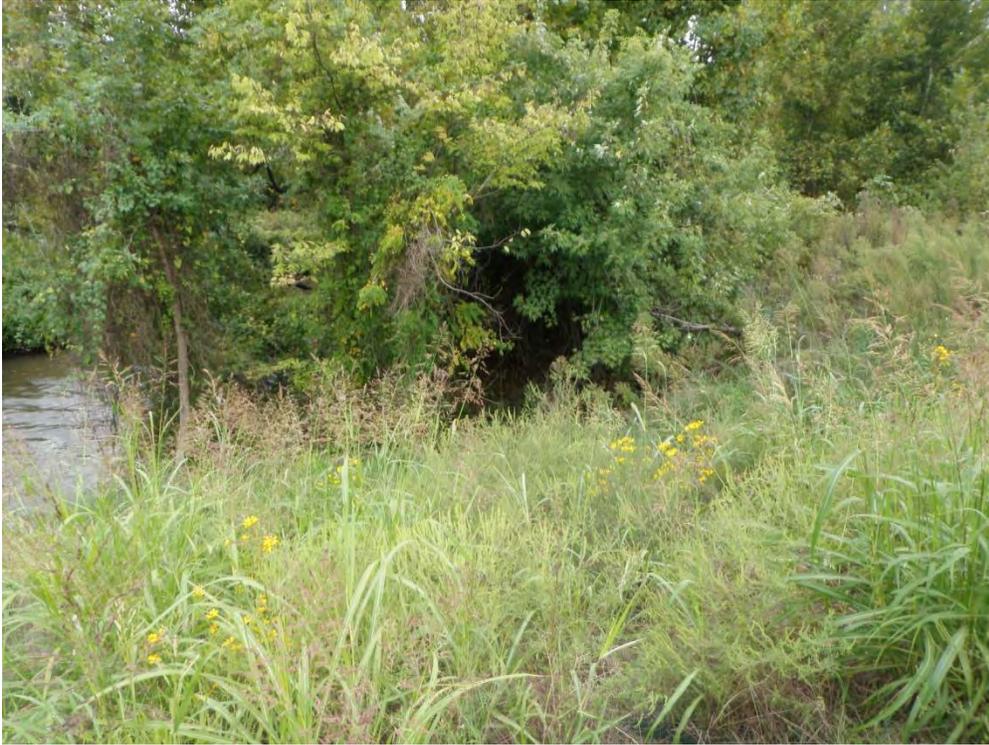
Photo 3: Heavy vegetation in downstream slope of east perimeter dike, East Cell.

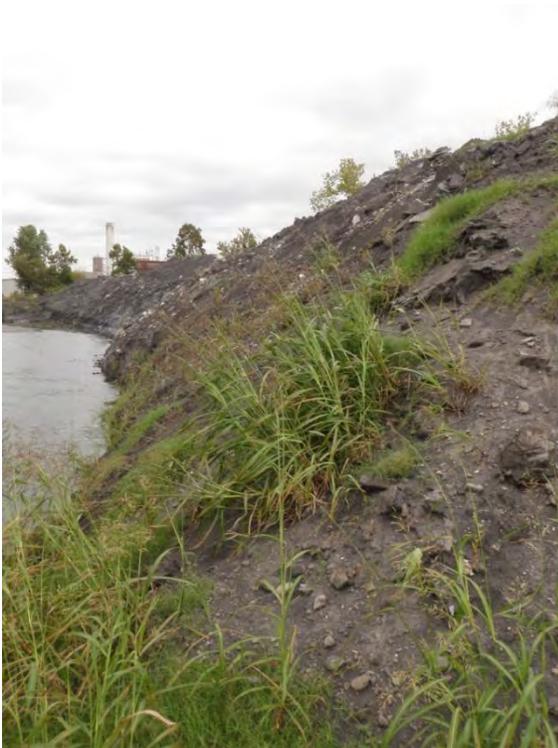
Photo 4: View of inside slope of ash piles in East Cell.

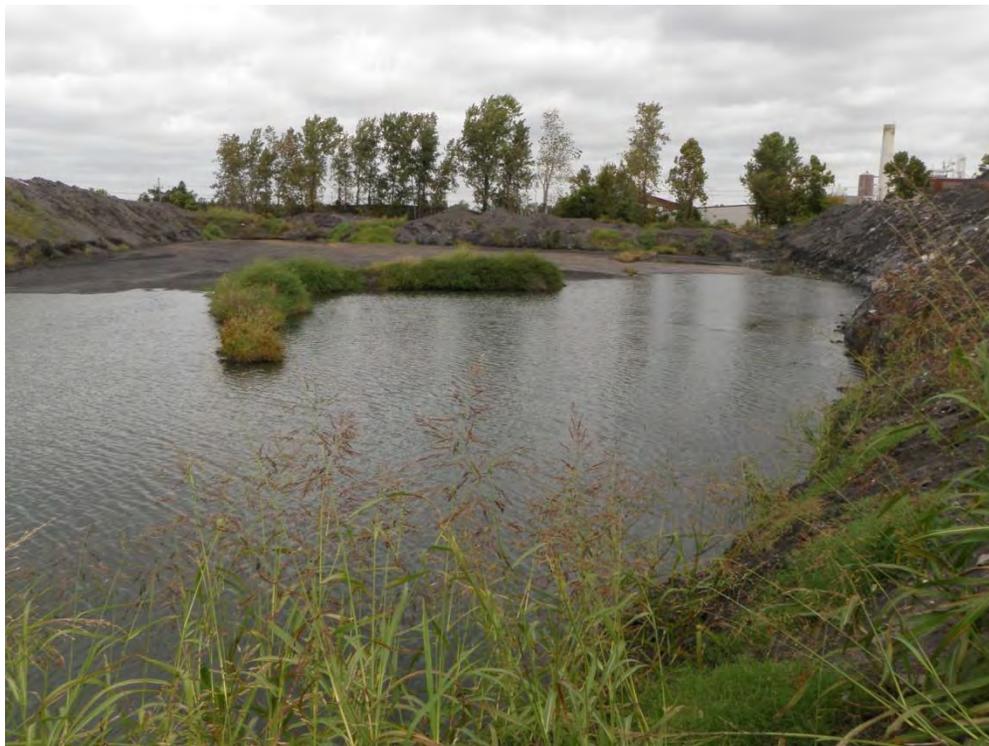
Photo 5: East Cell, looking northwest toward the location of the outlet pipe.

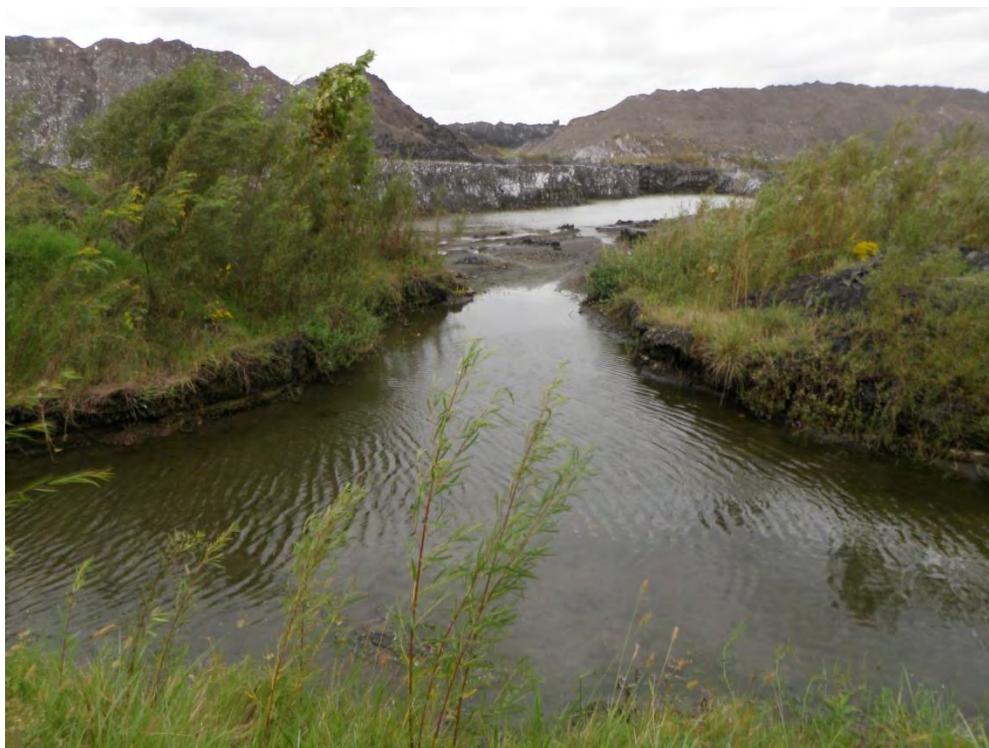
Photo 6: Inlet for perimeter dike drain connection to East Cell pond (dike drain ditch in foreground).

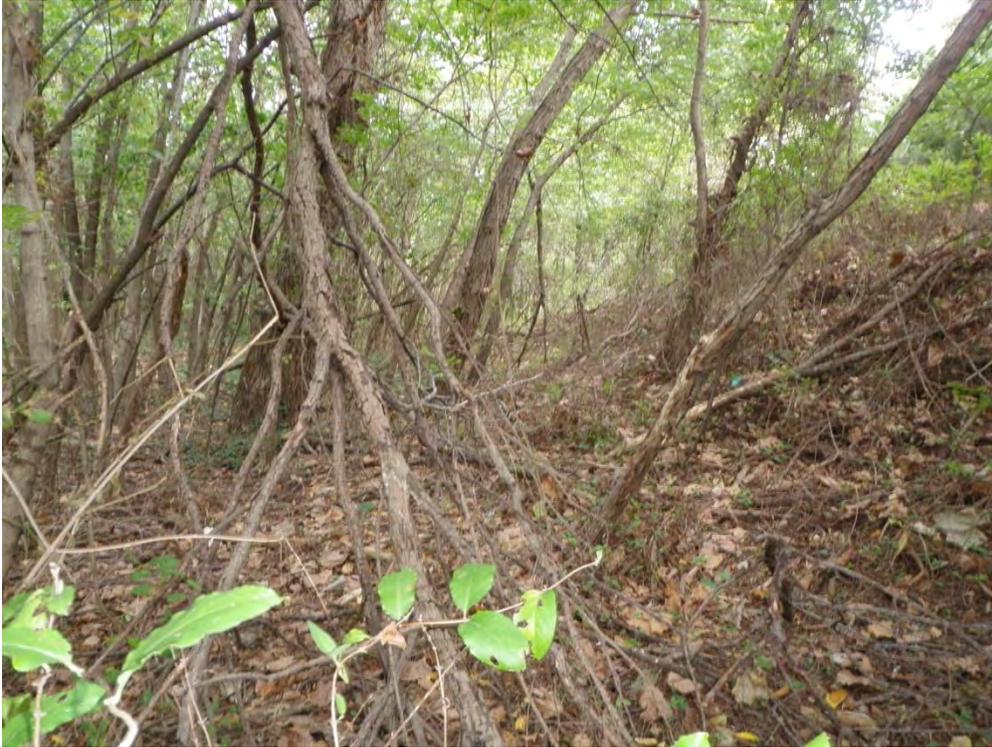
Photo 7: Trees at toe of south perimeter dike, shown at right.

2. Trees were observed near the downstream toe of the perimeter dike along most of the perimeter of the CCW impoundment. A minimum of about 25 feet of clear space should be provided between the downstream toe and the tree line. Removal of root balls of large trees can cause additional damage to a dike and is not recommended without proper engineering planning and consideration.

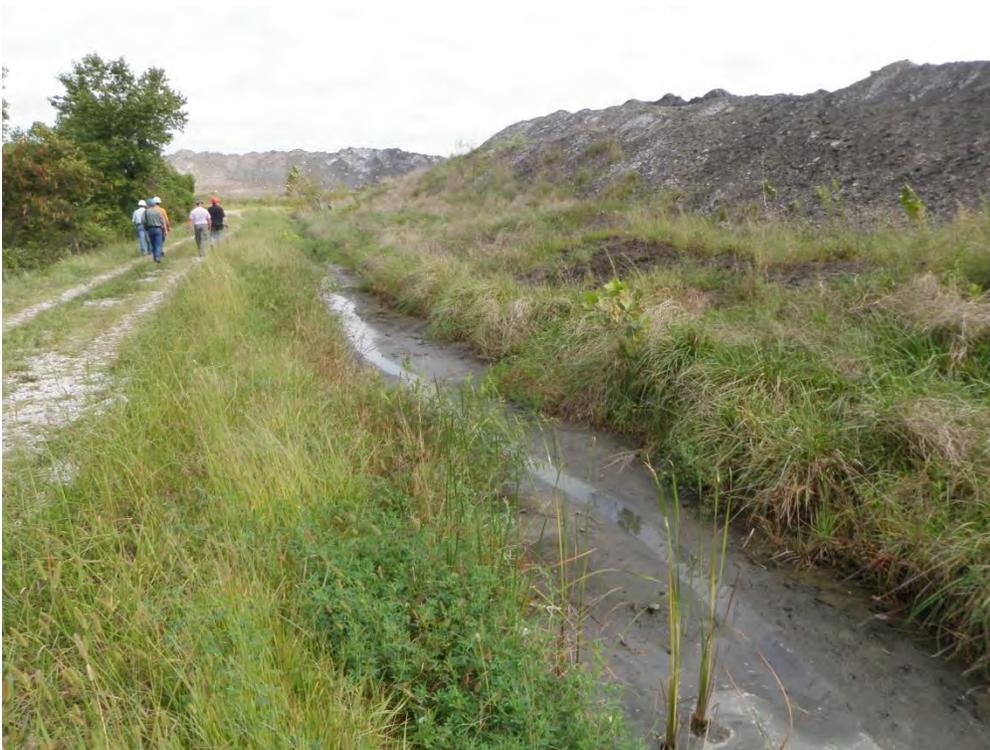
Photo 8: West perimeter dike showing interior drainage ditch and ash piles in East Cell.

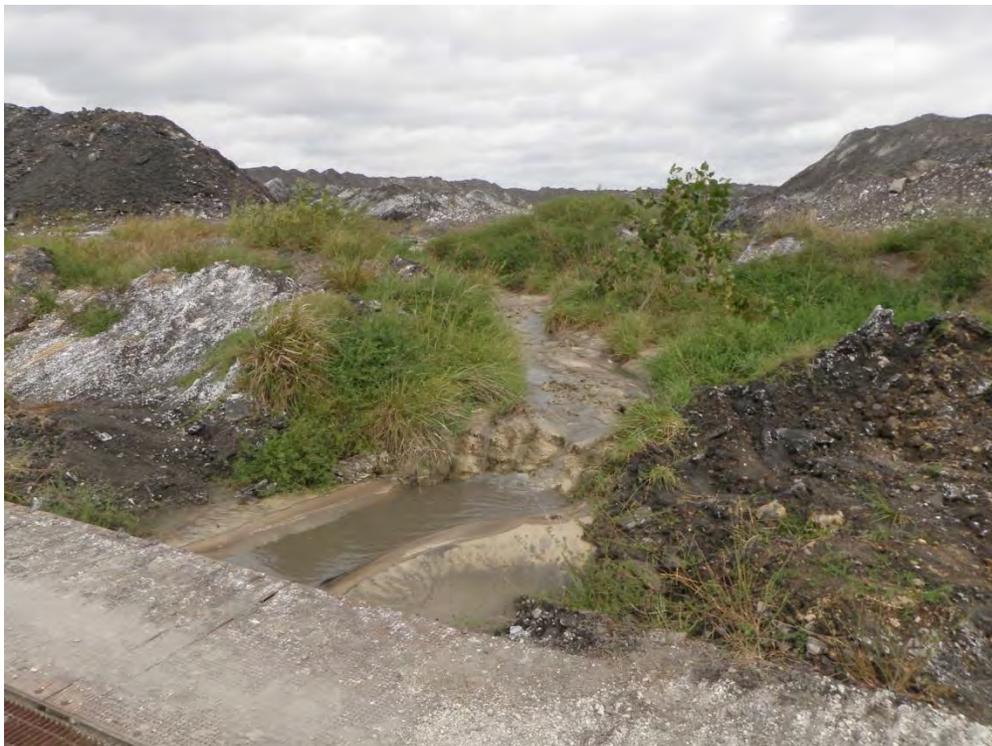
Photo 9: View of West Cell looking northwest from bridge over spillway between the East and West Cells.

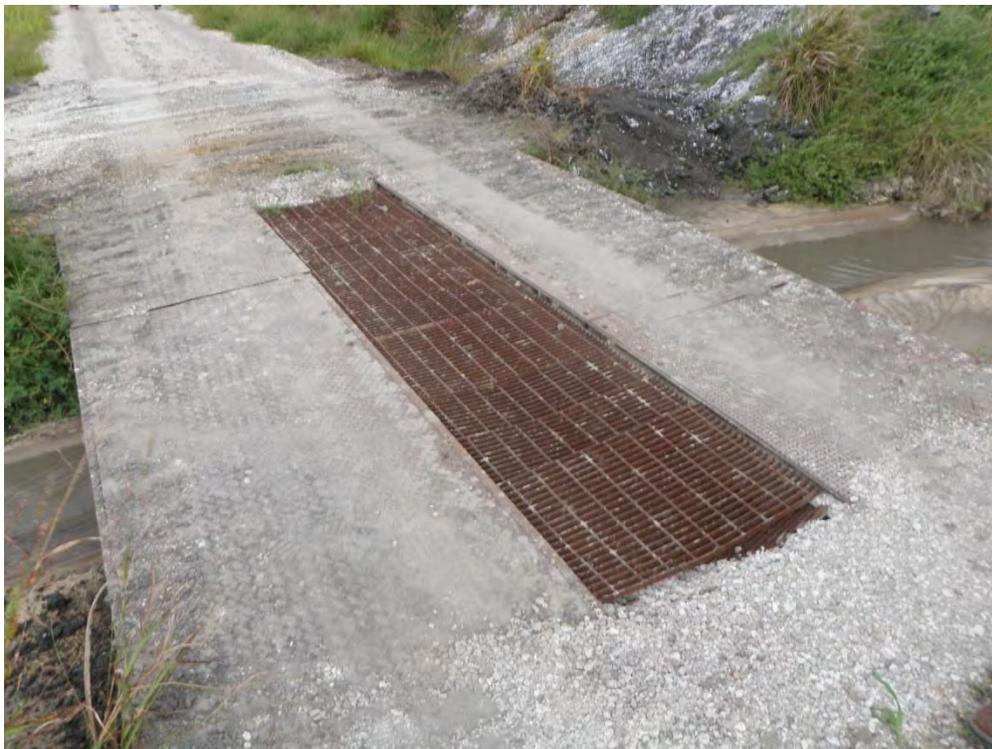
Photo 10: Bridge spanning spillway between the East and West Cells.

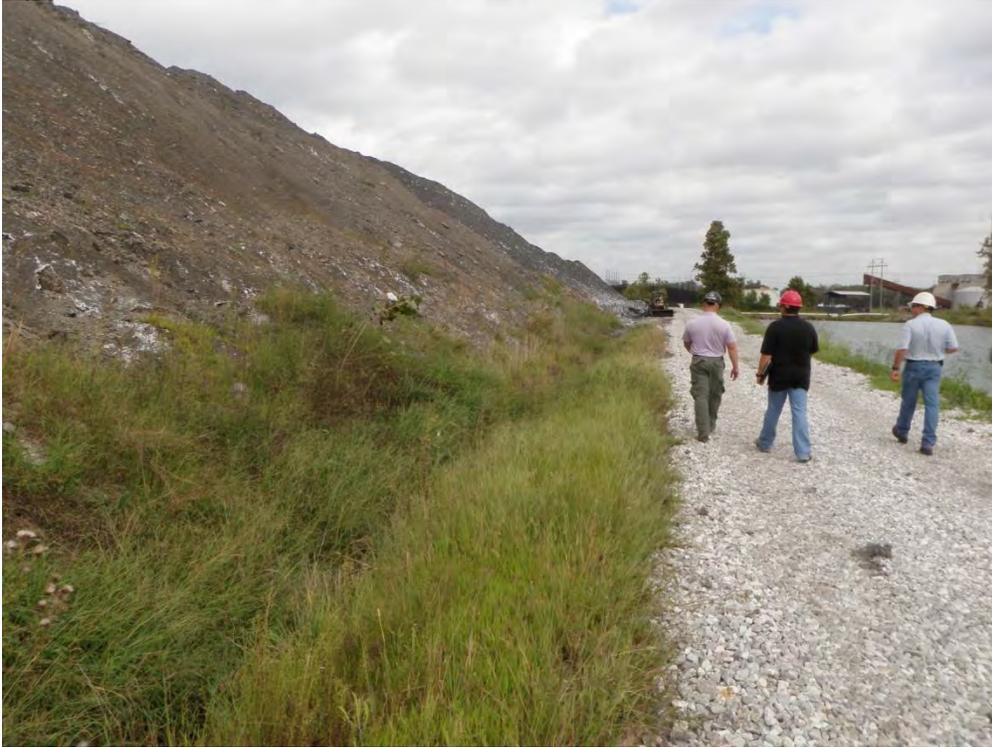
Photo 11: View of ash in the West Cell, looking north along the dike between the East and West Cells.

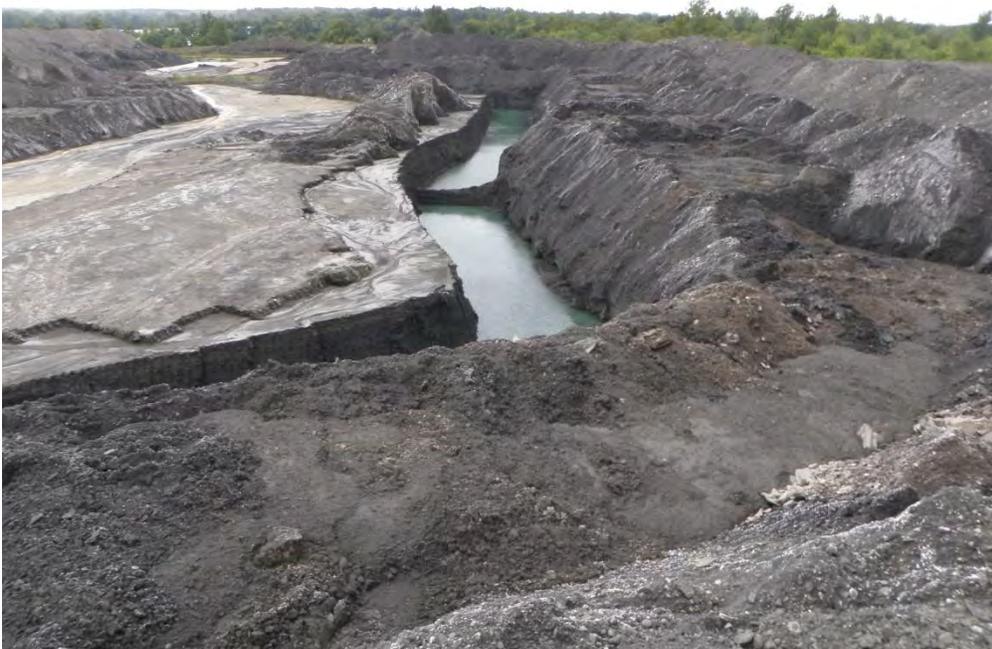
Photo 12: Excavation in West Cell showing how sluiced ash is conveyed through cell, looking south.

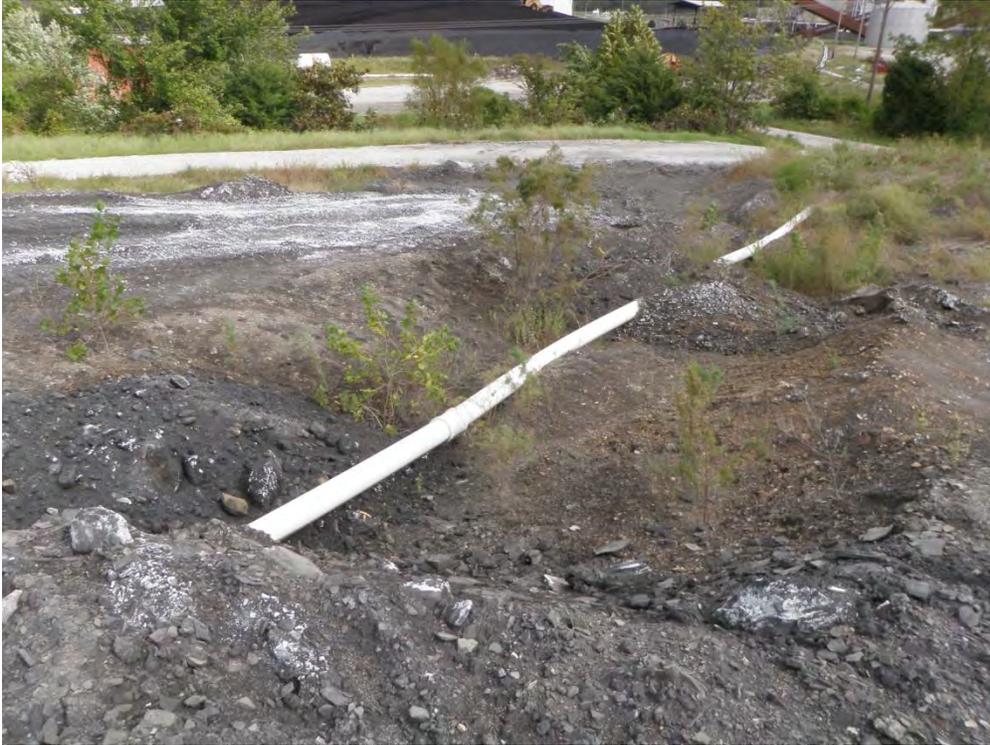
Photo 13: Intake to West Cell.

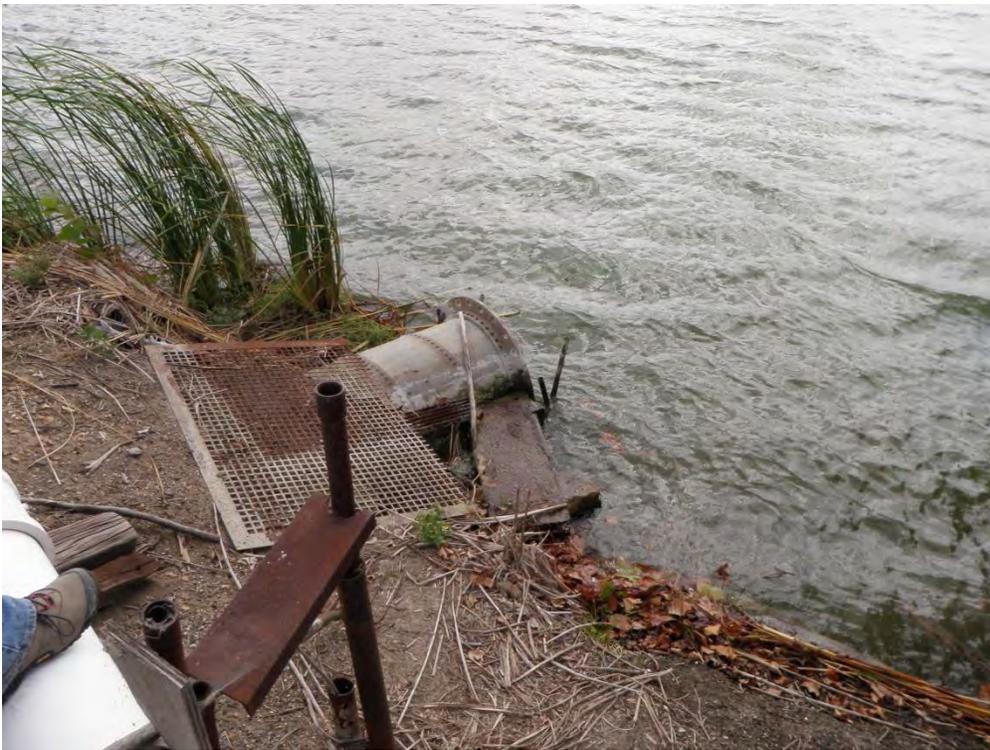
The riveted steel outlet pipe in the northwest corner of the East Cell appeared to be in good condition and showed no signs of corrosion or deterioration. The pipe was observed to be working properly and was discharging decant water to the north drainage ditch. The pipe has been in service for approximately 25 years.

Photo 14: Riveted steel outlet pipe located in northwest corner of the East Cell (note trashrack above pipe).

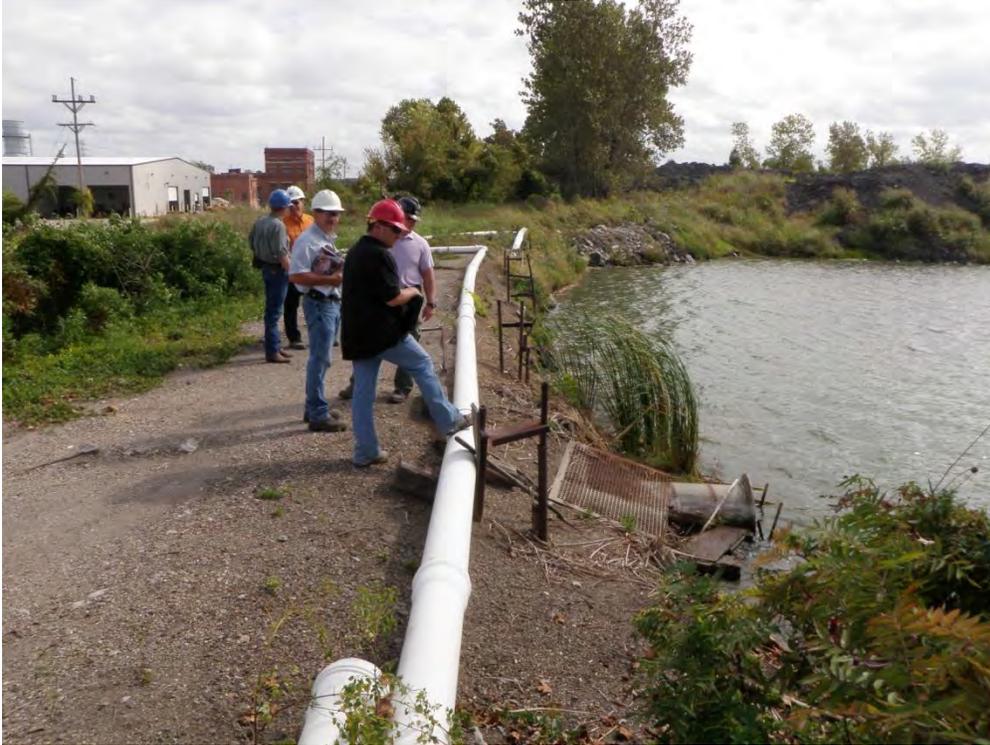
Photo 15: Outlet pipe in East Cell and PVC intake pipes located along north perimeter dike.

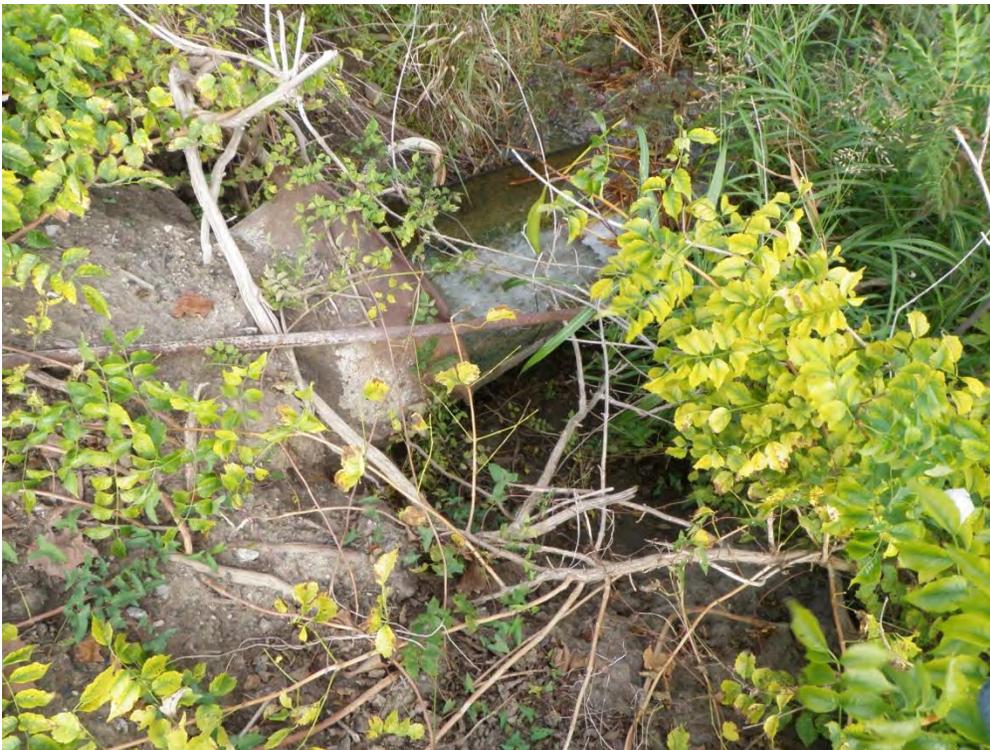
Photo 16: Discharge from outlet pipe.
