Assessment of Dam Safety Coal Combustion Surface Impoundments (Task 3) Final Report

Louisville Gas &
Electric Company
(A subsidiary of E.ON U.S.)

Cane Run Power Station
Louisville, Kentucky

April 16, 2010

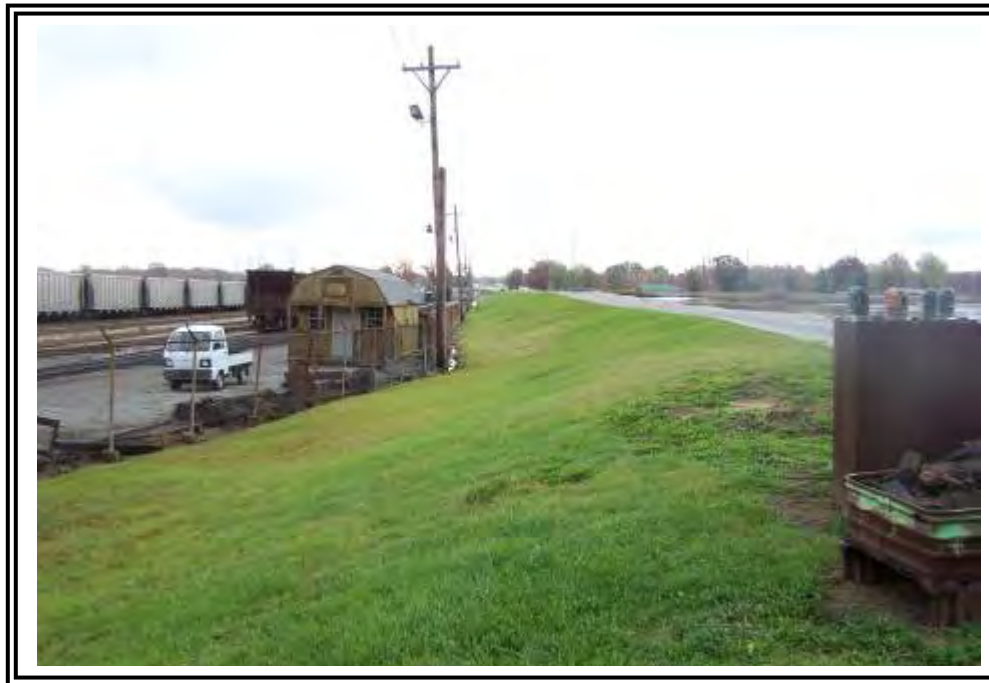
Photo 1 shows the north dike downstream slope is reasonably uniformly graded and appropriately vegetated with grass. Slope measurements indicate a variation from 2.5H:1V near the crest to 2H:1V near the toe. Occasional erosion rills have developed on the downstream slopes as shown in Photo 2. Photo 4 shows a slight irregularity in slope grading which occurs over a limited area of the downstream slope. This appears to be an overfilled repair, but could indicate soil creep. Tire ruts from mowers also exist in this area. This is common on earthen embankments, and requires observation to ensure that erosion and sloughing do not occur. Poor drainage at the toe of the slope results in ponding along much of the north dike. Photos 3, 5, and 6 show standing water and erosion at the toe likely resulting from this condition. E.ON U.S. is working with a consultant to design drainage improvements in this area. A small rodent hole, as shown in Photo 7 was seen in this area. A large area at the east end of the north dike has recently been re-graded (Summer 2009) with one to two feet of additional clay fill and sodded to address drainage problems, as shown in Photo 8. According to E.ON U.S., sod was used to avoid the

Downstream slope of north dike of the Ash Treatment Basin (ATB) from west intersection with county flood control dike looking east.

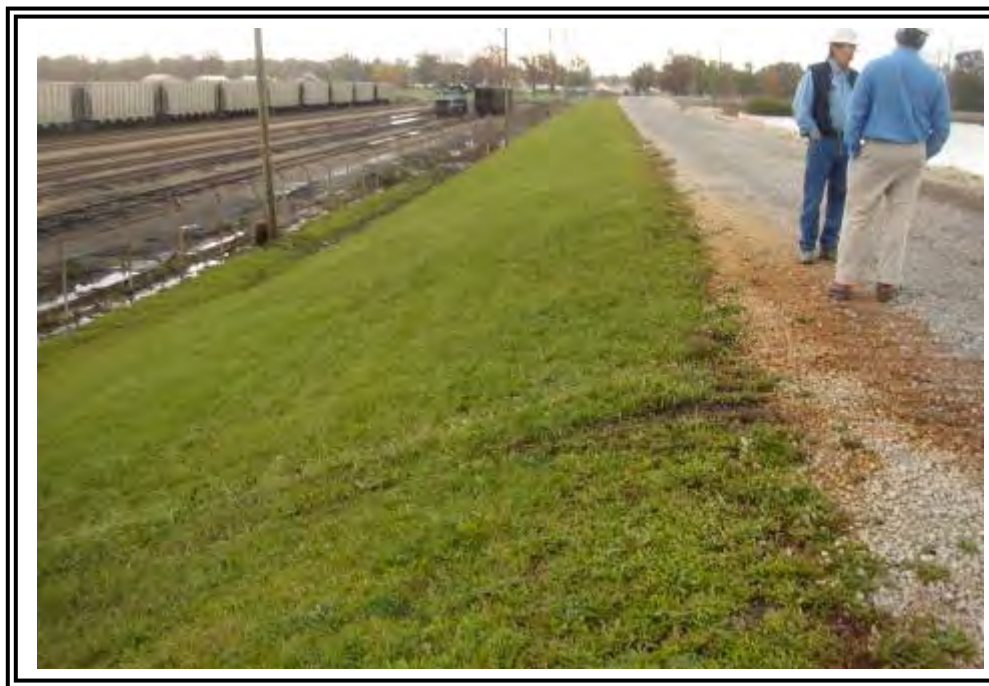
2

Slight erosion rill from crest on ATB north dike looking east.

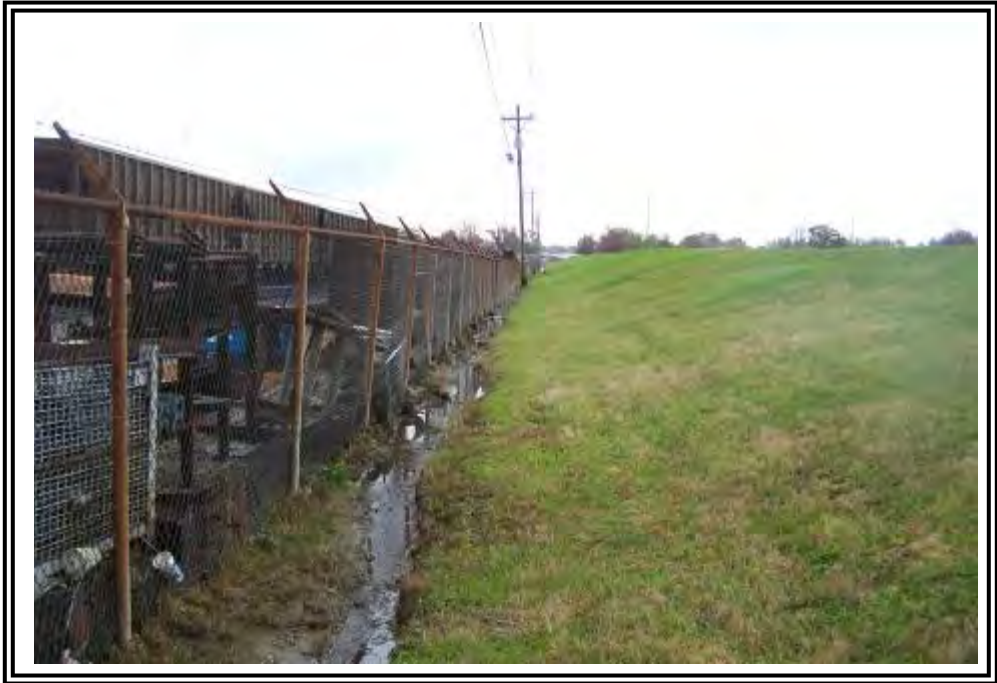
3

Downstream slope of north dike at ATB looking east. Poor drainage results in standing water at the toe of this dike. E.ON U.S. is working with a consultant to re-grade this area for better drainage.

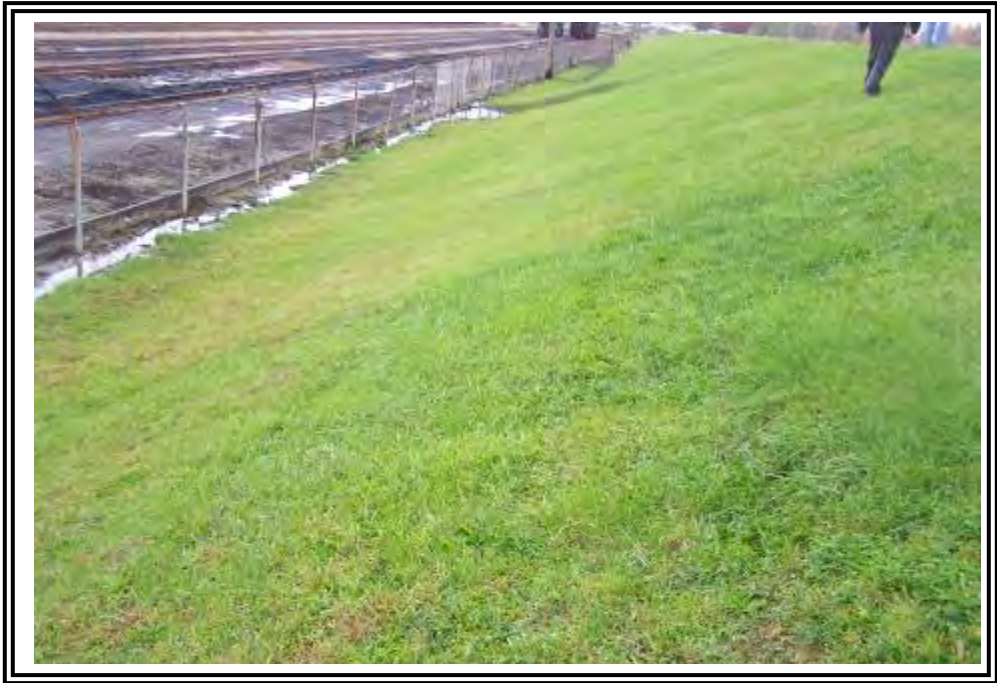
4

Downstream slope of north dike at ATB looking east. Slight irregularity in slope grading difficult to distinguish as an “as constructed” condition or soil creep.

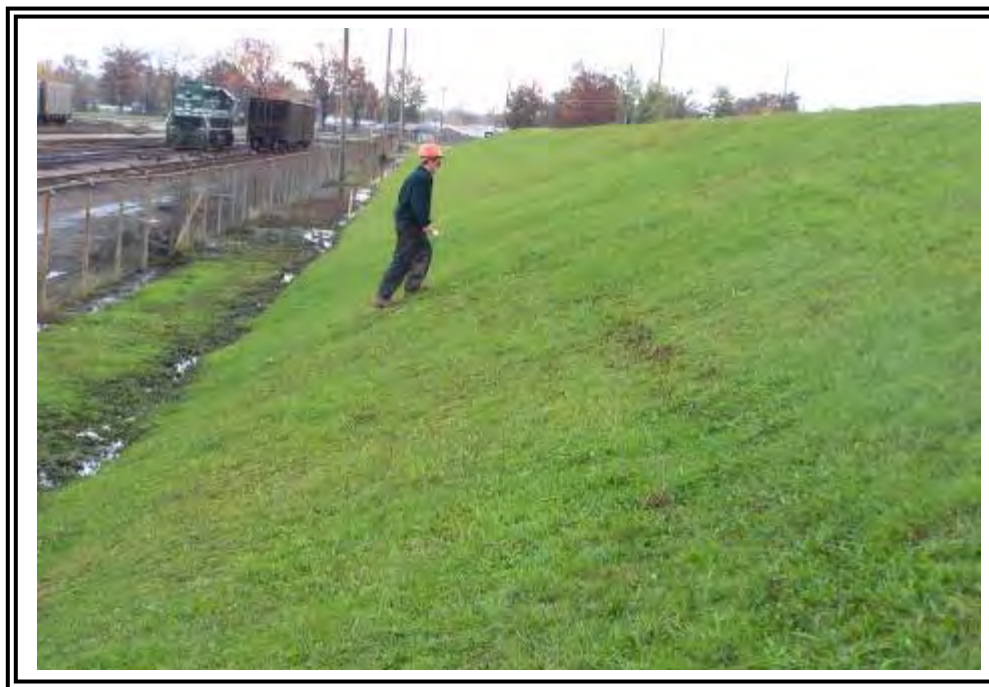
5

East end of north dike at ATB looking east. Mower ruts, and toe erosion from stormwater were observed.

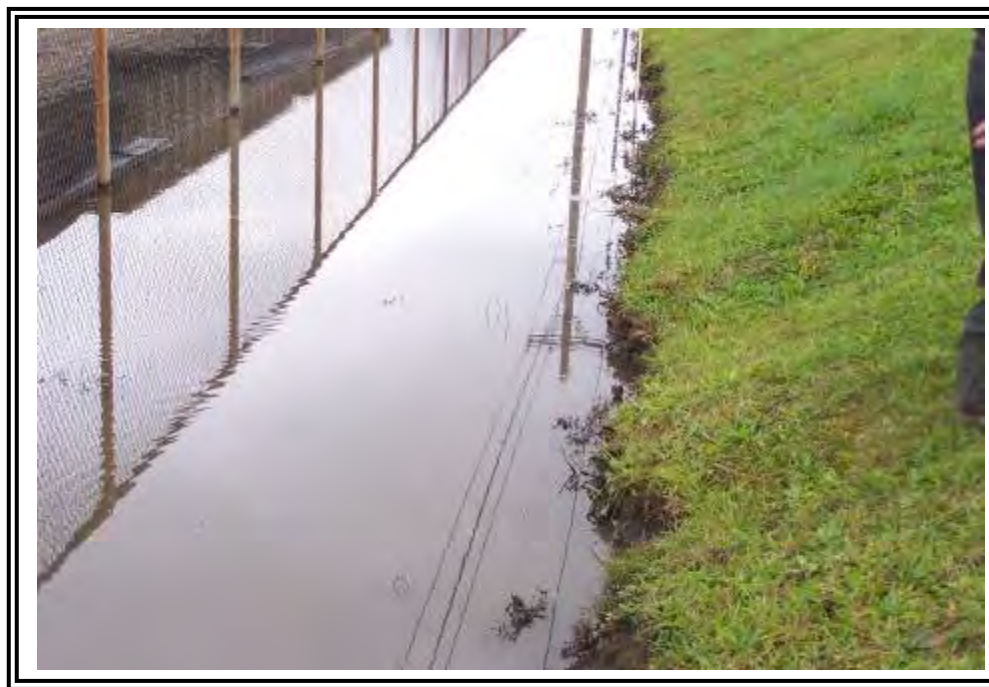
6

Close up of toe erosion on ATB north dike.

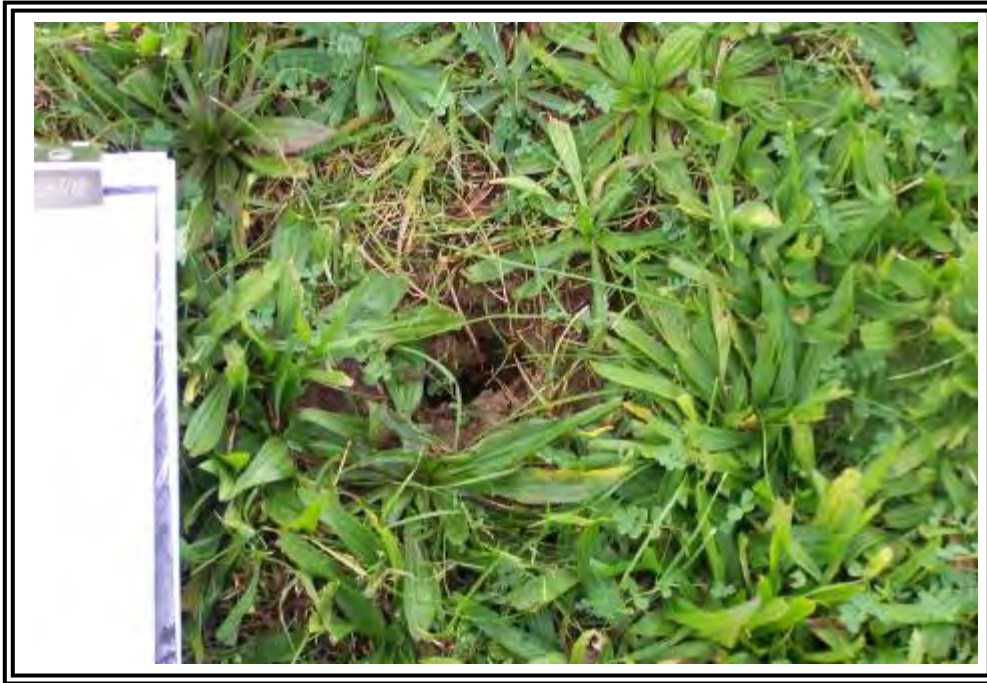
7

Small rodent hole on ATB north dike.

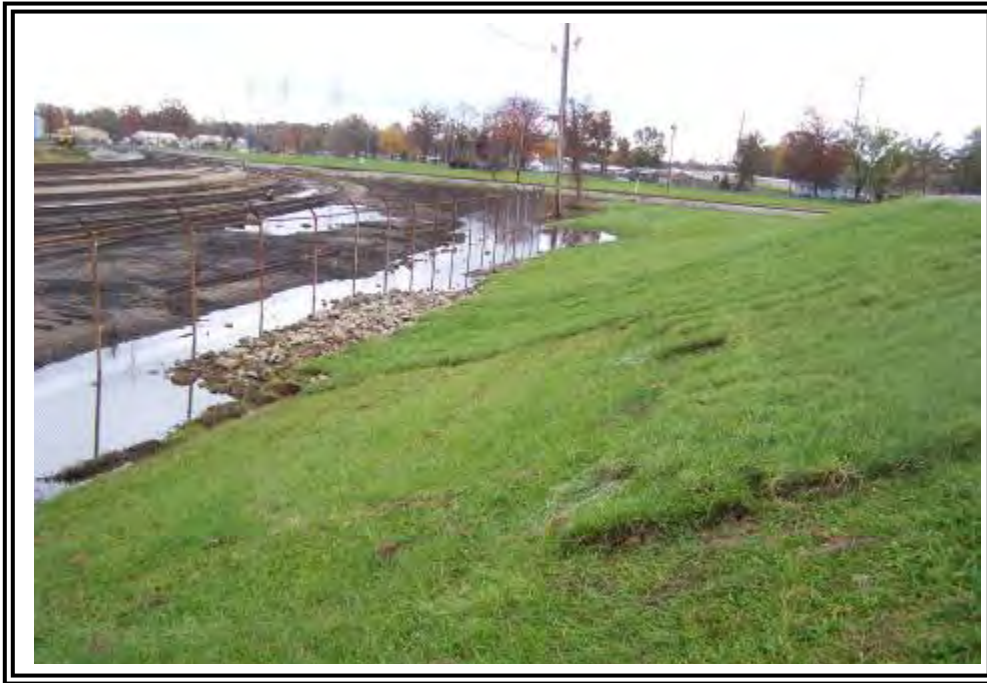
8

East end of ATB north dike has been regraded and had sod placed to address drainage problems. E.ON U.S elected to place new sod rather than seed because of this year's excessive rain.

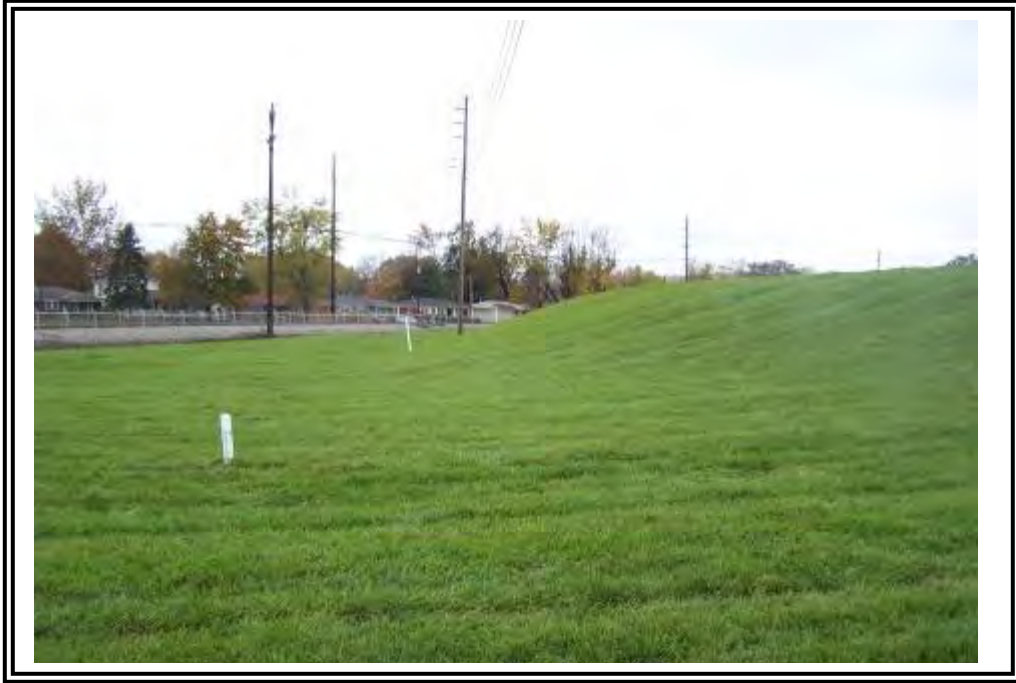
13

Downstream slope of ATB east dike looking south. The area at the toe was raised 1 to 2 feet in summer 2009 and sod placed to prevent stormwater pooling in this area. White markers indicate the location of a high pressure gas line installed in 2005.

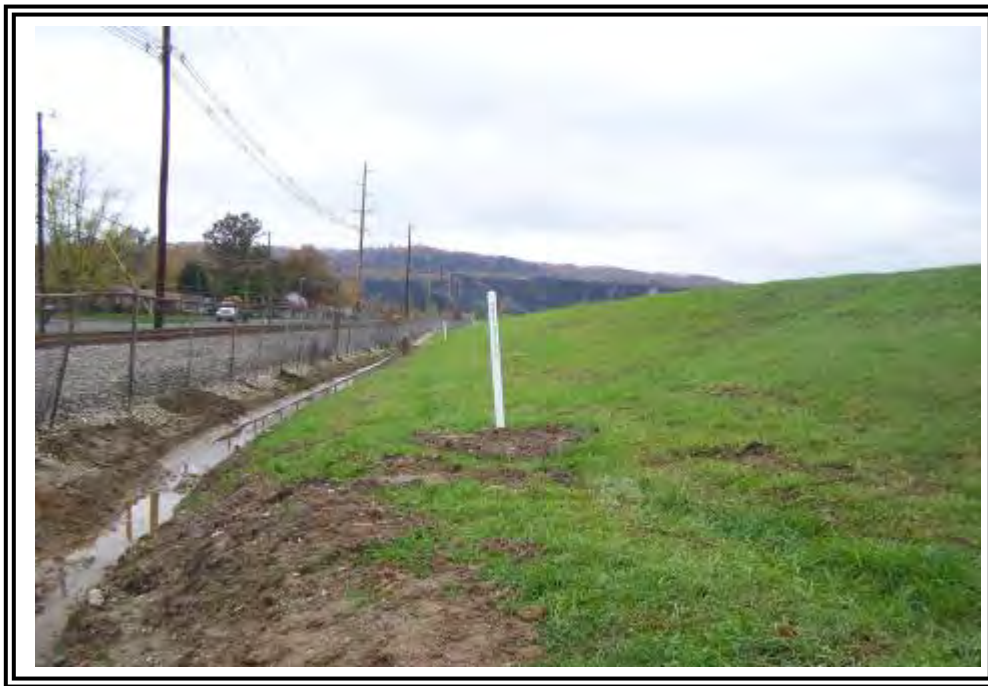
18

The gas line continues along the downstream toe of the south dike as shown in Photo 18. Photo 21 shows slight settlement which has occurred over the gas line in this area. Photo 19 shows a concrete lined swale running along the toe, which intercepts storm water and carries it to a culvert running under the adjacent railroad embankment (Photo 20). Photos 21 to 24 show the surface treatment and condition of both the upstream and downstream slopes are similar to the east dike, except for the west end, where soil material for use at the landfill has been stockpiled on the upstream side of the embankment (Photo 25).

Downstream slope of ATB south dike looking west.

White markers indicate the location of a high pressure gas line installed in 2005.

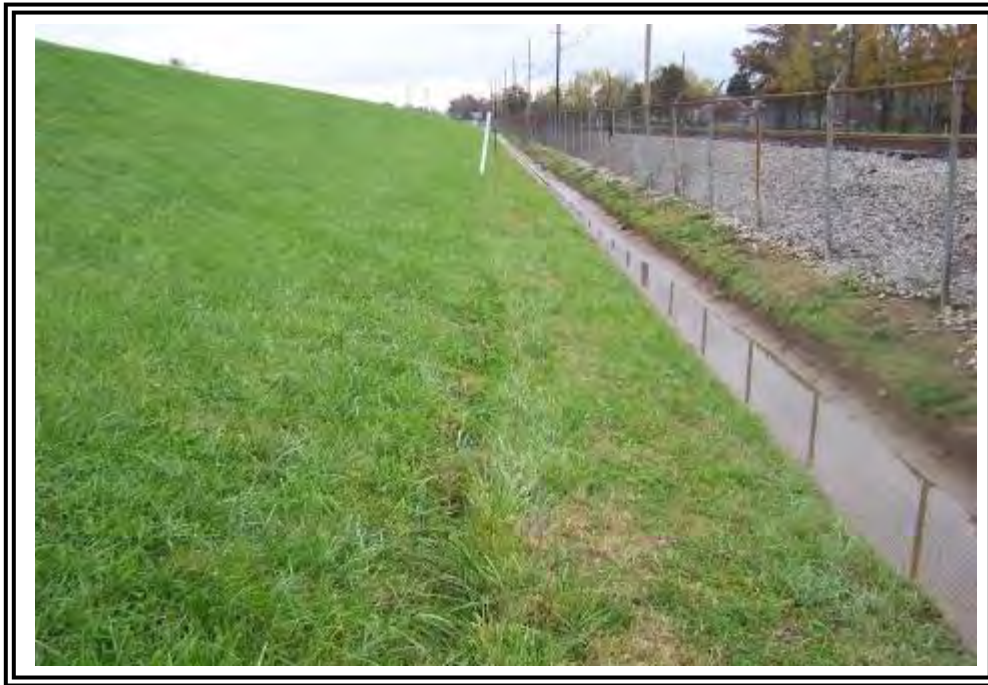
21

Downstream slope of ATB south dike looking east. White marker indicates locations of gas line. Slight depression appears to be over the pipe alignment along the south dike.

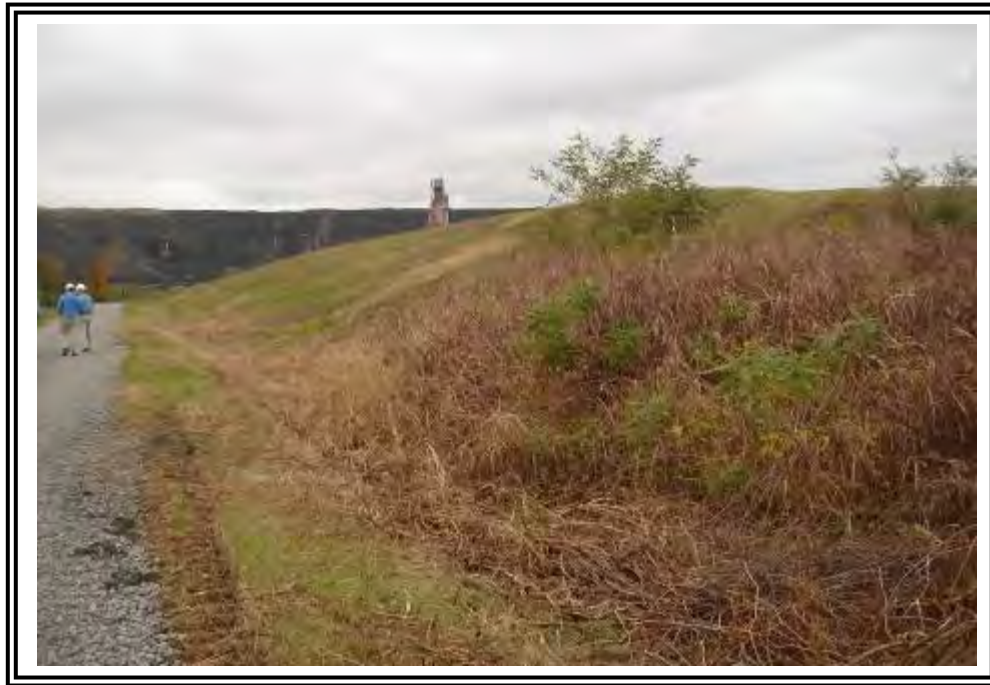
25

Stockpiled material for use at the landfill adjacent to ATB south dike looking west.

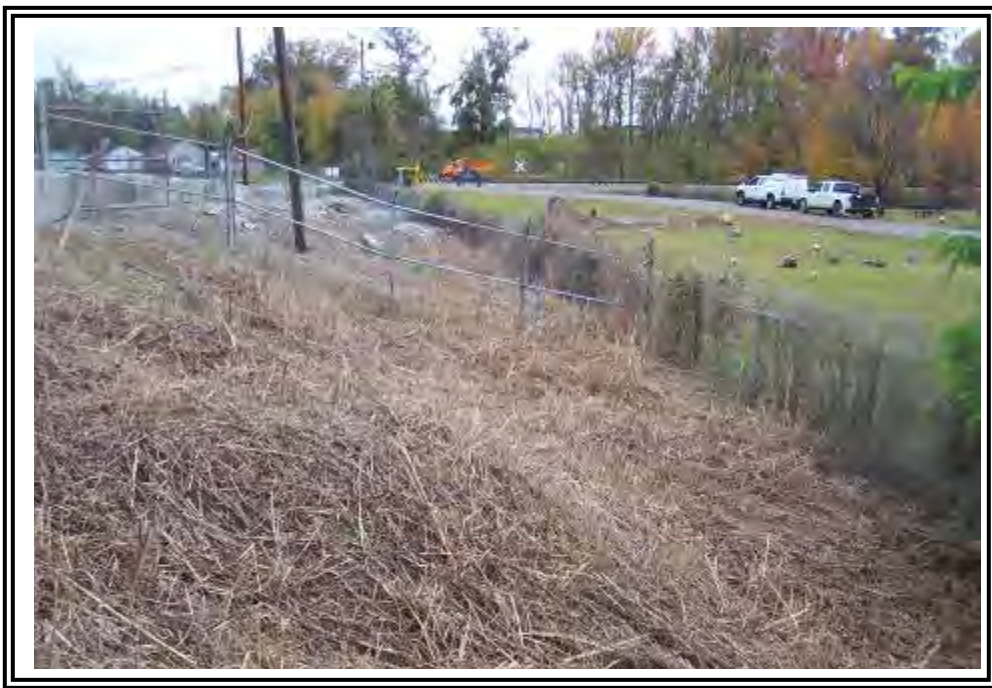
28

The ATB south dike continues along the E-Pond. The downstream embankment of the western 420 feet of the south dike, as shown in Photos 26 through 30, becomes over-steepened and irregular, and vegetation appears predominantly weedy. Surface probing indicated soft conditions, with up to 18" of penetration observed. A concrete barrier runs between the crest and the downstream face. Photo 29 shows several erosion rills which have developed under this barrier. Photo 31 shows the E-Pond which was excavated within previously deposited ash slightly to the northeast of the E-Pond location indicated on a 1972 proposed site plan. Storm

Downstream slope of west end of ATB south dike looking east. Note weedy vegetation and irregular grading.

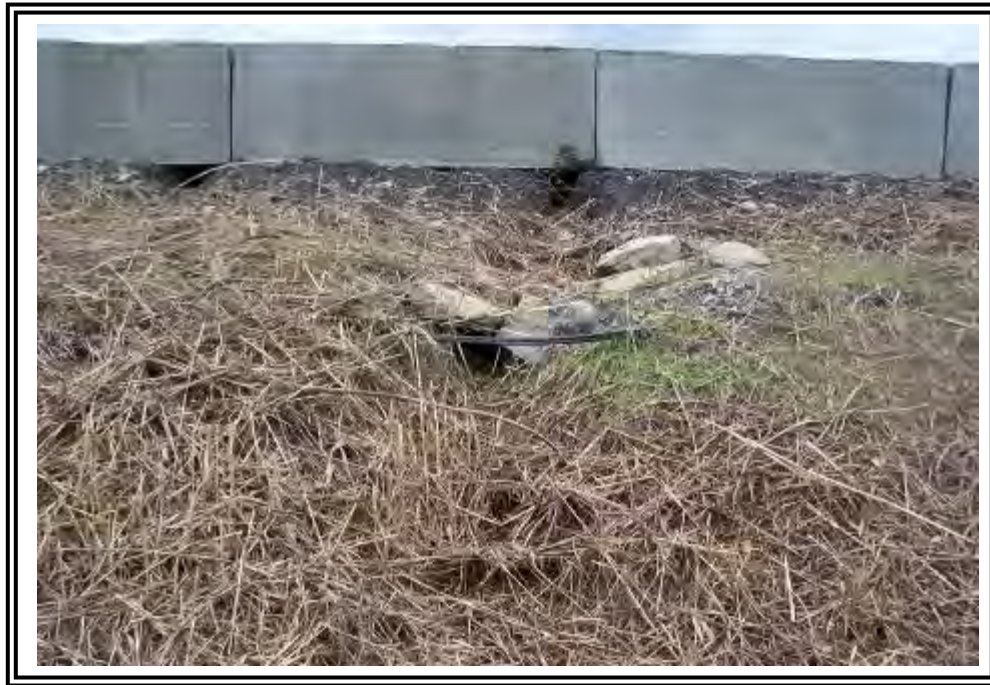
29

Erosion rills under concrete barriers at crest of south dike adjacent to the E-Pond.

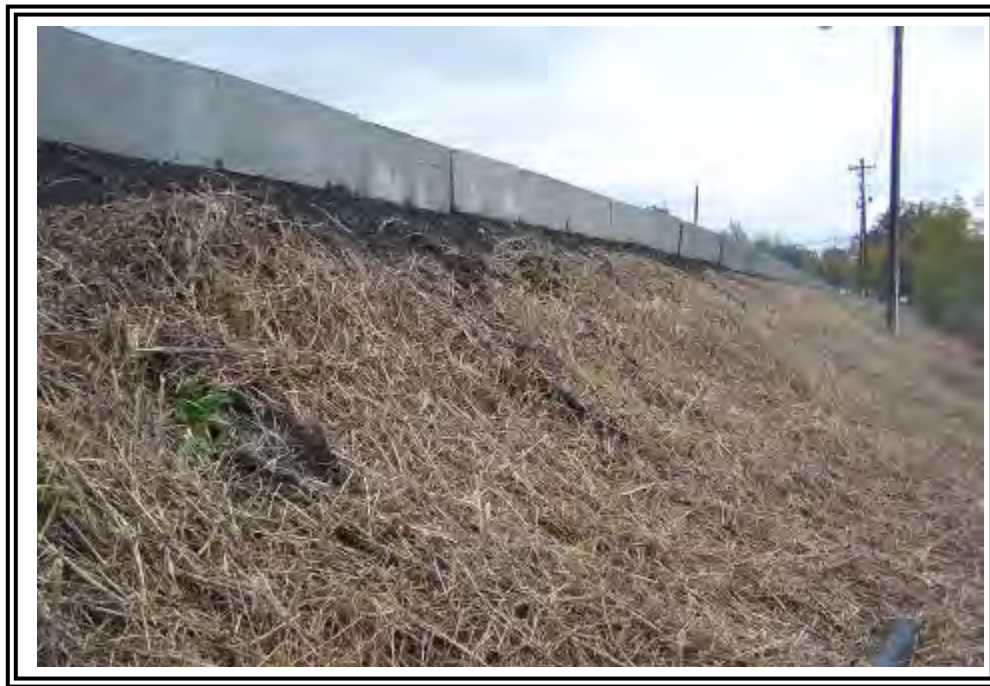
30

South dike of ATB adjacent to the E- Pond is quite steep. A January 2010 survey indicates it is at 2H:1V.

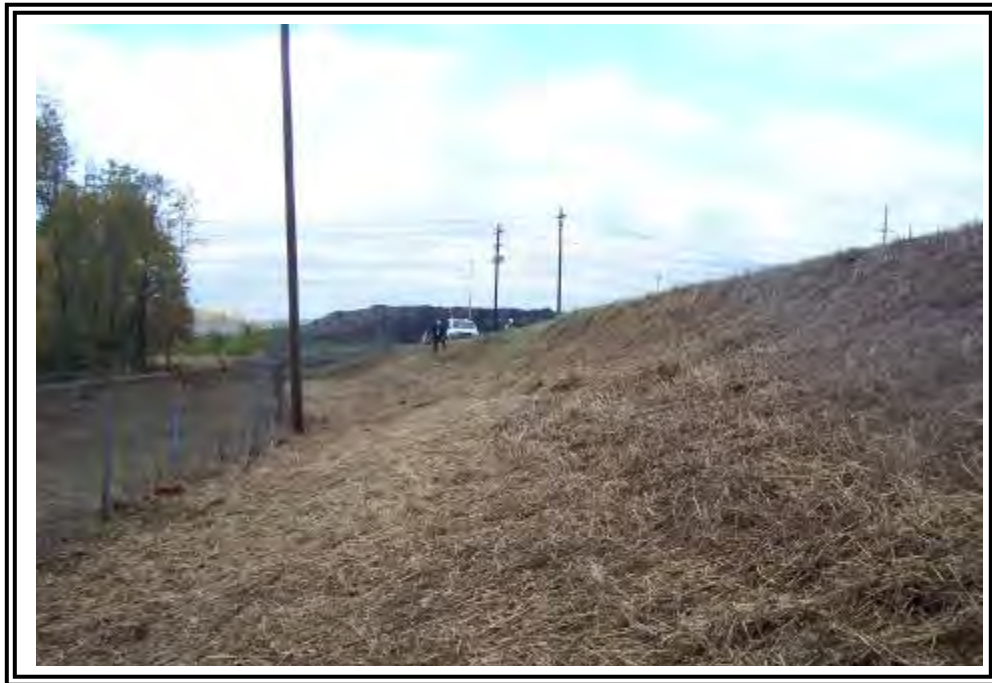
38

Downstream slope of east dike at Basin/ Dead Storage Pond looking south.
Note steepness of the embankment and irregularity of grading. January 2010 survey showed the upper portion of the slope to be 1.7H:1V flattening to 2.8H:1V at the toe.

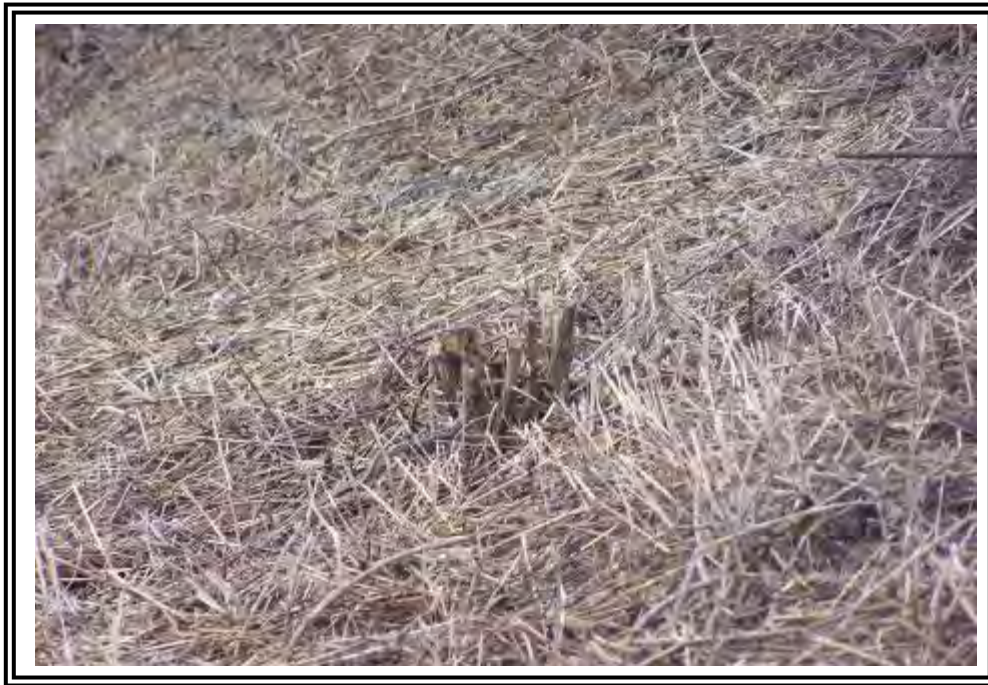
Vegetation is weedy and non-uniform. Photos 35 through 38, and 44 show typical slope conditions along the east dike. Photo 39 and 40 show woody brush and tree stumps on the downstream slope that have been recently cut following an inspection by E.ON U.S.'s independent consultant. Photo 41 shows an erosion rill that has developed on the east dike which is typical of the condition of the east dike. Both downstream and upstream slopes are steep and irregular as shown in Photo 42, 43, and 44. Photo 42 shows a depression that was observed near the toe at the corner between the east and north dikes. The crest road surface is crushed gravel, and water ponds in areas (Photo 45) due to wind-rowing of gravel along the edges from routine access road repair and maintenance.

Example of woody brush recently cut following LG&E's consultant's independent inspection.

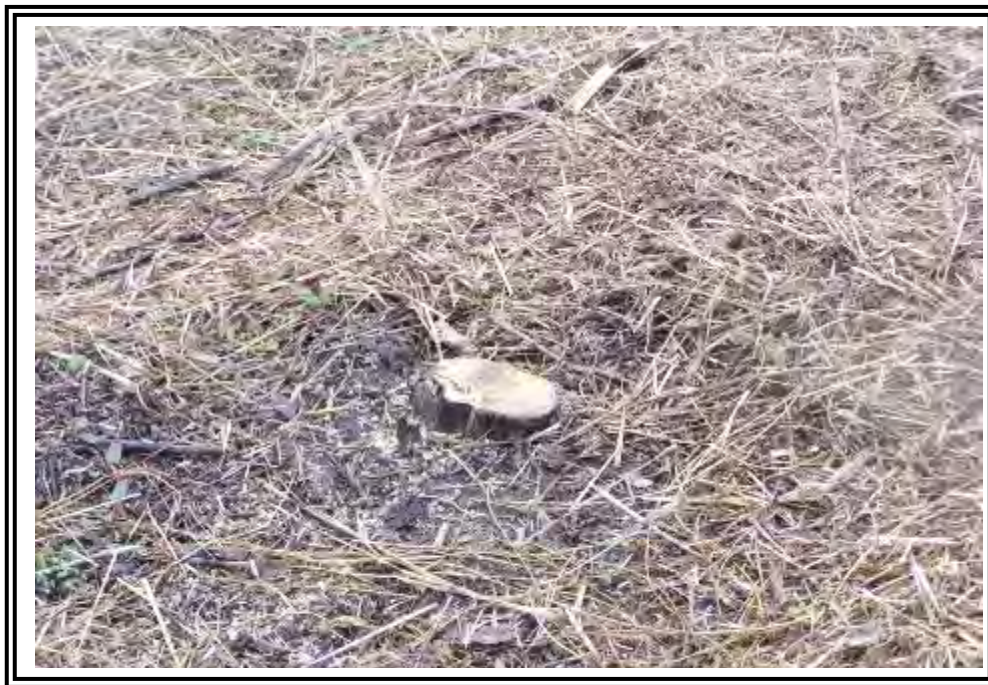
40

Example of cut, stump left in place following LG&E's consultant's independent inspection.

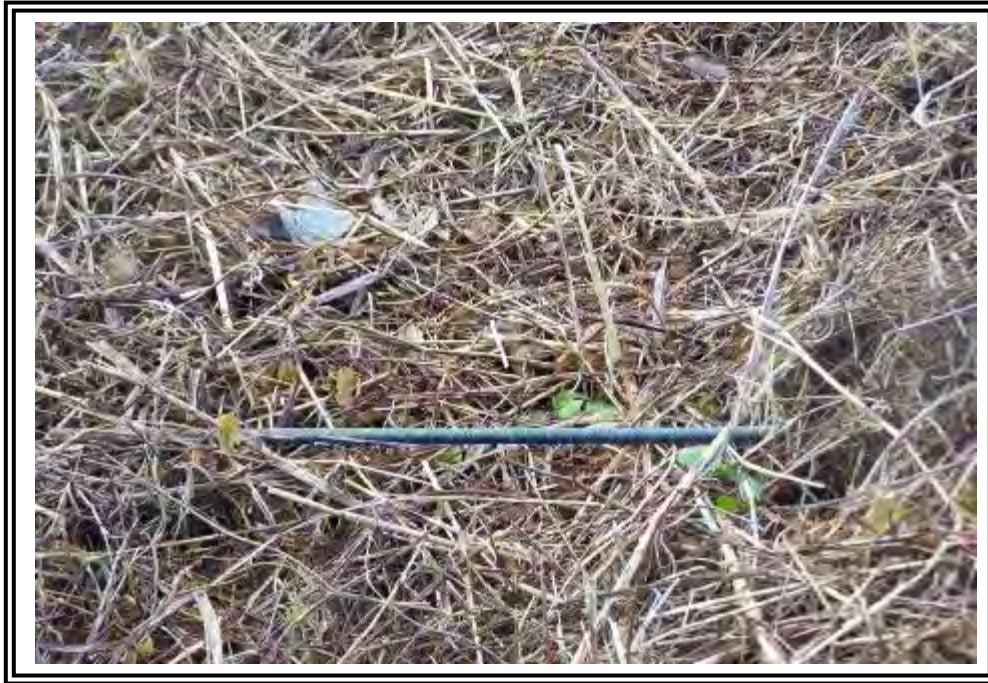
41

Erosion rill about 6 inches deep, 1.5 feet wide on east dike at Basin/ Dead Storage Pond.

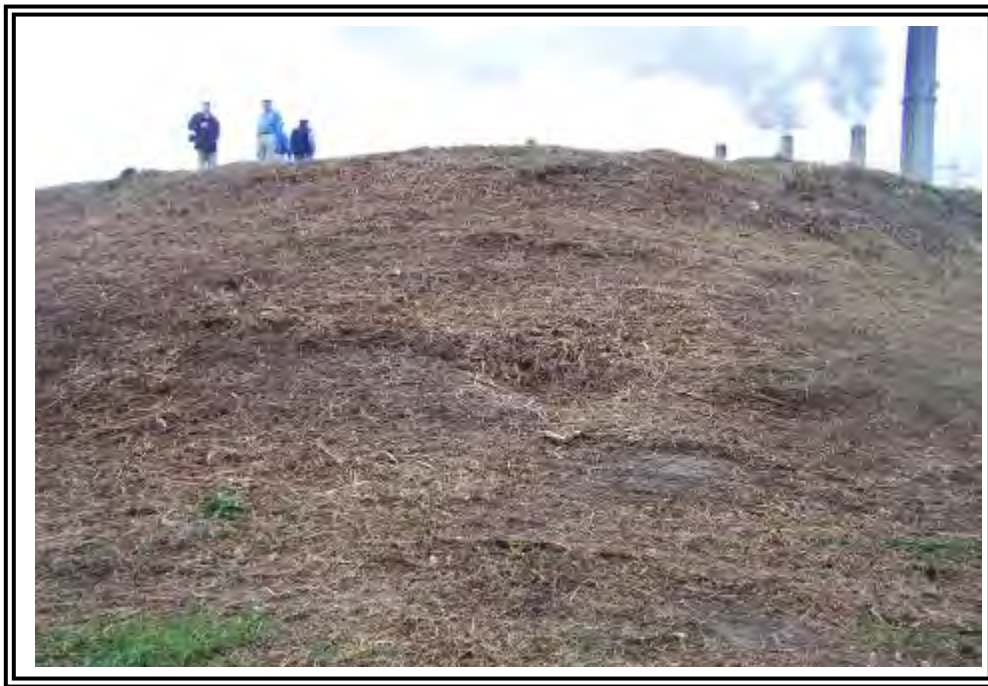
42

Depressions and irregular grading at northeast corner of Basin/ Dead storage pond dike.

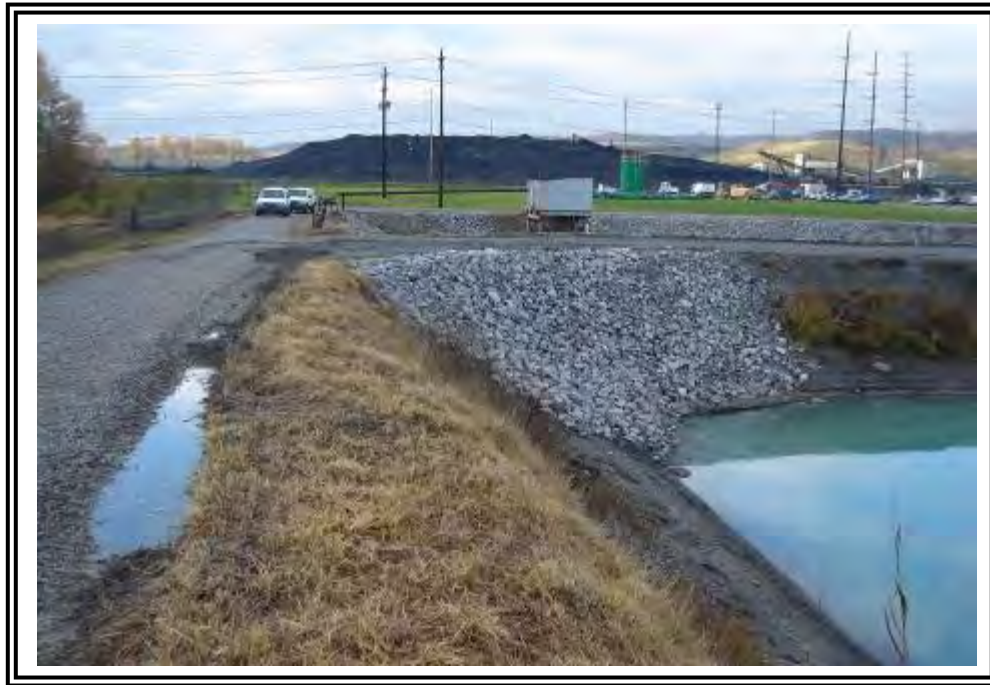
45

Standing water on east dike at Basin/ Dead Storage Pond looking south.

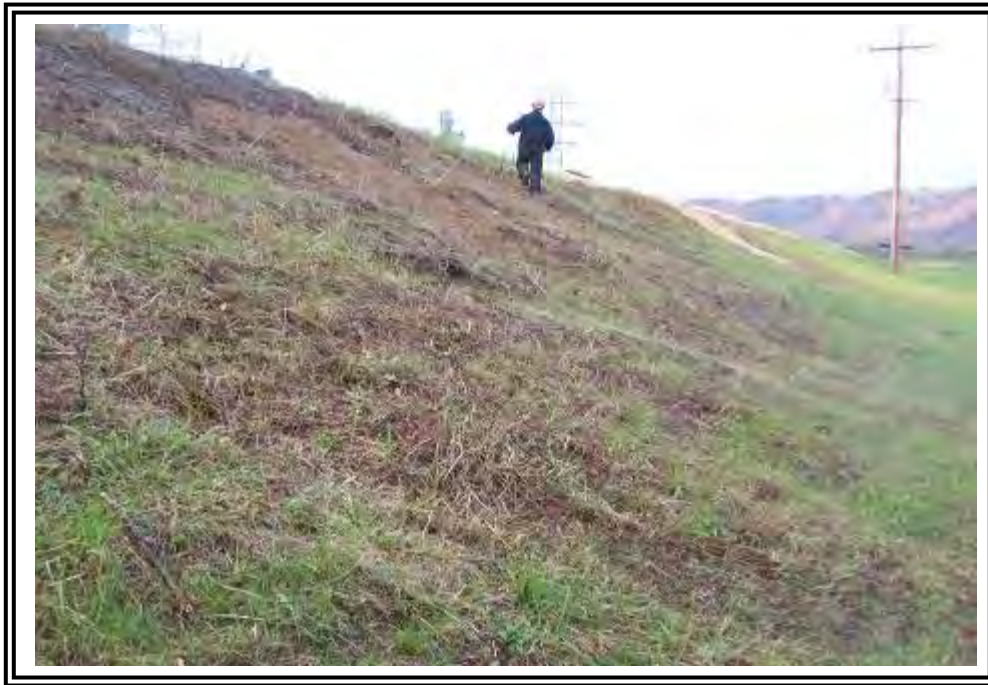
47

Surface irregularities as shown in Photos 46, 47, 50, and 51 are typical along the downstream slope of the north dike, consisting of surface slumps, erosion rills and tire ruts. Surface probing indicated firm soils approximately 9 inches below the surface. Photos 48, 49, 52, 54, and 55 show recent repairs near the north dike crest which have not yet established vegetation. Surface irregularities are also apparent on the upstream slope as shown in Photo 53.

Irregularity on north dike at Basin/ Dead Storage Pond.
Combination of surface slumps, erosion rills, etc. Probes soft to about 9" then firm.

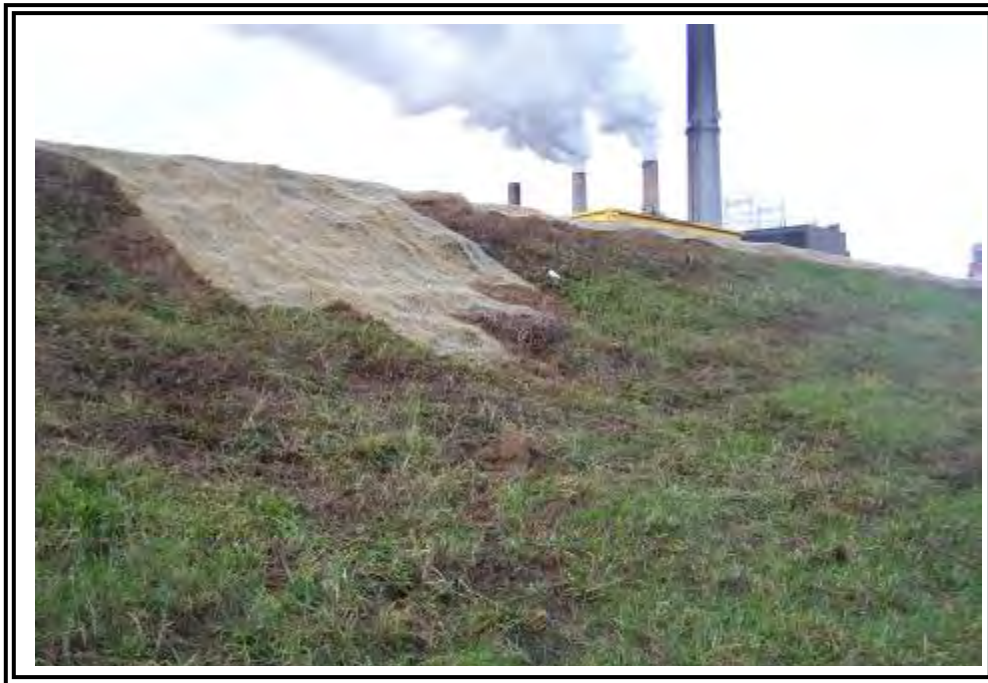
48

Recent patchwork repair along crest of north dike at Basin/ Dead Storage Pond.

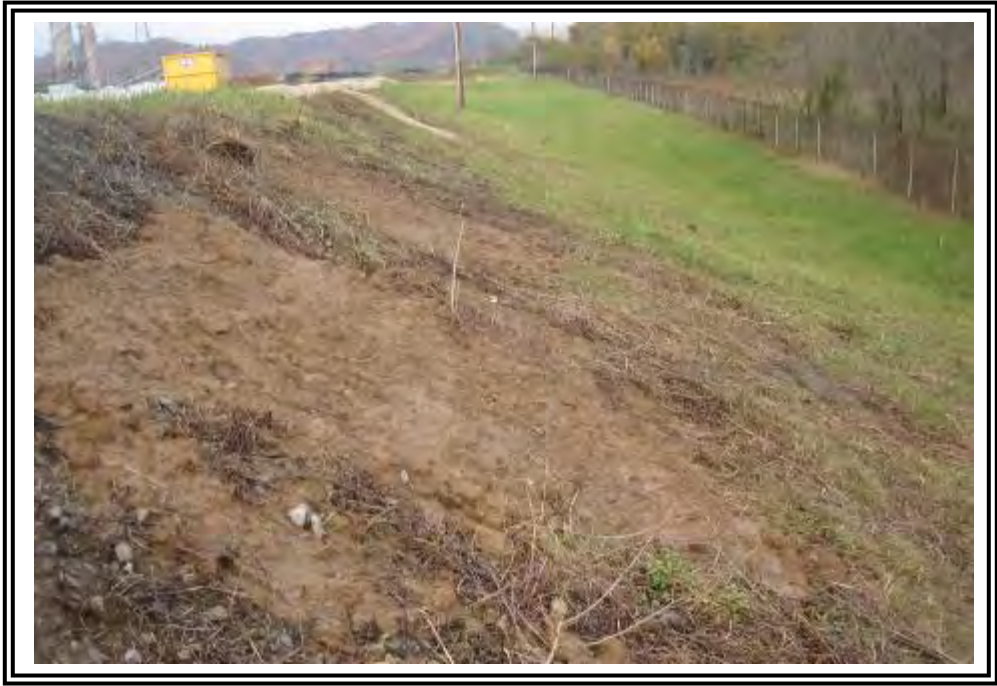
49

Repair area at north dike of Basin/ Dead Storage Pond not yet reseeded.

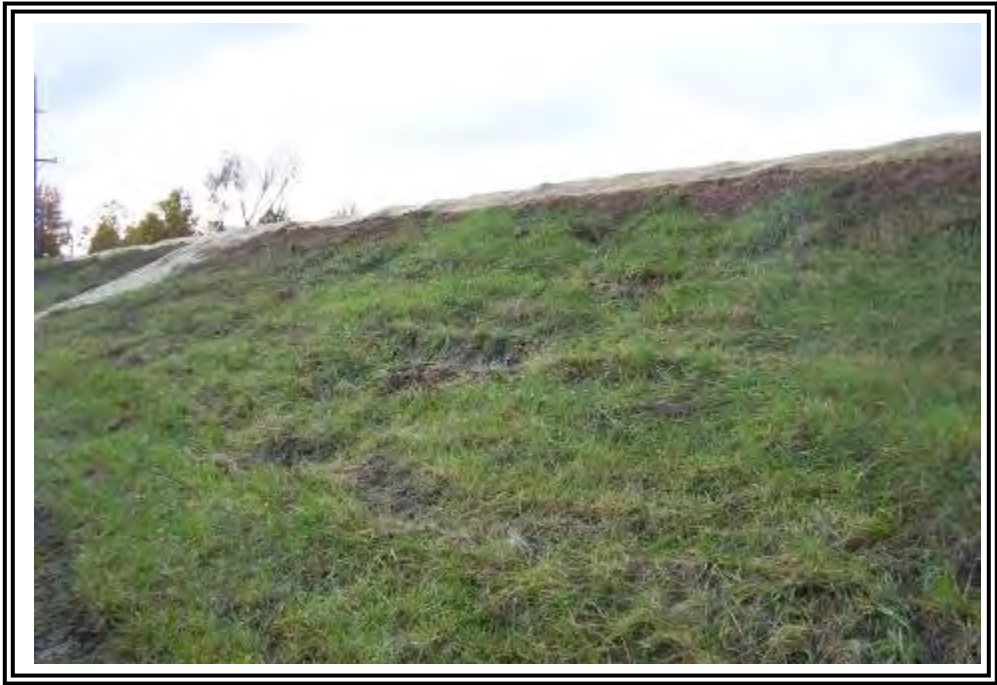
50

Tire ruts in north dike of Basin/ Dead Storage Pond.

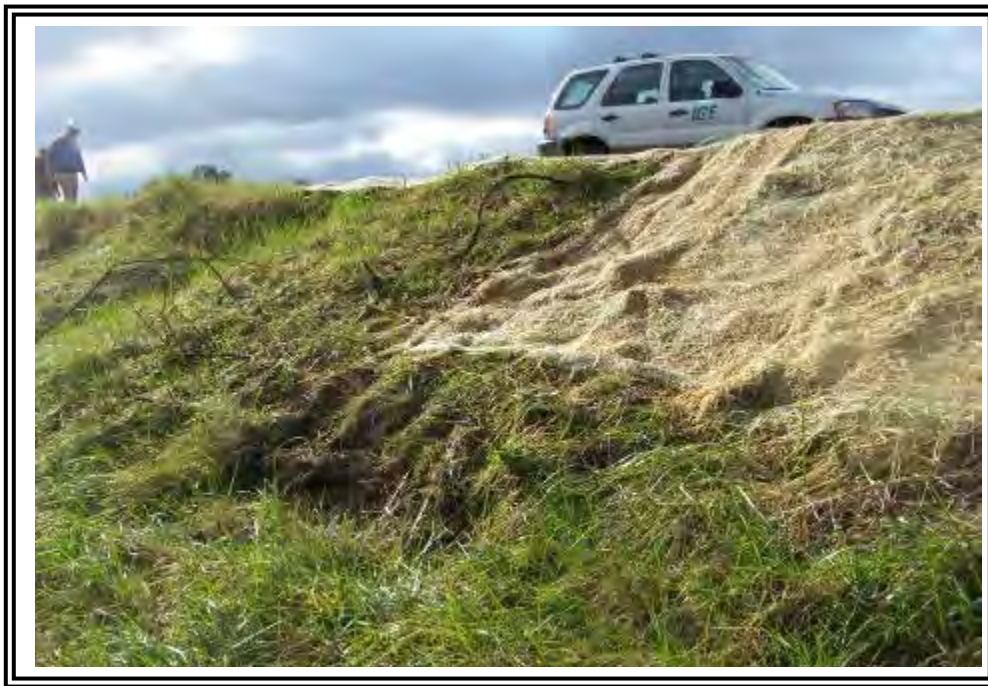
52

Irregularity on north dike at Basin/ Dead Storage Pond.
Combination of surface slumps, erosion rills, etc. Probes soft to about 9" then firm.

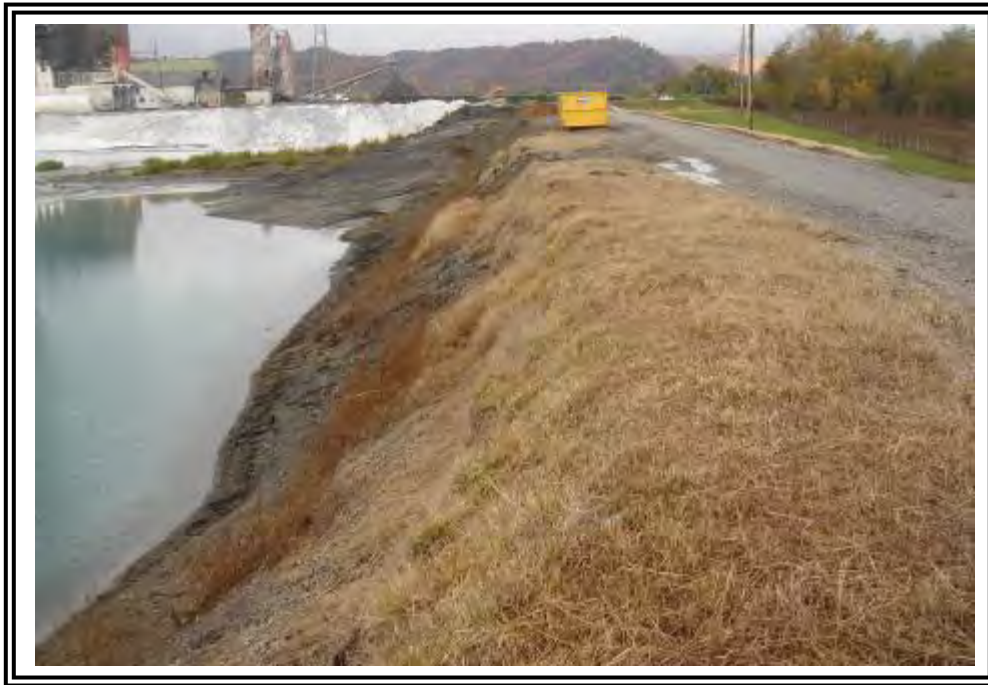
53

Upstream slope of north dike at Basin/ Dead Storage Pond looking west.

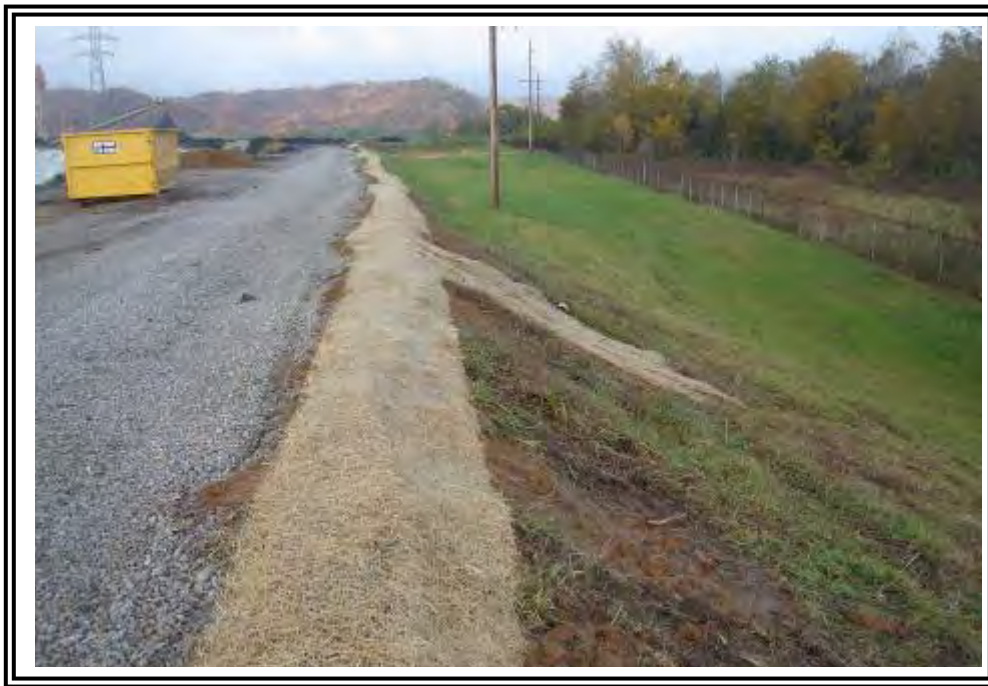
54

Recent regrading along crest of north dike of Basin/ Dead Storage Pond to improve stormwater control.
