Assessment of Dam Safety Coal Combustion Surface Impoundments (Task 3) Final Report

Louisville Gas &
Electric Company
(A subsidiary of E.ON U.S.)

Cane Run Power Station
Louisville, Kentucky

April 16, 2010

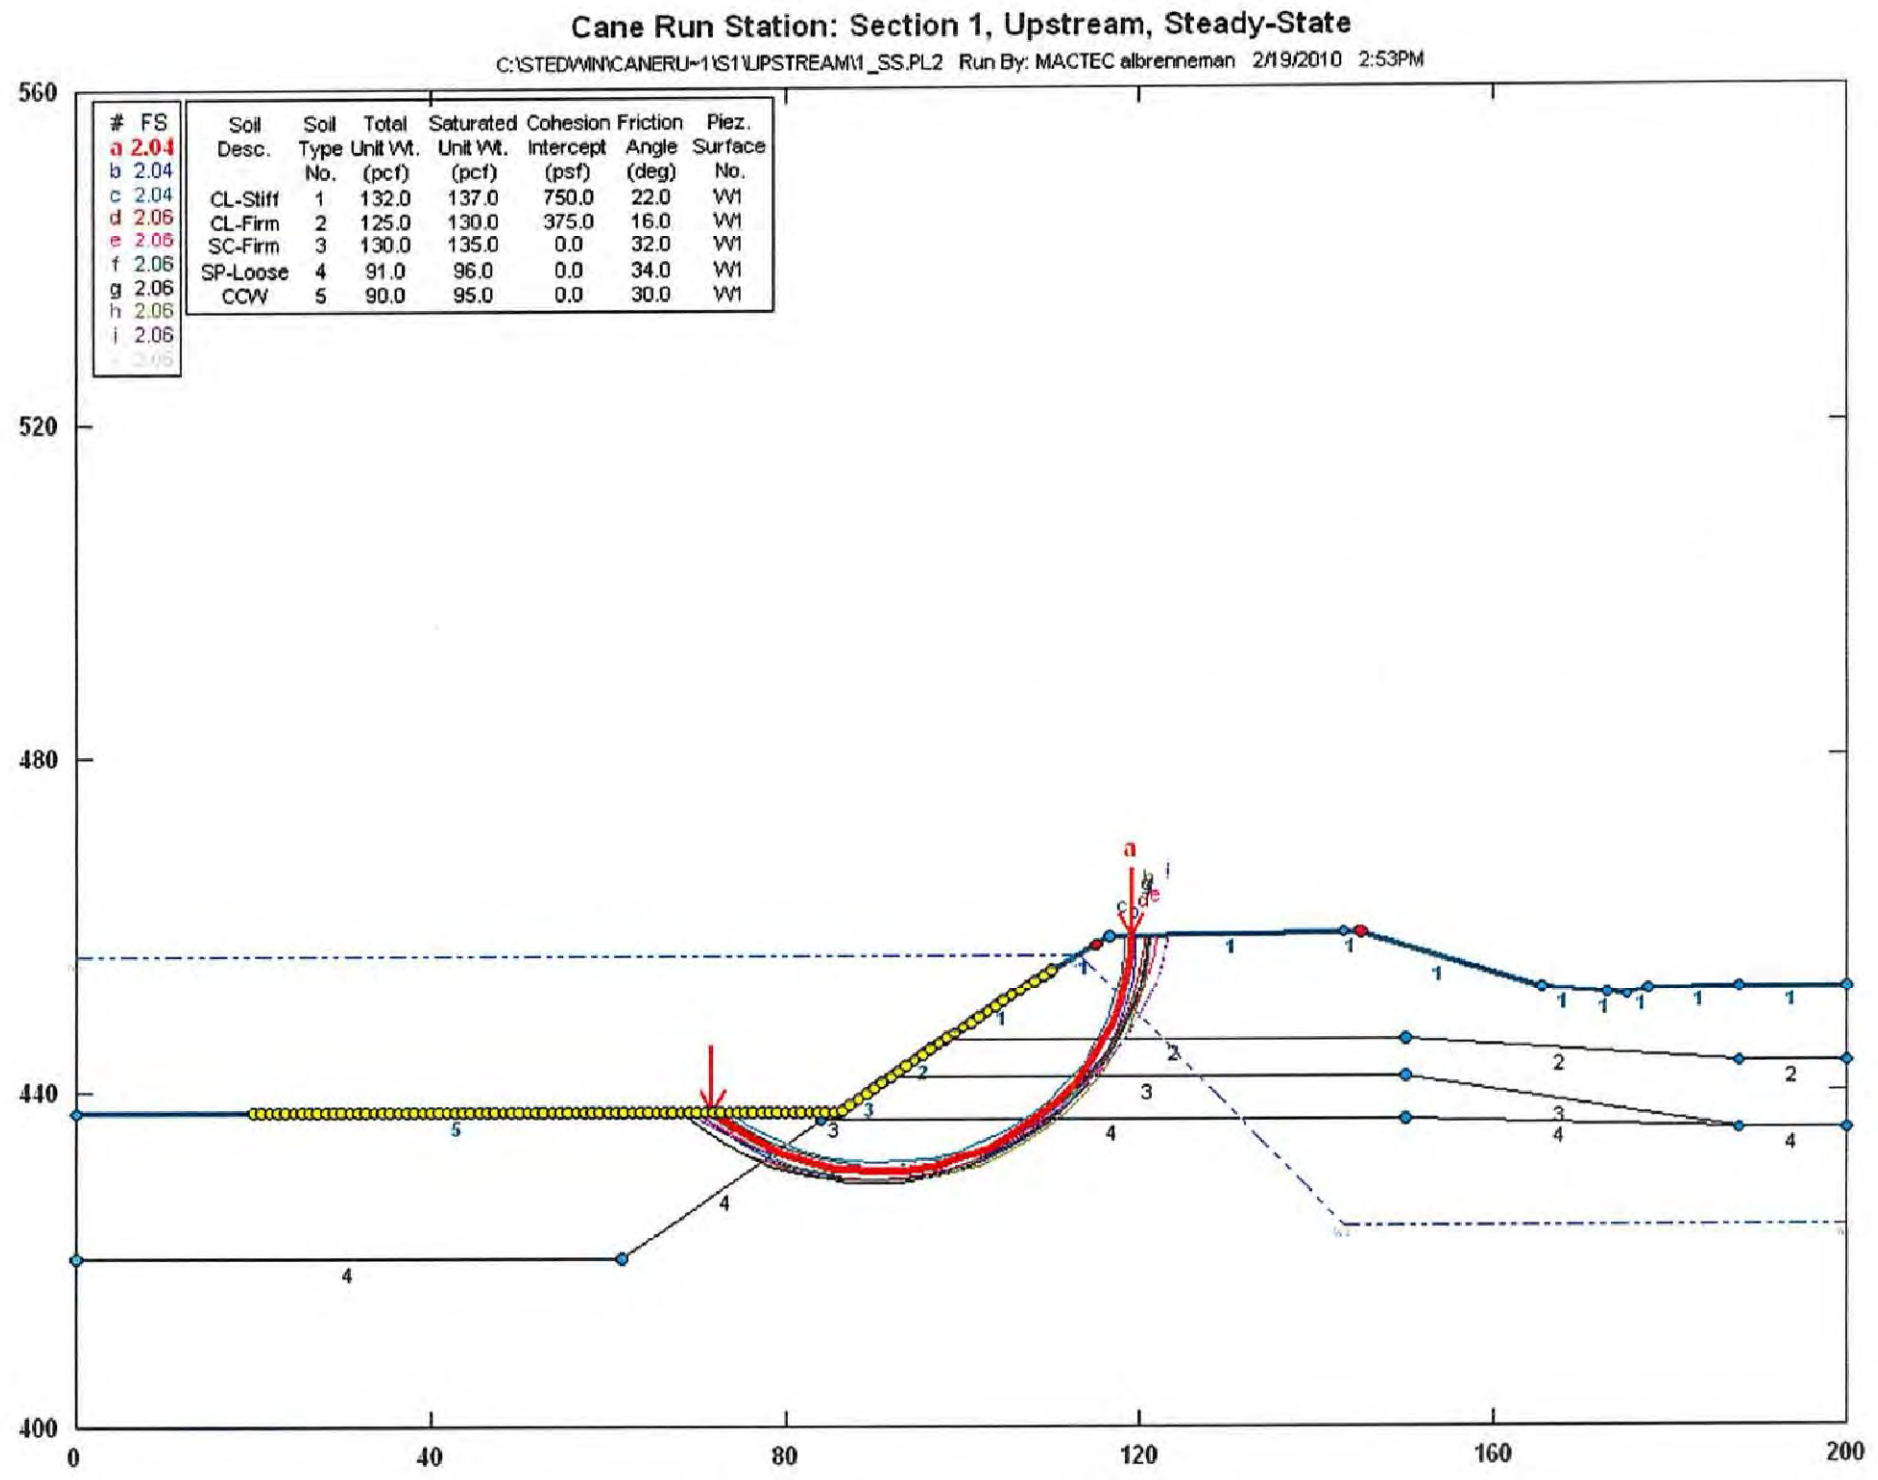
All analyses shown in this table show the ATB dike is stable under the required and recommended loading conditions. MACTEC noted in their Executive Summary that at Section 1, the upstream, rapid drawdown condition factor of safety was only 1.21 (the Table presents this factor of safety as 1.3). They note that this is in the area with the least deposited ash (near the discharge structure), and that if ash were to be dredged from this area, the loss of buttressing from the deposited ash would likely result in a factor of safety below the required value. MACTEC indicates that in their final report a critical ash elevation will be established to maintain adequate factors of safety under all loading conditions.

STABL6H FSmin=2.04
Safety Factors Are Calculated By The Modified Bishop Method
