Assessment of Dam Safety Coal Combustion Surface Impoundments (Task 3) Final Report

Kentucky Utilities

Ghent Generating Station

February 25, 2010

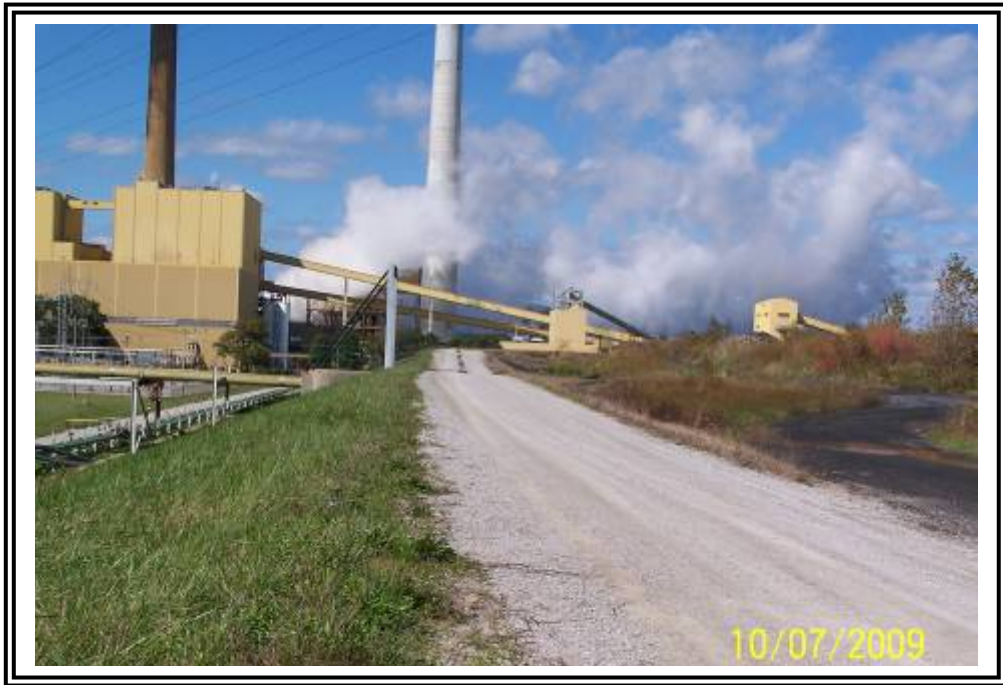
1

Crest of west dike ATB #1 looking north, "bumpiness" from buried sluice pipe crossing.

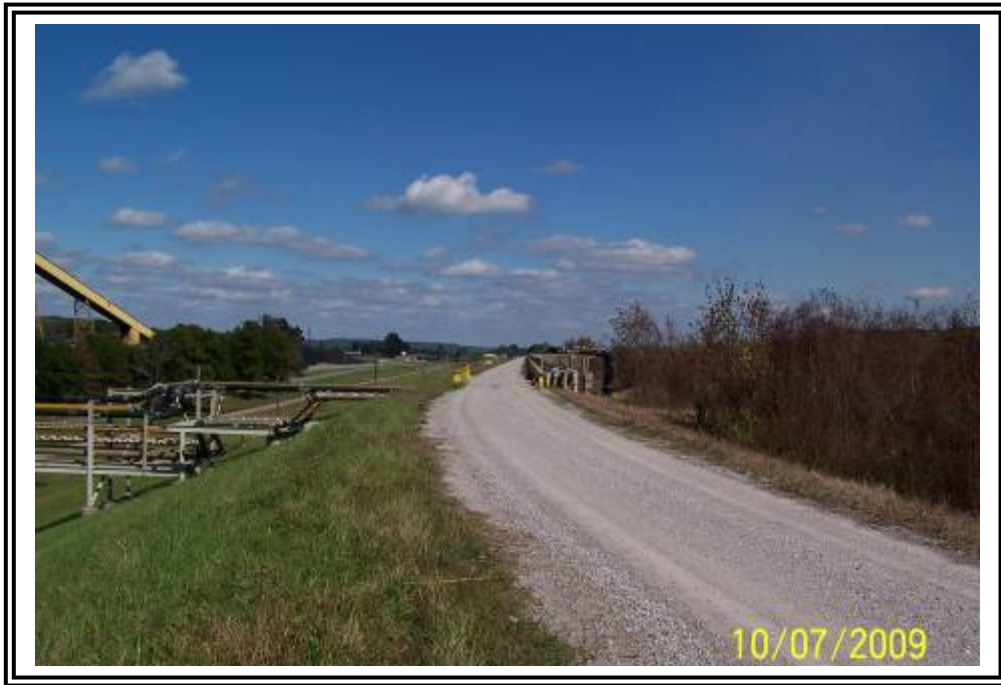
11

Crest of ATB #1 north dike looking east. Note trees are growing in deposited ash.

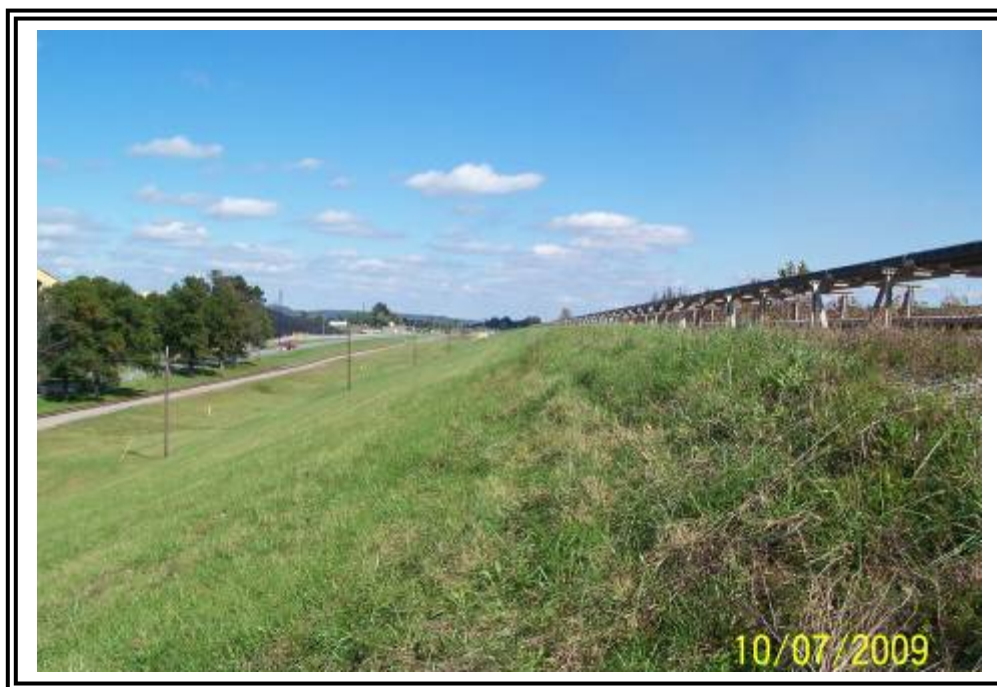
13

Downstream slope of ATB #1 north dike. Note over steepening adjacent to crest, looking east.

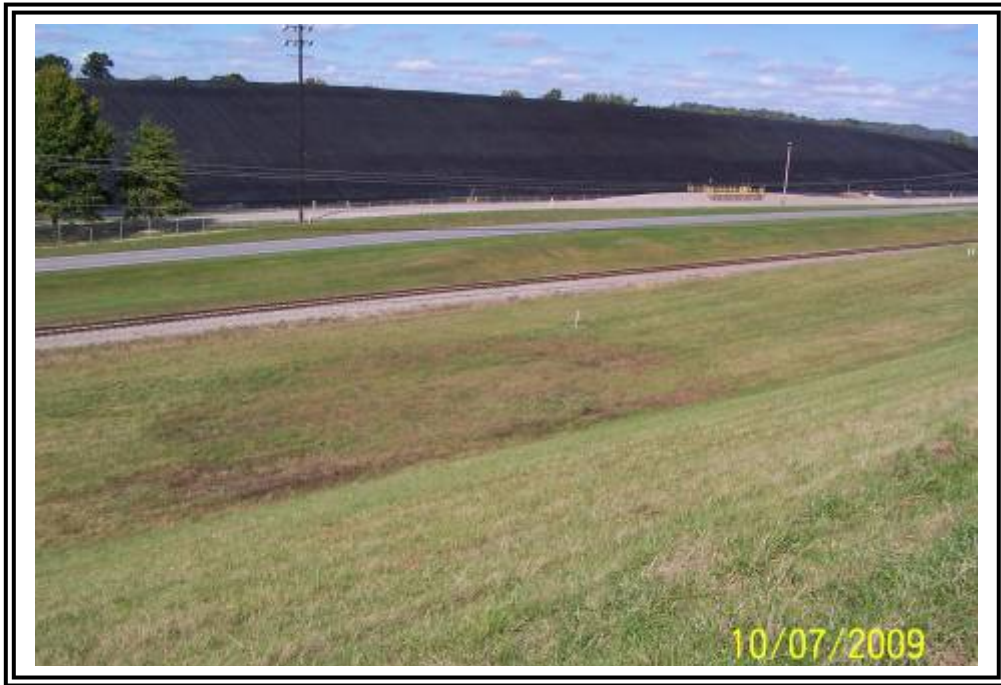
15

Area at mid point of ATB #1 north dike toe appeared wet. Area firm when probed, Kentucky Utilities indicated area may be where a water line burst and was repaired.

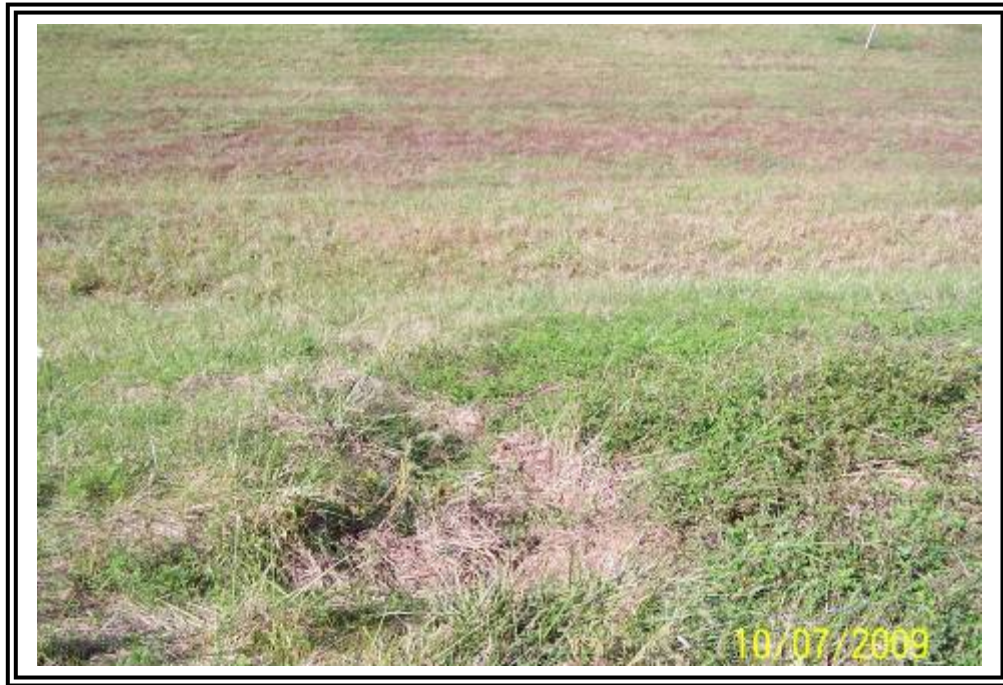
17

At the northeast corner of the embankment there is a bench about halfway down the slope as shown in Photos 16 and 22. A depression was observed in the bench near the northeast corner as shown in Photo 17. Occasional shallow erosion rills were also noted.

Depression in bench near northeast corner of ATB #1 dike.

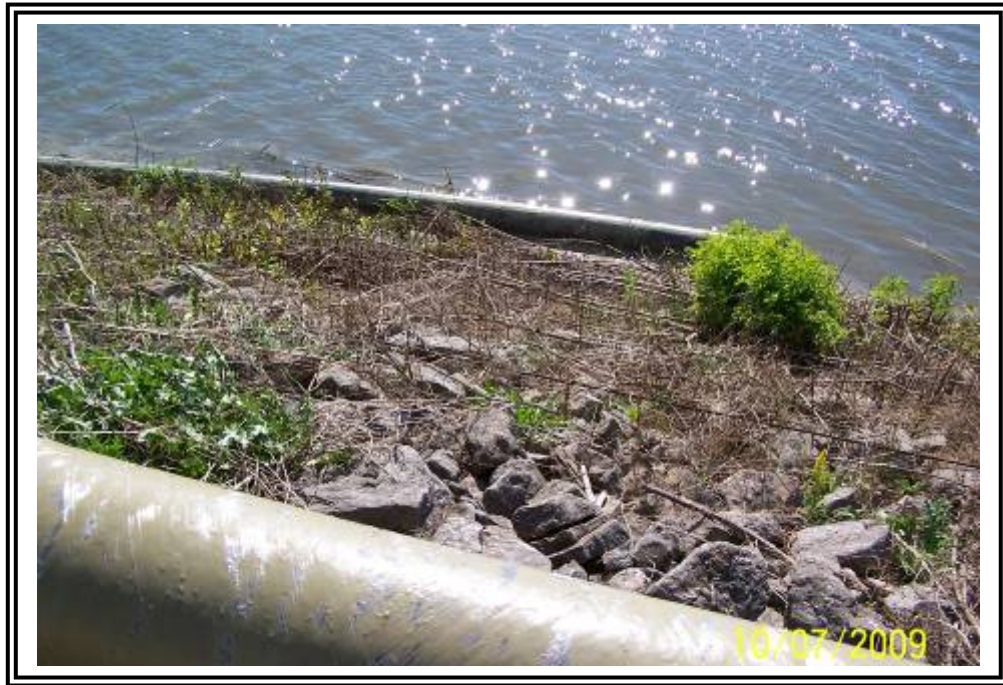
21

Upstream slope of ATB #1 east dike. Rip rap has been placed to fill areas of erosion.

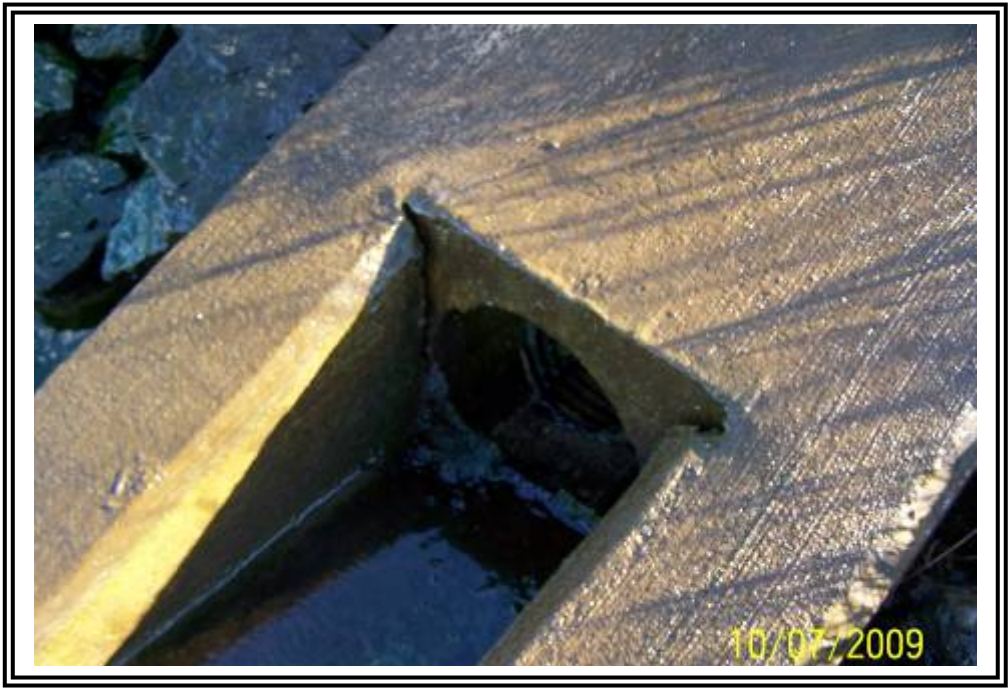
23

Toe drain at northeast corner of ATB #1. No apparent flow, concrete is wet from splash from outlet pipe.

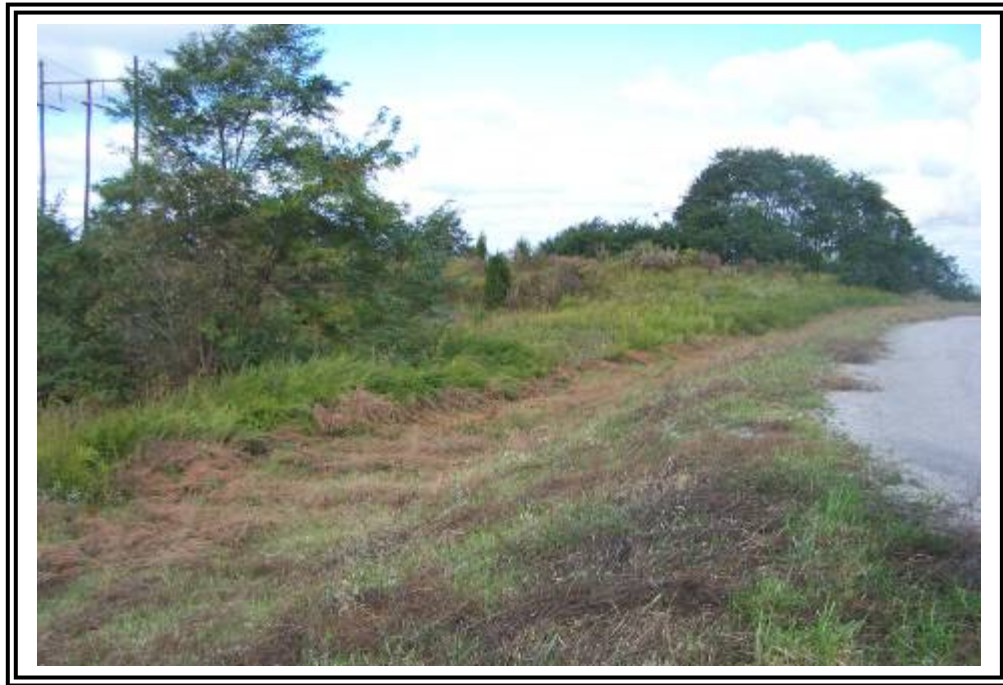
41

Downstream slope west end of dike looking north. Taller grass is on natural ground.

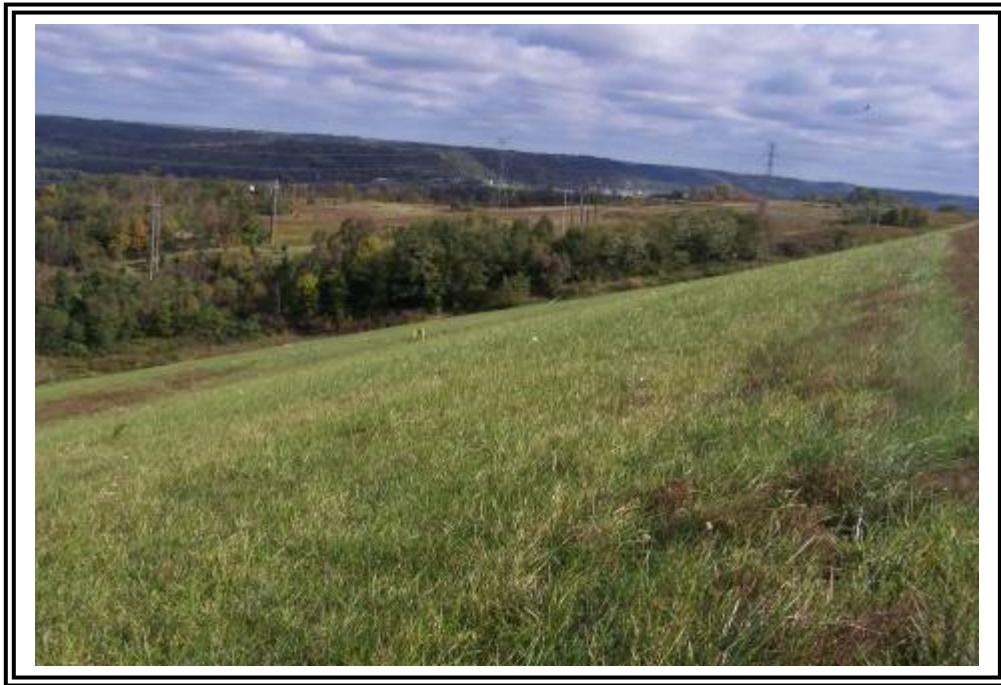
47

Upper portion of downstream slope of ATB #2 looking northeast. Instrumentation marked with yellow bollards, horizontal benched in main section of Dike at 50 vertical foot increments.

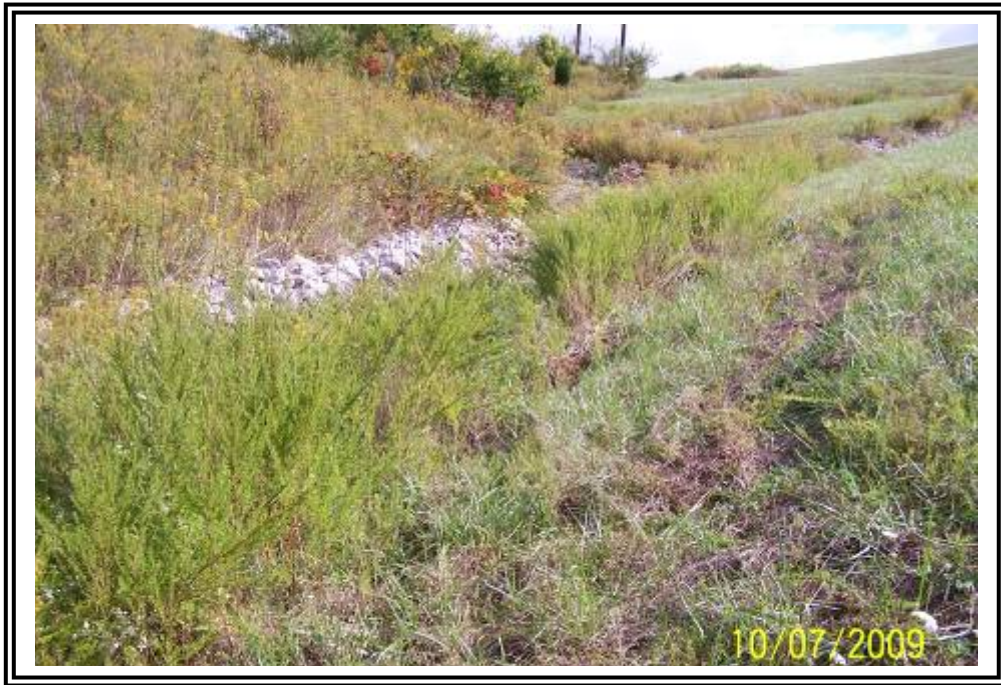
61

and 66. Taller weeds adjacent to drainage swales along the toe and groins along the dam were frequently observed as shown in Photo 61. Standing water was noted on benches as shown in Photos 64 and 72. The soil was firm in these areas indicating that this water is related to poor drainage of stormwater. Photo 70 shows an area of severe erosion on the west side of the main fill of the dam. This area is near the groin swale and was observed during a January 2009 inspection by ATC Associates, Inc. (ATC), and based on a comparison of CHA and ATC photographs appears to have worsened in the subsequent nine months.

Taller weeds along drainage swale at toe.

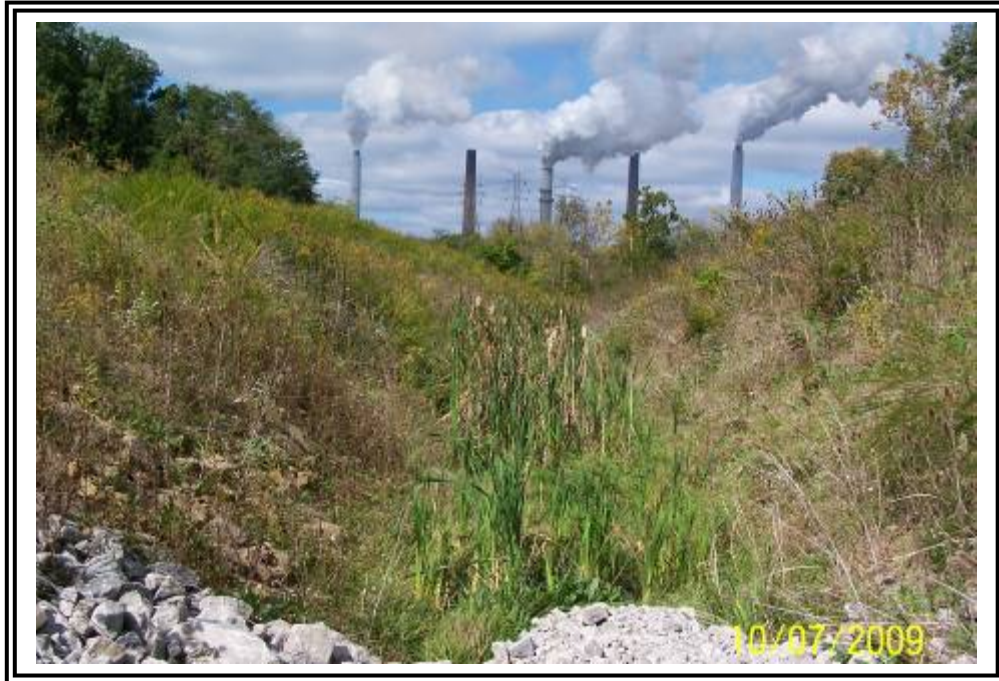
69

Channel below toe of main fill. No discharge, standing water and wetland plants observed likely from seepage/toe drain outlet.

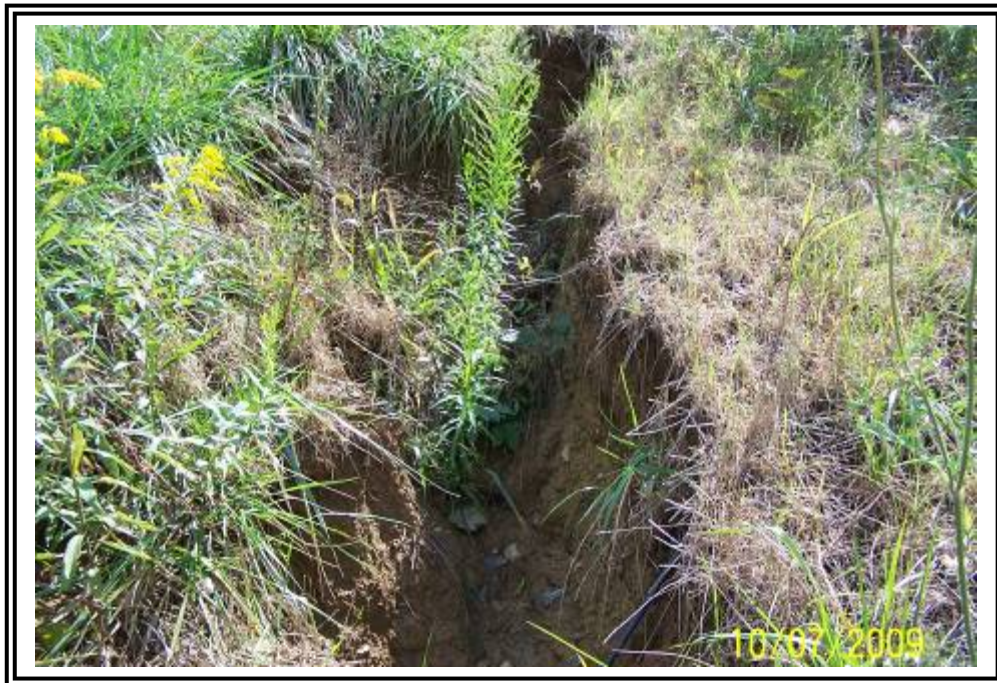
70

Erosion cut gully in west side of main fill about midway up slope from the base. About 2 feet deep.

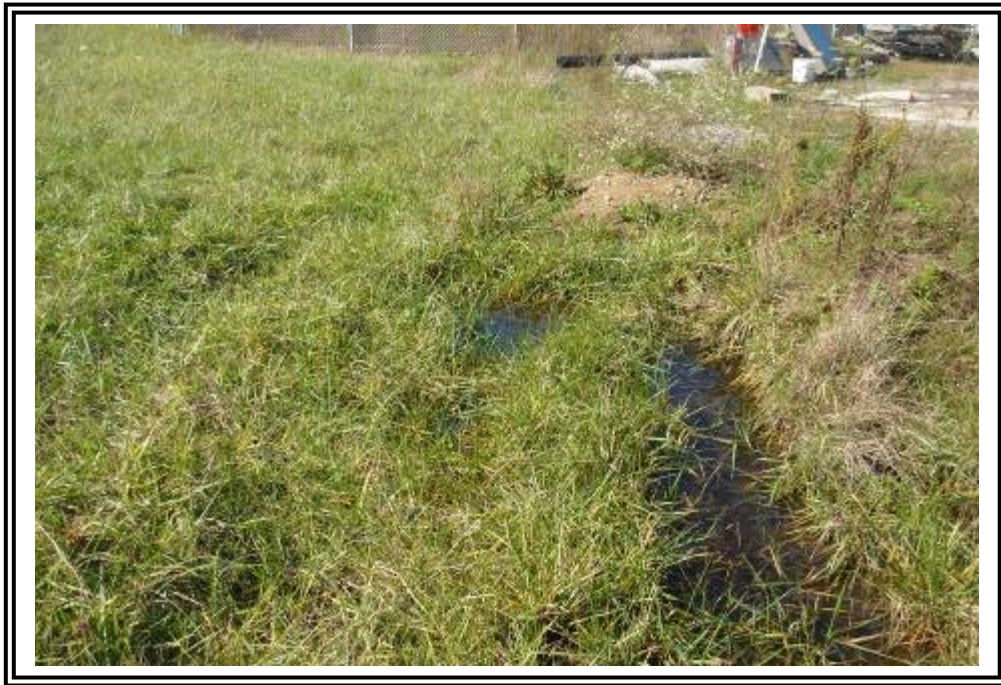
99

Standing water at the toe along the east side of the gypsum stacking facility starter dike.
Ground is firm, appears to be surface water drainage.

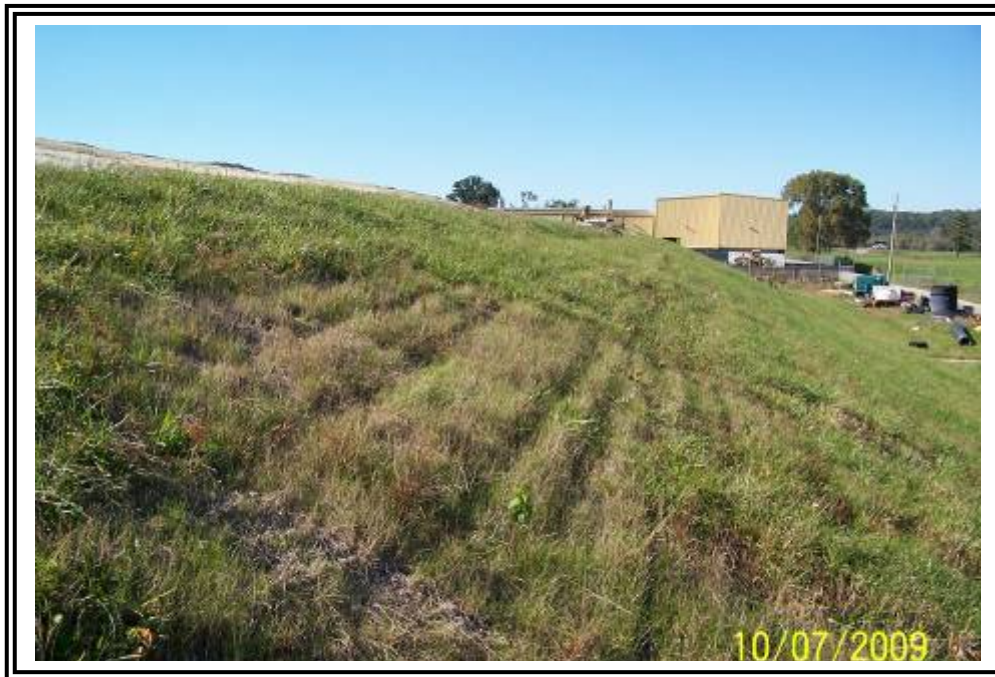
102

Area of repaired surficial slough on the east side of the gypsum stacking facility starter dike. Slough occurred and was repaired in Spring 2009.
