Report of Geotechnical Investigation
Dam Safety Assessment of Coal Combustion
Surface Impoundments
Georgia Power
Plant Scherer, Juliette, GA

AMEC Project No. 3-2106-0174.0200

June 2010

Southern Company, Georgia Power, Plant Scherer: Ash Pond and Settling Pond was assessed on May 12, 2010.

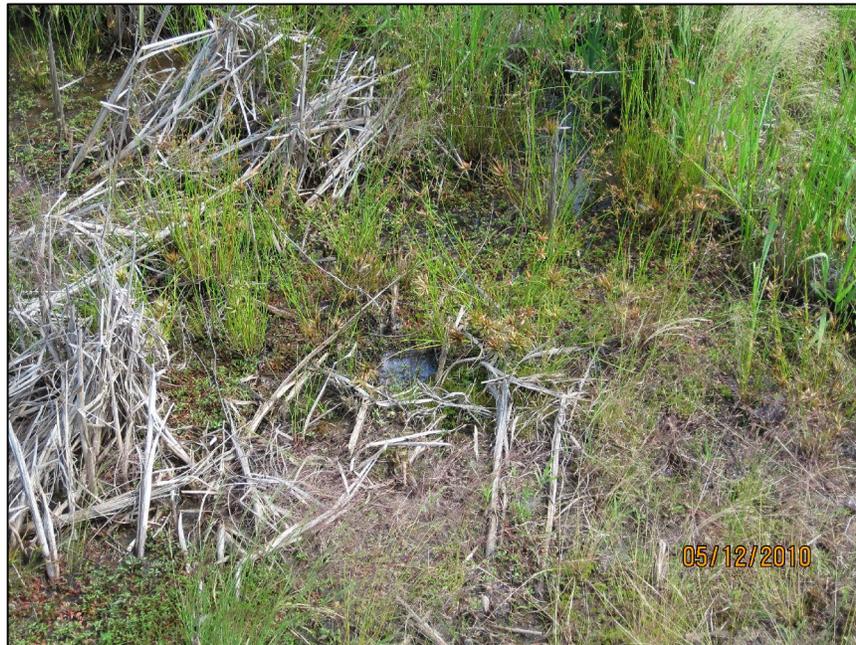
AP-15

DOWNSTREAM TOE OF NORTH DIKE, WET AREA NORTH OF PZ'S AP-6 AND 7

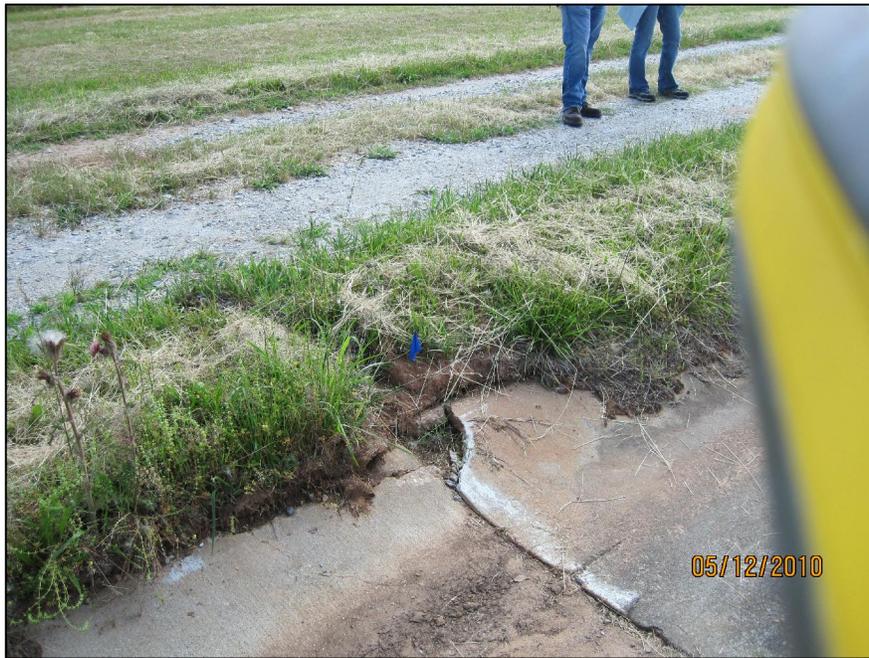
AP-17

DOWNSTREAM TOE OF NORTH DIKE, MINOR EROSION AND BROKEN CONCRETE DITCH

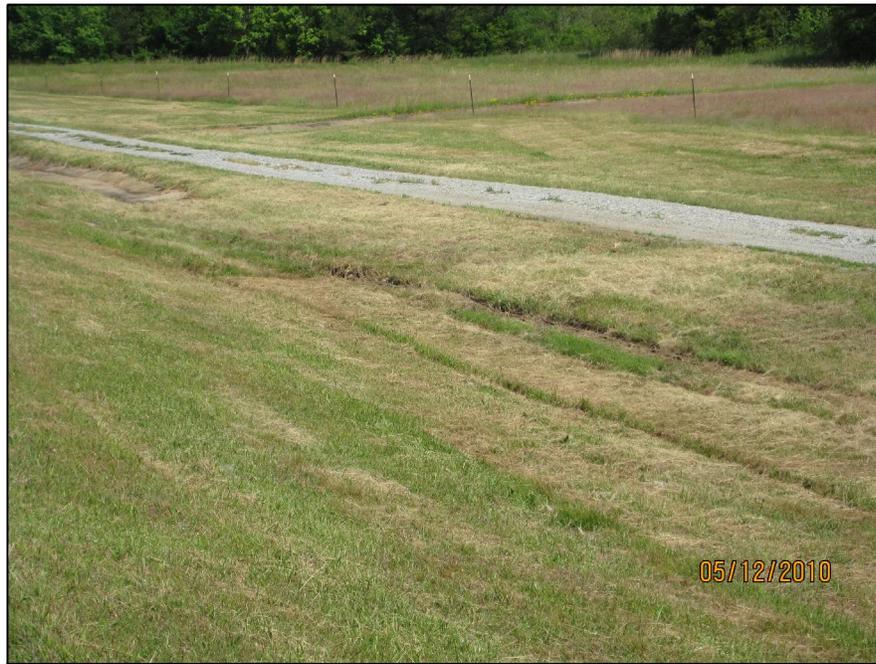
AP-19

No pronounced surface depressions or other deficiencies were noted on the upstream slope or crest of the Ash Pond. At the end of the north dike, a stockpile of emergency supplies was stored (photo AP-14). On the north dike of the embankment, a wet area was observed beyond the downstream slope from PZ's AP-6 and AP-7 (photo AP-15). A concrete ditch was observed at the toe of the downstream slope of the north dike. A broken area of concrete was observed in this ditch (photo AP-16 and AP-17). The outlet of this concrete ditch directed water away from the embankment (photo AP-18). A wet surface area at the toe extending about 125 feet was located beyond the east end of the concrete ditch (photo AP-19).

DOWNSTREAM TOE OF NORTH DIKE, APPROX. 125 FEET LONG WET SURFACE AREA AT EAST END OF CONCRETE DITCH

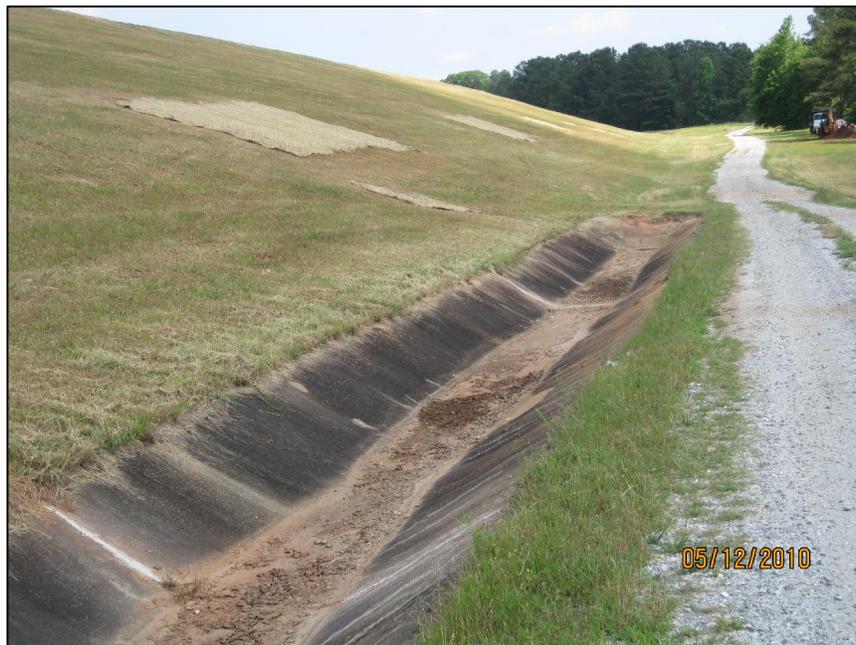
Repaired surficial areas were noted on the downstream embankment of the east dike (photos AP-20 and AP-24). A concrete ditch beginning at the intersection of the north and east dike extended south along the toe of the downstream slope and directed water away from the embankment (photos AP-21 and AP-22). An emergency stockpile of crushed stone and sand was located near this outlet (photo AP-23). The lower bench at the east dike extends the downstream embankment. A gravel access road crosses a middle bench in this area. A concrete ditch on the upstream side of this road is higher at the middle and directs water to each end (photo AP-24 and AP-25). The concrete ditch is piped beneath the road on both ends and extends down along the groin to the east (photo AP-26 and AP-34). On the south side of this groin ditch, water was observed entering and exiting the ditch at a joint (photo AP-27). Near the bottom of the ditch, water is entering from pipes at blanket drain outlets BD-2 and BD-3 (photos AP-28 and AP-30). Likewise, on the north groin ditch, water is entering the ditch at an upper damaged joint and two lower piped outlets from the blanket drain (photos AP-33 and AP-32).. The two ditches combine at the toe into a concrete channel and outlet including a 4-inch diameter pipe and overflow weir (photo AP-31). A dry blanket drain outlet (BD-1) is located in the groin area above the road. Some minor surface scour/erosion was noted in this area(photo AP-35).

AP-24
**LOWER DOWNSTREAM SLOPE OF EAST DIKE, LOOKING NORTH, END OF CONCRETE DITCH ABOVE
 GRAVEL ROAD, REPAIRED AREAS ON DOWNSTREAM SLOPE**

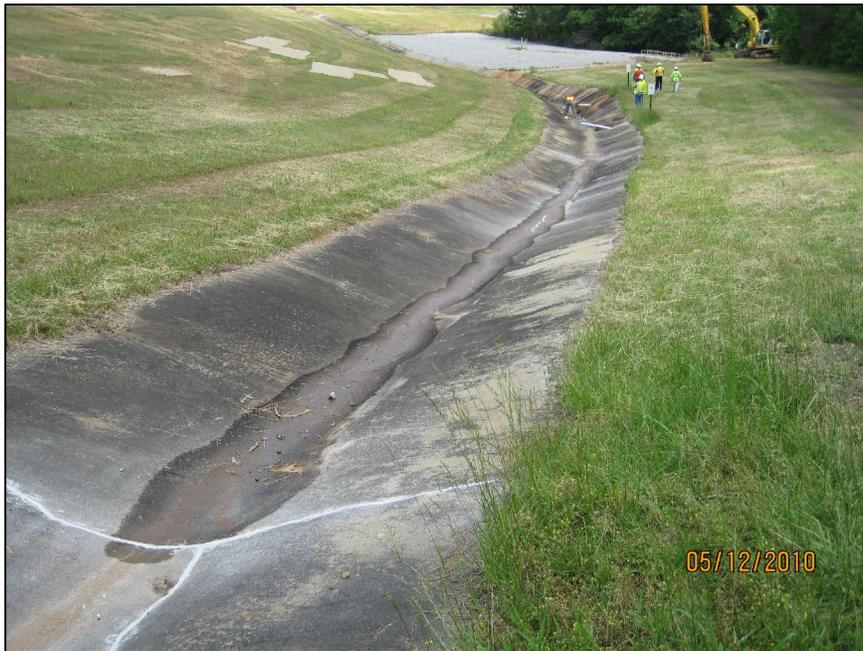
AP-27

DOWNSTREAM SLOPE OF EAST DIKE, LOOKING NORTH, WATER SEEPING INTO AND BACK OUT OF DITCH AT JOINTS

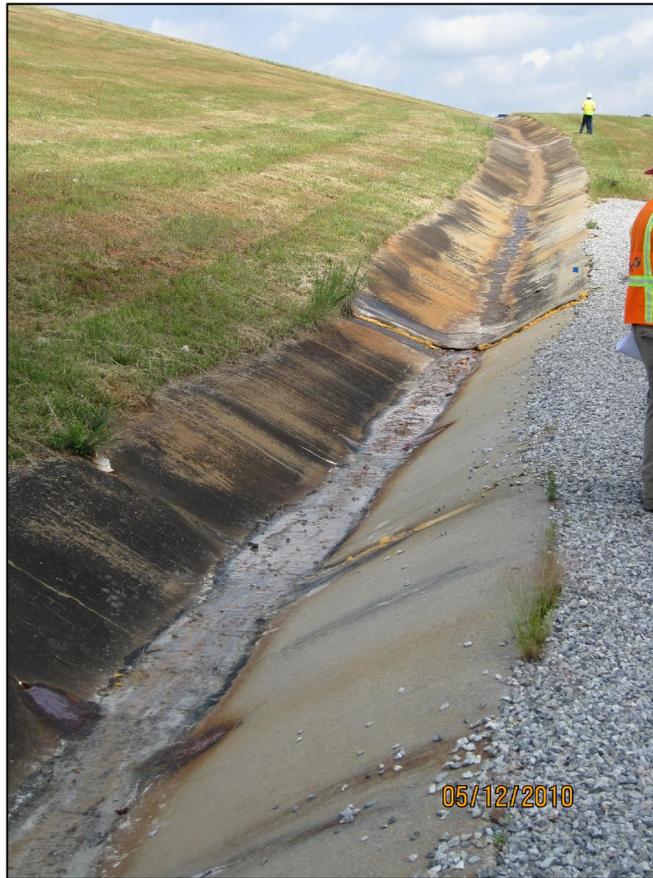
AP-33
 DOWNSTREAM SLOPE OF EAST DIKE, LOOKING NORTH AT WATER SEEPING IN DITCH AND HEAVED JOINT ON NORTH SIDE OF BLANKET DRAIN OUTLET

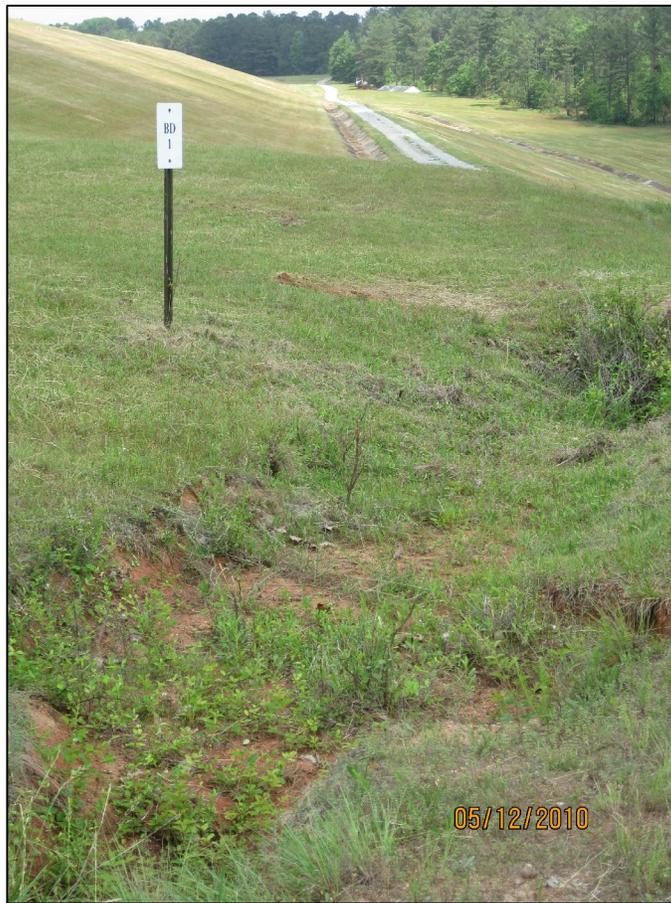
AP-35
 DOWNSTREAM SLOPE OF EAST DIKE, LOOKING NORTHEAST AT BD-1 OUTLET, MINOR
 EROSION ABOVE THIS AREA

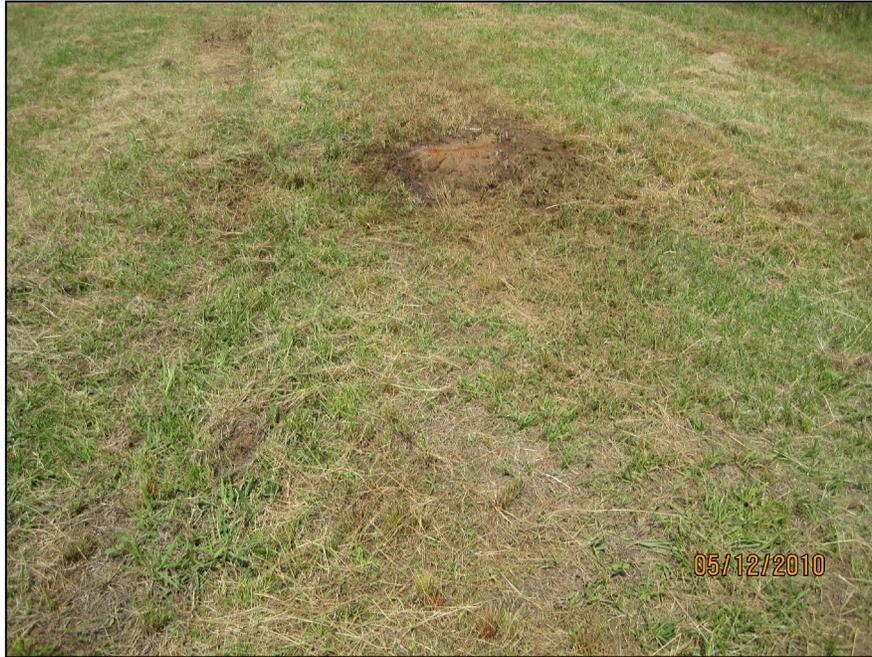
AP-47

TOE OF SOUTH DIKE, LOOKING EAST AT TWO SMALL 8X5 FEET BOILS/SEEPS

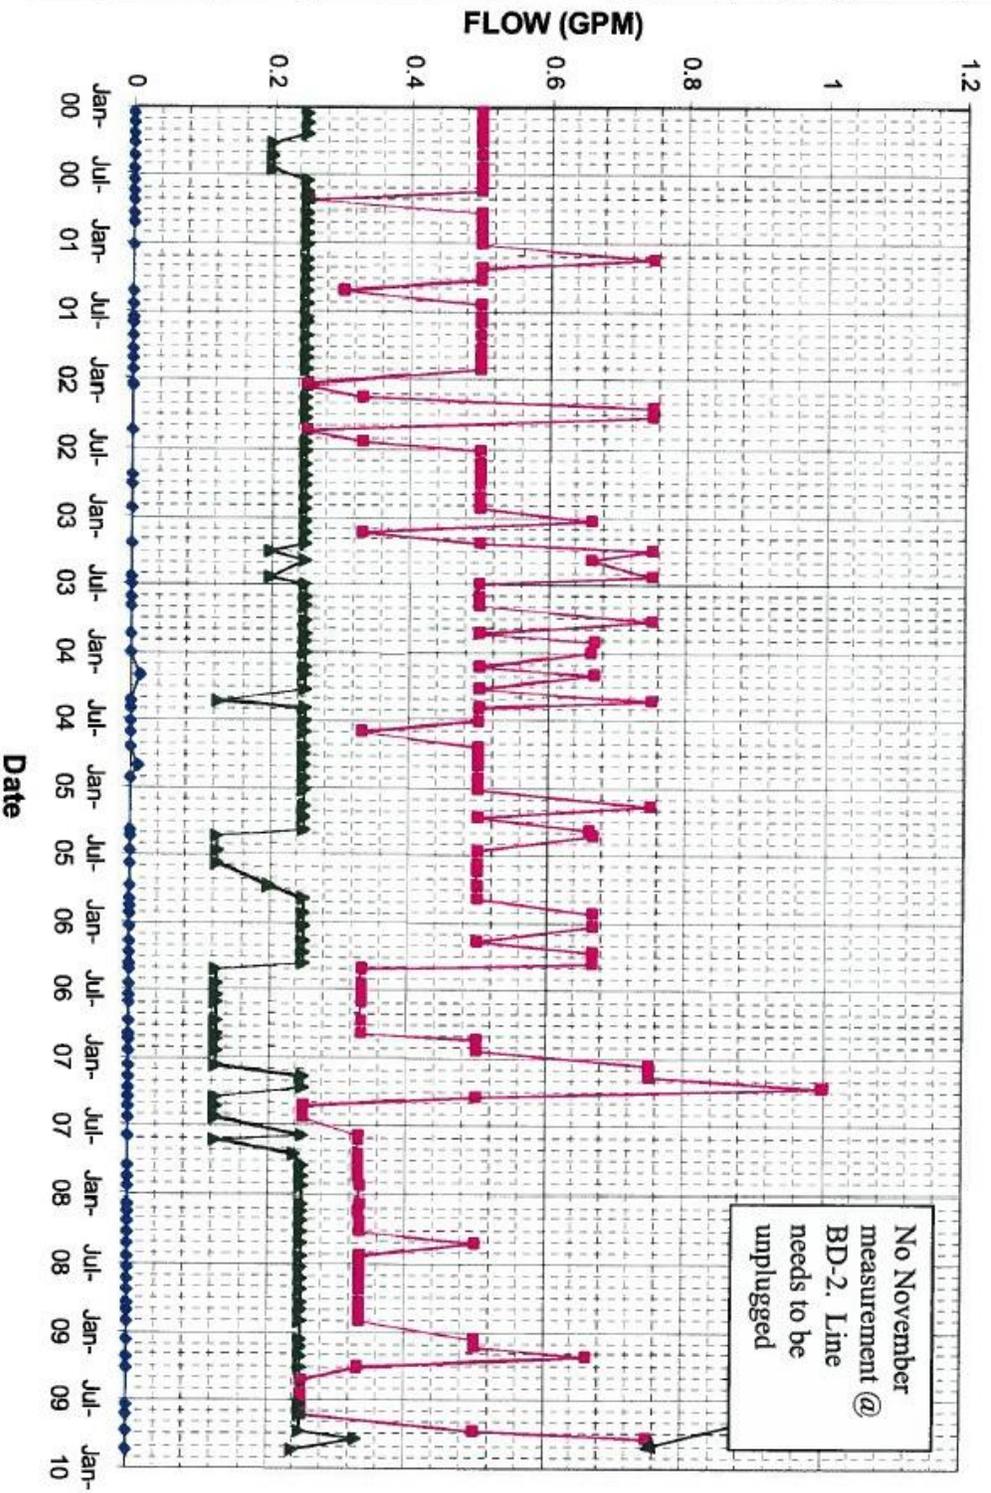
Scherer Ash Pond Blanket Drain Flows

No November measurement @ BD-2. Line needs to be unplugged
