Report of Dam Safety Assessment
of Coal Combustion Surface Impoundments
Georgia Power
Plant Scherer, Juliette, GA

AMEC Project No. 3-2106-0174.0200

December 2010

Southern Company, Georgia Power, Plant Scherer Ash Pond and Settling Pond
were assessed on May 12, 2010.

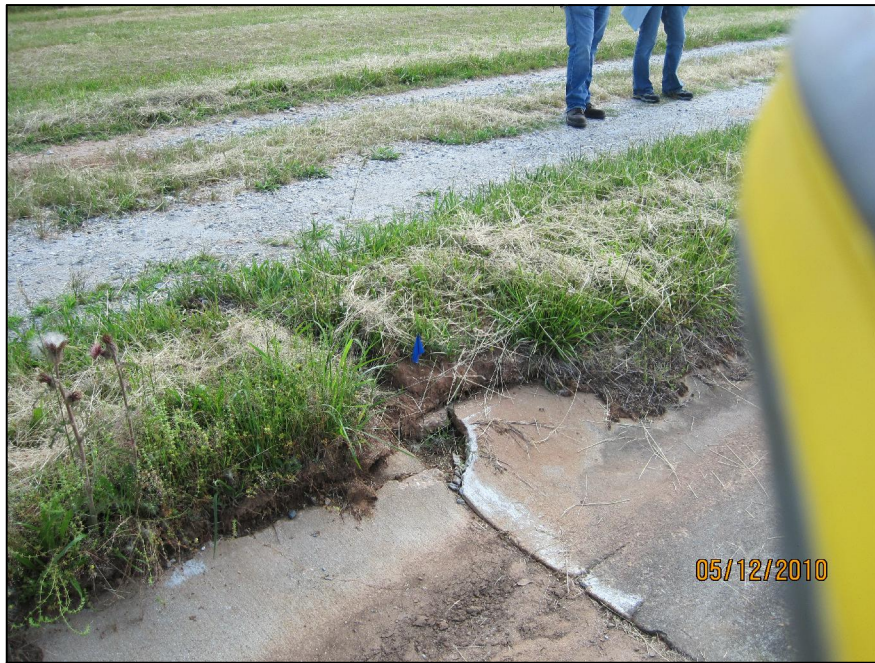
AP-17

DOWNSTREAM TOE OF NORTH DIKE, MINOR EROSION AND BROKEN CONCRETE DITCH

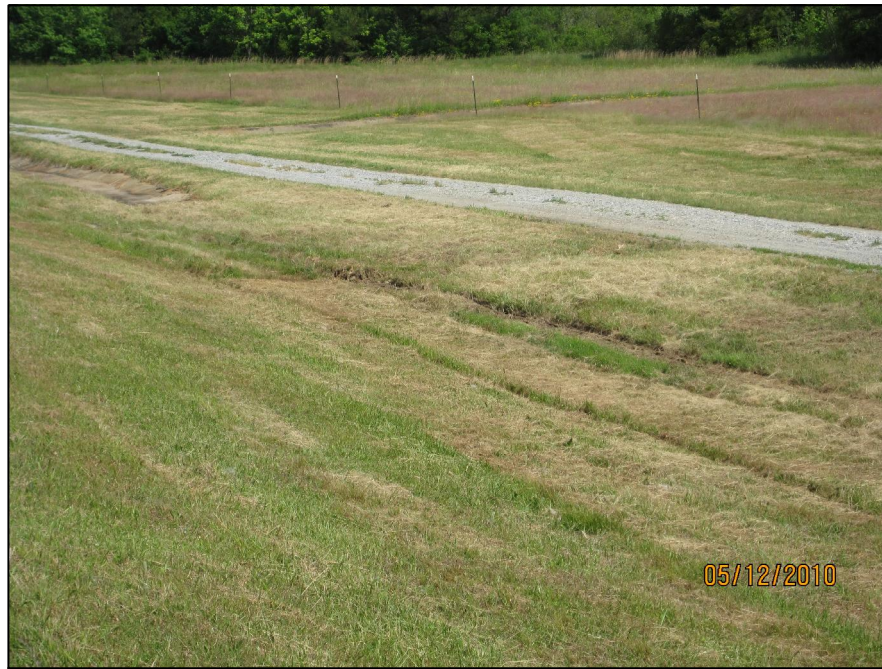
AP-19

No pronounced surface depressions or other deficiencies were noted on the upstream slope or crest of the Ash Pond. At the end of the north dike, a stockpile of emergency supplies was stored (photo AP-14). On the north dike of the embankment, a wet area was observed beyond the downstream slope from PZ's AP-6 and AP-7 (photo AP-15). A concrete ditch was observed at the toe of the downstream slope of the north dike. A broken area of concrete was observed in this ditch (photo AP-16 and AP-17). The outlet of this concrete ditch directed water away from the embankment (photo AP-18). A wet surface area at the toe extending about 125 feet was located beyond the east end of the concrete ditch (photo AP-19).

DOWNSTREAM TOE OF NORTH DIKE, APPROX. 125 FEET LONG WET SURFACE AREA AT EAST END OF CONCRETE DITCH

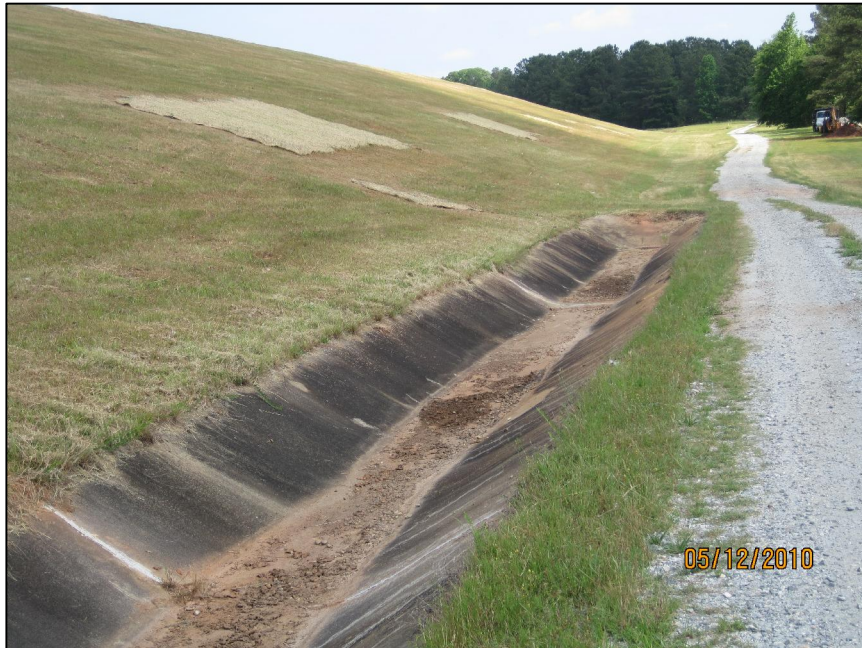
Repaired surficial areas were noted on the downstream embankment of the east dike (photos AP-20 and AP-24). A concrete ditch beginning at the intersection of the north and east dike extended south along the toe of the downstream slope and directed water away from the embankment (photos AP-21 and AP-22). An emergency stockpile of crushed stone and sand was located near this outlet (photo AP-23). The lower bench at the east dike extends the downstream embankment. A gravel access road crosses a middle bench in this area. A concrete ditch on the upstream side of this road is higher at the middle and directs water to each end (photo AP-24 and AP-25). The concrete ditch is piped beneath the road on both ends and extends down along the groin to the east (photo AP-26 and AP-34). On the south side of this groin ditch, water was observed entering and exiting the ditch at a joint (photo AP-27). Near the bottom of the ditch, water is entering from pipes at blanket drain outlets BD-2 and BD-3 (photos AP-28 and AP-30). Likewise, on the north groin ditch, water is entering the ditch at an upper damaged joint and two lower piped outlets from the blanket drain (photos AP-33 and AP-32). The two ditches combine at the toe into a concrete channel and outlet including a 4-inch diameter pipe and overflow weir (photo AP-31). A dry blanket drain outlet (BD-1) is located in the groin area above the road. Some minor surface scour/erosion was noted in this area(photo AP-35).

AP-24
**LOWER DOWNSTREAM SLOPE OF EAST DIKE, LOOKING NORTH, END OF CONCRETE DITCH ABOVE
 GRAVEL ROAD, REPAIRED AREAS ON DOWNSTREAM SLOPE**

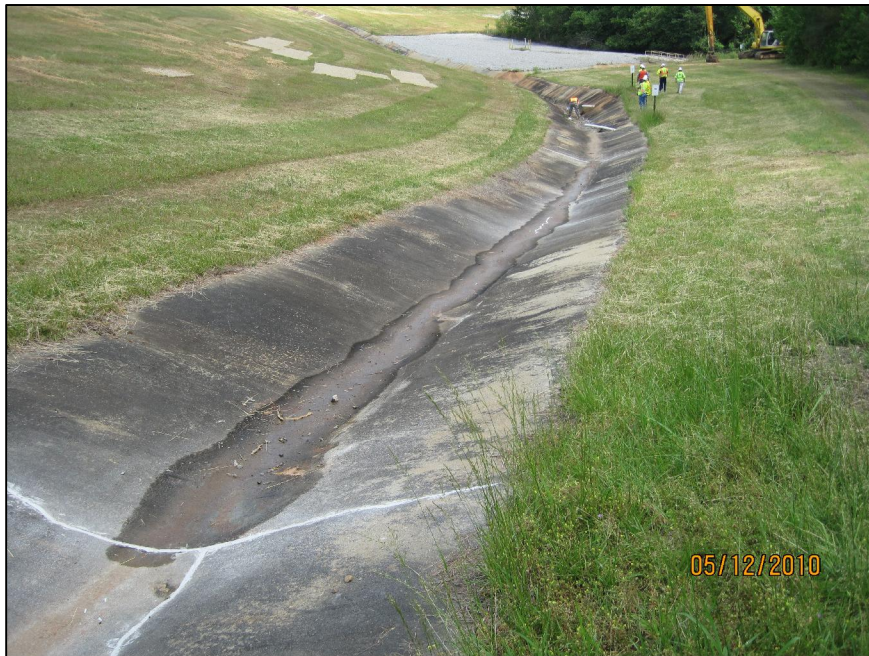
AP-27

DOWNSTREAM SLOPE OF EAST DIKE, LOOKING NORTH, WATER SEEPING INTO AND BACK OUT OF DITCH AT JOINTS

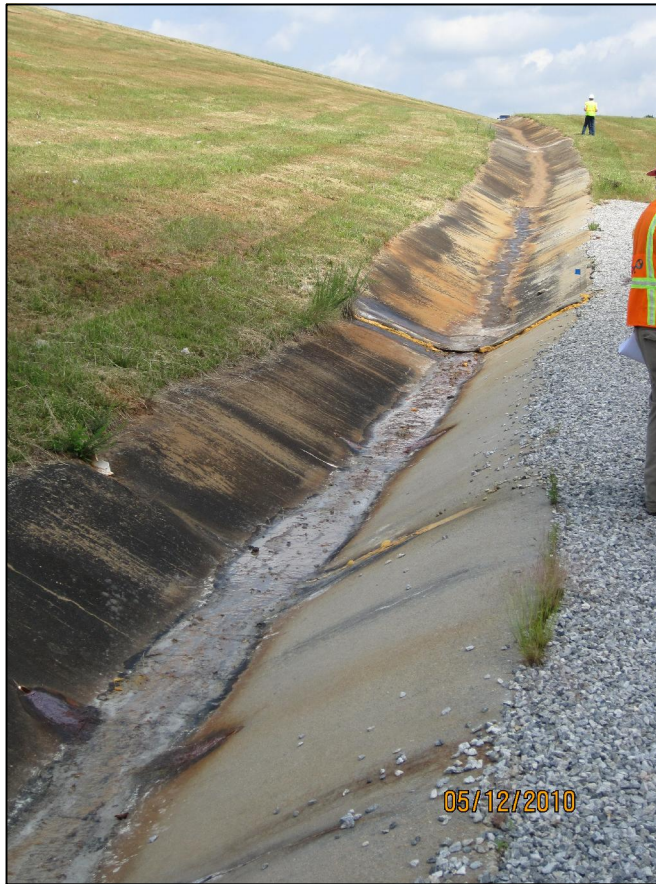
AP-33
 DOWNSTREAM SLOPE OF EAST DIKE, LOOKING NORTH AT WATER SEEPING IN DITCH AND HEAVED JOINT ON NORTH SIDE OF BLANKET DRAIN OUTLET

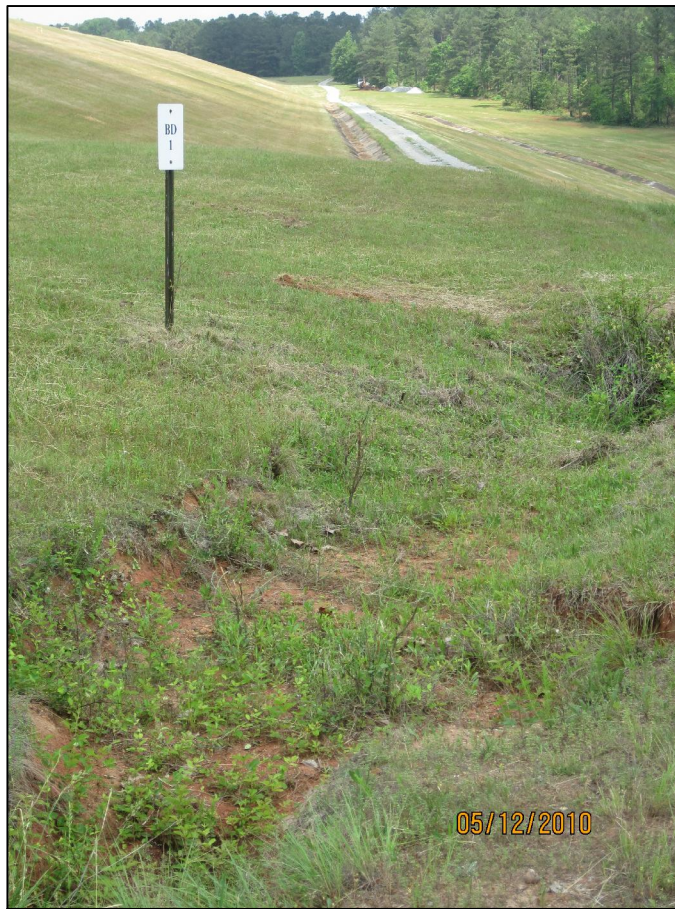
AP-35
 DOWNSTREAM SLOPE OF EAST DIKE, LOOKING NORTHEAST AT BD-1 OUTLET, MINOR
 EROSION ABOVE THIS AREA

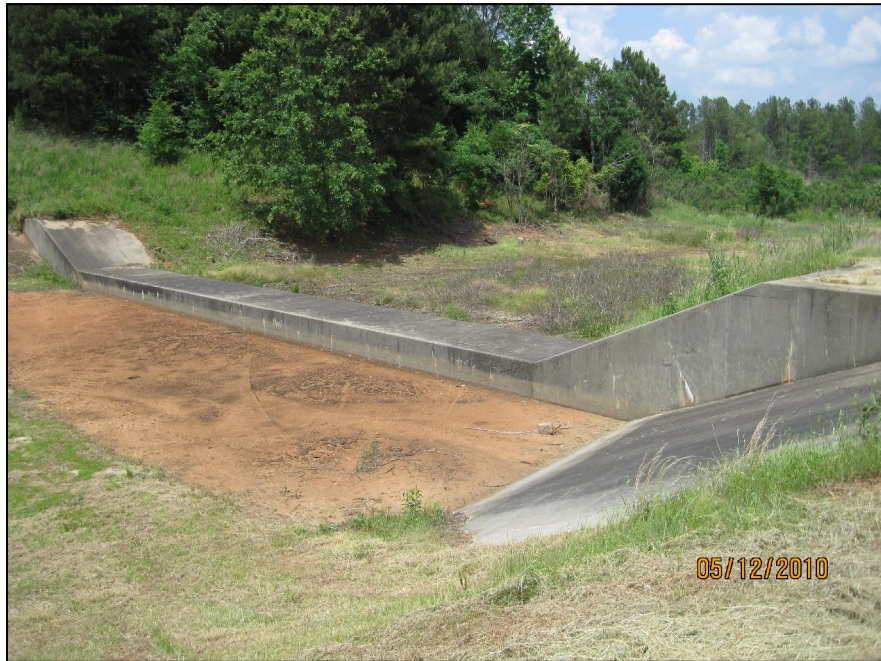
The open channel emergency spillway is located adjacent and west of the outlet structure. Plans indicate the concrete control structure at the head of the spillway is elevation 498.5 feet and appears to be in good condition. The bottom of the spillway channel is 120 feet wide and the grass slopes were in good condition. The emergency spillway discharges to the settling pond. See photos AP-38, AP-39 and AP-41.

AP-38
EMERGENCY SPILLWAY

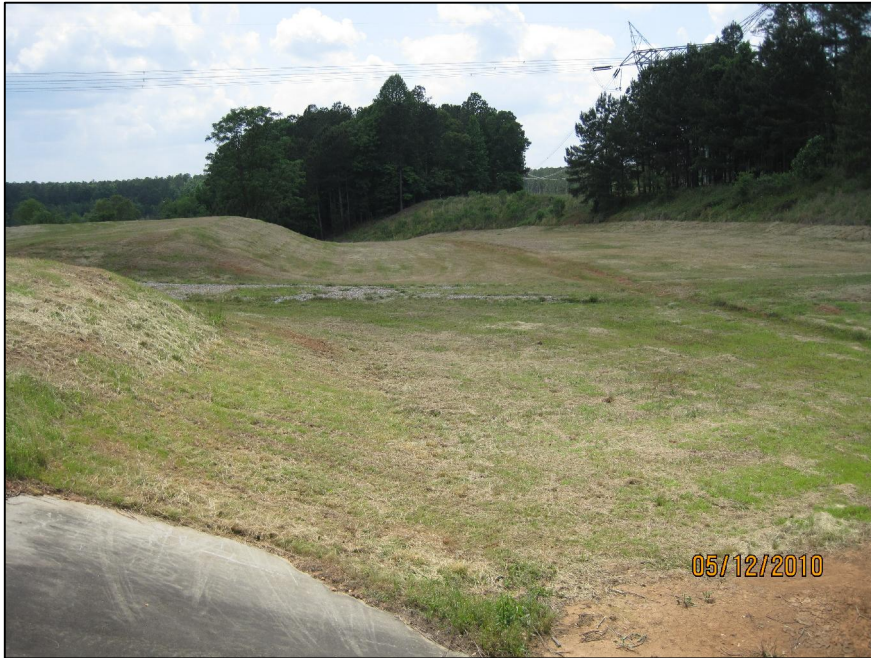
AP-39
LOOKING SOUTH THROUGH EMERGENCY SPILLWAY

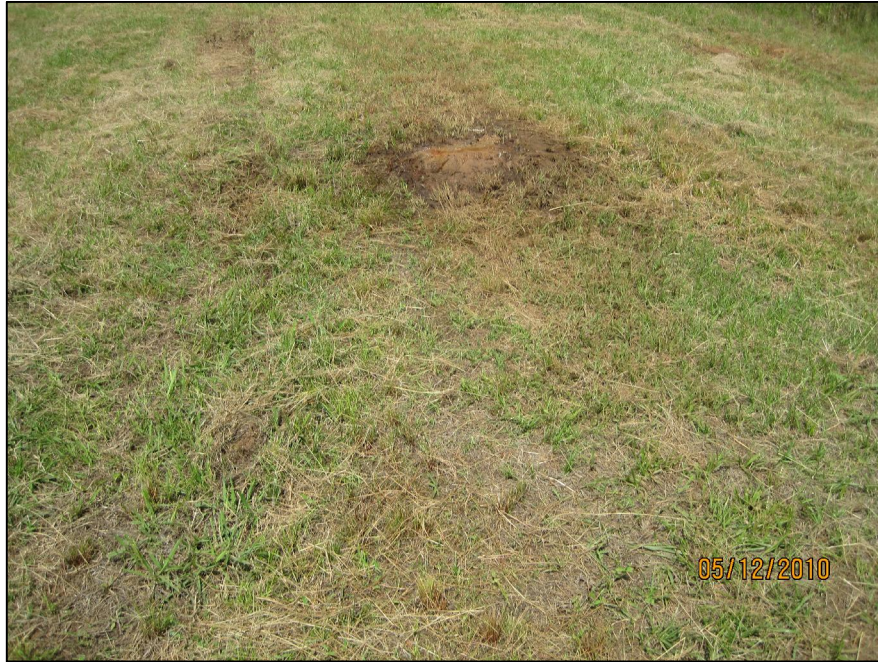
AP-47

TOE OF SOUTH DIKE, LOOKING EAST AT TWO SMALL 8X5 FEET BOILS/SEEPS

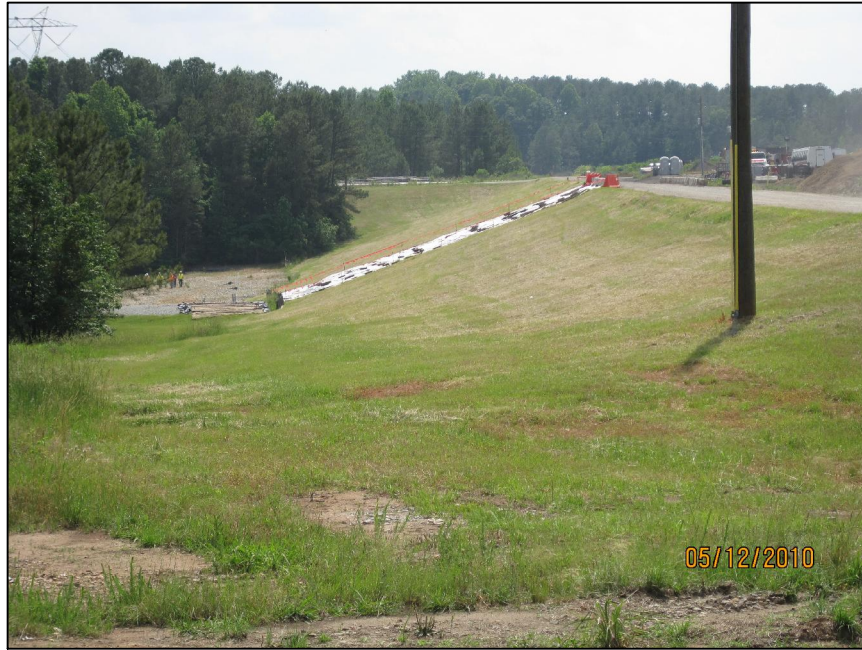
The south dike of the Ash Pond is directly upstream of the plant. Runoff pipelines and coal ash pipelines enter the pond at the south dike (photos AP-42 thru AP-44). In addition, much of the ash being stored in the pond is in the south end of the impoundment (photos AP-45 and AP-10). A road leading from the plant to the Ash Pond bisects the downstream slope of the south dike. On the west section of the south dike (photo AP-46), two small 8 by 5 feet seeps are located at the toe of the downstream embankment (photo AP-47). An eroded area was observed in the downstream groin at the right abutment (photo AP-48). Other photos of the west half include AP-49 and AP-50. A surface slough repair is located on the downstream slope on the east half of the south dike (photos AP-51 and AP-52). The slough, which is about 3 feet deep by 100 feet

long and extends about 20 feet up from the toe, developed recently. Georgia Power has started repairs, covered the area for protection, and is waiting for good weather conditions to allow final grading, seeding, and mulching.

INTERSECTION OF SOUTH AND EAST DIKE LOOKING WEST AT SOUTH DIKE DOWNSTREAM SLOPE
