DRAFT
**Specific Site Assessment for
Coal Combustion Waste
Impoundments at
Intermountain Power Station
Delta, Utah**

Submitted by:
GEI Consultants, Inc.
4601 DTC Blvd., Suite 900
Denver, CO 80237

December 2010
Project 092884

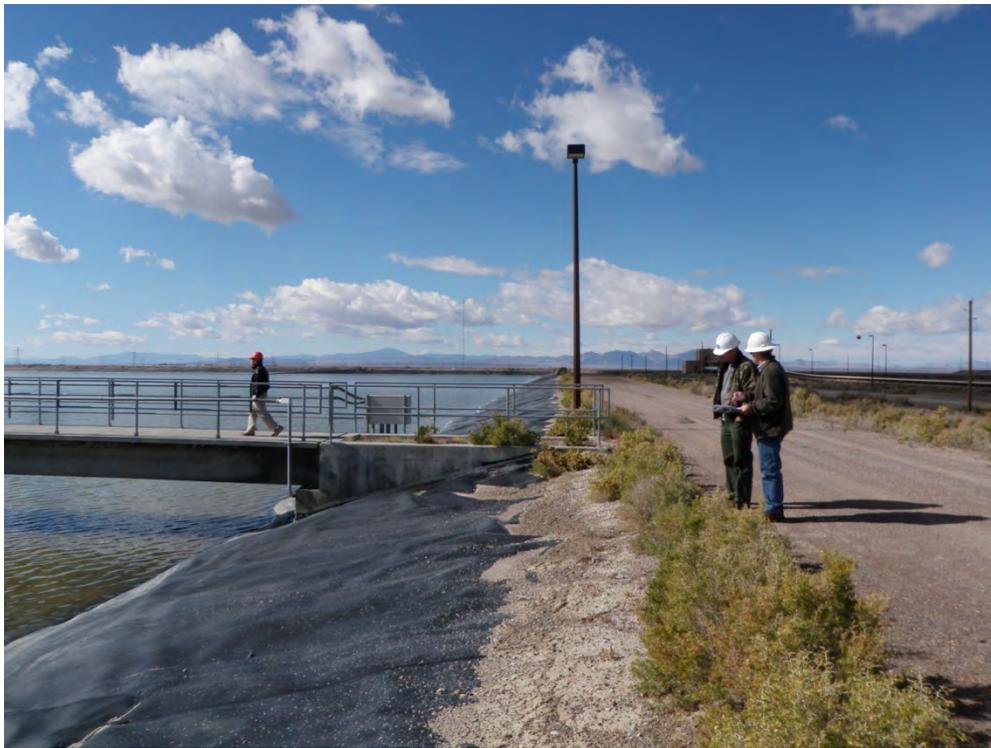
The upstream slope of the Bottom Ash Basins and Wastewater Holding Basin is protected by an 80 mil HDPE liner. The HDPE liner and the upstream slopes appeared to be in satisfactory condition. No scarps, sloughs, depressions or other indications of slope instability were observed during the inspection of the CCW impoundments. The previously described lining failure at the Wastewater Holding Basin resulted in saturated embankments. The repairs included improving the saturated subgrade with flowable concrete such that repairs could be made to the lining. A result of the repair is somewhat uneven appearance of the embankment, though the subgrade is judged to be sound.

Photo 2: Wastewater Holding Pond, looking west at north dike upstream slope.

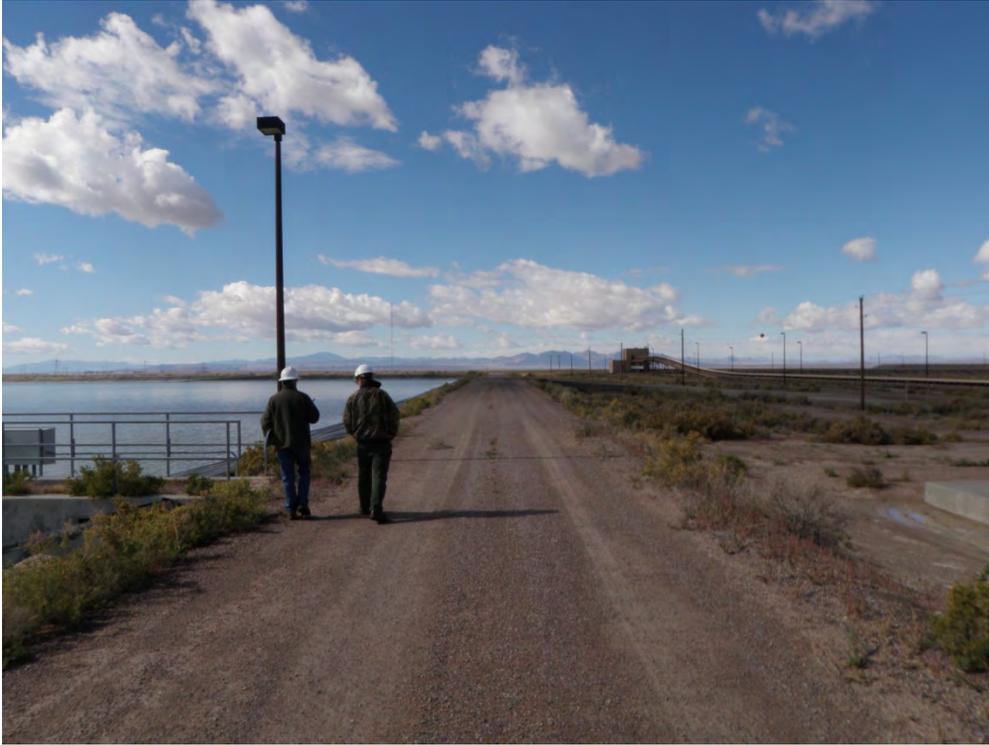
Photo 3: Wastewater Holding Pond, looking west at north dike crest and downstream slope.

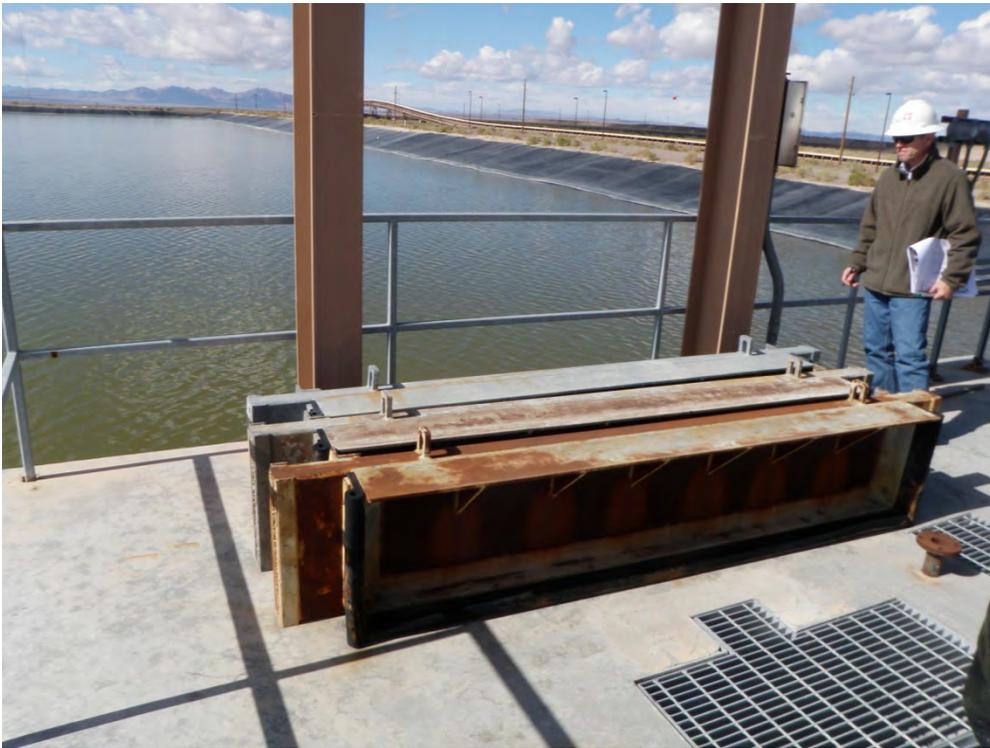
Photo 6: Wastewater Holding Pond, intake structure steel stop logs.

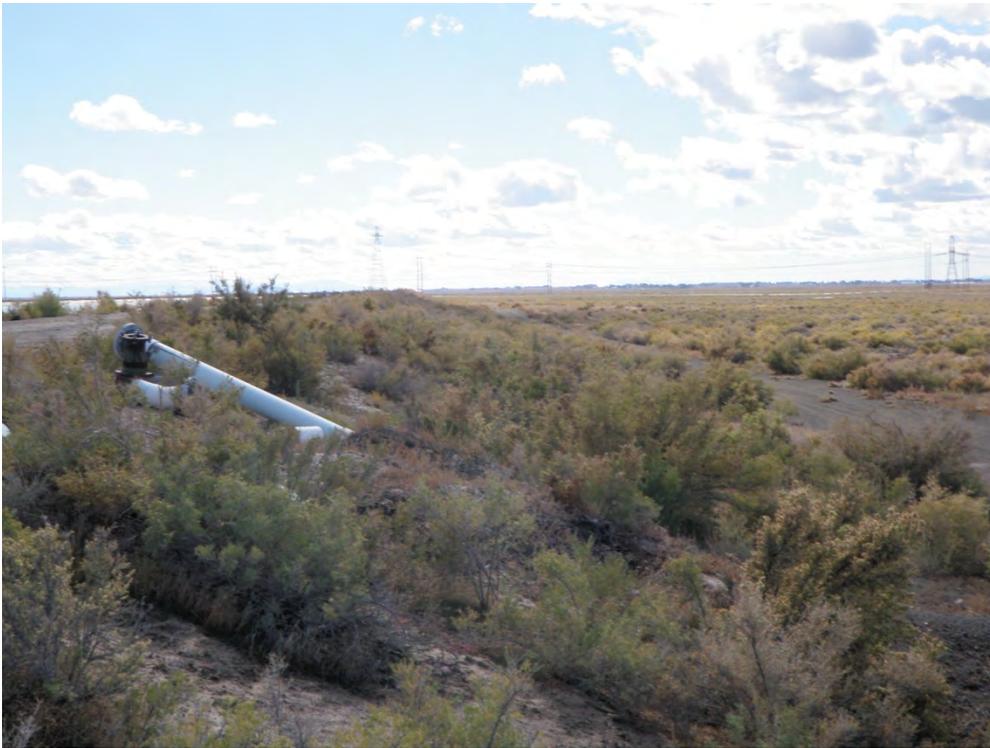
Basin are sparsely covered with vegetation consisting greasewood shrubs, wheat grass and other native vegetation. The downstream slopes showed no signs of significant erosion. However, minor erosion rill on the downstream slope of the Wastewater Holding Basin west embankment was observed, most likely due to surface runoff.

Photo 12: Wastewater Holding Pond, looking south at west dike downstream slope.

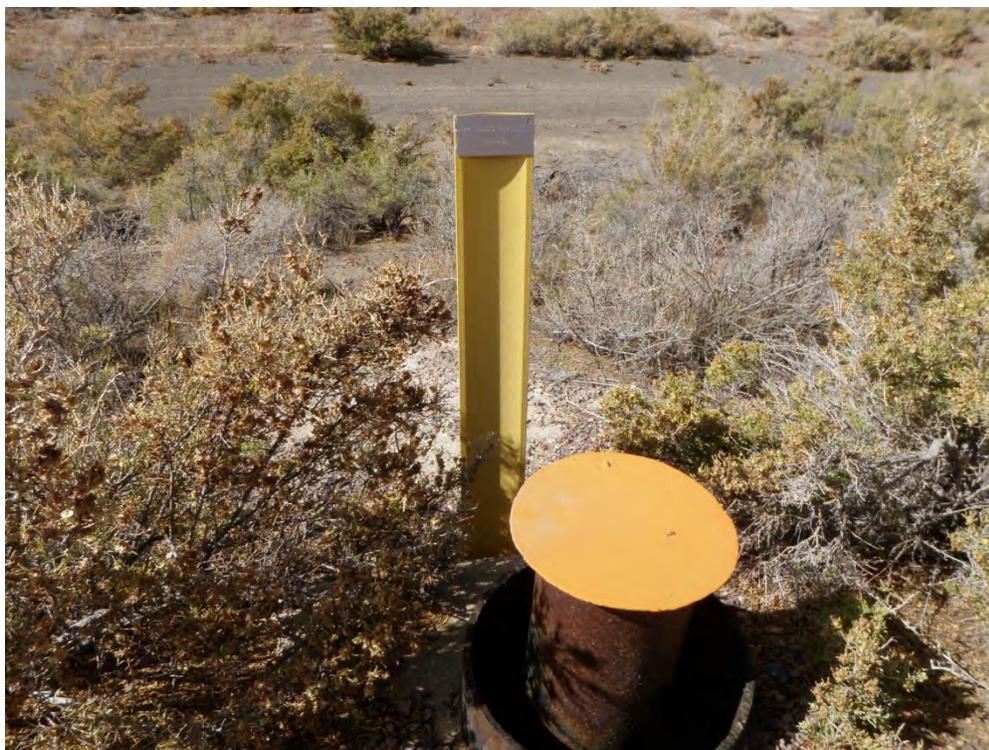
Photo 14: Wastewater Holding Pond, looking at groundwater well along west dike.

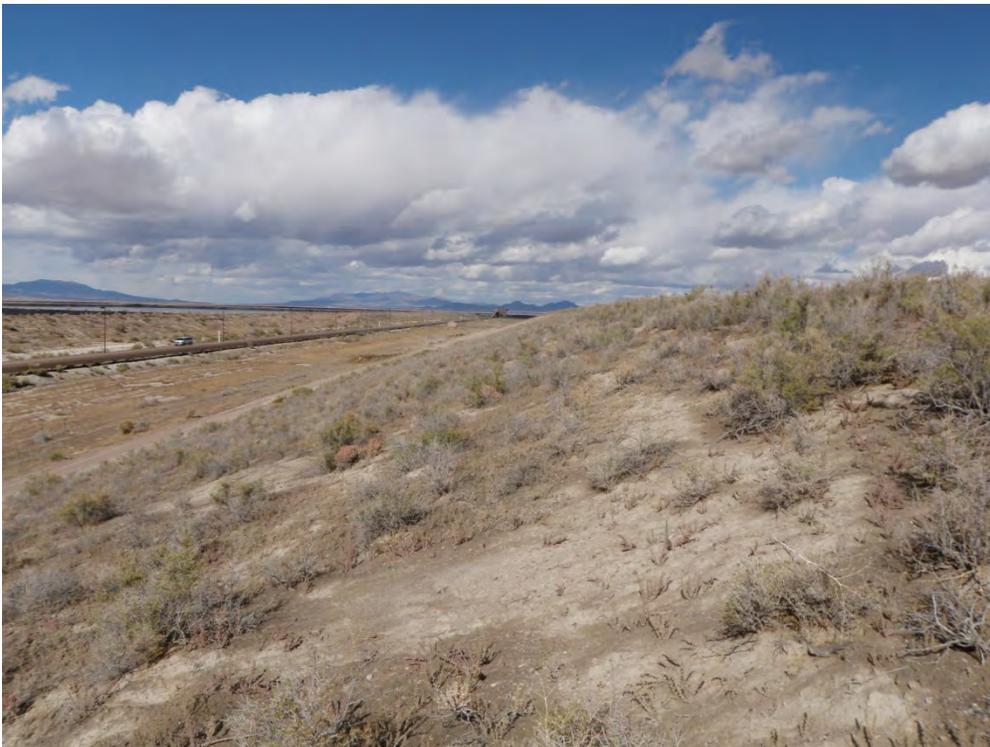
Photo 22: Bottom Ash Basin #3, looking north at west dike downstream slope.

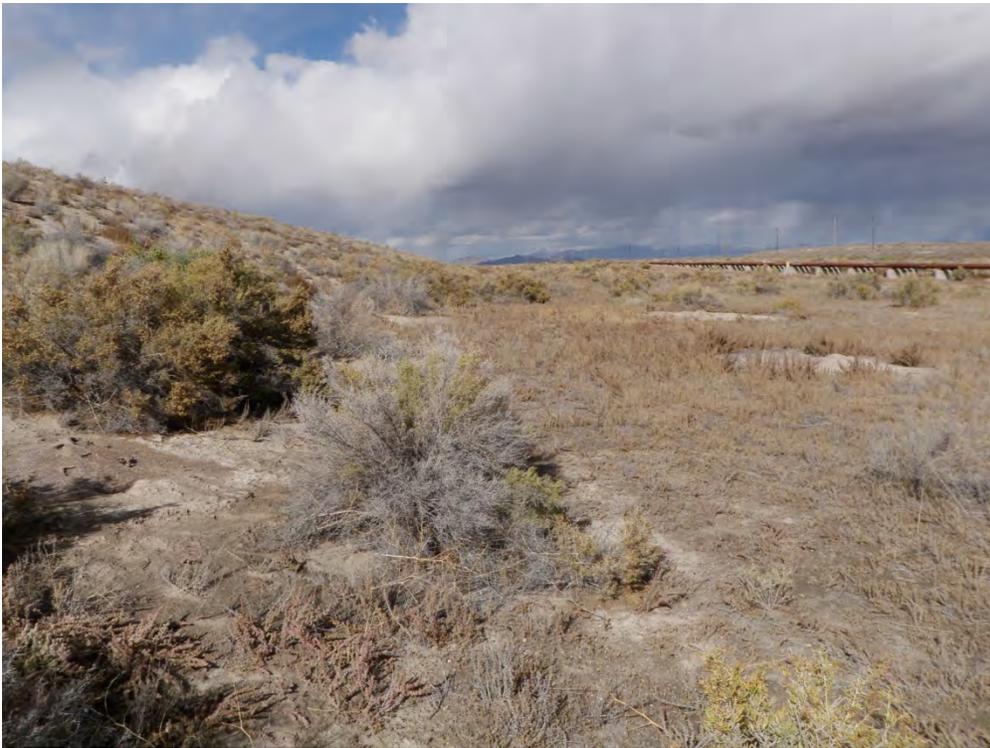
Photo 38: Bottom Ash Basin #1, looking north at east dike downstream toe.

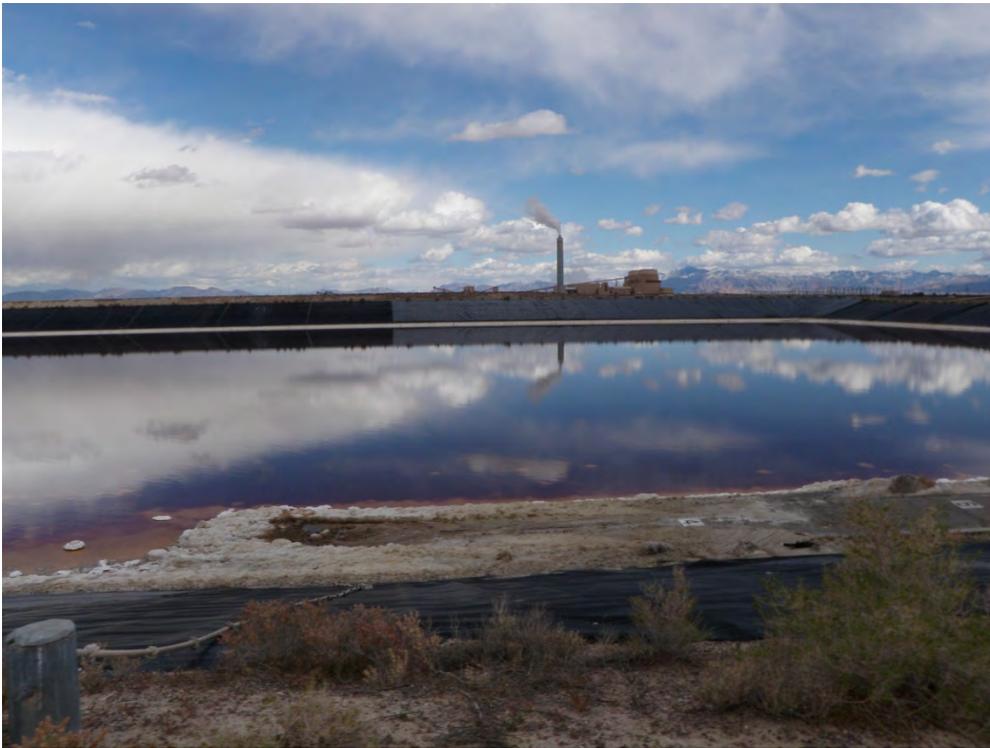
Photo 44: Evaporation Pond #2, looking east at reservoir area and upstream liner, note considerable salt accumulation.
