# **Assessment of Dam Safety of Coal Combustion Surface Impoundments**

**Indianapolis Power & Light Company**

**Petersburg Generating Station**

**June 8, 2010**

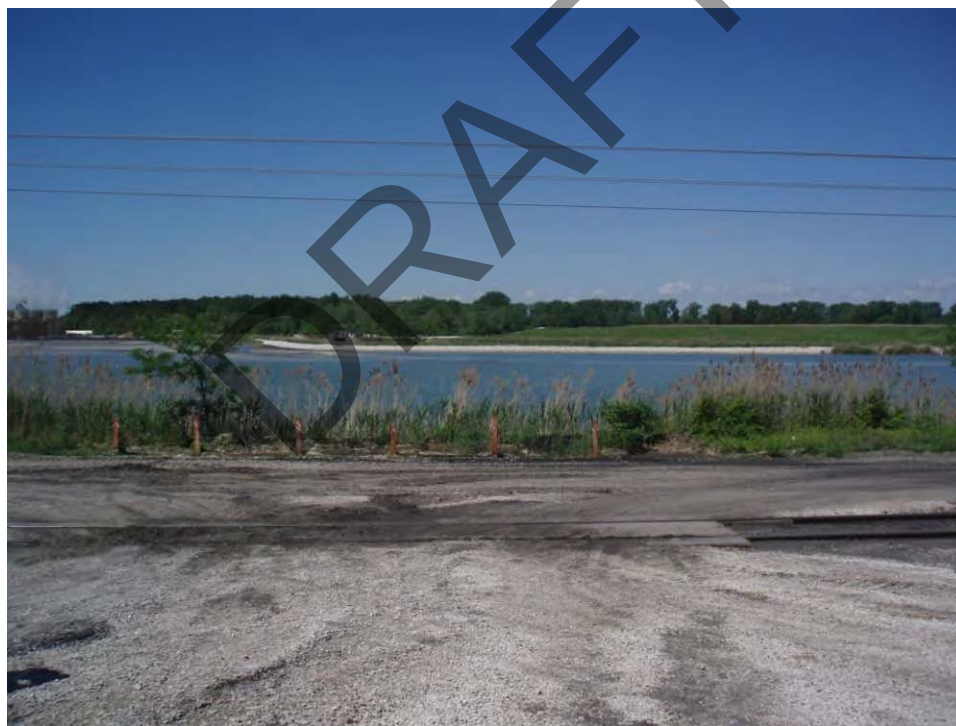
2. Overview of Pond A and east slope of divider embankment, looking west

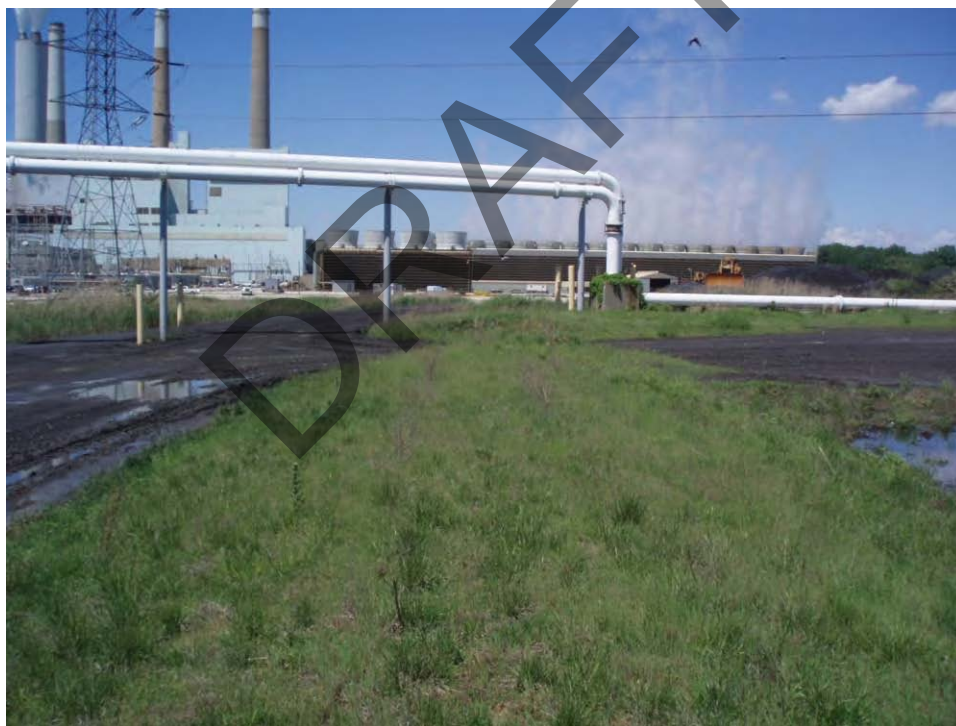
10. Pond A - South embankment crest, looking west. Note access ramp excavated in crest to access the sluice pipes.

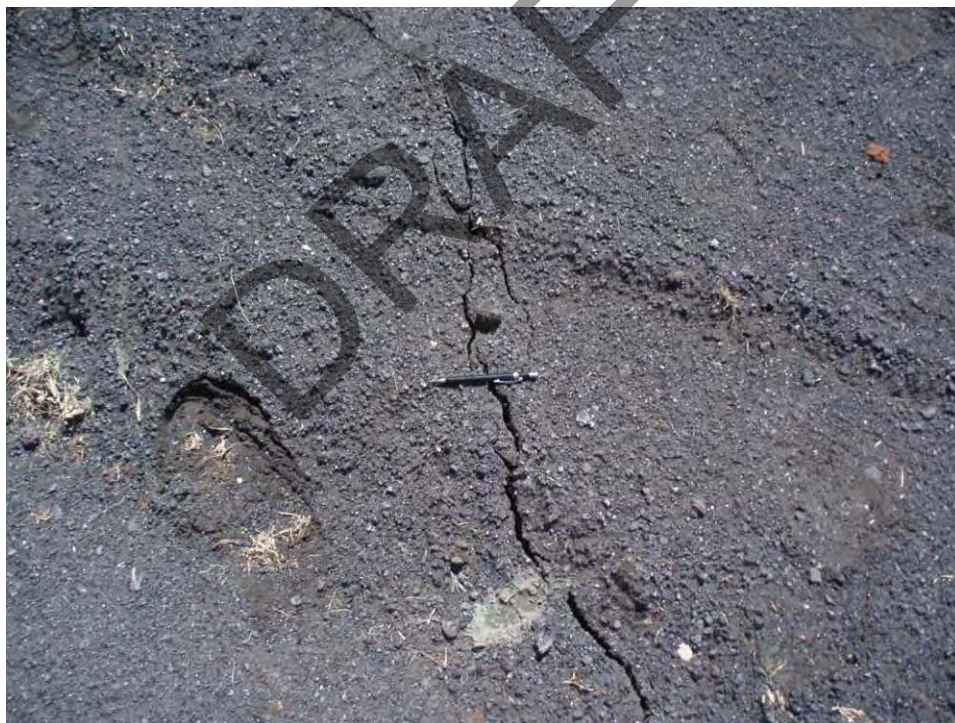
18. Pond A - Surface cracks in recently placed ash material on south embankment crest.

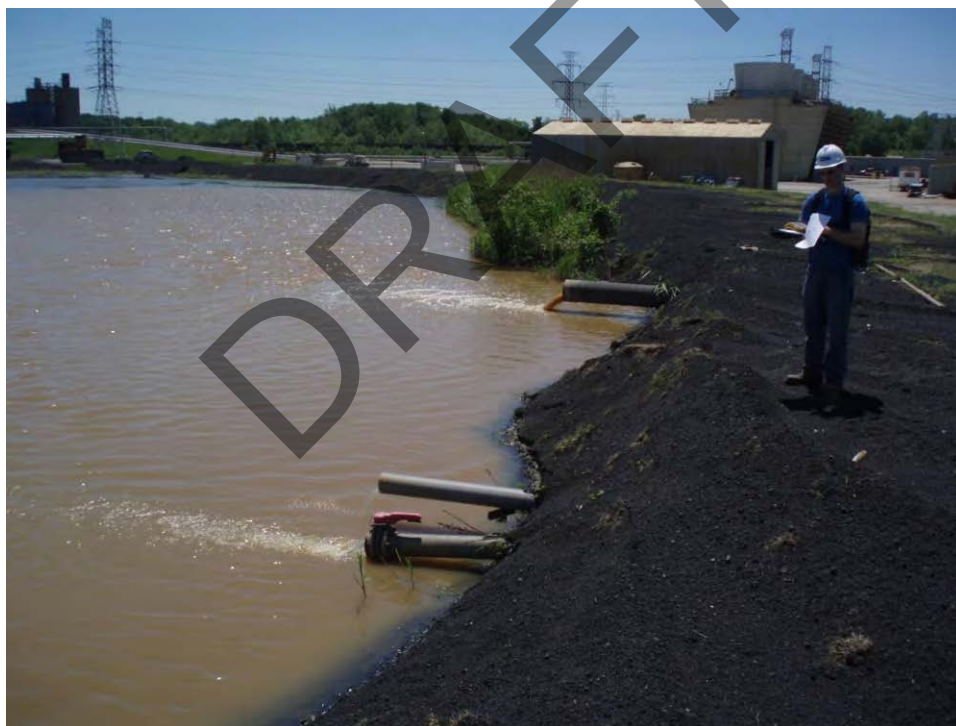
During the site visit four sets of sluice pipes were observed. The CCW sluice pipes on the south embankment appeared to be in fair condition (Photo 8). The two sets of active sluice pipes on the west embankment (Photo 20) and at the west embankment headwall also appeared to be in fair condition (Photo 36). A fourth set of inactive or abandoned pipes appeared to be in poor condition (Photo 30, 33, and 35). The IPL staff did not know the origin or purpose of these pipes. The excavator operator placed ash over the 24-inch-diameter RCP at the fourth set of pipes.

20. Pond A - West embankment interior slope, looking south at one (1) 12-inch-diameter DI pipe and two (2) 8-inch-diameter steel pipes from plant.

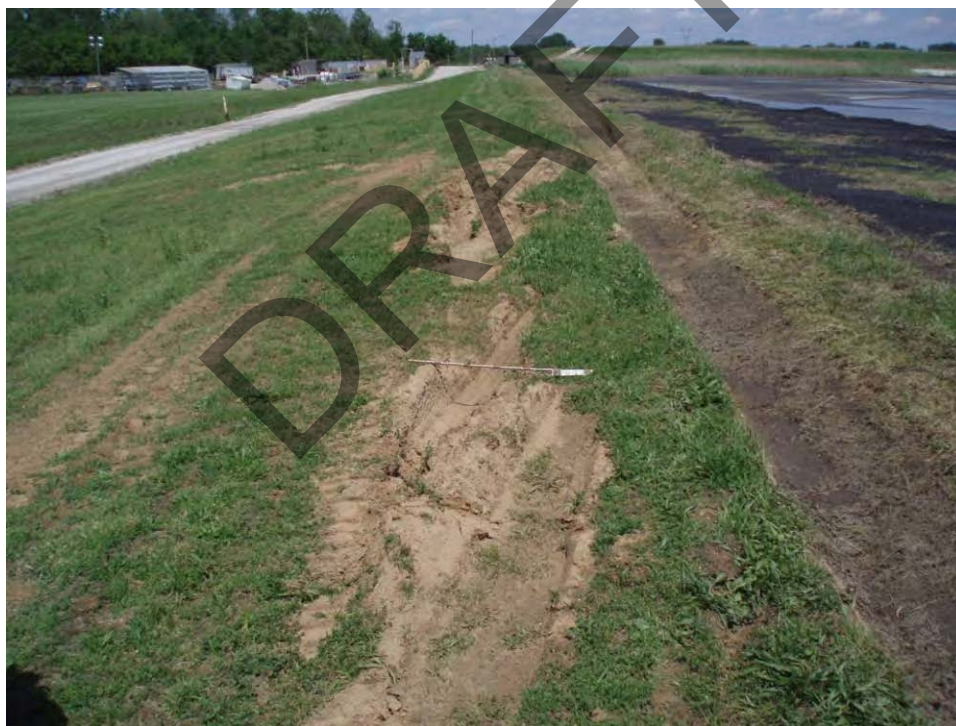
26. Pond A - West embankment exterior slope, looking north at large tractor ruts and excavator tracks.

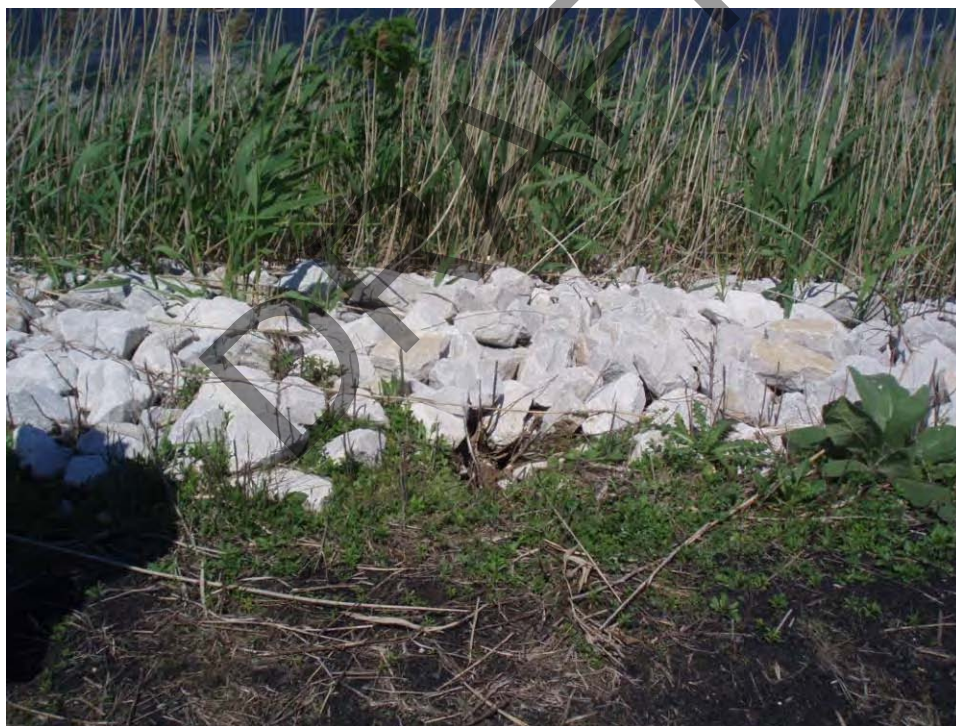
Some surficial erosion under the riprap on the north slope of the divider embankment was observed (Photo 40).

40. Surficial erosion under riprap on north slope of divider embankment between Pond A and Pond A - Discharge.

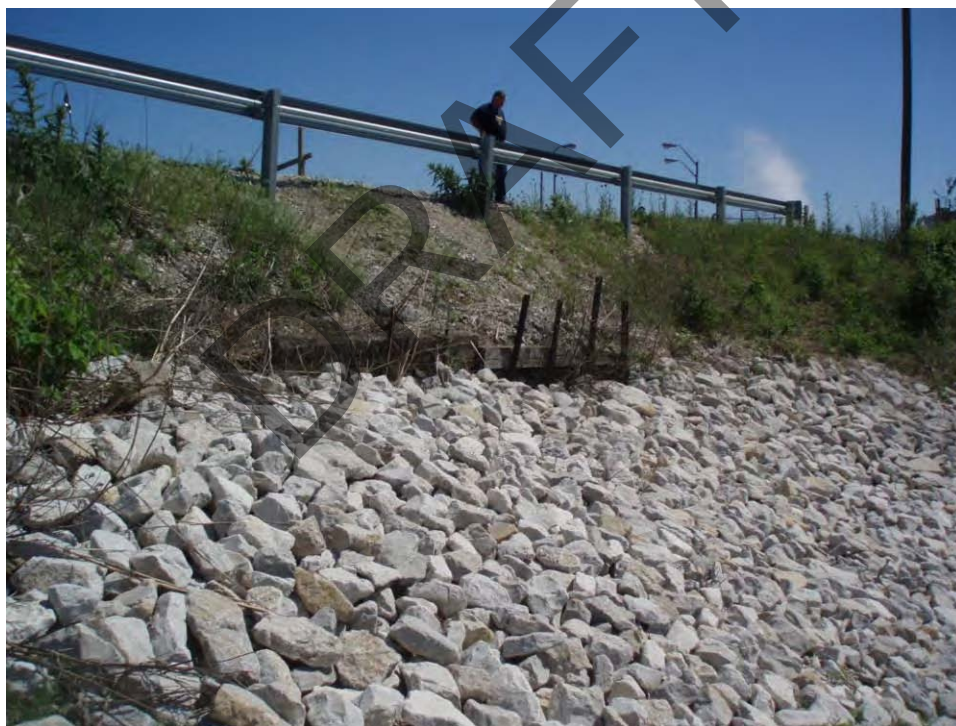
70. Pond A - Discharge, southwest embankment exterior slope looking at steep slope above outfall repaired recently with riprap.

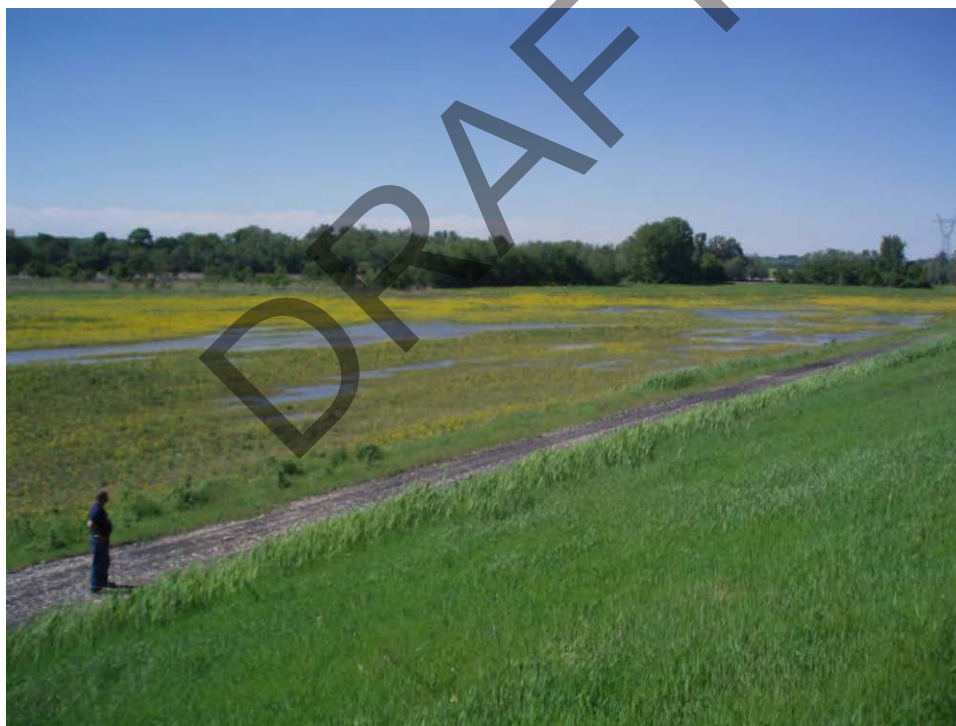
The floodplain at the toe of the west embankment was saturated and flooded from recent storm events (Photos 77, 78, and 84). Possible seepage was observed at the toe of the south embankment and the bench of the west embankment (Photos 63 and 79).

84. Overview of Pond B - West embankment, downstream area, looking northwest. Note field area is flooded from recent storm events.

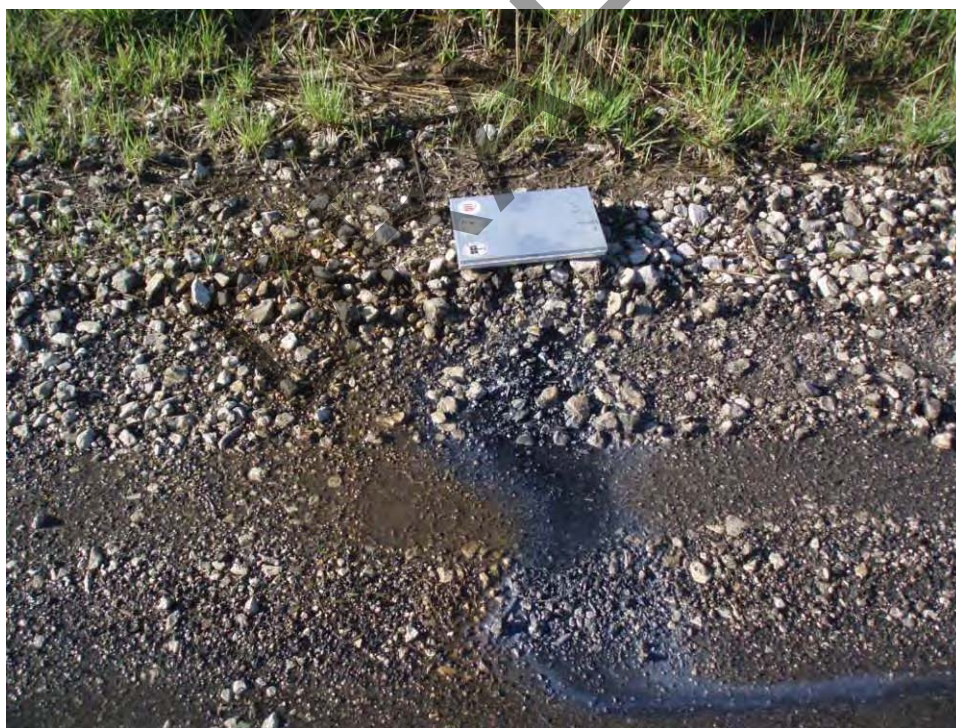
and west embankment (Photos 116, 122, and 125). A white and/or black sheen as well as iron staining was observed in the seepage water.

116. Pond C - West embankment bench, looking at active seepage located at toe of upper exterior slope. Note the white and black sheen in the water.

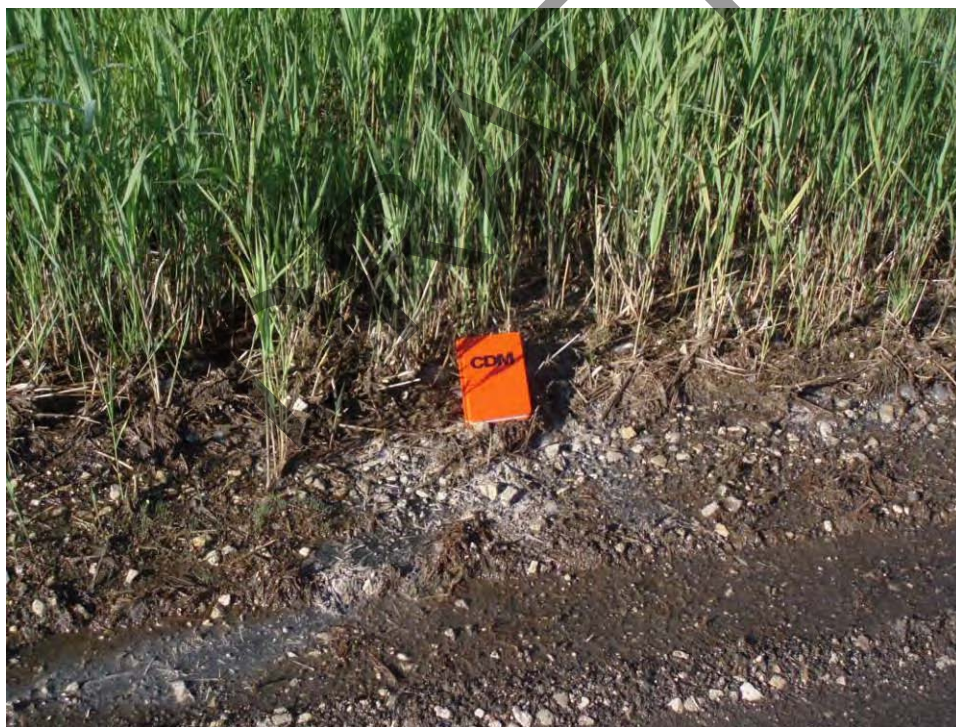
122. Pond C - North embankment bench, looking at active seepage located at toe of upper exterior slope. Note the white sheen in the water.

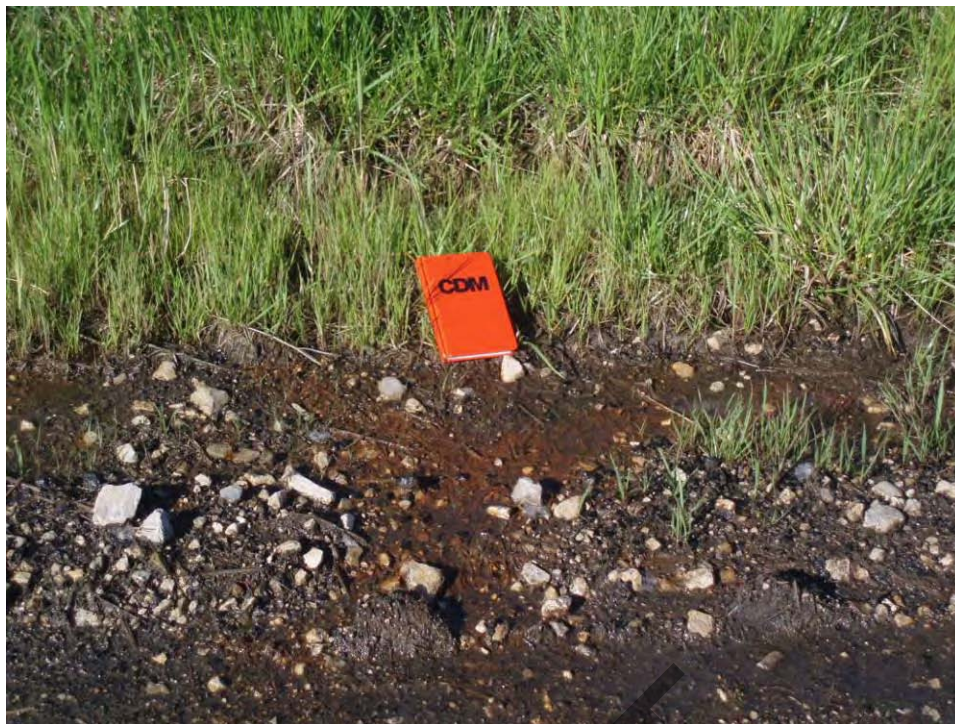
125. Pond C - North embankment bench, looking at active seepage located at toe of upper exterior slope. Note the iron staining in the water

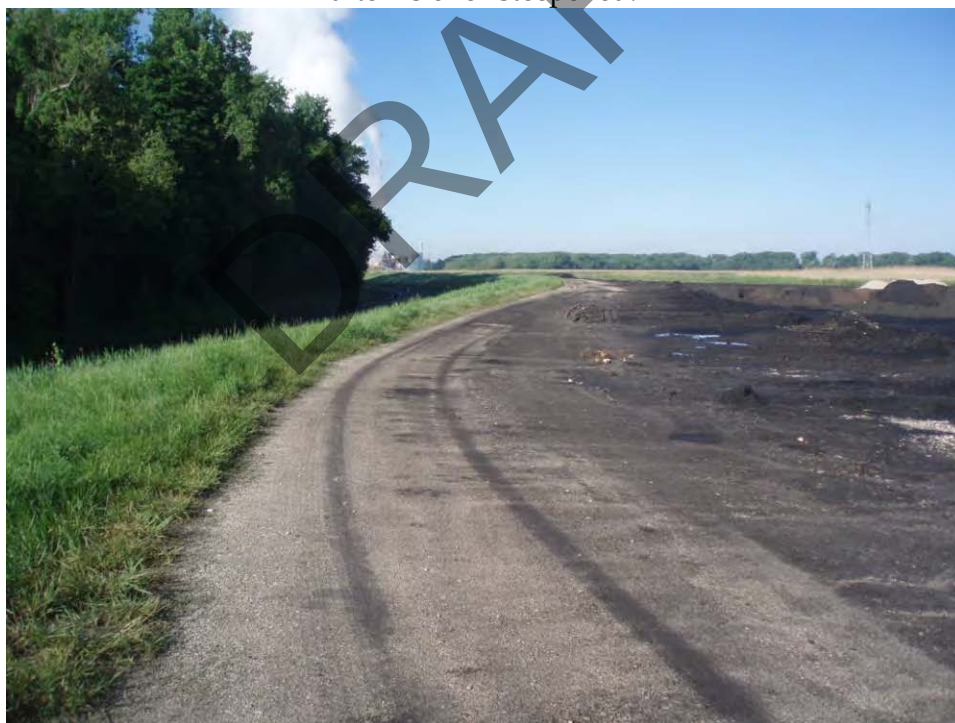
Tractor ruts were observed on the exterior slopes near the crest (Photos 119 and 128) in the very soft, fine grained, stabilized FGD.

128. Pond C -East embankment crest, looking southwest. Note tire rutting was observed in very soft stabilized FGD near the crest.

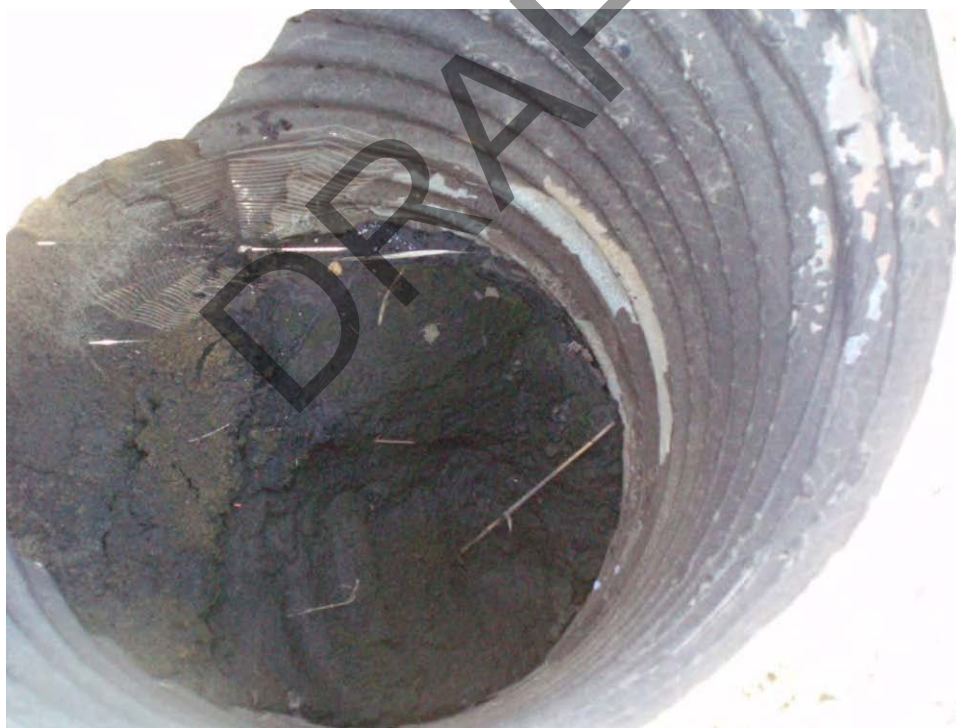
The equalizer pipe in Pond C was in poor condition (Photos 141 and 142). The "T" at the end of the pipe was filled half way with ash.

142. Inside of equalizer pipe at Pond C. Note approximately half of the pipe is filled ash.

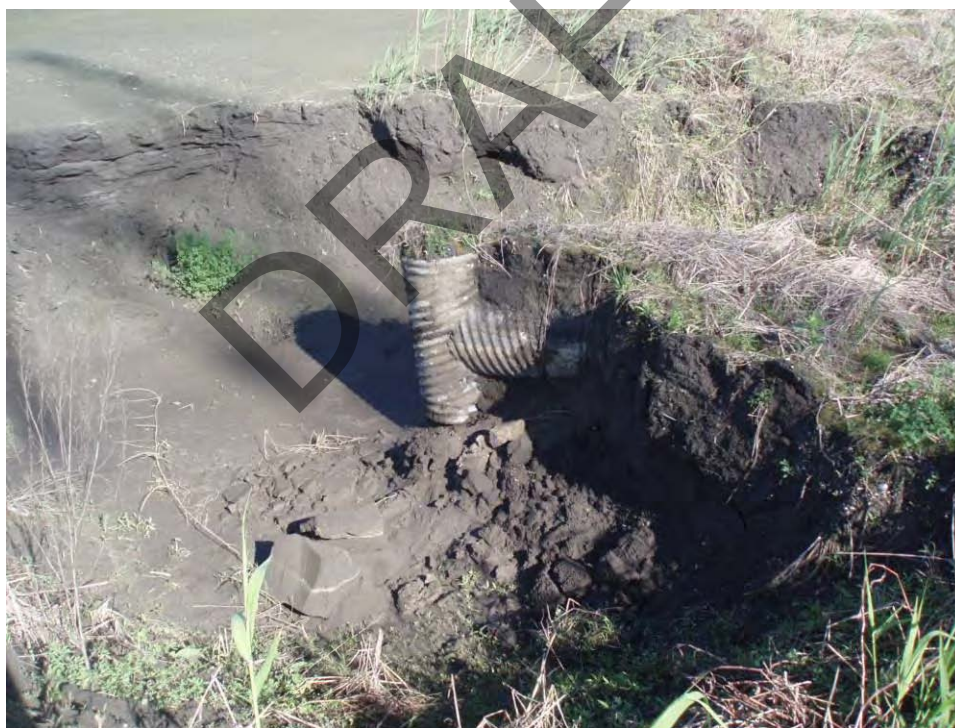
The equalizer pipe in Pond B was in poor condition (Photo 146). The “T” at the end of the pipe was filled to the top with ash.

146. 24-inch-diameter CM equalizer pipe from Pond B to Pond C. Note inlet has a T connection on the end of the pipe and is filled with ash.
