Subject: EPA Comments on Kansas City Board of Public Utilities, Nearman Creek Power Station, Kansas City, KS  
Round 7 Draft Assessment Report

**Subject:     Comments on Draft Coal Combustion Waste Impoundment Round 7 –  
Dam Assessment Report (Site #009), Nearman Creek Power Station,  
Coal Ash Pond Dike, Kansas City Board of Public Utilities, Kansas City,  
Kansas**

## Coal Combustion Waste Impoundment Round 7 - Dam Assessment Report (Site #009)

*Nearman Creek Power Station*  
*Coal Ash Pond Dike*  
*Kansas City Board of Public Utilities*  
*Kansas City, Kansas*

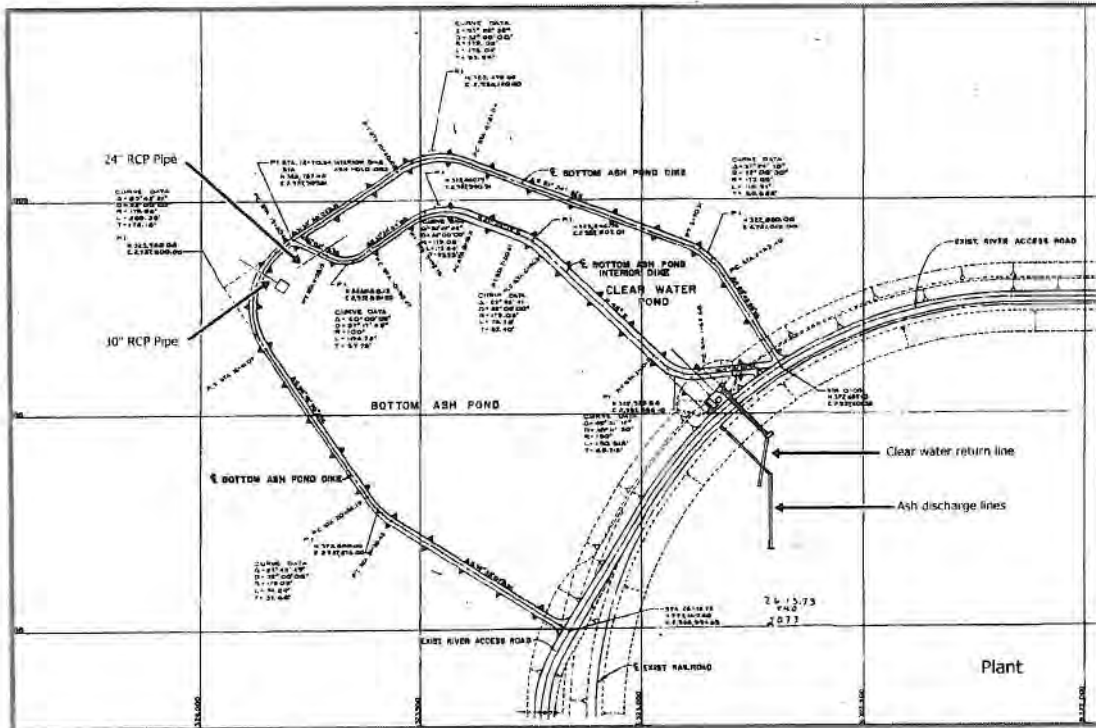
Figure 4.2.1-1: Configuration of the Ash Pond at the KCBPU Nearman Creek Facility

The impoundment was designed and operated for bottom ash sedimentation and control. Bottom ash is transported by slurry to the west end of the impoundment for primary sedimentation. An internal dike divides the impoundment into two cells; the north cell is the primary settling pond and a smaller southern cell is the clear water pond. Water flows from the north to south sections of the impoundment by gravity via a pipe through the cell divider dike. Water from the clear water cell is recycled back to the plant for reuse. Figure 4.2.1-1 shows the configuration of the pond cells.

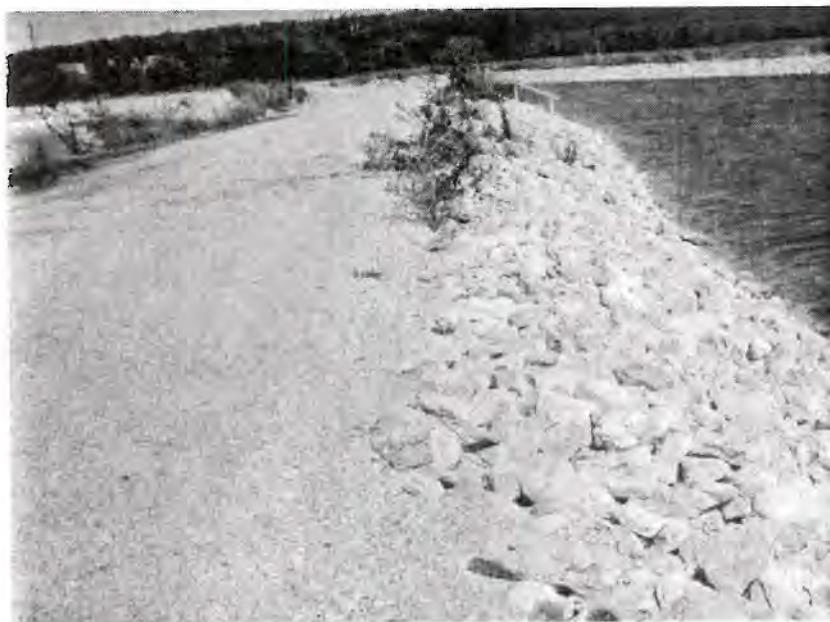
Figure 5.2.1-1: Photograph of Impoundment Dike Crest View

The crest of the embankment had no signs of significant depressions, tension cracks or other indications of settlement or shear failure. Figure 5.2.1-1 shows the typical crest conditions.

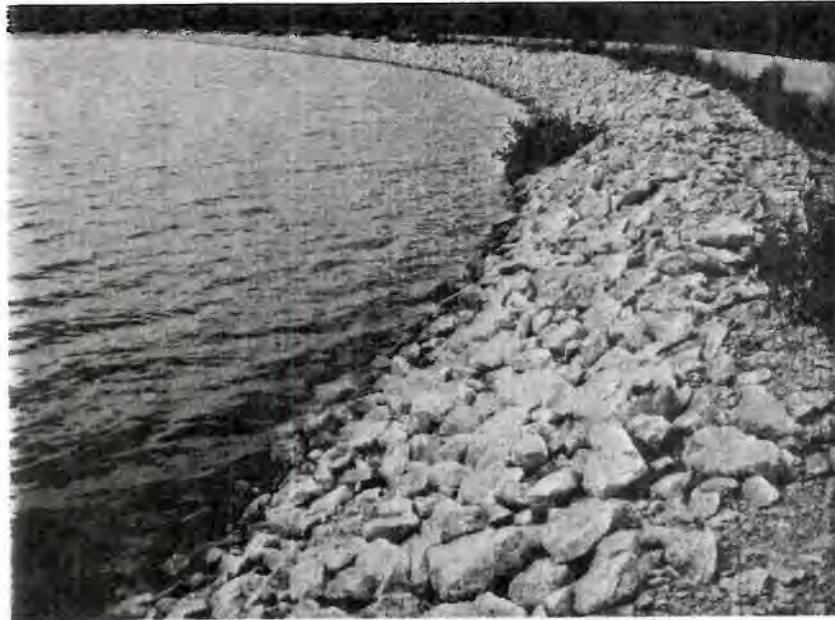
Figure 5.2.2-1: Photo of Embankment Inside Slope View – East end of ash pond looking northwest.

The inside slope of the embankment has been covered with medium (8-16") rip rap per the recommendation of Terracon Engineers. There were no observed scarps, sloughs, bulging, cracks, depressions or other indications of slope instability. Figure 5.2.2-1 shows a representative section of the interior slope of the embankment.

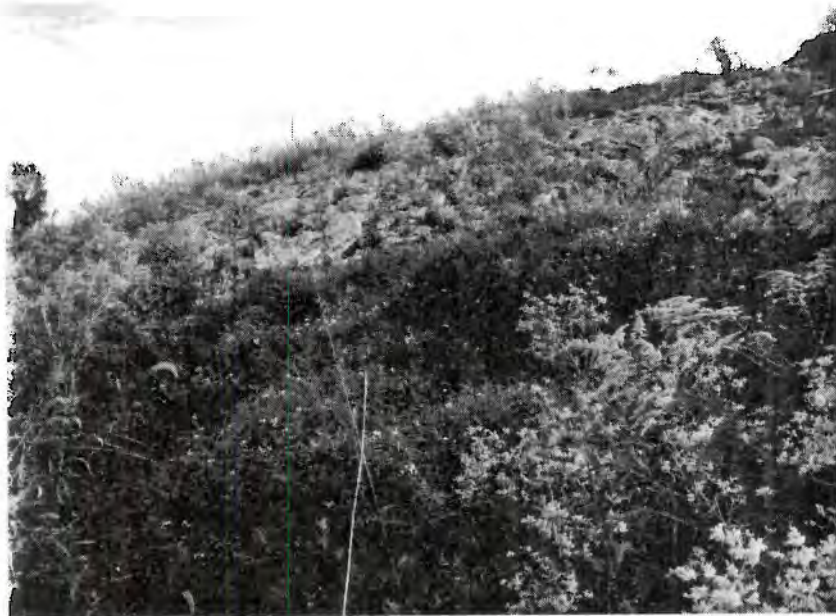
The outside slope of the embankment is also covered with rip rap. A significant amount of vegetation is present in several areas, particularly along the northern slope. No major scarps, sloughs, bulging, cracks, depressions or other indications of slope instability, or signs of uncontrolled seepage were observed. Figure 5.2.3-1 shows a representative section of the outside slope of the embankment.

Figure 5.2.3-1: Photo of Embankment Outside Slope View – North side of ash pond dike looking up the exterior of the dike.

*and* ~~Although the maintenance program appears to be adequate, it is recommended that a vegetation control program be instituted.~~ A regular mowing ~~or~~ spraying program ~~would improve~~ periodic inspections as well as improve the ability to identify ~~animal borrows~~ or other potential problems. *is used* *and prevent* } \*!

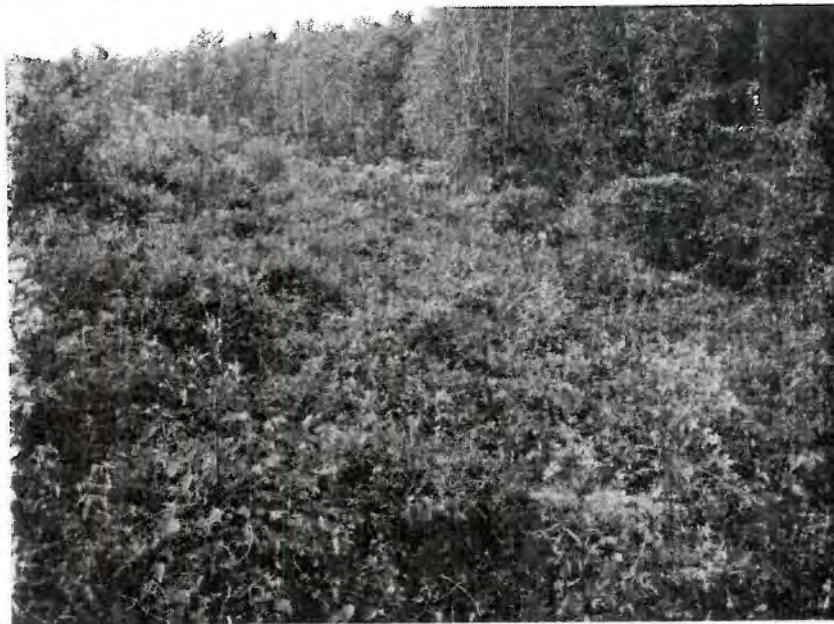
Figure 5.2.3-2: Photo of Embankment Outside Slope View – East side of ash pond dike looking north.

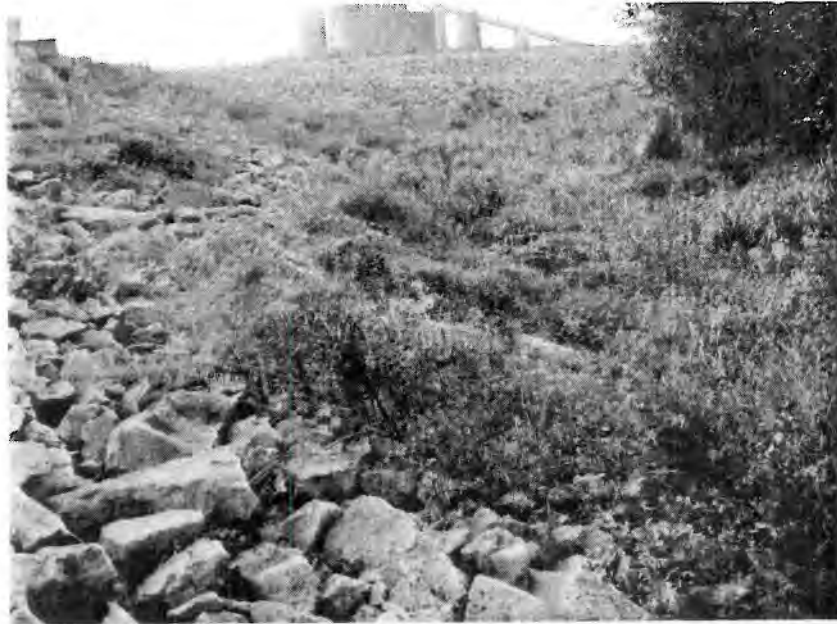
Heavy vegetation along the northern slope made access and visual observation difficult, but there were no obvious areas of seepage or soft soils along the toe of the down-gradient slope.

Figure 5.2.3-3: Photo of Outside Embankment Toe – North side of ash pond dike looking west.

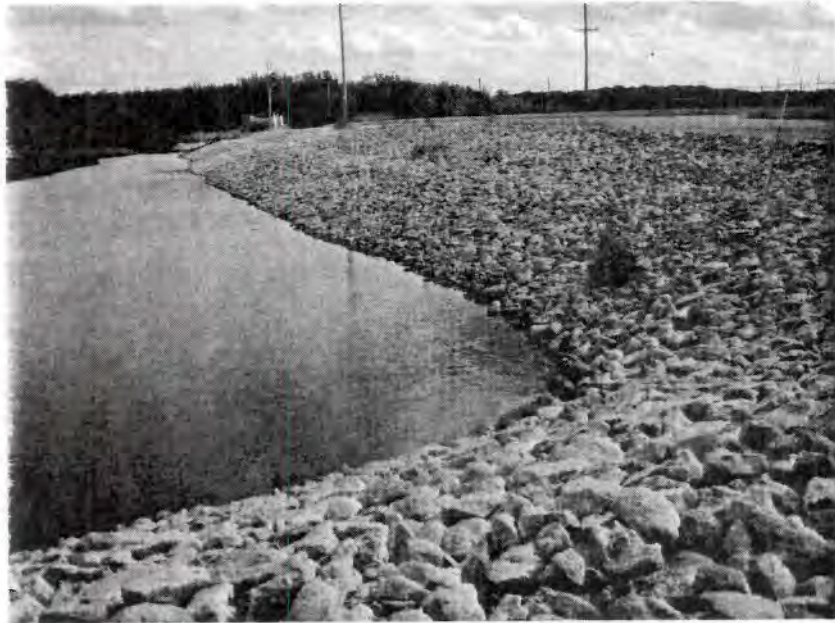
Neither erosion nor uncontrolled seepage was observed along the groins or abutments. Groin slopes and abutments are protected with the same rip rap cover as the adjoining slopes. Figures 5.2.4-1 and 5.2.4-2 show typical conditions observed at the groins and abutments.

Rip rap had been recently added and appeared in good condition.

Figure 5.2.4-1: Photo of Interior Groin at Northwest Corner of Impoundment. Note that the dike in upper right hand corner also serves as the flood prevention dike for the plant.

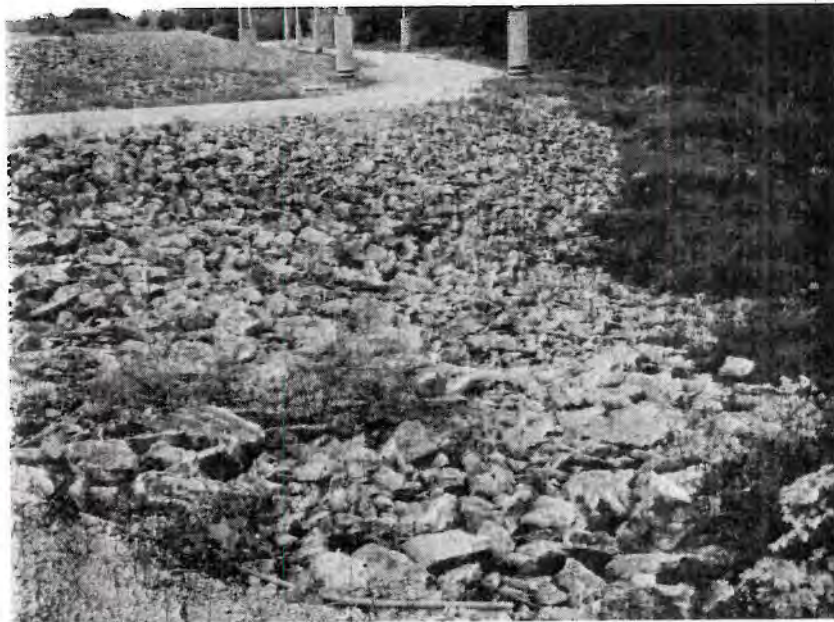
Figure 5.2.4-2: Photo of Exterior Groin at Northwest Corner of Impoundment. Note that the dike in upper left hand corner also serves as the flood prevention dike for the plant.

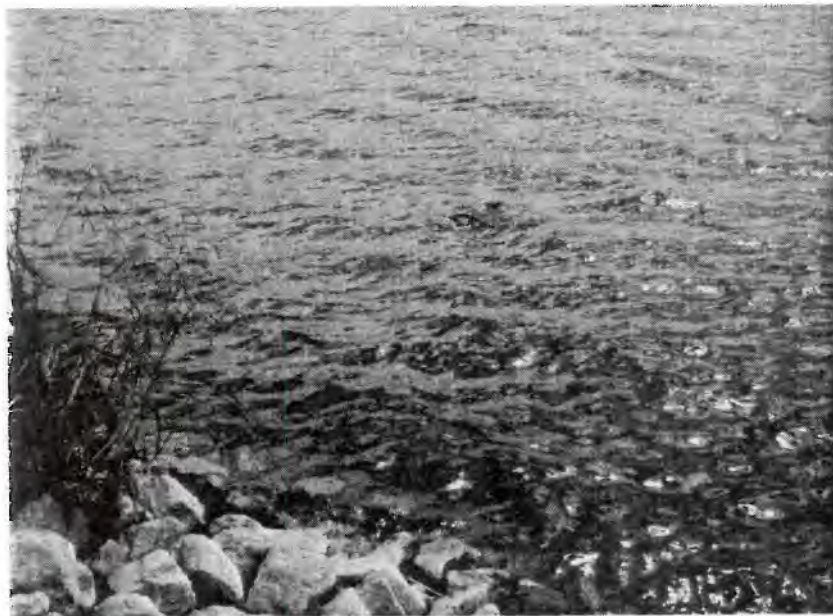
Figure 5.3.1-1: Photo of Mechanical Gate on Discharge Pipe in Interior of Ash Pond

The original design included a 30-inch mid-depth discharge pipe regulated with a mechanical gate. The purpose of this pipe was to permit inflow into the pond in case of flooding to help stabilize the embankments during construction and prior to operational start-up. This pipe has reportedly been closed since construction of the pond was completed. When the mechanical gate started leaking, plant management decided to close this pipe using an inflatable balloon system. However, a small amount of leakage was observed from this pipe during the site visit, raising questions regarding the reliability of these closure mechanisms.

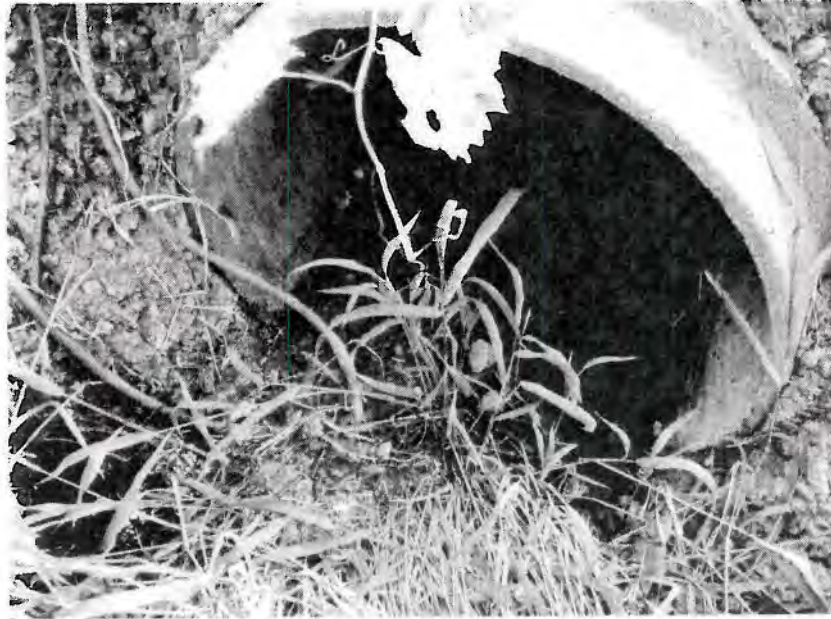
Minor ~~seepage~~ was occurring <sup>through a balloon plug located in</sup> the 30" reinforced concrete outlet. This outlet is equipped with both a manual valve system and an inflatable balloon system. The observed leakage ~~raises questions about the overall reliability of these closure mechanisms.~~ See recommendations in Section 1.2.5. *requires corrective action.*

However, as shown in Figure 5.3.1-2, a small amount of ~~discharge was~~ ~~observed leaking from~~ the outlet at the time of the site visit. The pipe's invert elevation is 751.5ft. The purpose and current condition of this structure is discussed further in Section 4.2.2.

Figure 5.3.2-2: Photo of Drainage at Exterior End of 30" Discharge Pipe

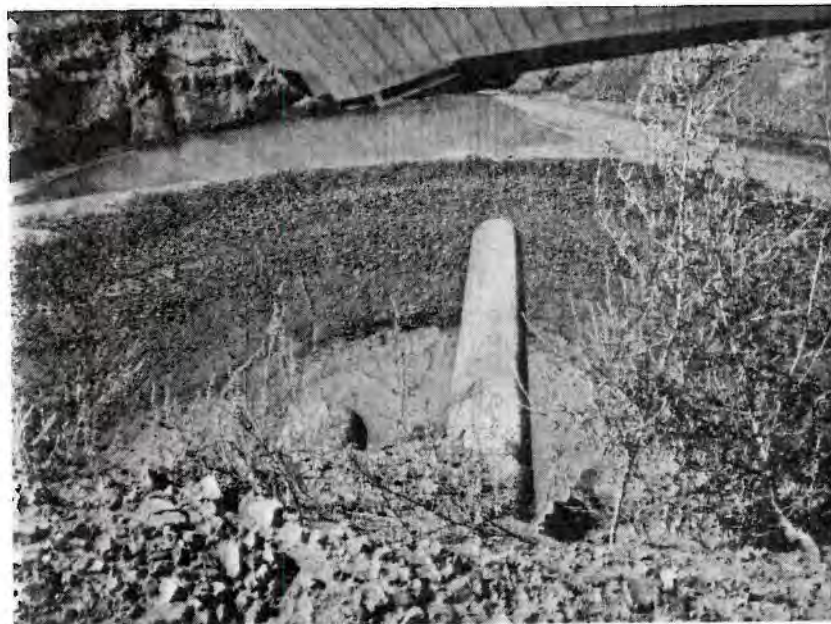
Figure 5.3.2-1: Photo of Bottom Ash Discharging into Ash Pond.

Two 10" ductile iron pipes discharge bottom ash into the south section of the bottom ash settling pond, see Figure 5.3.2-1.

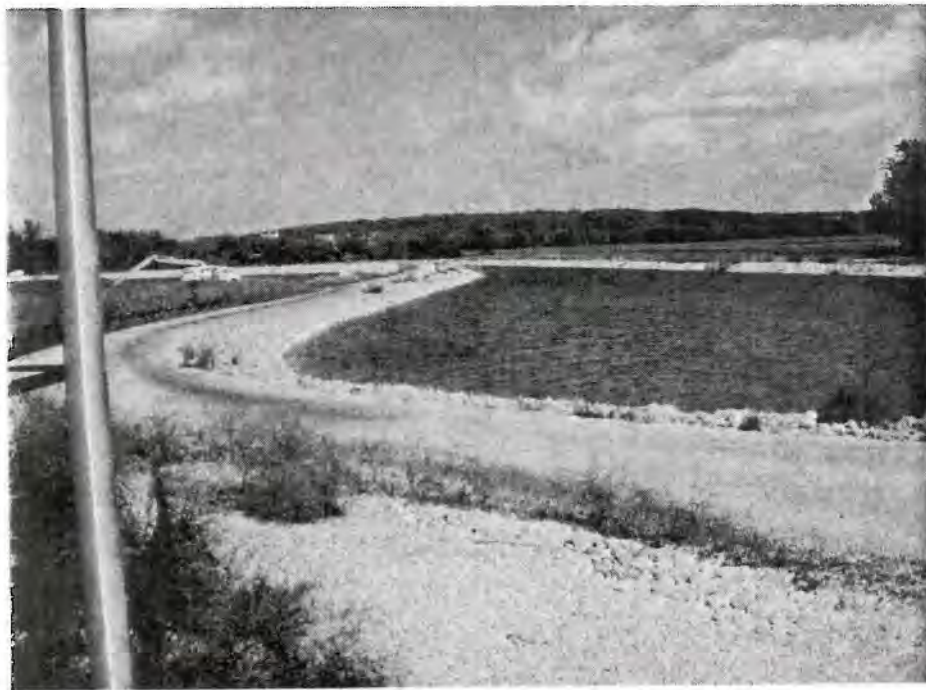
Figure 8.1-1: Photo of dike dividing ash pond from clear water pond.

The facility is operated for the settlement and storage of wet bottom ash. Coal combustion waste process water discharges into the west side of the north cell, which is separated from the south section by an earthen dike. The north side of the impoundment is the primary sedimentation area. Decant water flows by gravity to the southeast section of the impoundment through a pipe in the dividing dike. Figure 8.1-1 shows the dividing dike.
