Comments on Draft Report on Kentucky Utilities – Green River Station

**Re: Kentucky Utilities' Comments on  
*DRAFT Report of Geotechnical Investigation Dam Safety Assessment of Coal Combustion Surface  
Impoundments Kentucky Utilities, a Subsidiary of E.ON U.S. Green River Station, Central City, Kentucky***

***Report of Geotechnical Exploration and Slope Stability Analyses  
Kentucky Utilities (KU) Green River Power Station  
No. 2 Pond/Coal Pile Runoff Pond and Scrubber Pond  
South Carrollton, Muhlenberg County, Kentucky***

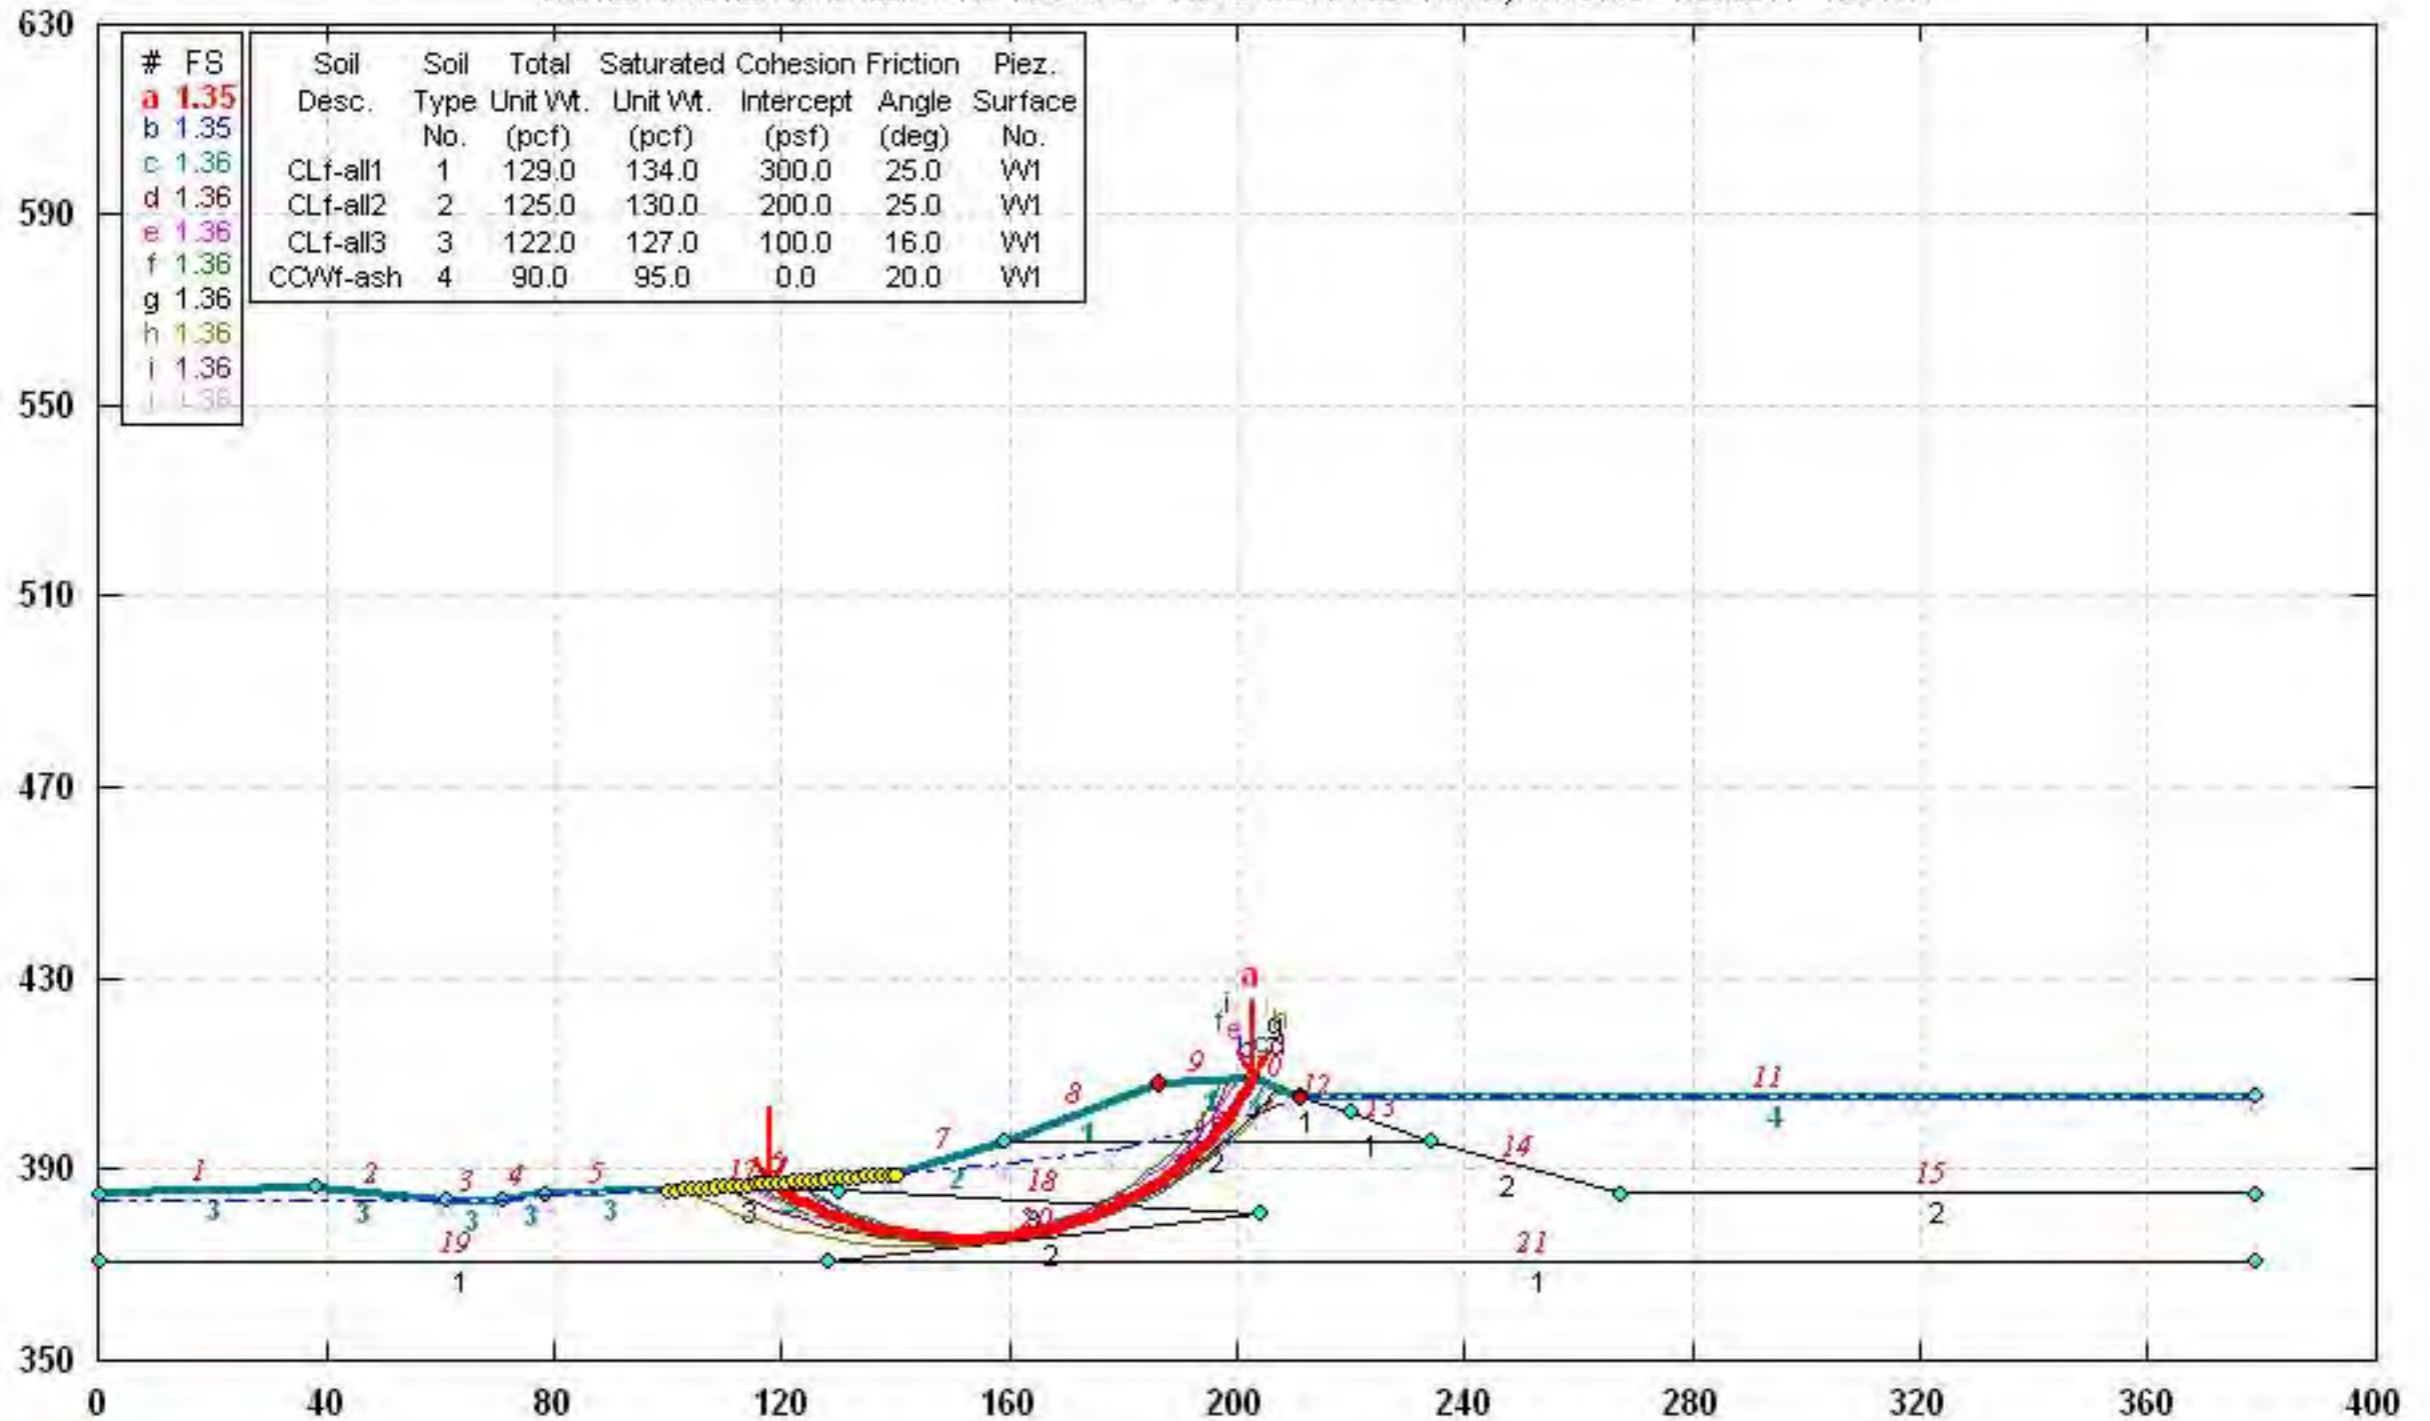
Slope stability analyses showed factors of safety below KY DEP recommended values at a cross section 1 of the Coal Pile Runoff Pond and a cross section 5 of the Ash Treatment Basin #2. These analyses concluded that the impoundment slopes are stable under steady-state conditions and did not conclude there was a safety concern.

For cross section 1 of the Coal Pile Runoff Pond, the downstream model for the steady-state/maximum surcharge pool conditions indicated a theoretical minimum FS of 1.4. Theoretical factors of safety above 1.0 indicate a stable slope under modeled conditions; therefore, the slopes are currently stable and should not be expected to fail under normal operating conditions. KU is currently evaluating the results of the analysis and plans to study options to improve the section if necessary to increase the factor of safety above KY DEP recommended values.

STABL6H FSmin=1.35  
 Safety Factors Are Calculated By The Modified Bishop Method

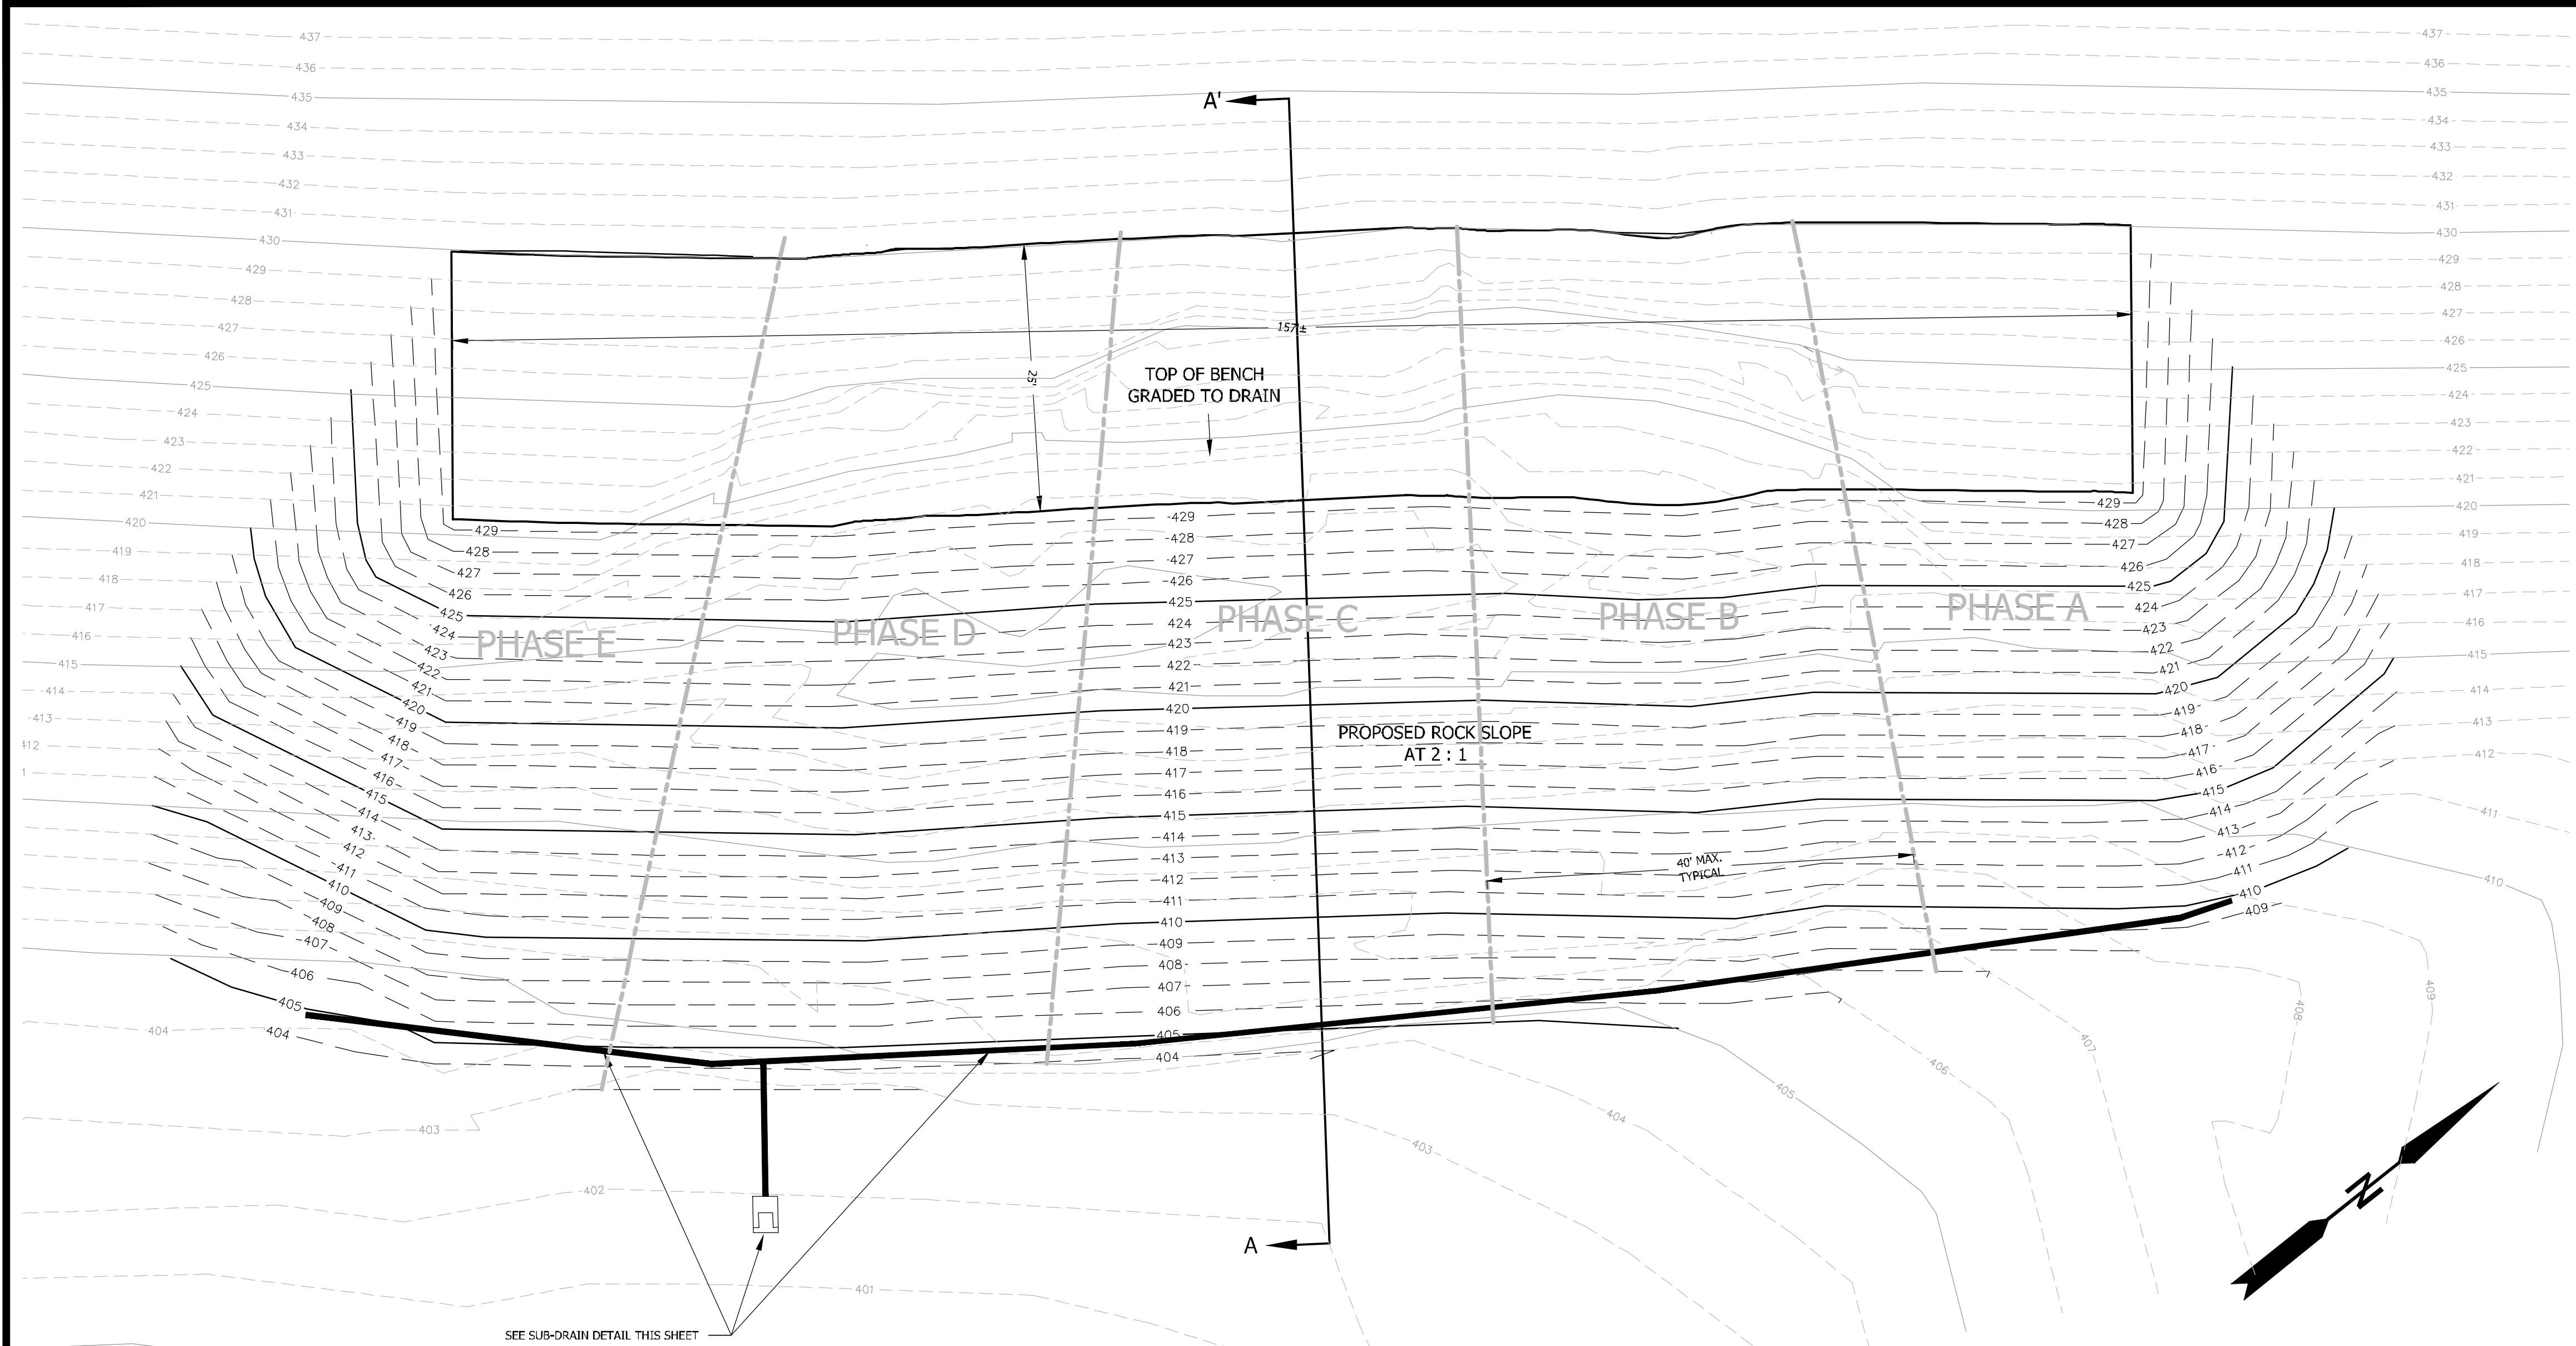
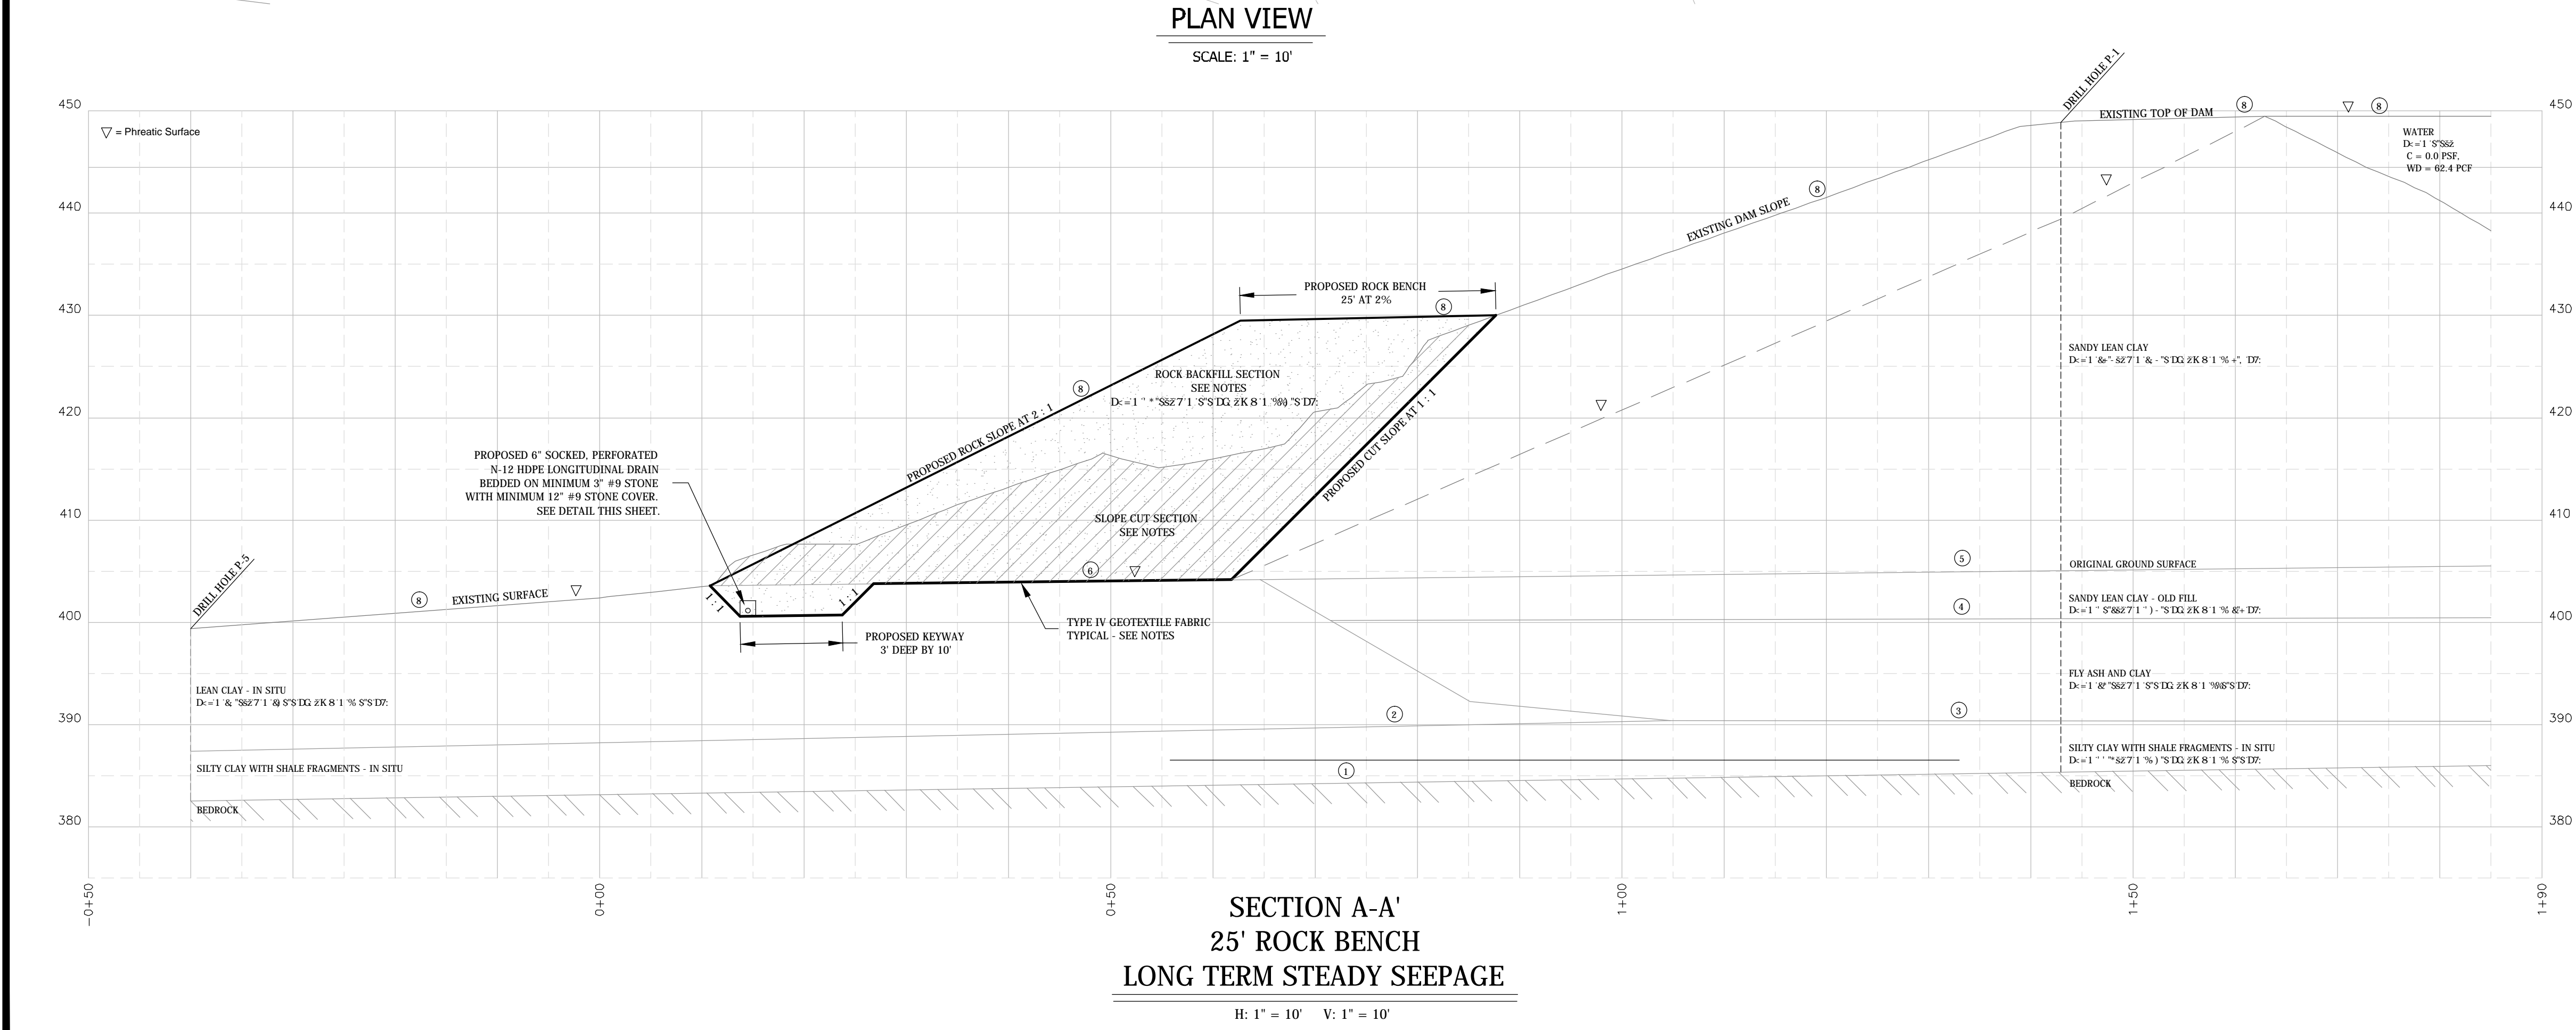
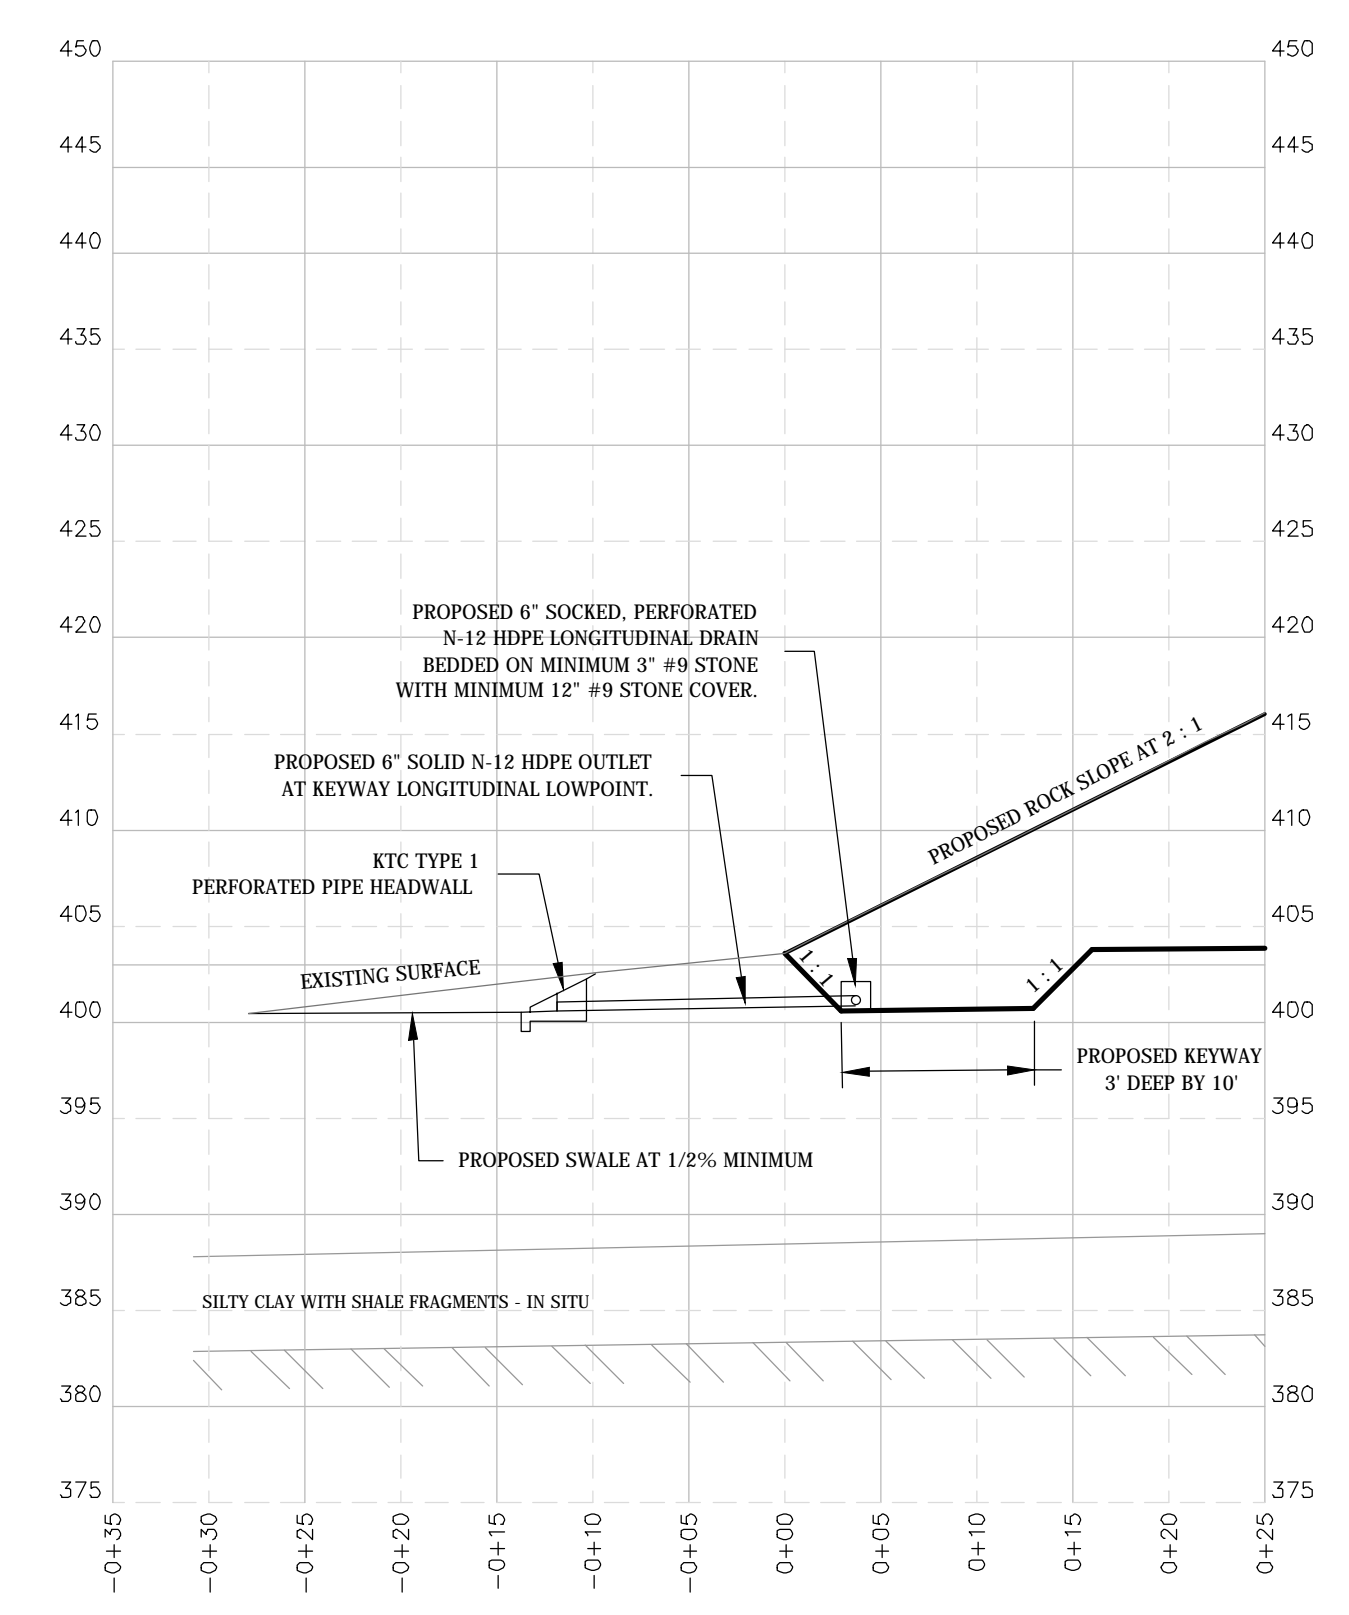
**EON U.S. GREEN RIVER STATION**  
**MAIN ASH POND**  
**SLOPE REPAIR PLAN**

KU Note: The Green River Ash Treatment Basin #1 slope failures were shallow, maintenance type sloughs, commonly associated with earthen dams. KU promptly took action to repair these areas. Qualified KU staff routinely monitors these areas and the repairs have continued to perform satisfactorily.

Place Geotextile Fabric, Type Iv On Excavated Soil Area Meeting The Requirements Of Section 843, Type Iv, Of The Current Edition Of Kentucky Dot, Standard Specifications For Road And Bridge Construction. Install Geotextile Fabric According To Section 214 Of The Standard Specifications For Road And Bridge Construction. Prepare The Surface To A Smooth Condition, Free Of Obstructions, Debris, Or Sharp Objects That May Puncture The Fabric. Place The Fabric Smooth And Free Of Tension, Stress, Folds, Wrinkles, Or Creases. Do Not Operate Equipment Directly On The Fabric. Overlap Strips At Least 18 Inches. Place Transverse Laps So The Upslope Strip Laps Over The Downslope Strip. Install Fastener Pins Through Both Strips Of Overlapped Fabric At No Less Than 5-foot Intervals Along A Line Through The Midpoint Of The Overlap, And At Any Other Locations As Necessary To Prevent Any Slippage Of The Fabric. Place Fabric With The Long Dimension Parallel To The Long Dimension Of The Section To Be Covered.

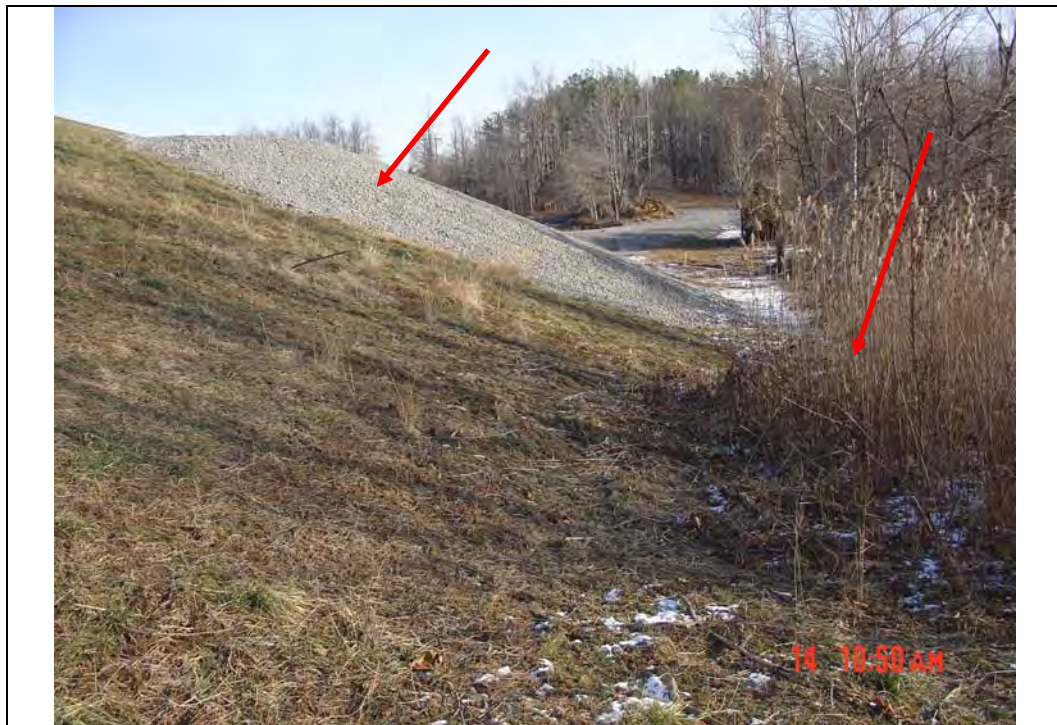
Photo #11: Toe of south exterior slope, looking NE

Note: Recently installed rock toe berm and observed tall vegetation at toe

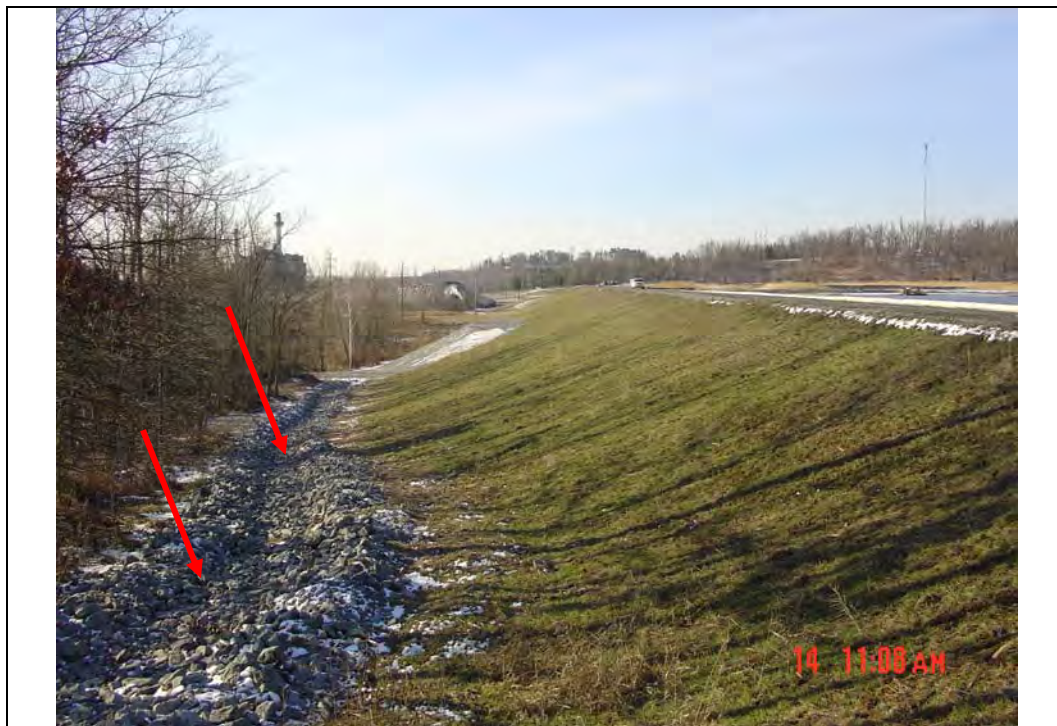
Photo #12: East end of south embankment, exterior slope, looking south

Note: Rock groin ditch recently installed along toe

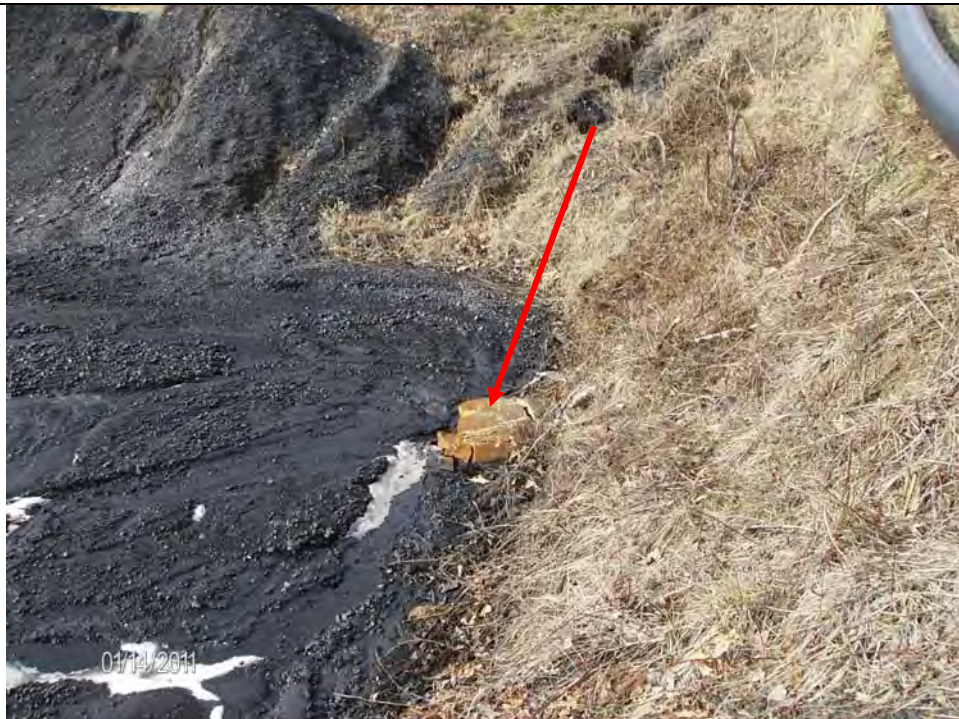
Photo #14: Repair concrete culvert inlet at toe near west end of south embankment, looking NW

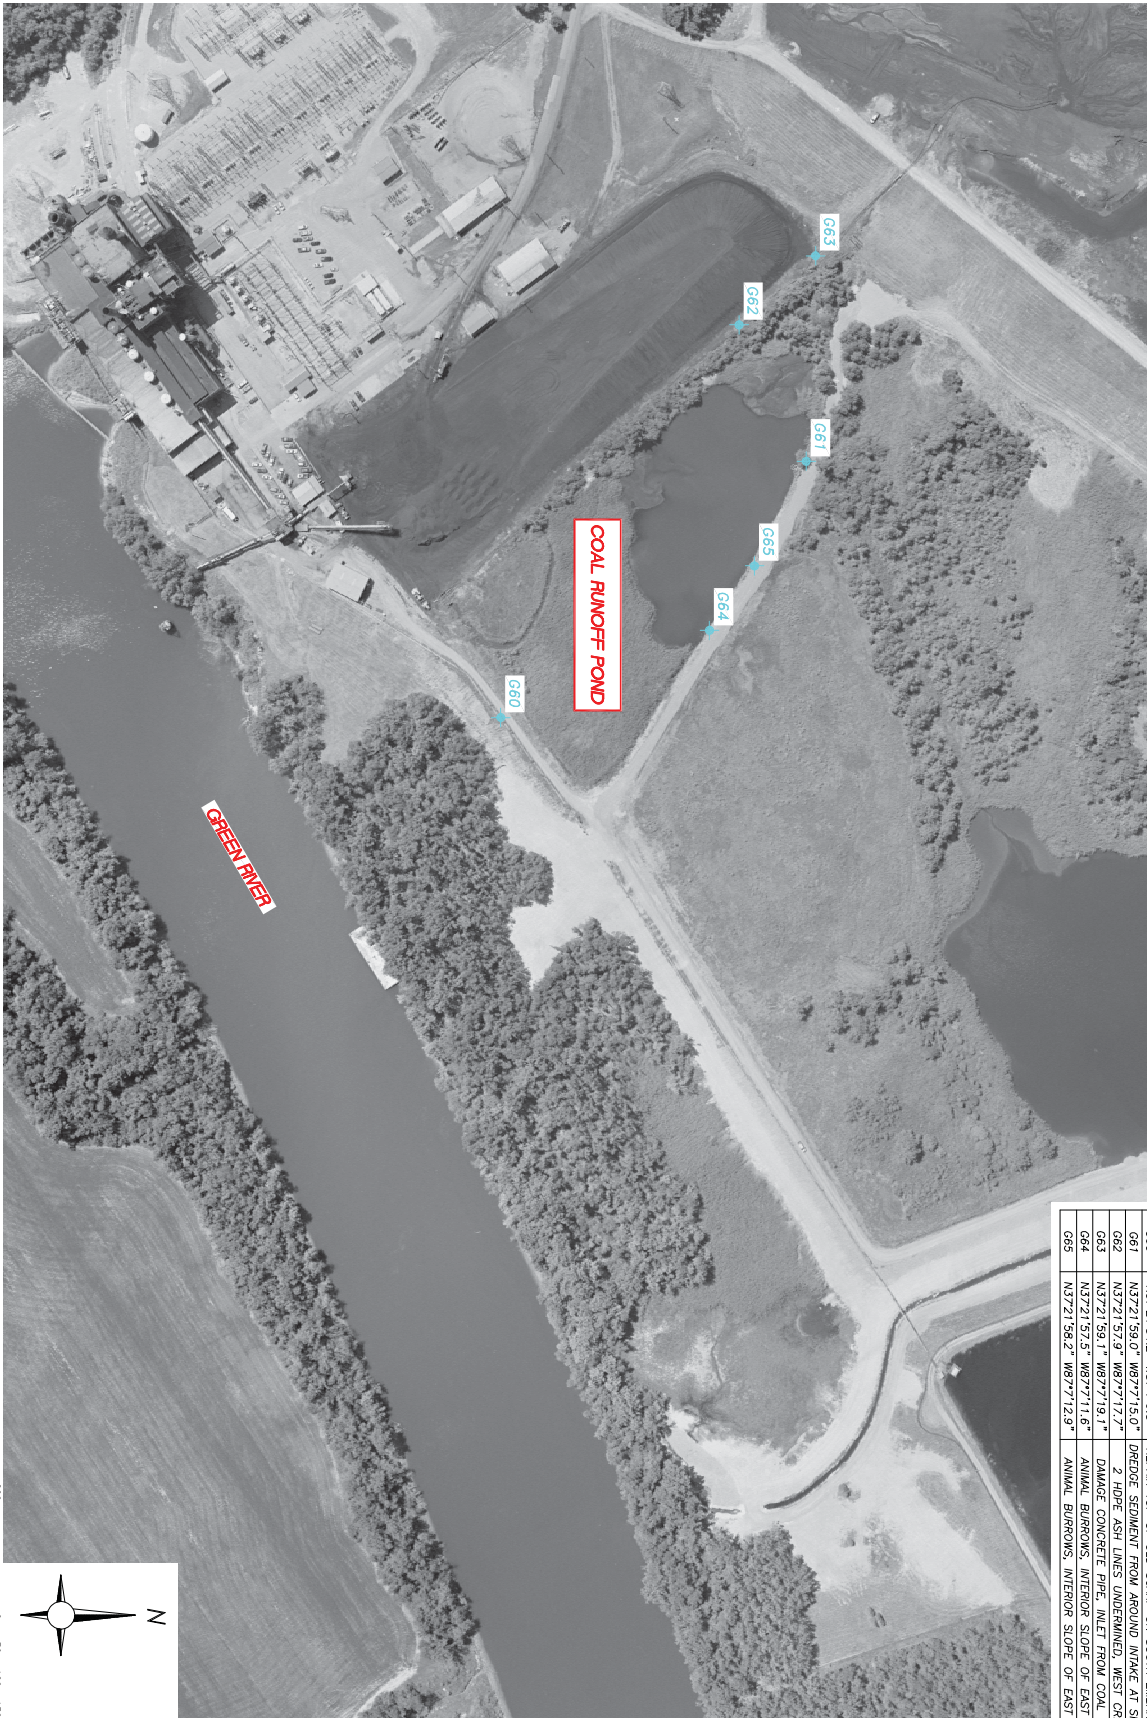
GPS PT.	COORDINATES	DESCRIPTION
G60	N37°21'54.2" W87°7'9.8"	REPAIR TOP OF OLD SCARP ON SOUTH EMBANKMENT
G61	N37°21'59.0" W87°7'15.0"	DREDGE SEDIMENT FROM AROUND INTAKE AT SPILLWAY
G62	N37°21'57.9" W87°7'17.7"	2 HOPE ASH LINES UNDERMINED, WEST CREST
G63	N37°21'59.1" W87°7'19.1"	DAMAGE CONCRETE PIPE INLET FROM COAL YARD
G64	N37°21'57.5" W87°7'11.6"	ANIMAL BURROWS, INTERIOR SLOPE OF EAST EMB.
G65	N37°21'58.2" W87°7'12.9"	ANIMAL BURROWS, INTERIOR SLOPE OF EAST EMB.
