Report of Geotechnical Investigation
Dam Safety Assessment of Coal Combustion
Surface Impoundments
Kentucky Utilities, a Subsidiary of E.ON U.S.
Pineville Generating Station, Pineville, KY

AMEC Project No. 3-2106-0177.0003

September 2010

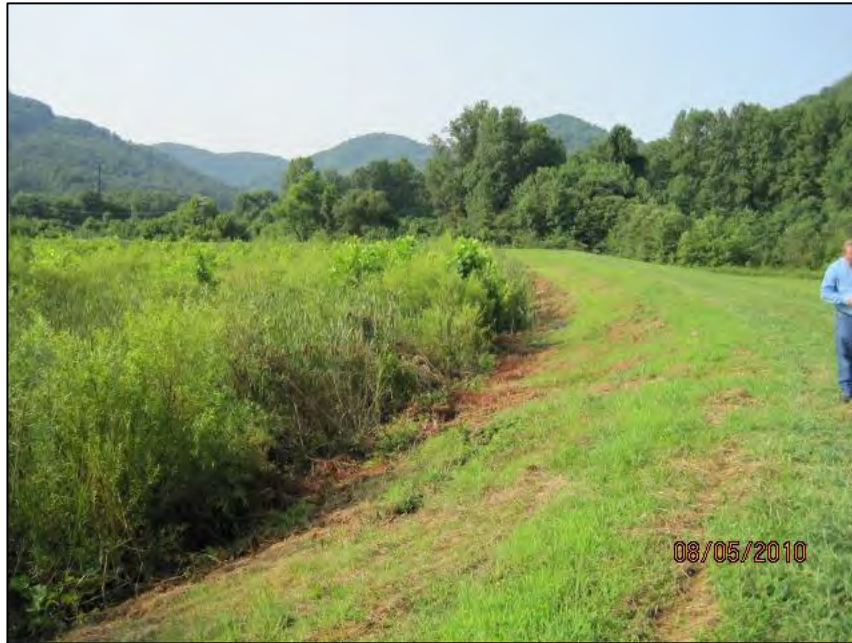
1-1
SOUTHWEST INTERIOR SLOPE AND CREST

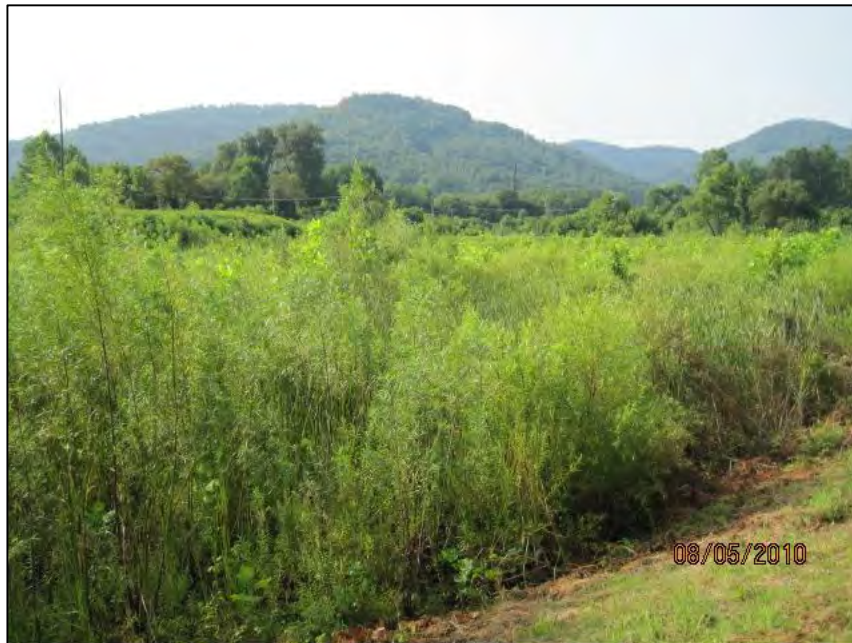
1-2
FROM SOUTHWEST DIKE LOOKING SOUTHEAST AT POND INTERIOR

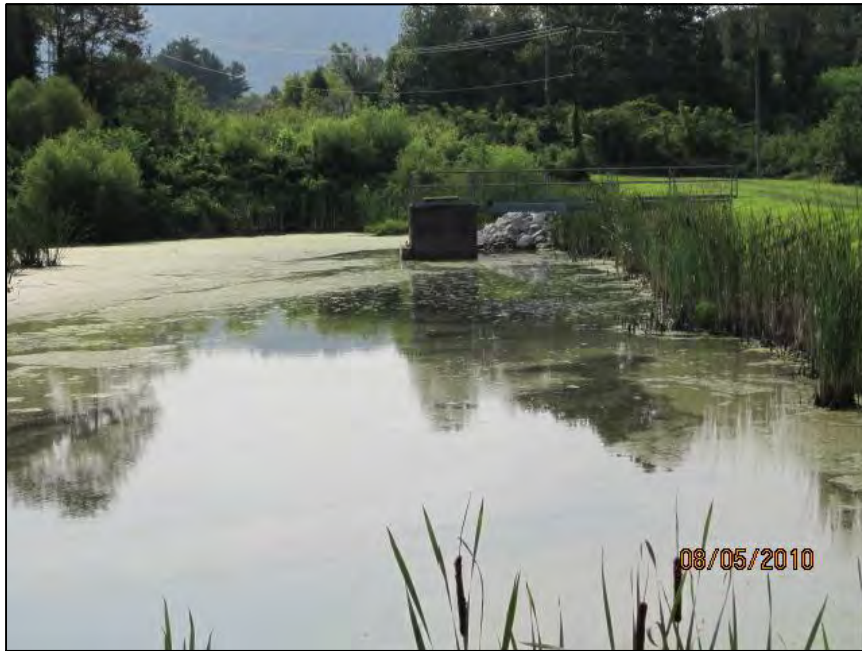
1-3

FROM SOUTHWEST DIKE LOOKING EAST TOWARDS OUTLET STRUCTURE

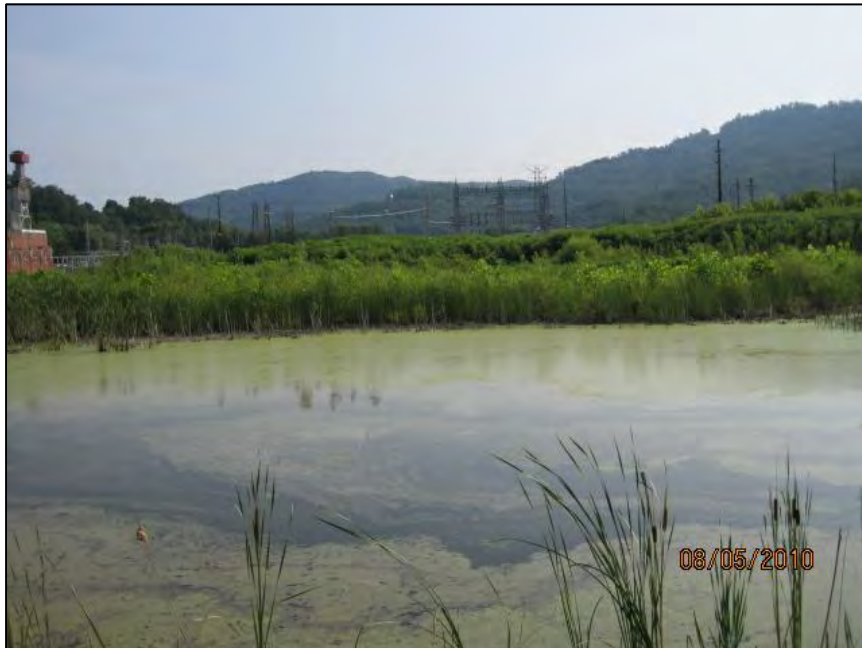
1-4

FROM SOUTH DIKE LOOKING NORTH TOWARDS SUBSTATION

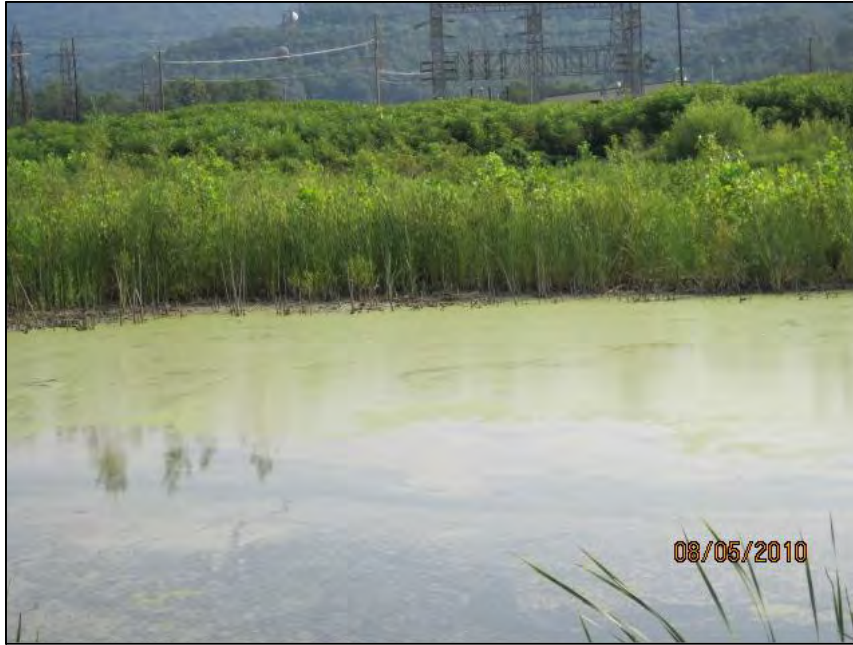
1-5

FROM SOUTH DIKE LOOKING EAST TOWARDS SUBSTATION

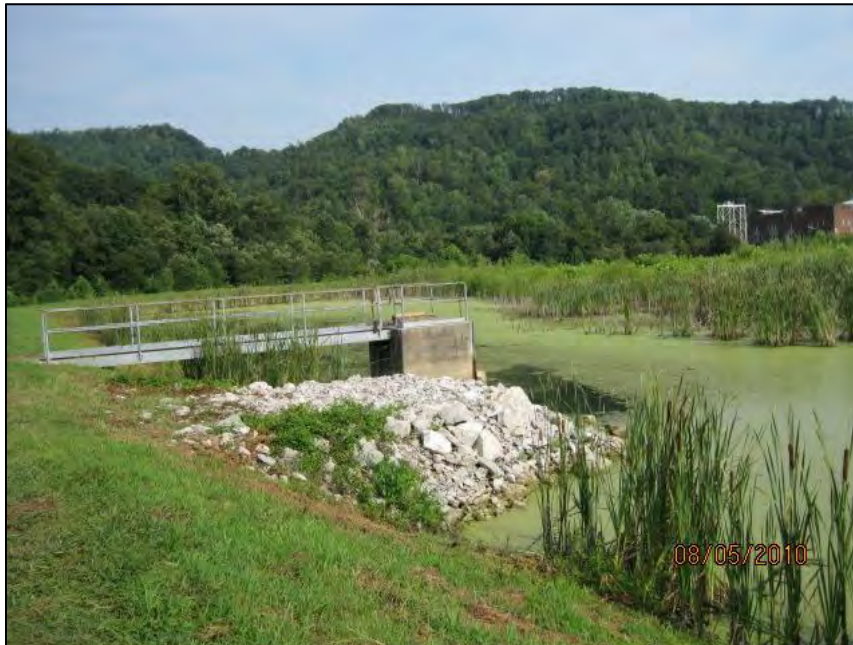
1-6

FROM EAST END OF SOUTH DIKE LOOKING NORTHWEST TOWARDS OUTLET STRUCTURE

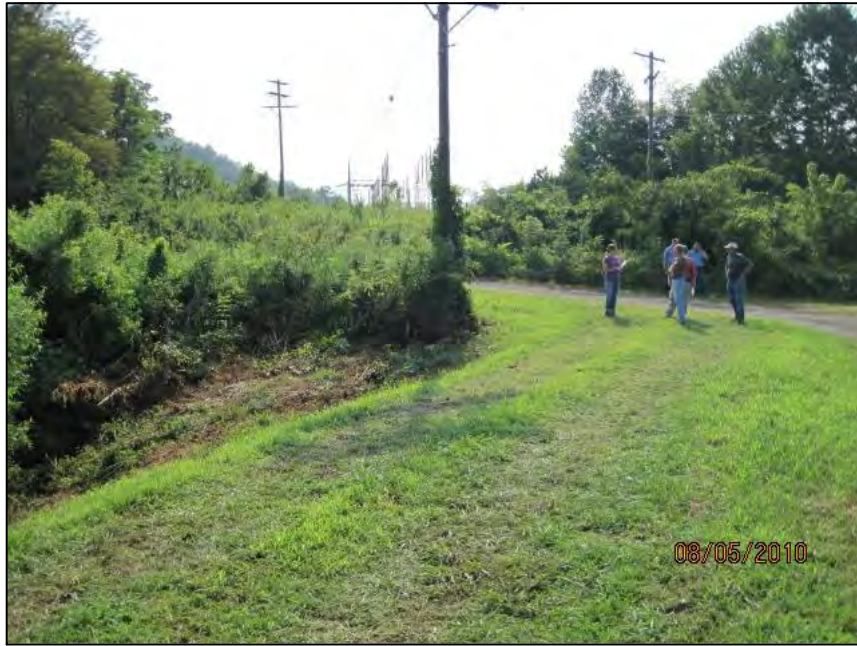
1-7

LOOKING EAST AT TIE-IN TO ORIGINAL GROUND AT SOUTHEAST CORNER

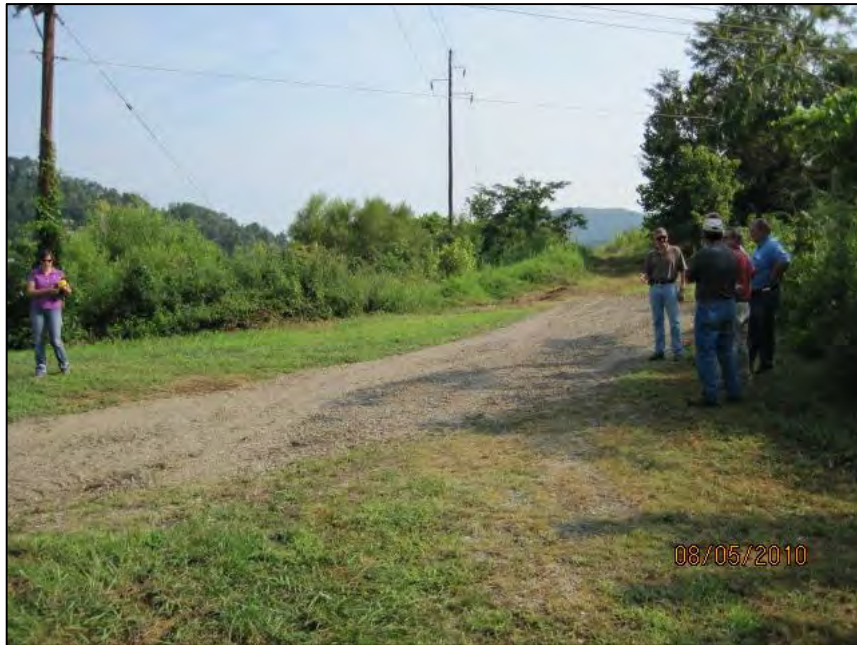
1-8

LOOKING NORTH AT SOUTHEAST CORNER

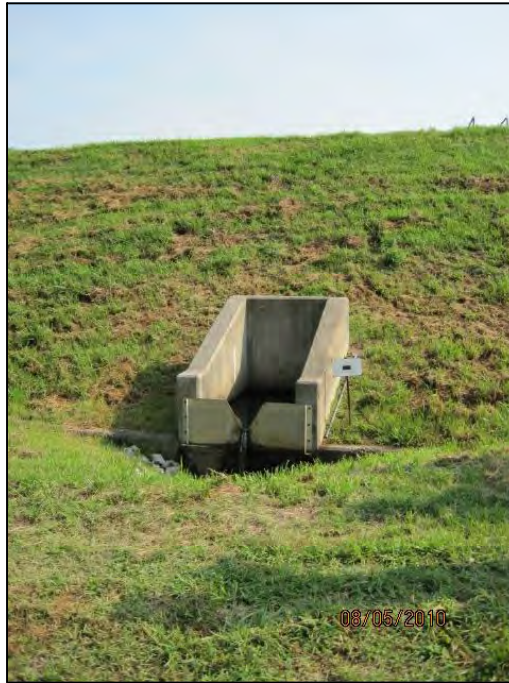
1-9

POND OUTLET AND KPDES OUTFALL 001 AT TOE OF SOUTH DIKE

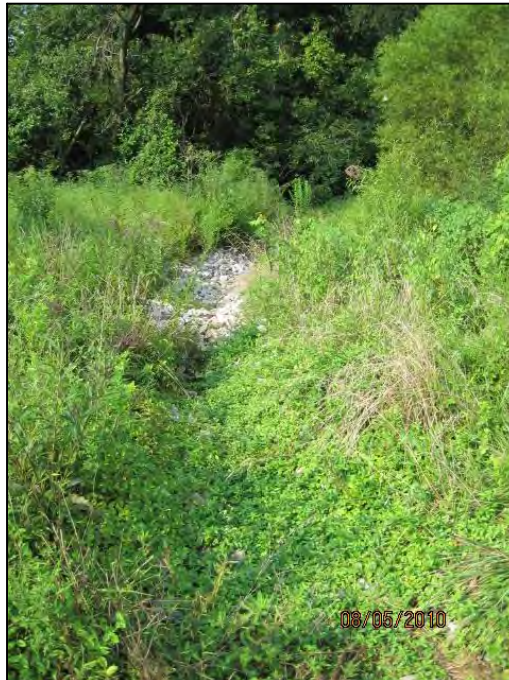
1-10

LOOKING SOUTH AT DRAINAGE CHANNEL FROM OUTFALL TO CUMBERLAND RIVER

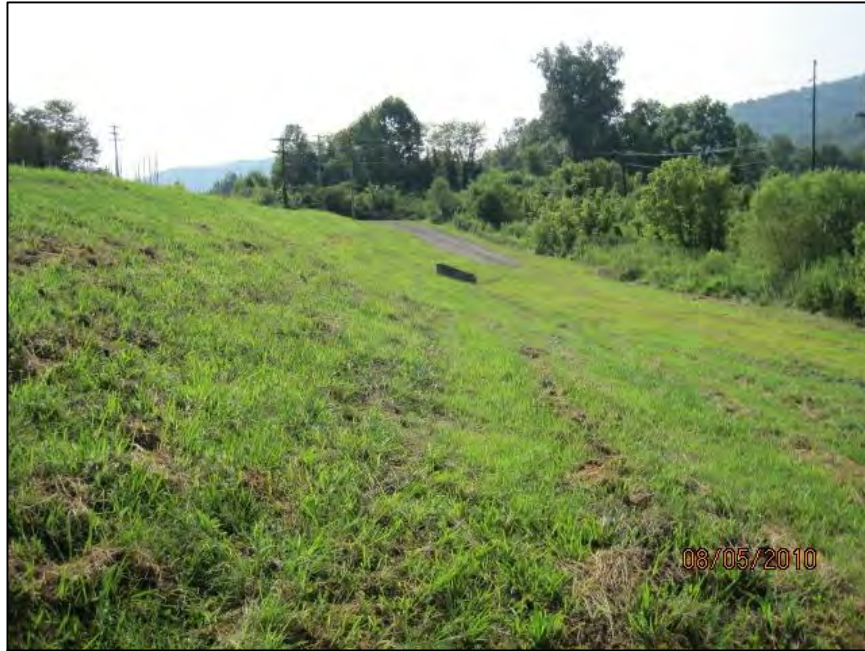
The Ash Pond has a side-hill configuration consisting of two constructed embankments along the south and west pond limits. A freeboard of approximately 6 feet between the top of ash and top of dike was observed during the site visit (photos 1-1 and 1-6). The crest and dikes (upstream and downstream) of the dam are primarily surfaced with grass (photos 1-1, 1-7, and 1-11 through 1-14). Vegetation was observed along the pond interior at the north and central sections of the pond (photos 1-1, 1-2, 1-4, 1-14 and 1-15). Vegetation along the interior slopes of the south end of the pond was noticeably less dense (photo 1-6). KU personnel reported they had used farm machinery on the higher central and north sections of the pond in 2009 to cut the vegetation. Two small repaired animal burrow areas were observed on the upstream slope of the south dike (photo 1-6). Uneven slopes were observed on the downstream slopes from the west half of the south dike extending around the southwest corner to the south end of the west dike (photos 1-11 and 1-12).

LOOKING EAST AT SOUTH DIKE DOWNSTREAM SLOPE

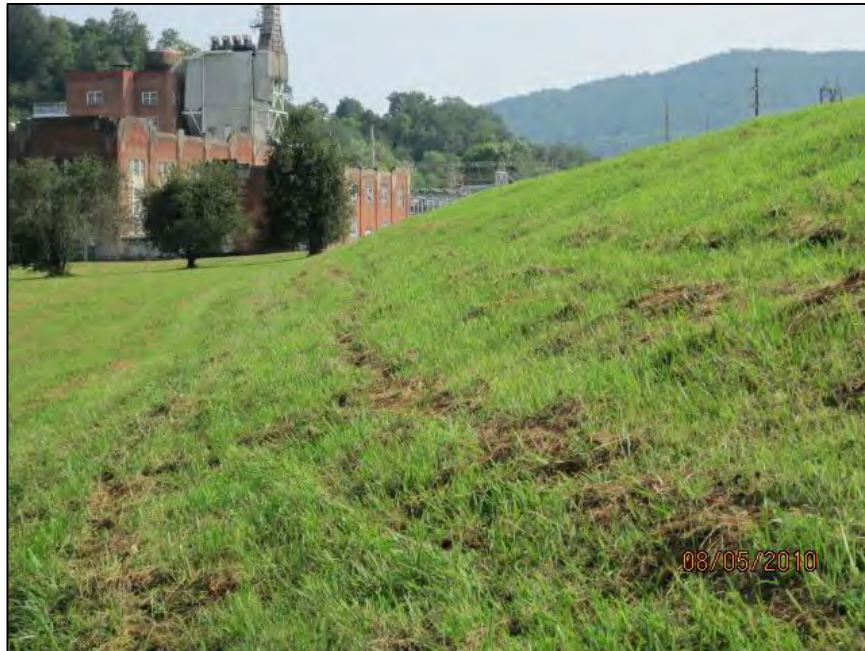
1-12

LOOKING NORTH AT SOUTHWEST DOWNSTREAM SLOPE

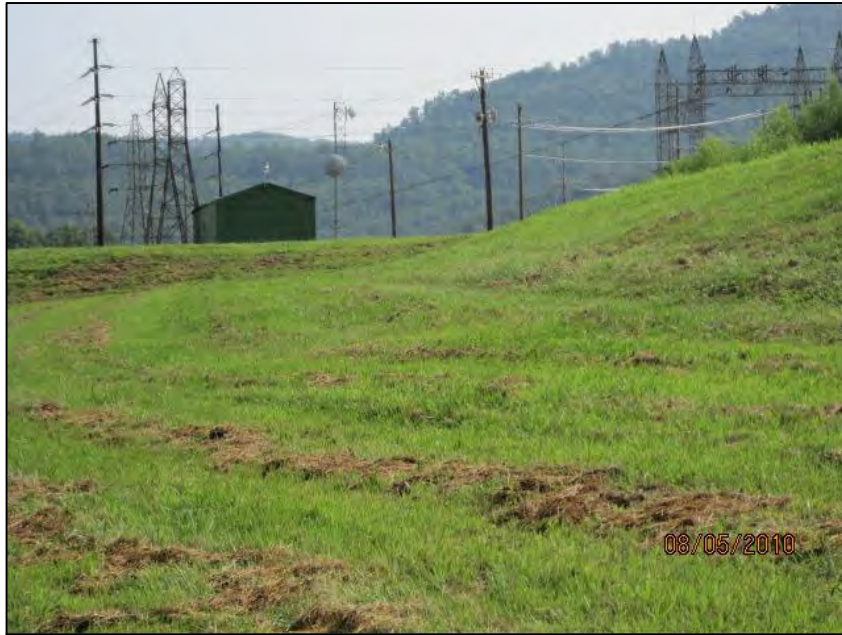
1-13

LOOKING NORTHEAST AT UPPER SECTION OF WEST DIKE, TIE-IN TO ORIGINAL GROUND

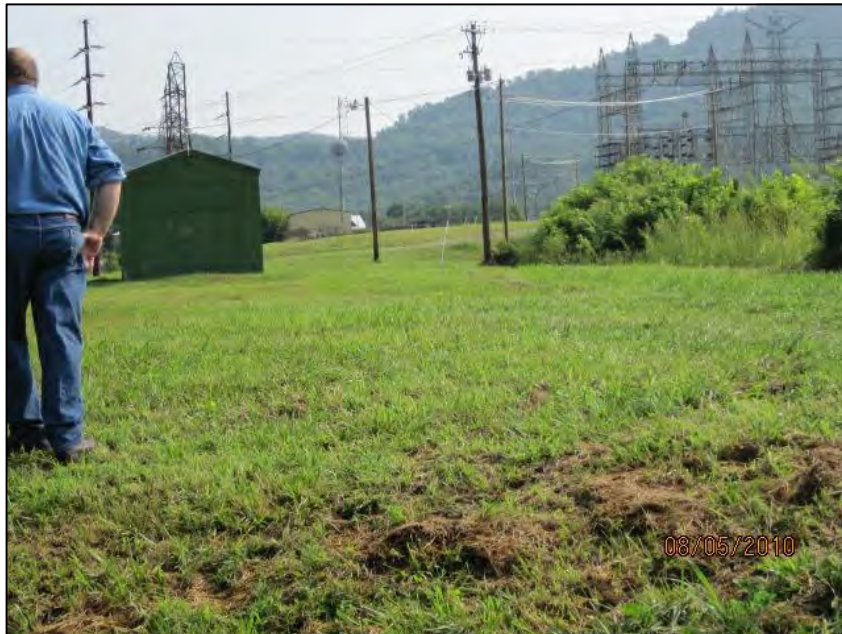
1-14

LOOKING NORTHEAST AT WEST CORNER OF NORTH SIDE OF POND

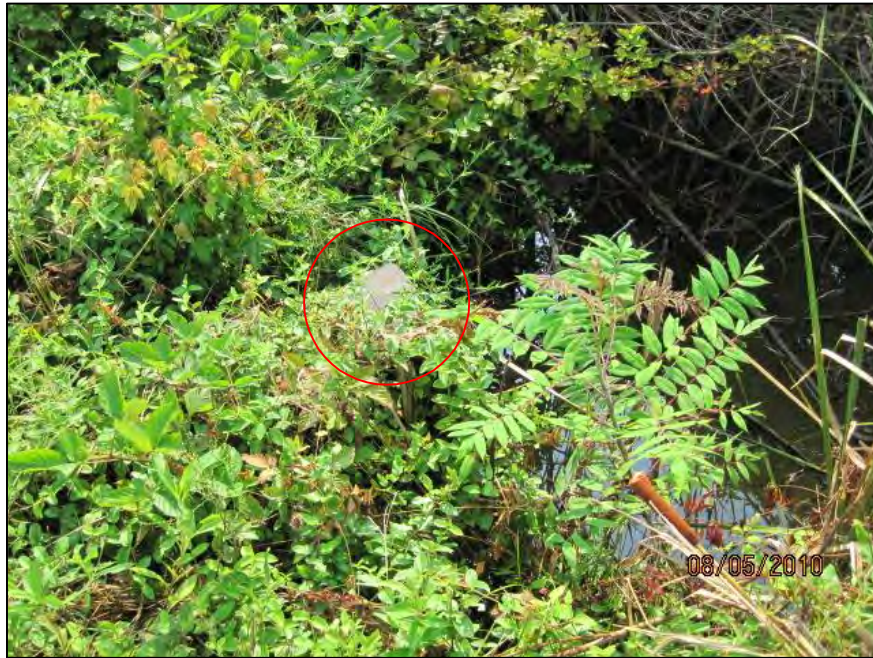
1-15

POND INLET NEAR WEST CORNER OF NORTH SIDE OF POND
